RE: Administrative Order; Docket Number: CWA-06-2025-1736  
NPDES Permit Number: NM0028827

### FINDINGS OF VIOLATION AND COMPLIANCE ORDER

Docket Number: CWA-06-2025-1736; NPDES Permit Number: NM0028827

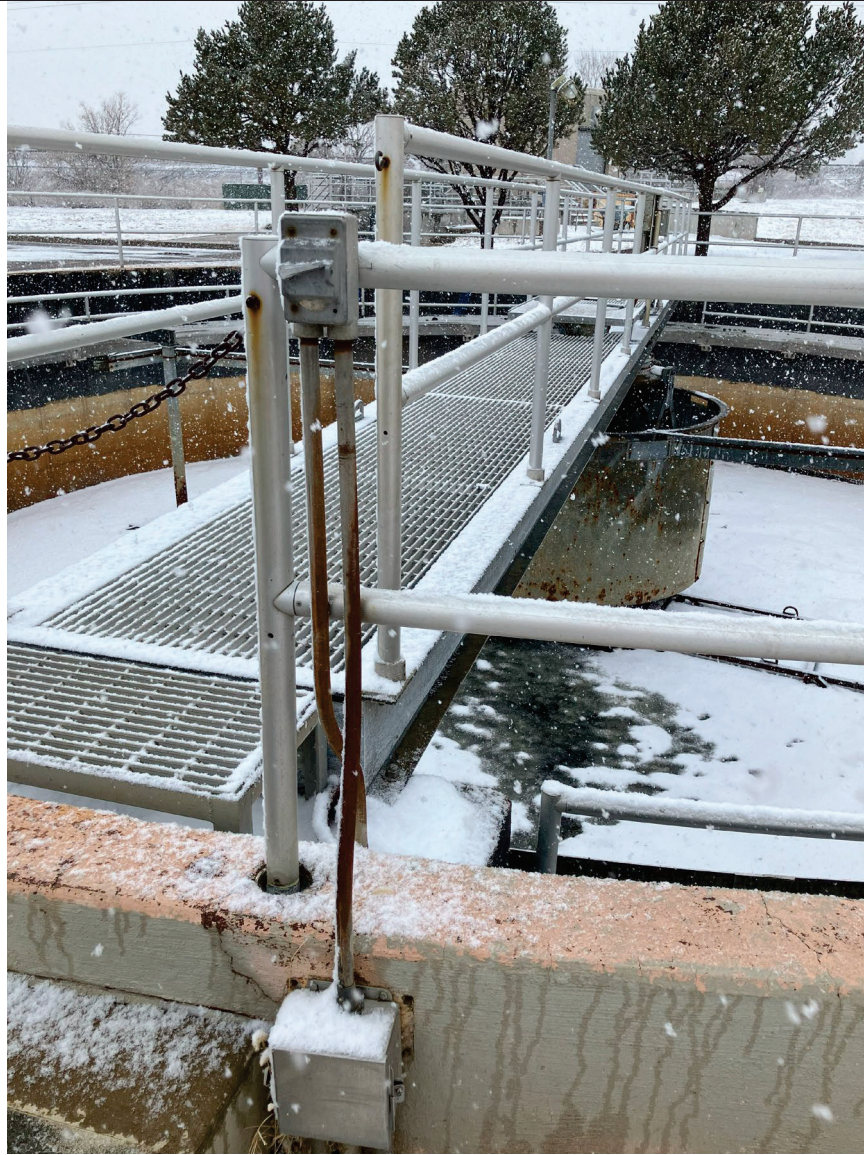
| Photographer: Nafis Fuad | File Name: IMG_0676 | Date: 01/13/2025 |

We observed the decommissioned primary clarifiers had wastewater in them. Rober Espinoza explained that due to the pump being taken offline when those clarifiers were decommissioned, when the facility is hydraulically overloaded, the primary clarifiers receive wastewater which are then pumped to the digester directly, bypassing the treatment system. Robert Espinoza informed us that the pumps are still housed and can be brought into operation.

Decommissioned primary clarifier accumulating wastewater during hydraulic overloading. Refer to AOC #5.

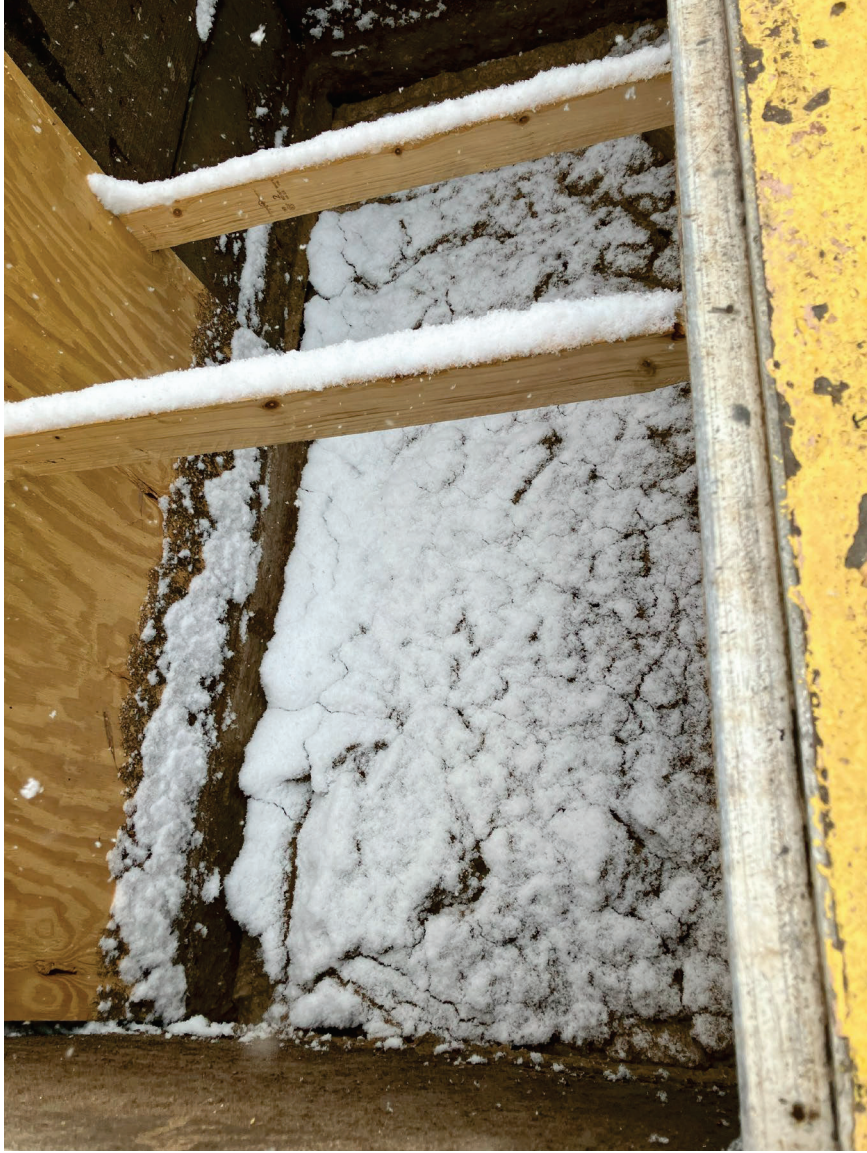
| Photographer: Nafis Fuad | File Name: IMG_0679 | Date: 01/13/2025 | |

| Flow box with device to block overflow into the decommissioned racetrack aeration basin. | | | |

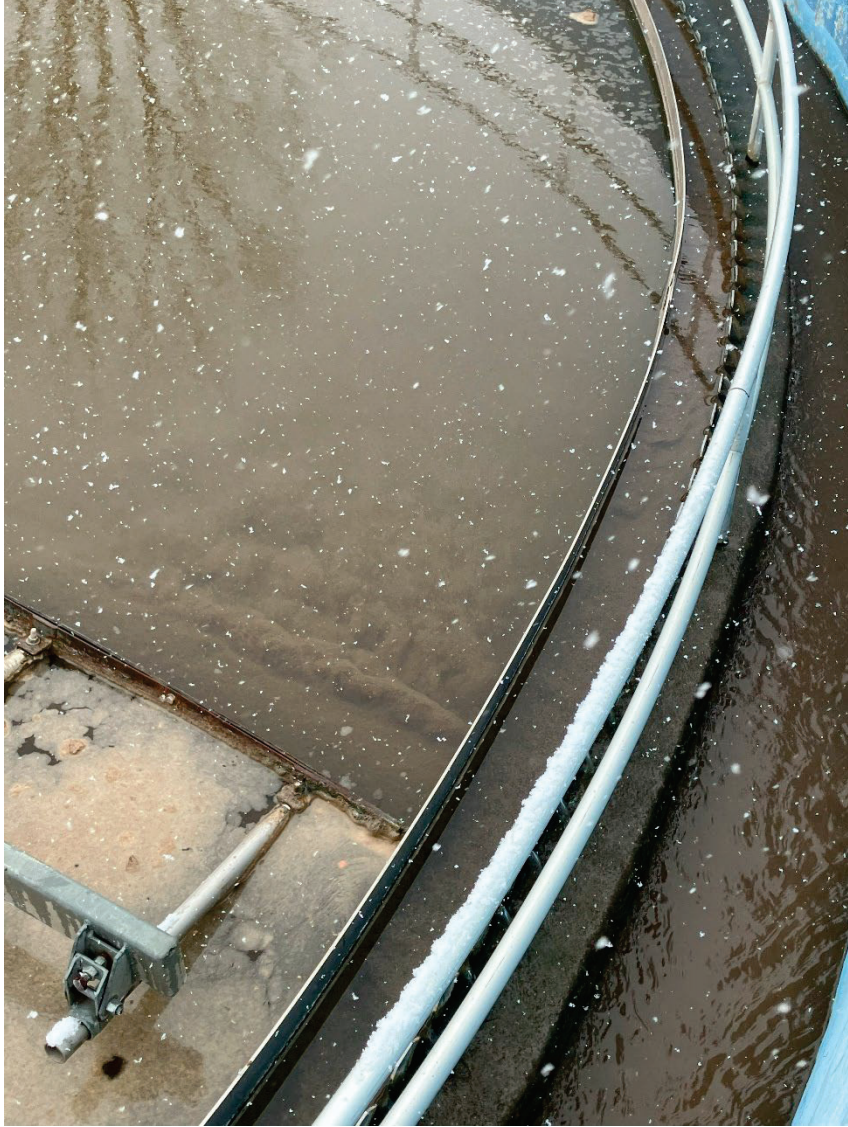
| Photographer: Nafis Fuad | File Name: IMG_0690 | Date: 01/13/2025 | |

During the inspection we observed another overflow of solids from the overflowing clarifier being discharged into the Gallinas River through the outfall 001 at around 2:45 pm. We observed the east clarifier to overflow solids. Robert Espinoza explained the difficulty the facility is facing to adequately distribute flow to the east and west clarifier. Per the follow-up on-site training and technical assistance report (Appendix 6), approximately 2/3 of the flow is diverted to the east clarifier. That report also identified that the sludge blanket in the east clarifier is only a few feet below the surface by mid-morning, suggesting the hydraulic overload is affecting this clarifier more adversely. The report identified replacing the secondary clarifier splitter box to be a possible solution to remediate this issue.

| Unsettled solids in the east clarifier. | | | |

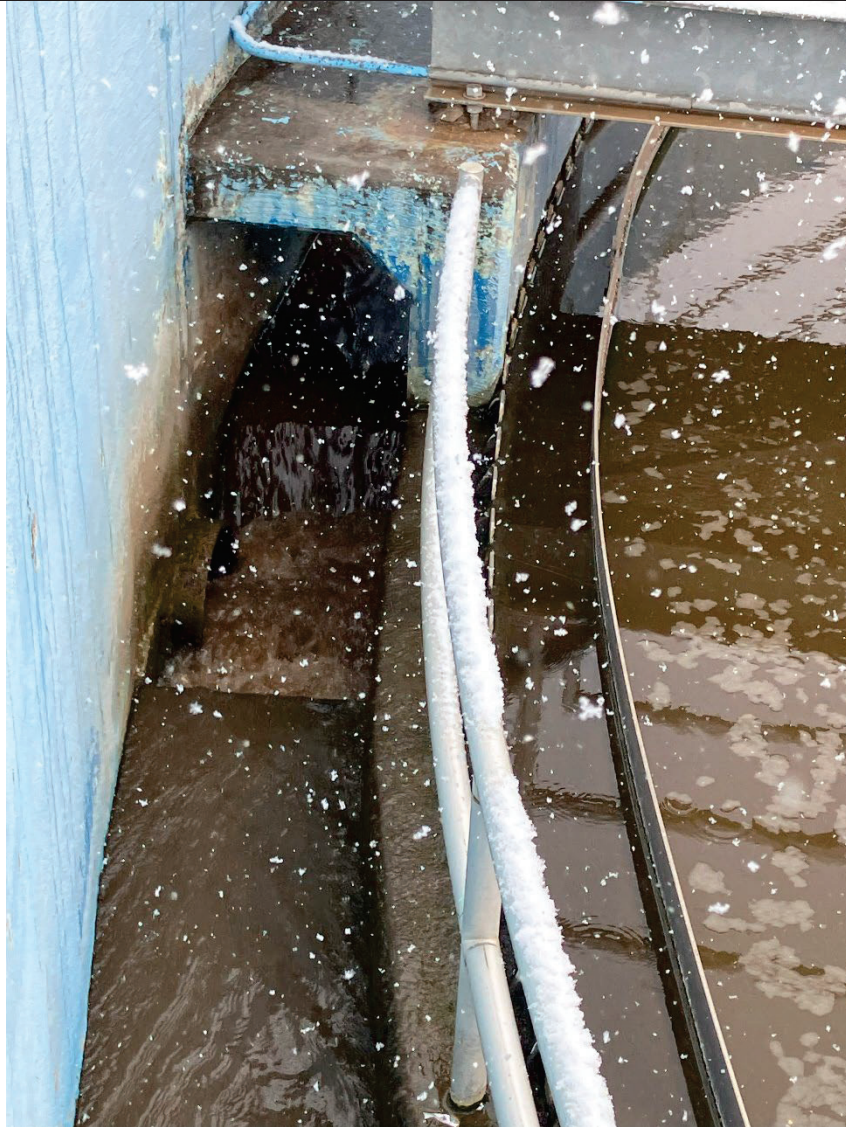
| Photographer: Nafis Fuad | File Name: IMG_0687 | Date: 01/13/2025 | |

Unsettled solids overflowing with the effluent from the east secondary clarifier.

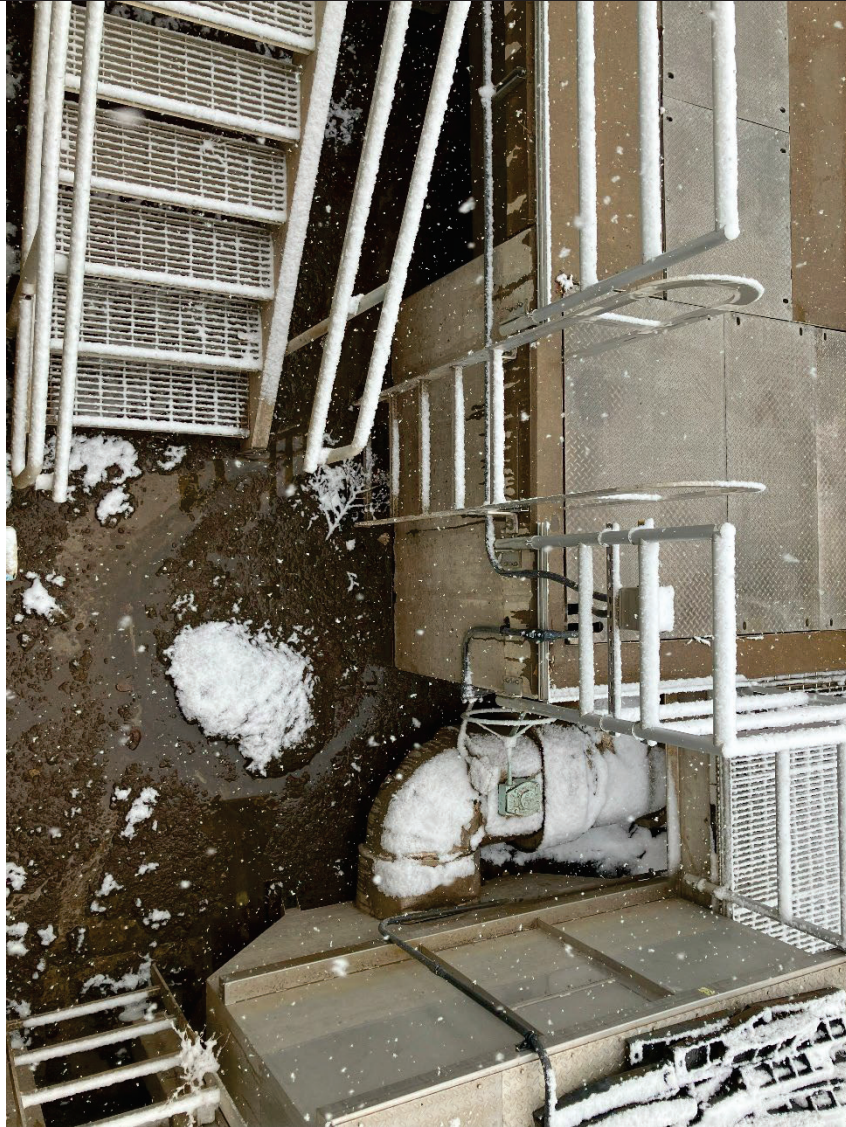
| Photographer: Nafis Fuad | File Name: IMG_0692 | Date: 01/13/2025 | |

We also observed overflowing solids into the UV housing during the overflow event. The facility informed us that after the overflow events the facility cleans the UV housing. We observed the proper placement of flow measurement device. We confirmed that the secondary flow measuring device is not compared to confirming the reading to be 10% of the primary weir. We observed solids in the effluent at the primary effluent flow measurement device, the weir. We observed the laboratory technician, Alyssa Chavez, and the laboratory uncertified staff taking sample of the effluent during the discharge event. We observed the autosampler (Global Water WS700) used to collect composite samples, stationed next to the sampling location did not have any thermometer to monitor the sample temperature.

Solids in the UV channel and disc filter housing during the overflow event.

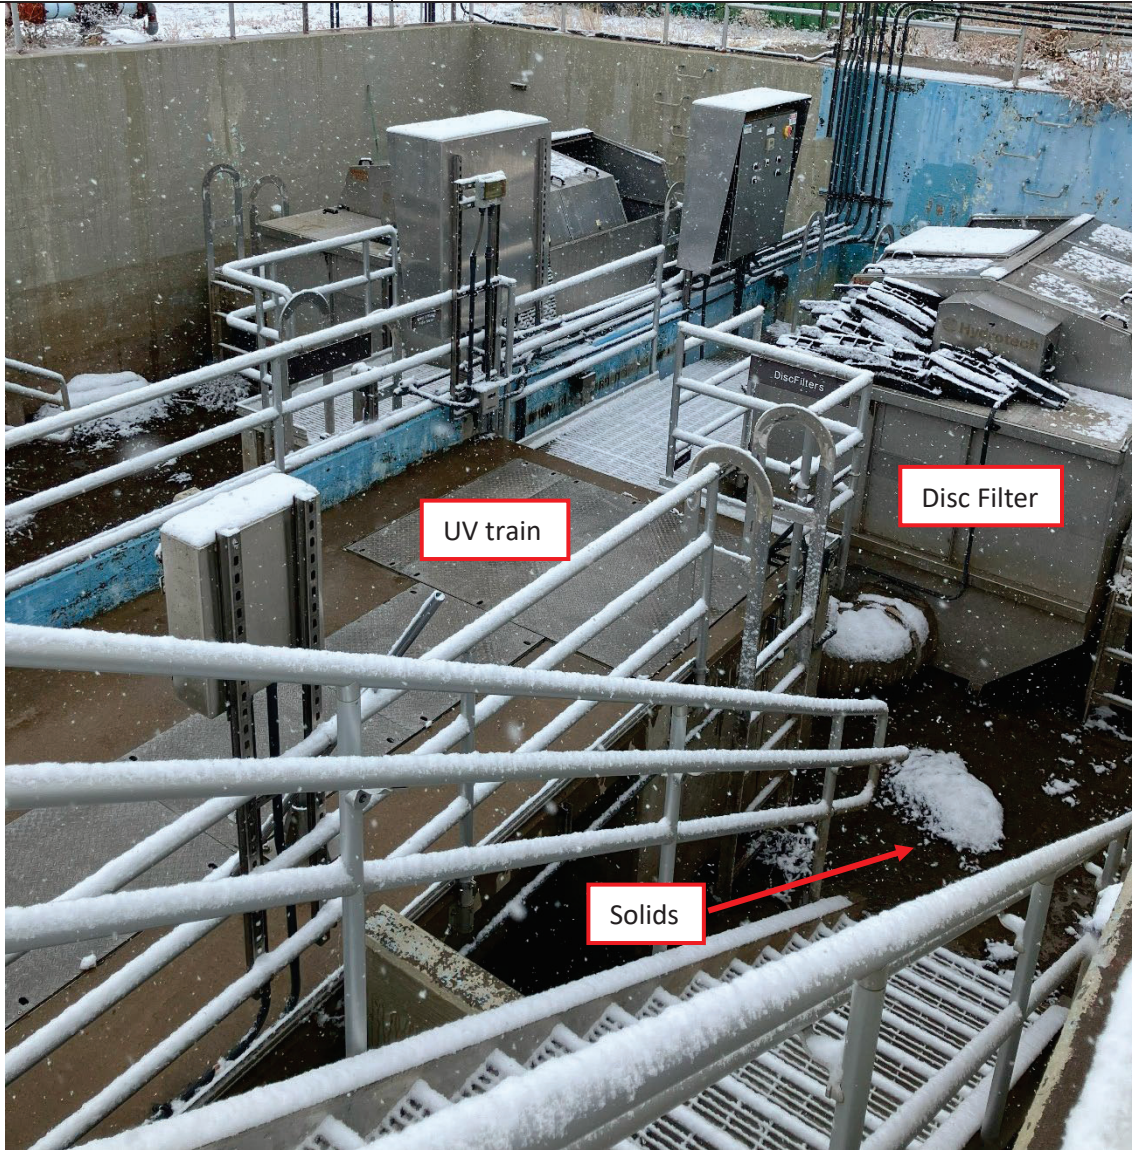
| Photographer: Nafis Fuad | File Name: IMG_0694 | Date: 01/13/2025 | |

Solids in the UV channel and disk filter housing during the overflow event.

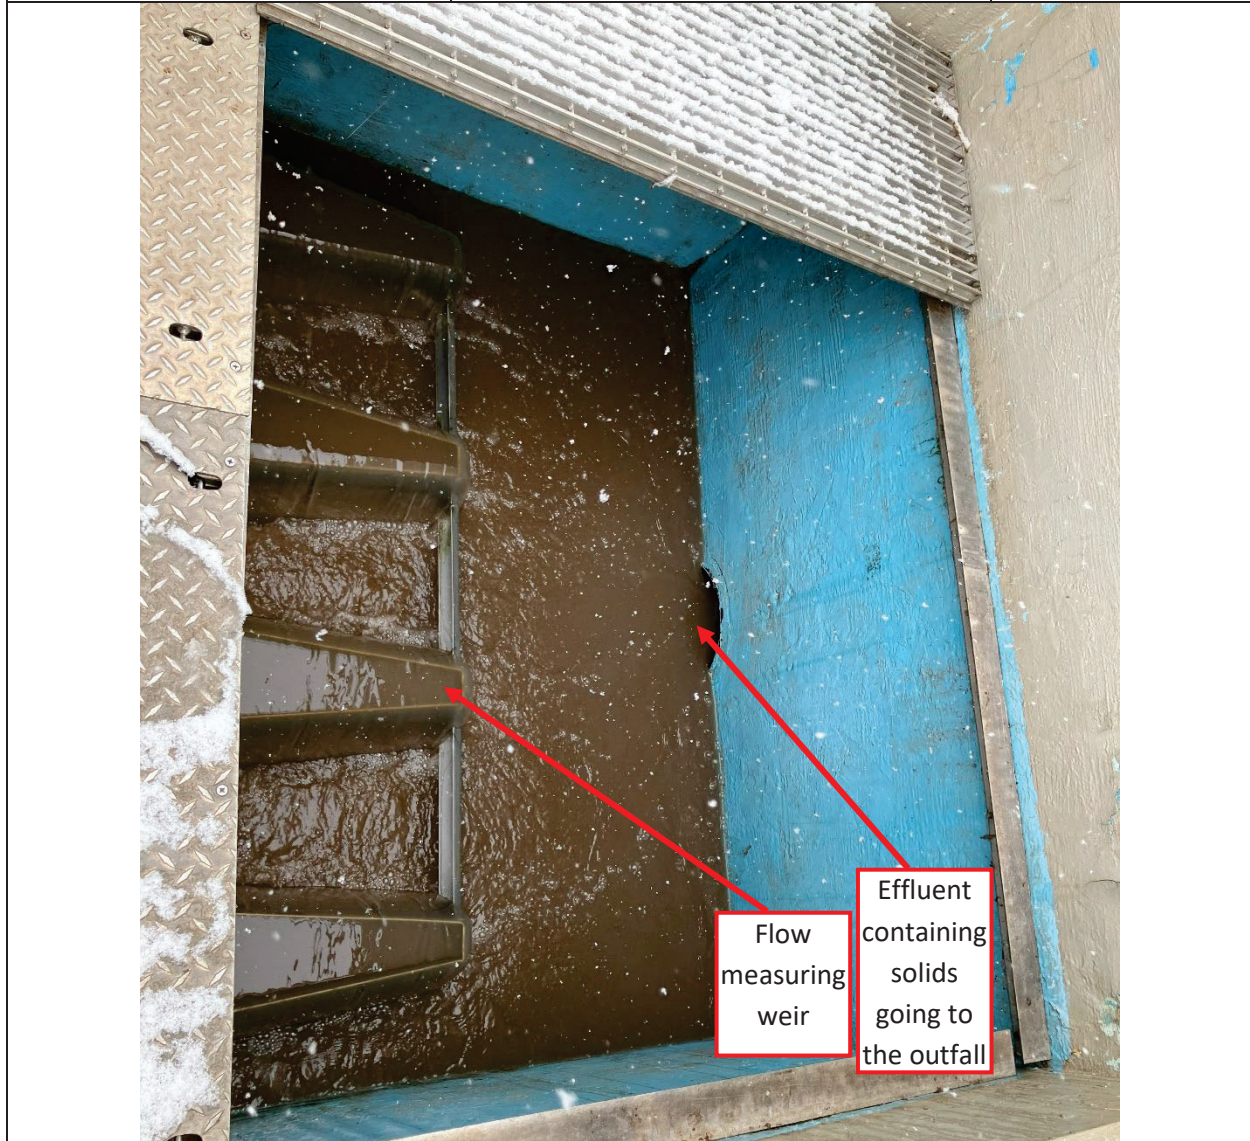
| Photographer: Nafis Fuad | File Name: IMG_0695 | Date: 01/13/2025 |

Solids in the flow measuring device, which is also the sampling location for monitoring requirements.

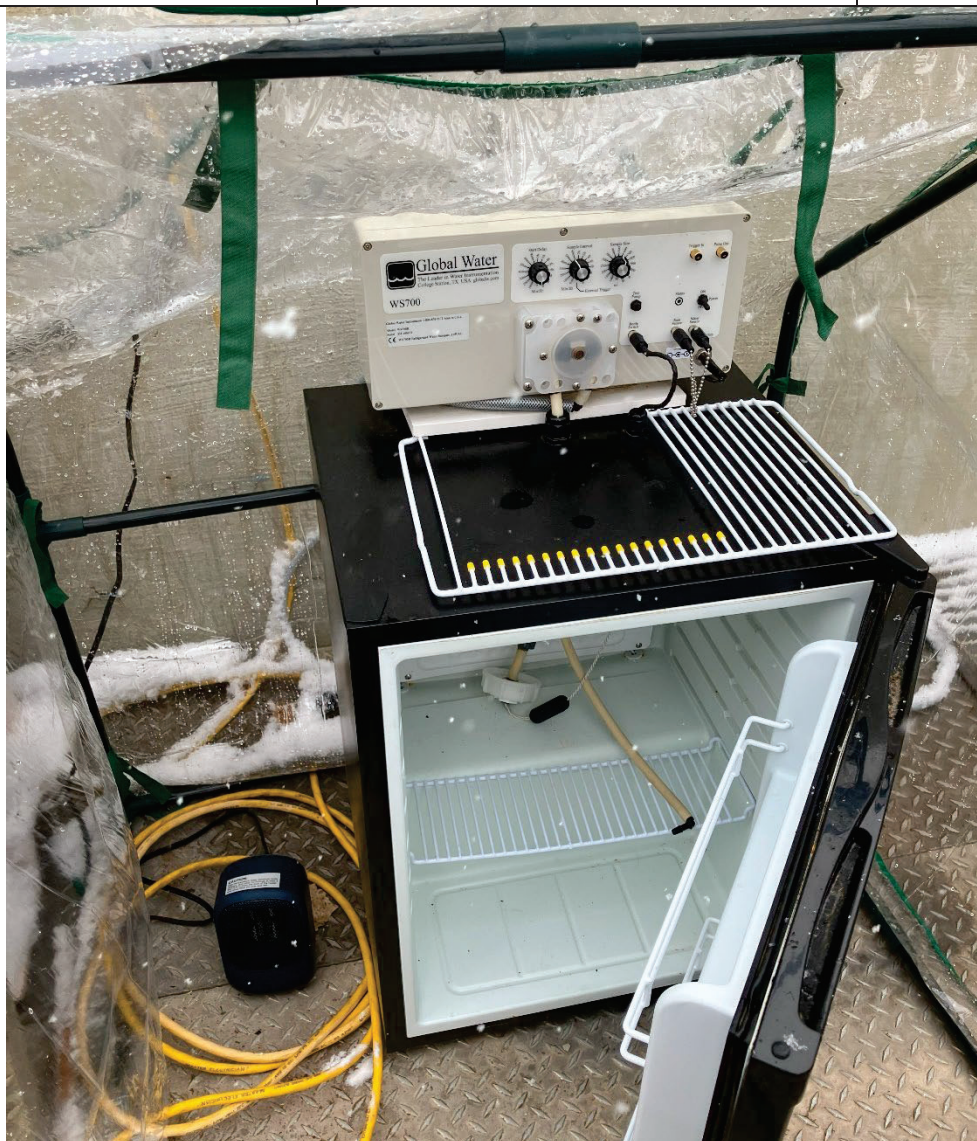
| Photographer: Nafis Fuad | File Name: IMG_0696 | Date: 01/13/2025 |

Autosampler (Global Water WS700) used to collect composite samples, stationed next to the sampling location with no thermometer to monitor the sample temperature.

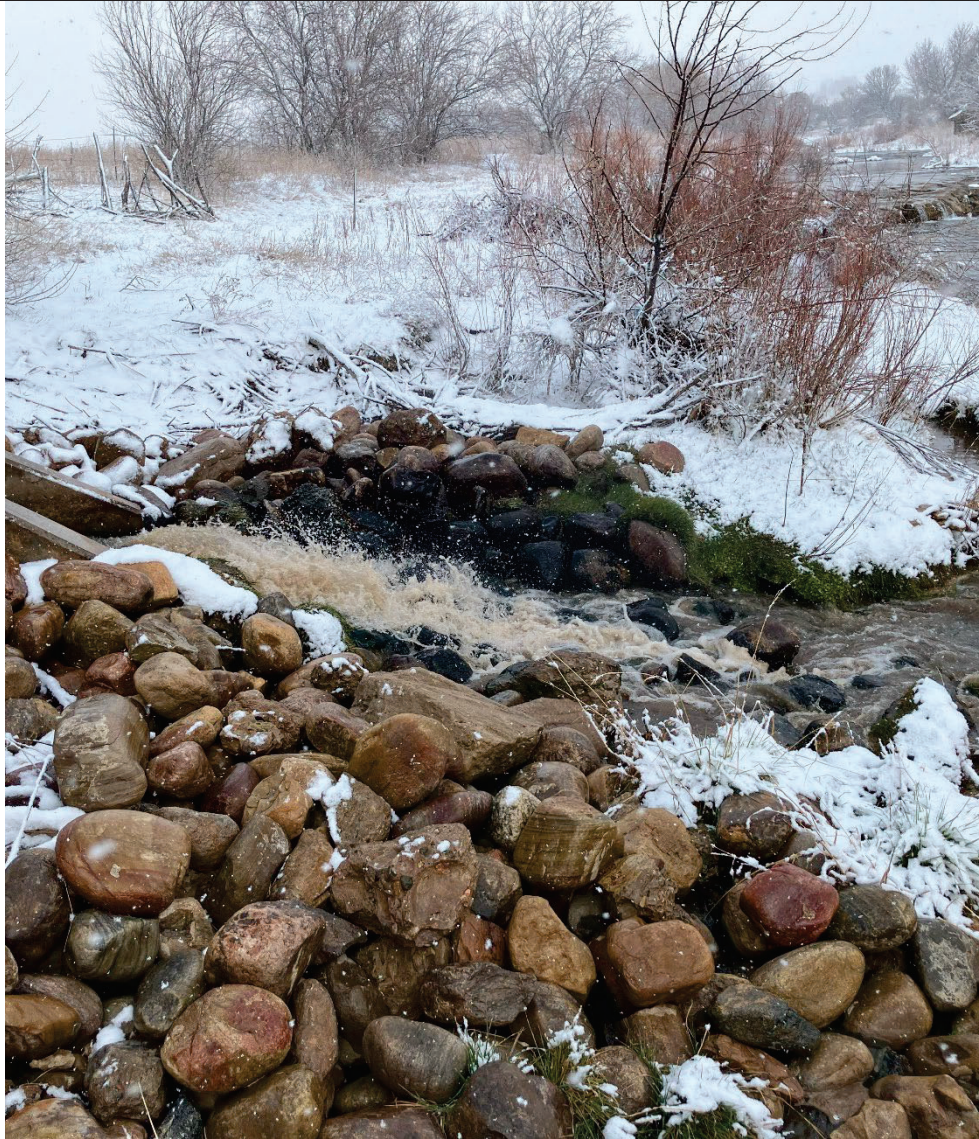
| Photographer: Nafis Fuad | File Name: IMG_0697 | Date: 01/13/2025 |

We visited the outfall 001 and observed discolored effluent containing solids being discharged into the Gallinas River.

Discolored effluent containing solids being discharged into the Gallinas River though outfall 001.

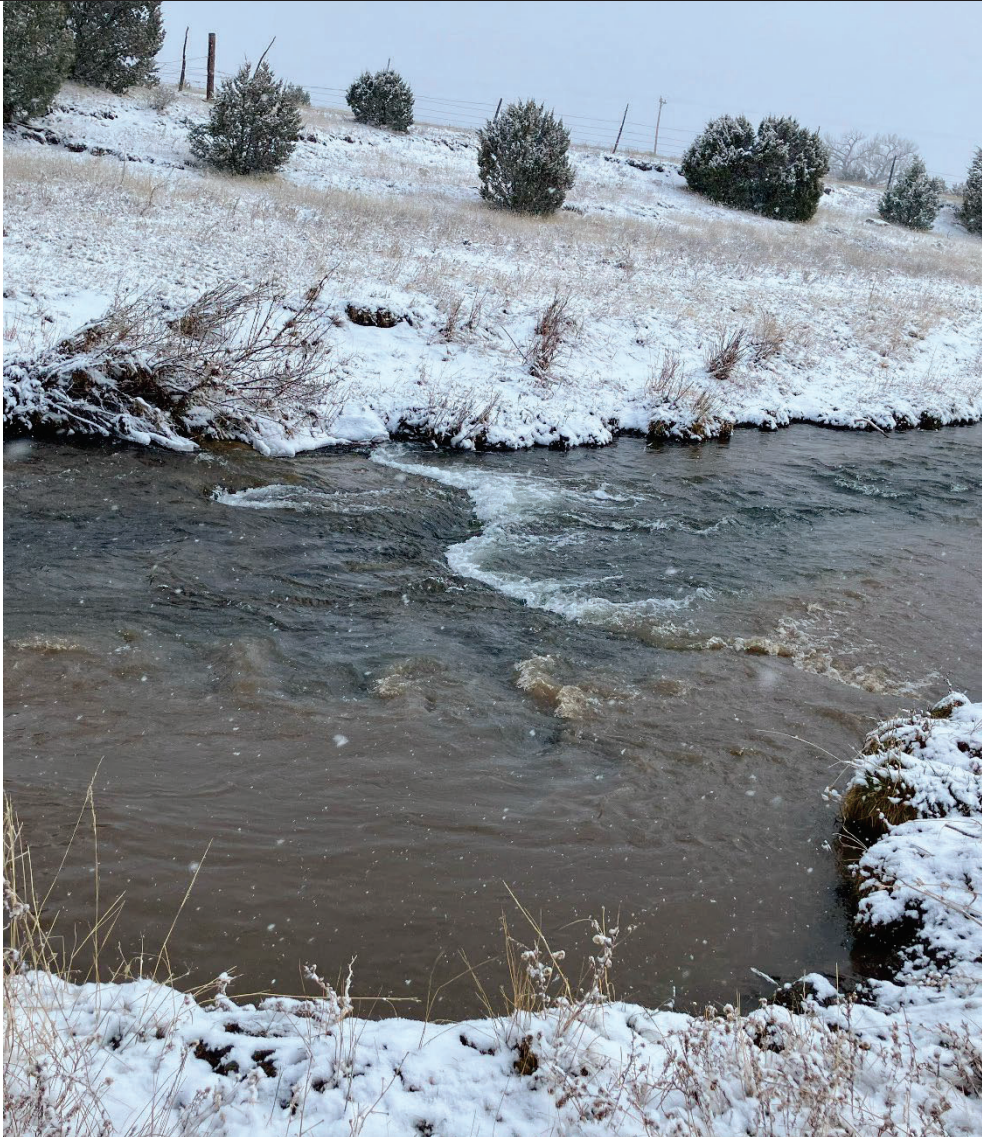
| Photographer: Nafis Fuad | | File Name: IMG_0700 | Date: 01/13/2025 |

| Discolored effluent containing solids discharged into the Gallinas River through outfall 001, directly downstream of outfall 001. | | | |

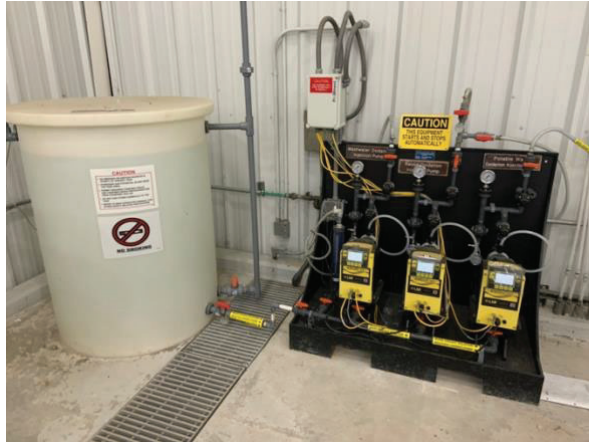
***Chlorine Pumps***

***New Conduit/Injection Point:*** By installing a below ground conduit from the existing chlorine pumps to the inlet line to the tank (a distance of around 50 ft) and routing tubing

through the conduit, chlorine could be injected at the inlet of the tank. These photos show the locations involved:

A saddle will need to be installed in the effluent tank inlet piping (located in a manhole). The conduit will need to be routed from inside the building housing the chlorine pumps and buried deep enough to winterize the tubing conveying the chlorine solution to the injection point. The conduit should be properly sized and use only long sweep elbows to ensure that tubing can be pulled through it and replaced when necessary.

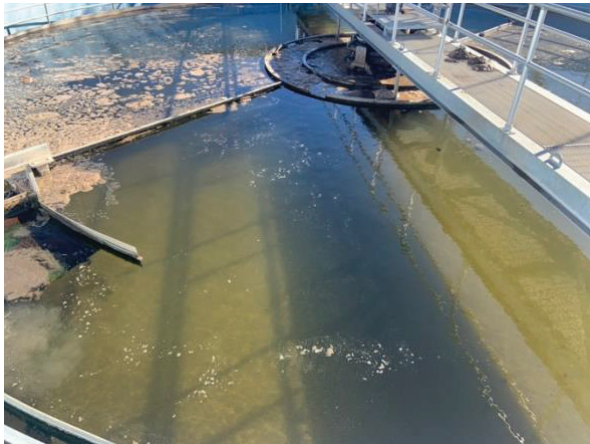
Photo 1: East 2° Clarifier (note sludge blanket level)

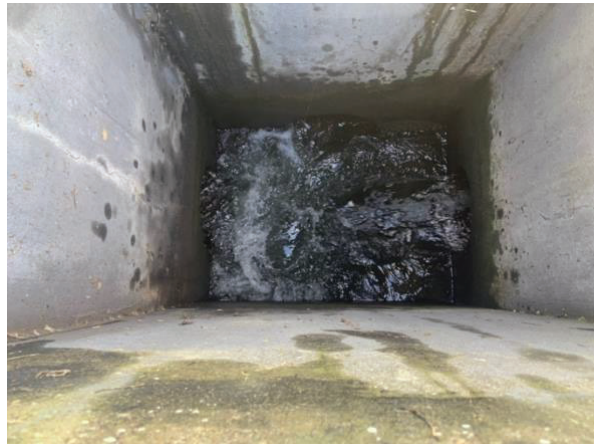
Photo 2: Discharge from west (left) and east (right) clarifiers

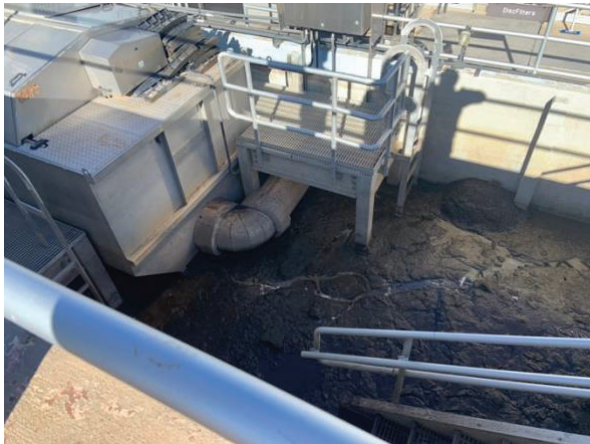
Photo 3: Sludge spilled from plant sump to UV enclosure

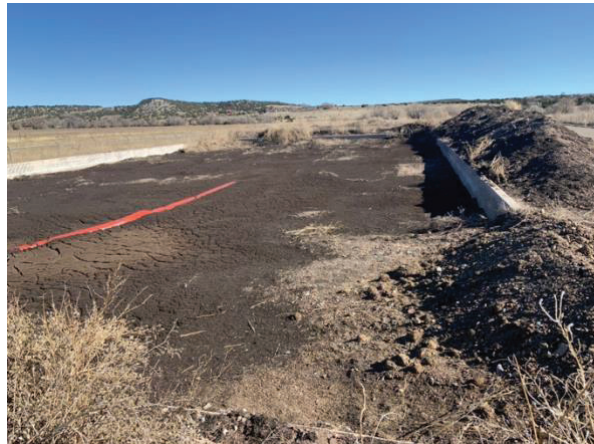
Photo 4: Drying bed nearly ready for cleaning
