| <b>Class I and II Well Inspection Form</b><br><b>US Environmental Protection Agency – Region 4</b><br><b>Underground Injection Control Program</b><br><b>61 Forsyth Street SW, MC 9T25, Atlanta, Georgia, 30303</b><br><b>Phone: (404)562-9424</b> | | | | | <b>Inspection ID</b> | EPA Well ID#: F L S 1 1 3 0 0 5 9<br>Year-Month-Day: 2 0 2 2 – 0 9 – 1 3<br>EPA Permit # (or RA): _____<br><div style="text-align: right;">Page 1 Of 2</div> | | | | | | | | | | | |
| | <b>Well Data from File</b> | Well Name & #: <i>Black Jack Creek SWDS 1-1 #24-1A</i><br>Well Type (see table): <i>Disposal</i> _____ State Permit: <i>API # 0911320060</i> _____<br>Latitude (°N): <i>30.846795°N</i> _____ Longitude (°W): <i>-87.094177°W</i> _____ Elevation (ft): <i>115.9'</i> _____<br>Injection Method (check applicable): <input type="checkbox"/> Casing Injector; <input checked="" type="checkbox"/> Tubing & Packer; <input type="checkbox"/> Cemented Injection Tubing<br><div style="border: 1px solid black; padding: 2px; display: inline-block;">PBTB 7400'</div> <input type="checkbox"/> Other: _____<br>Total Depth (ft): <i>7480'</i> _____ Inner Casing Size (in): <i>7"</i> _____ Tubing Size (in): <i>2 – 7/8"</i> _____ P

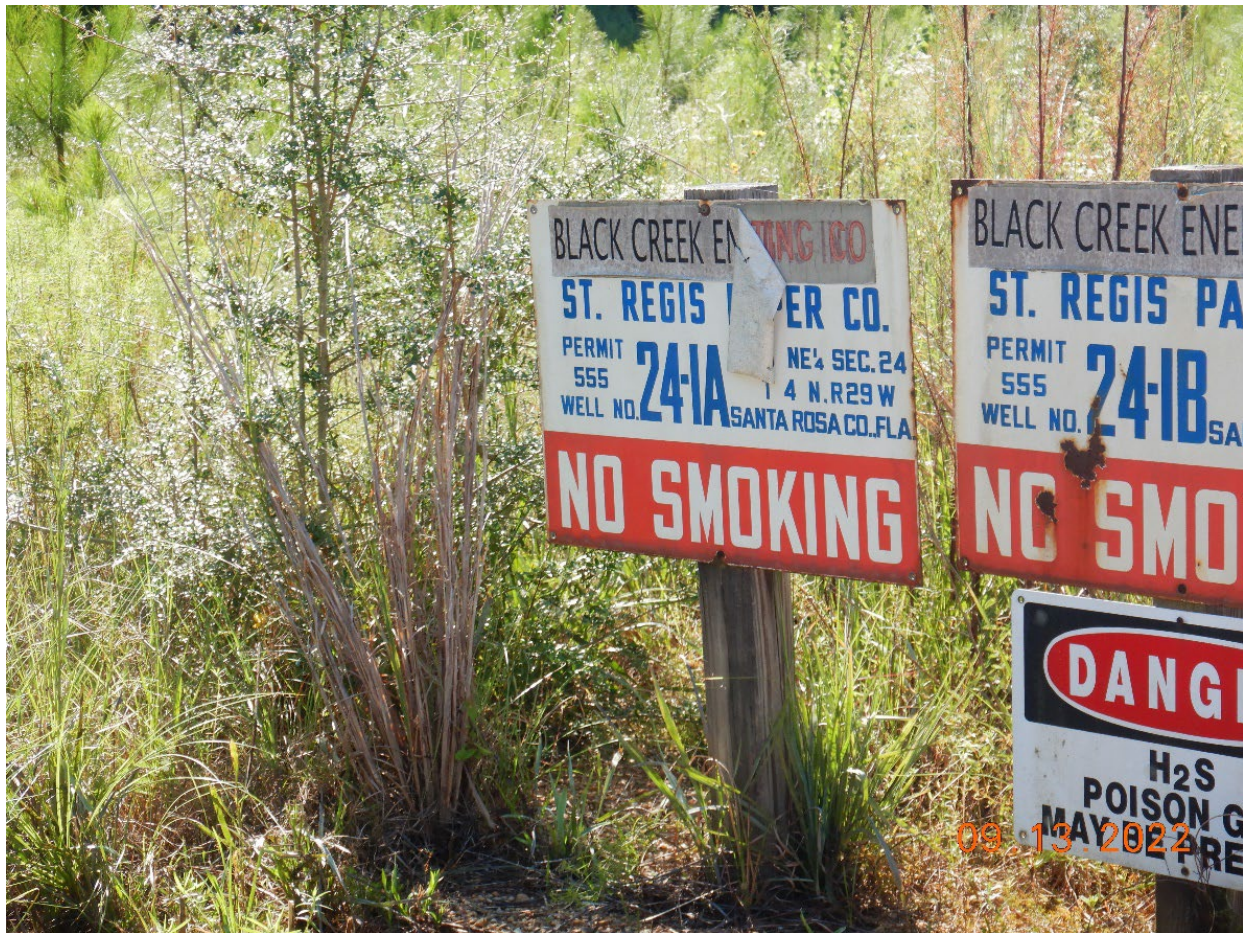
Photo ID:1 \_\_\_\_\_ Time: 10:01 AM \_\_\_\_ Lat (°N): NA \_\_\_\_\_ Long (°W) NA \_\_\_\_\_

Description: Looking south, Black Jack Creek SWDS #1-1 sign alongside access road. \_\_\_\_\_

**Photograph 1:** Looking south, Blackjack Creek SWDS 1-1 #24-1A sign alongside access road.

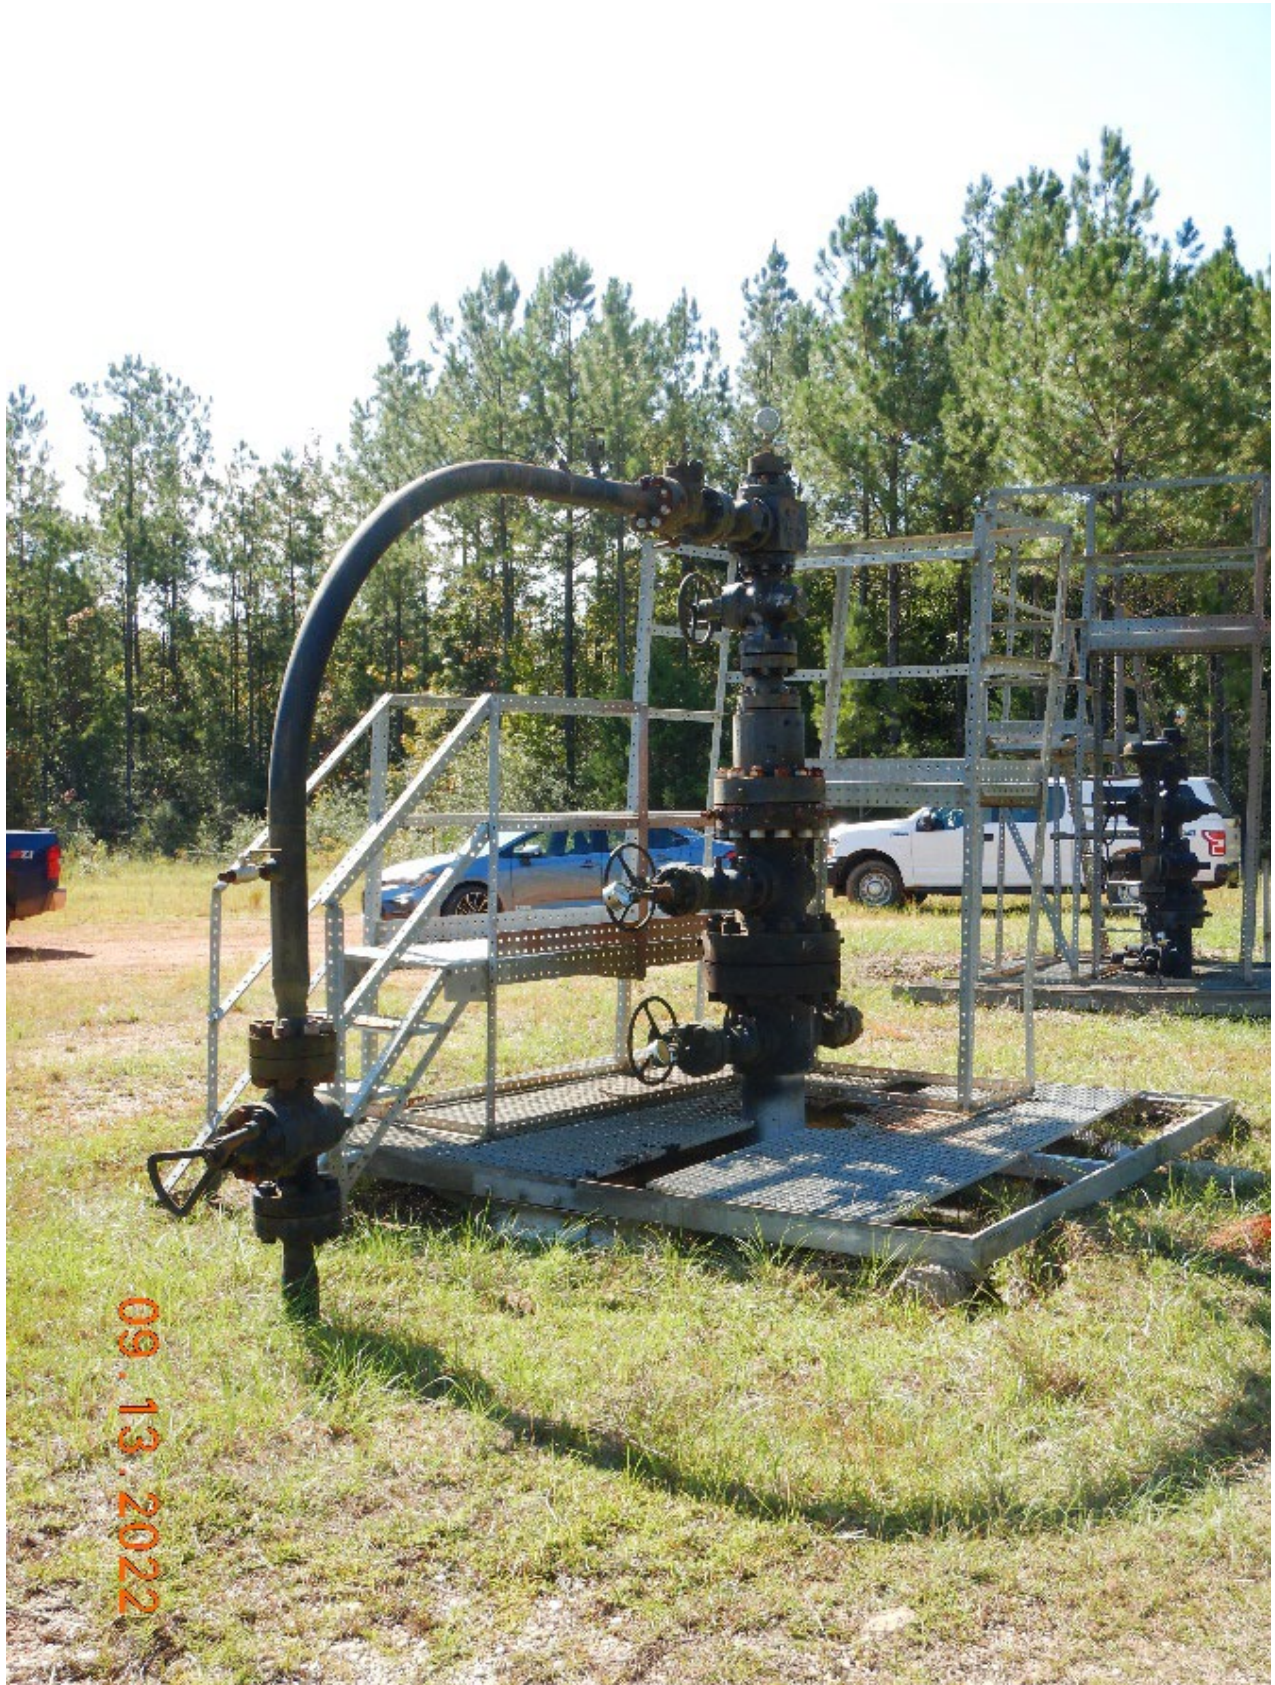
Photo ID:2 \_\_\_\_\_ Time: 10:04 AM \_\_\_\_ Lat (°N): NA \_\_\_\_\_ Long (°W) NA \_\_\_\_\_

Description: Looking east, site overview, including well head, pressure gauges, valves, and access stairs. \_\_\_\_\_

**Photograph 2:** Looking east, site overview, including well head, pressure gauges, valves, and access stairs.

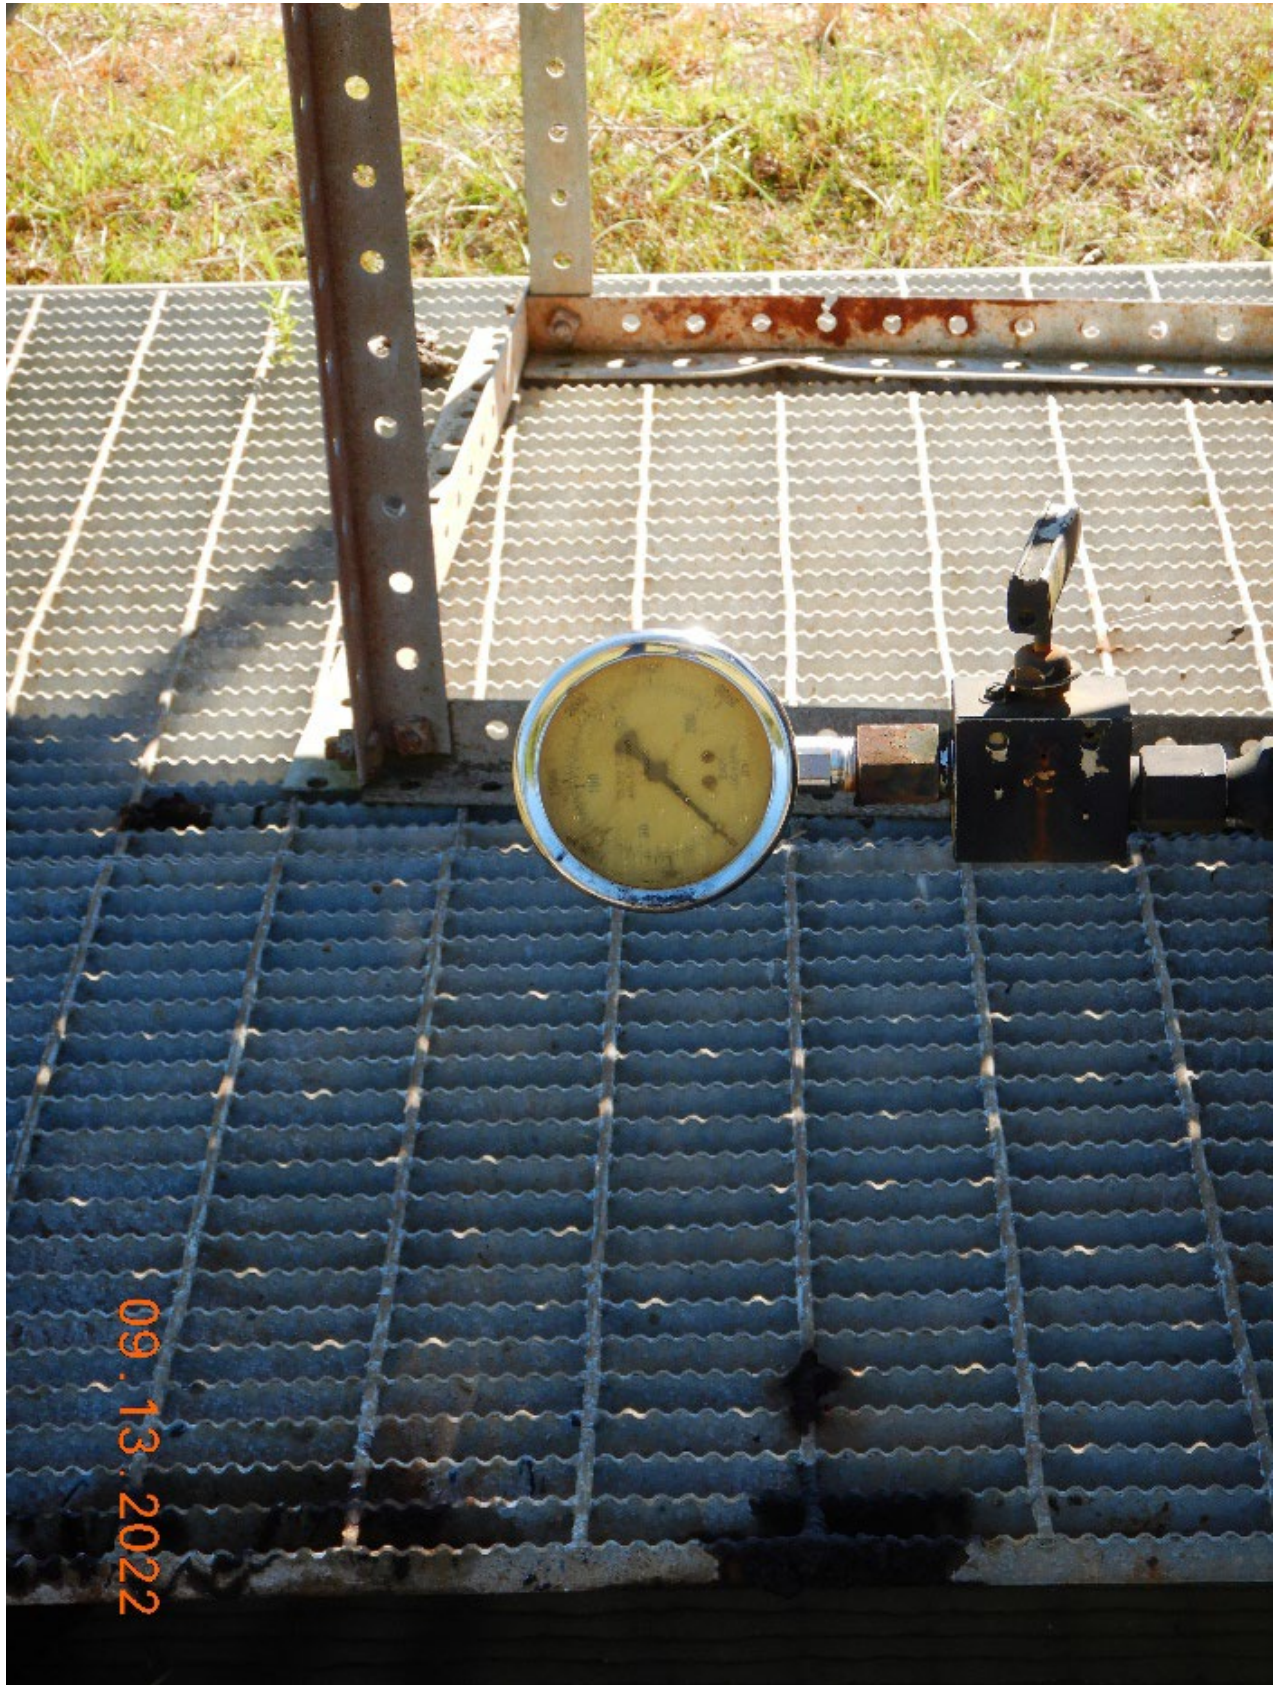
Photo ID:3 \_\_\_\_\_ Time: 10:05 AM \_\_\_\_ Lat (°N): NA \_\_\_\_\_ Long (°W) NA \_\_\_\_\_

Description: Looking east, closeup view of surface casing pressure gauge reading 0 psi. \_\_\_\_\_

**Photograph 3:** Looking east, closeup view of surface casing pressure gauge reading 0 psi.

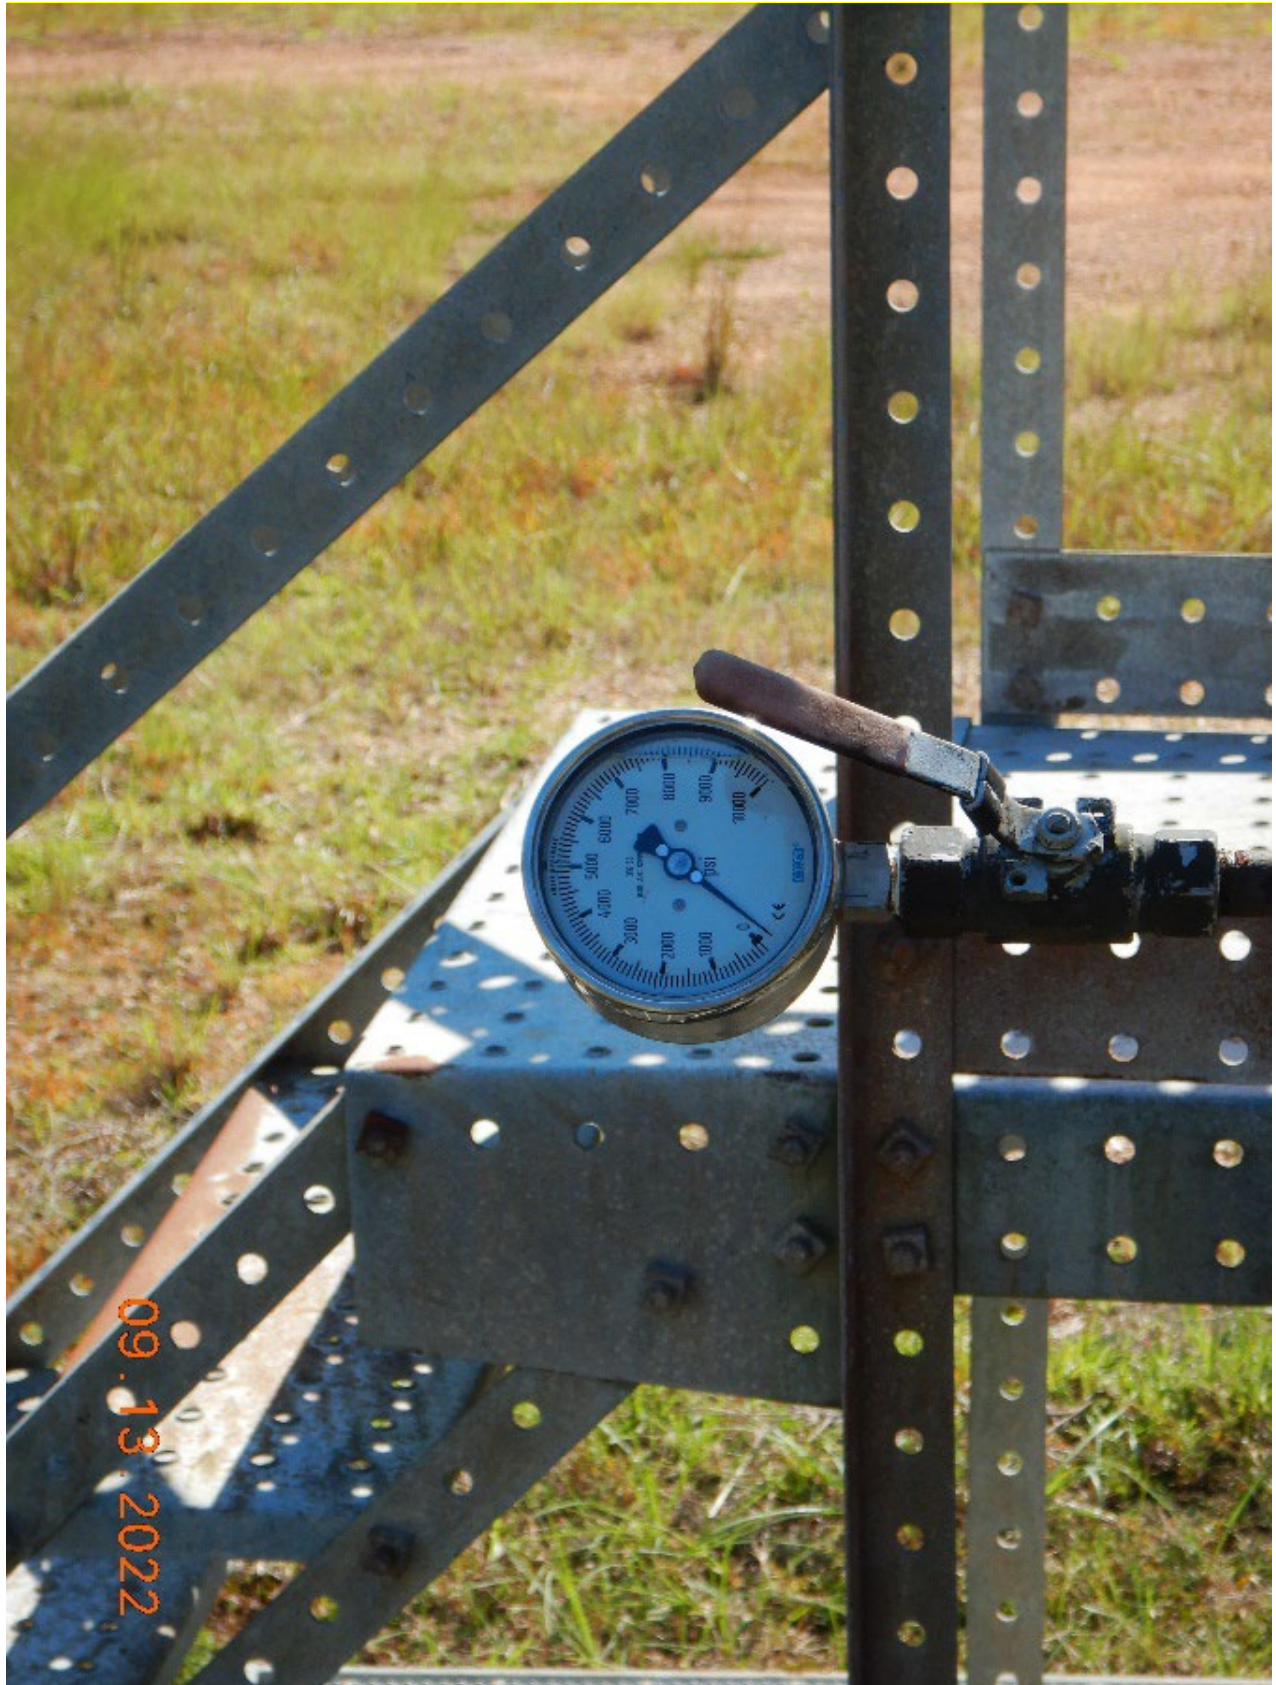
Photo ID:4 \_\_\_\_\_ Time: 10:05 AM \_\_\_\_ Lat (°N): NA \_\_\_\_\_ Long (°W) NA \_\_\_\_\_

Description: Looking east, closeup view of production casing pressure gauge reading 0 psi. \_\_\_\_\_

**Photograph 4:** Looking east, closeup view of internal pressure gauge reading 0 psi.

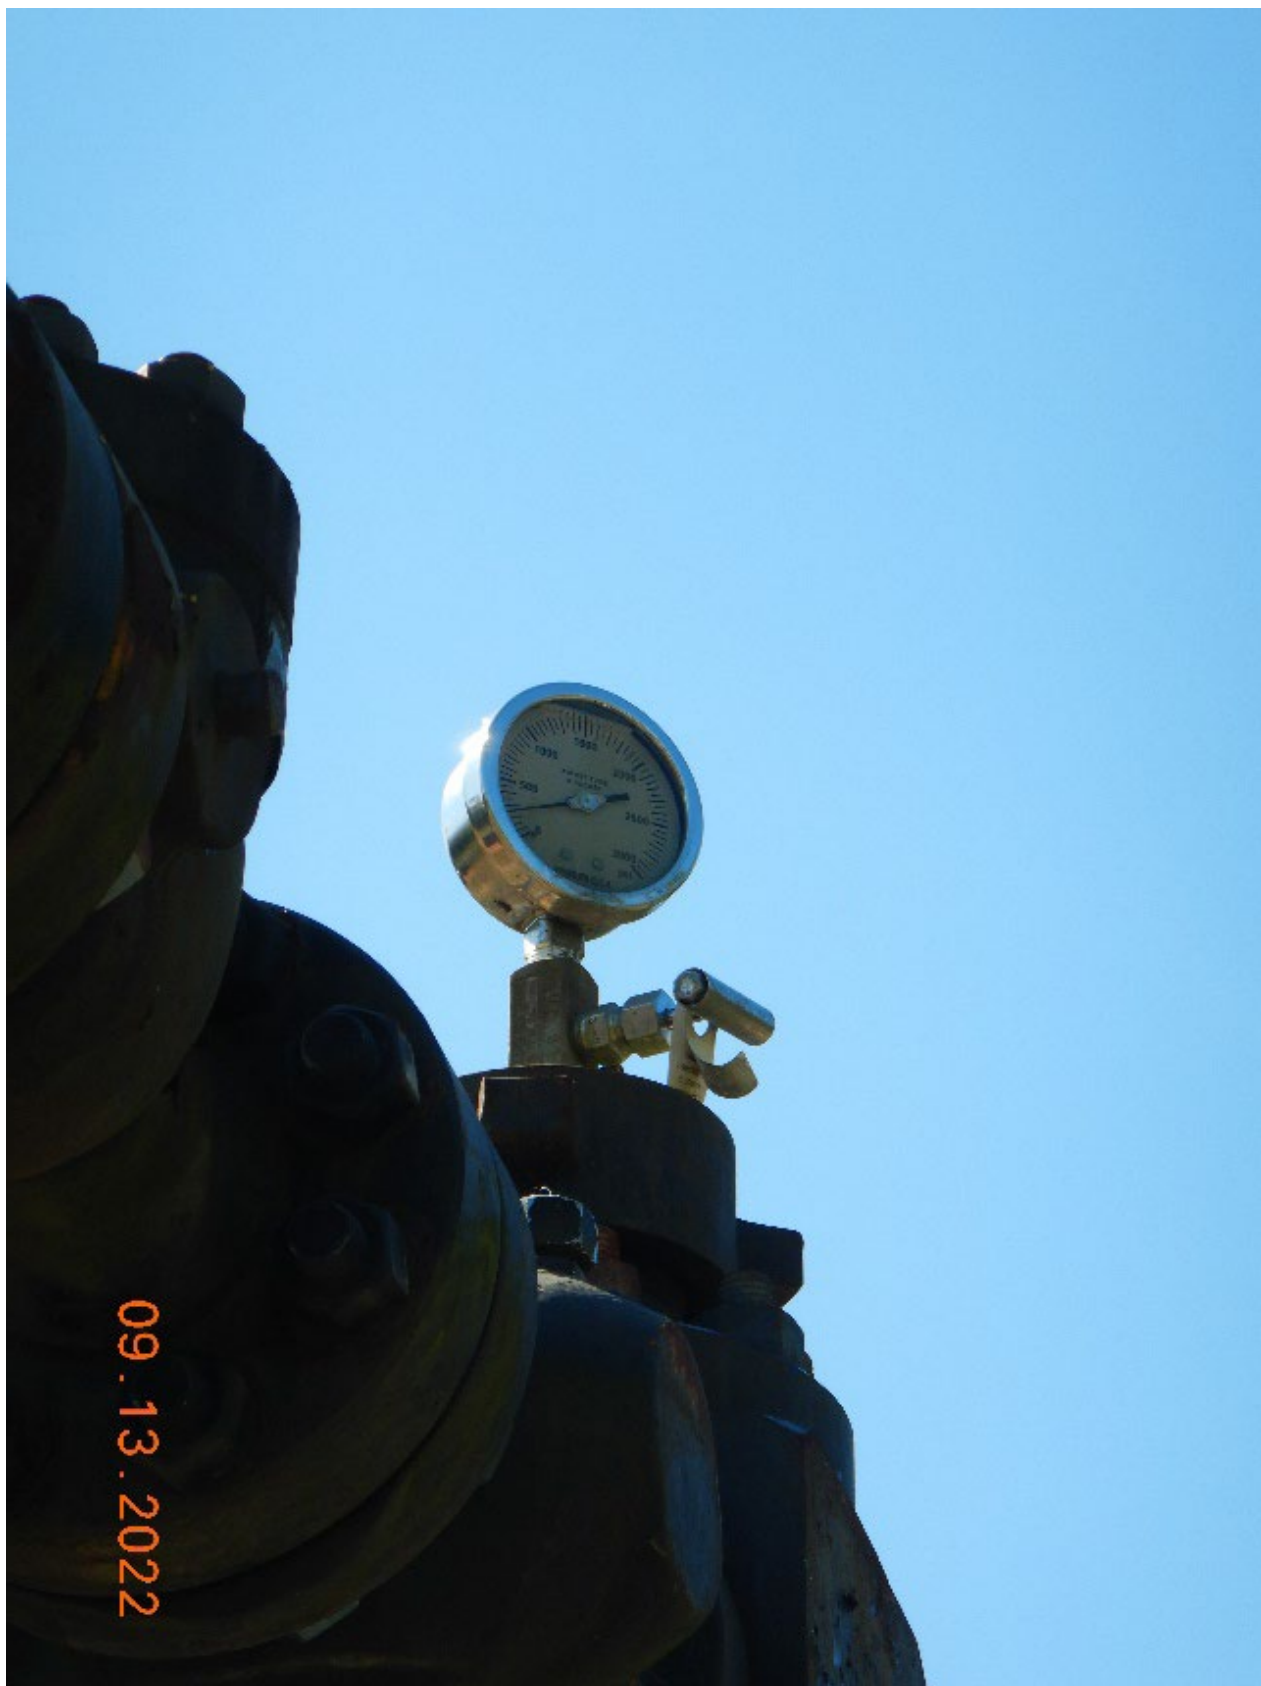
Photo ID:5 \_\_\_\_\_ Time: 10:07 AM \_\_\_\_ Lat (°N): NA \_\_\_\_\_ Long (°W) NA \_\_\_\_\_

Description: Looking southeast, closeup view of internal pressure gauge reading 250 psi. \_\_\_\_\_

**Photograph 5:** Looking southeast, closeup view of internal pressure gauge reading 250 psi.
