## Region 6 - Enforcement & Compliance Assurance Division

### INSPECTION REPORT

| Company Name: | <b>Village of Taos Ski Valley</b> | |
| Facility Name: | <b>Taos Ski Valley WWTP</b> | |

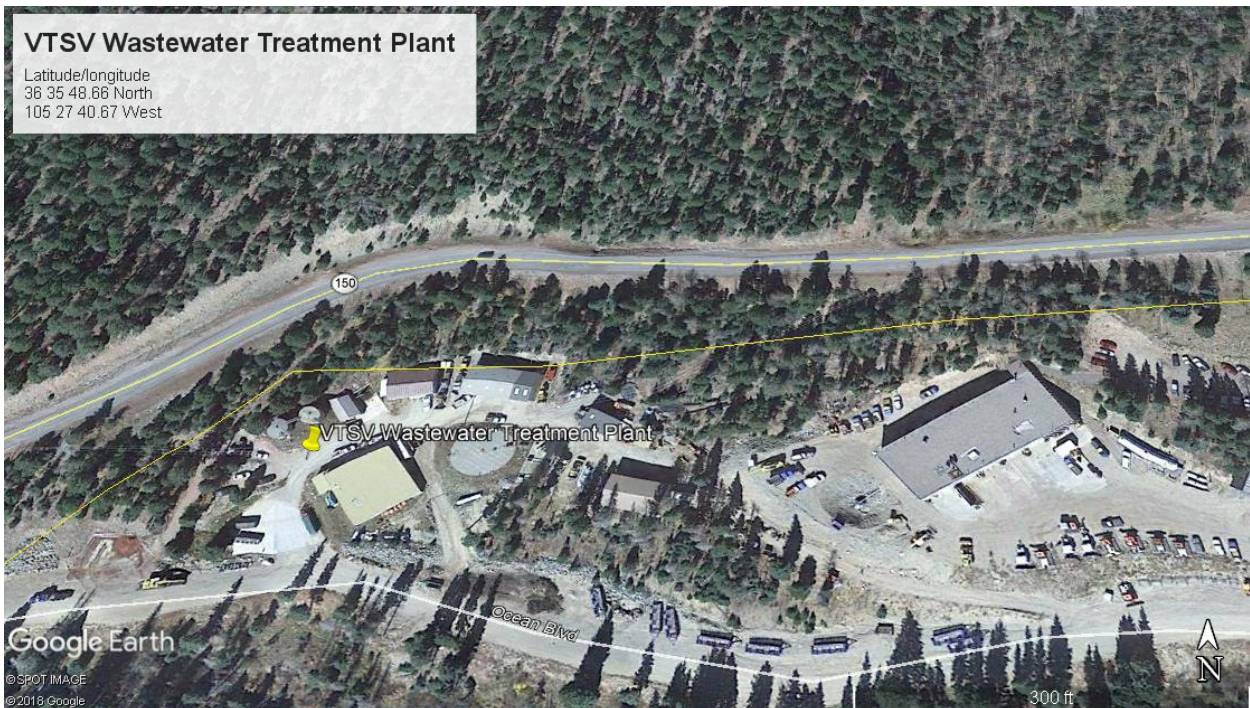
**Aerial Image #1:** Overall view of the Village of Taos Ski Valley's Wastewater Treatment Plant. Aerial from Google Earth maps.

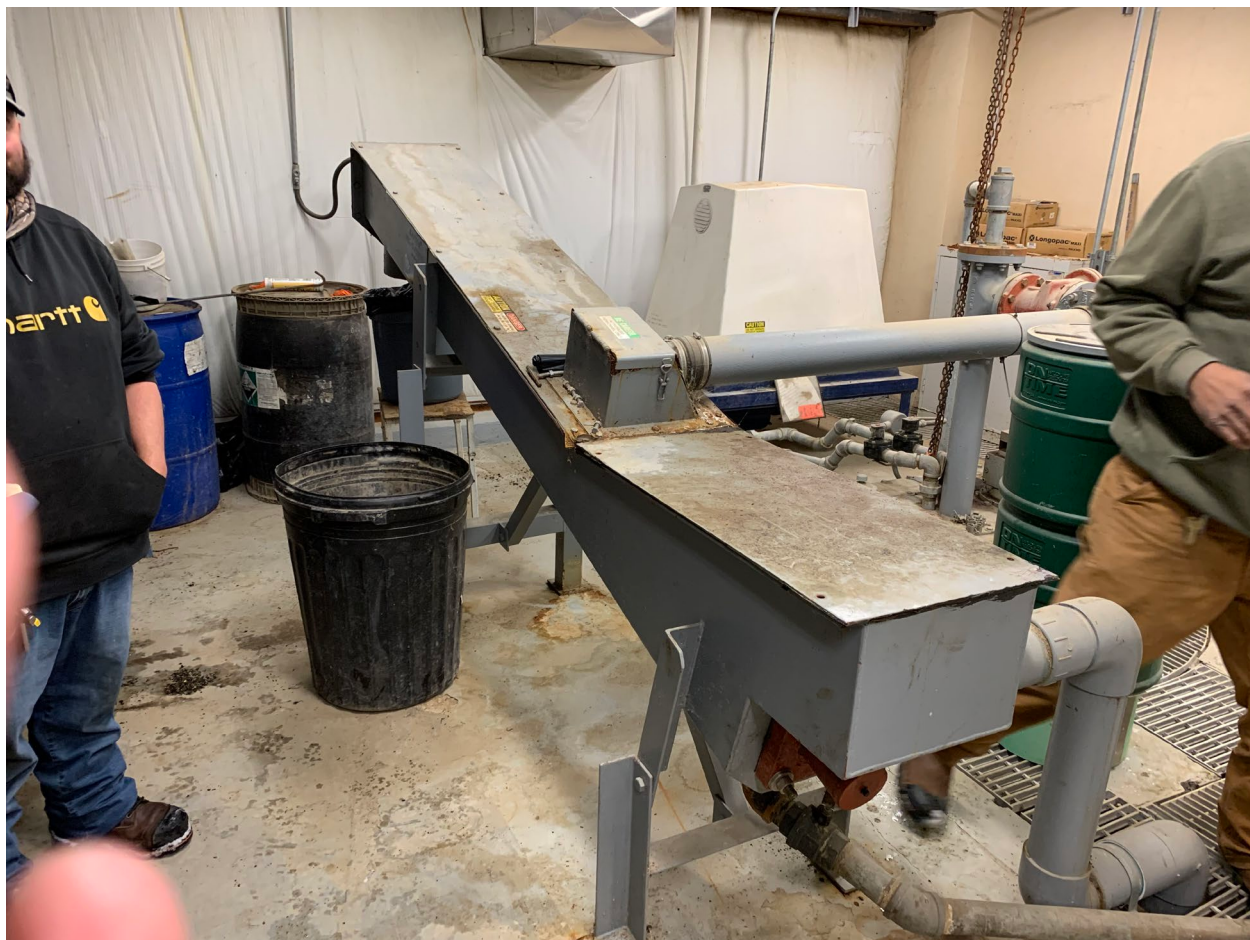
Photo No. 1

View of one (1) of the WWTP two (2) pieces of process equipment associated with the headworks. (IMG\_0216) (09:14 AM:01/18/2024). Photographed by D. Esparza

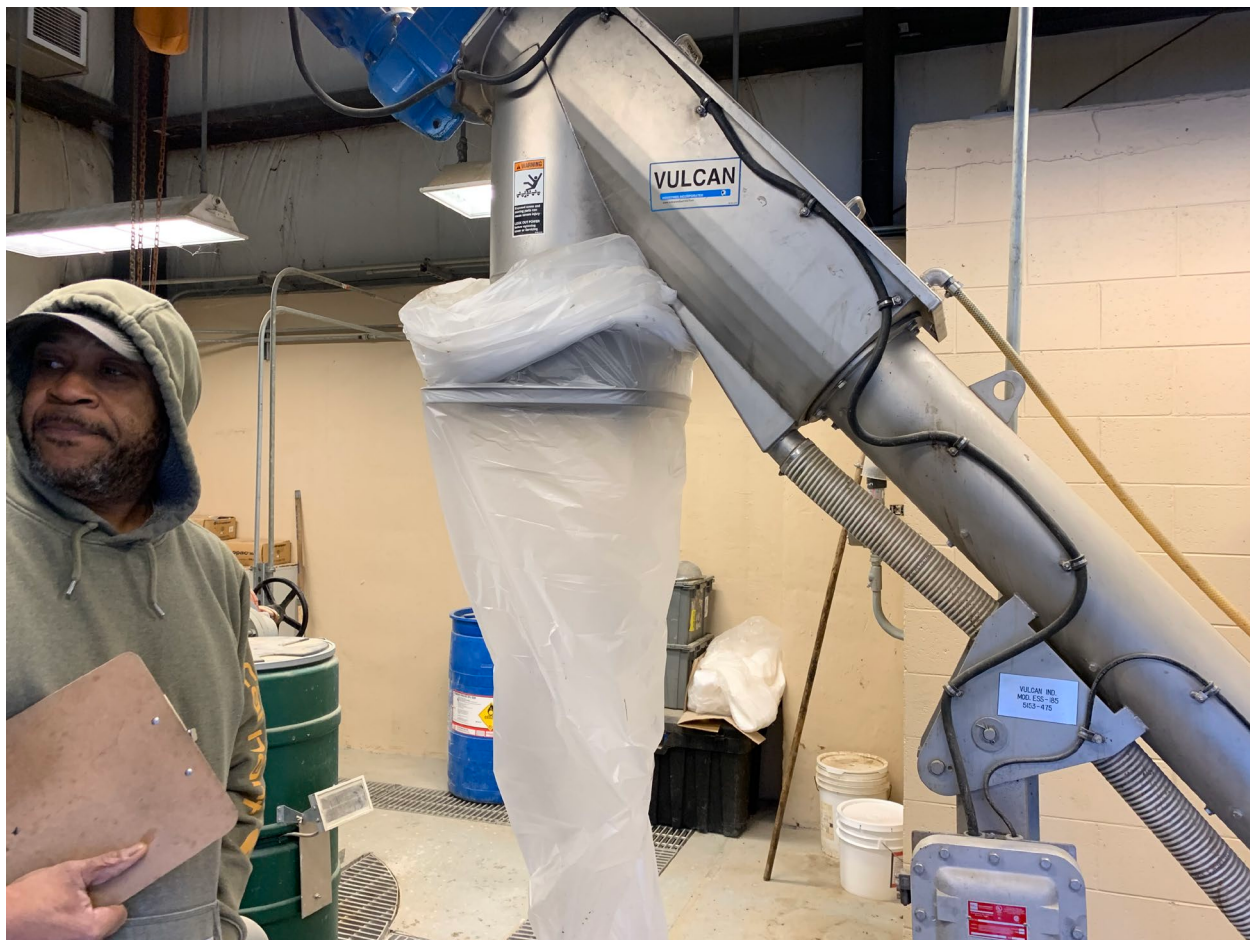
Photo No. 2

View of the grit bagging system within the headworks. (IMG\_0217) (09:15 AM :01/18/2024).  
Photographed by D. Esparza

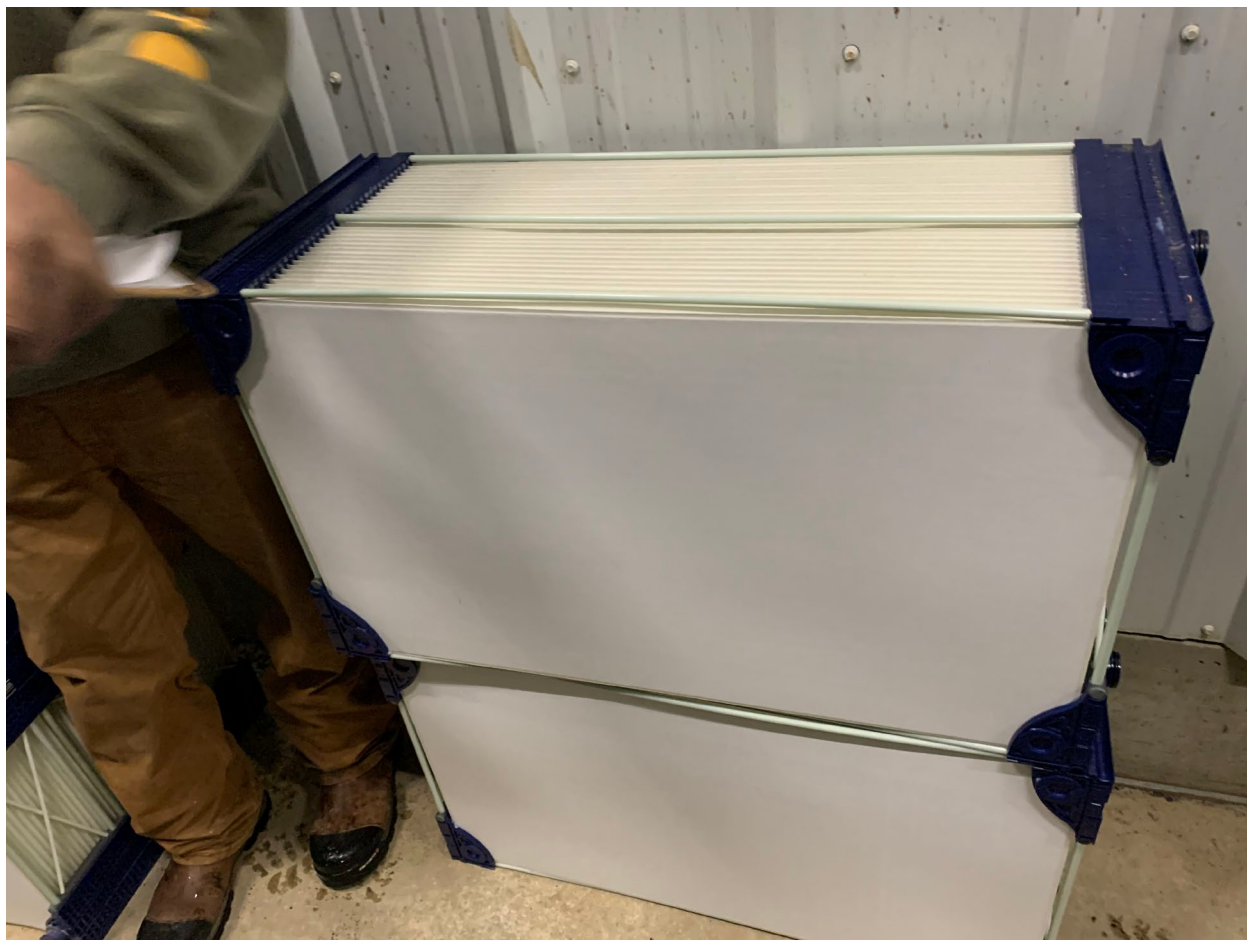
Photo No. 3

View of some of the Ovivo MBR membrane modules. (IMG\_0218). (10:16 AM :01/18/2024).  
Photographed by D. Esparza

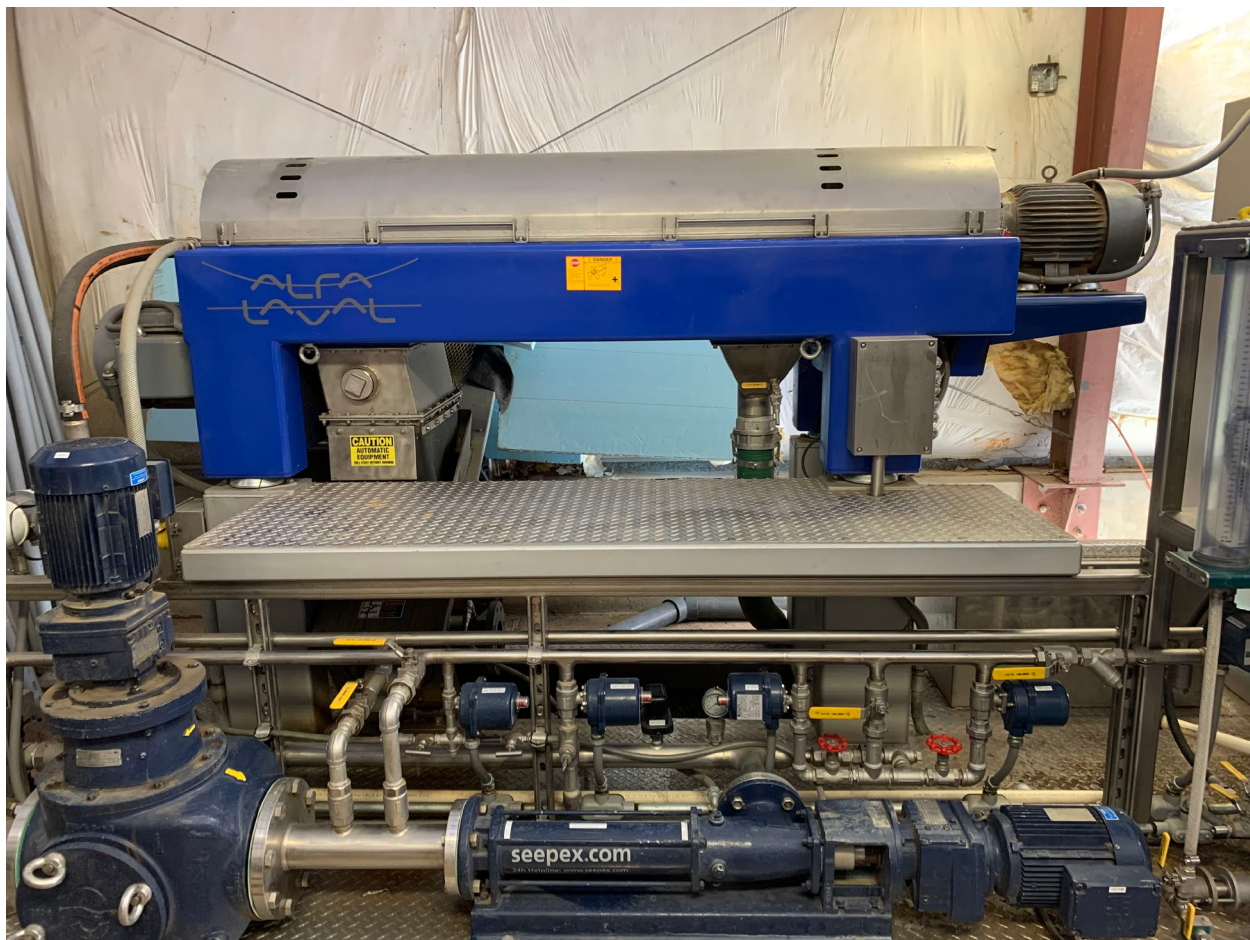
Photo No. 4

A view of the Alfa Laval centrifuge within the dewatering building. (IMG\_0221). (10:43 AM:01/18/2024)  
Photographed by D. Esparza

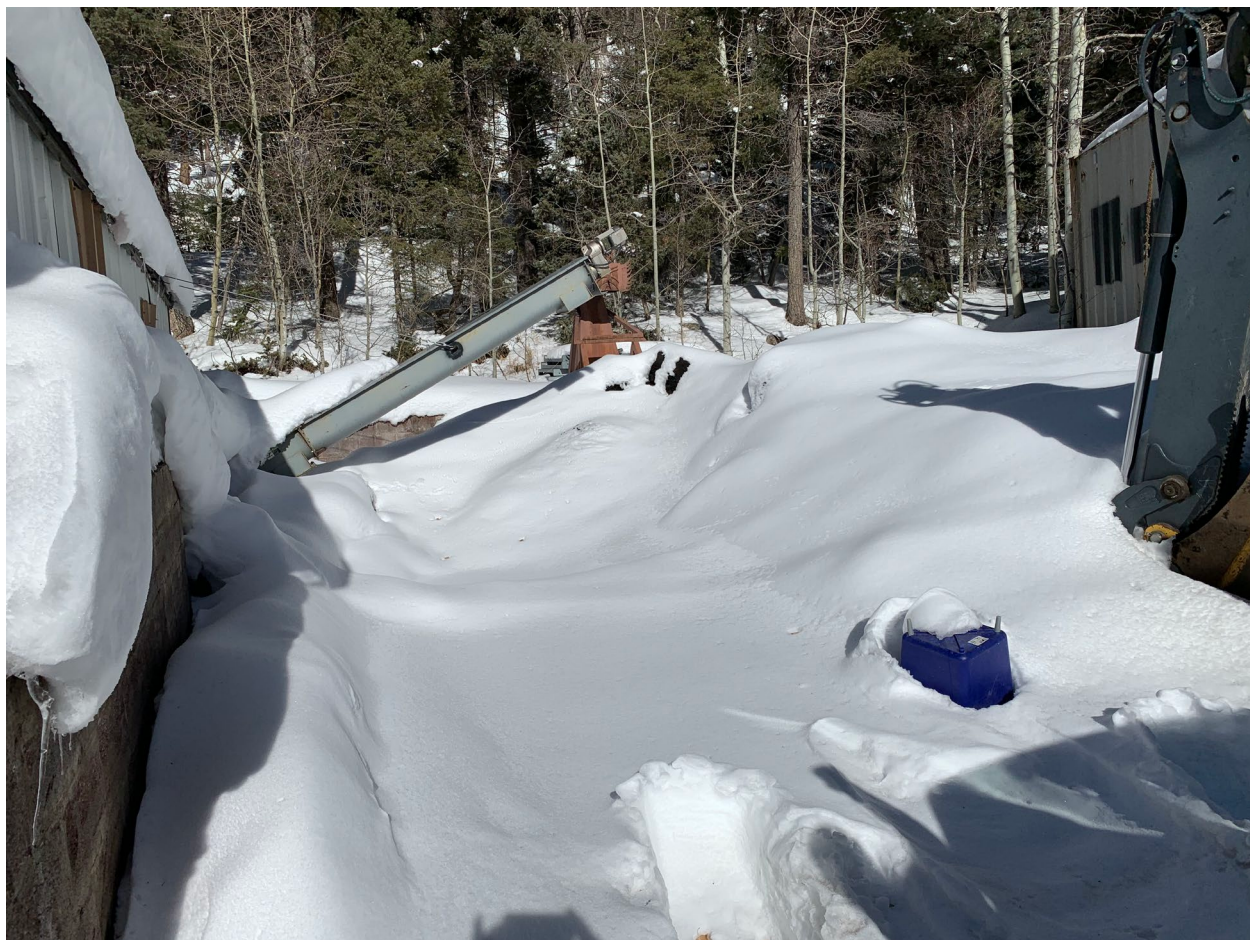
Photo No. 5

View of the WWTP's snow covered sludge pad. Note: Final, disposal of the sludge is at the Taos County Regional Landfill or Rio Rancho Landfill. (IMG\_0222) (10:47 AM:01/18/2024) Photographed by D. Esparza
