## Clean Water Act Section 404: Site Visit/Case Development

| Site Name | Bart Wodzinski Property - 41 Bowery Lane | | | | |

CWA 404 Inspection Photolog  
Wodzinski Property  
41 Bowery Lane  
Minisink, Orange County, NY

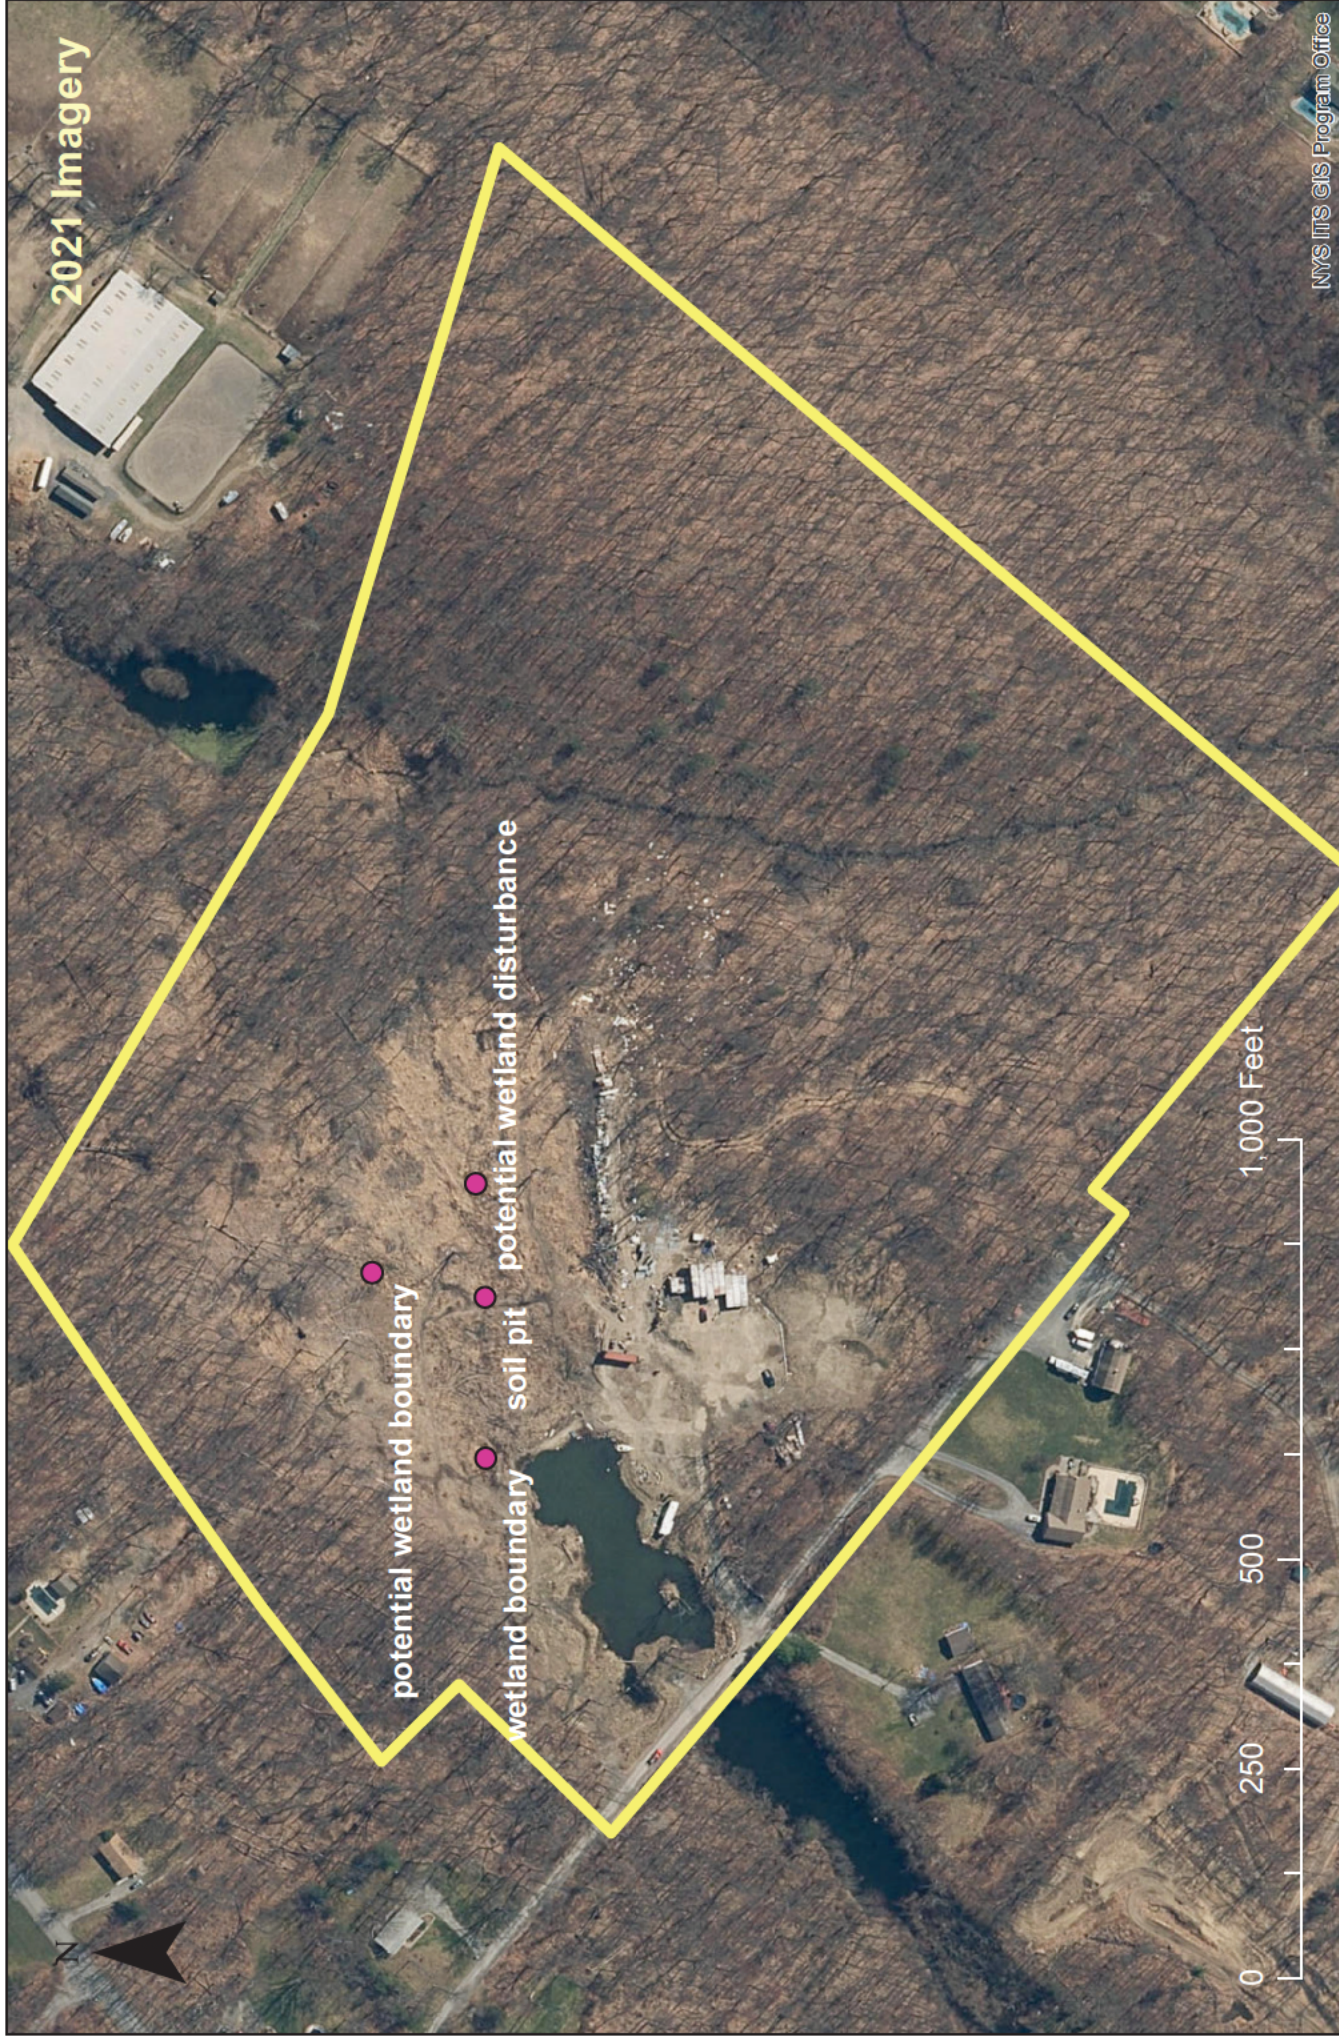
- 5/16/2023 EPA GPS Points
- Parcel Boundary

Wodzinski Property  
41 Bowery Lane, Minisink, NY  
41.36931, -74.54301

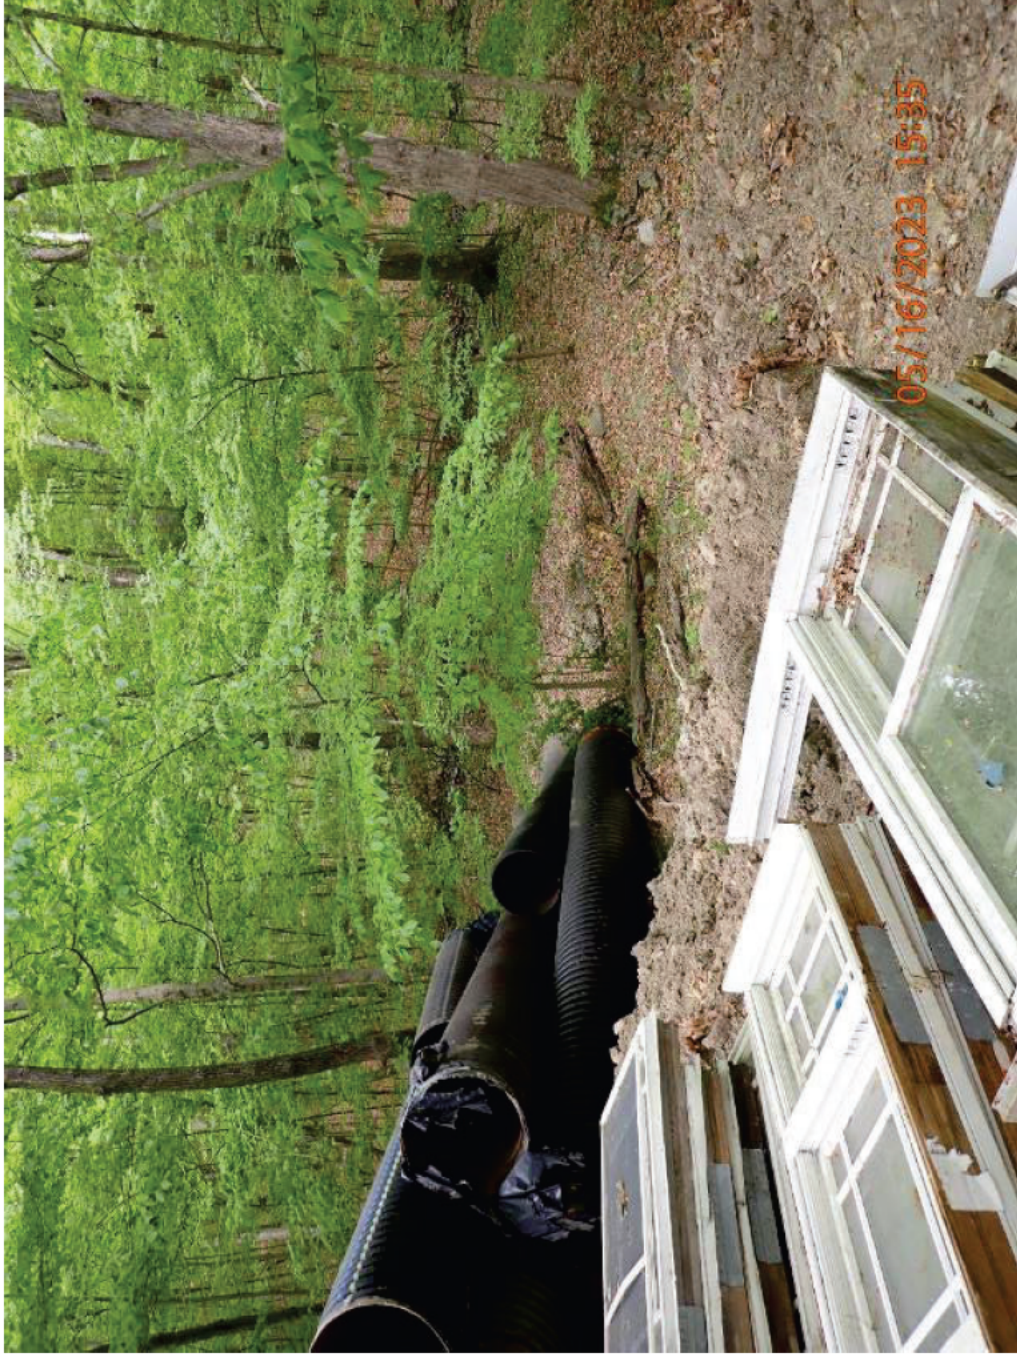
**Date:** 5/16/2023  
**Time:** 3:35 PM  
**Photographer:** SSA  
**Photo ID:** 1 – P5160043

Culvert pipes on hill side;  
stream in background

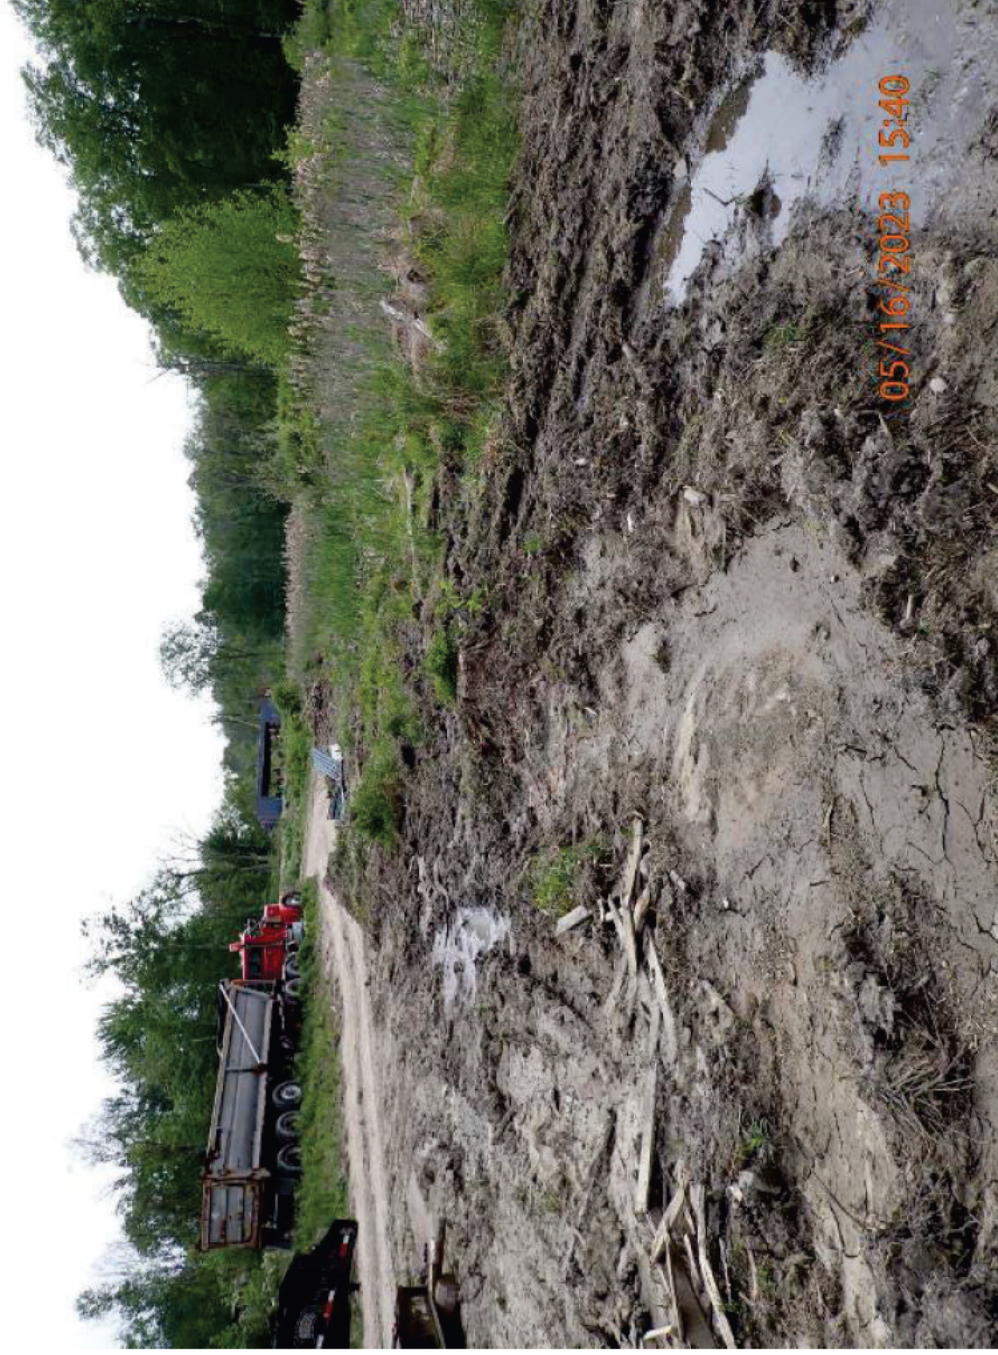
**Date:** 5/16/2023  
**Time:** 3:40 PM  
**Photographer:** SSA  
**Photo ID:** 3 – P5160045

**Description:**  
(1/5) Panorama of wetland  
disturbance

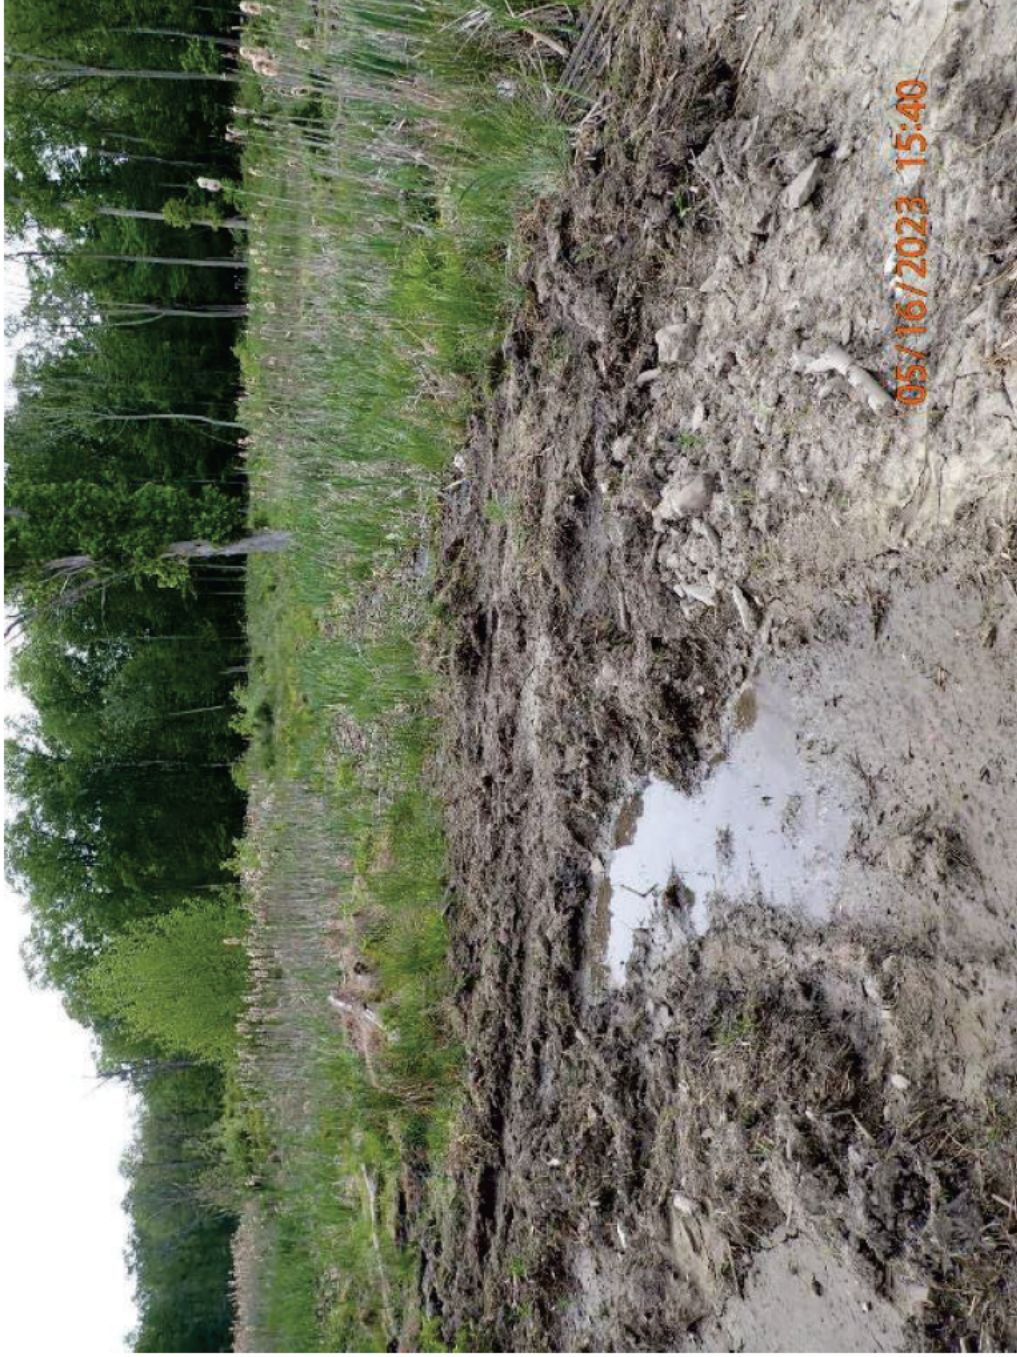
**Date:** 5/16/2023  
**Time:** 3:40 PM  
**Photographer:** SSA  
**Photo ID:** 4 – P5160046

**Description:**  
(2/5) Panorama of wetland  
disturbance

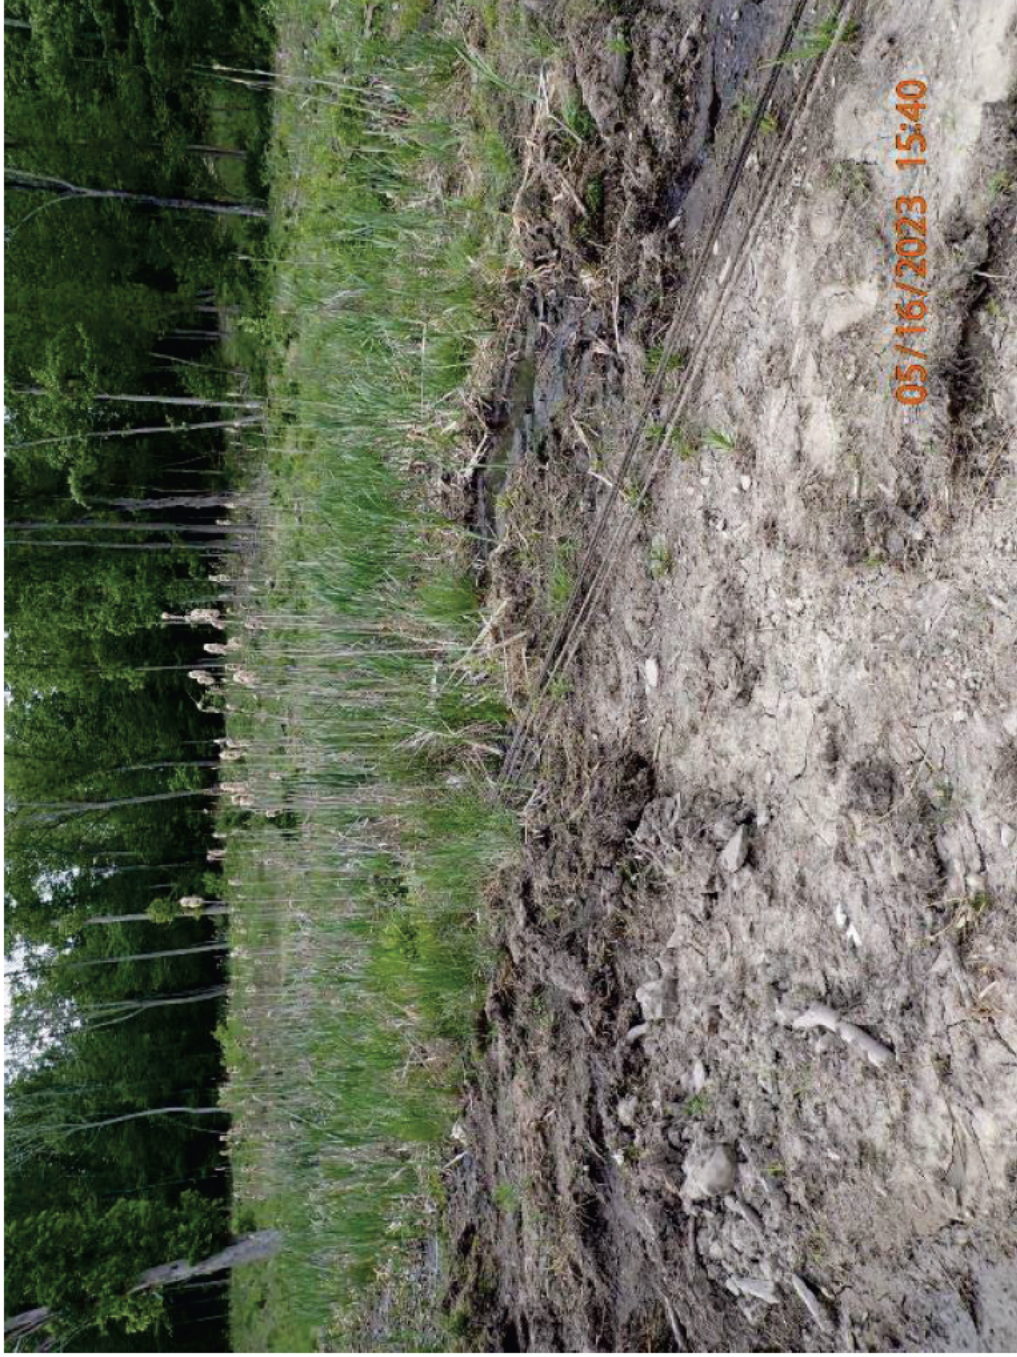
**Date:** 5/16/2023  
**Time:** 3:40 PM  
**Photographer:** SSA  
**Photo ID:** 5 – P5160047

(3/5) Panorama of wetland disturbance

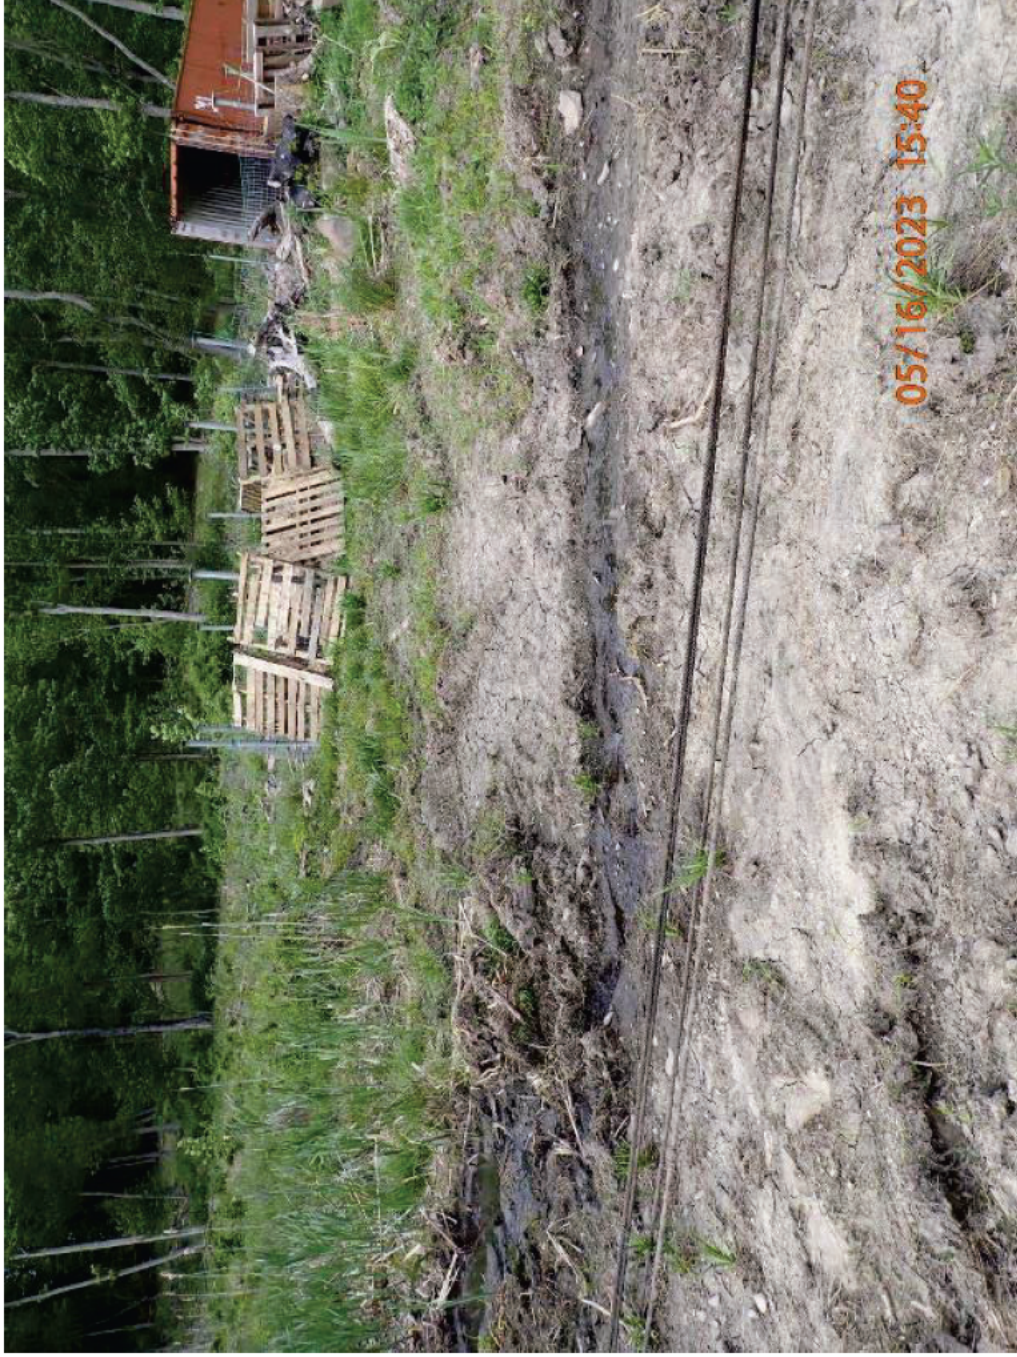
**Date:** 5/16/2023  
**Time:** 3:40 PM  
**Photographer:** SSA  
**Photo ID:** 6 – P5160048

(4/5) Panorama of wetland disturbance

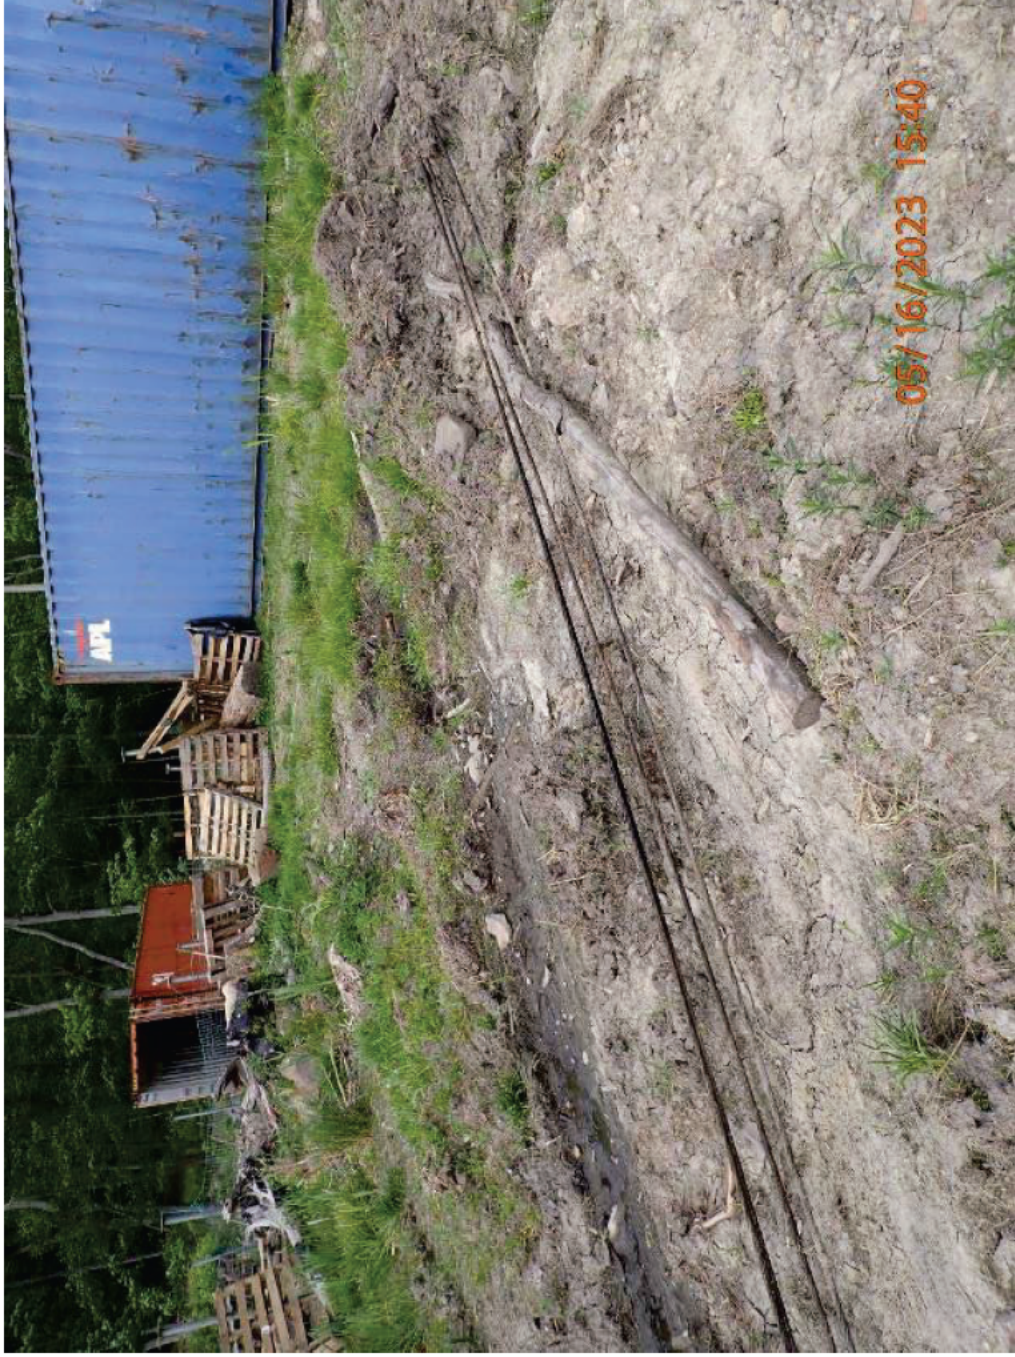
**Date:** 5/16/2023  
**Time:** 3:40 PM  
**Photographer:** SSA  
**Photo ID:** 7 – P5160049

**Description:**  
(5/5) Panorama of wetland  
disturbance

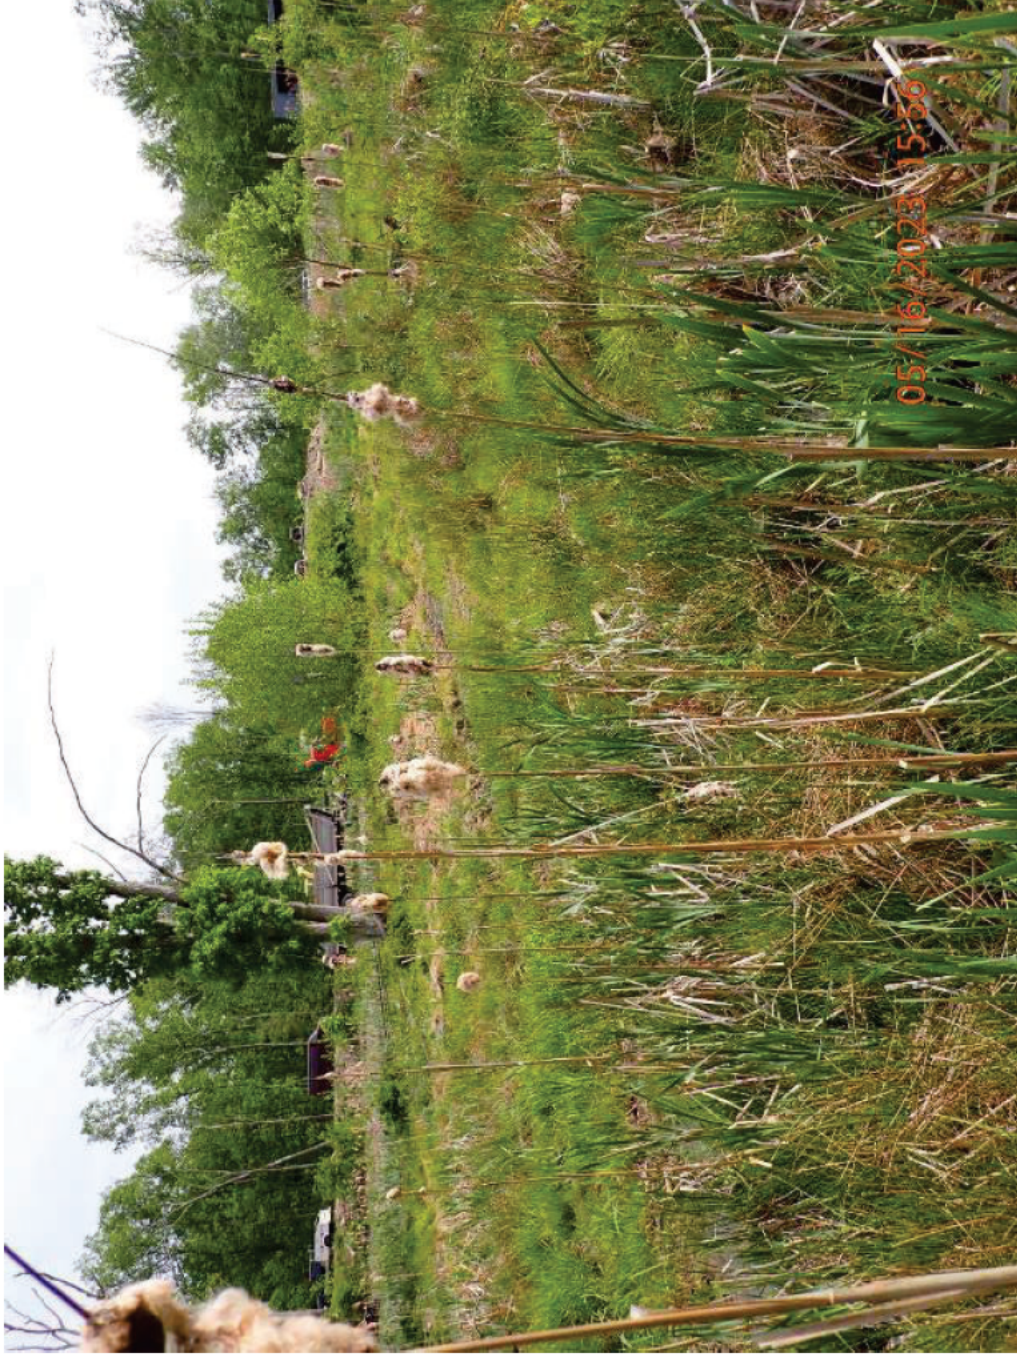
**Date:** 5/16/2023  
**Time:** 3:56 PM  
**Photographer:** SSA  
**Photo ID:** 8 – P5160050

**Description:**  
(1/4) Potential wetland to  
upland transition

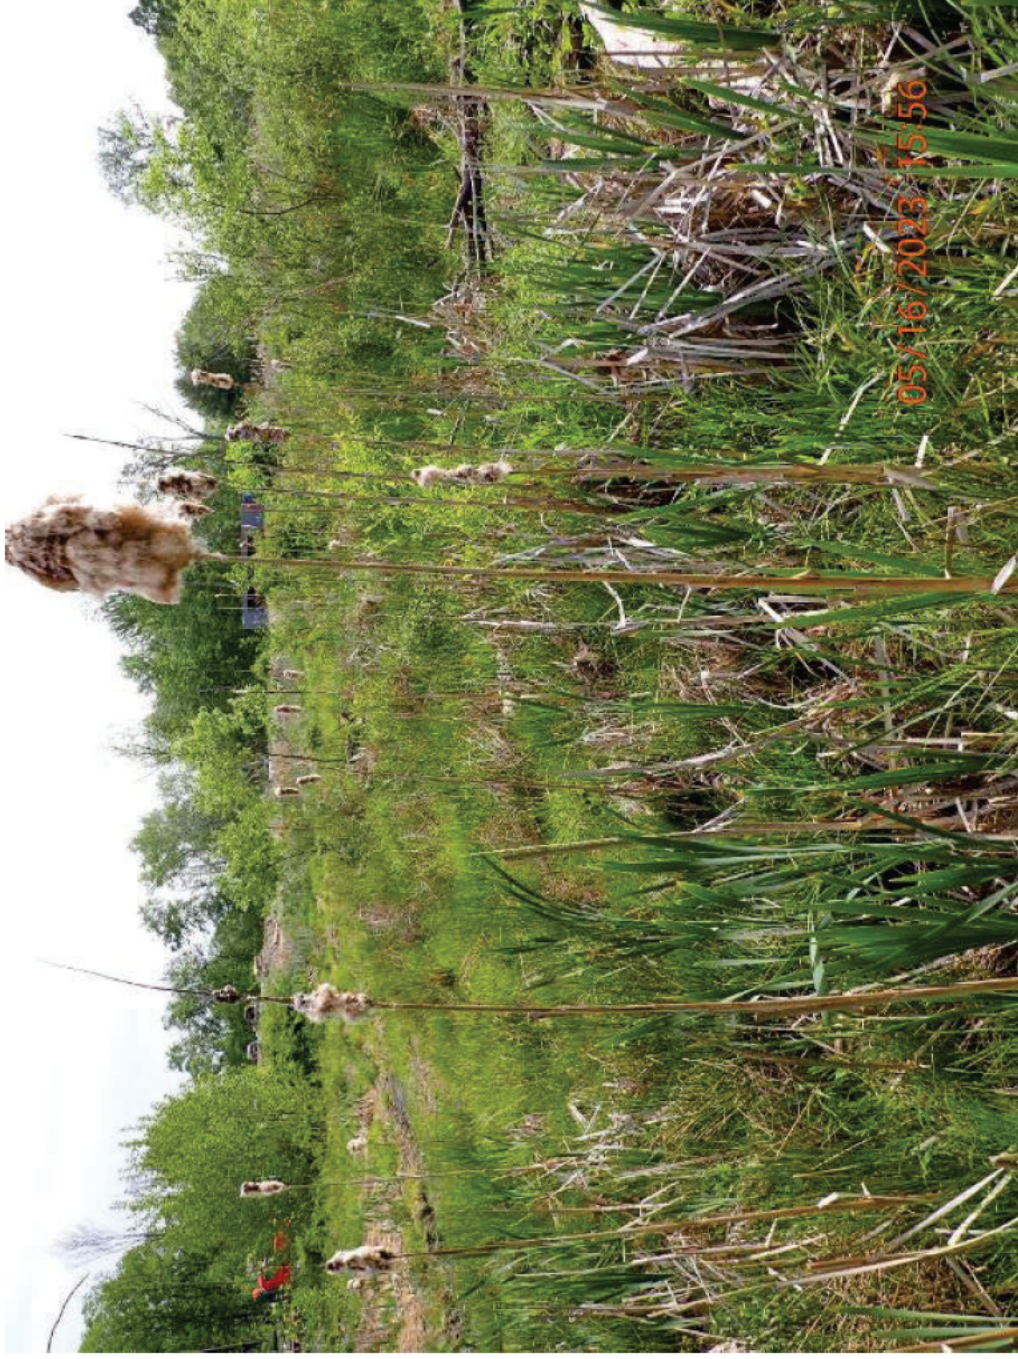
**Date:** 5/16/2023  
**Time:** 3:56 PM  
**Photographer:** SSA  
**Photo ID:** 9 – P5160051

**Description:**  
(2/4) Potential wetland to  
upland transition

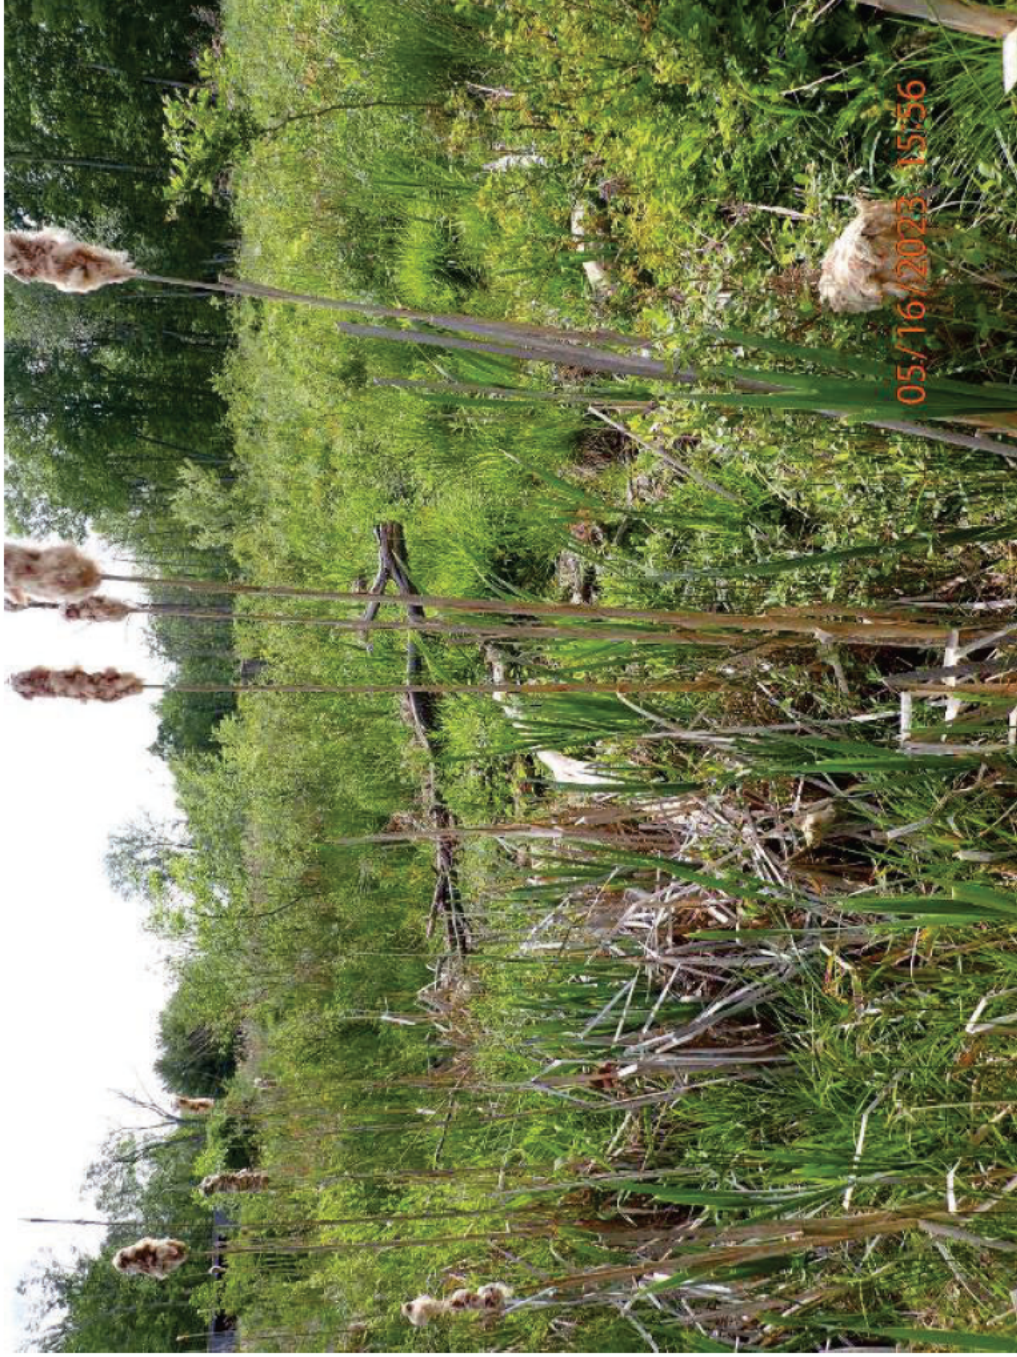
**Date:** 5/16/2023  
**Time:** 3:56 PM  
**Photographer:** SSA  
**Photo ID:** 10 – P5160052

**Description:**  
(3/4) Potential wetland to  
upland transition

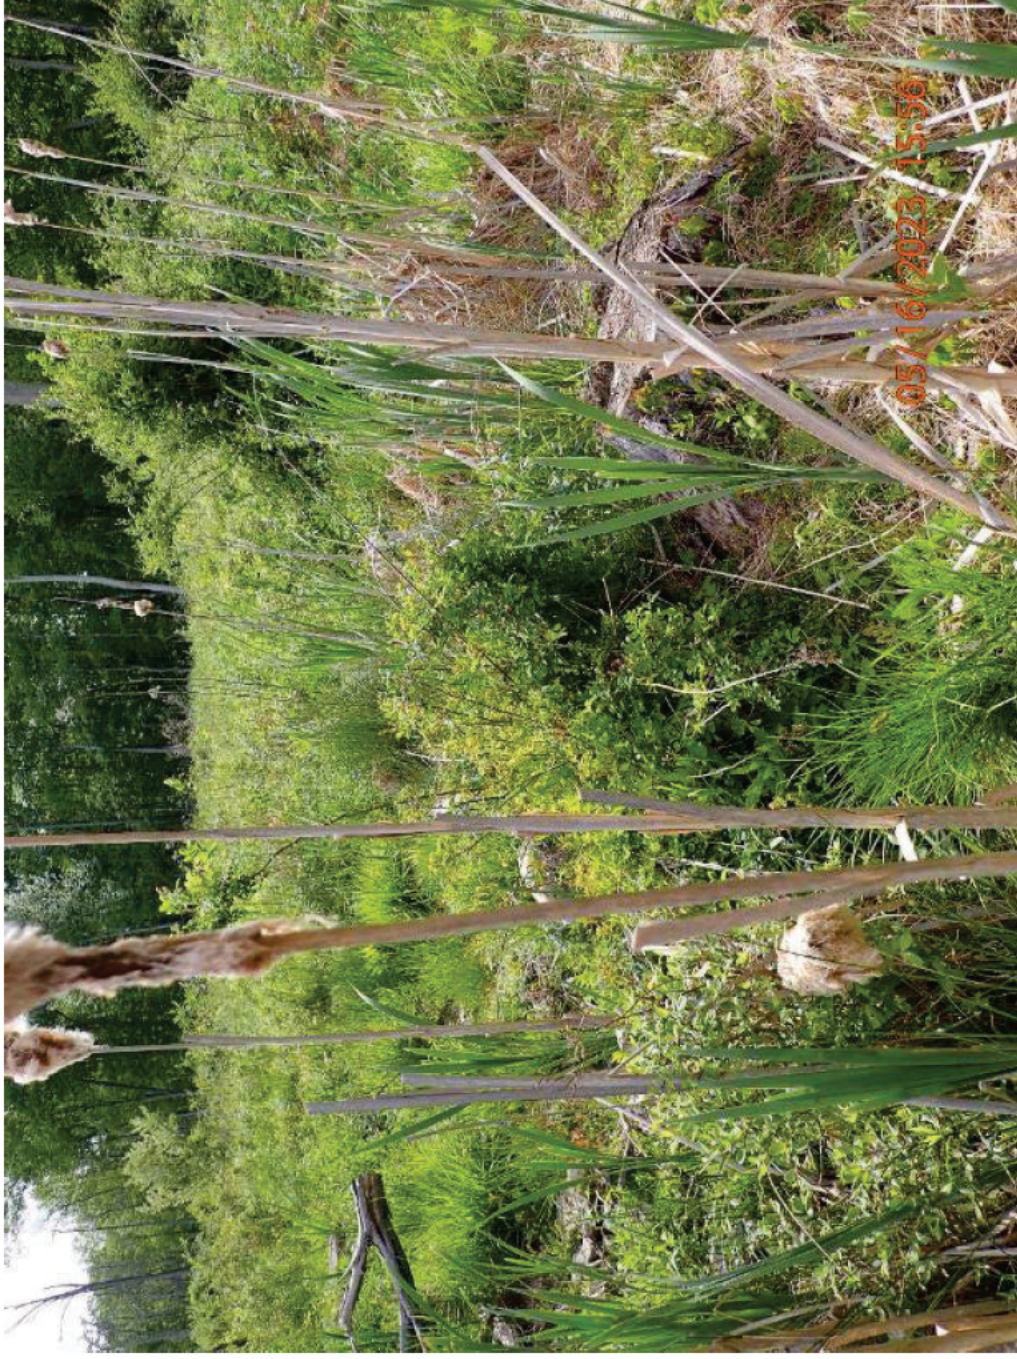
**Date:** 5/16/2023  
**Time:** 3:56 PM  
**Photographer:** SSA  
**Photo ID:** 11 – P5160053

**Description:**  
(4/4) Potential wetland to  
upland transition

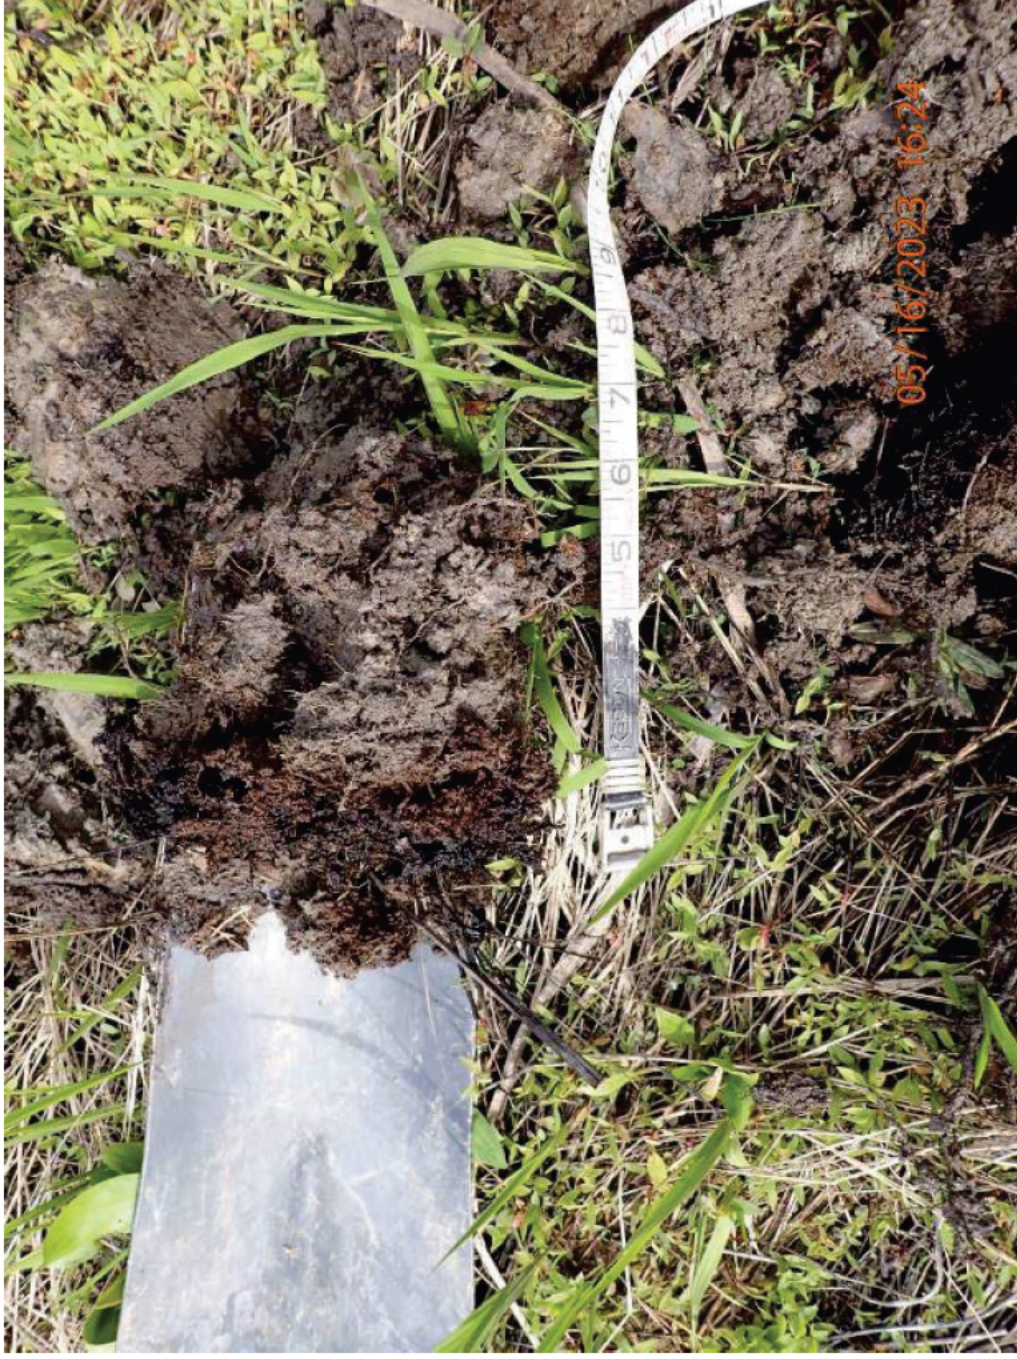
**Date:** 5/16/2023  
**Time:** 4:24 PM  
**Photographer:** SSA  
**Photo ID:** 12 – P5160054  
**Description:**  
Soil profile

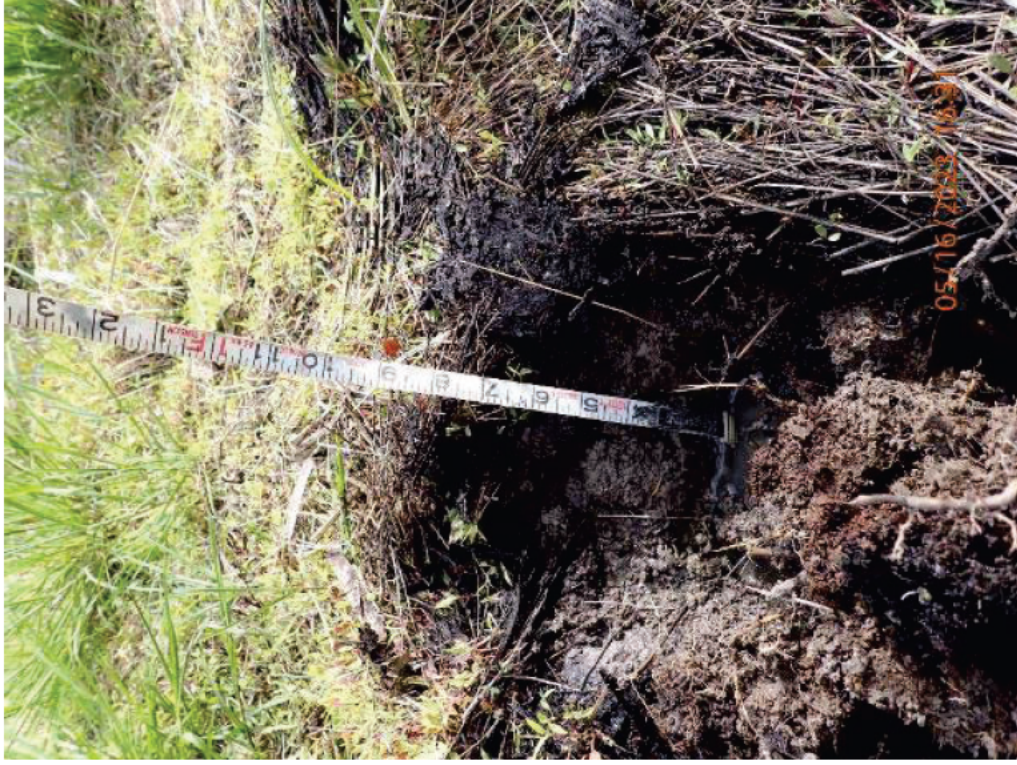
**Date:** 5/16/2023  
**Time:** 4:31 PM  
**Photographer:** SSA  
**Photo ID:** 13 – P5160055  
**Description:**  
Soil pit
