## Clean Water Act Section 404: Site Visit/Case Development

| Site Name | Bart Wodzinski Property - 41 Bowery Lane | | | | |

CWA 404 Inspection Photolog  
Wodzinski Property  
41 Bowery Lane  
Minisink, Orange County, NY

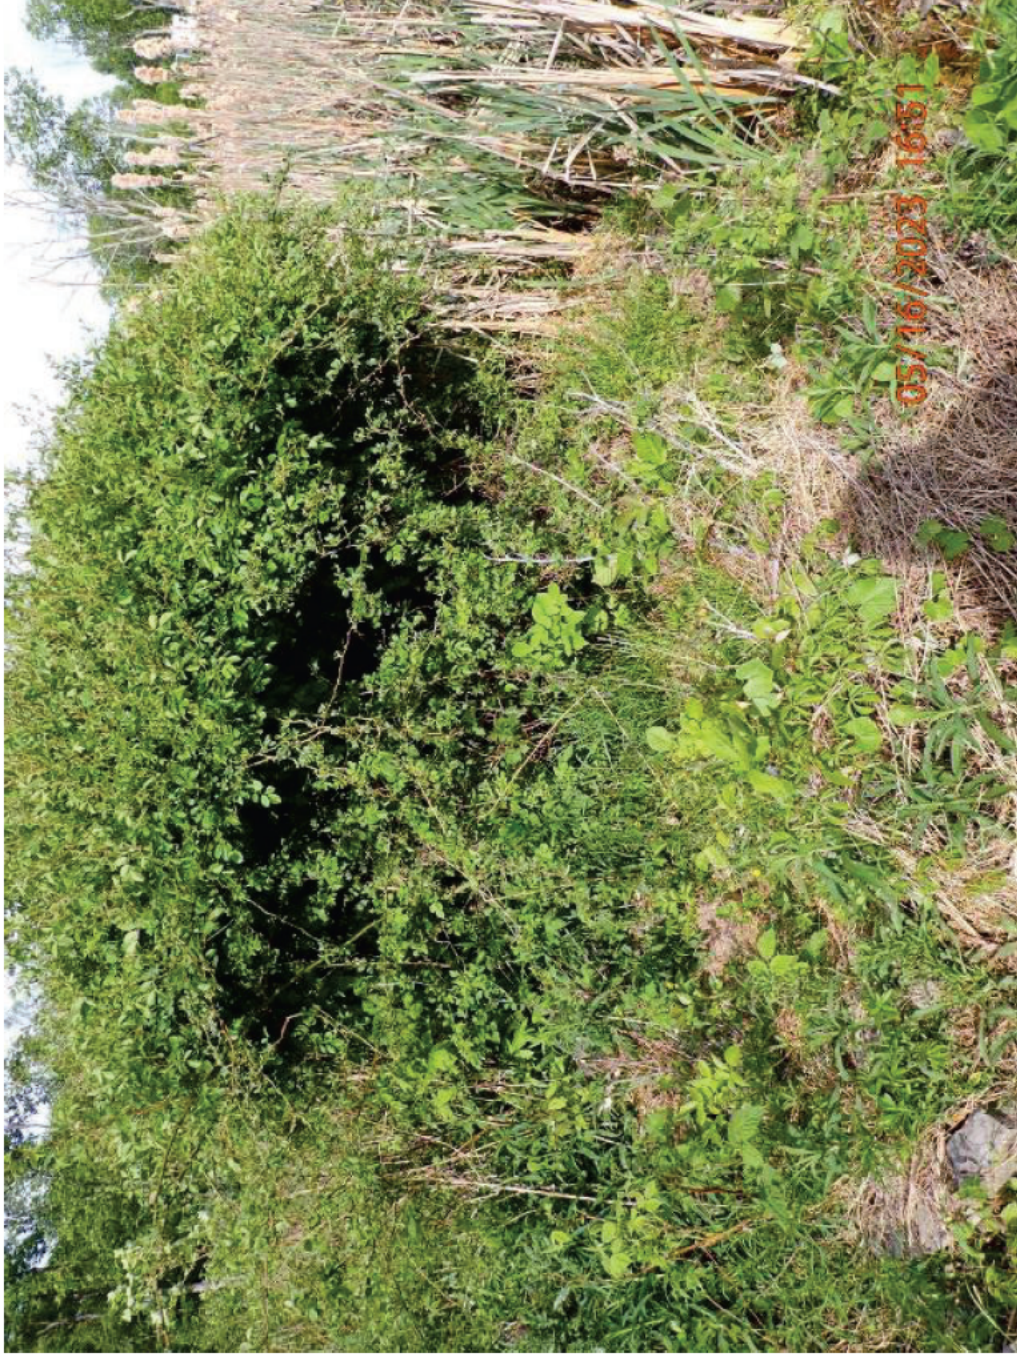
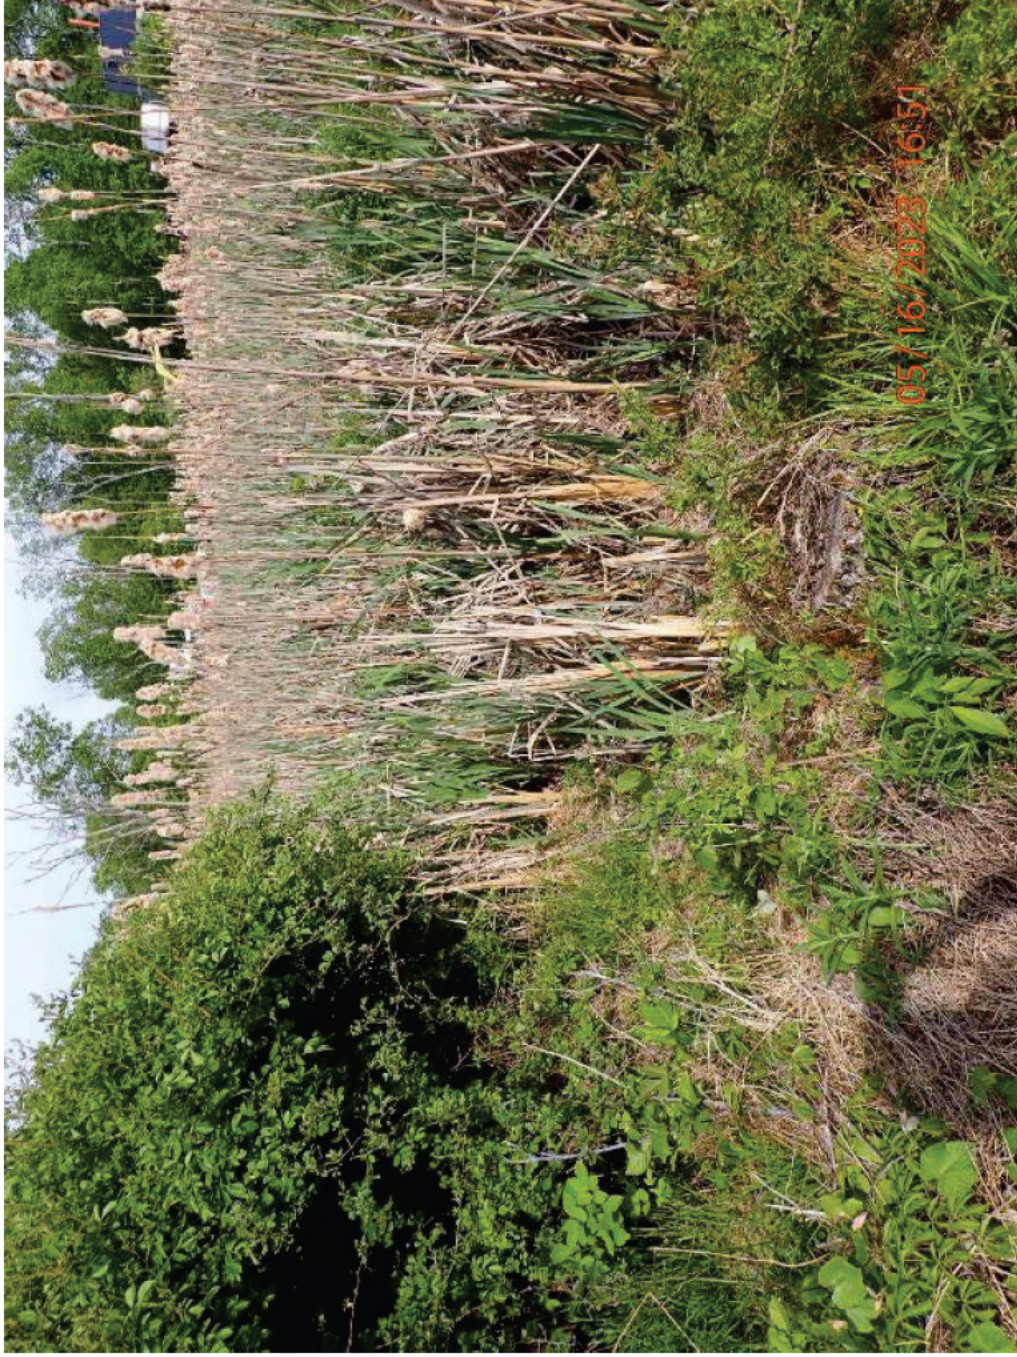
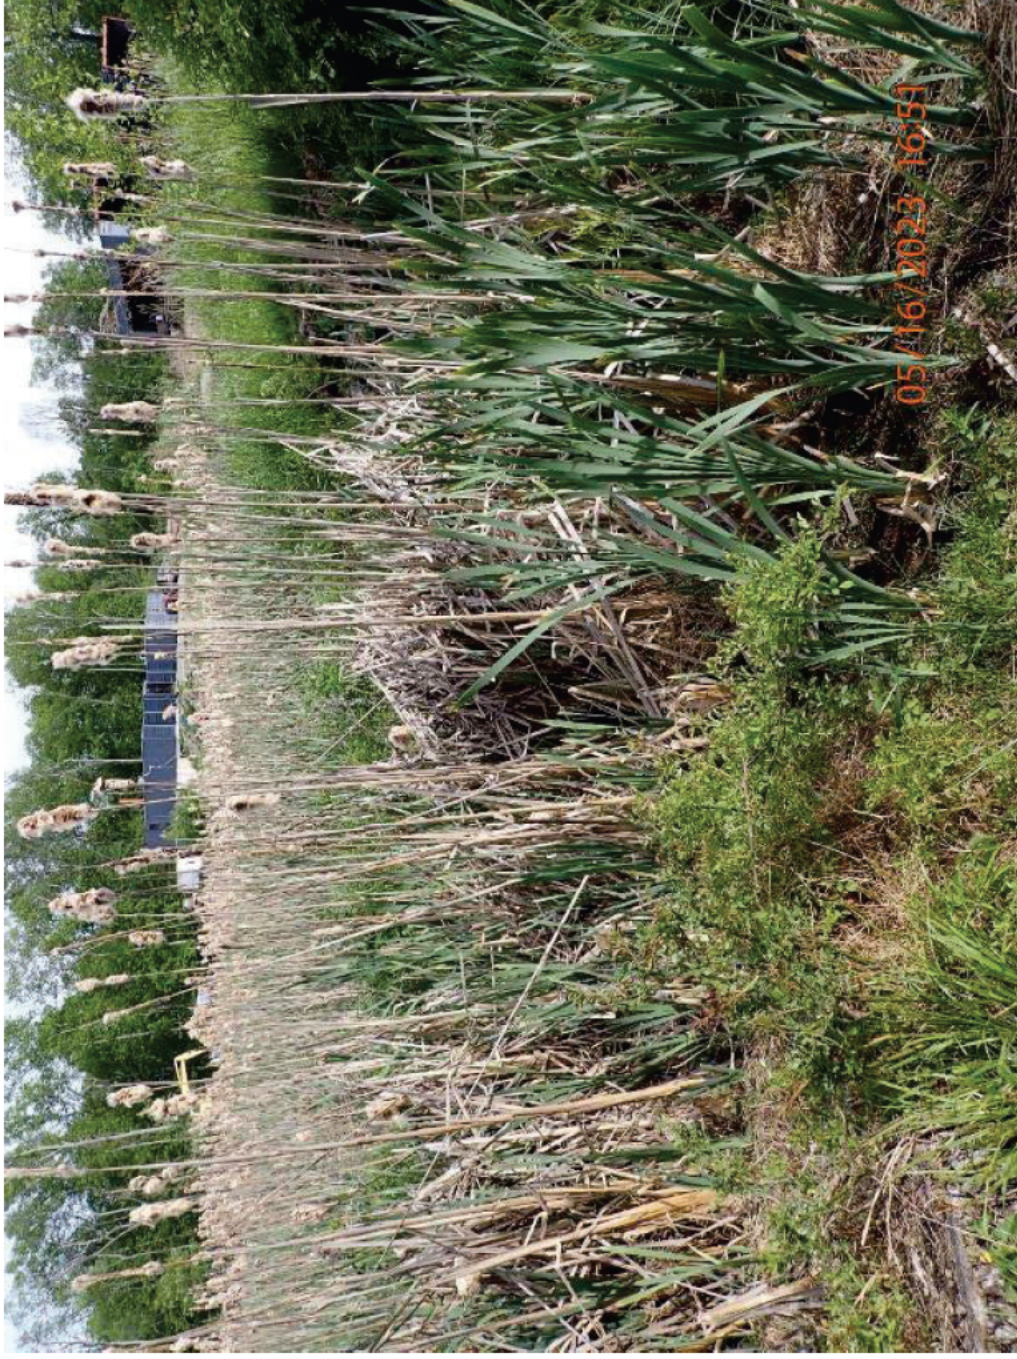
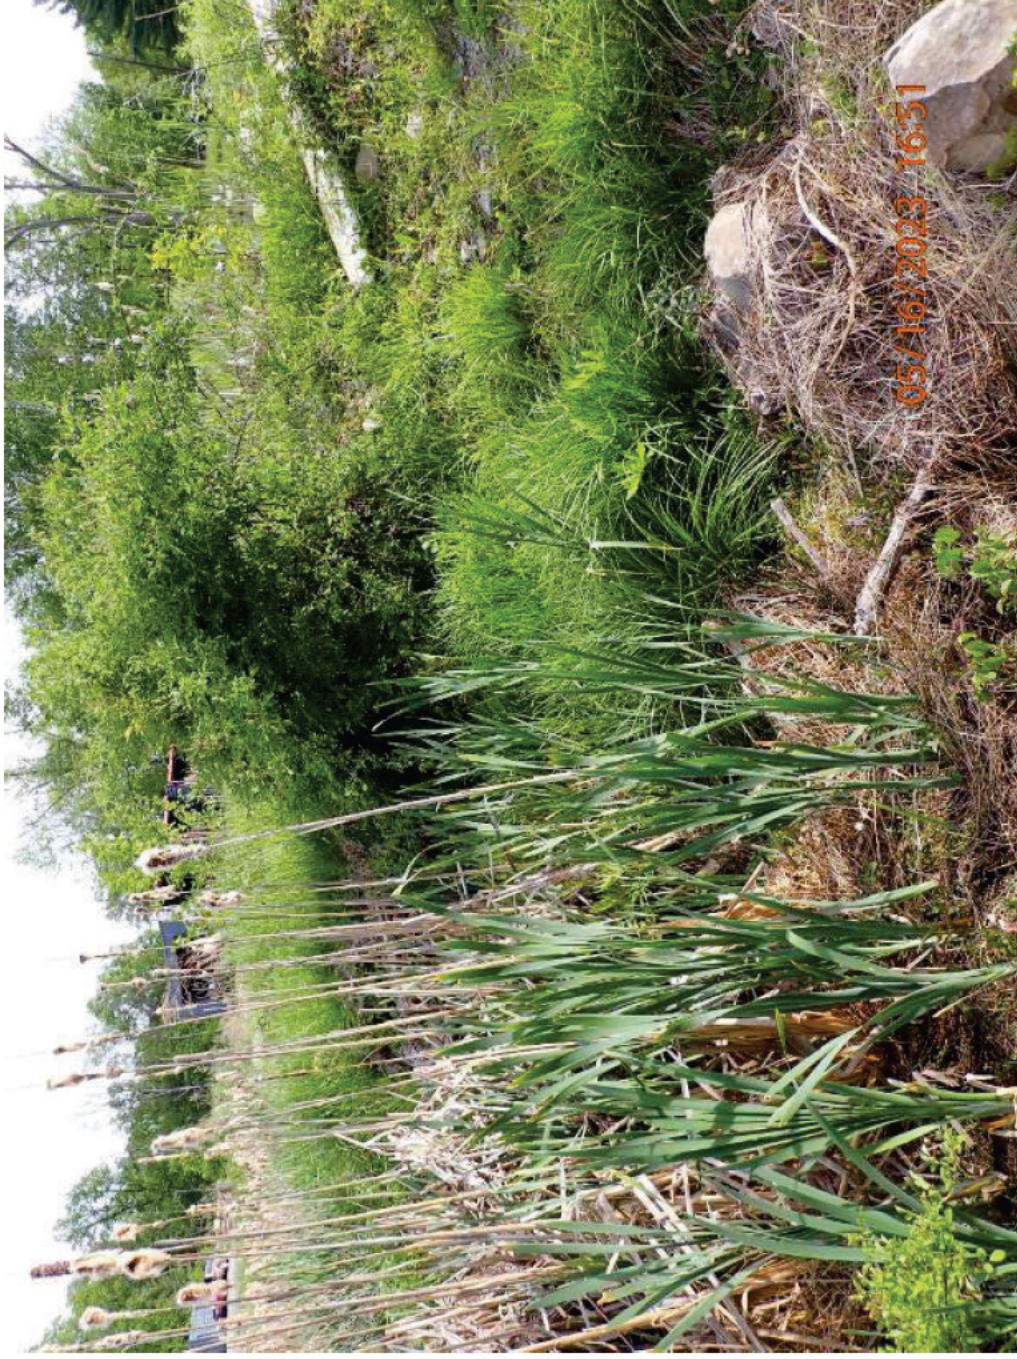
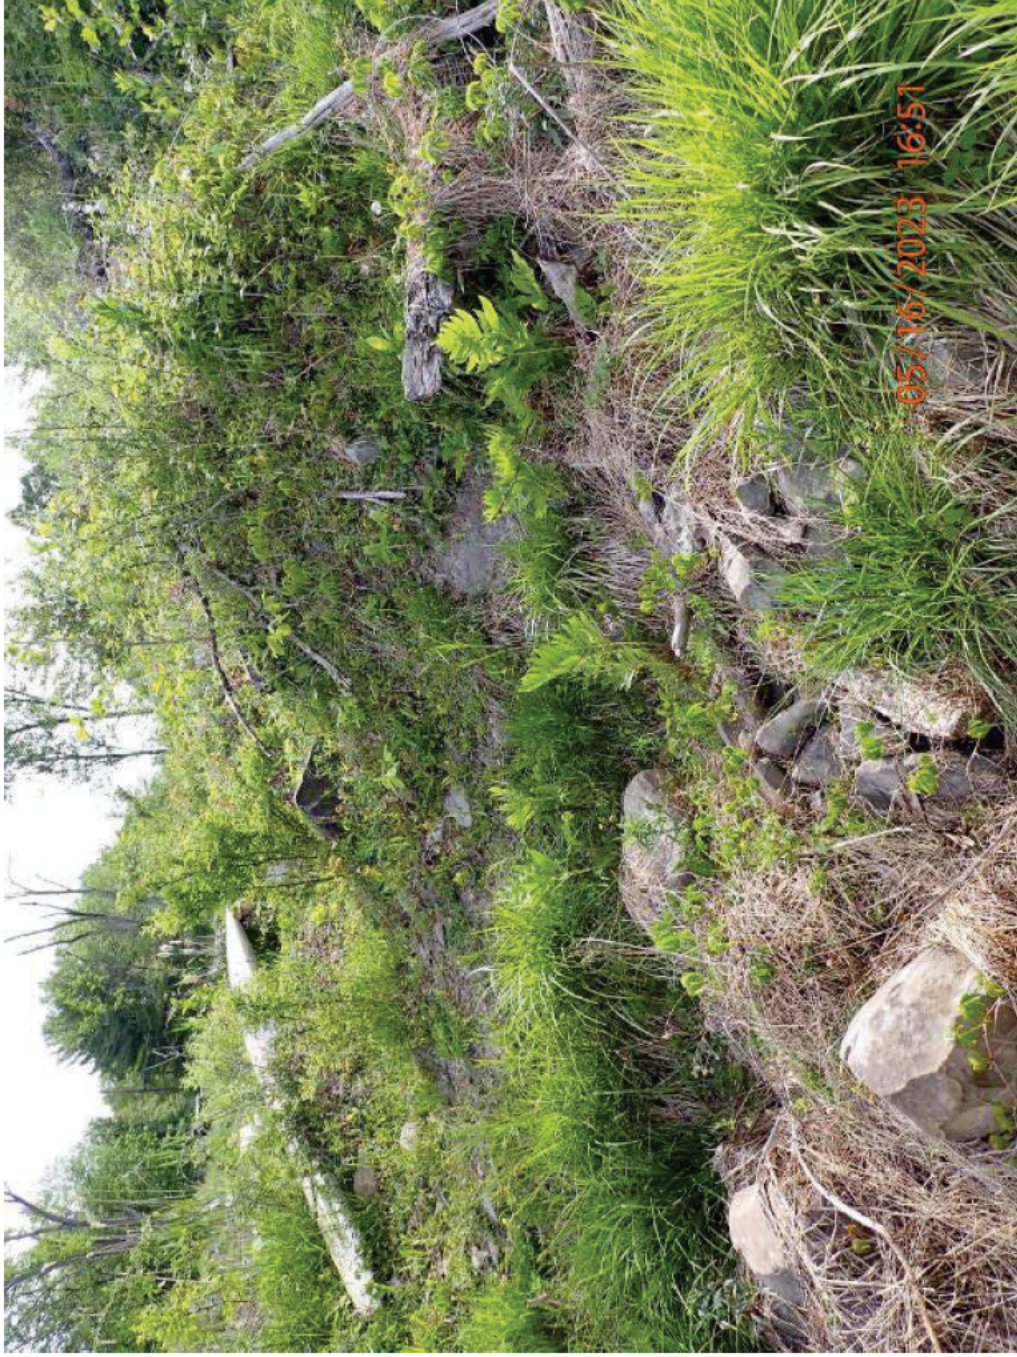
(1/5) Panorama of wetland edge

(2/5) Panorama of wetland edge

(3/5) Panorama of wetland edge

(4/5) Panorama of wetland edge

(5/5) Panorama of wetland edge

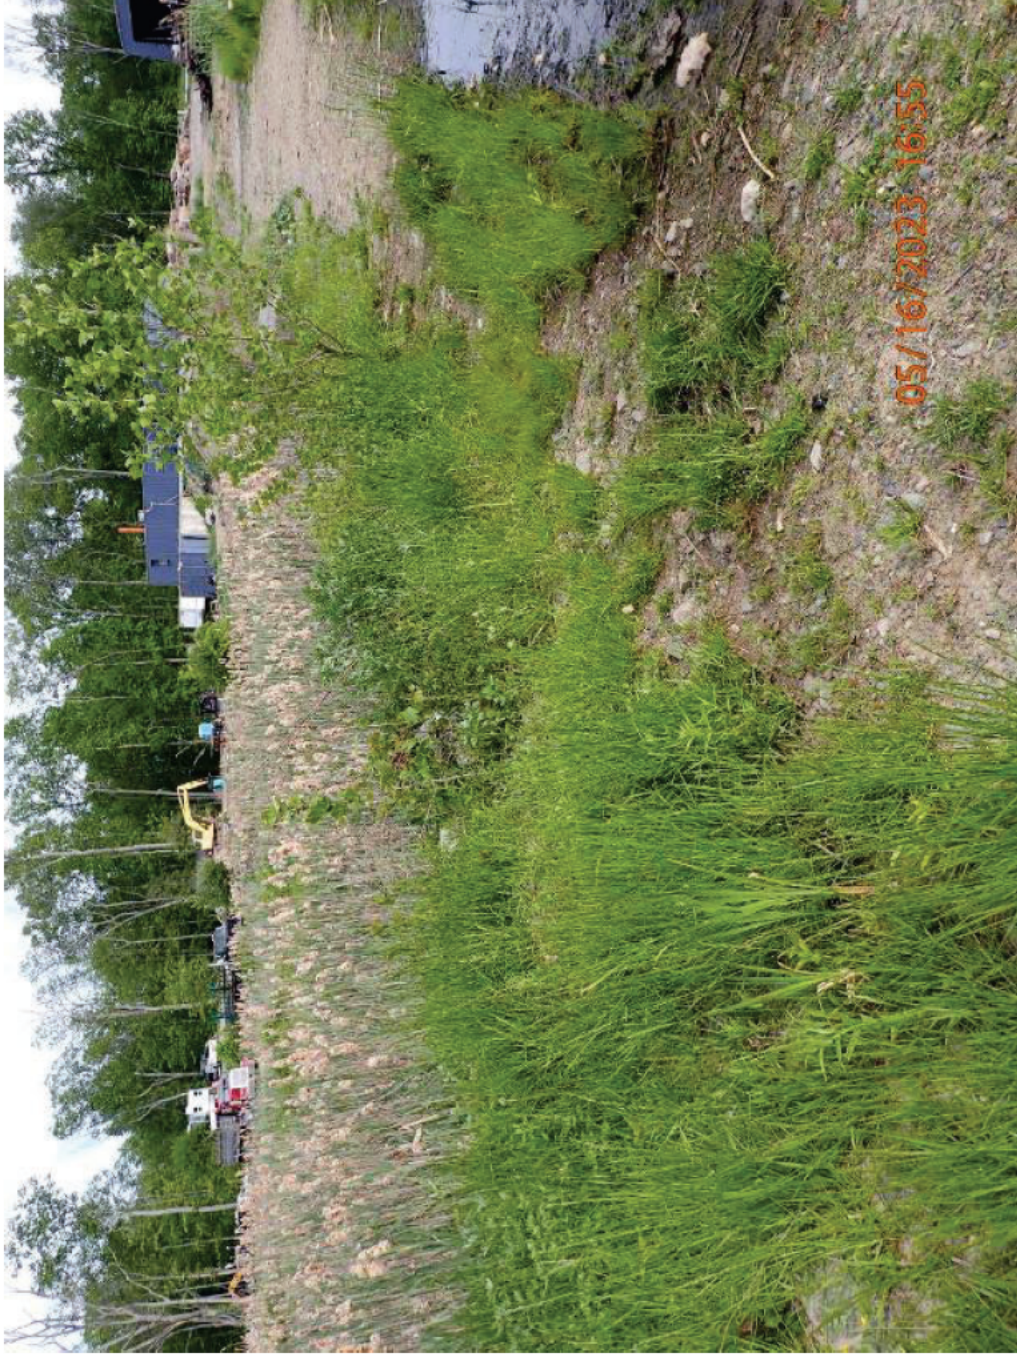
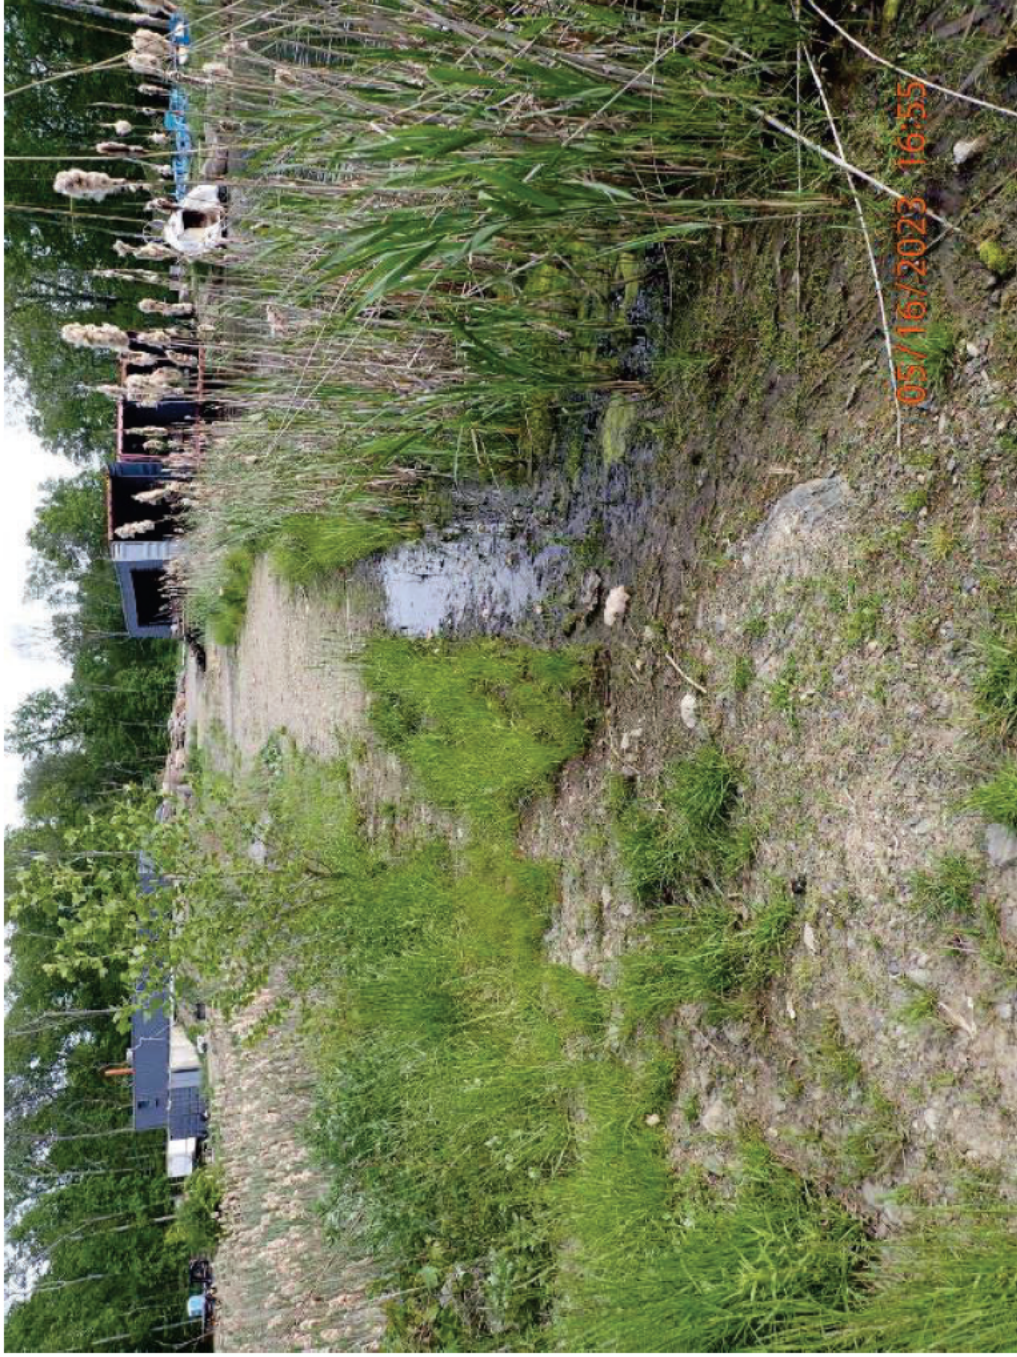
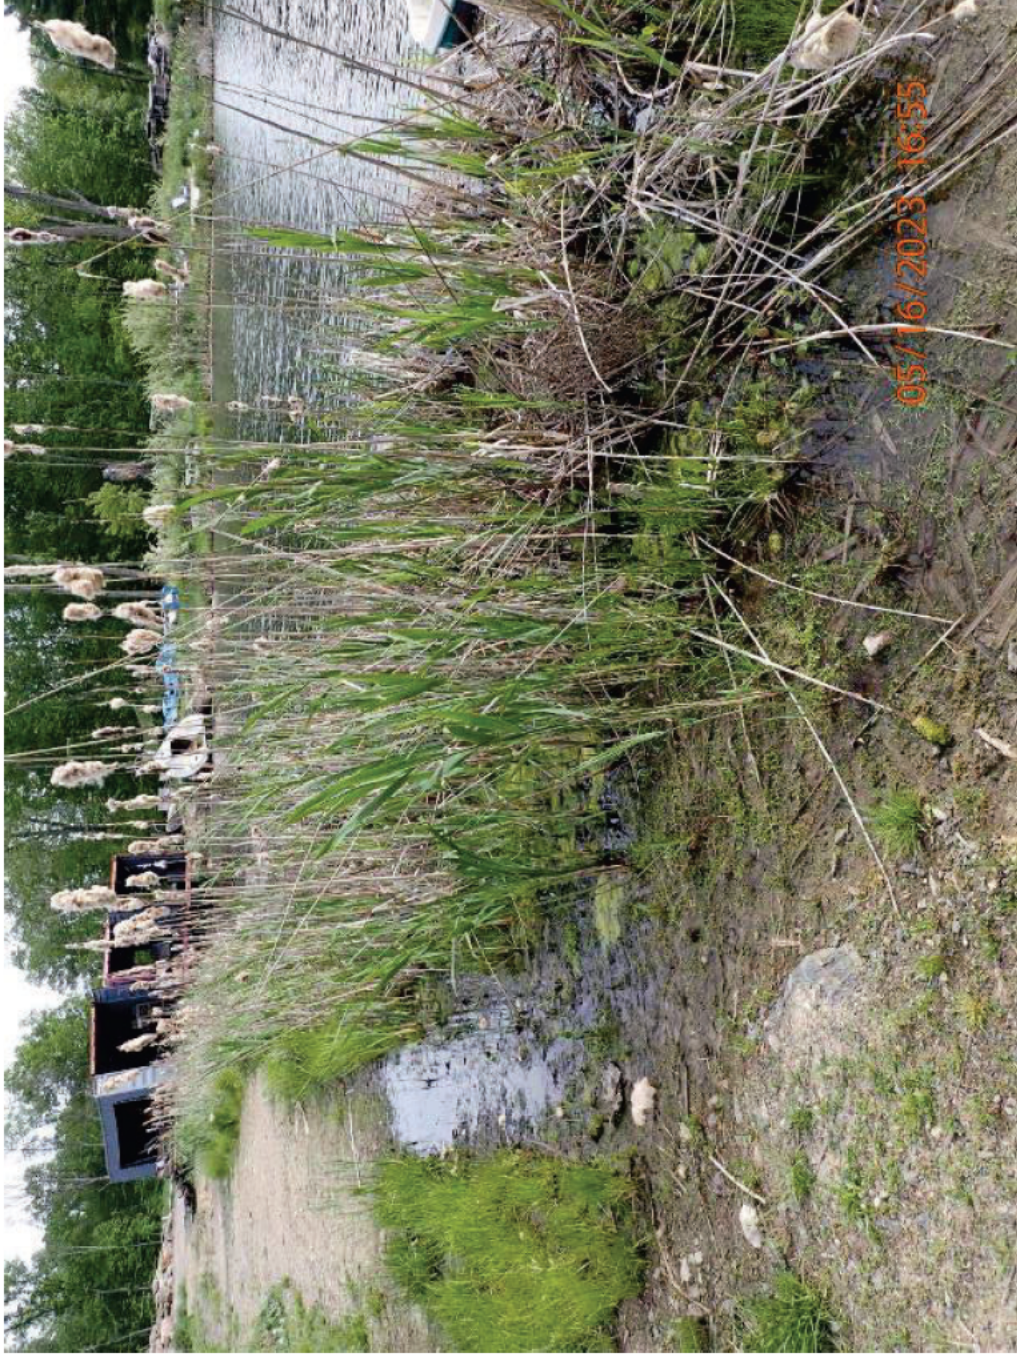
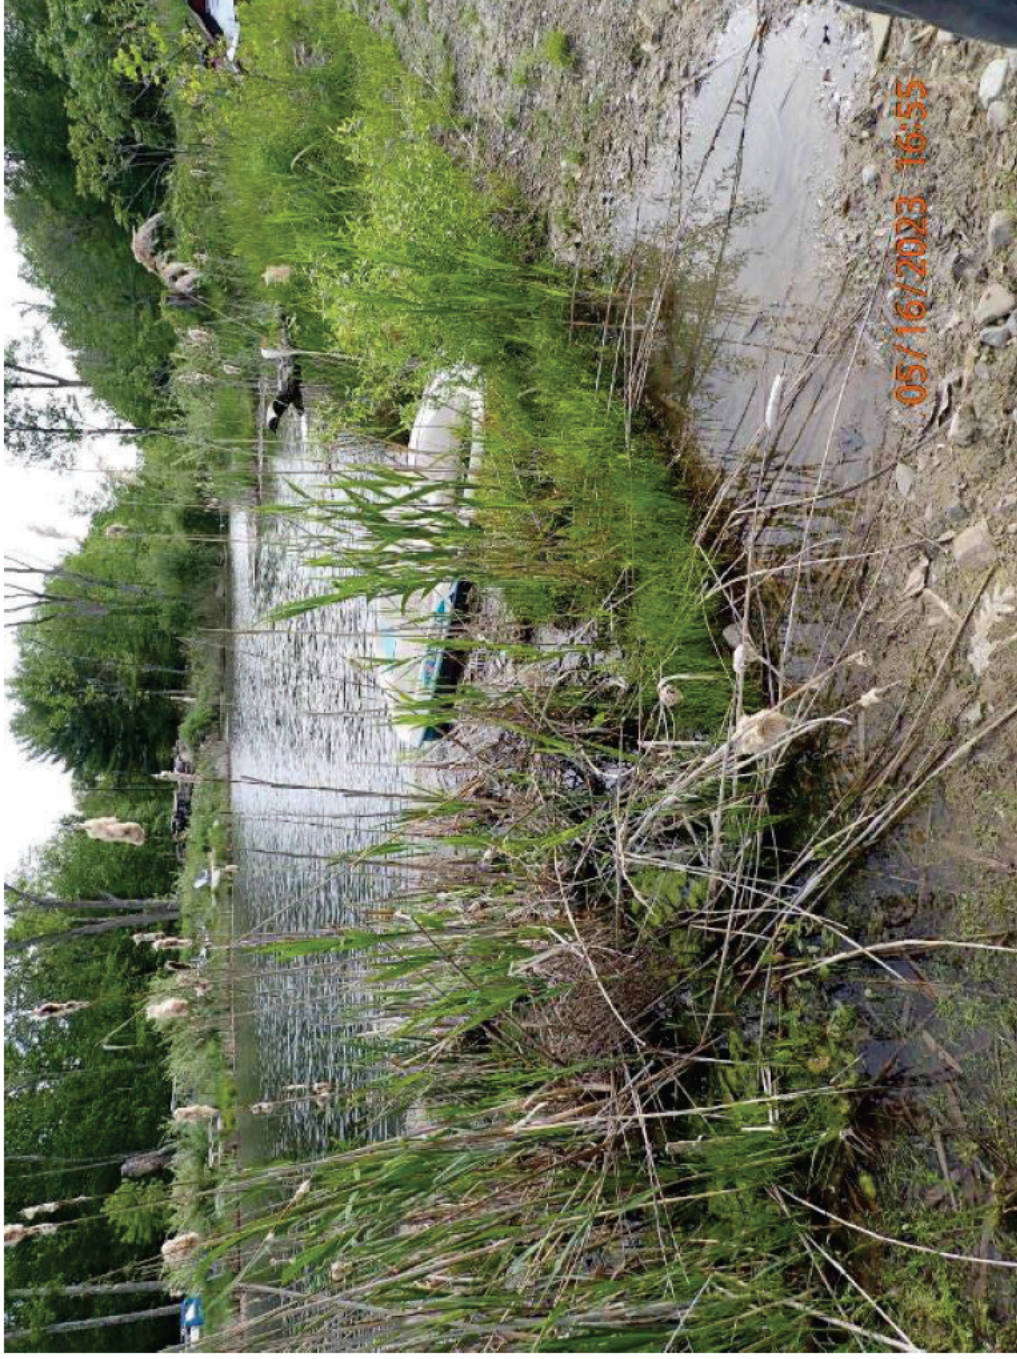
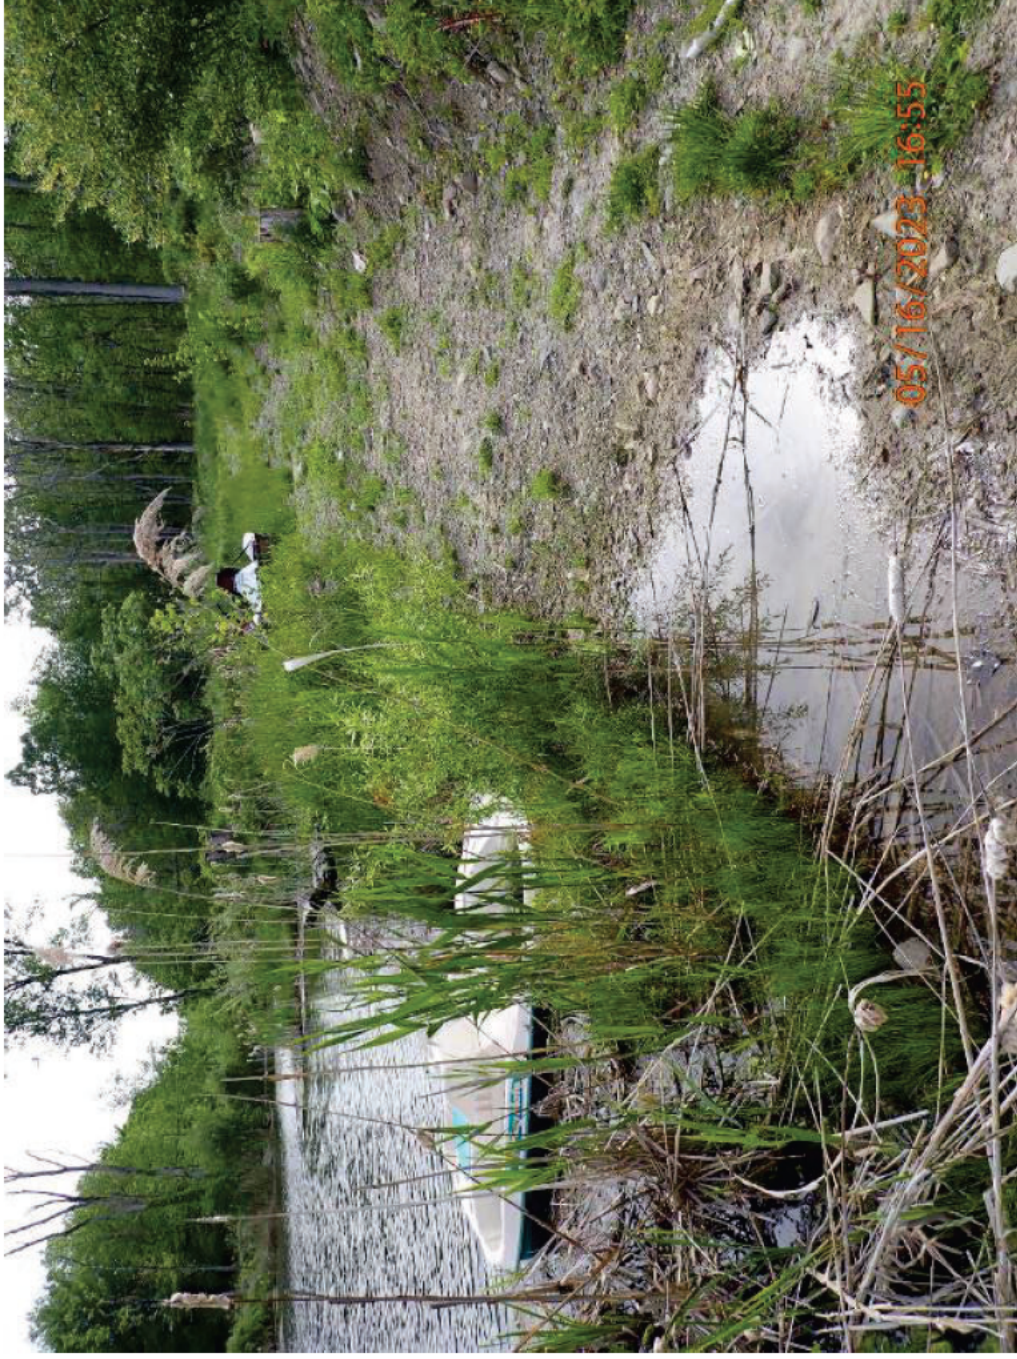
**Description:**  
(1/5) Panorama of wetland,  
dam, and pond

**Description:**  
(2/5) Panorama of wetland,  
dam, and pond

(3/5) Panorama of wetland,  
dam, and pond

**Description:**  
(4/5) Panorama of wetland,  
dam, and pond

**Description:**  
(5/5) Panorama of wetland,  
dam, and pond

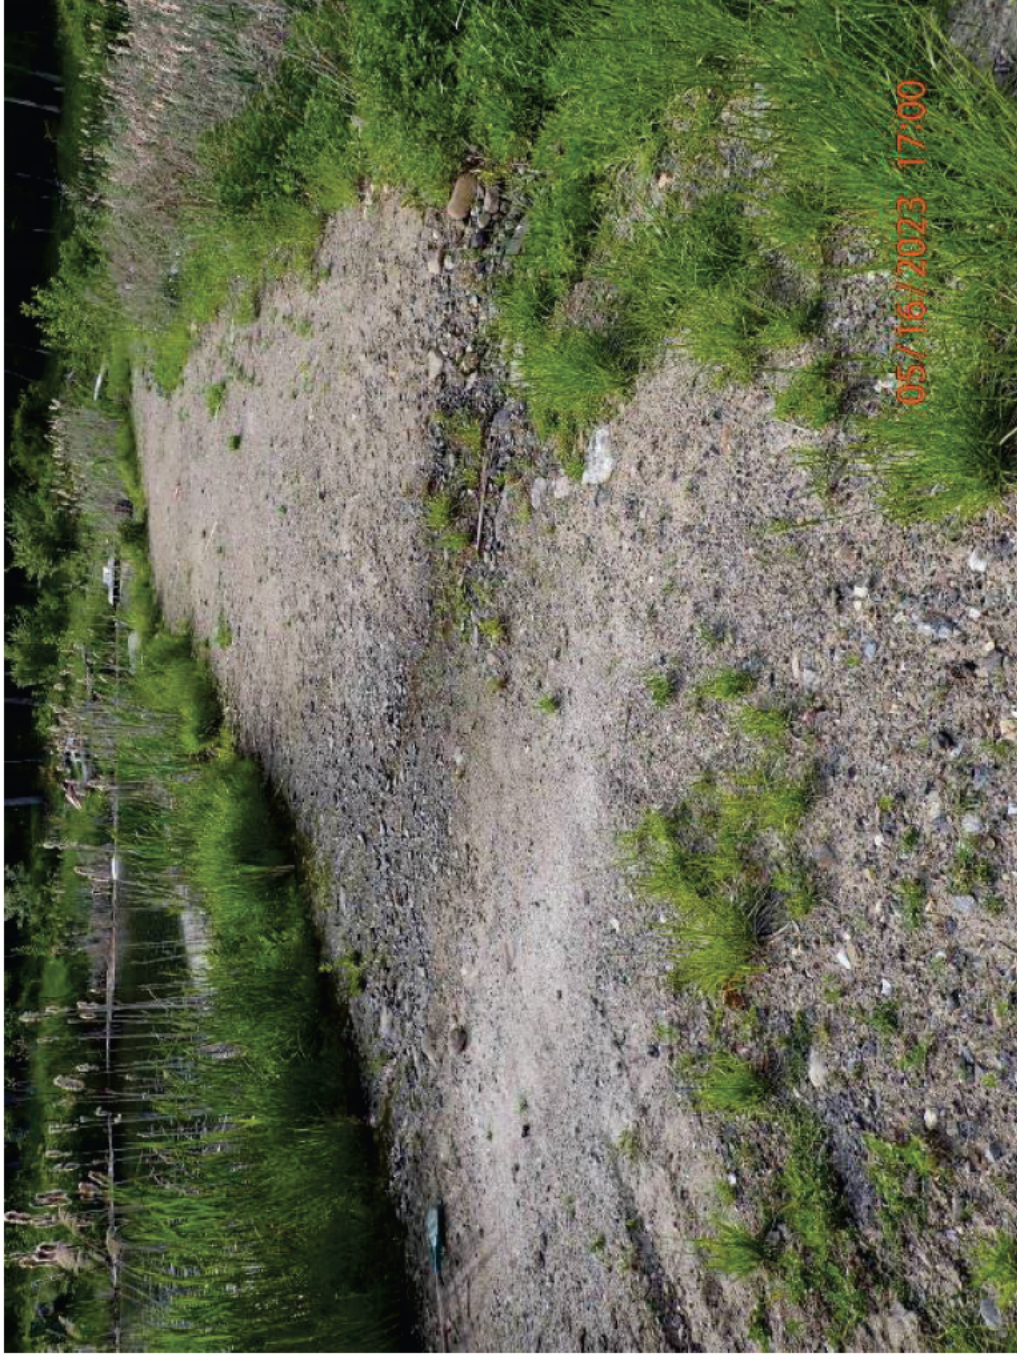
**Date:** 5/16/2023  
**Time:** 5:00 PM  
**Photographer:** SSA  
**Photo ID:** 25 – P5160067

Flow over dam from pond to wetlands

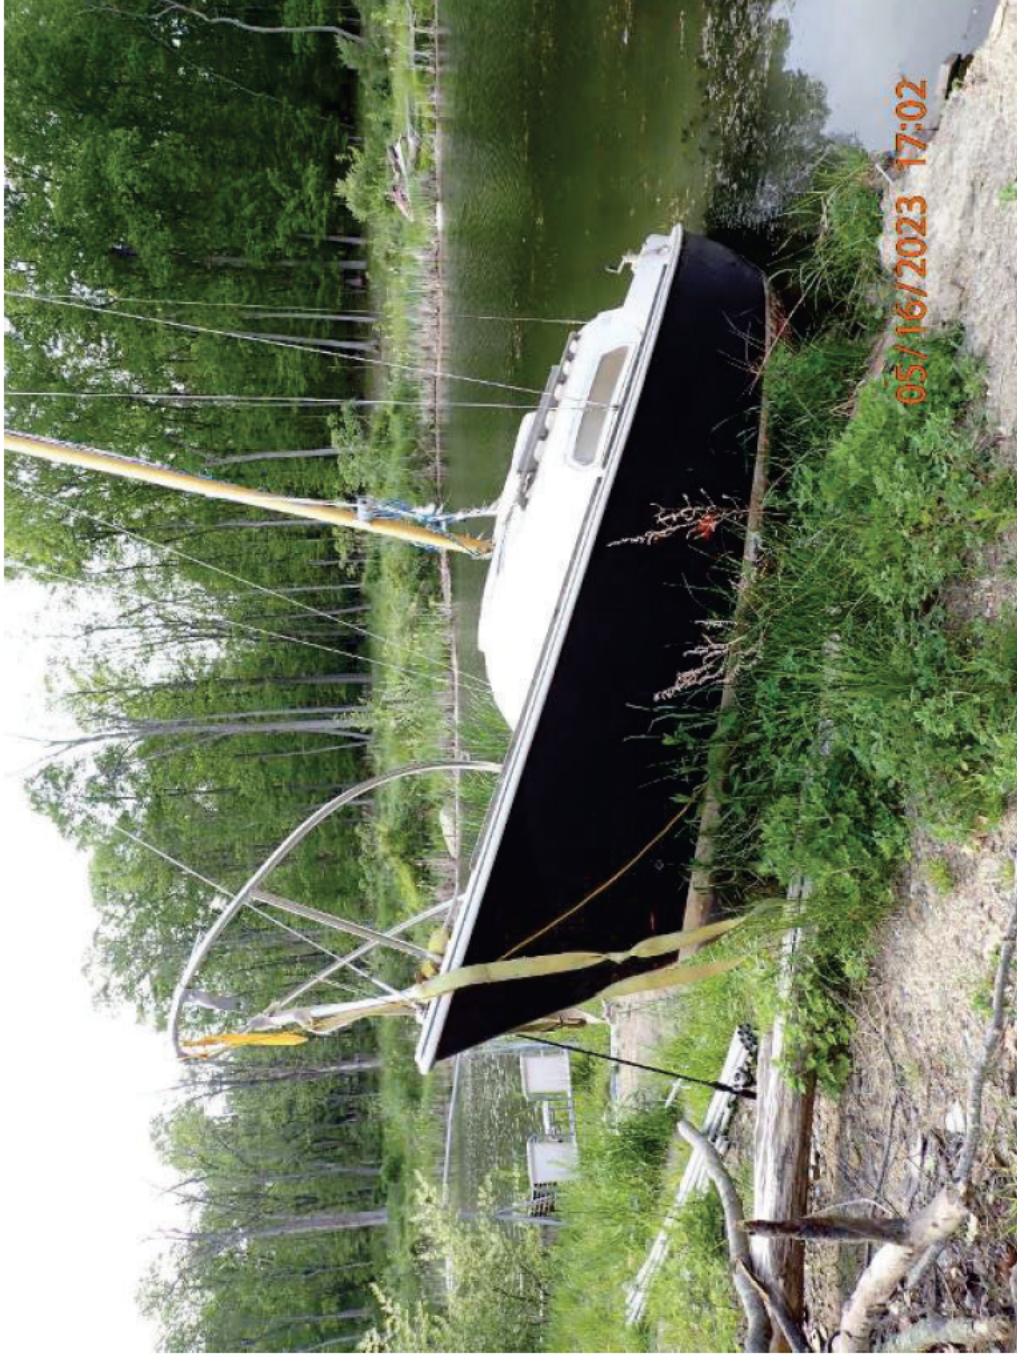
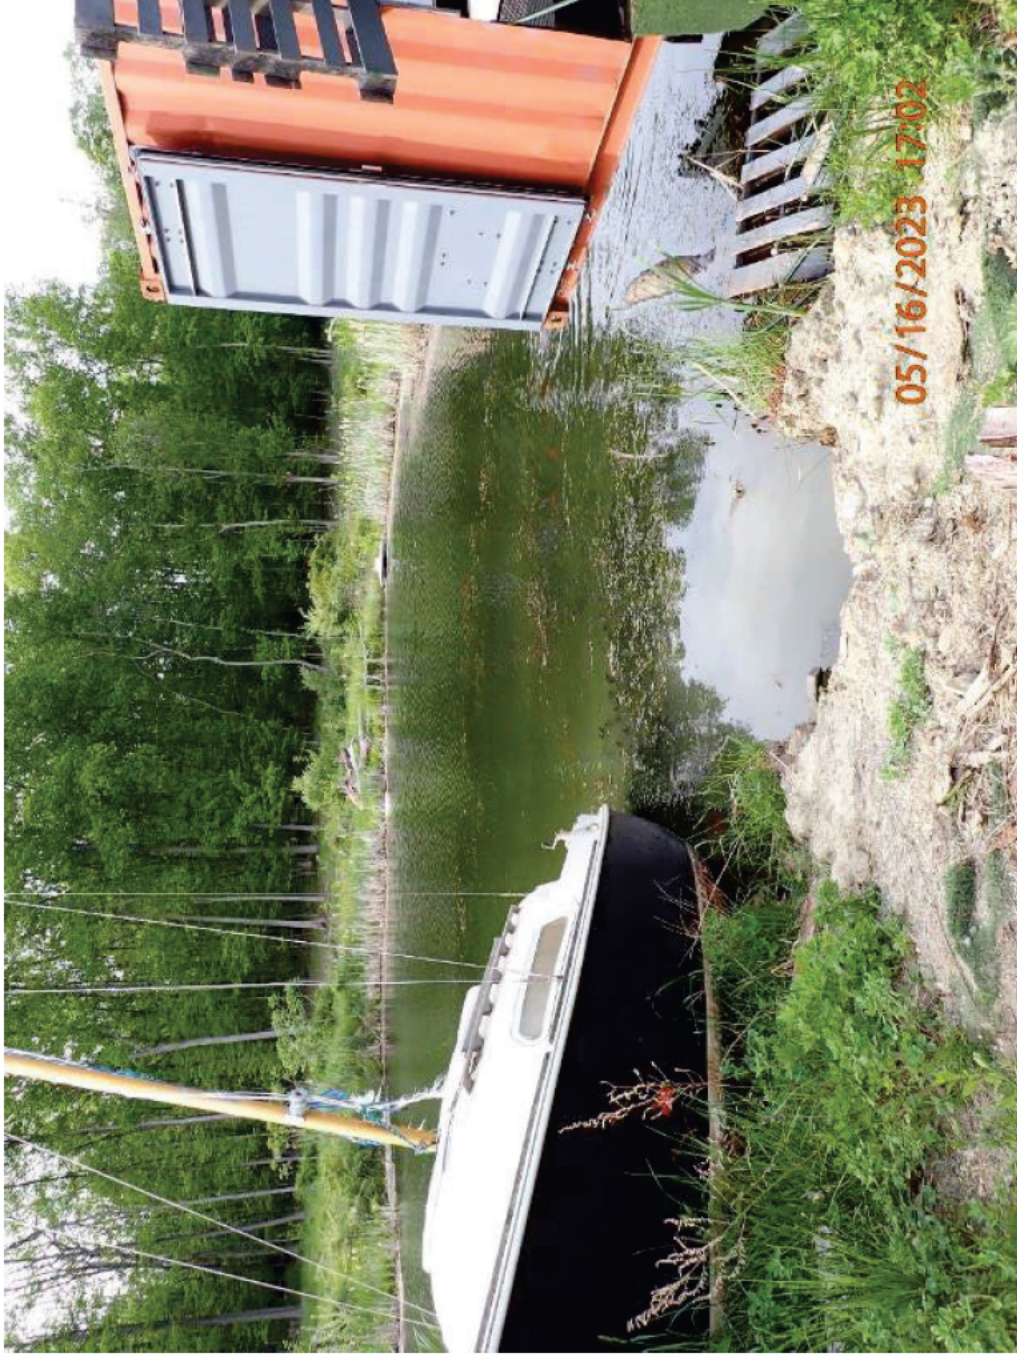
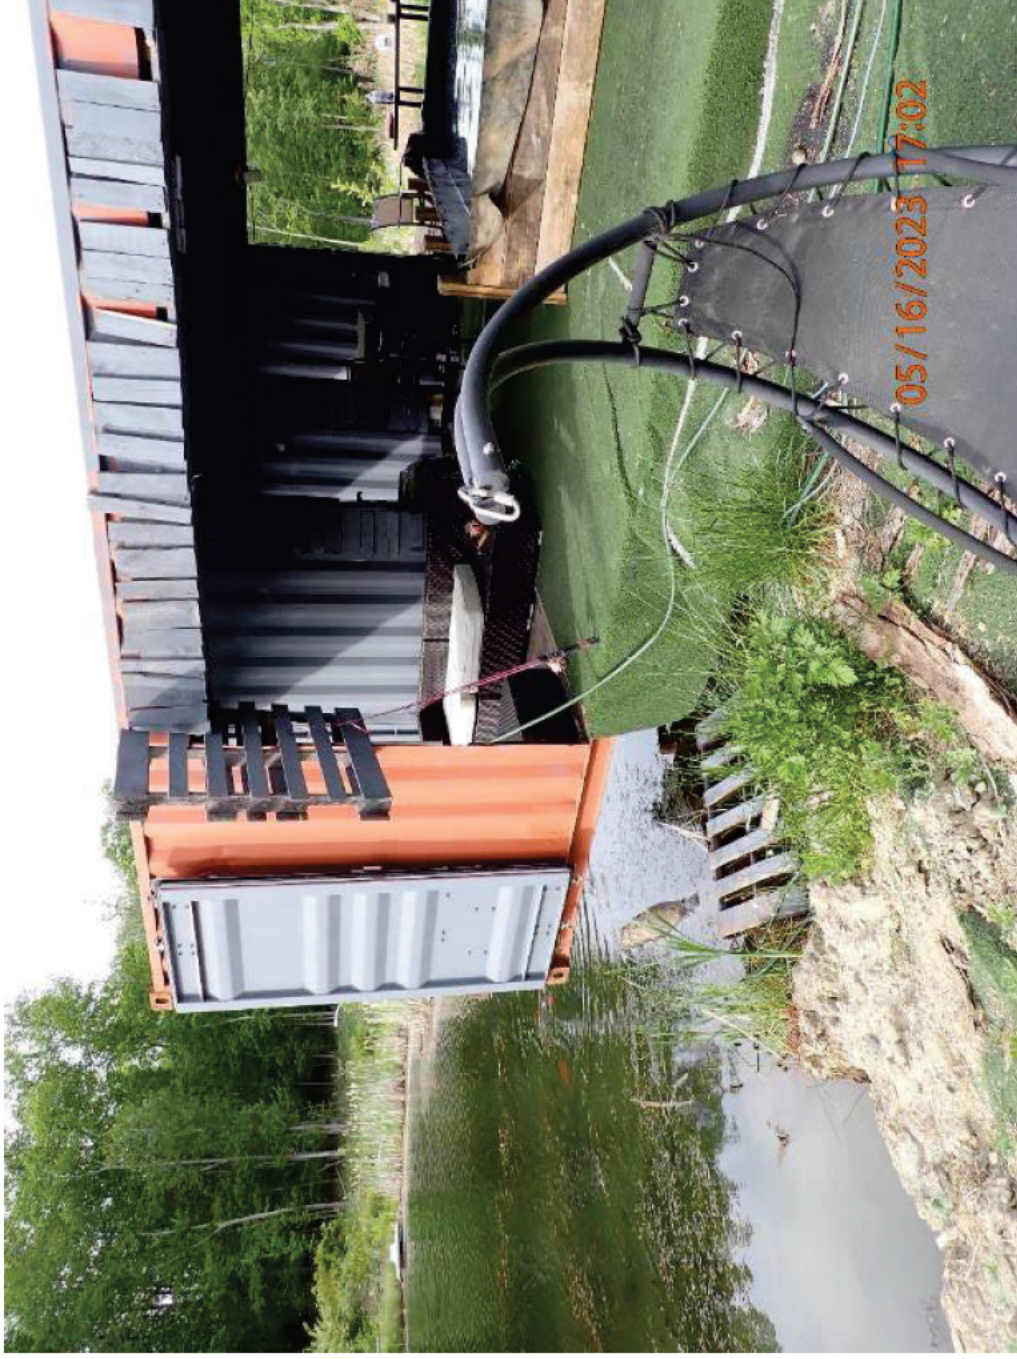
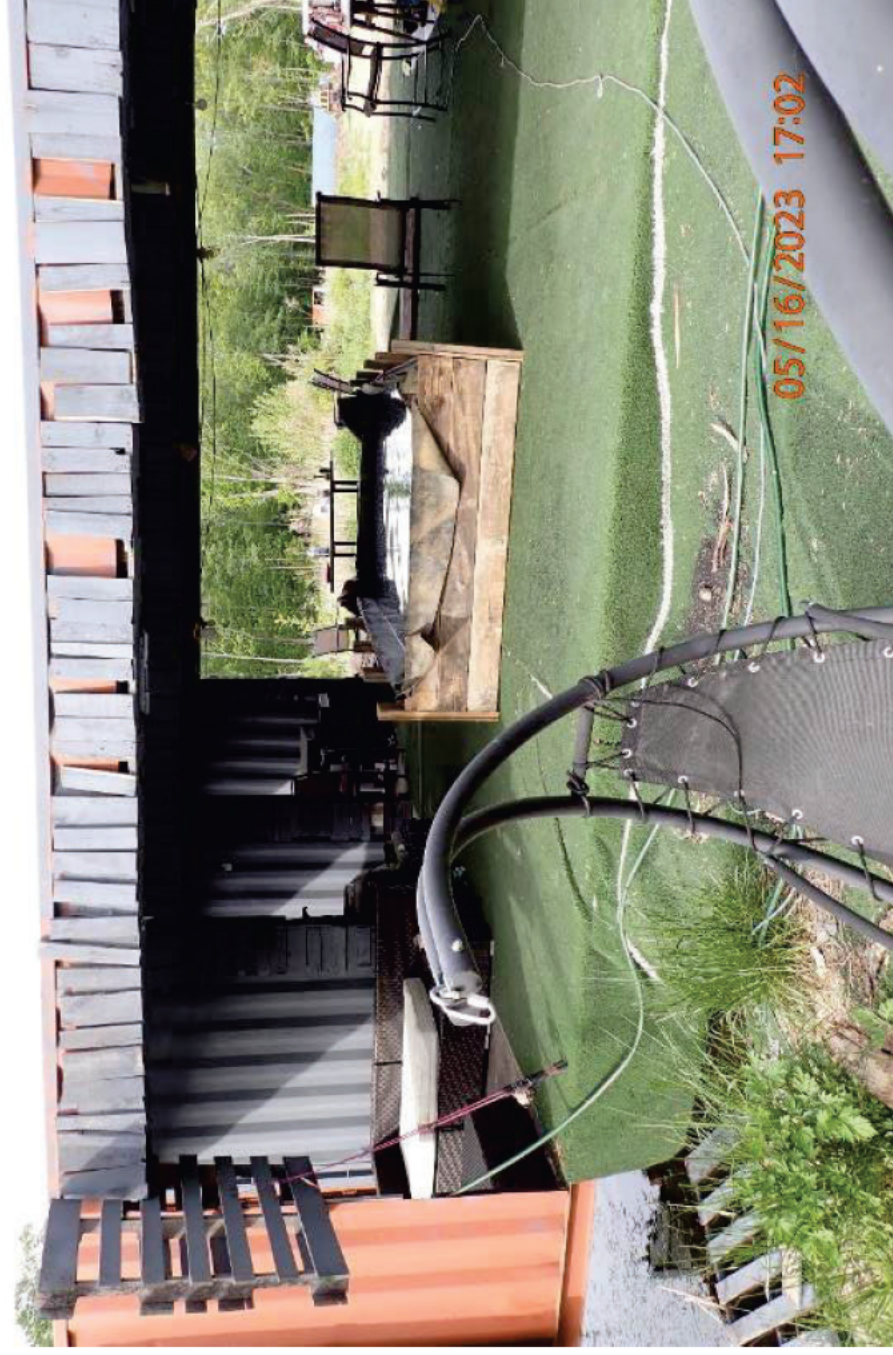
**Description:**  
(1/4) Panorama of pond

**Description:**  
(2/4) Panorama of pond

Description:  
(3/4) Panorama of pond

**Description:**  
(4/4) Panorama of pond

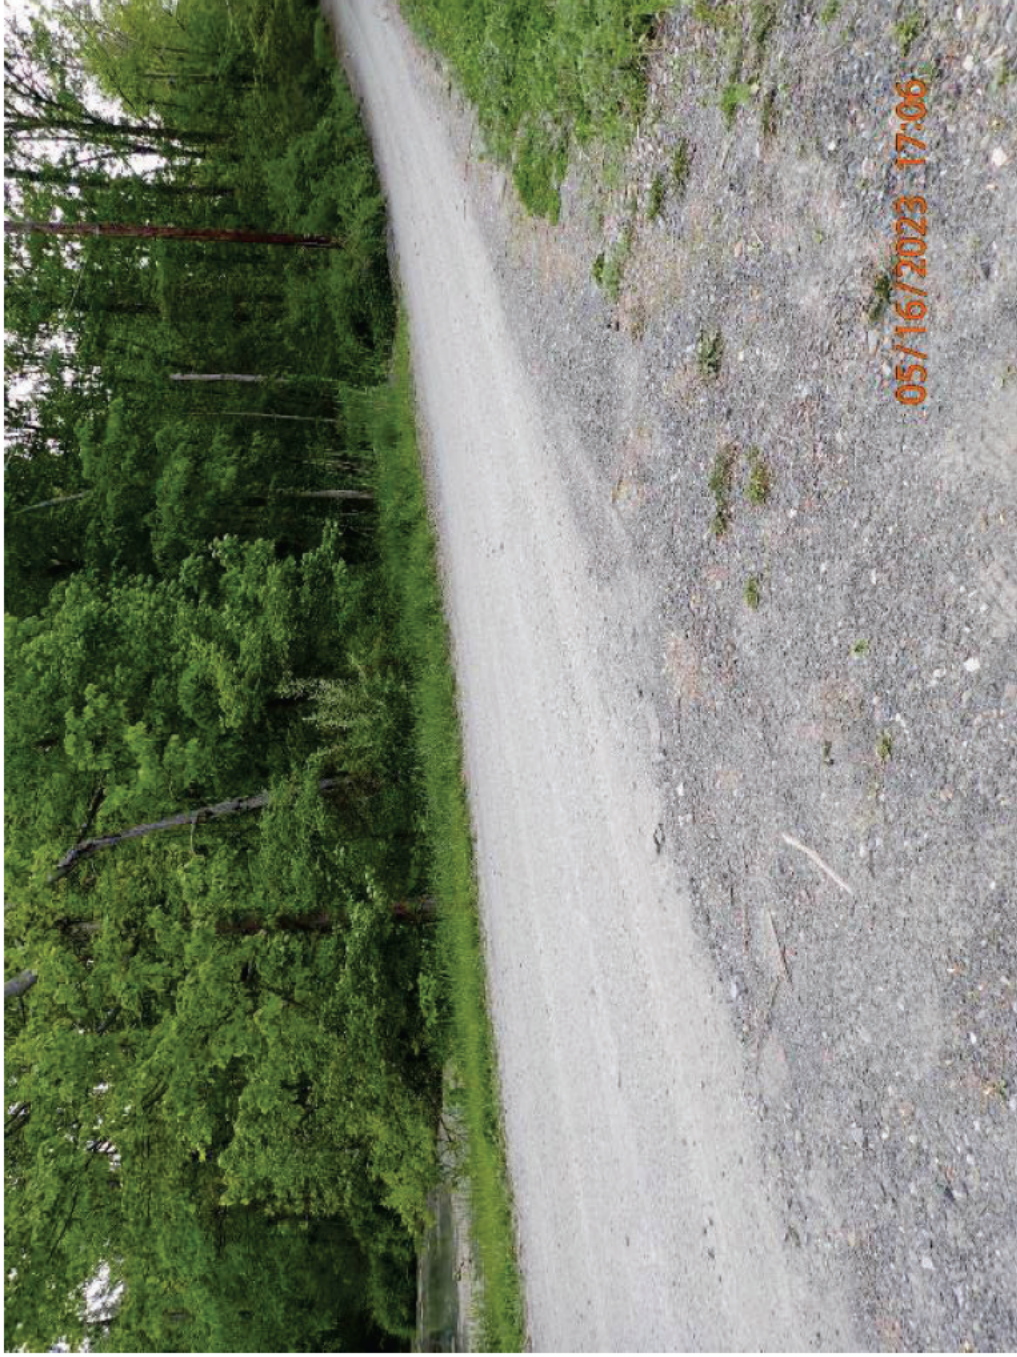
**Date:** 5/16/2023  
**Time:** 5:06 PM  
**Photographer:** SSA  
**Photo ID:** 30 – P5160072

**Description:**  
(1/6) Panorama from road  
beginning at neighboring pond
