## Clean Water Act Section 404: Site Visit/Case Development

| Site Name | Bart Wodzinski Property - 41 Bowery Lane | | | | |

CWA 404 Inspection Photolog  
Wodzinski Property  
41 Bowery Lane  
Minisink, Orange County, NY

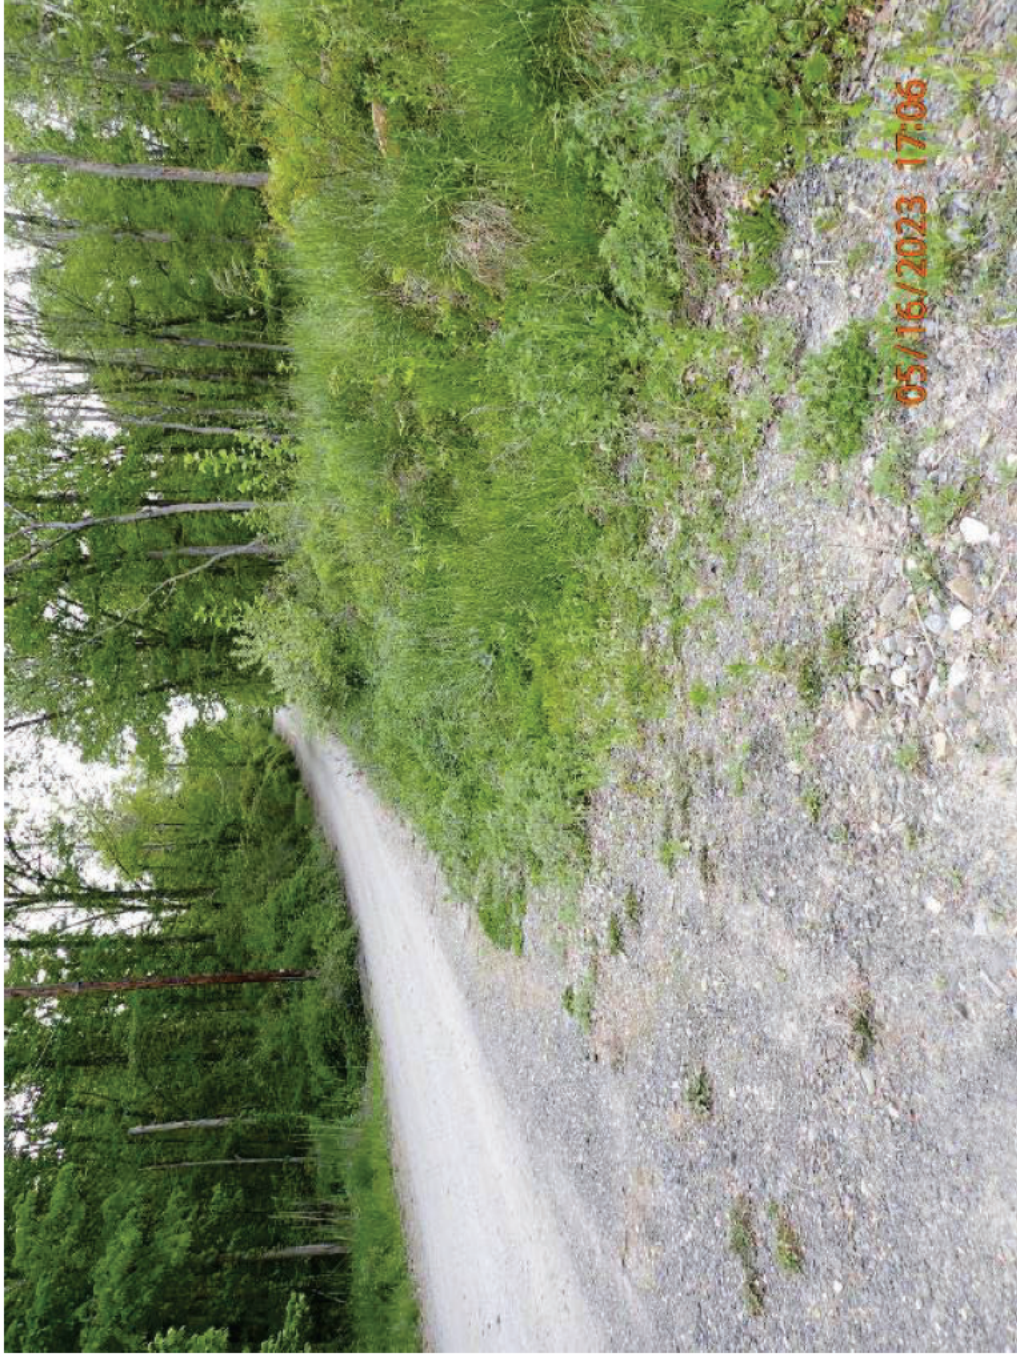
**Date:** 5/16/2023  
**Time:** 5:06 PM  
**Photographer:** SSA  
**Photo ID:** 31 – P5160073

(2/6) Panorama from road  
beginning at neighboring pond

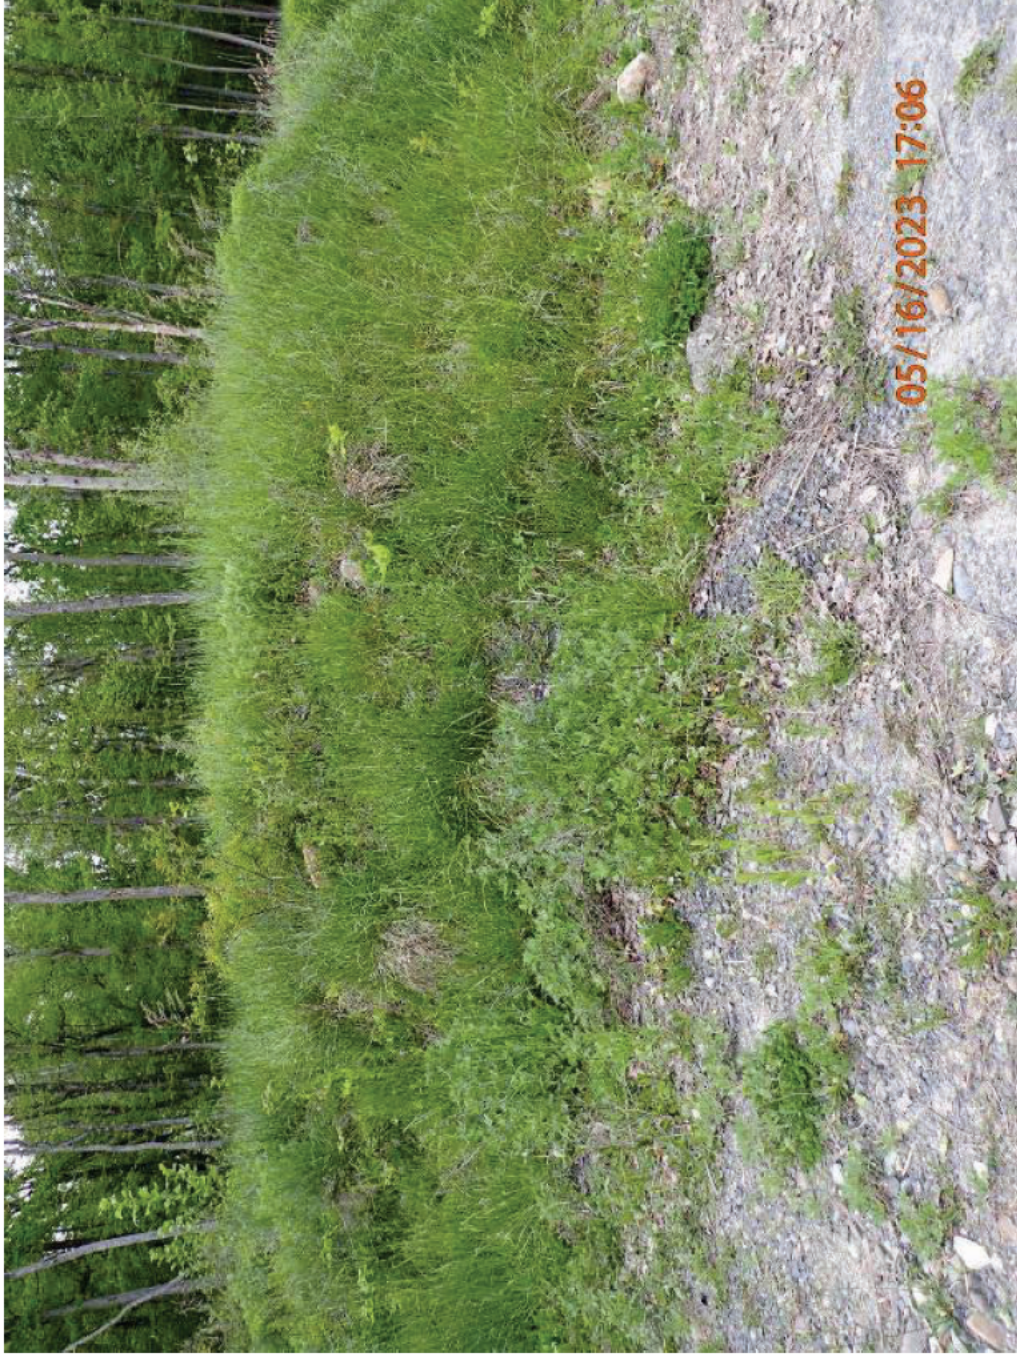
**Date:** 5/16/2023  
**Time:** 5:06 PM  
**Photographer:** SSA  
**Photo ID:** 32 – P5160074

(3/6) Panorama from road  
beginning at neighboring pond

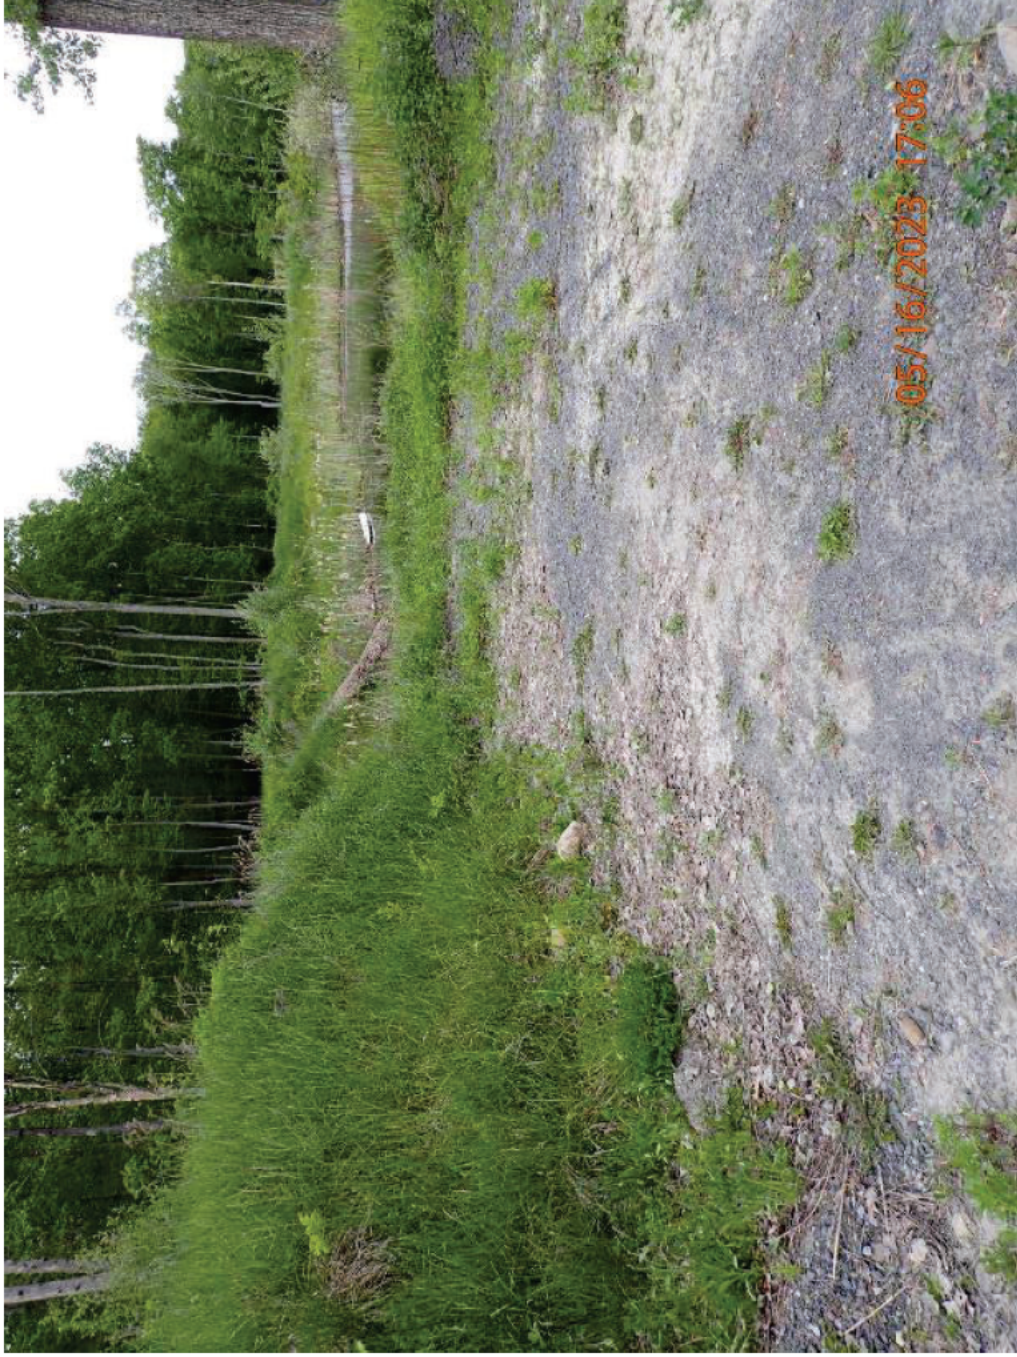
**Date:** 5/16/2023  
**Time:** 5:06 PM  
**Photographer:** SSA  
**Photo ID:** 33 – P5160075

(4/6) Panorama from road  
beginning at neighboring pond

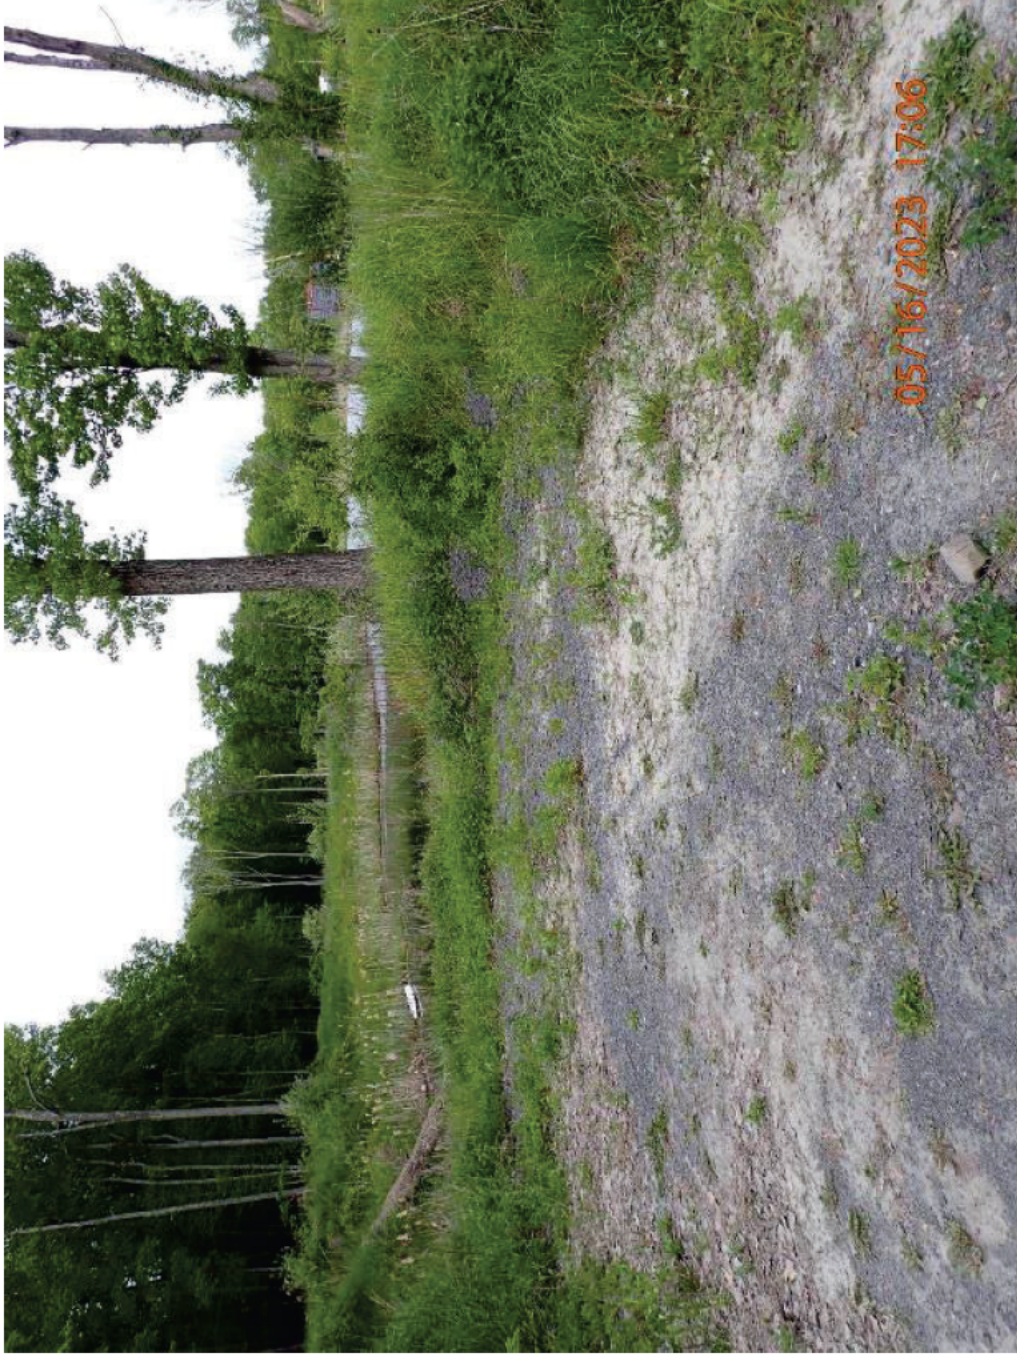
**Date:** 5/16/2023  
**Time:** 5:06 PM  
**Photographer:** SSA  
**Photo ID:** 34 – P5160076

(5/6) Panorama from road  
beginning at neighboring pond

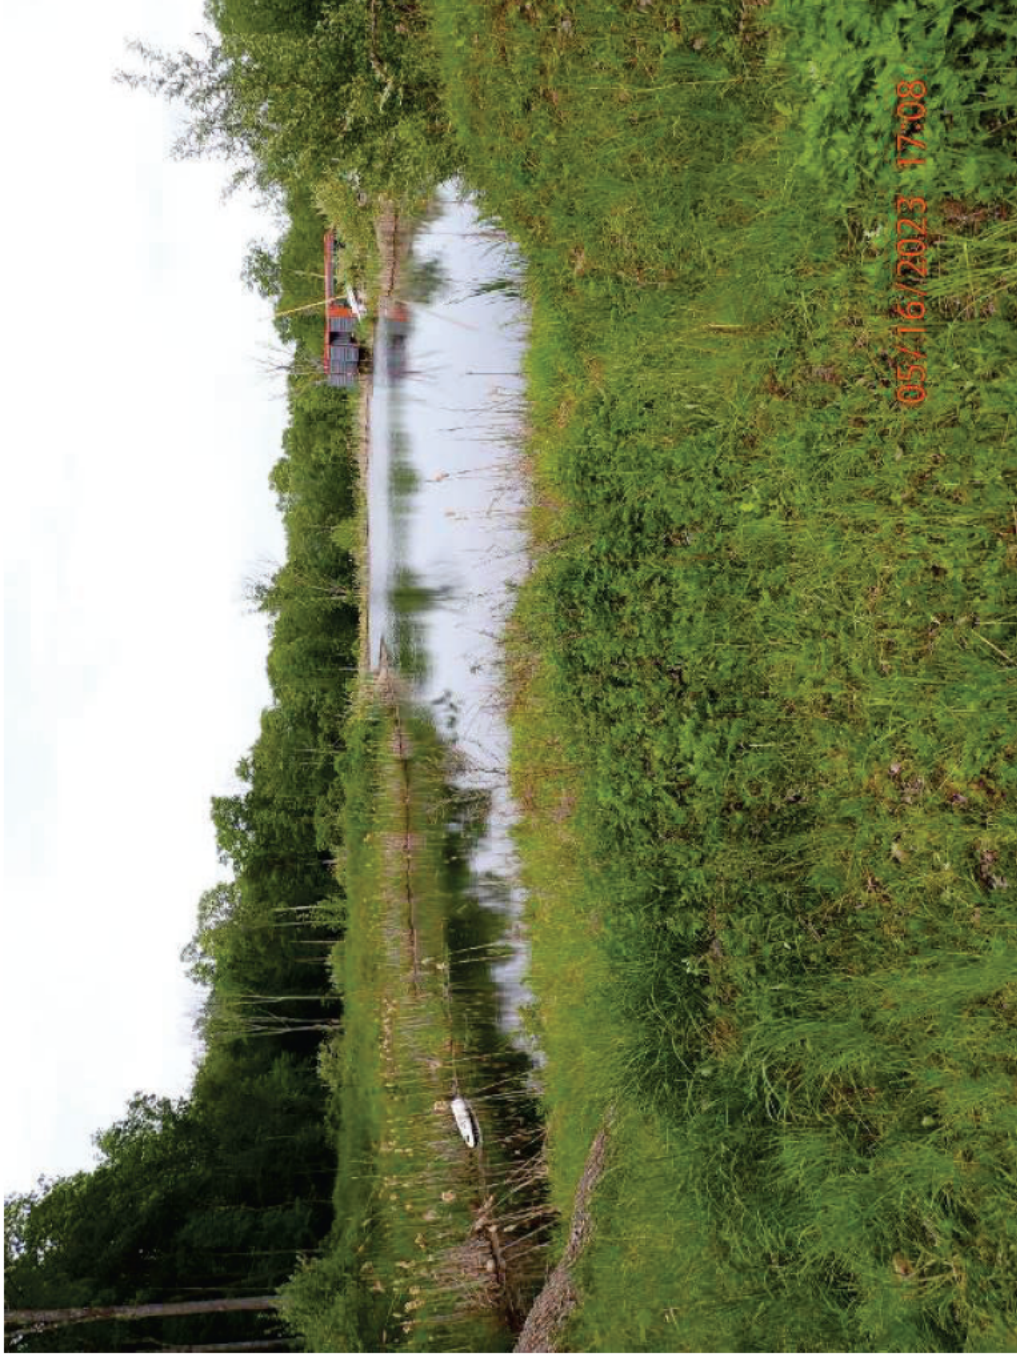
**Date:** 5/16/2023  
**Time:** 5:06 PM  
**Photographer:** SSA  
**Photo ID:** 35 – P5160077

**Description:**  
(6/6) Panorama from road  
beginning at neighboring pond

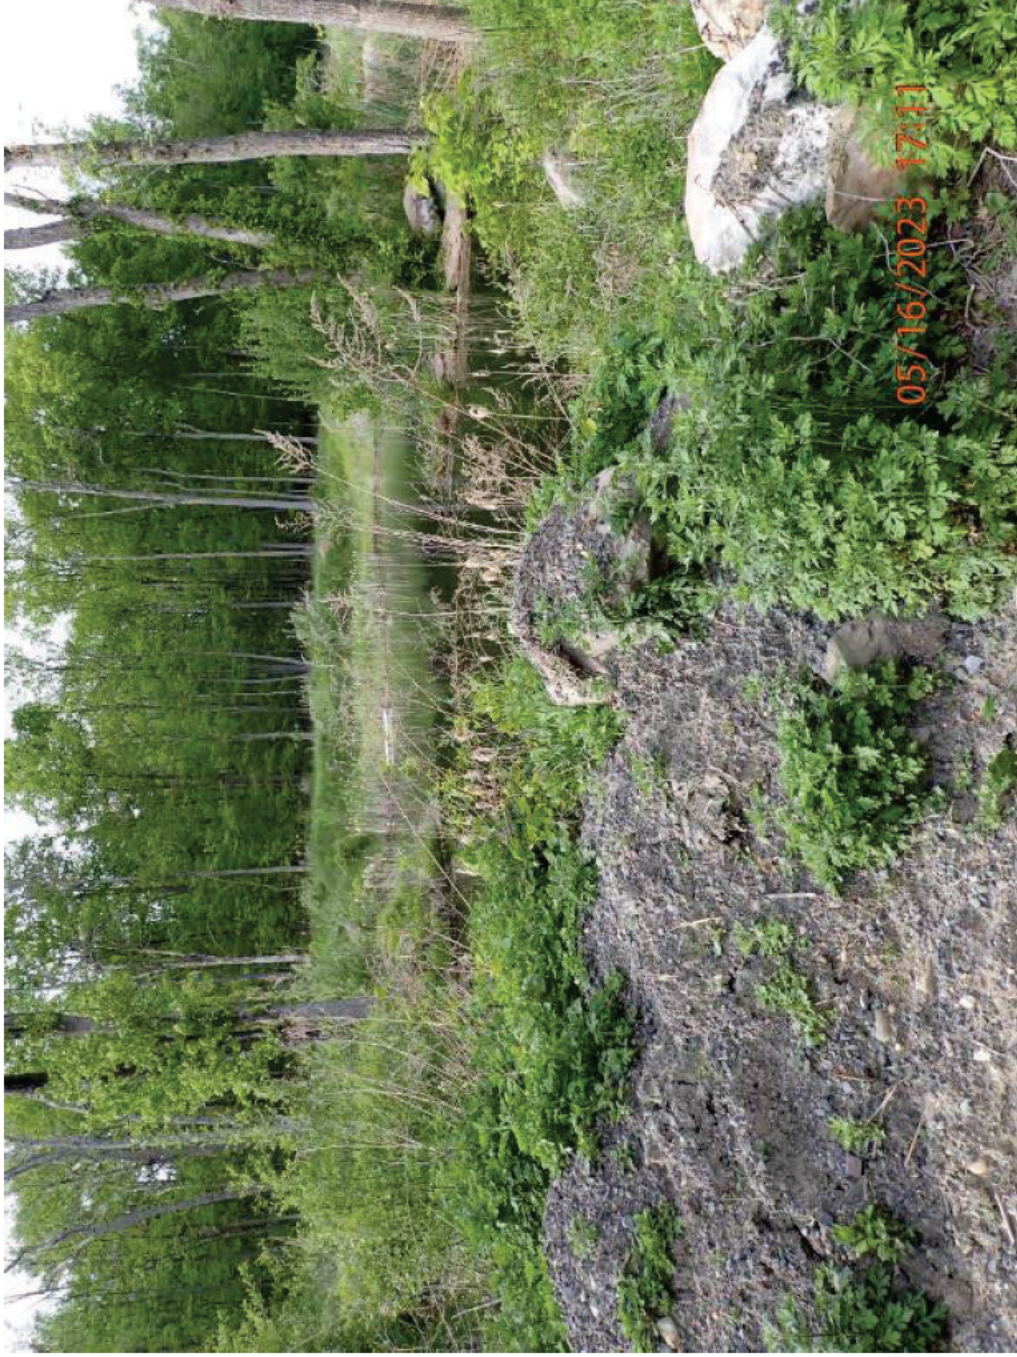
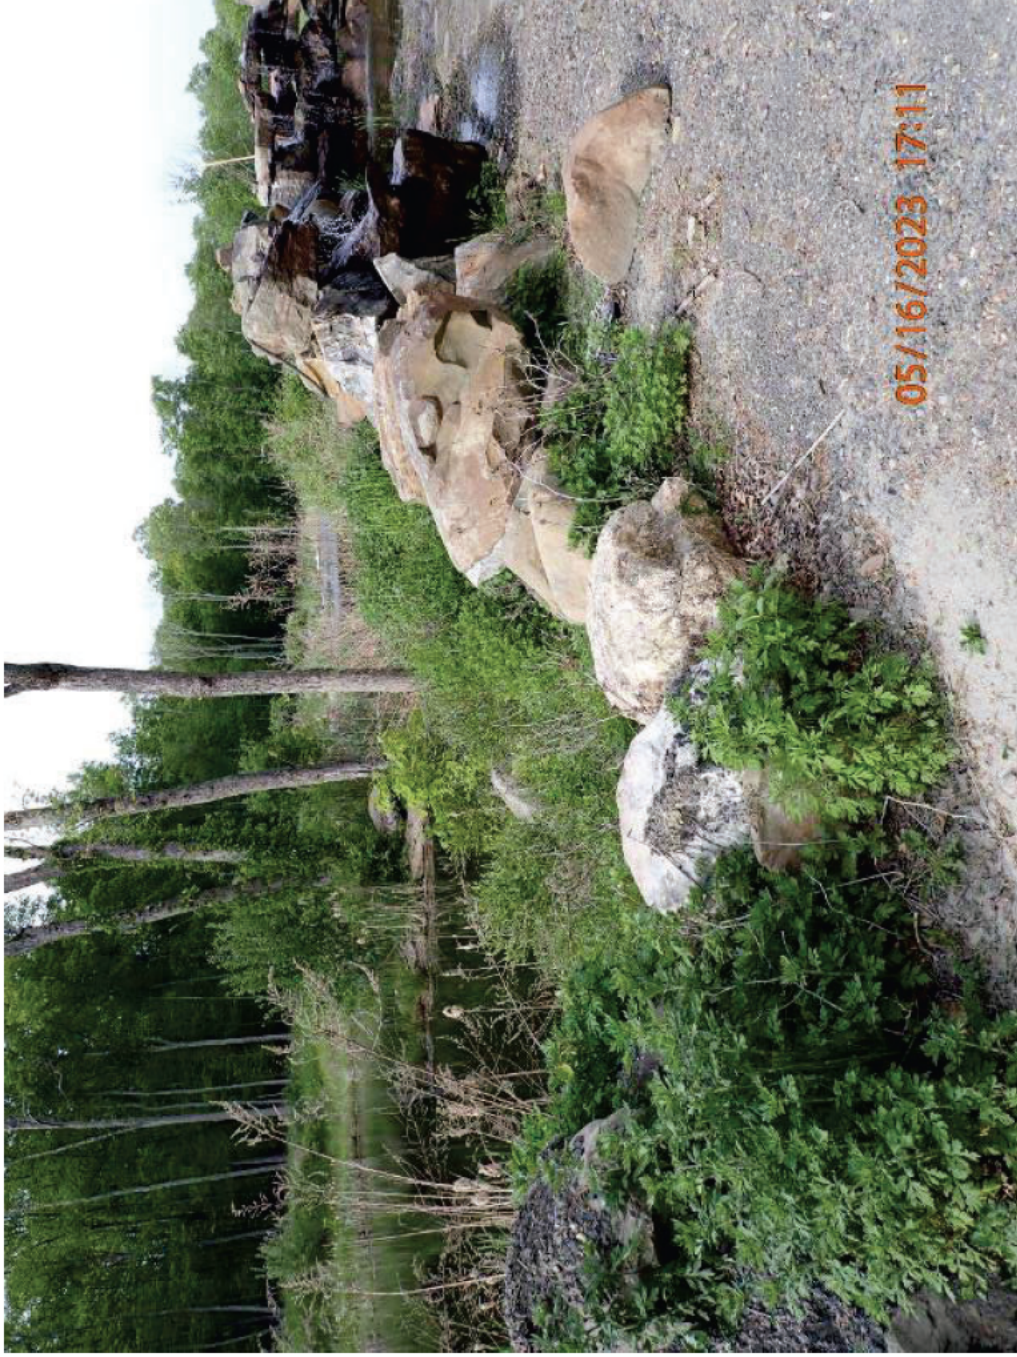
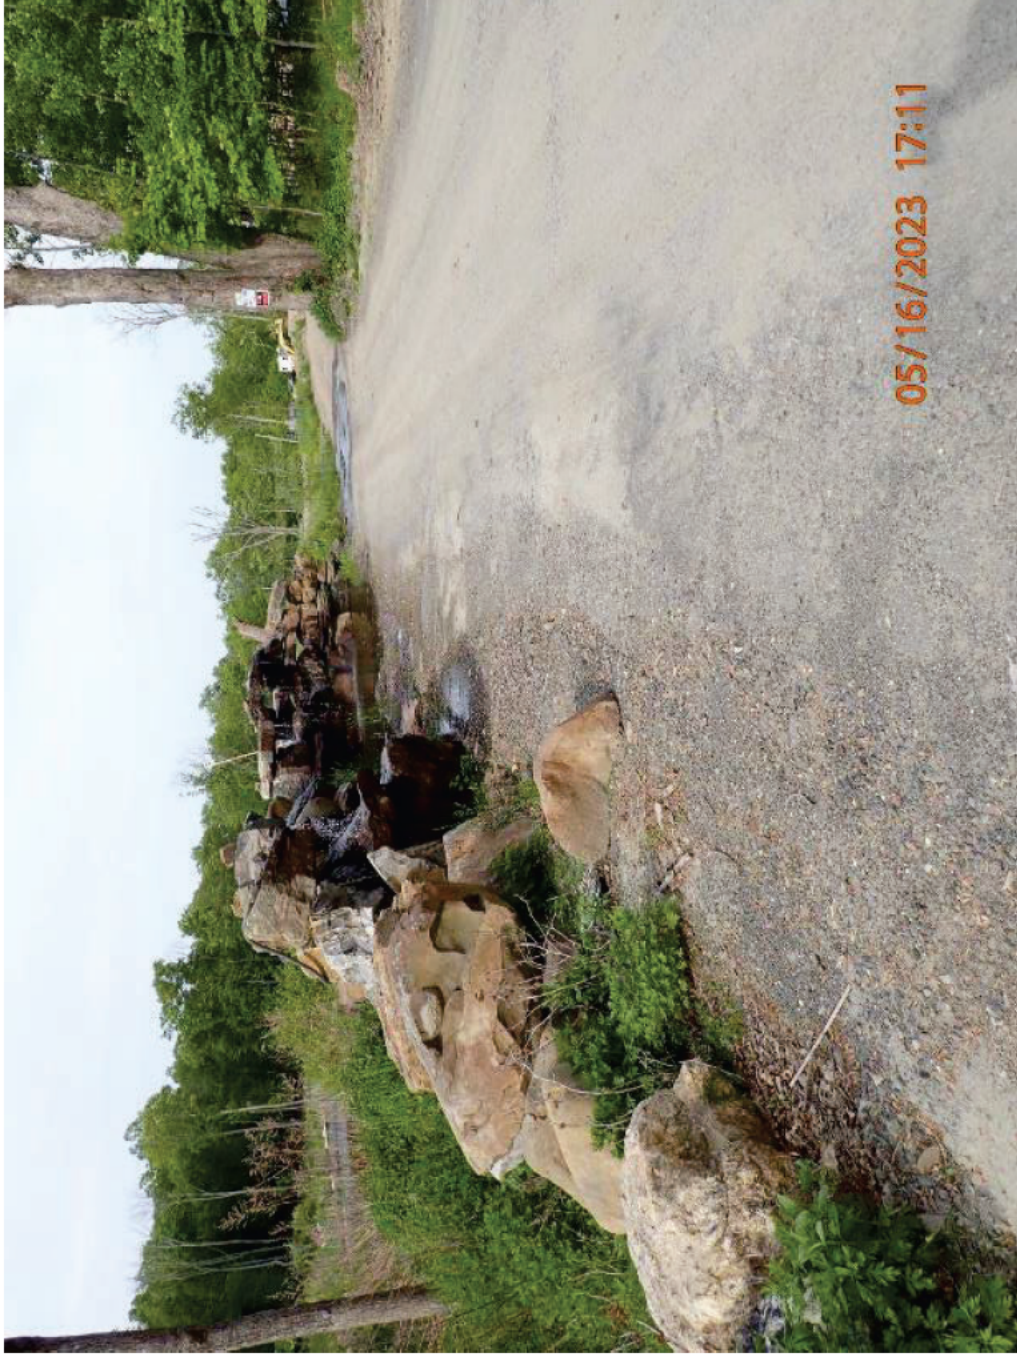
| Fill material was discharged to construct a 1-acre recreational pond and dam. Clearing and excavation work to start the expansion of the 1-acre pond to a 5-acre pond also occurred. According to Mr. Wodzinski, this work was stopped by court order. | | | |

**Description:**  
(1/3) Panorama of pond  
excavation

**Description:**  
(2/3) Panorama of pond  
excavation

**Description:**  
(3/3) Panorama of pond  
excavation
