**Region 6 - Enforcement & Compliance Assurance Division**  
**INSPECTION REPORT**

| Media Program: | Water | |
| Regulatory Program(s) | CWA | |
| Company Name: | [REDACTED] | |

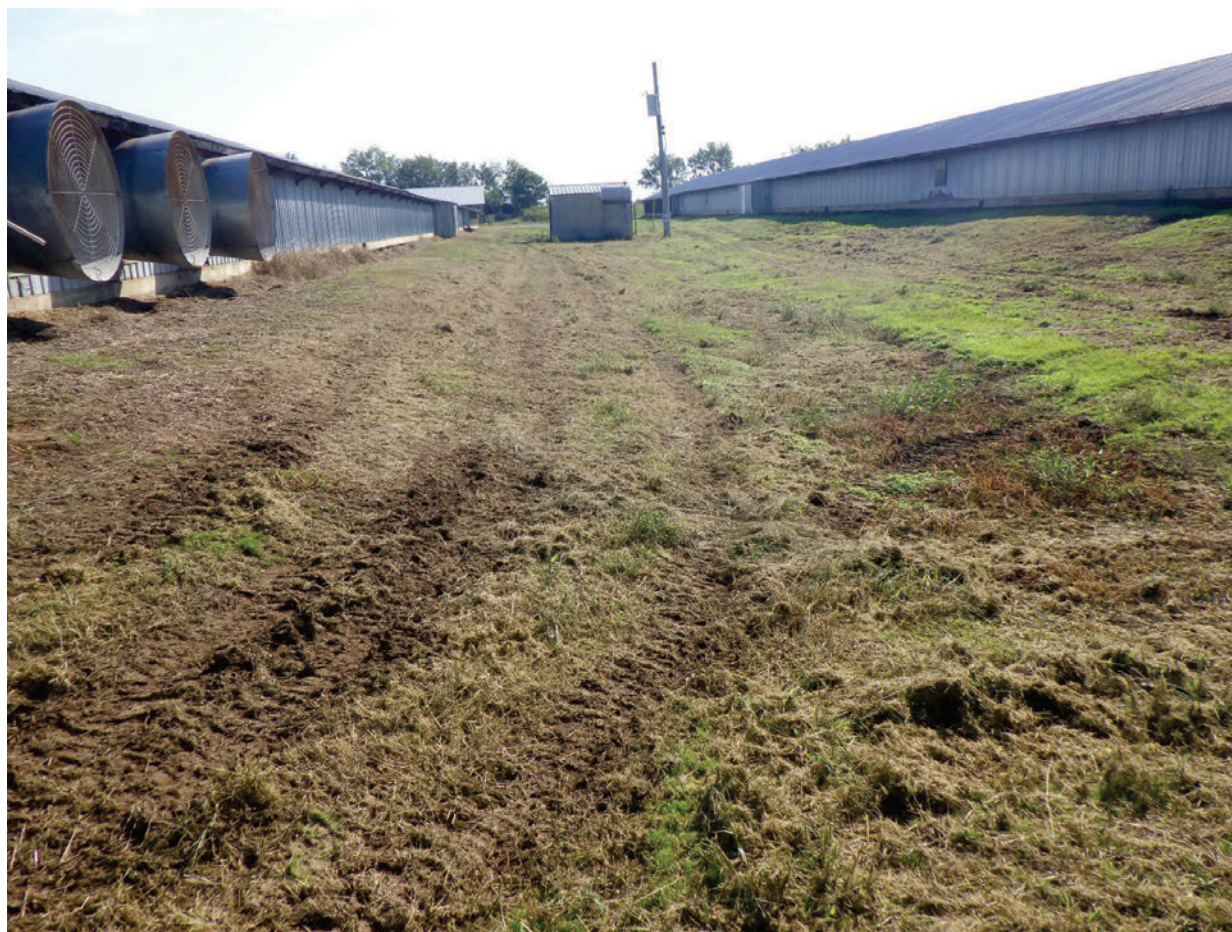
Photo No. 1

- Mortalities were not observed outside of containment.
- The vegetated buffer between chicken houses 8 and 9 appears to need to be regrown (Photo 1, Appendix 1).
- There were signs of track-out at the entrance of the litter barn (Photo 2, Appendix 1).
- No broken wooden wall boards were observed on the northern side of the litter barn (Photo 3, Appendix 1).

| Description: | The photo was taken between chicken houses 8 and 9. The vegetative buffer meager and need of regrowing. | | |

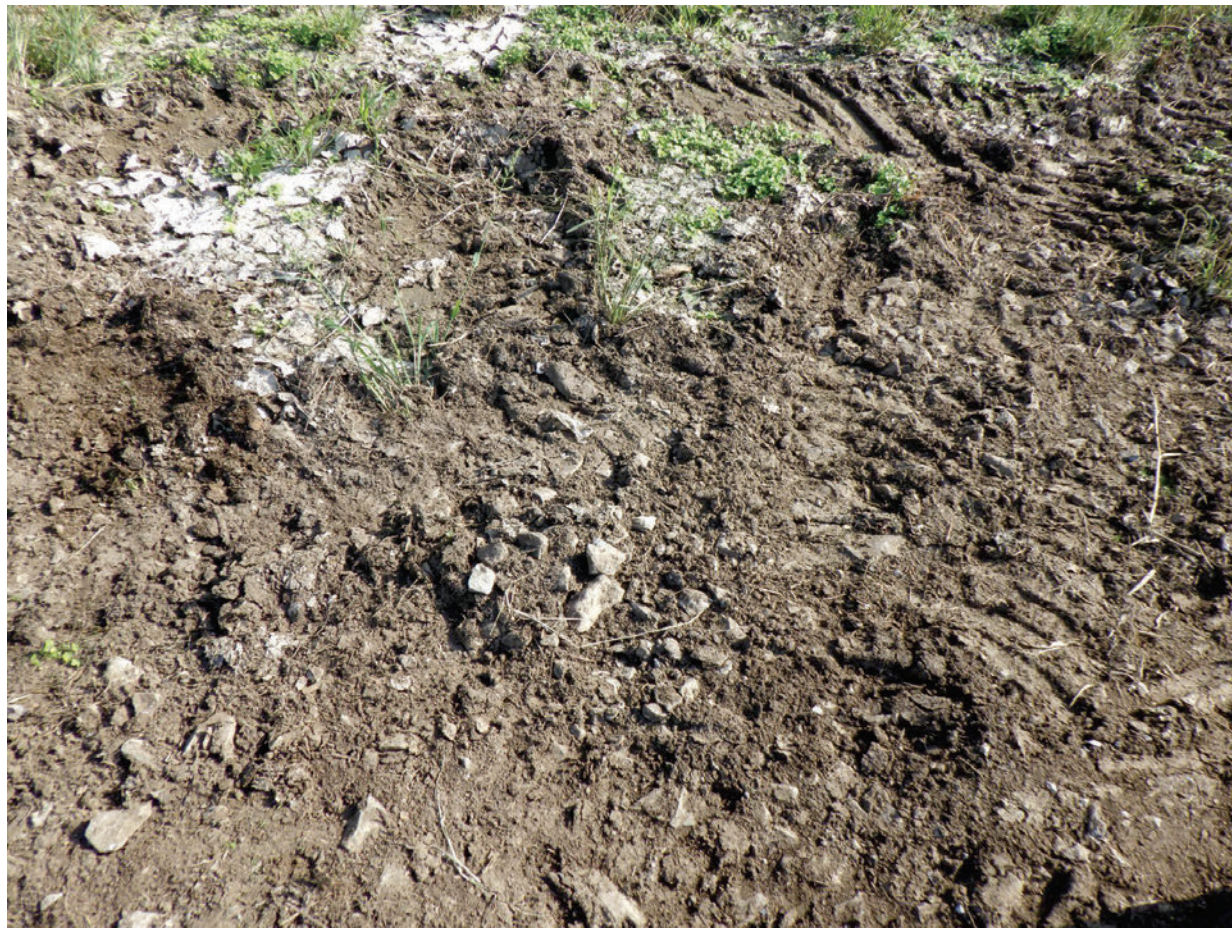
Photo No. 2

| Description: | Litter track-out was observed outside the litter barn. | | |

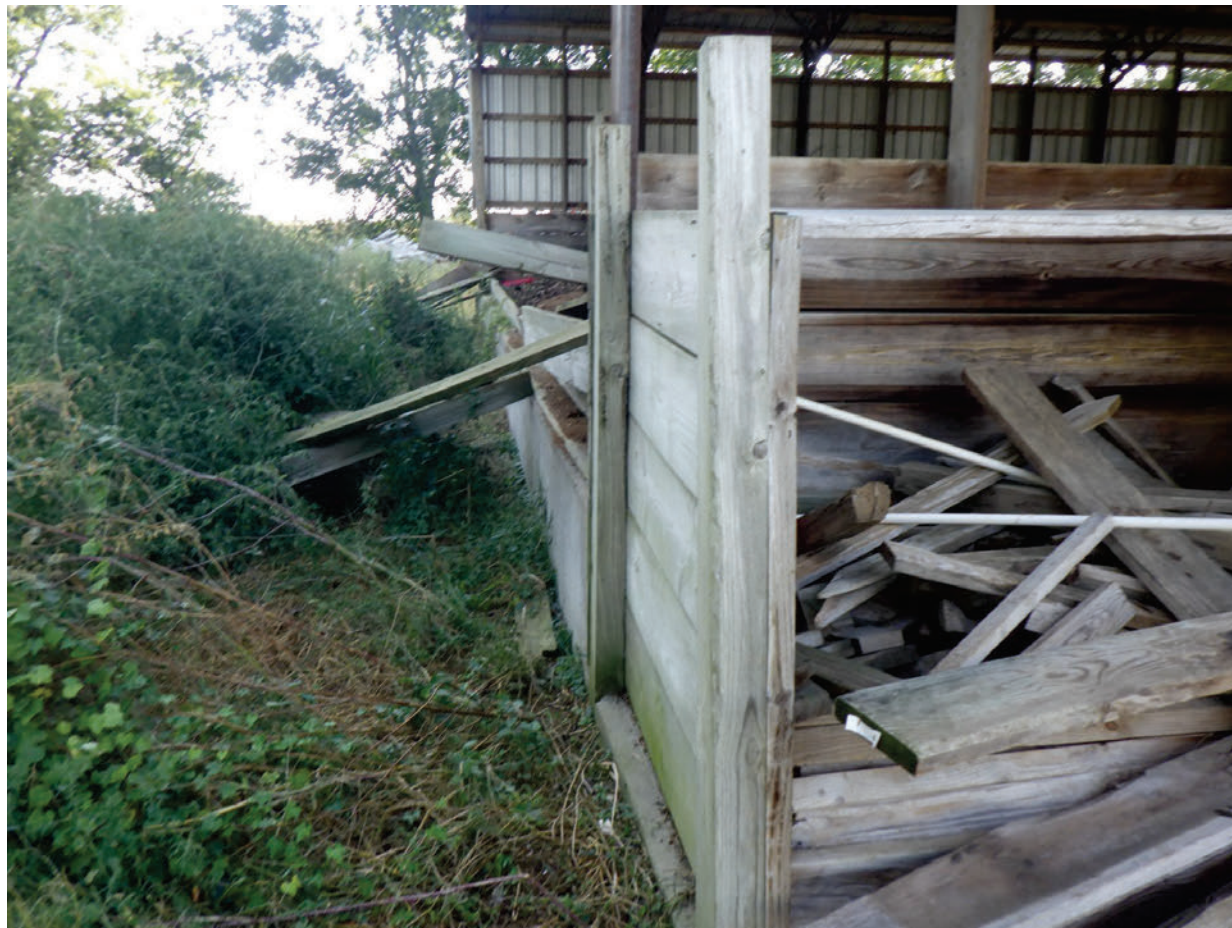
Photo No. 3

- The contents of the litter barn are vulnerable to precipitation. (Photo 3, Appendix 1) 40 CFR §122.23(b)(7).

| Description: | Litter spillage was observed on the back end of the litter barn due to broken wood boards. | | |
