INSPECTION REPORT

| Type of Inspection | Compliance Evaluation Inspection (CEI) | |
| Permittee Name | Westwood Regional STP | |
| Permit Number(s) (If Applicable) | LA0063991 | |

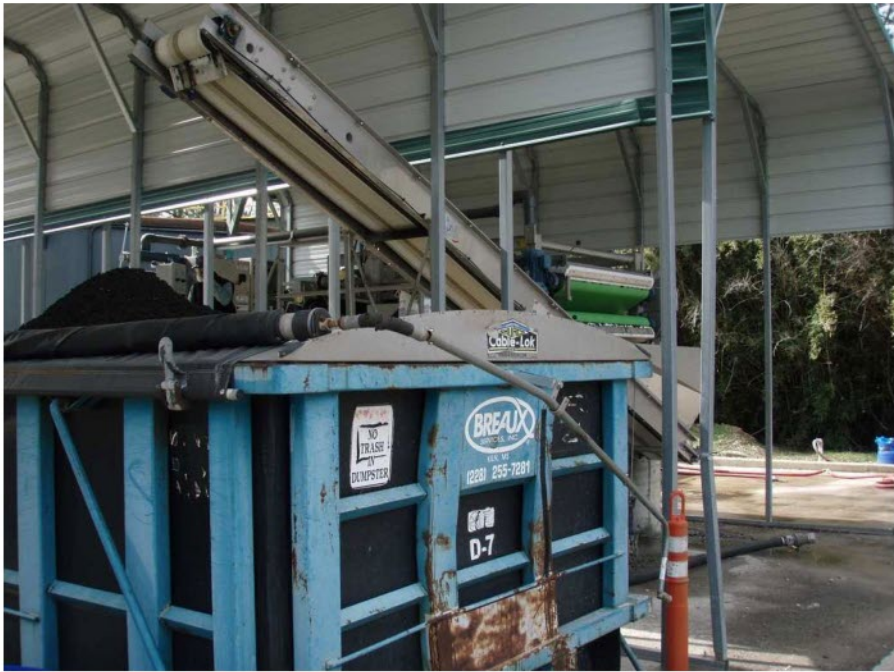
| Belt Press | | | P1010023.JPG |

| Belt Press used for dewatering sludge that is sent for beneficial reuse. | | | |

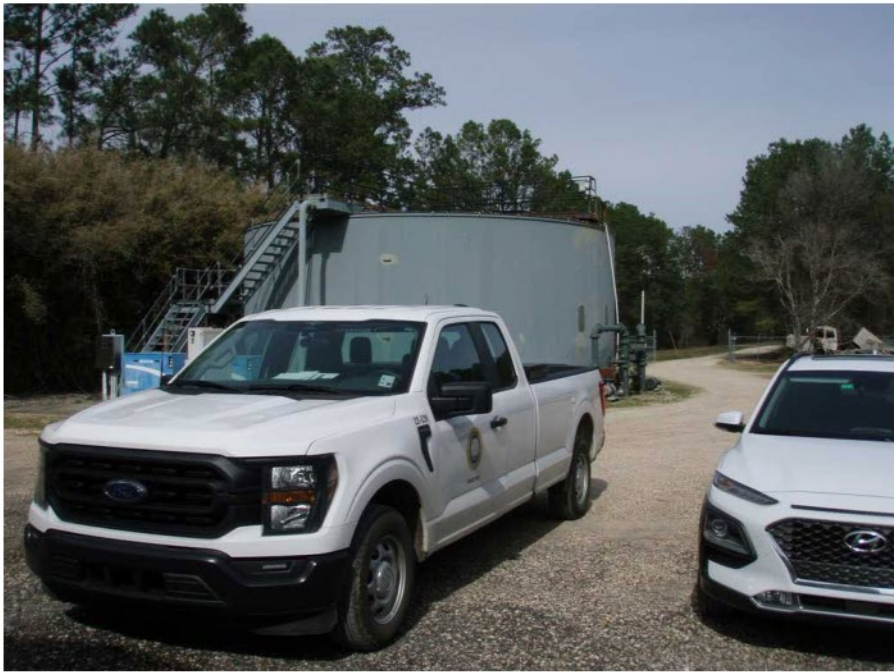
| Equalization Tank | | | P1010022.JPG |

| Equalization tank at the Westwood facility before entering the WWTP. | | | |

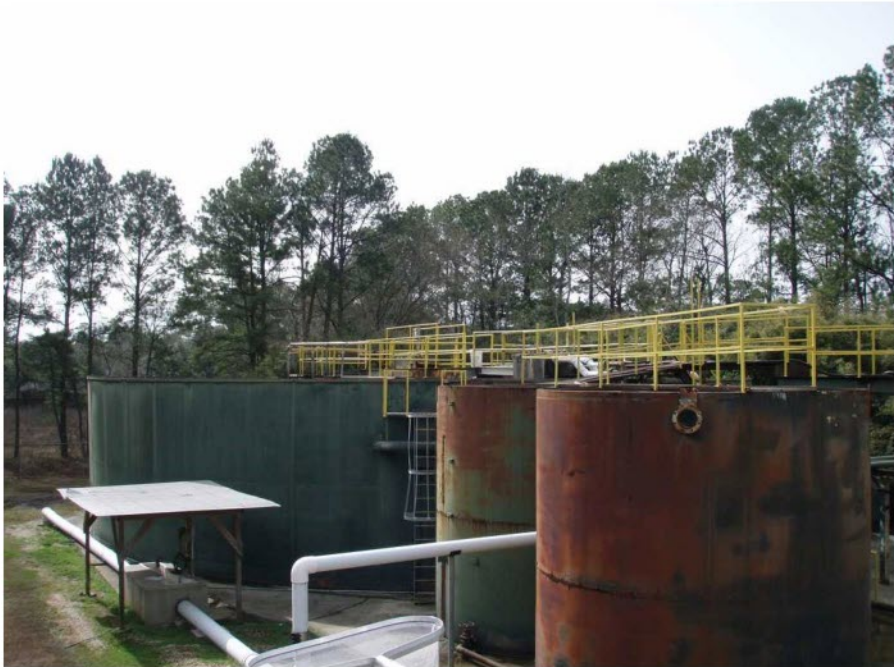
| Treatment Tanks | | | P1010028.JPG |

At the time of the inspection, it was explained that the treatment system consisted of a combination of two separate treatment plant trains. The original tank system was constructed in 1997 with an expansion/upgrade in 2004 to increase the treatment plants capacity. The older tank system, being 25+ years in operation, was observed to be aged with several large, welded patches with concerning structural integrity.

| Treatment tanks used at the facility. | | | |

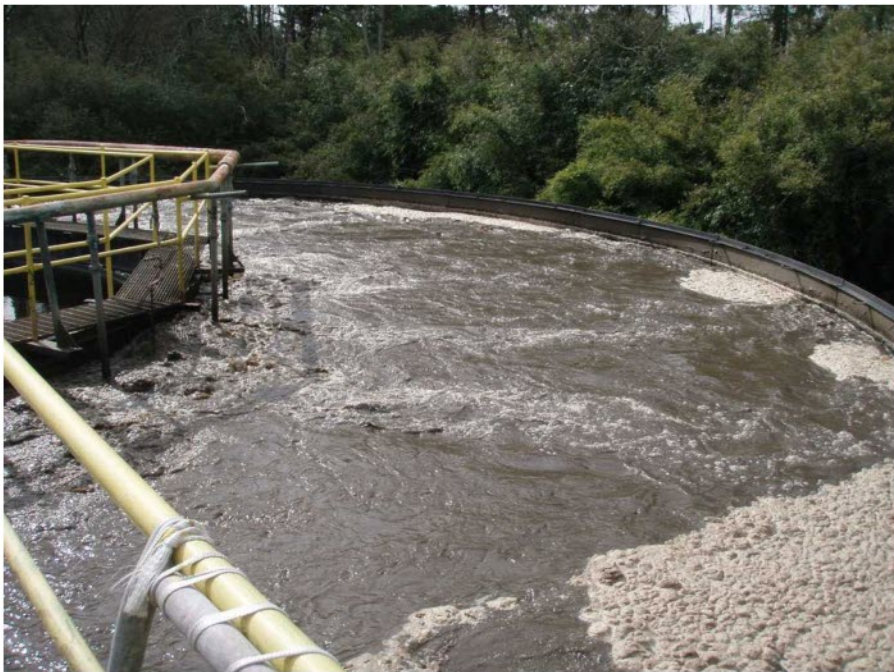
| Aeration Basin/Tank | | | P1010031.JPG |

| Aeration Basin/Tank with several large, welded patches with concerning structural integrity. | | | |

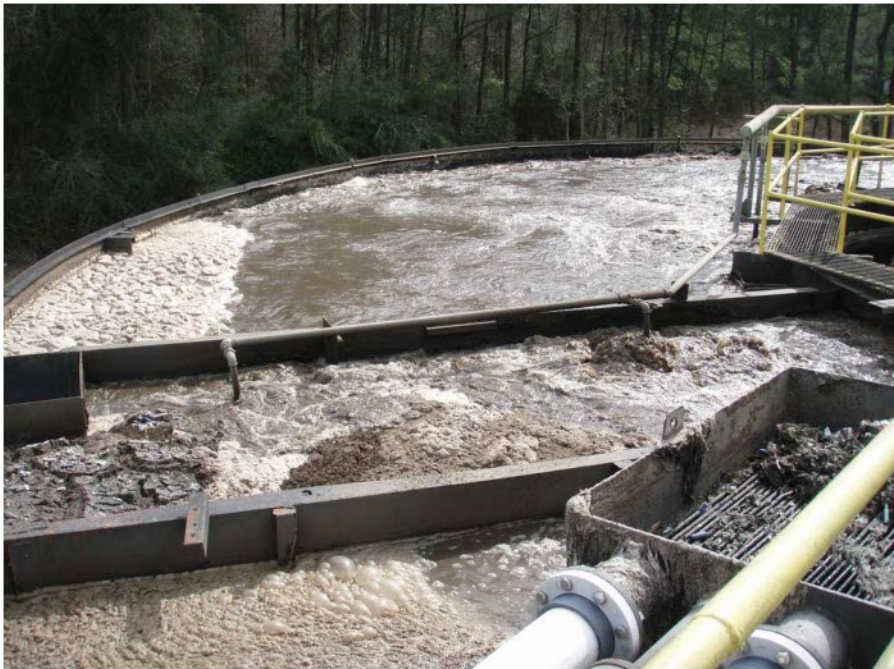
| Aeration Basin/Tank | | | P1010032.JPG |

| Aeration Basin/Tank with several large, welded patches with concerning structural integrity. | | | |

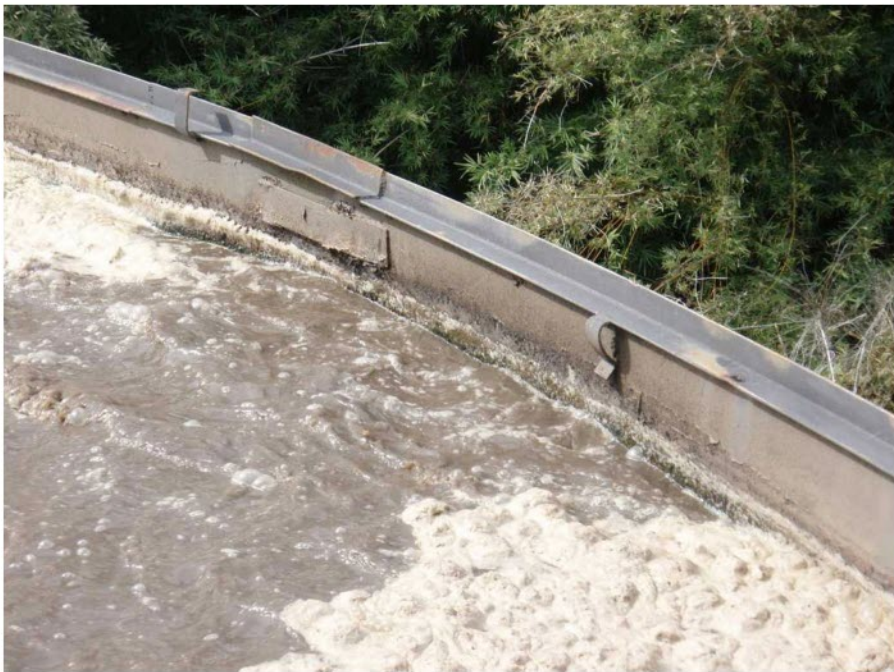
| Aeration Basin/Tank | | | P1010033.JPG |

| Aeration Basin/Tank with several large, welded patches with concerning structural integrity. | | | |

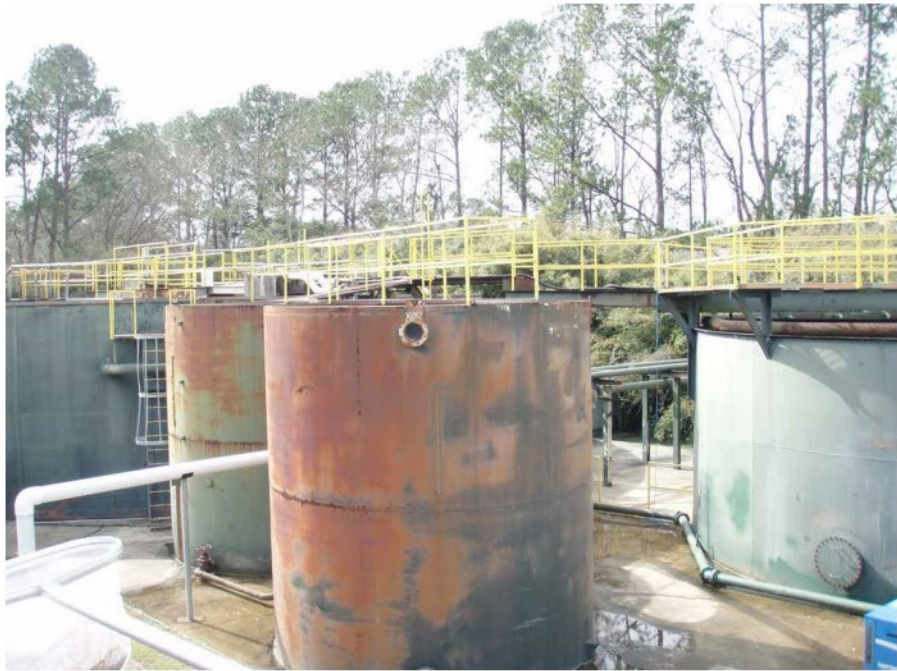
| Treatment Tanks | | | P1010029.JPG |

| Treatment tanks used at the facility. The tanks have several large, welded patches with concerning structural integrity. | | | |
