**EPA REGION 10**  
**Enforcement and Compliance Assurance Division**

**INSPECTION REPORT**

| <b>Type of Inspection</b> | Compliance Evaluation Inspection | | |
| <b>Facility Name</b> | Salish Seafoods | | |

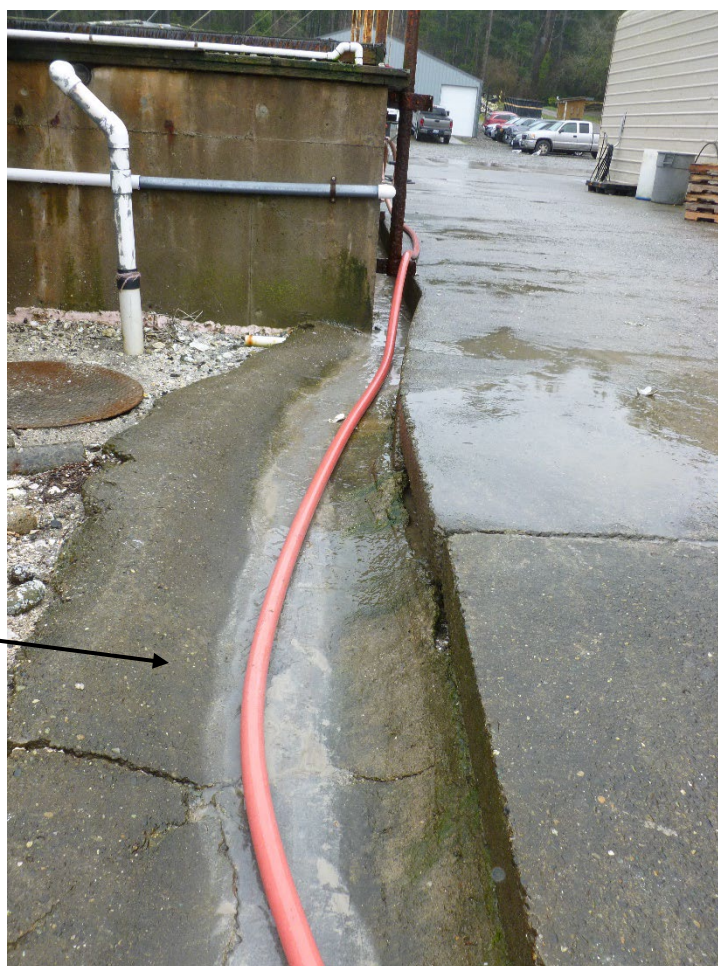
Outfall

The rearing (setting) tanks are used to hold oyster shells so they can be seeded with oyster larvae. The tanks are filled with water by drawing it directly from Peale Passage. At no point is food or chemicals added to the rearing tanks. Once the pallets of seeded oyster shells have been removed from the tanks, the water is allowed to drain back downhill into Peale Passage.

The outfall for the rearing tanks is a shallow concrete ditch or trough.

The rearing tanks were not in operation at the time of the inspection so there was no discharge; however, due to the outfall's design, stormwater could easily mix with the process wastewater.

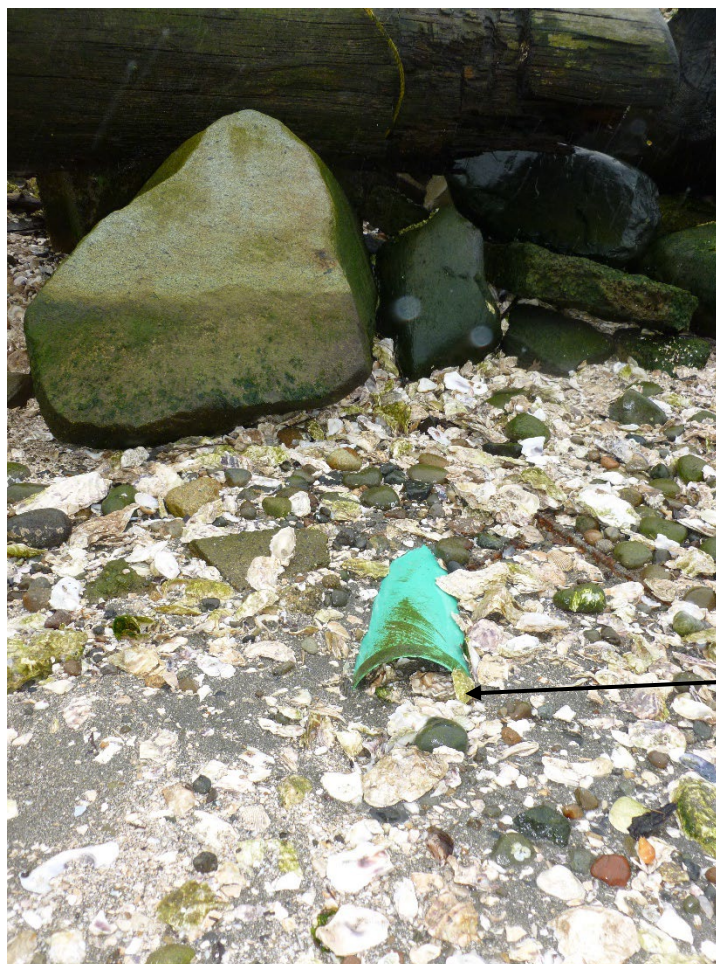
**Observation #:** RA1-OB-002

The Trommel Screener is used to clean oyster shells prior to the shells being used in the rearing tanks to seed with oyster larvae. The Trommel was not in operation at the time of the inspection so there was no discharge. The outfall from the Trommel is a PVC pipe with about a 6-inch diameter that is primarily underground and breaks the surface near the high tide line of the beach. The mouth of the outfall was nearly completely occluded. Mr. Schuffenhauer said the outfall are cleared of debris prior to discharging.

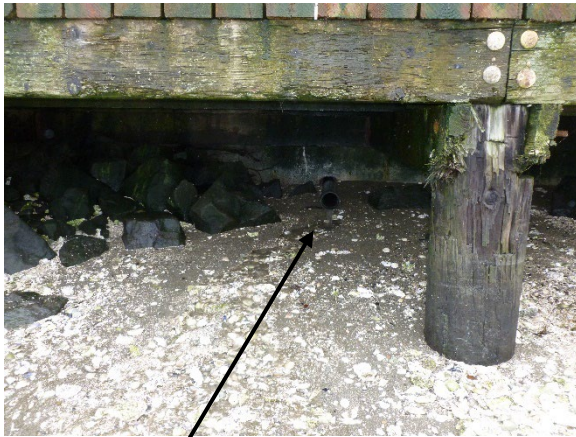
**Outfall**

The outfall from the processing building is a PVC pipe of about a 6-inch diameter that extends from the building under a narrow deck. The outfall discharges under the deck and the wastewater flows downhill to enter Peale Passage.
