## **RCRA Inspection Report**

Honda Manufacturing of Alabama, LLC  
1800 Honda Drive  
Lincoln, Alabama 35096  
Talladega County

EPA ID No.: ALR000016261

August 18, 2020, at 9:45 a.m.

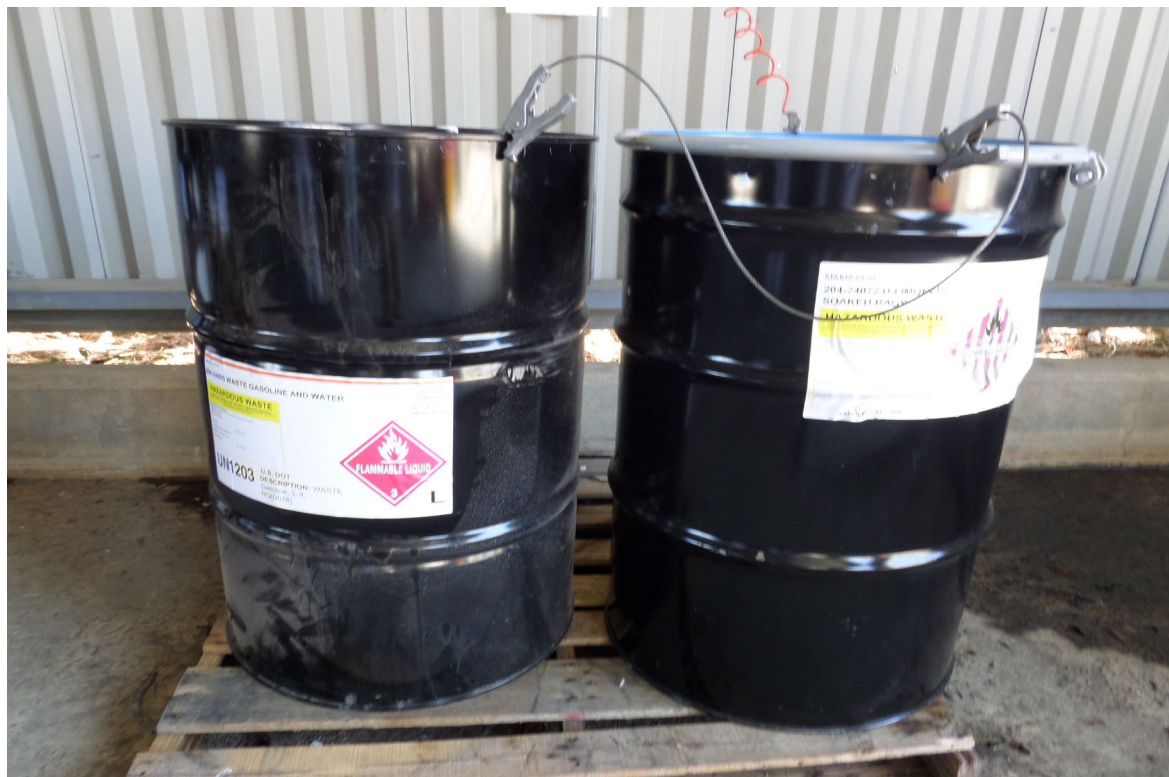
The inspector observed a SAA for the accumulation of waste gasoline and waste D-Limonene contaminated rags. The SAA is identified by a sign. The waste gasoline is generated from the Line 2 manufacturing process and the waste D-Limonene rags are generated at the end of the assembly area from the Line 2 manufacturing process. The waste streams are then transferred to this 90-Day and accumulated in a SAA. The inspector observed two 55-gallon containers accumulating waste gasoline and waste D-Limonene contaminated rags. The containers were closed, in good condition, labeled with the words hazardous waste and labeled with the word flammable to indicate the hazard of the contents. The inspector observed the containers were not marked with a date (photographs 1, 2, and 3). It appears the hazardous waste is initially accumulated in the Manufacturing Line 2 building. Since the containers are not at or near the initial point of accumulation, the containers should be marked with an accumulation start date. On August 28, 2020, Honda explained their countermeasure in an email to EPA and ADEM to mark a date on the container of waste gasoline and D-Limonene rags as soon as material is introduced into the container in this area. A picture showed the containers marked with the date August 18, 2020.

Honda Mfg. of Alabama LLC. 90-Day or Less Accumulation Area Line 2. The inspector observed a SAA for waste gasoline and waste D-Limonene contaminated rags. The waste gasoline is generated from the Line 2 manufacturing process and the waste rags are generated at the end of the Line 2 assembly area. The wastes are then transferred to this 90-Day and accumulated in a SAA. The containers were not marked with a date. Photographs 1 taken at 12:45 p.m. (EST).

**Pursuant to ADEM Admin. Code r. 335-14-3-.01(7)(a)5.(i)c, [40 C.F.R. § 262.17(a)(5)(i)], which is a condition of the LQG Permit Exemption, a generator must mark or label the date upon which each period of accumulation begins clearly visible for inspection on each container.**

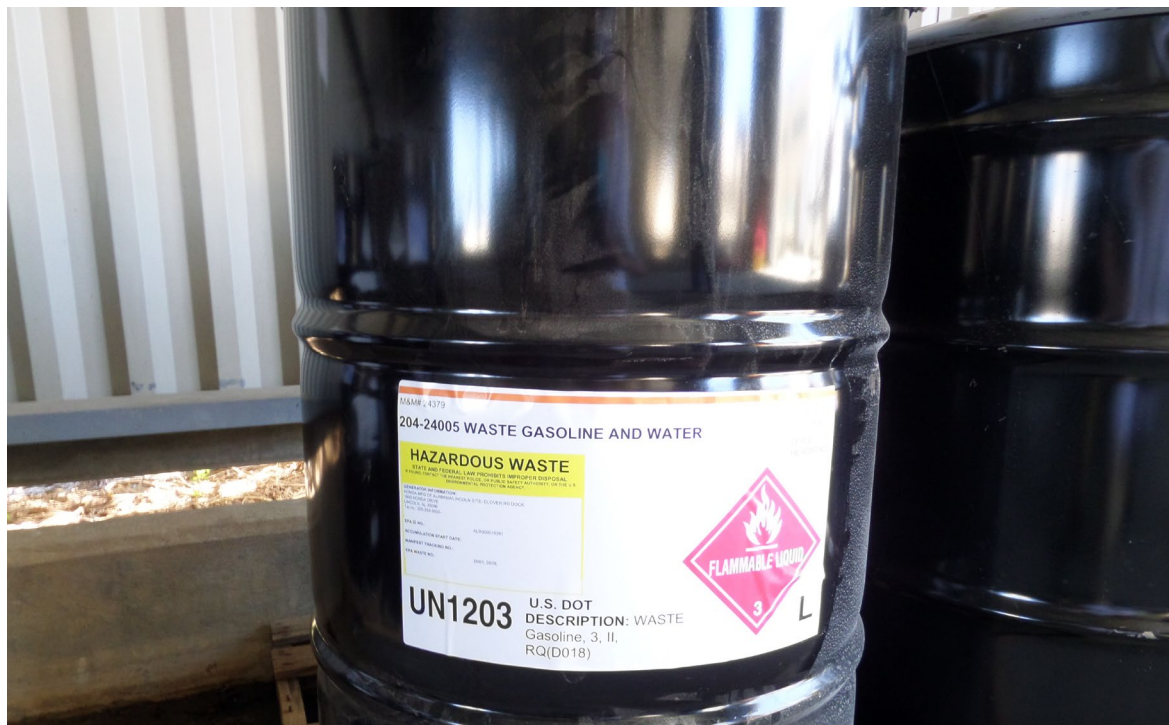
Honda Mfg. of Alabama LLC. 90-Day or Less Accumulation Area Line 2. The waste gasoline is generated from the Line 2 manufacturing process. The waste is then transferred to this 90-Day and accumulated in a SAA. The container was not marked with a date. Photograph 2 taken at 12:45 p.m. (EST).

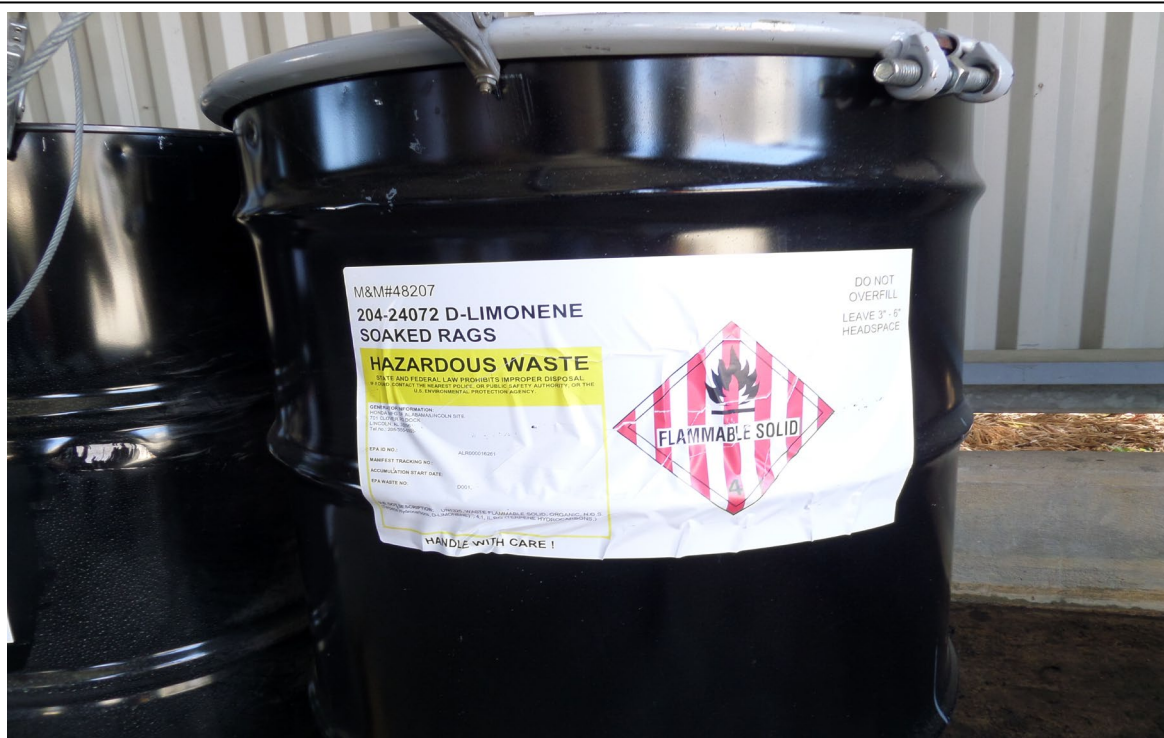
Honda Mfg. of Alabama LLC. 90-Day or Less Accumulation Area Line 2. The waste D-Limonene rags are generated at the end of the Line 2 assembly area. The waste is then transferred to this 90-Day and accumulated in a SAA. The container was not marked with a date. Photograph 3 taken at 12:45 p.m. (EST).

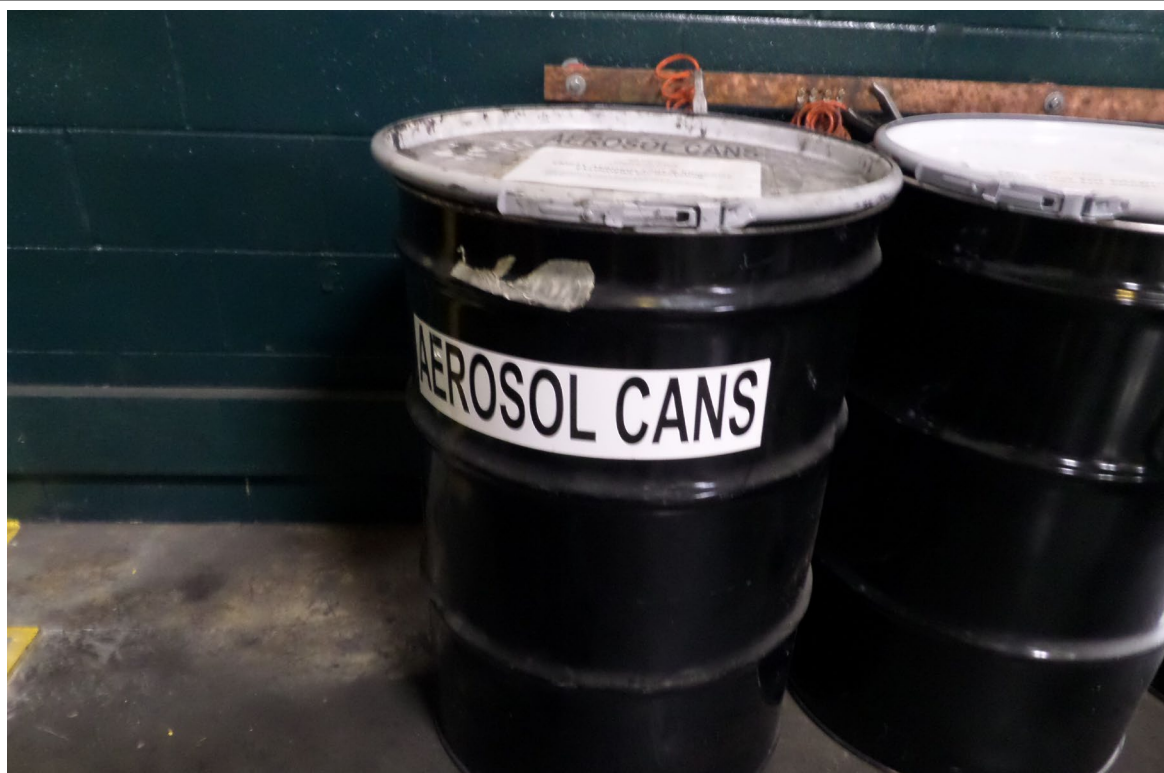
This SAA is for the accumulation of aerosol cans generated from the manufacturing operations. The inspector observed one 55-gallon metal container accumulating waste aerosol cans. The top lid of the container was marked with the words “Empty Aerosol Cans & Propane Cylinders for Recycling”. The inspector observed the container was not kept closed. Inspectors observed the container was approximately one-quarter full and at least one aerosol can was observed containing liquid. The container was not labeled with the words hazardous waste and not labeled with an indication of the hazard of the contents (photographs 4, 5, and 6). The inspector asked Ms. Rainwater to provide the waste determination result conducted on this waste stream. On August 28, 2020, Honda explained their countermeasure and attached a picture in an email to EPA and ADEM showing the container was closed, labeled with the words hazardous waste, labeled with the word flammable to indicate the hazard of the contents, and marked with a date.

Honda Mfg. of Alabama LLC. Weld Department for Manufacturing Line 2 SAA. The inspector observed one 55-gallon metal container accumulating aerosol cans not kept closed and not marked or labeled with the words hazardous waste and not labeled with an indication of the hazard of the container contents. Photograph 4 taken at 1:06 p.m. (EST).

Pursuant to ADEM Admin. Code r. 335-14-3-.01(5)(a)5.(i-ii), [40 C.F.R. § 262.15(a)(5)], which is a condition of the SAA Permit Exemption, a generator is required to mark or label its containers (i) with the words “Hazardous Waste” and (ii) with an indication of the hazards of the contents.

Pursuant to ADEM Admin. Code r. 335-14-3-.01(5)(a)4., [40 C.F.R. § 262.15(a)(4)], which is a condition of the SAA Permit Exemption, a generator is required to keep containers of hazardous waste closed at all times during accumulation, except when adding, removing, or consolidating waste; or when temporary venting of a container is necessary for the proper operation of equipment, or to prevent dangerous situations, such as build-up of extreme pressure.

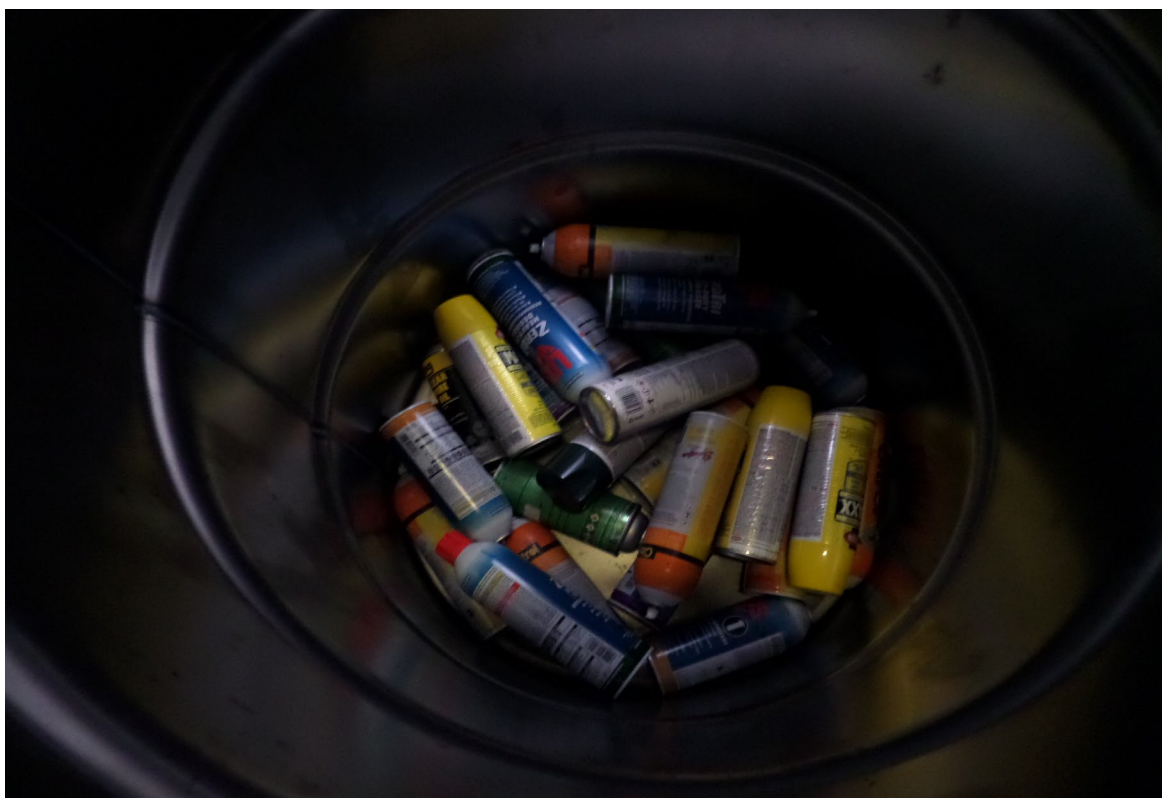
Honda Mfg. of Alabama LLC. Weld Department for Manufacturing Line 2 SAA. The inspector observed one 55-gallon metal container accumulating aerosol cans not kept closed and not marked or labeled with the words hazardous waste and not labeled with an indication of the hazard of the container contents. Photograph 6 taken at 1:06 p.m. (EST).
