## INSPECTION REPORT

| <b>Type of Inspection</b> | Industrial Stormwater Inspection | | |
| <b>Facility or Site Name</b> | Interstate Concrete and Asphalt – Richland Facility | | |

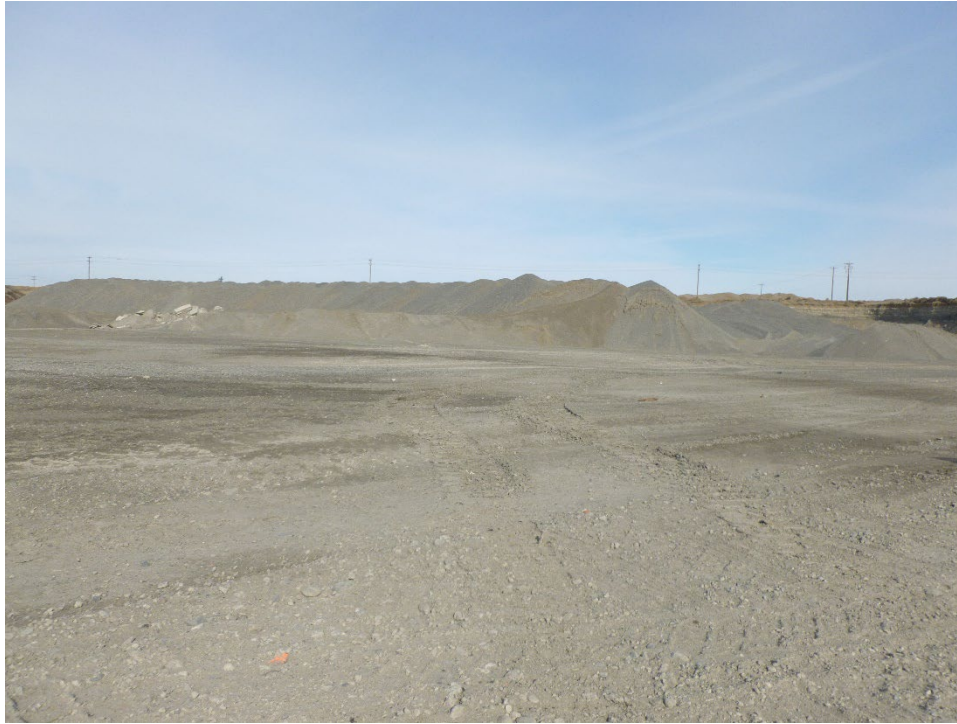
We walked the production portion first, and then drove to the back of the property where sand and gravel quarrying operations occurred (**Photos 1 & 2**) as needed to acquire more raw materials for production. At the time of my visit to the quarry area, minimal activity was on-going.

**Photo 1/P1010587** – Quarry Area, facing north

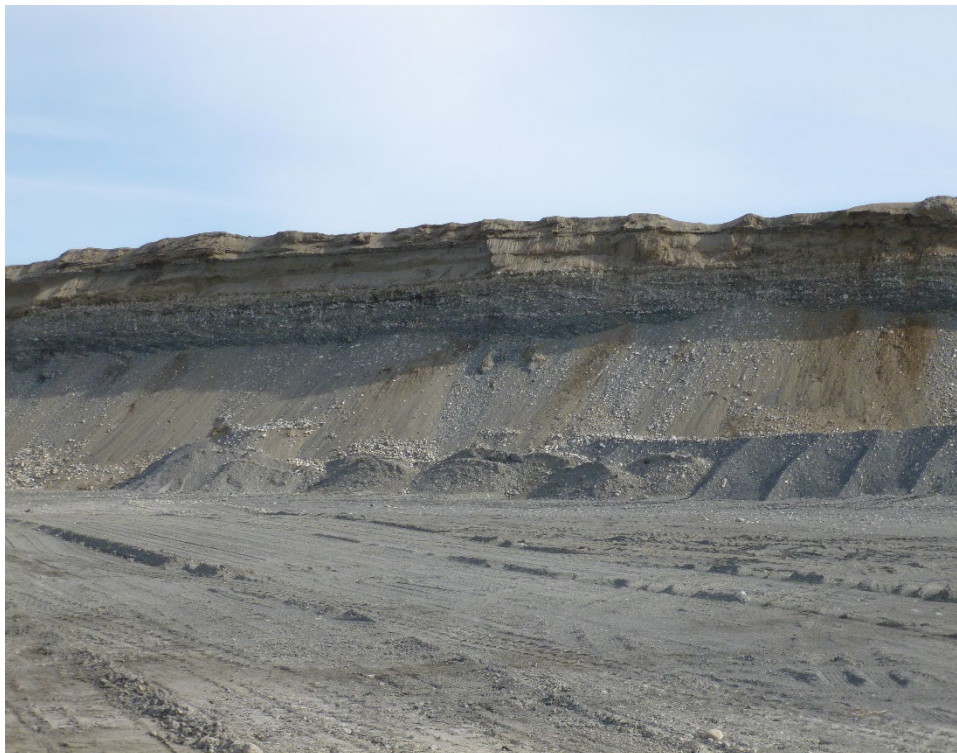
**Photo 2/P1010588** – Quarry Side Wall, facing east

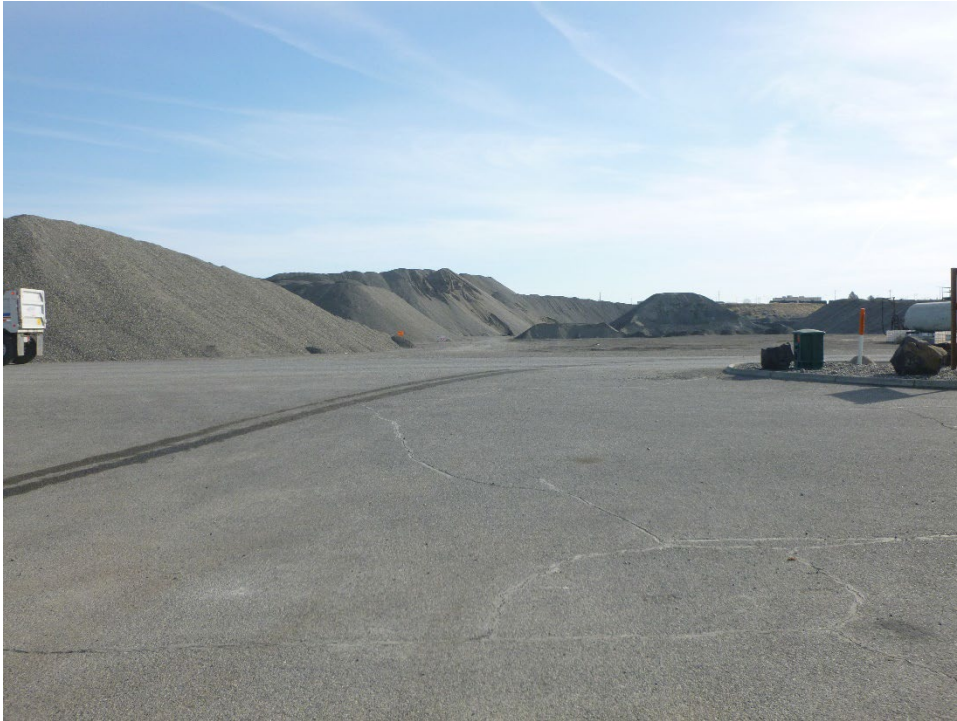
In the production area, there were gravel and sand piles located around the site. The topography of the site appeared to be graded slightly down towards the north (**Photo 3**). On the northern perimeter of the property is a berm that helps keep any stormwater on-site (**Photo 4**). The northern perimeter berm is a remnant from when the front area was quarried.

**Photo 3/P1010578** – Gravel Piles, site graded down to north

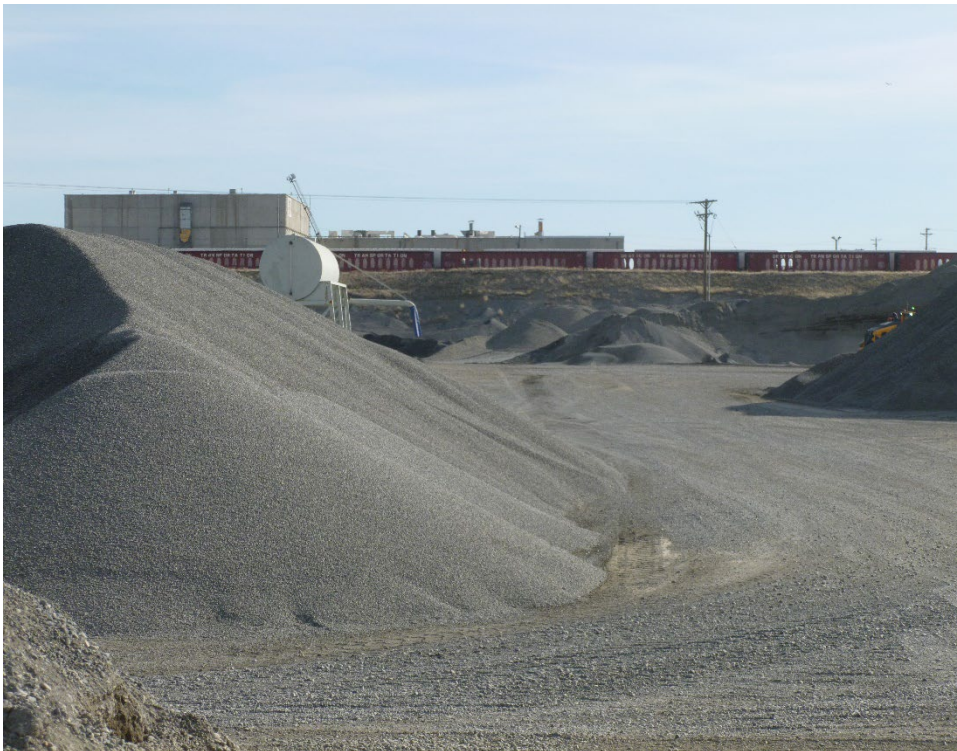
**Photo 4/P1010580** – Gravel Piles, berm to north

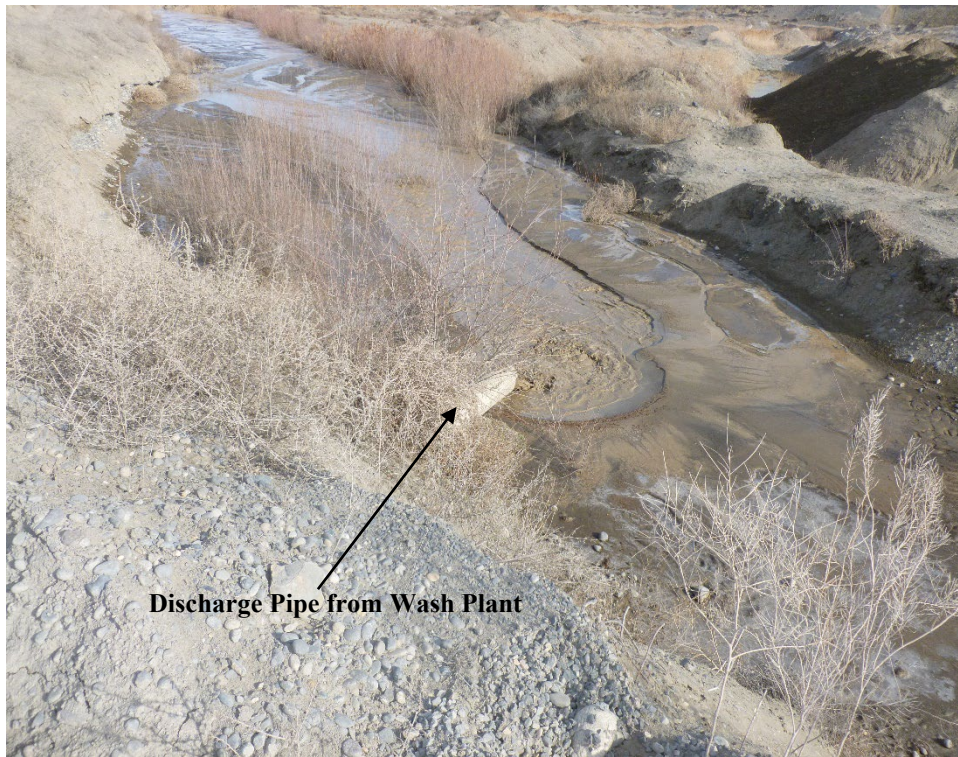
As I stated in “Site Information” above, the quarried material is sent to a Wash Plant. The Wash Plant discharges wastewater into a gulley where it infiltrates (**Photos 5 – 7**).

**Photo 5/P1010581 – Discharge from Wash Plant, photo 1**

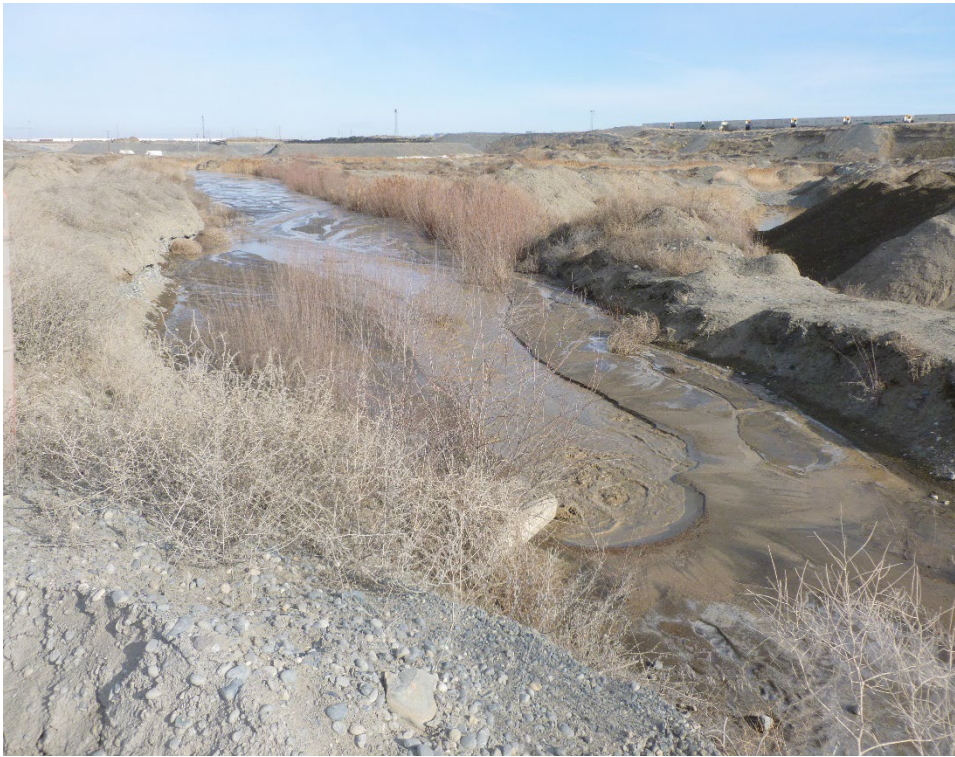
**Photo 7/P1010583** – Discharge from Wash Plant, photo 3

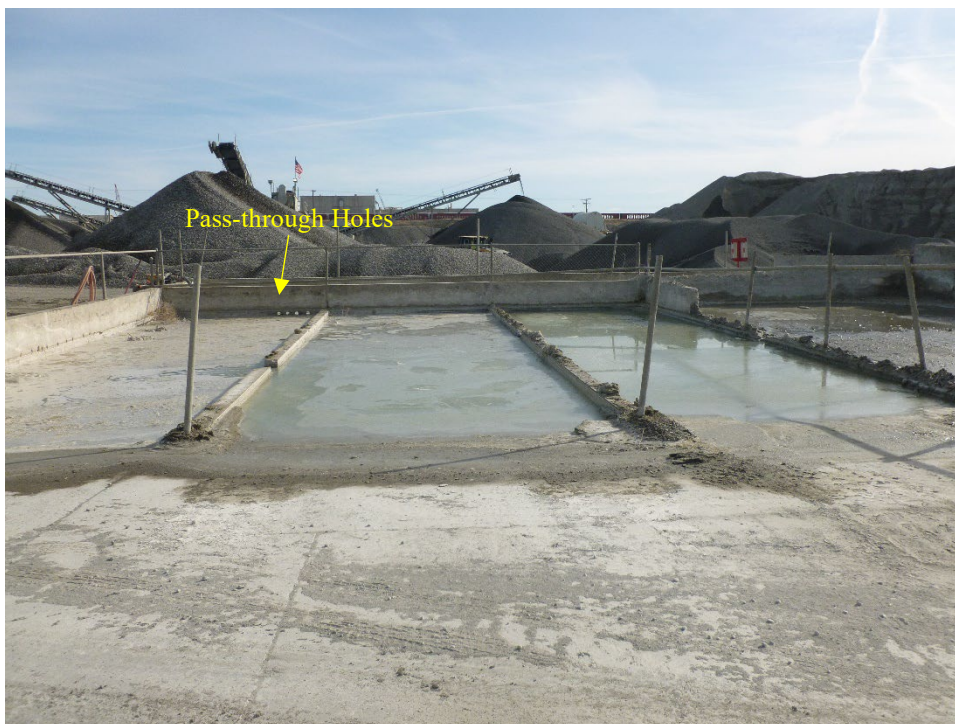
The site also maintains a truck washing area (**Photo 8**). The trucks pull into chutes which are part of a closed loop water recycling system. The water used to wash the trucks runs to the rear of the chute and enters a concrete pond that collects the water (**Photo 9**). Water enters the pond from the washing chutes via pass-through holes at the bottom of the diving wall.

**Photo 8/P1010585** – Truck Wash Area

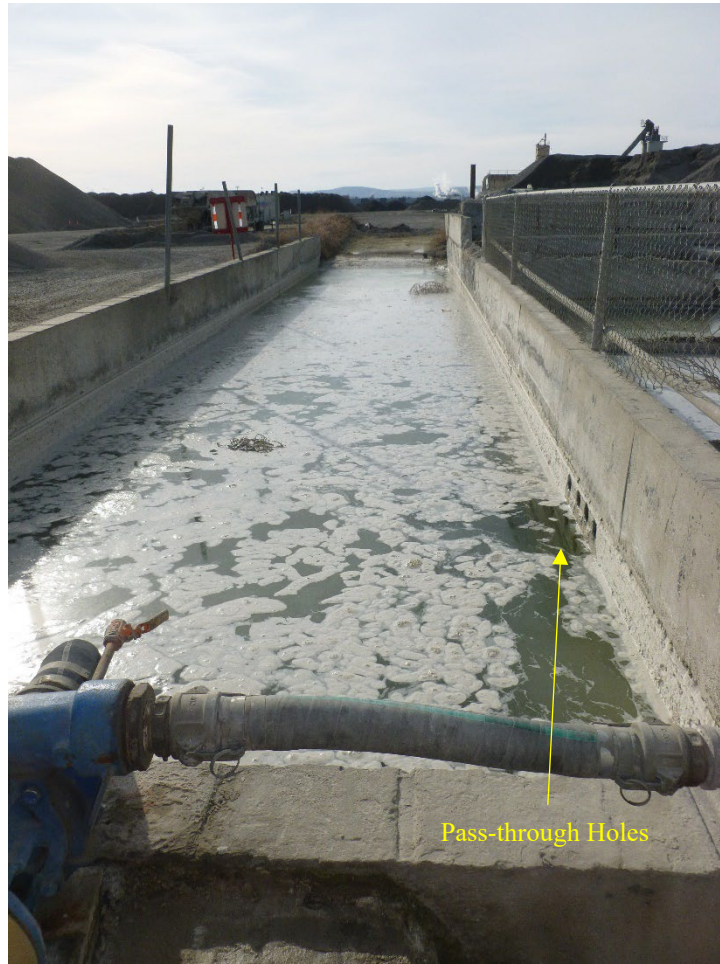
**Photo 9/P1010586 – Concrete Pond**

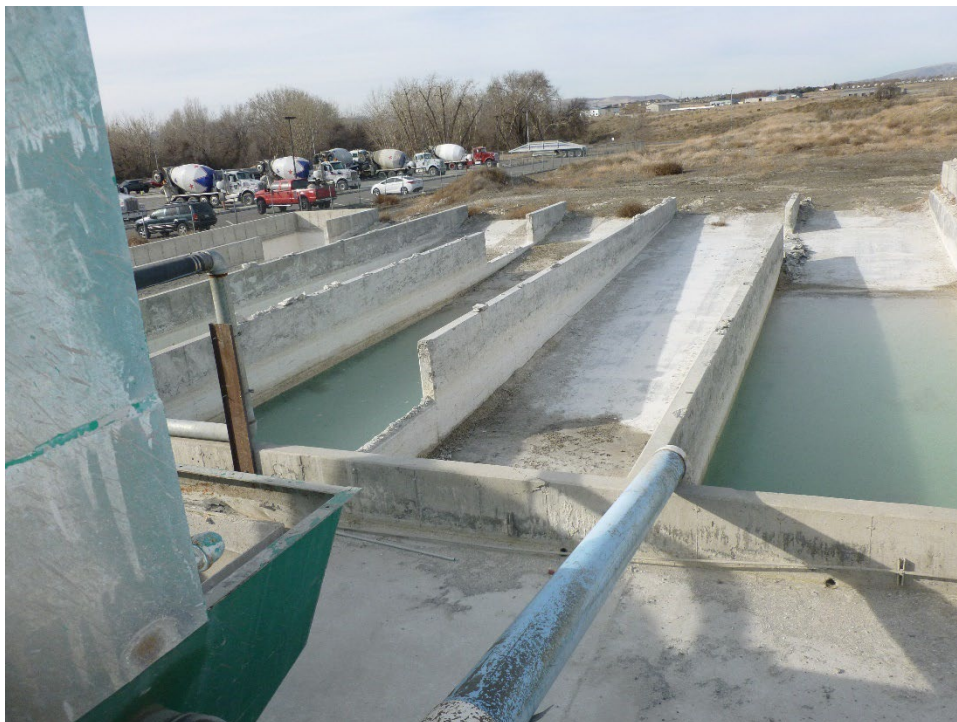
The facility tries to capture and reuse as much water as possible. All captured water is carried by underground piping that surfaces at the site's concrete reclamation settling pond (**Photo 10**). The sediment settles out and the water is siphoned out for reuse. The settling ponds are cleaned of sediment as needed.

**Photo 10/ P1010586 – Concrete Reclamation Water Settling Pond**
