**Air Branch Inspection Report**  
**Unannounced Full Compliance Evaluation**  
**Hamm Sanitary Landfill**  
16984 3rd Street  
Lawrence, Kansas 66044  
FRS# 110007364495

**Inspection Date(s):**  
March 29, 2022

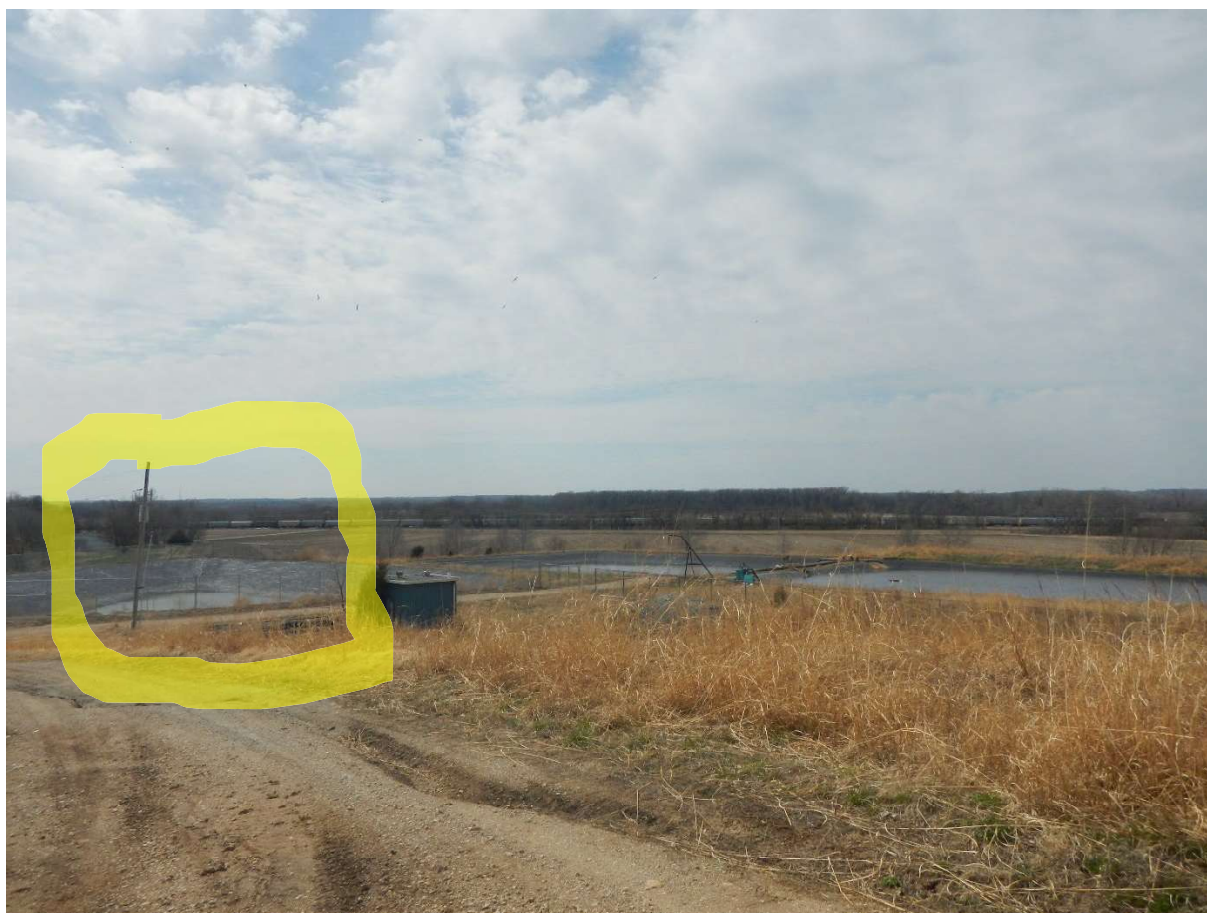
Hamm Sanitary Landfill has been owned and operated by N.R. Hamm Quarry, LLC since its first permit was issued in March 1976. The facility began receiving waste on its 360 acres in 1981. There are 18 employees that help run and manage all site activities. The landfill runs Monday-Friday from 7:30 am until 4:30 pm and on Saturdays from 7:30 am until 1:00 pm. The gas system in place is a combination of lateral and header piping. Collected gas is routed to a mini-flare for combustion.<sup>1</sup> Prior to the installation of the mini-flare, the gas was routed to a thermal oxidizer for treatment. In 2019 the facility installed its third leachate pond to help increase proper landfill gas management. (**Figure 1**).

**Figure 1. Three leachate ponds. Newly installed pond to the left**

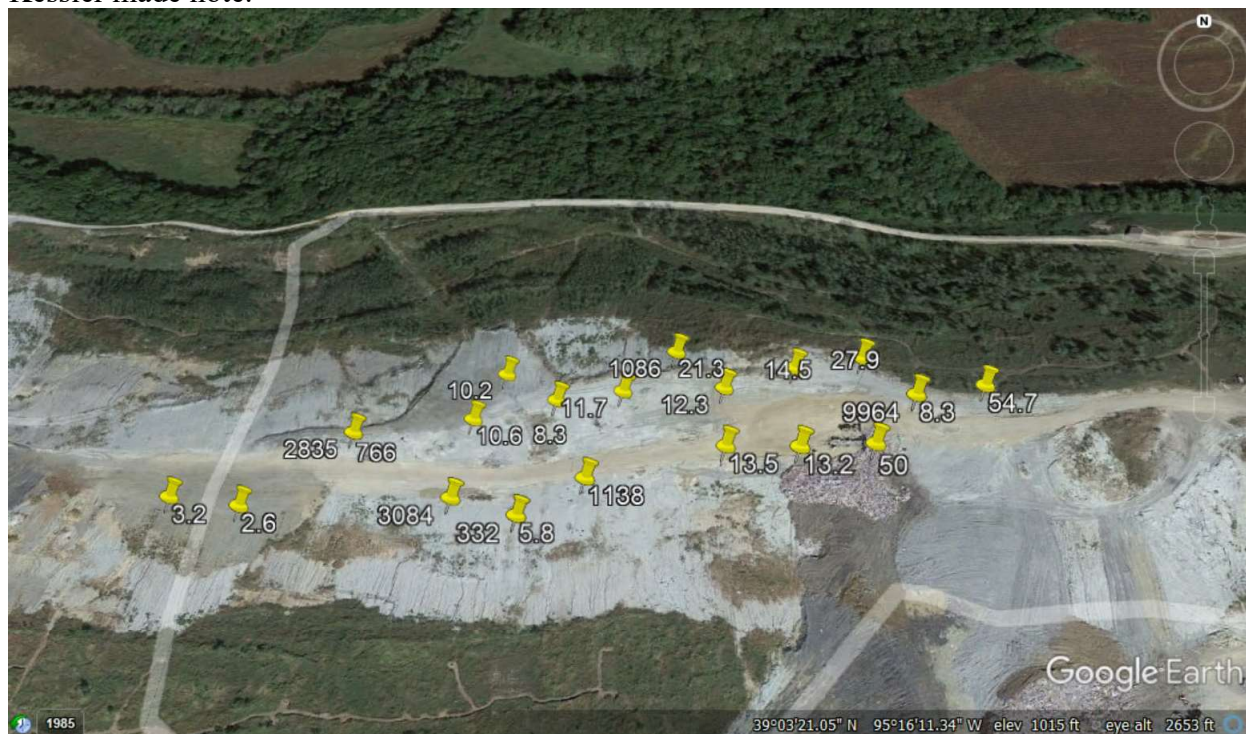
seconds. Ms. Kessler and I walked around the landfill and noted 7 areas where methane emissions exceeded the 500 parts per million (ppm) threshold (Table 5). We did not collect TVA readings around active cell 112 because there were trucks operating and dumping waste. Around 1:58 pm, while we were conducting the surface emission monitoring, the flare began operating and Mr. Meyers noted that a horizontal gas line well was cracked and that the system went down.<sup>2</sup> He said that may contribute to the higher methane values shown on the TVA and Ms. Kessler made note.

**Figure 2. Areas surveyed with TVA and respective methane values in parts per million.**

The inspection team conducted field measurements via Method 21, as required by 40 CFR Part 62, Subpart OOO. Figure 2 shows the areas on the landfill that were measured throughout the inspection. **Table 5** summarizes field measurements that were above the 500 ppm threshold for methane.
