**Region 6 - Enforcement & Compliance Assurance Division**  
**INSPECTION REPORT**

| Company Name: | <b>Lamkin Oil, Inc.</b> | |
| Facility Name: | <b>Linkous B Tank Battery</b> | |

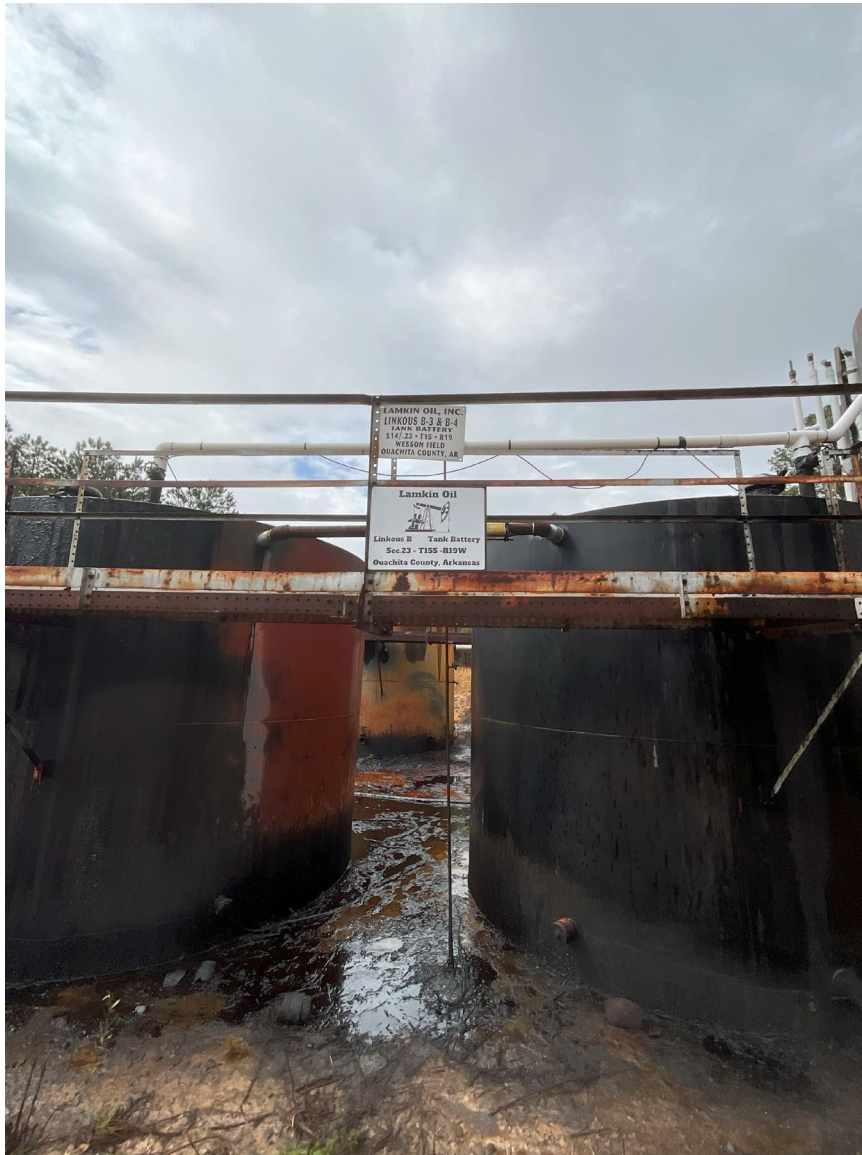
Photo No. 1

I observed the facility sign, secondary containment, pipes, valves, and storage tanks located at the facility; see Appendix 1 (photo log), photo No. 1 and No. 2. For additional GPS location and photo metadata, see Appendix 1.

**Description:** This photo was taken looking northwest and shows the facility sign.

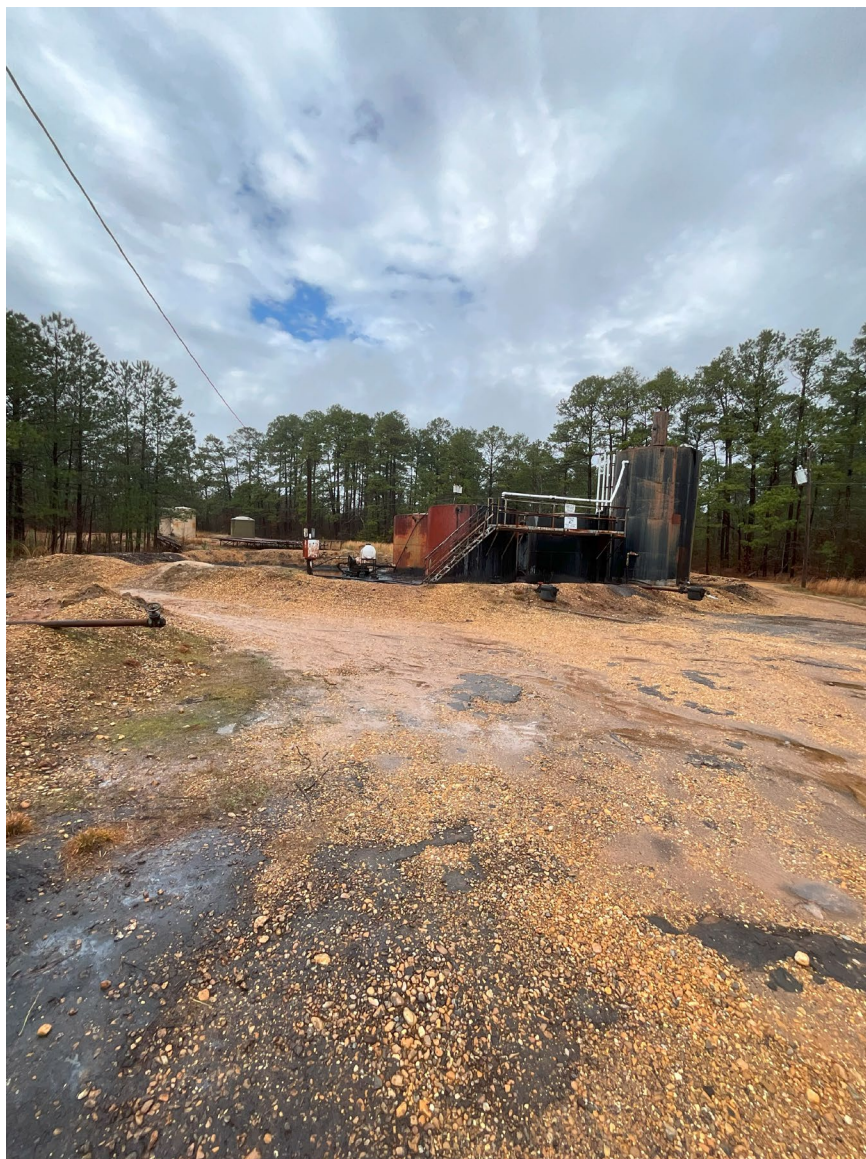
Photo No. 2

**Description:** This photo was taken looking north and shows an overview of the facility.

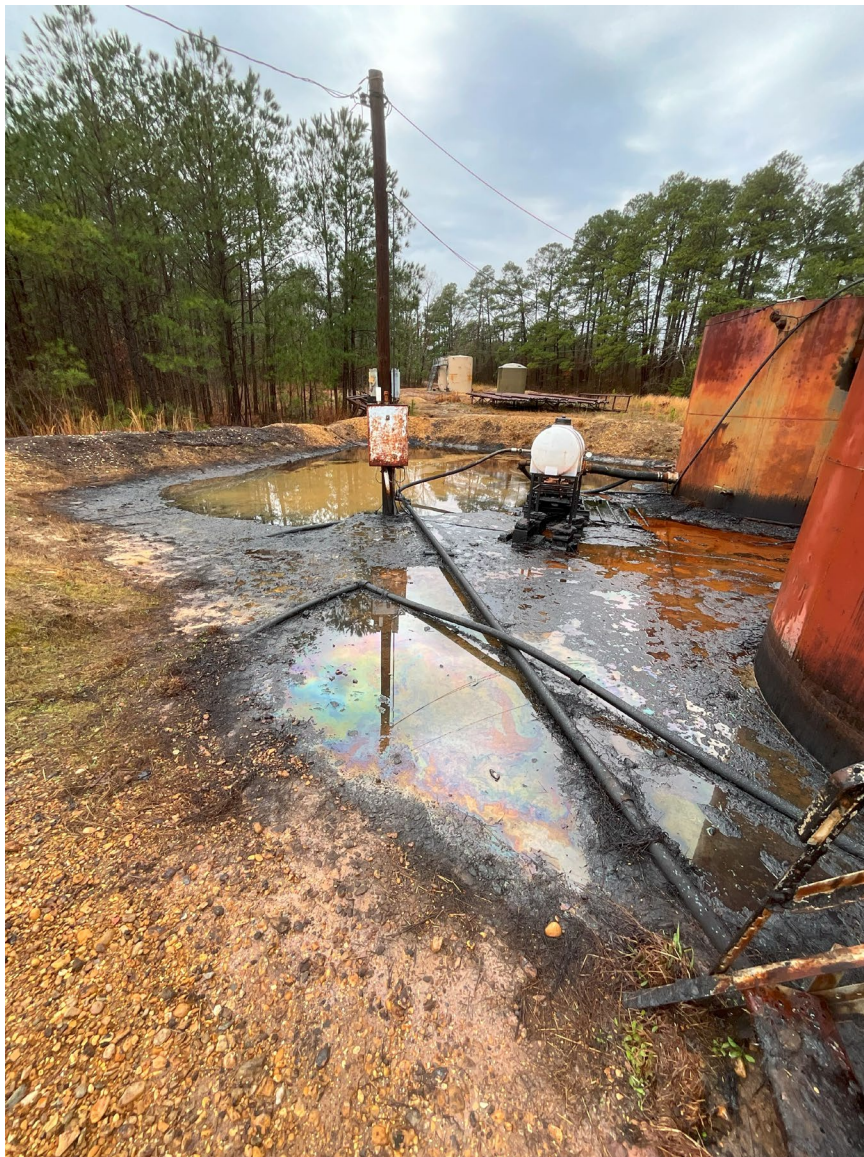
Photo No. 3

I observed loose oil and sheen inside secondary containment, see photo No. 3.

No closing conference was held due to no Lamkin Oil, Inc. staff being present during the inspection. Areas of concern at the time of the inspection include loose oil inside secondary containment and gapping under the tanks.

**Description:** This photo was taken looking west and shows loose oil and sheen inside secondary containment.

Inspector will conduct follow-up phone calls with the company representatives over the coming weeks and months to ensure areas of concern are properly addressed.

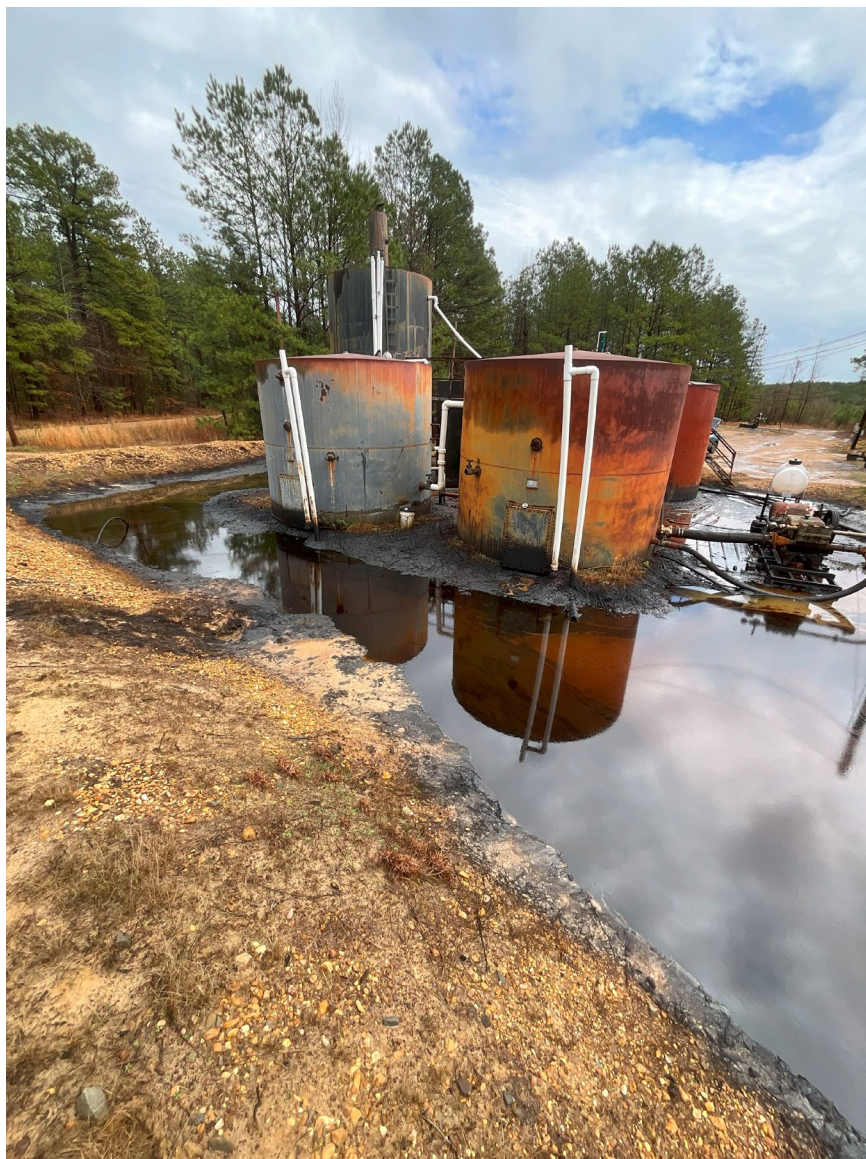
Photo No. 4

I observed gapping under the storage tanks, see photo No. 4.

**Description:** This photo was taken looking northeast and shows gapping under the tanks.
