**Region 6 - Enforcement & Compliance Assurance Division**  
**INSPECTION REPORT**

| Regulatory Program(s) | Water (CWA) Brine Program (Oil & Gas inspection) | |
| Company Name: | <b>Jerry Langley Oil Company, LLC</b> | |
| Facility Name: | <b>Meekins Lease Tank Battery</b> | |

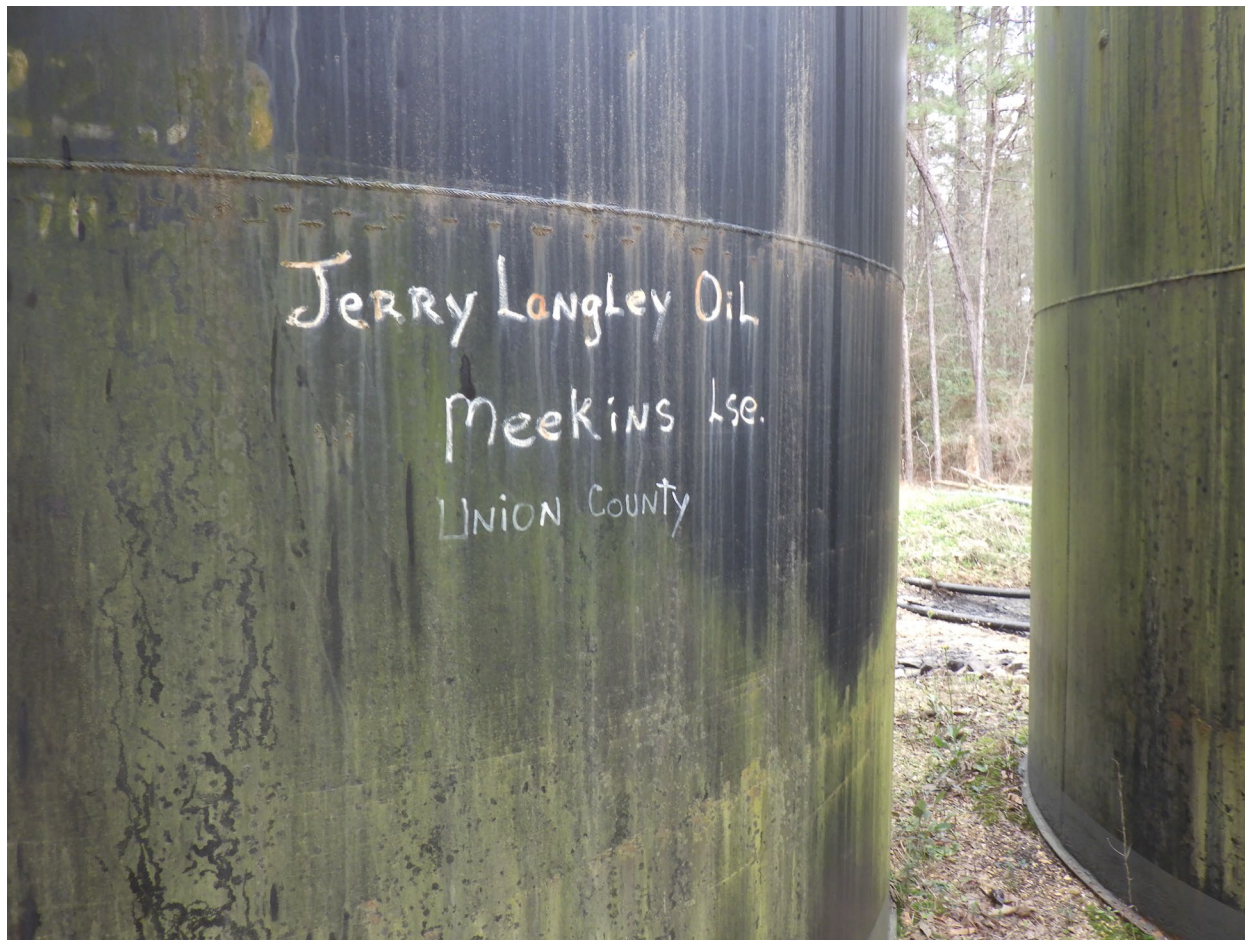
Photo No. 1

**Description:** This photo was taken looking SE at the facility showing the facility signage on a tank.

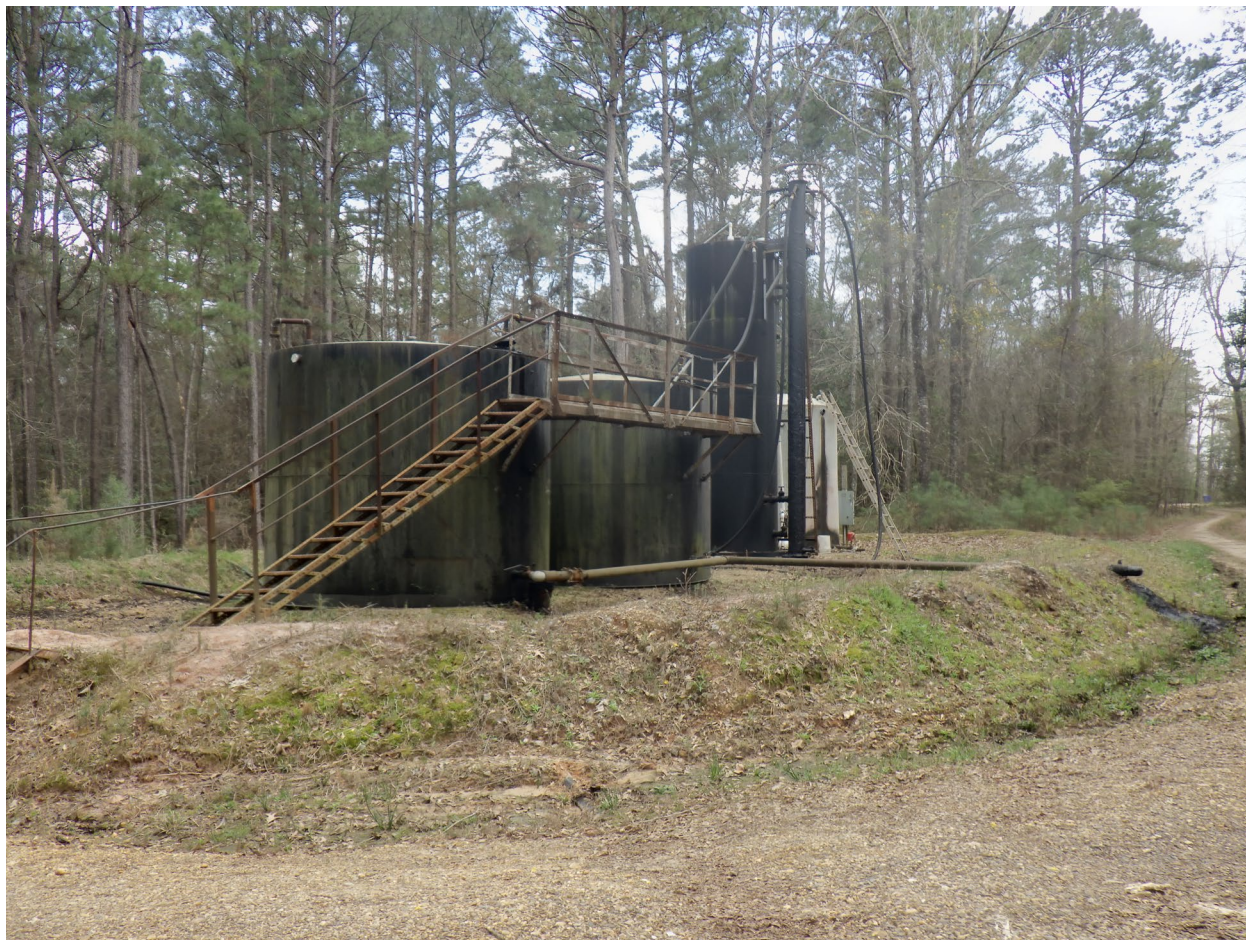
Photo No. 2

I observed the facility sign, secondary containment, oil-water separator, pipes and valves, and storage tanks located at the facility; see Appendix 1 (Photographs Log), Photo No. 1 and No. 2. For additional GPS location and photo metadata, see Appendix 1.

**Description:** This photo was taken looking S-SE at the facility showing overview of the facility.

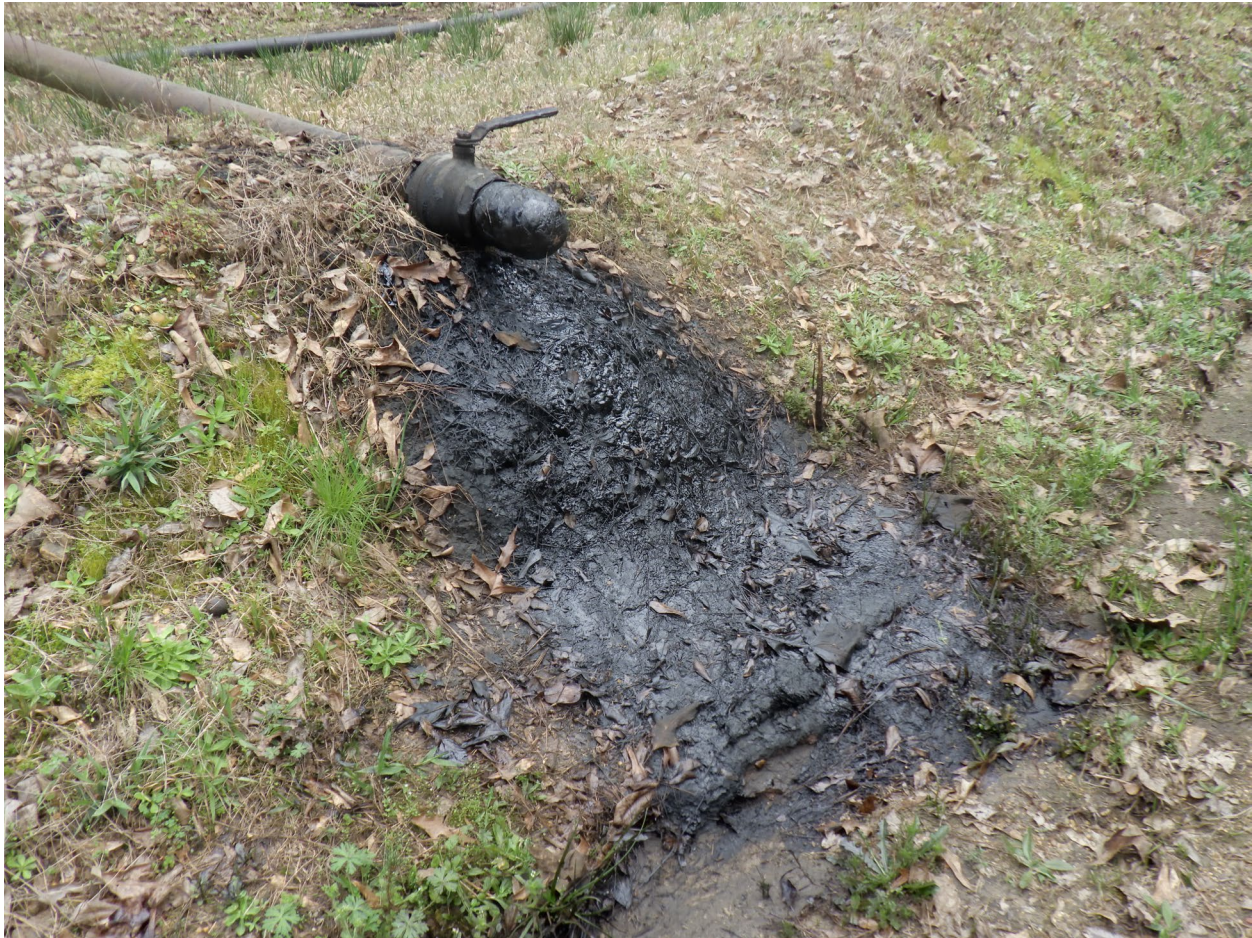
Photo No. 3

I observed a transfer pipe through secondary containment with loose oil around the area and no catch bucket below the pipe, see Photo No. 3.

No closing conference was held due to no personnel with Jerry Langley Oil Co., LLC being present during the inspection. Areas of concern at the time of the inspection include the loose oil around the transfer pipe, no catchment for the transfer pipe, loose oil inside secondary containment, pipes to and from

**Description:** This photo was taken looking S-SE showing loose oil around transfer pipe with no catch bucket.

Inspector will conduct follow-up phone calls with the company representative(s) over the coming weeks and months to ensure areas of concern are properly addressed.

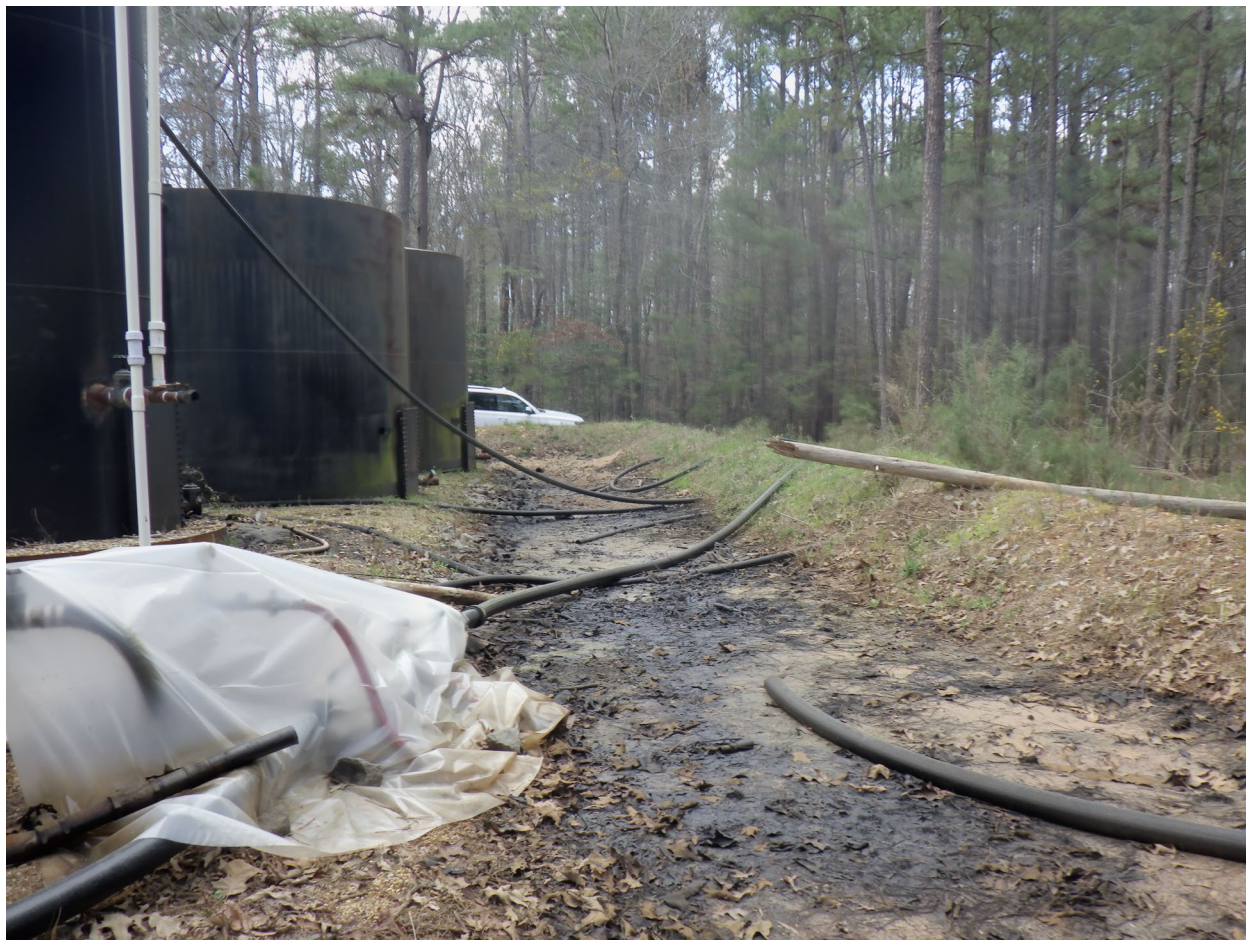
Looking N-NE inside the front of secondary containment, I observed loose oil on the ground and an active leak around a tank; see Photo No. 4 through Photo No. 6.

**Description:** This photo was taken looking N-NE showing loose oil inside secondary containment.

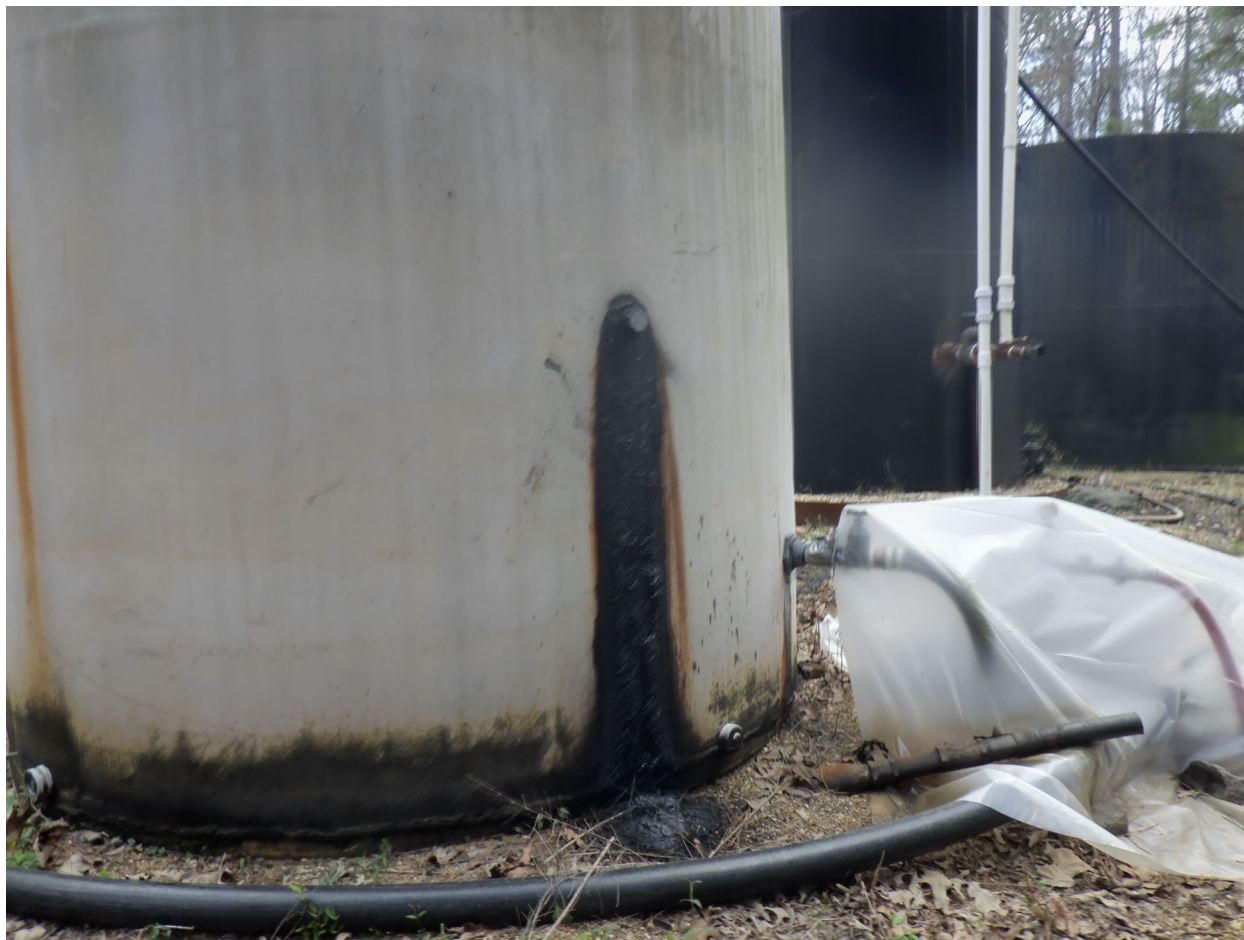
Photo No. 5

**Description:** This photo was taken looking NW showing an active leak from one of the tanks.

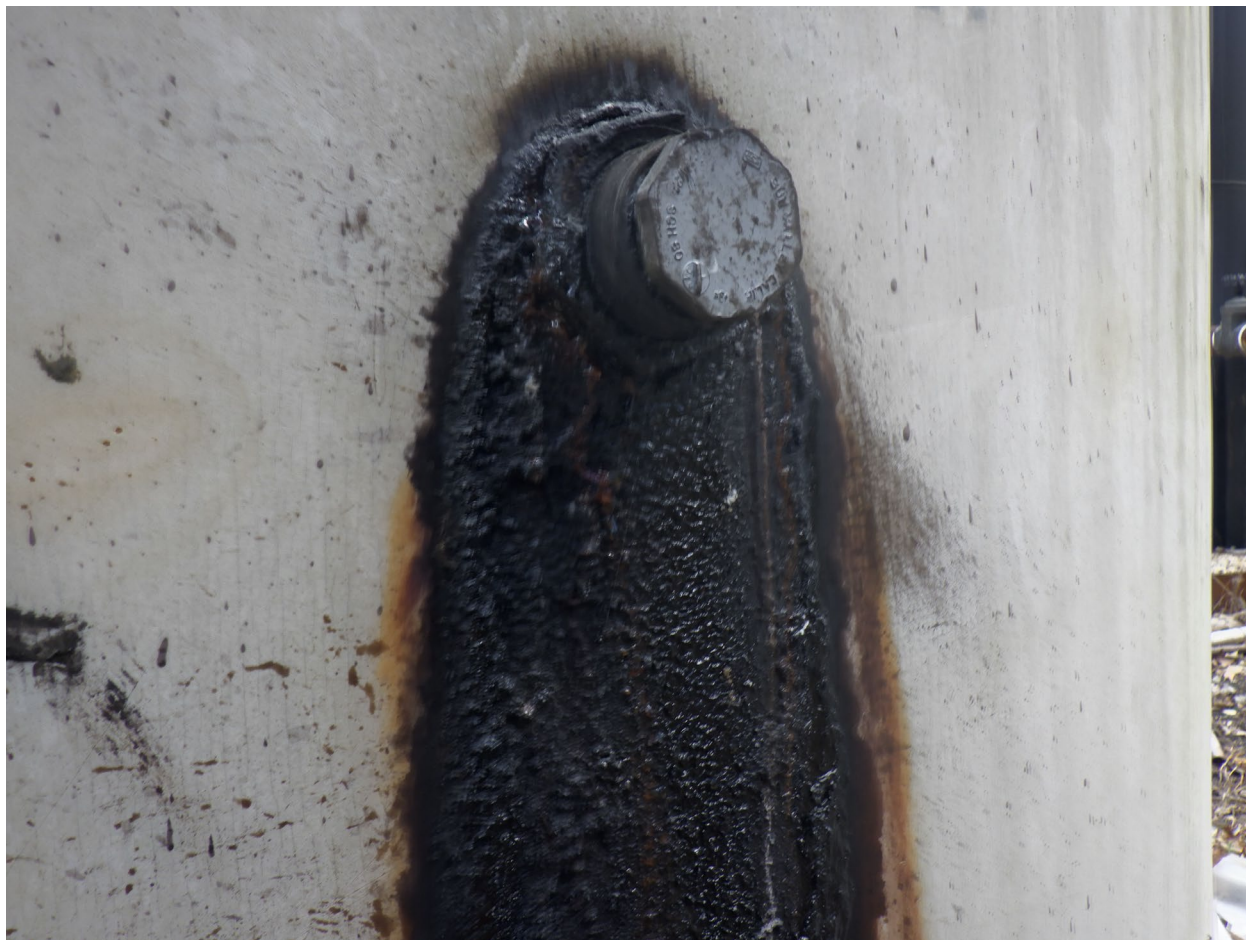
Photo No. 6

**Description:** This photo was taken looking NW showing a closeup of the active leak from one of the tanks from Photo No. 5.

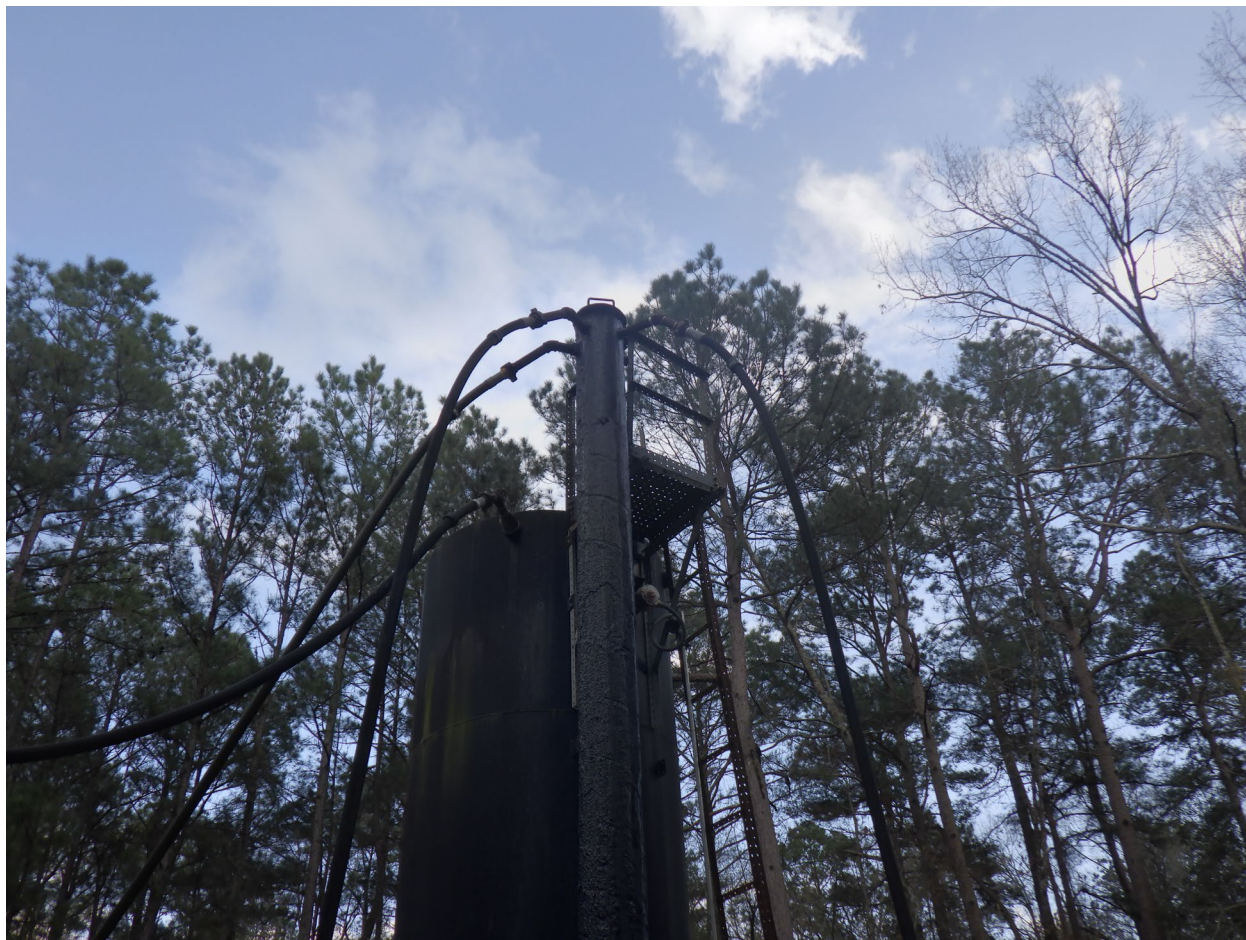
I observed pipes without support leading to and from the tanks inside secondary containment, see Photo No. 7 and No. 8.

**Description:** This photo was taken looking SE showing a tank with pipes without support.

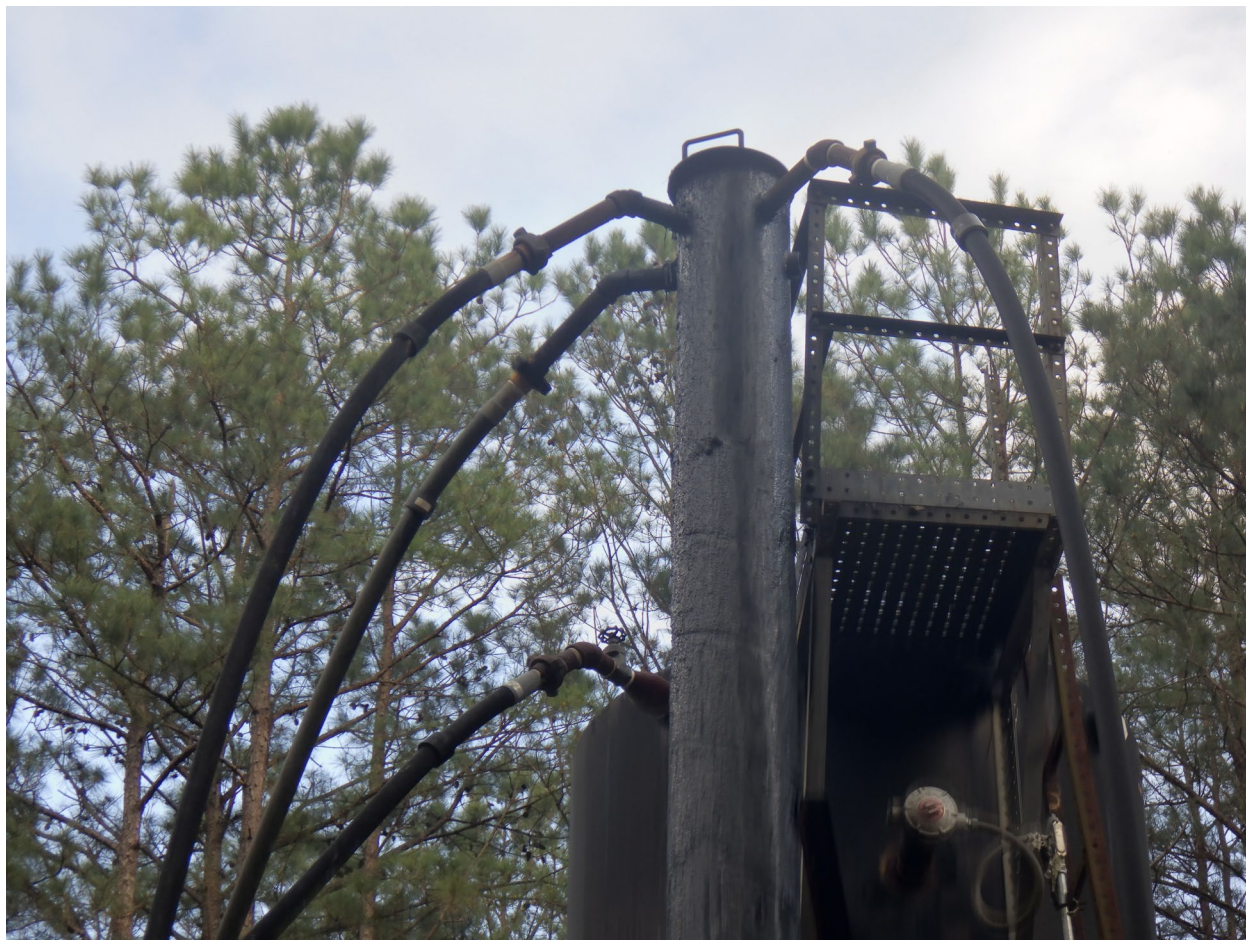
Photo No. 8

**Description:** This photo was taken looking E-SE showing a closeup of the tank with pipes without support from Photo No. 7.

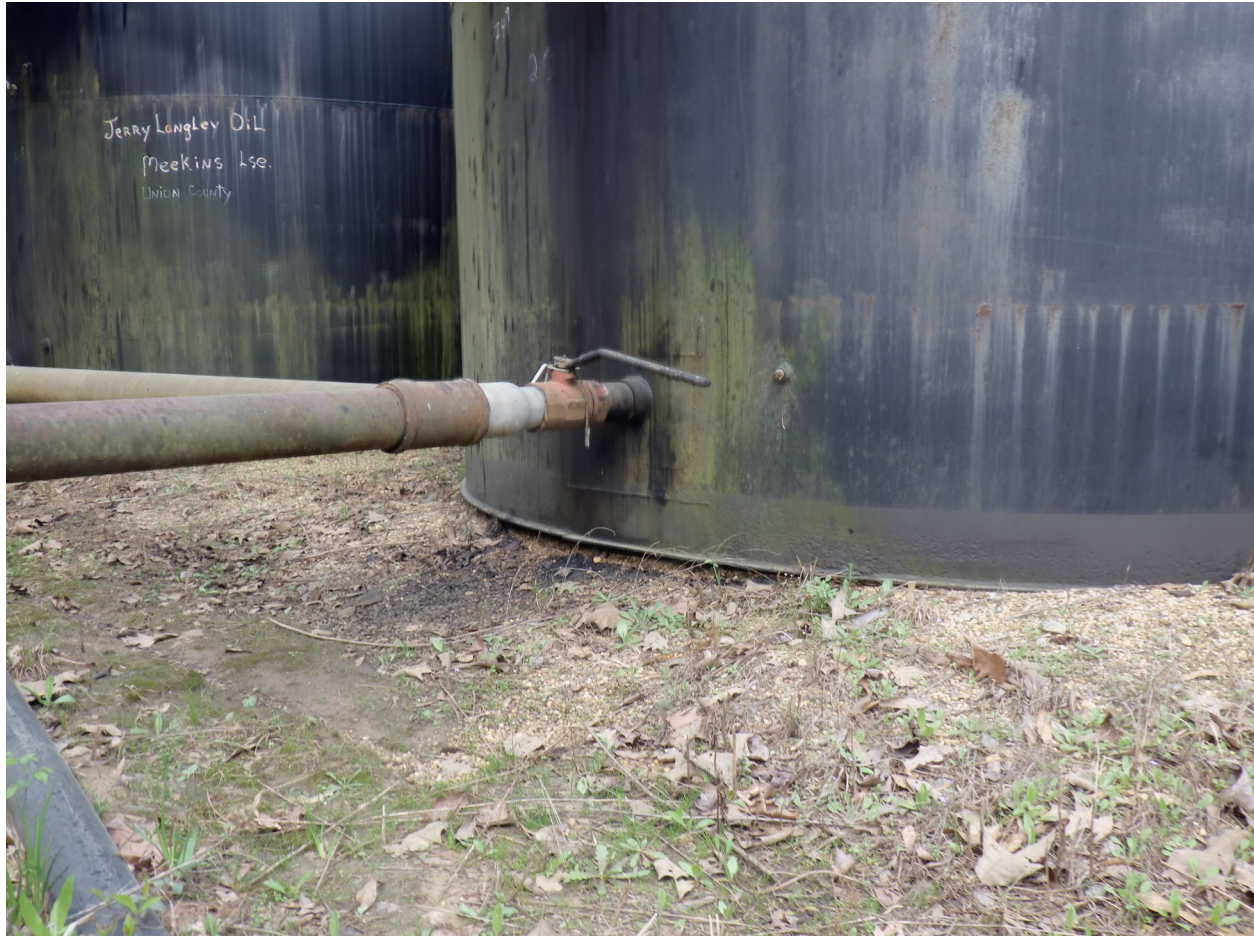
For tanks identified as Tank 2298 and Tank 2299, I observed gaps at the bottom of each of the tanks; see Photo No. 9 through Photo No. 12.

**Description:** This photo was taken looking E-NE showing Tank 2299 with a gap at the bottom of the tank.

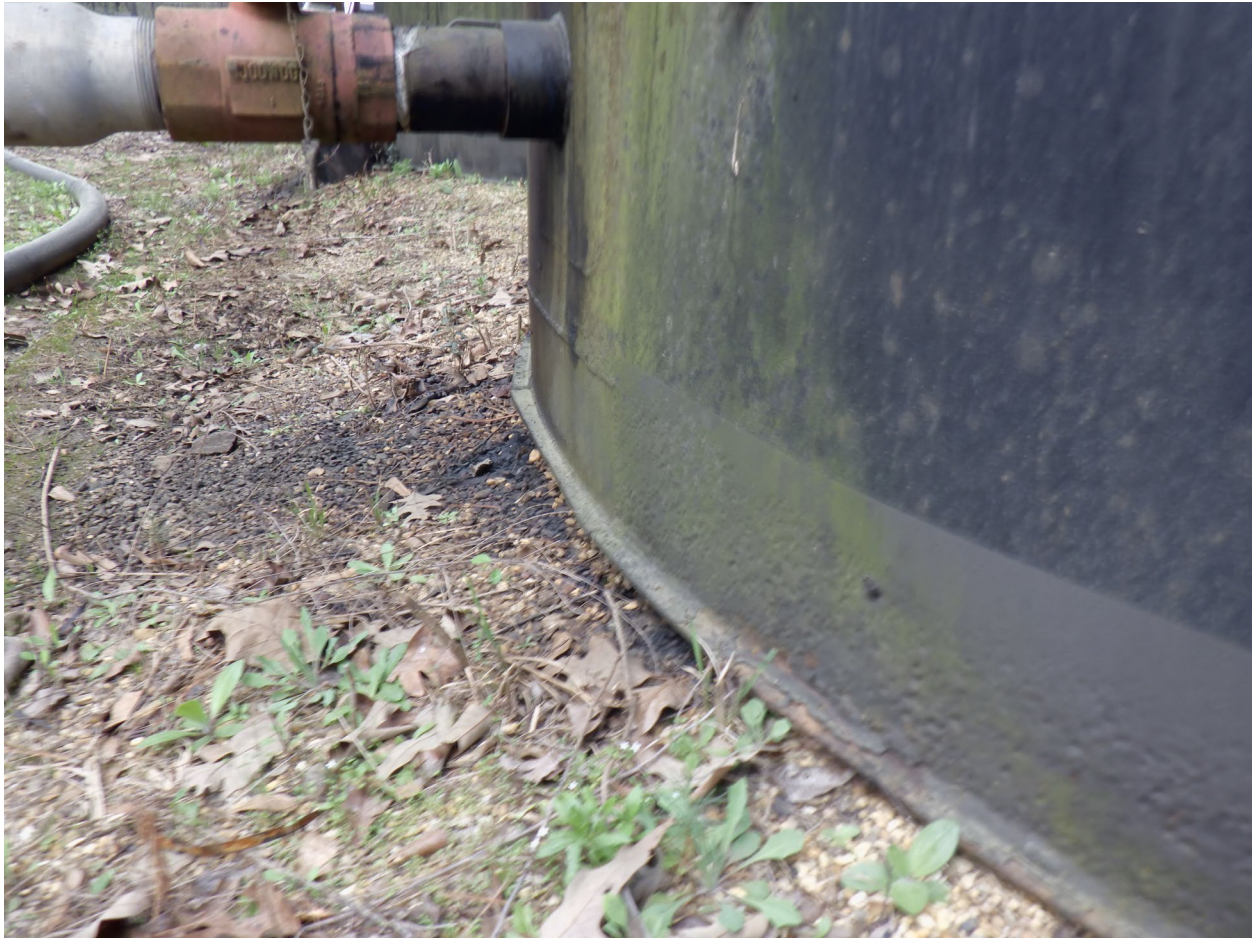
Photo No. 10

**Description:** This photo was taken looking E-NE showing a closeup of Tank 2299 with a gap at the bottom of the tank from Photo No. 9.

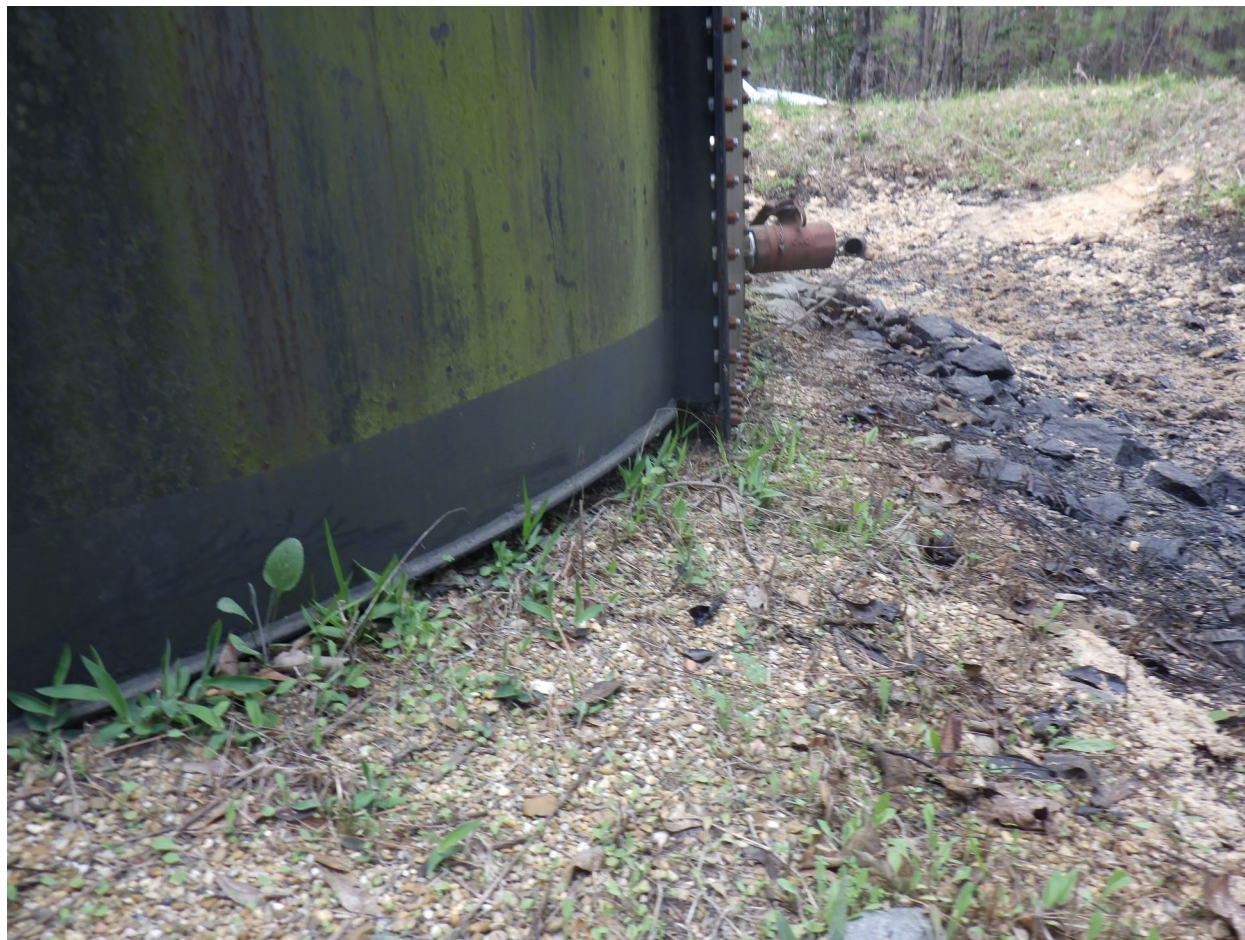
Photo No. 11

**Description:** This photo was taken looking N-NW showing Tank 2298 with a gap at the bottom of the tank.

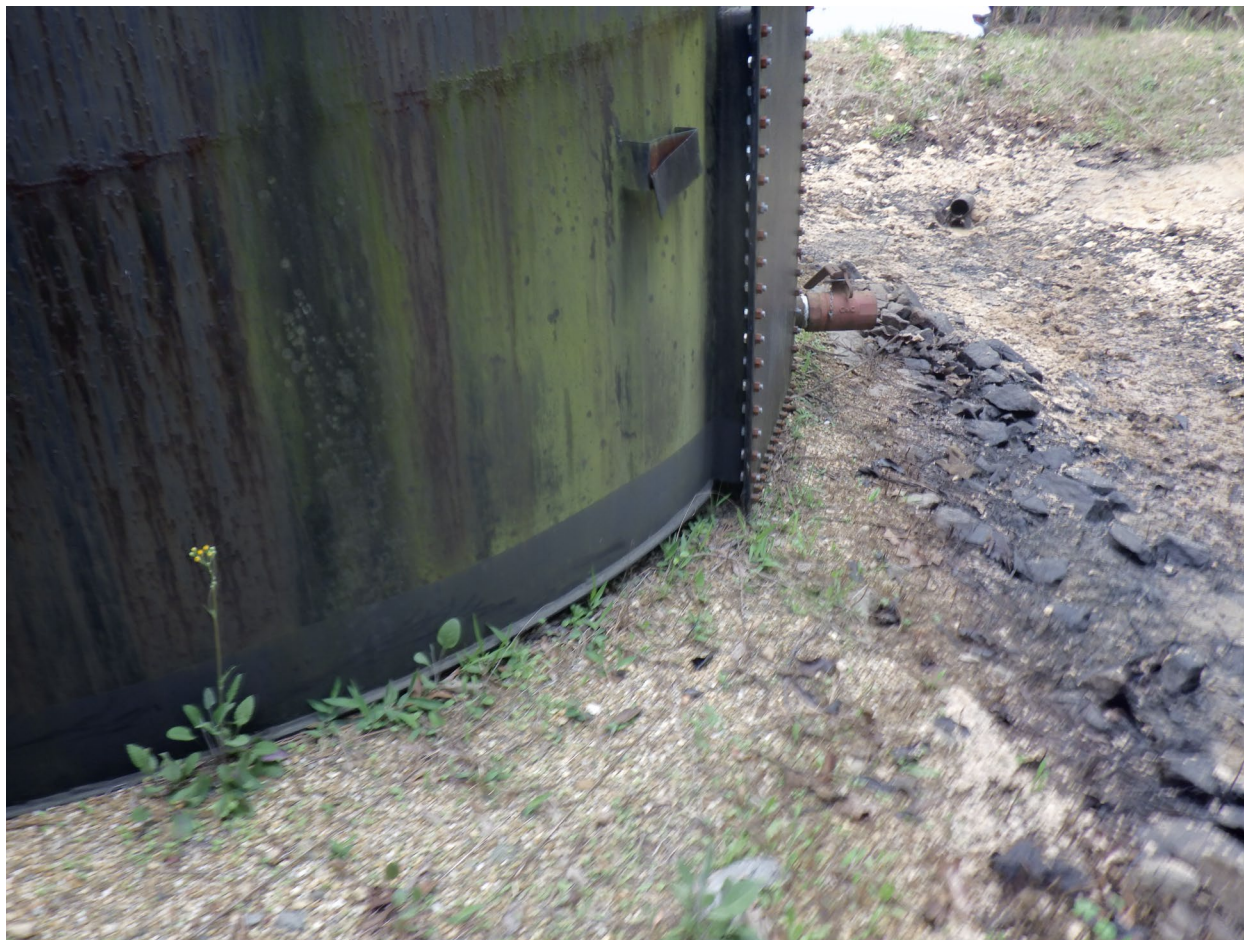
Photo No. 12

**Description:** This photo was taken looking N-NW showing a closeup of Tank 2298 with a gap at the bottom of the tank from Photo No. 11.

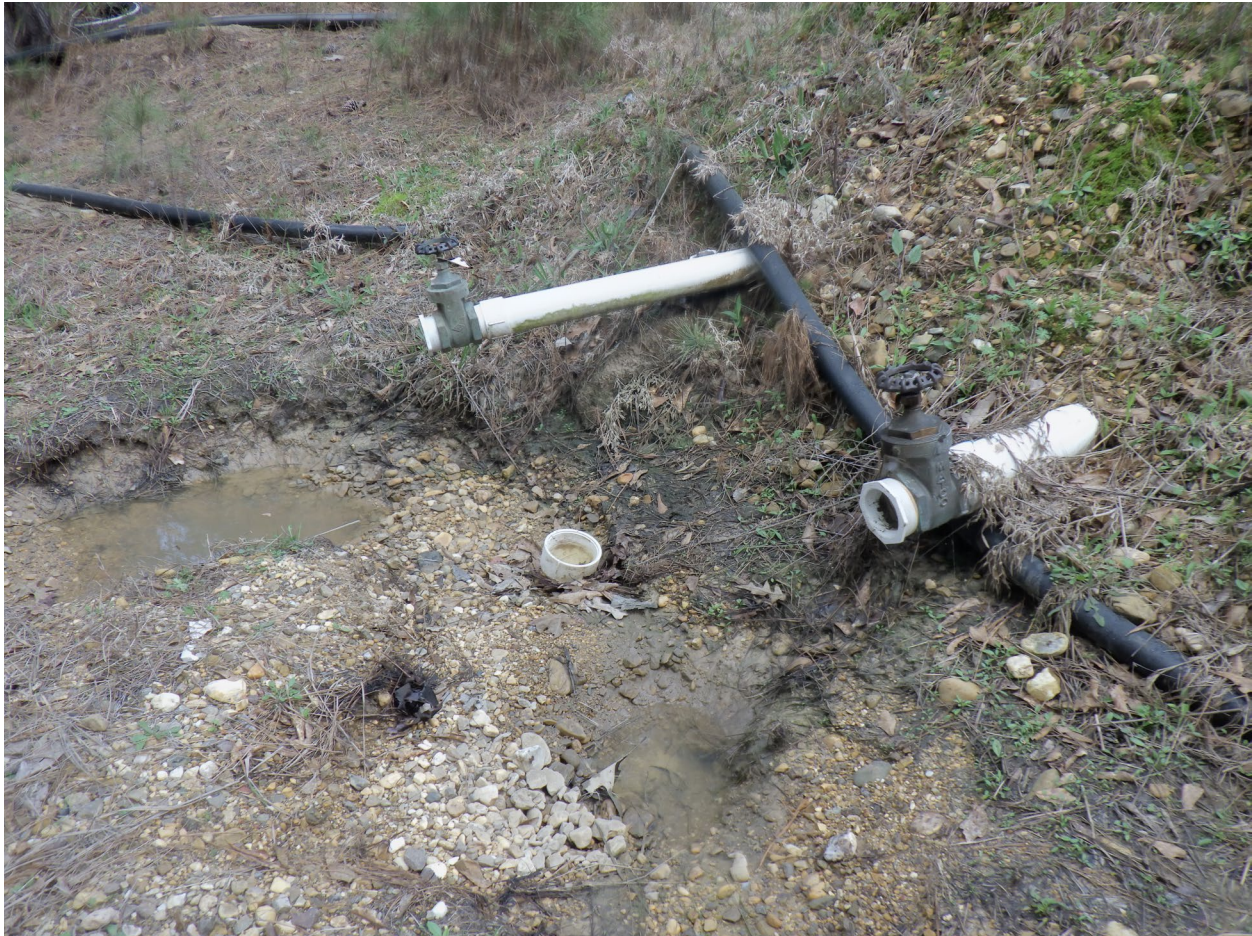
Looking S-SE outside the back of the secondary containment, I observed two secondary containment drainpipes that did not have caps; see Photo No. 13 and No. 14. There was no leakage from either of the drainpipes during the inspection.

**Description:** This photo was taken looking S-SE showing drainpipes for the secondary containment without caps.

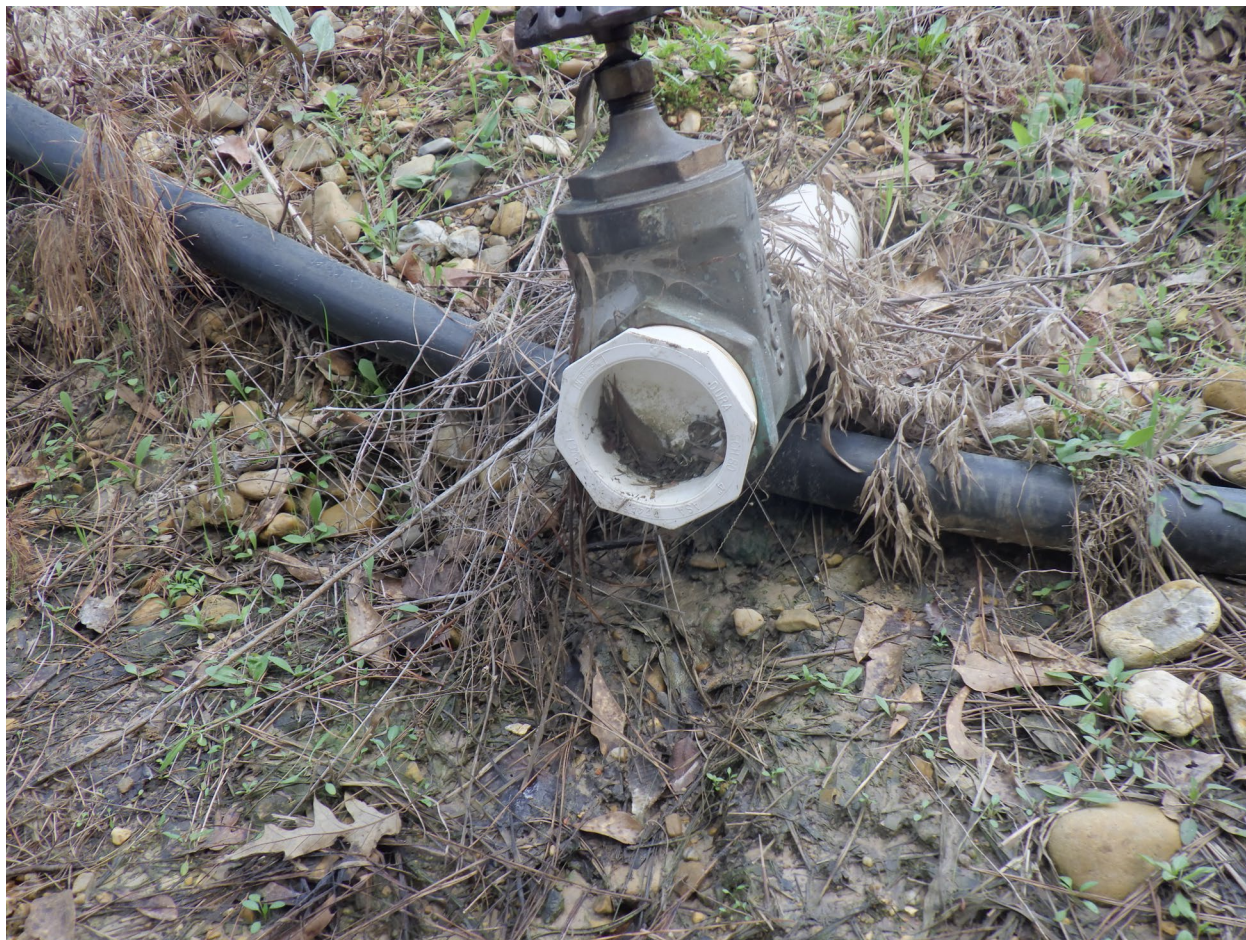
Photo No. 14

**Description:** This photo was taken looking S showing a closeup of one of the drainpipes for secondary containment without a cap; valve closed with no active leak during the inspection.
