### INSPECTION REPORT

| Inspection Date(s): | 4/2/24 | |
| Company Name: | <b>Owen Drilling Company, Inc.</b> | |
| Facility Name: | <b>International Paper Co. "B" 1 Tank Battery</b> | |

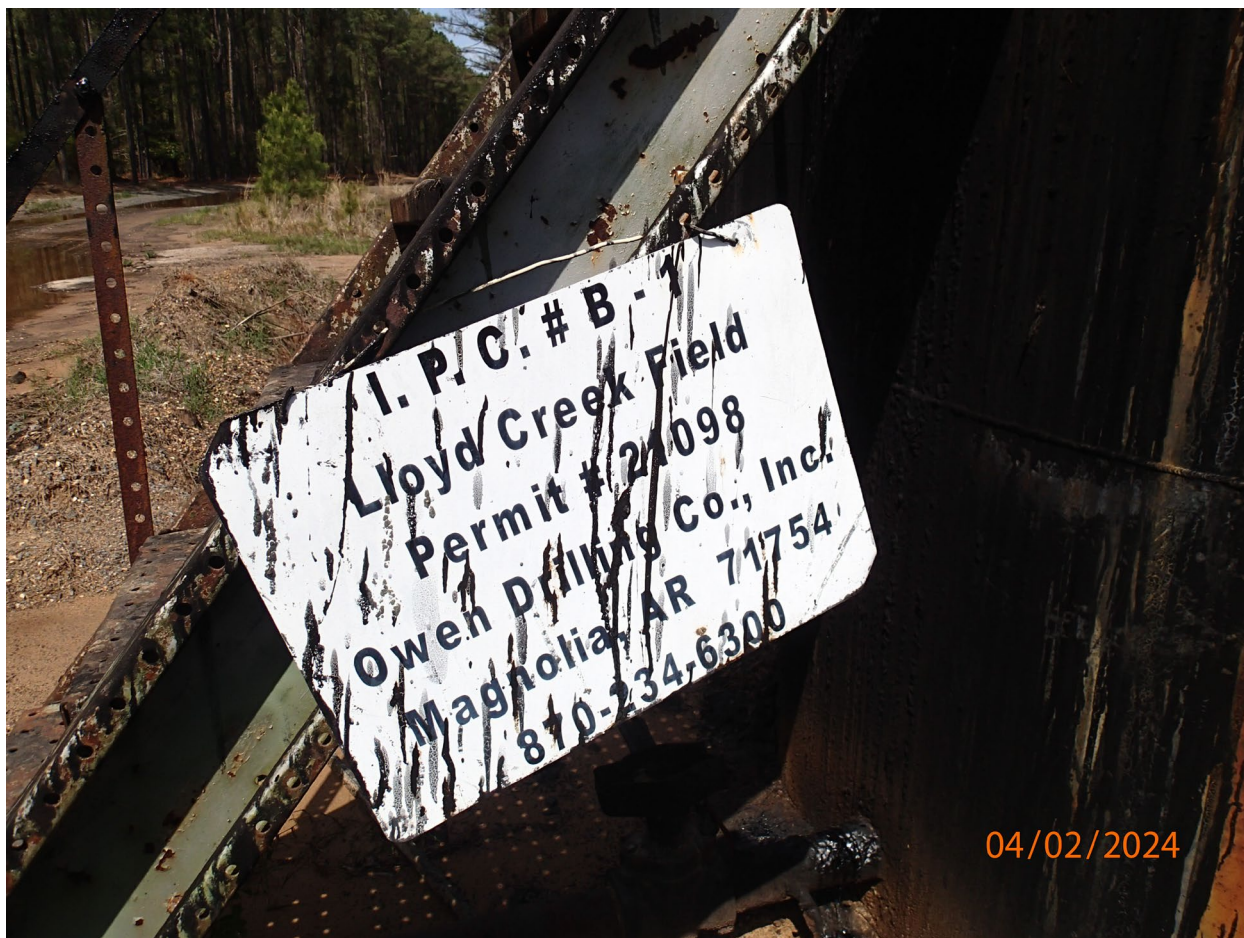
Photo No. 1

**Description:** Looking NNE, this photo showed the signage at the facility.

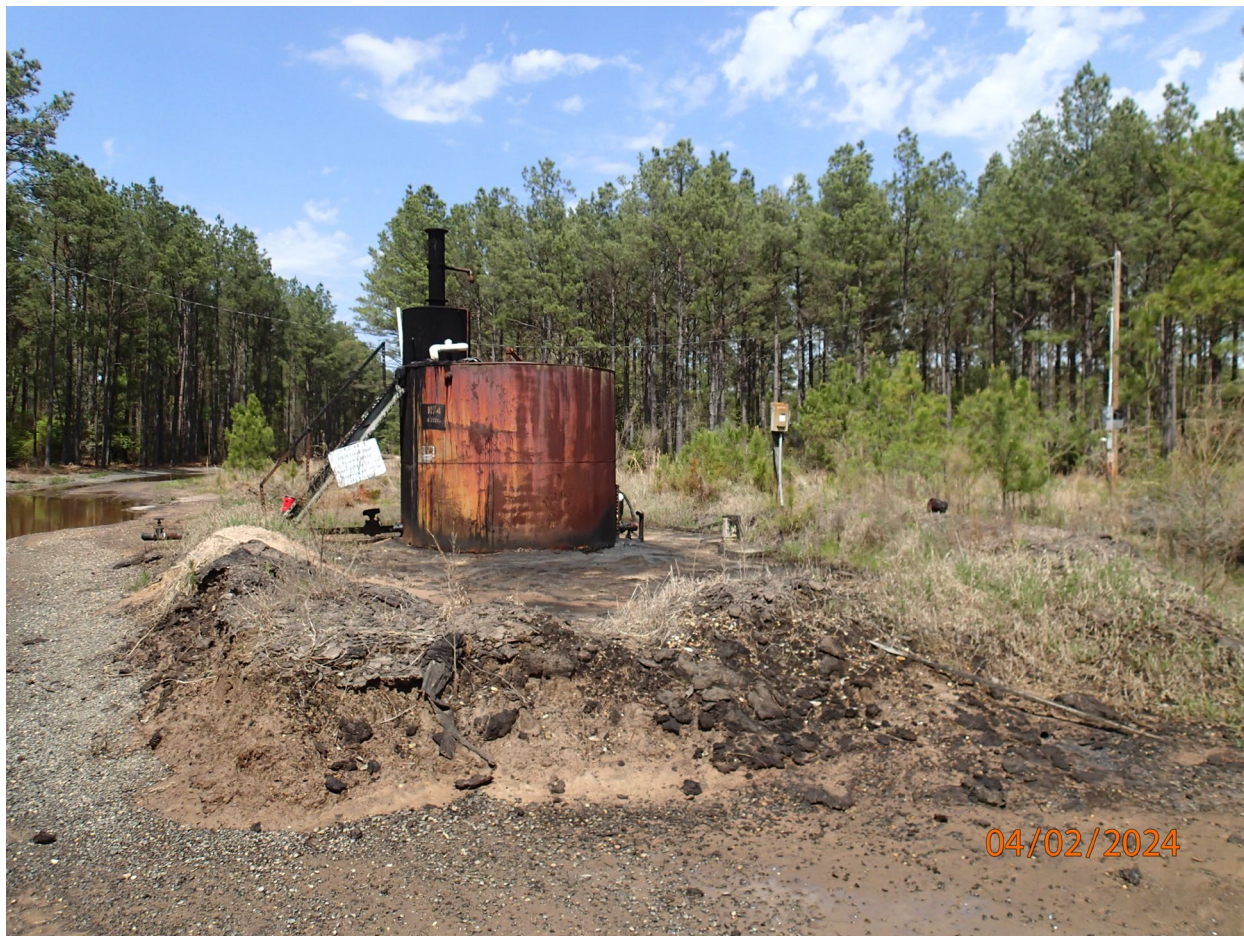
Photo No. 2

I observed the facility sign, secondary containment, oil-water separator, pipes and valves, storage tanks, and the production well located at the facility; see Appendix 1 (Photograph Log), Photo No. 1 and No. 2. For additional GPS location and photo metadata, see Appendix 1.

**Description:** Looking NNW, this photo showed an overview of the facility.

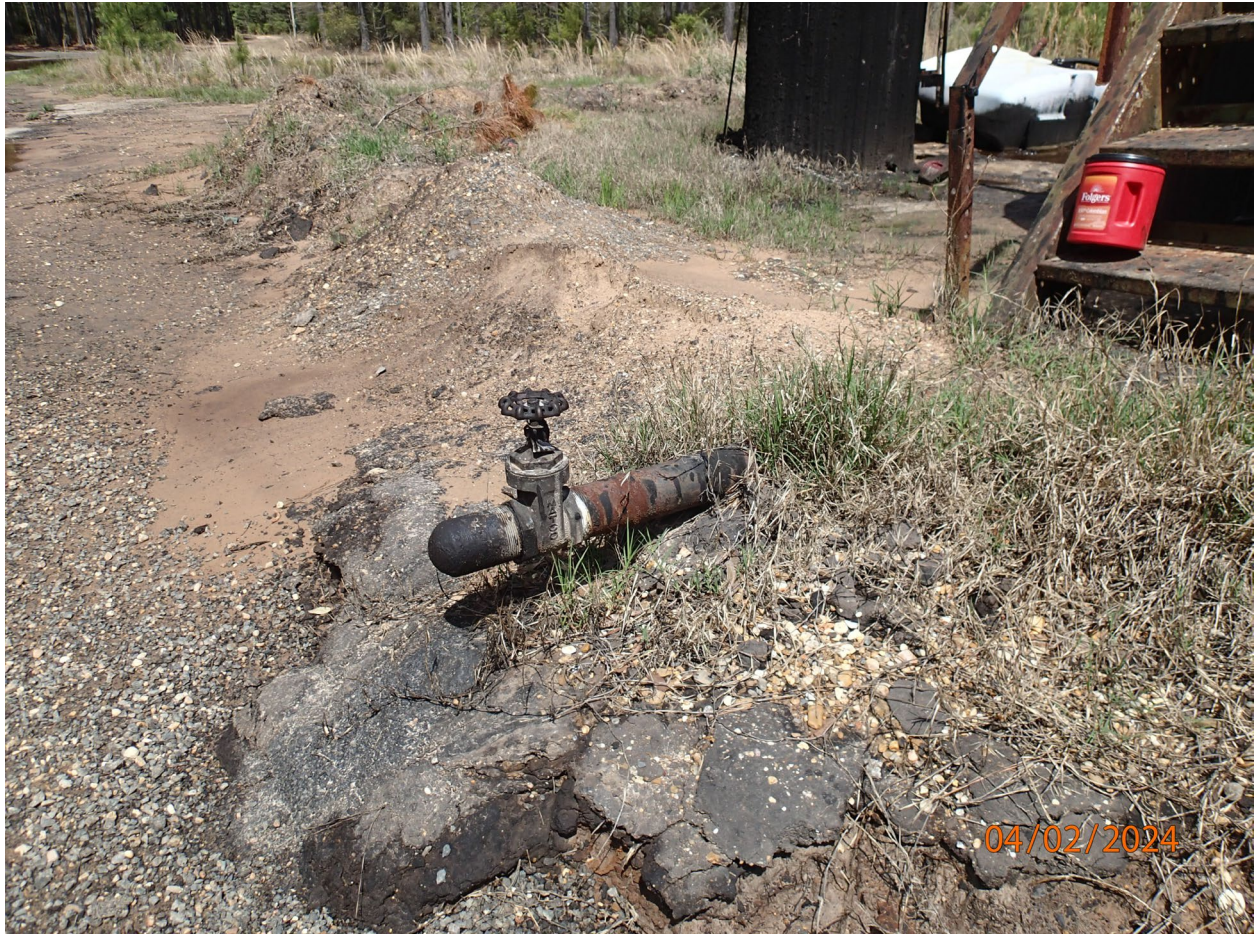
Photo No. 3

I observed a transfer pipe from secondary containment with no catch bucket, see Photo No. 3.

**Description:** Looking NNW, this photo showed a transfer pipe through secondary containment without a catch bucket.

No closing conference was held due to no personnel with Owen Drilling Company, Inc. being present during the inspection. Areas of concern at the time of the inspection include the transfer pipe through secondary containment with no catch bucket, loose oil around the production well, the drainpipe for secondary containment with no shutoff valve or cap, a low area in the firewall berm, and an active leak from a valve for the storage tank.

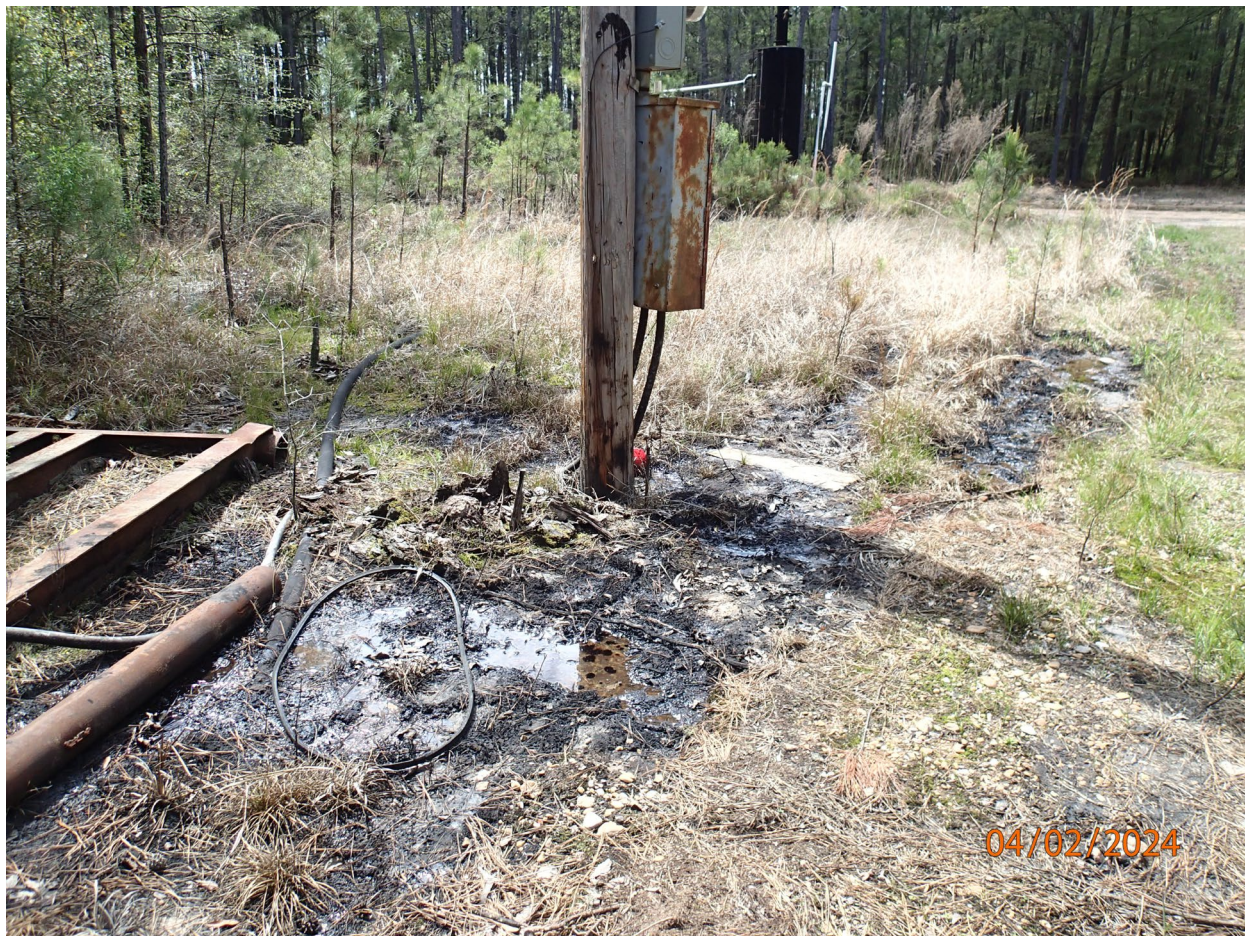
I observed loose oil around the production well onsite, Photo No. 4 and No. 5.

**Description:** Looking SE, this photo showed loose oil in stormwater from the production wellhead onsite.

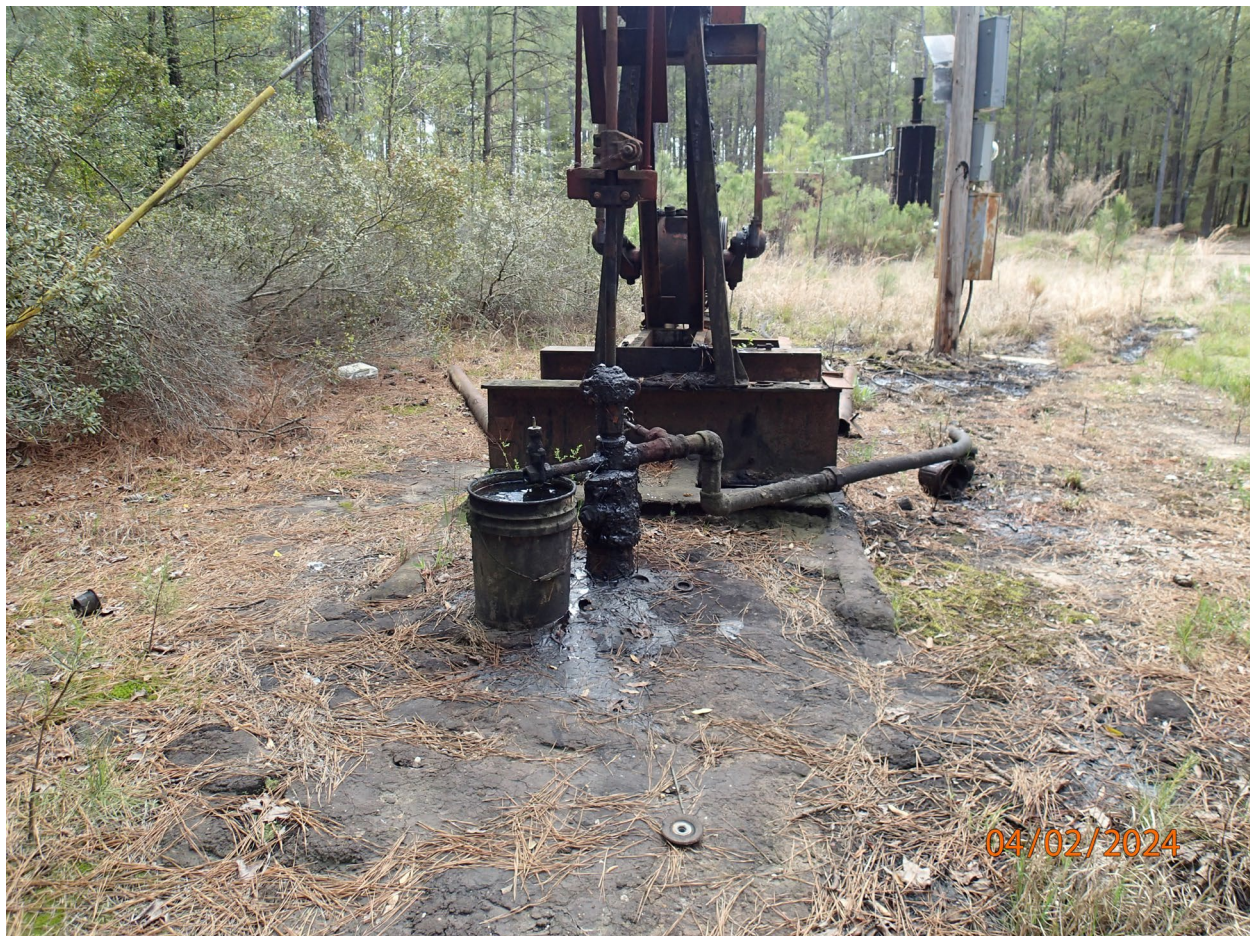
Photo No. 5

**Description:** Looking SE, this photo showed loose oil around the production wellhead onsite.

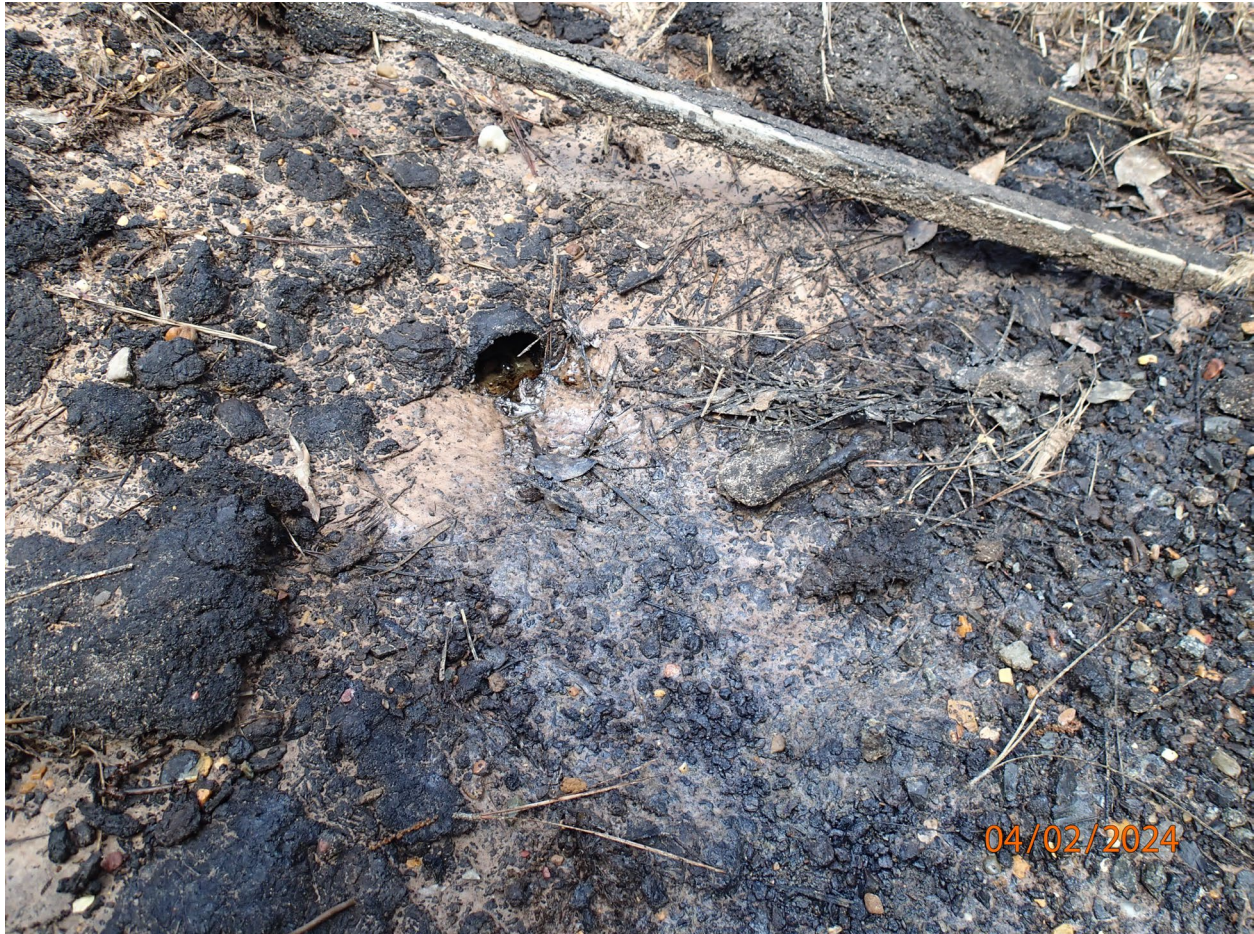
I observed the drainpipe for secondary containment without a shutoff valve, cap, or sump pump installed for the drainpipe; I noted sheen on the ground outside secondary containment, see Photo No. 6 and No. 7.

**Description:** Looking NW, this photo showed the open drainpipe for secondary containment without a shutoff valve or cap and oil sheen on the ground.

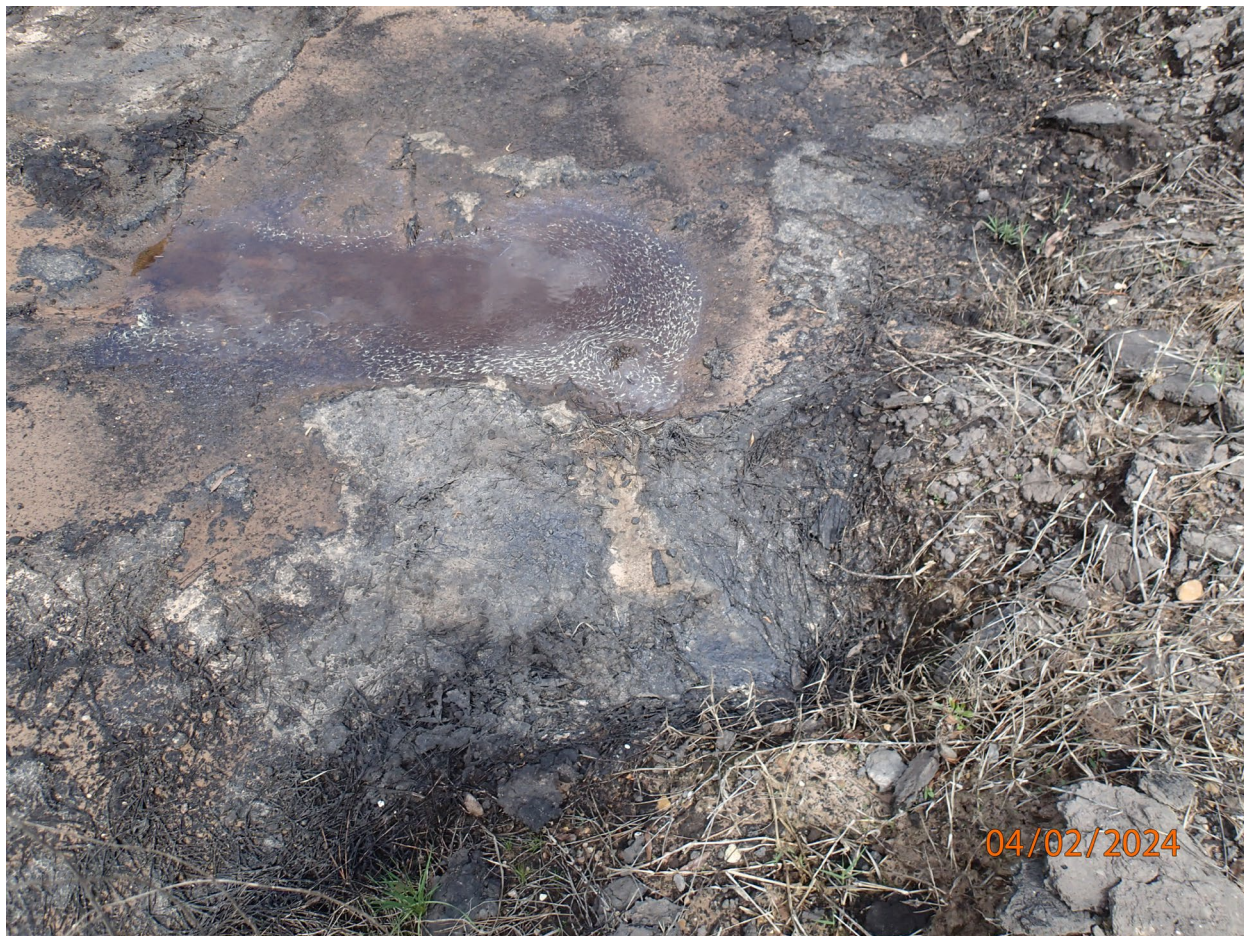
Photo No. 7

**Description:** Looking NW, this photo showed the inside of secondary containment at the drainpipe with residual oil inside the firewall (secondary containment).

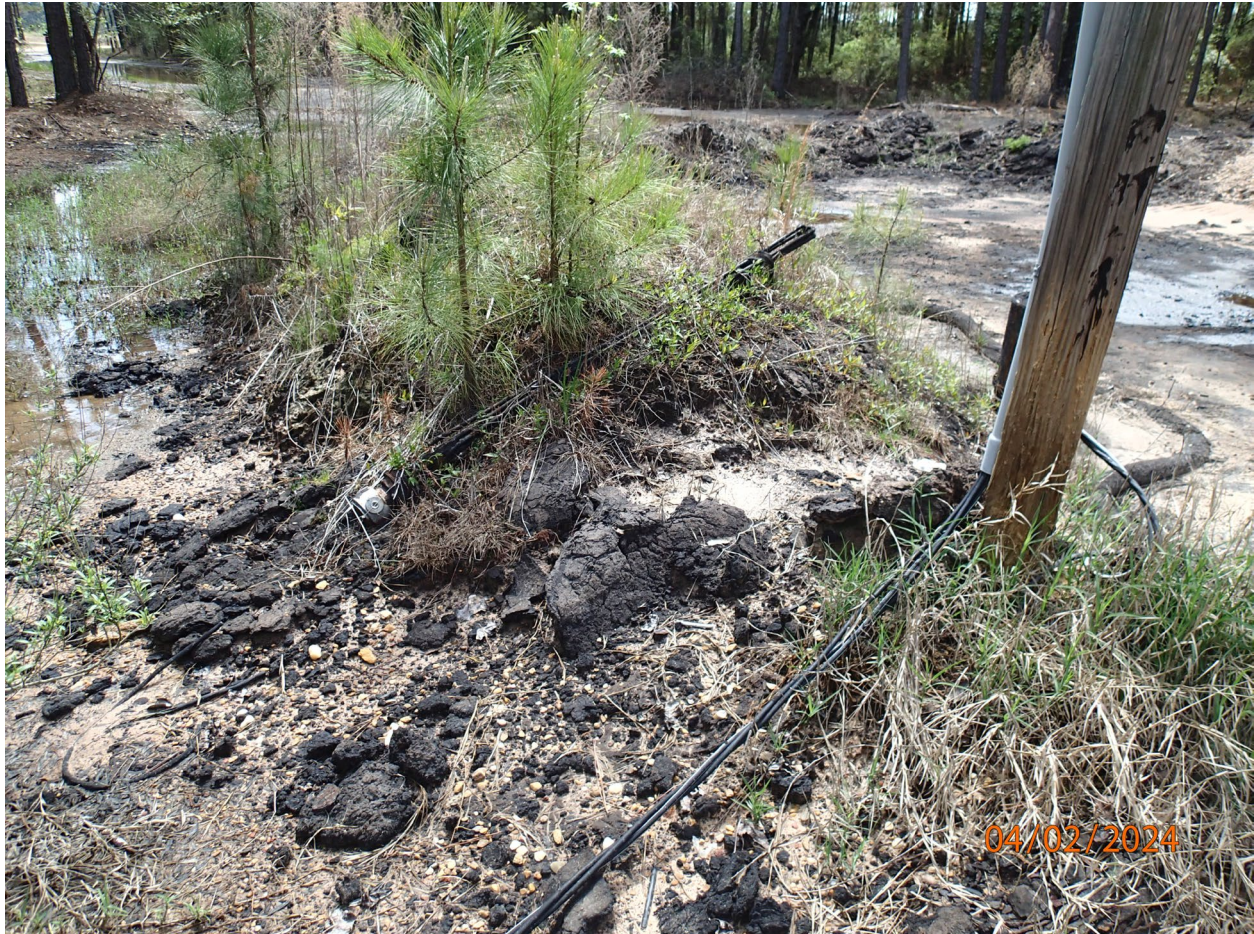
Photo No. 8

I observed a low area in the secondary containment (firewall) berm, see Photo No. 8.

**Description:** Looking S-E, this photo showed a low area in the secondary containment with loose oil visible inside the firewall.

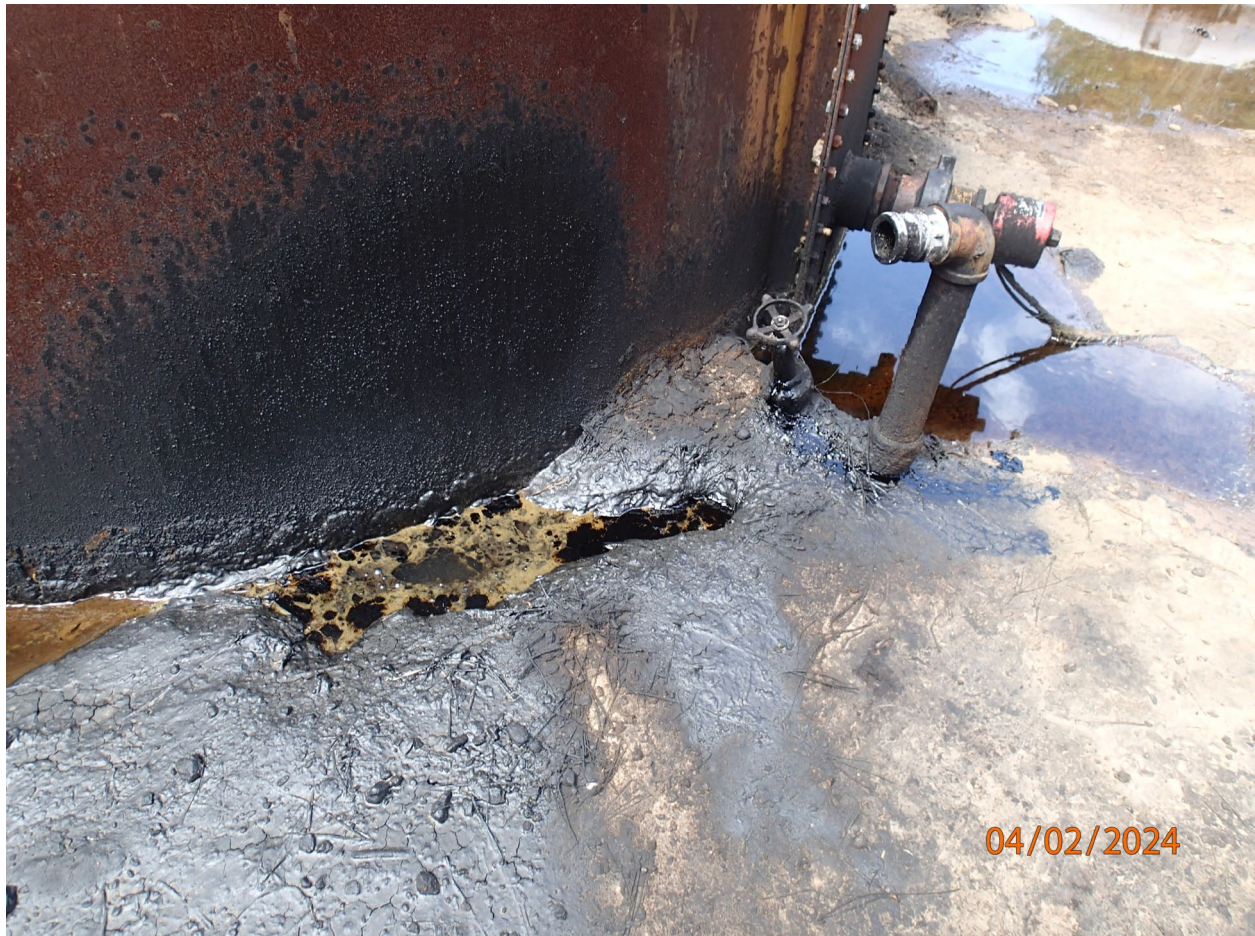
For the storage tank, I observed an active leak from a valve; see Photo No. 9 and No. 10.

**Description:** Looking ENE, this photo showed an active leak at a valve and loose oil inside the secondary containment.

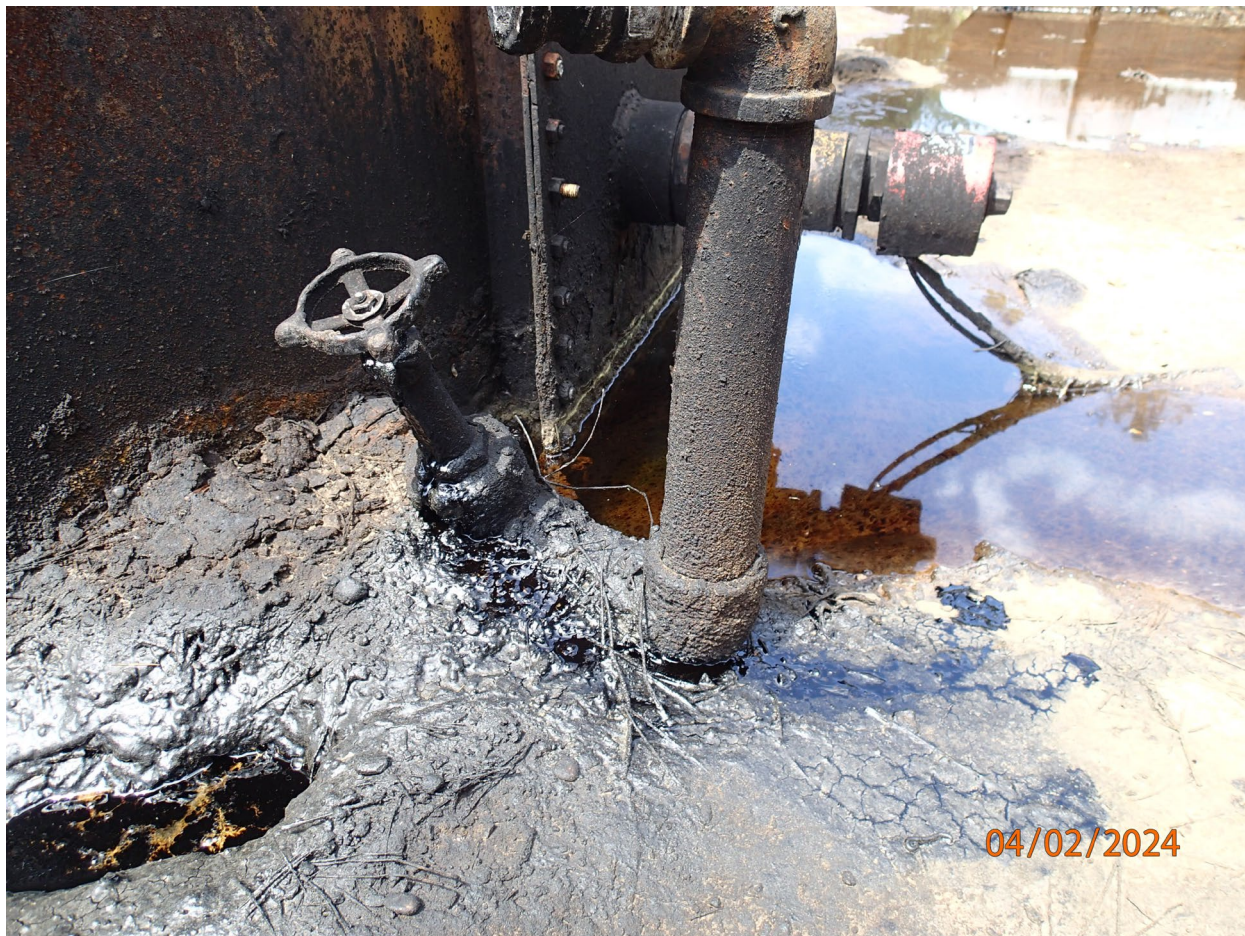
Photo No. 10

**Description:** Looking E, this photo showed a closeup of the active leak at a valve inside the secondary containment.
