## **RCRA Inspection Report**

ABB Motors and Mechanical Inc.  
70 Industrial Park Access Road  
Columbus, Mississippi 39701  
EPA ID# MSR000103531  
NAICS: 335312 - Motor and General Manufacturing

March 10, 2021, 09:00 hours

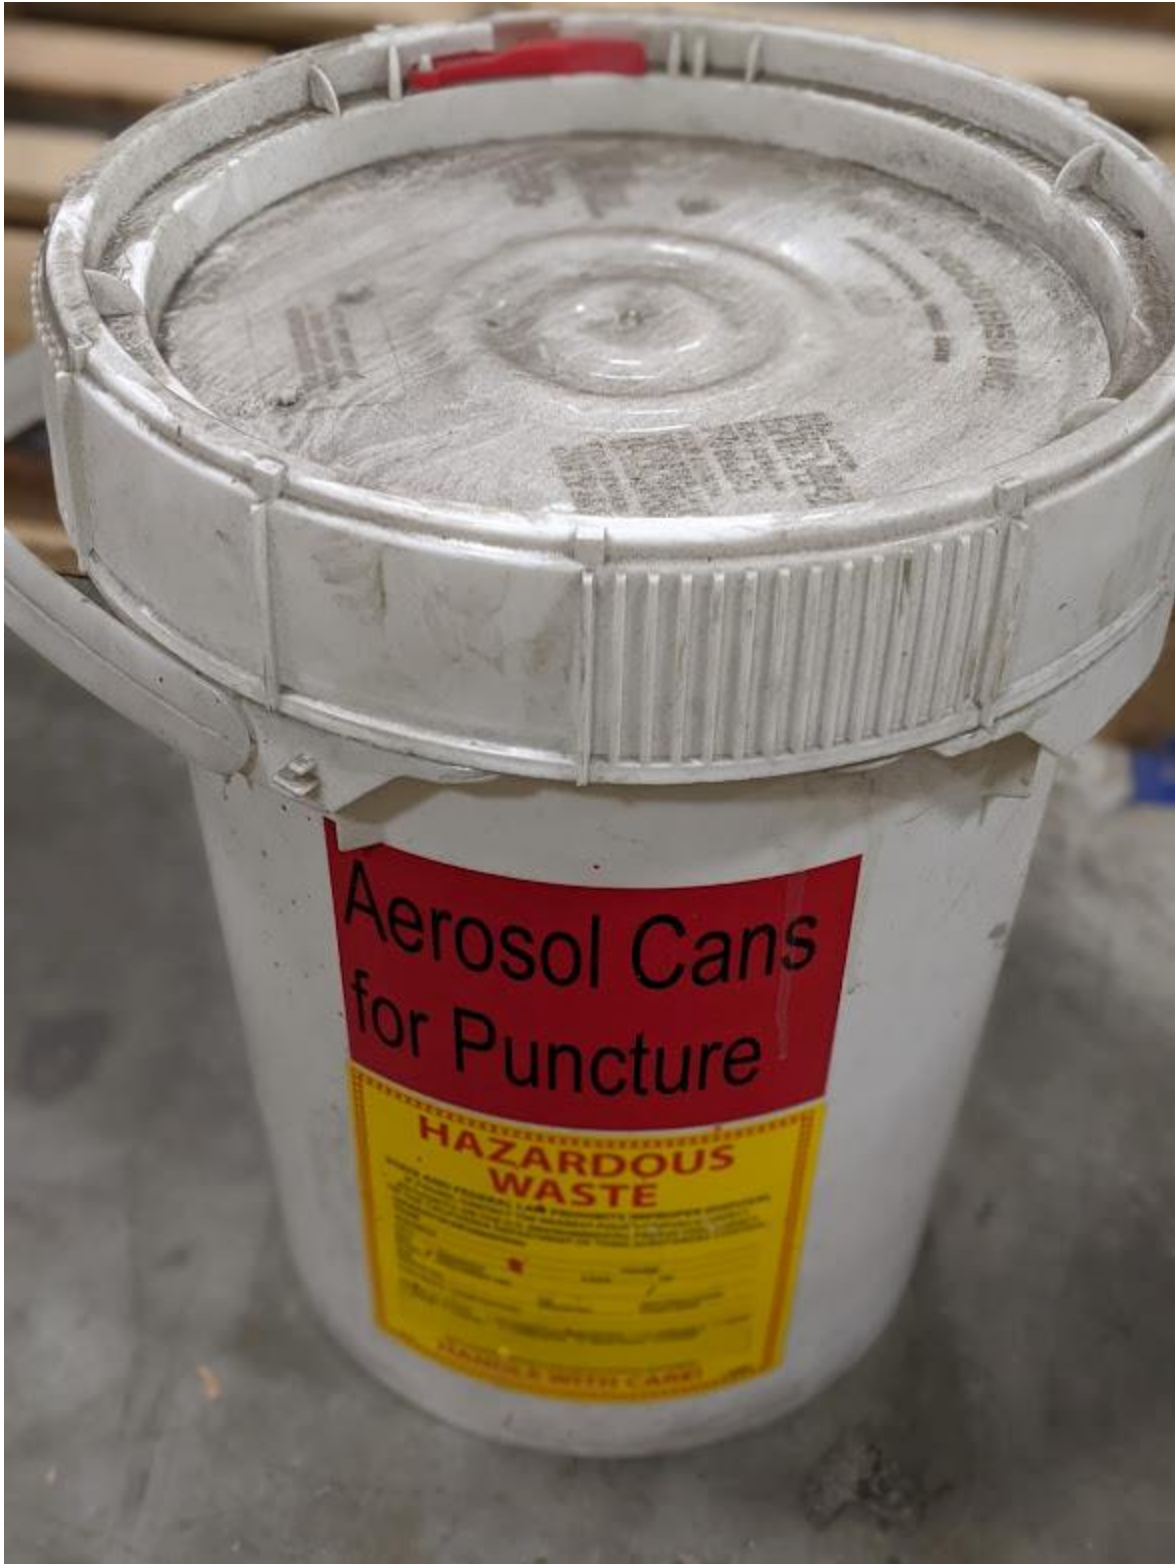
Operations in this location include maintenance on motor winding inserters. Grease is wiped off pads and various aerosols are used during the maintenance of the motors. Aerosols are collected in a 5-gallon SAA container. At the time of the inspection, the SAA container did not have a characteristic labeled identifying the hazardous contents of the container (Photograph 1 of 2).

Photograph 1 of 2: SAA Container for hazardous waste aerosols

**Pursuant to 11 Miss. Admin. Code Pt. 3, R. 1.3 [40 C.F.R. § 262.15(a)(5)], which is a condition of the SAA Permit Exemption, a generator is required to mark or label its containers with an indication of the hazards of the contents.**

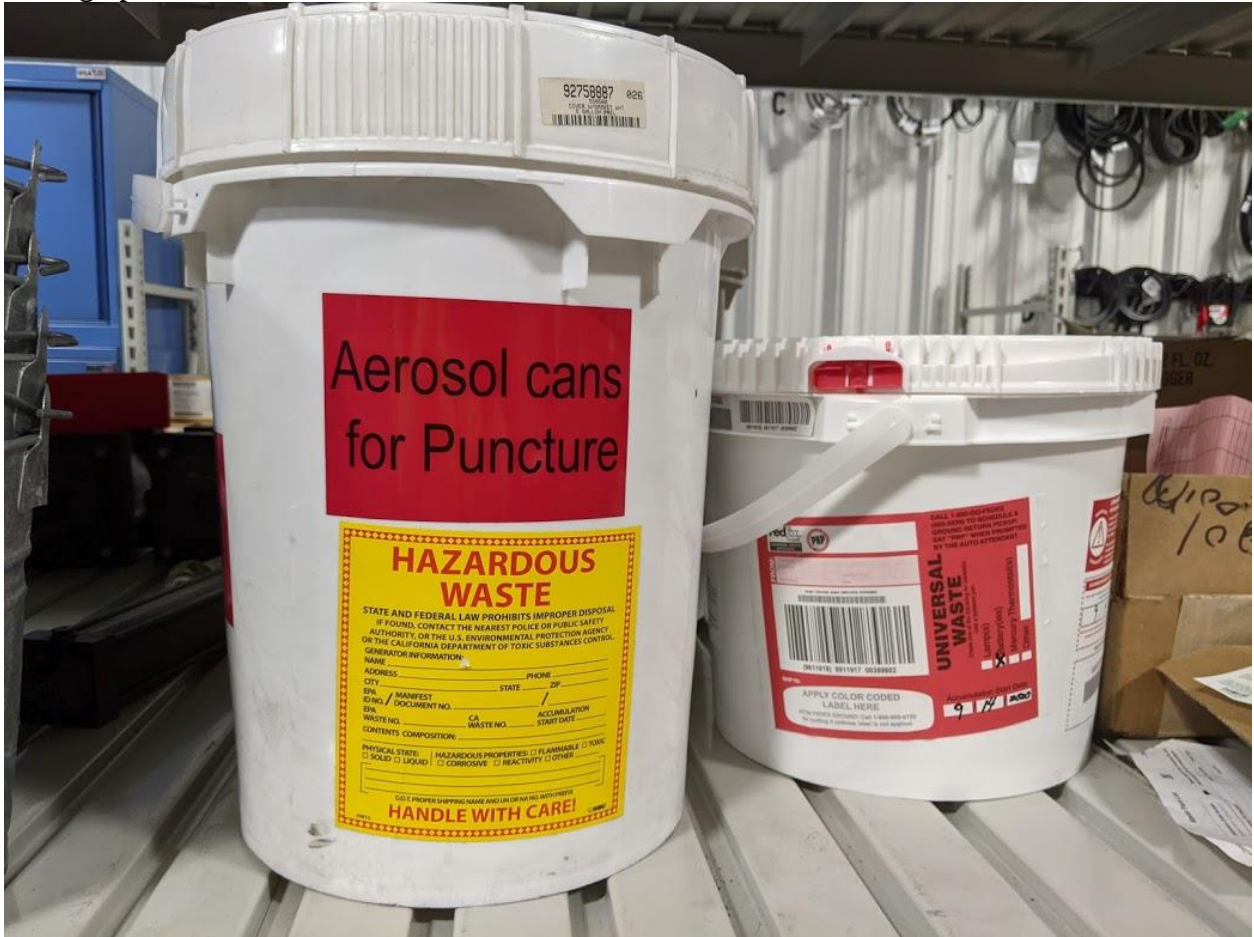
Storage for various power tools are kept in this area. At the time of the inspection, there was one (1) 2.5-gallon container of Universal Waste Batteries labeled and dated (9/14/2020) and one (1) 5-gallon container of aerosols labeled "Hazardous Waste" but missing the characteristic label identifying the hazardous contents of the container (Photograph 2 of 2).

Photograph 2 of 2: SAA container used to hazardous waste aerosols

**Pursuant to 11 Miss. Admin. Code Pt. 3, R. 1.3 [40 C.F.R. § 262.15(a)(5)], which is a condition of the SAA Permit Exemption, a generator is required to mark or label its containers with an indication of the hazards of the contents.**
