**INSPECTION REPORT**

| <b>Type of inspection:</b> | PCI – Pretreatment Compliance Inspection | |
| <b>Permittee Name:</b> | City of Joliet Eastside STP | |
| <b>Permit Number:</b> | IL0022519 | |

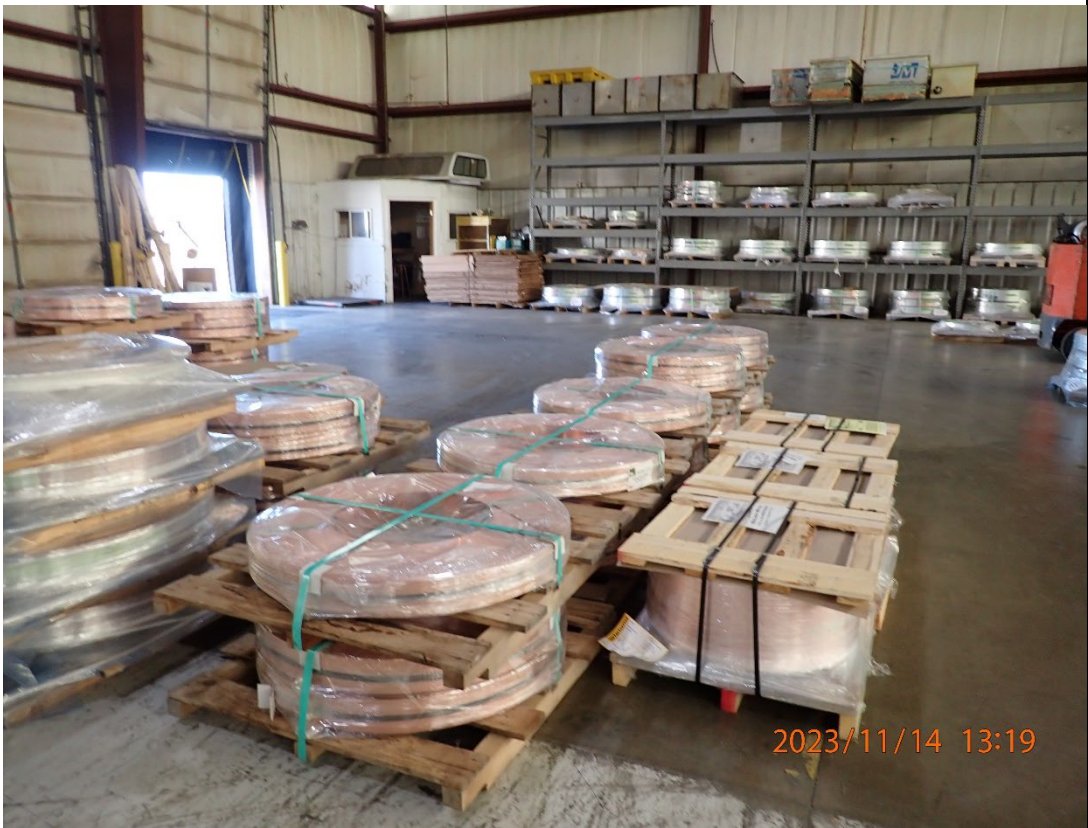
| <b>Photo No.: 1</b> | <b>Time:</b><br>11:12 a.m. | | |

| <b>Photo Description:</b><br>Overview of raw products stored onsite. | | | |

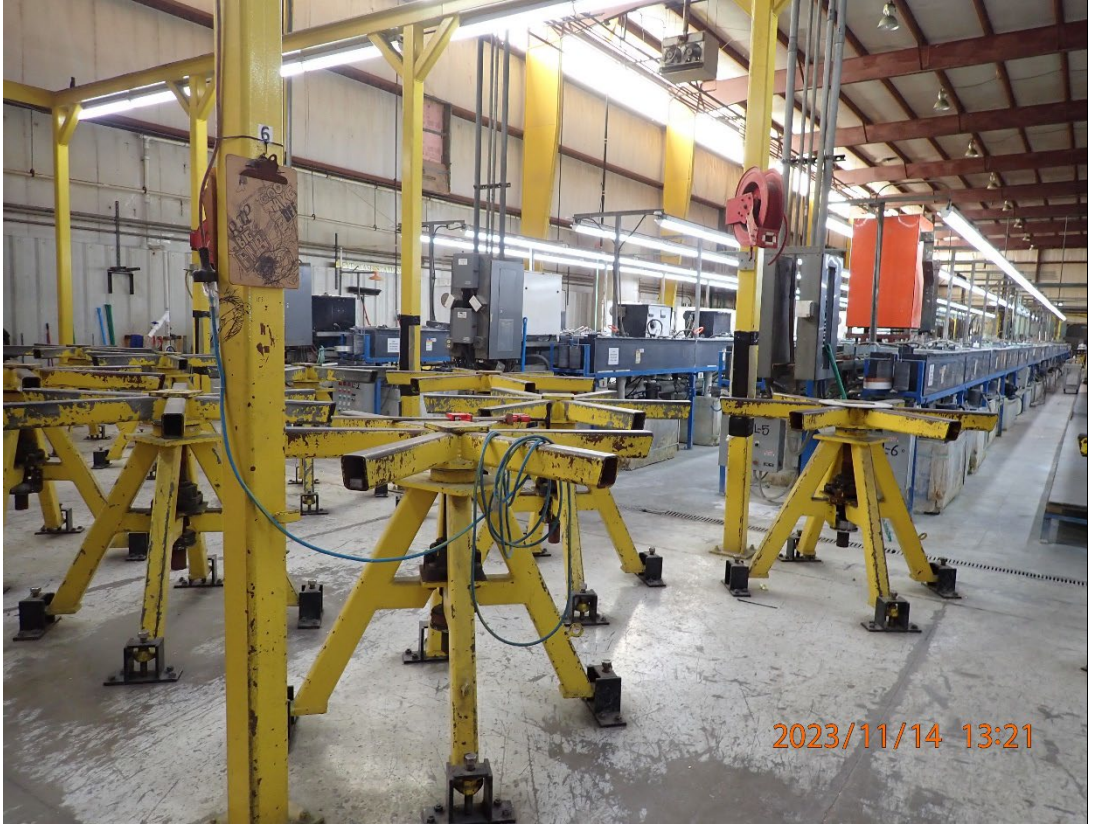
| <b>Photo No.:</b> 2 | <b>Time:</b><br>11:14 a.m. | | |

| <b>Photo Description:</b><br>Overview of start of production lines.<br>Line 6 in forefront. | | | |

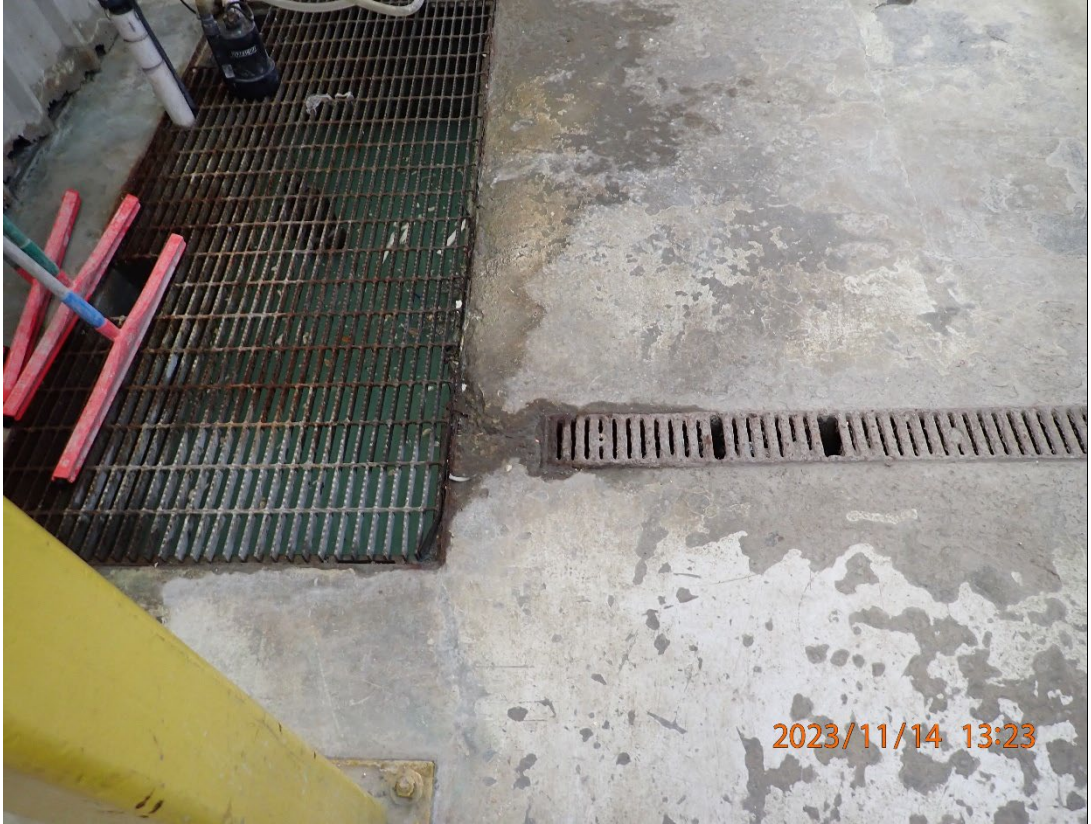
| <b>Photo No.:</b> 3 | <b>Time:</b><br>11:16 a.m. | | |

| <b>Photo Description:</b><br>Drains leading to east pit near beginning of line 1. | | | |

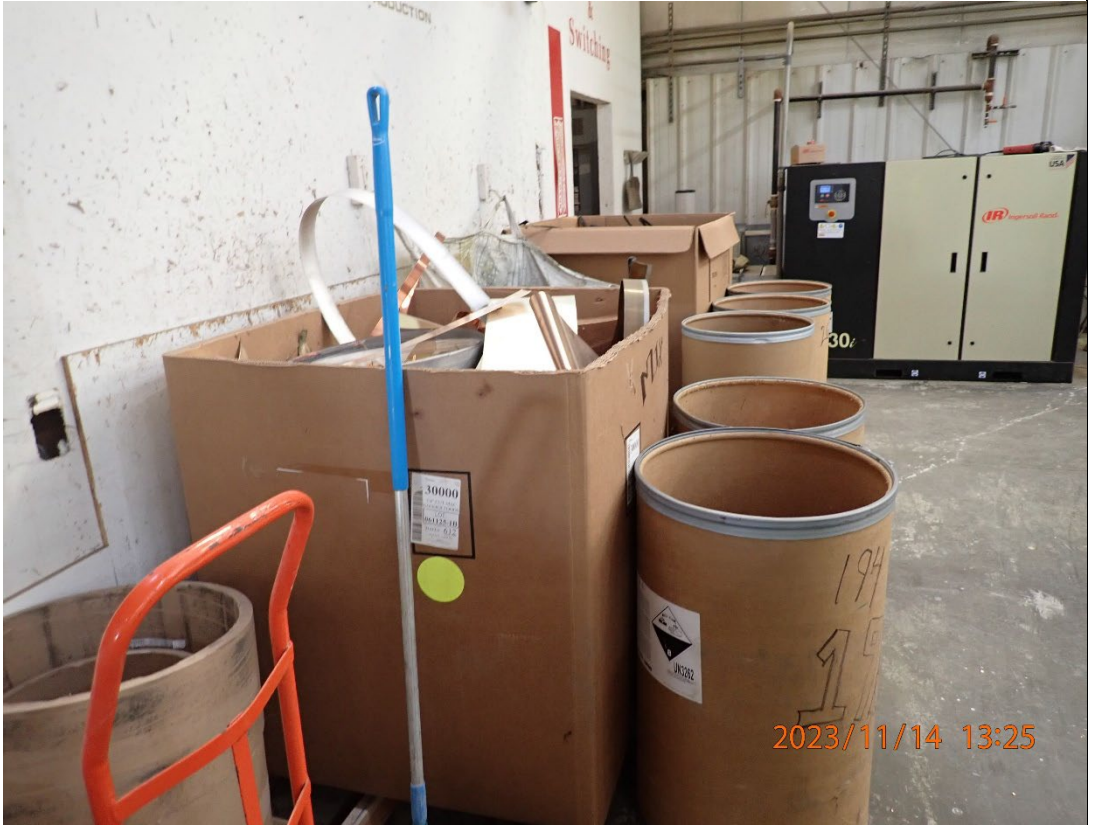
| <b>Photo No.:</b> 4 | <b>Time:</b><br>11:18 a.m. | | |

| <b>Photo Description:</b><br>Scrap metal storage<br>roughly 40-50,000<br>lbs per month. | | | |

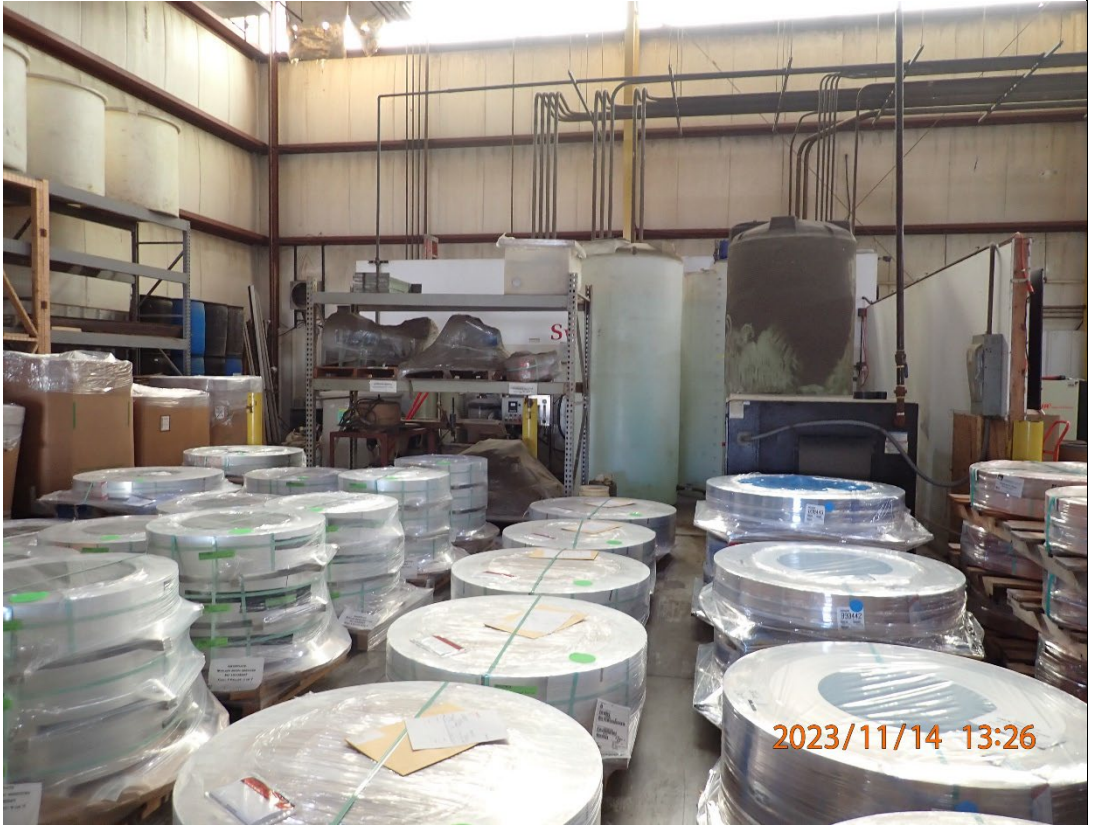
| <b>Photo No.:</b> 5 | <b>Time:</b><br>11:19 a.m. | | |

| <b>Photo Description:</b><br>DI water tanks with finished product in foreground. | | | |

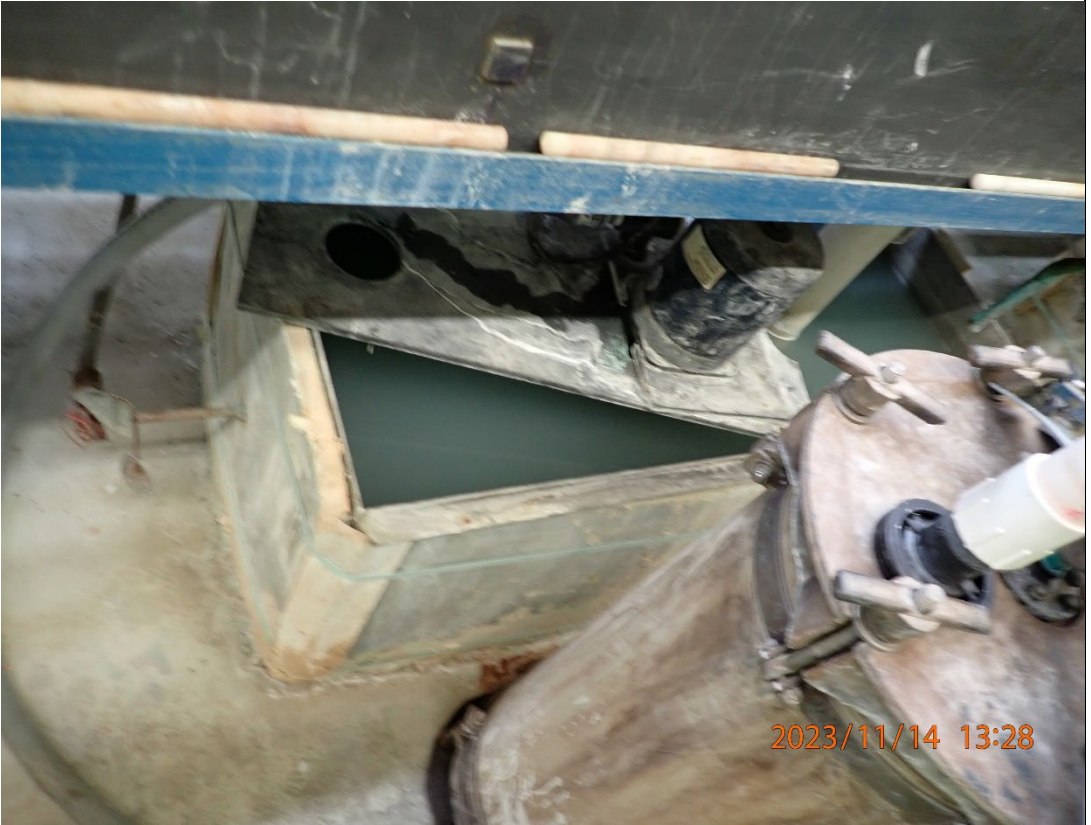
| <b>Photo No.:</b> 6 | <b>Time:</b><br>11:21 a.m. | | |

| <b>Photo Description:</b><br>Soap tank under line 1 used for electro-cleaning process. | | | |

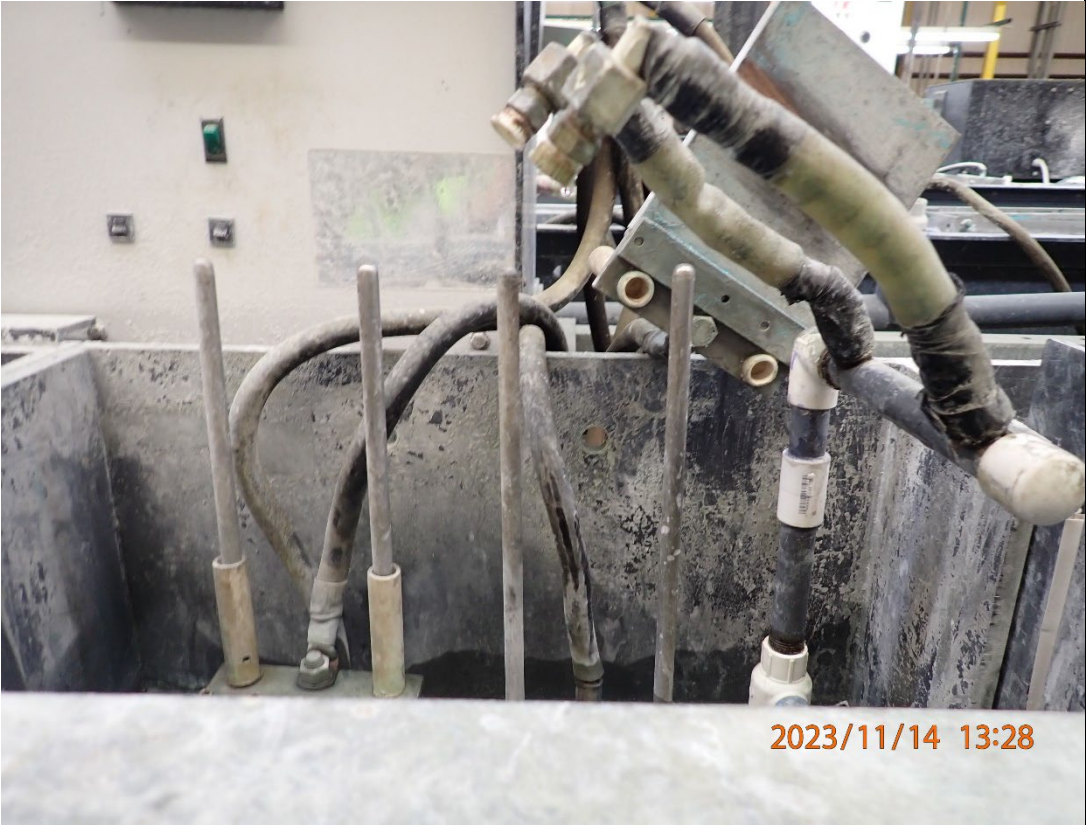
| <b>Photo No.:</b> 7 | <b>Time:</b><br>11:21 a.m. | | |

| <b>Photo Description:</b><br>Nozzles for rinse water. | | | |

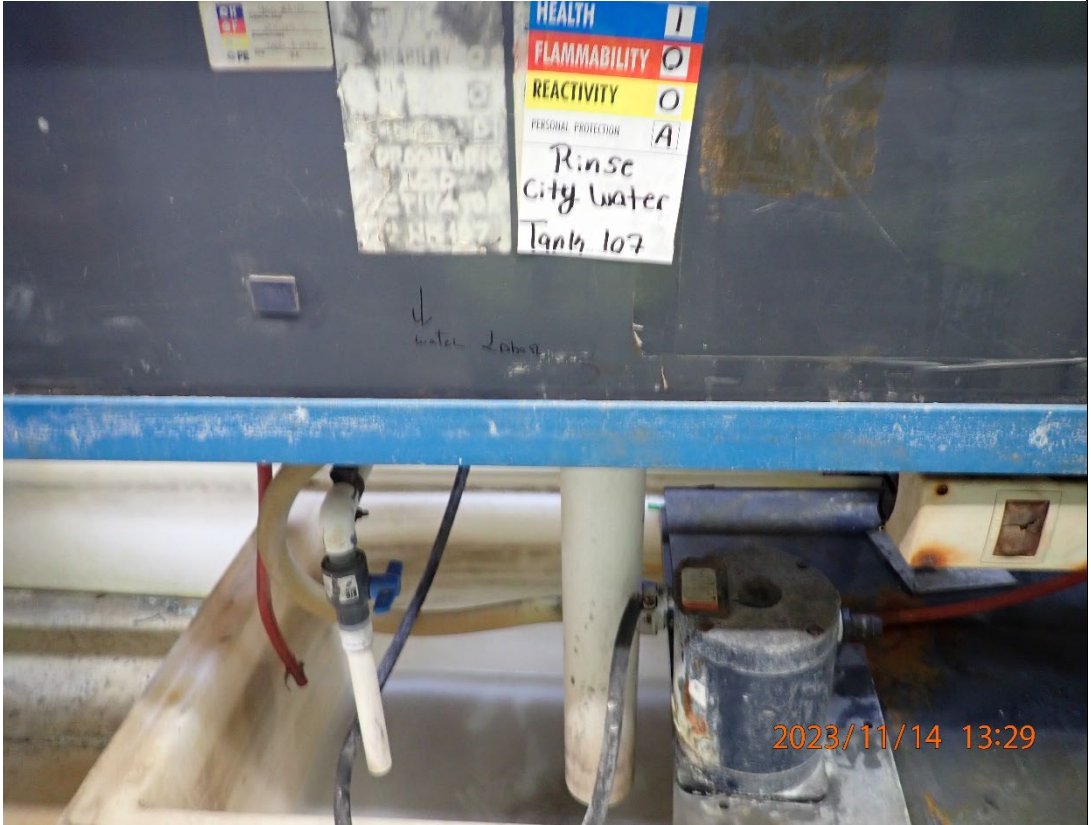
| <b>Photo No.:</b> 8 | <b>Time:</b><br>11:22 a.m. | | |

| <b>Photo Description:</b><br>Rinse City water on line 1. | | | |

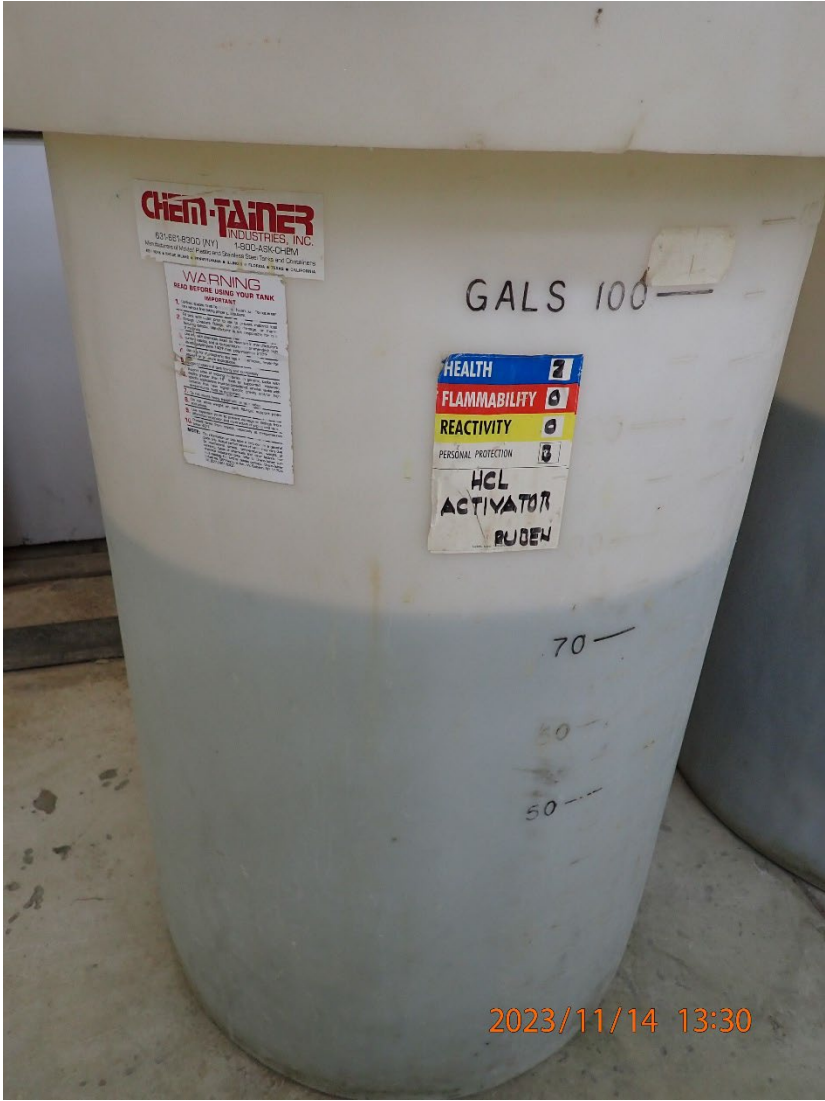
| <b>Photo No.:</b> 9 | <b>Time:</b><br>11:22 a.m. | | |

| <b>Photo Description:</b><br>HCL activator storage tank. | | | |

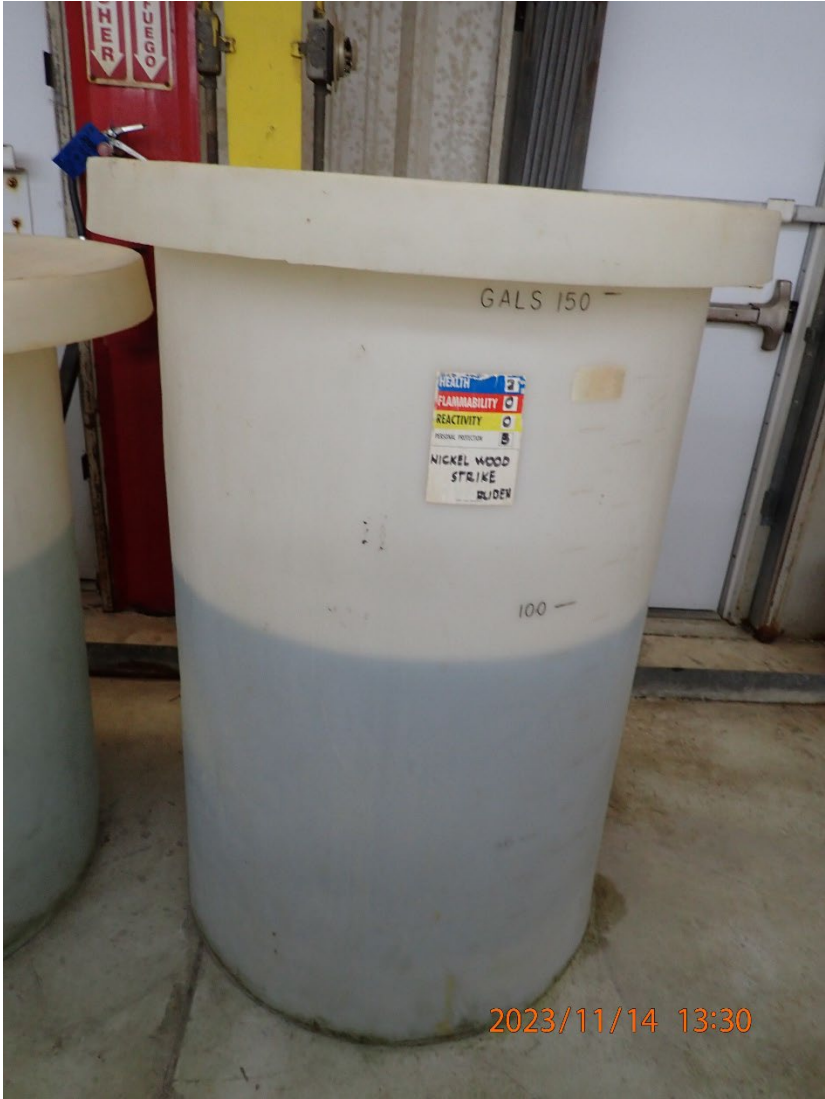
| <b>Photo No.: 10</b> | <b>Time:</b><br>11:22 a.m. | | |

| <b>Photo Description:</b><br>Nickel wood strike storage tank. | | | |

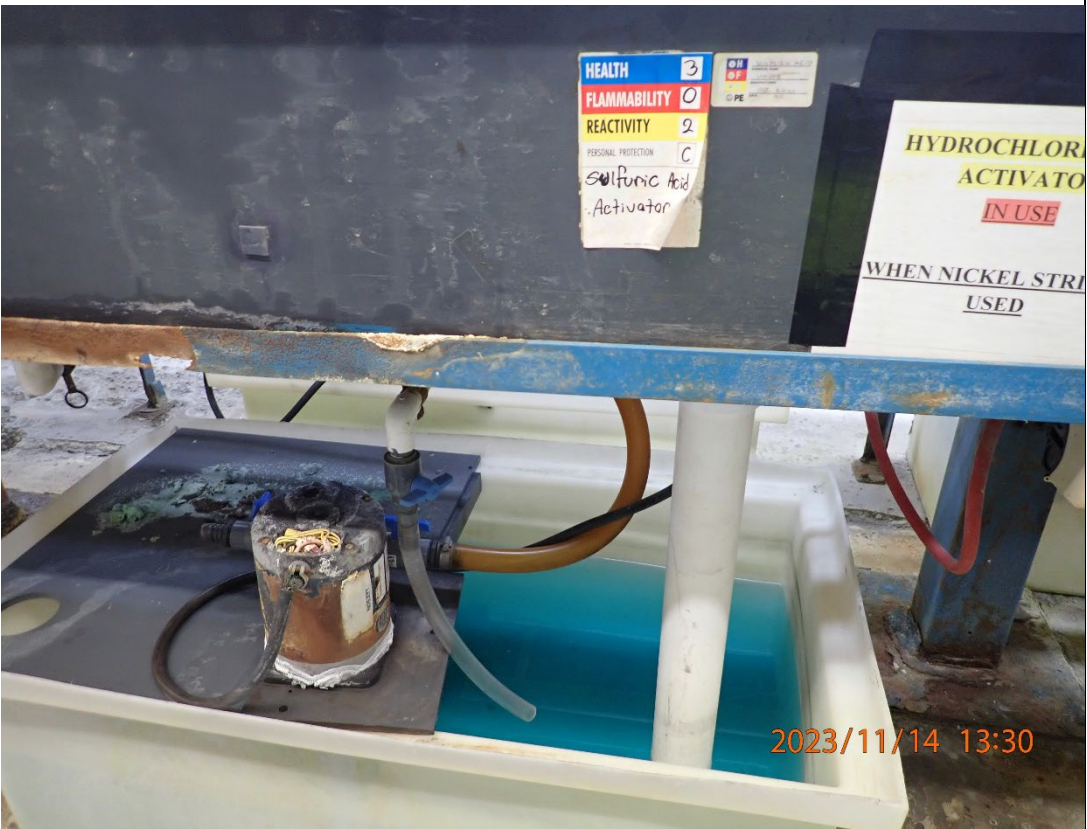
| <b>Photo No.:</b> 11 | <b>Time:</b><br>11:22 a.m. | | |

| <b>Photo Description:</b><br>Hydrochloric acid activator on line 1.<br>Filled by storage tank substance. | | | |

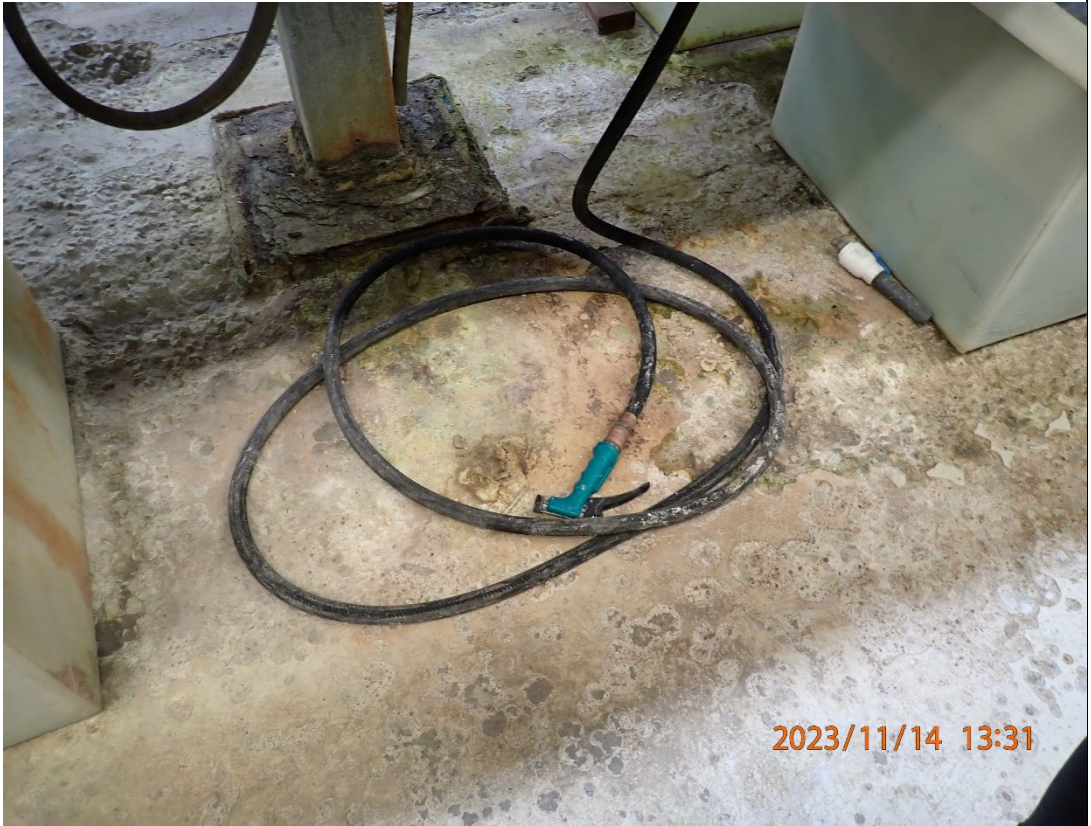
| <b>Photo No.:</b> 12 | <b>Time:</b><br>11:24 a.m. | | |

| <b>Photo Description:</b><br>City water cleaning hose under line 1.<br>Water used for general rinsing. | | | |

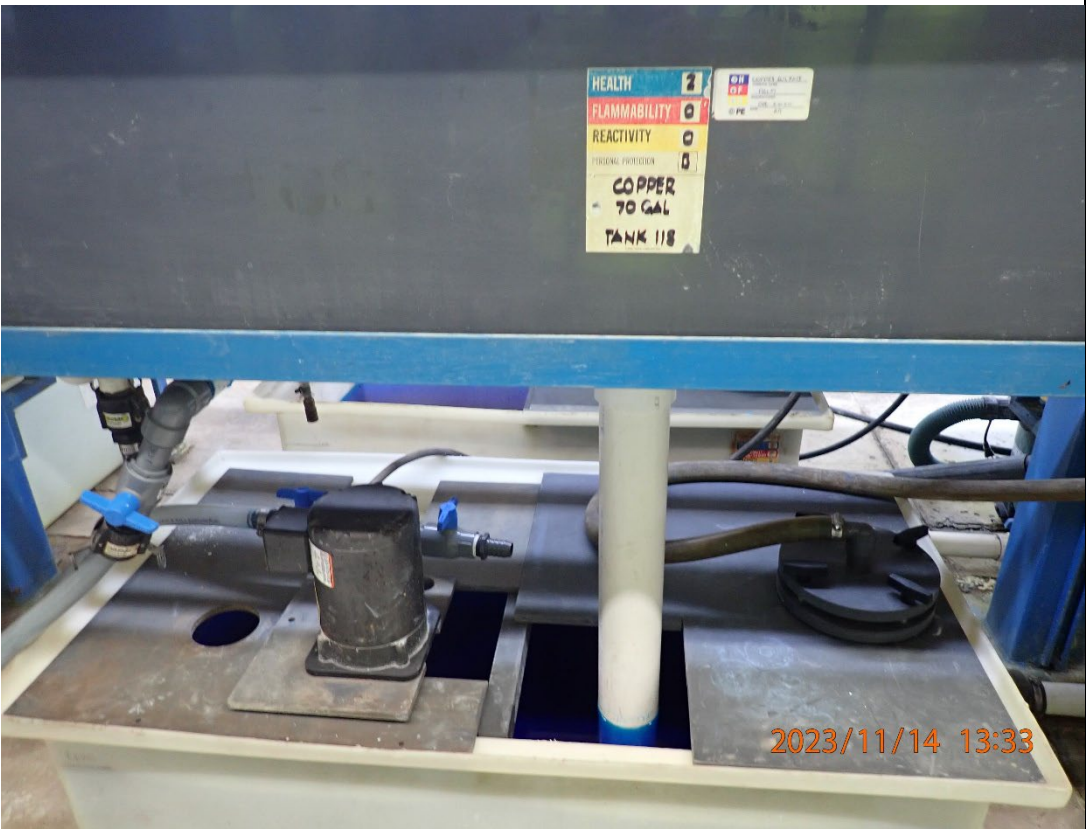
| <b>Photo No.:</b> 13 | <b>Time:</b><br>11:26 a.m. | | |

| <b>Photo Description:</b><br>Copper Sulfate on line 1. | | | |

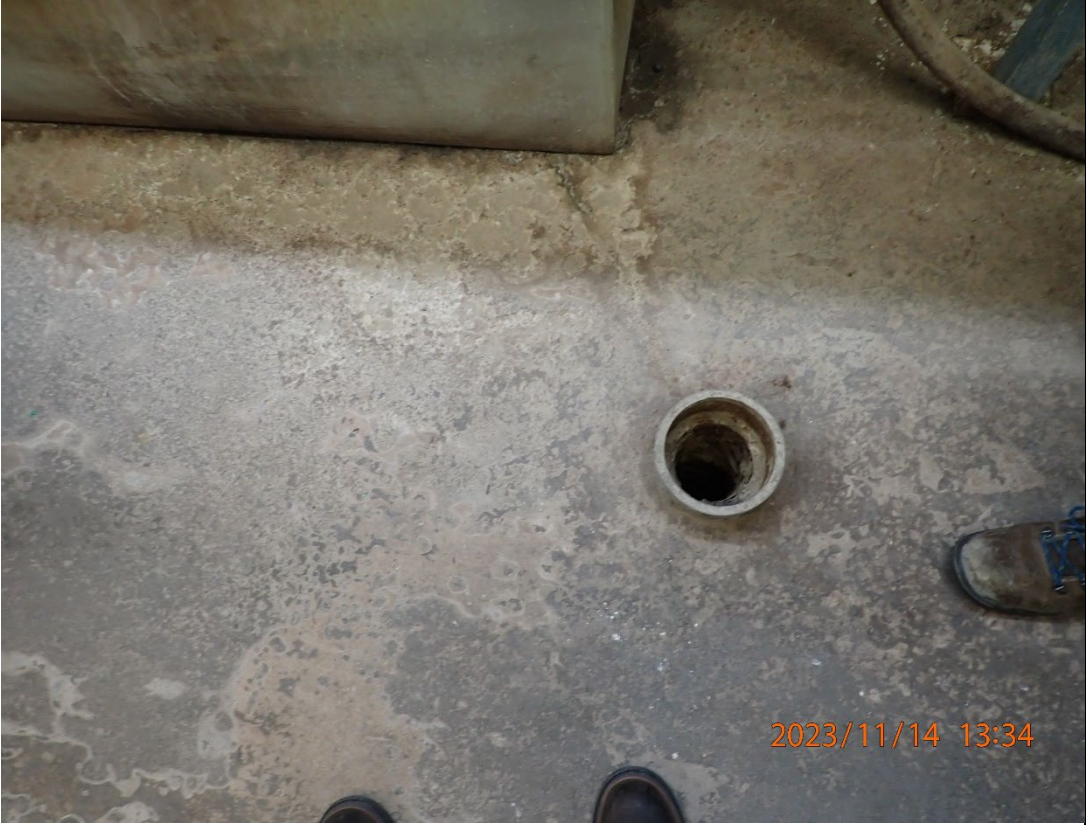
| <b>Photo No.: 14</b> | <b>Time:</b><br>11:28 a.m. | | |

| Unique Identifying No. | Observation | Area of Concern? |
|---|---|---|
| <b>MS-OB-001</b> | AmeriPlate had an uncovered pipe that connected to the sewer next to their production lines and chemical tanks. (photo: 14) | Yes |

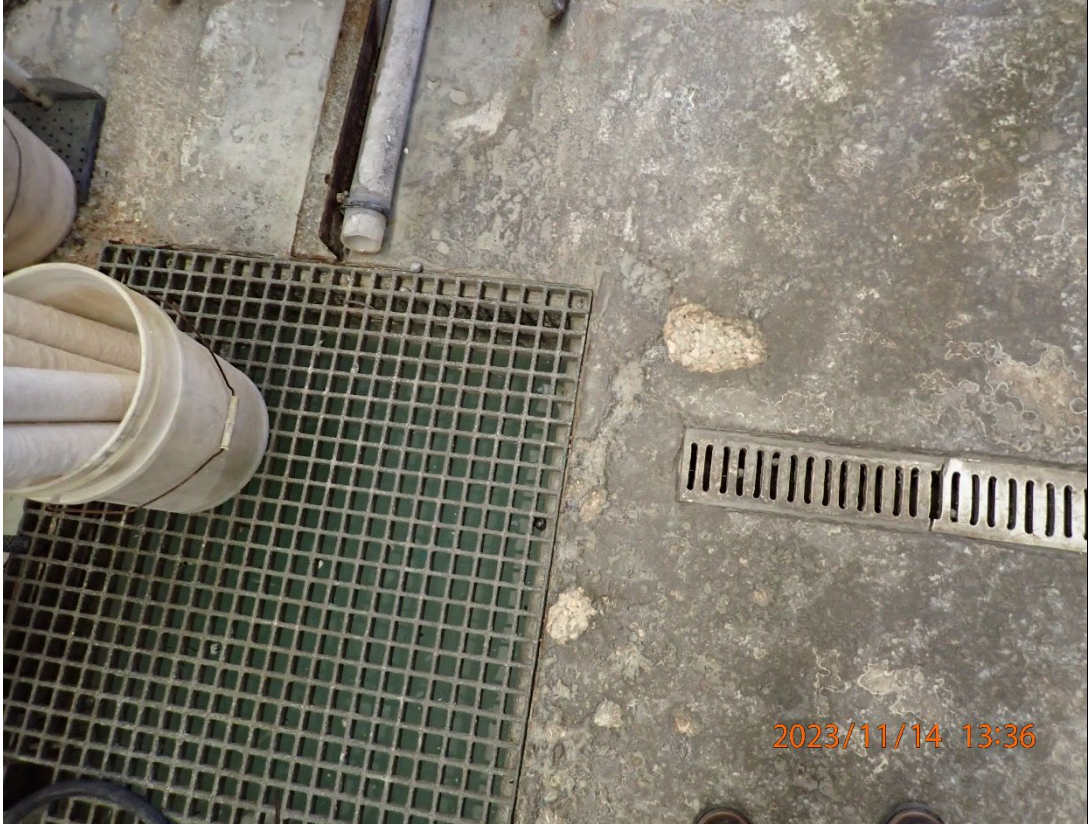
| <b>Photo No.: 15</b> | <b>Time:</b><br>11:29 a.m. | | |

| <b>Photo Description:</b><br>Dain at end of line 1 leading to the west pit. | | | |

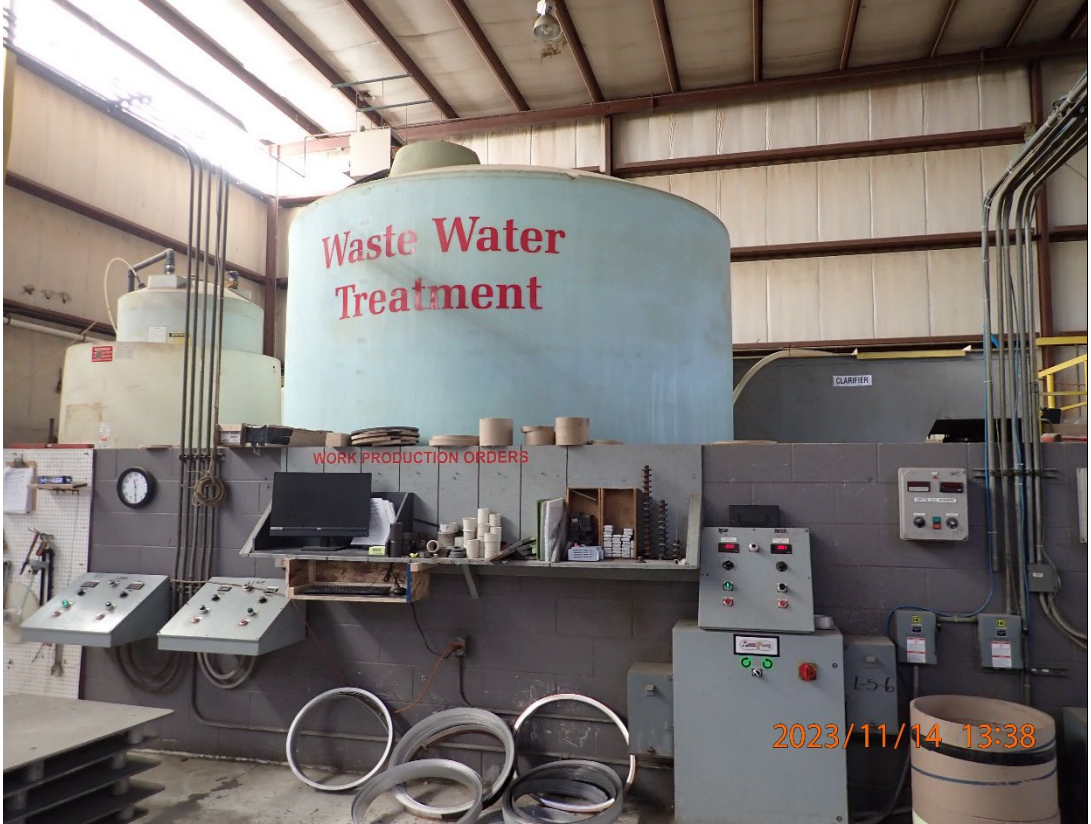
| <b>Photo No.:</b> 16 | <b>Time:</b> 11:30 a.m. | | |

| <b>Photo Description:</b><br>Overview of wastewater treatment area on west end of lines. | | | |

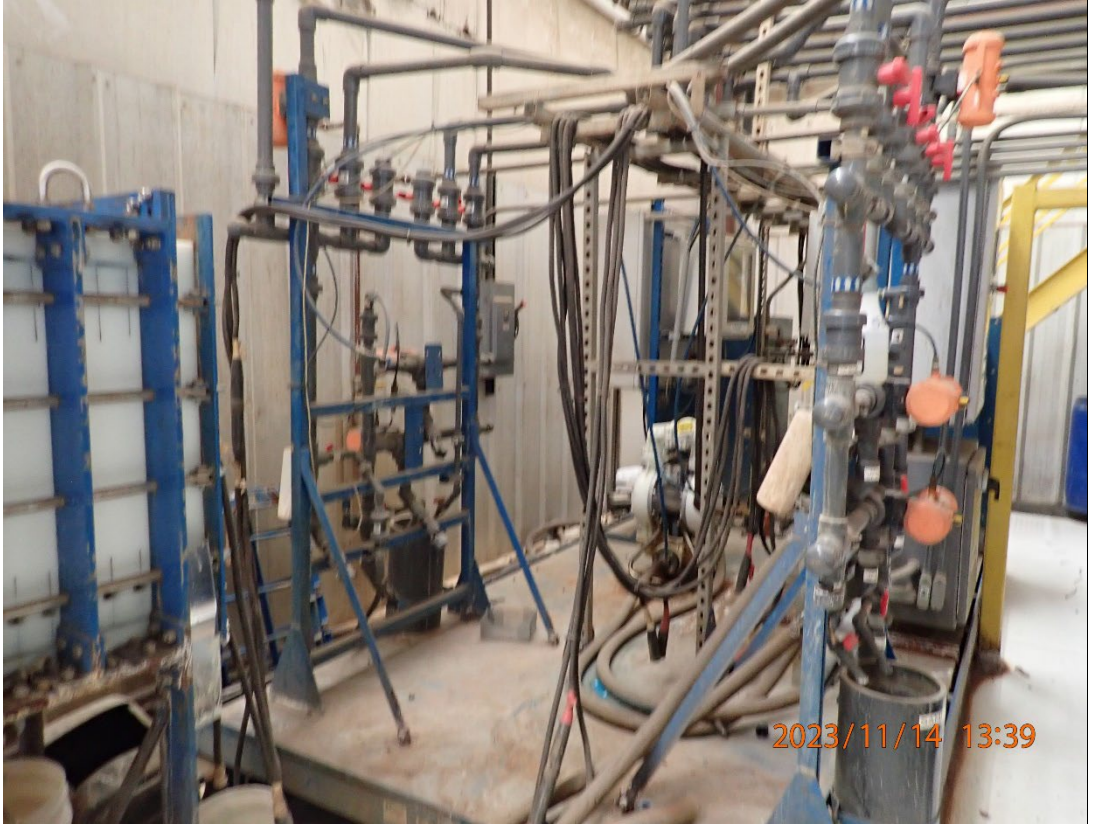
| <b>Photo No.: 17</b> | <b>Time:</b><br>11:32 a.m. | | |

| <b>Photo Description:</b><br>Overview of Baker corporation reactors. | | | |

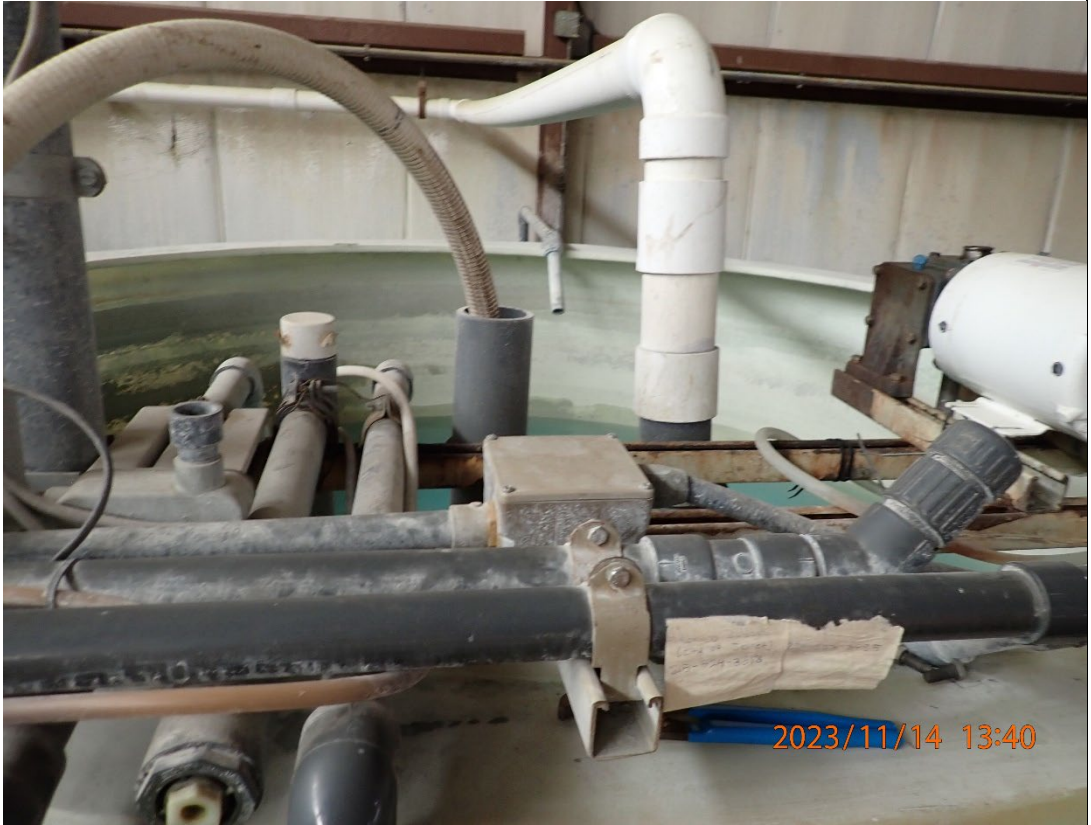
| <b>Photo No.: 18</b> | <b>Time:</b><br>11:33 a.m. | | |

| <b>Photo Description:</b><br>Accumulation tank where pH is adjusted. | | | |

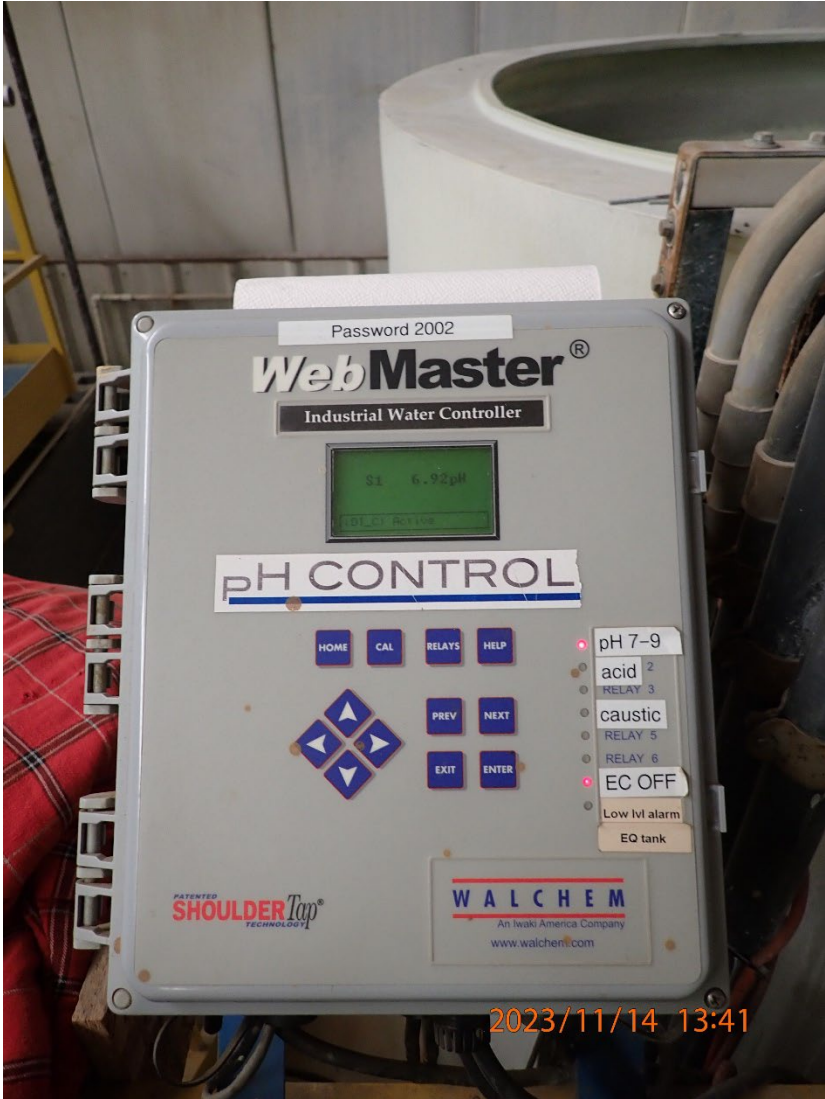
| <b>Photo No.:</b> 19 | <b>Time:</b><br>11:34 a.m. | | |

| <b>Photo Description:</b><br>pH control box next to accumulation tank. pH was 6.92 at time of photo. | | | |

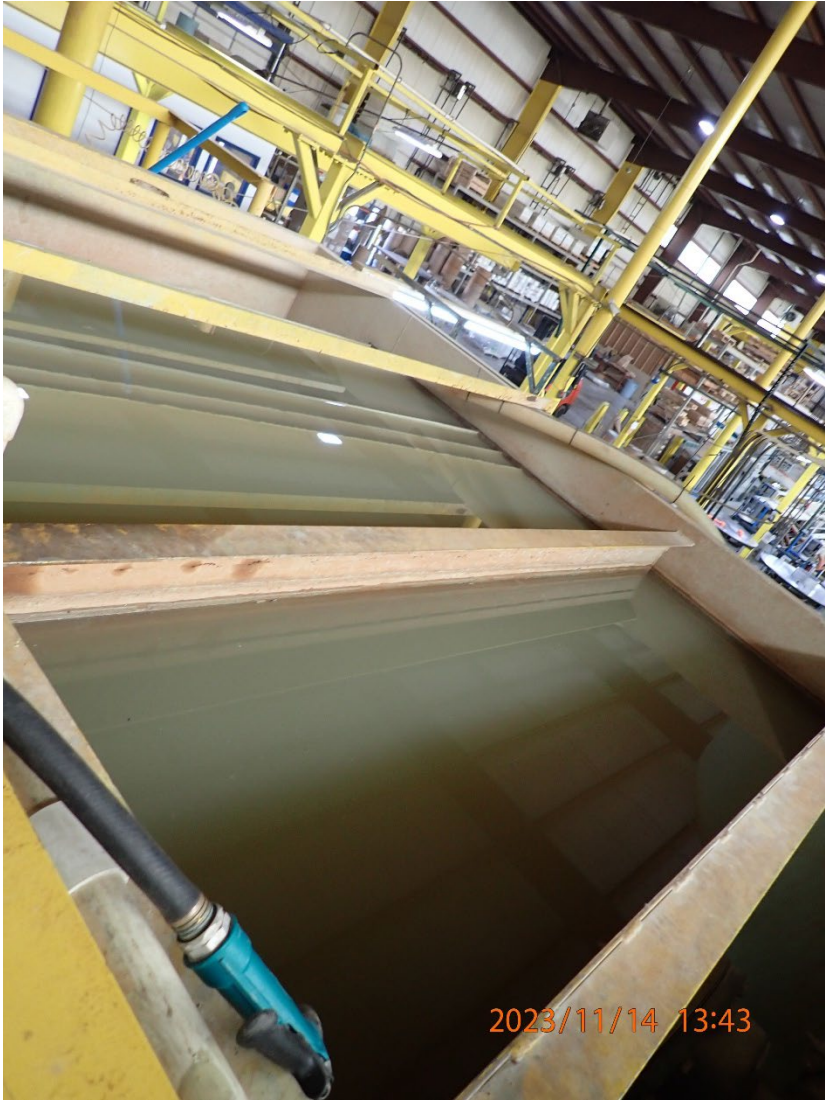
| <b>Photo No.:</b> 20 | <b>Time:</b><br>11:36 a.m. | | |

| <b>Photo Description:</b><br>Onsite clarifier. | | | |

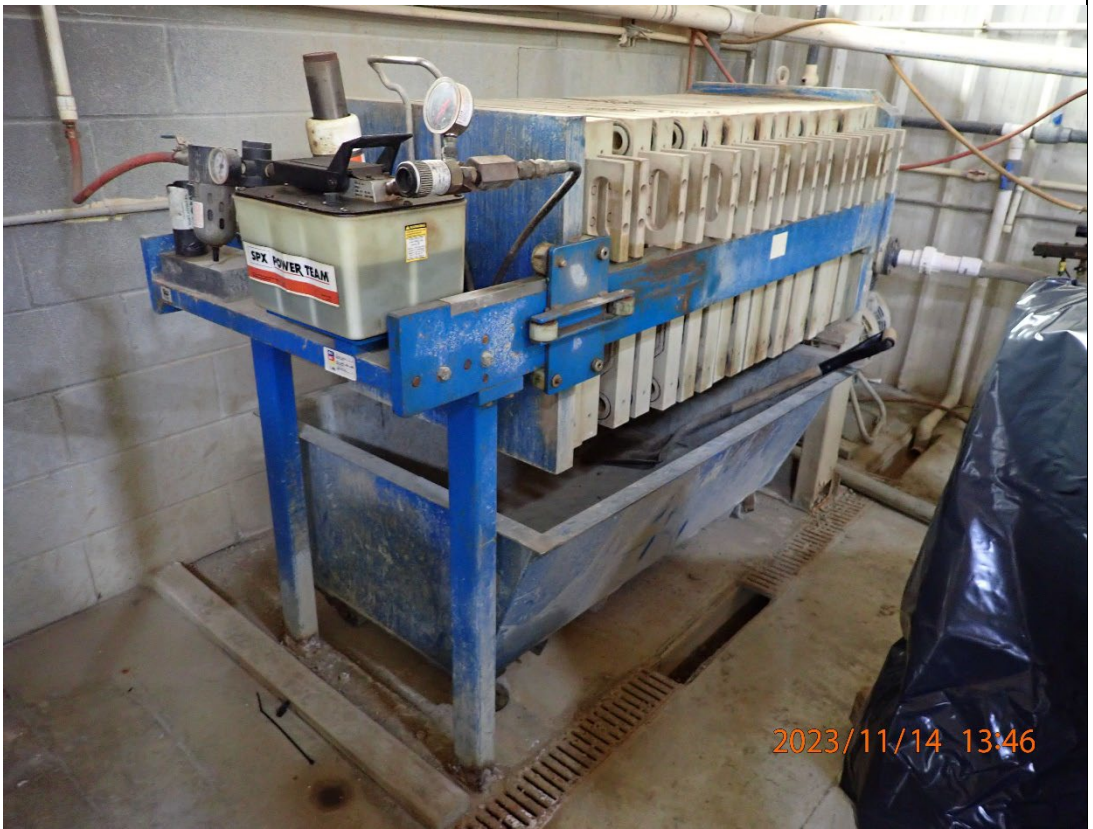
| <b>Photo No.:</b> 21 | <b>Time:</b><br>11:40 a.m. | | |

| <b>Photo Description:</b><br>Sludge filter press. | | | |

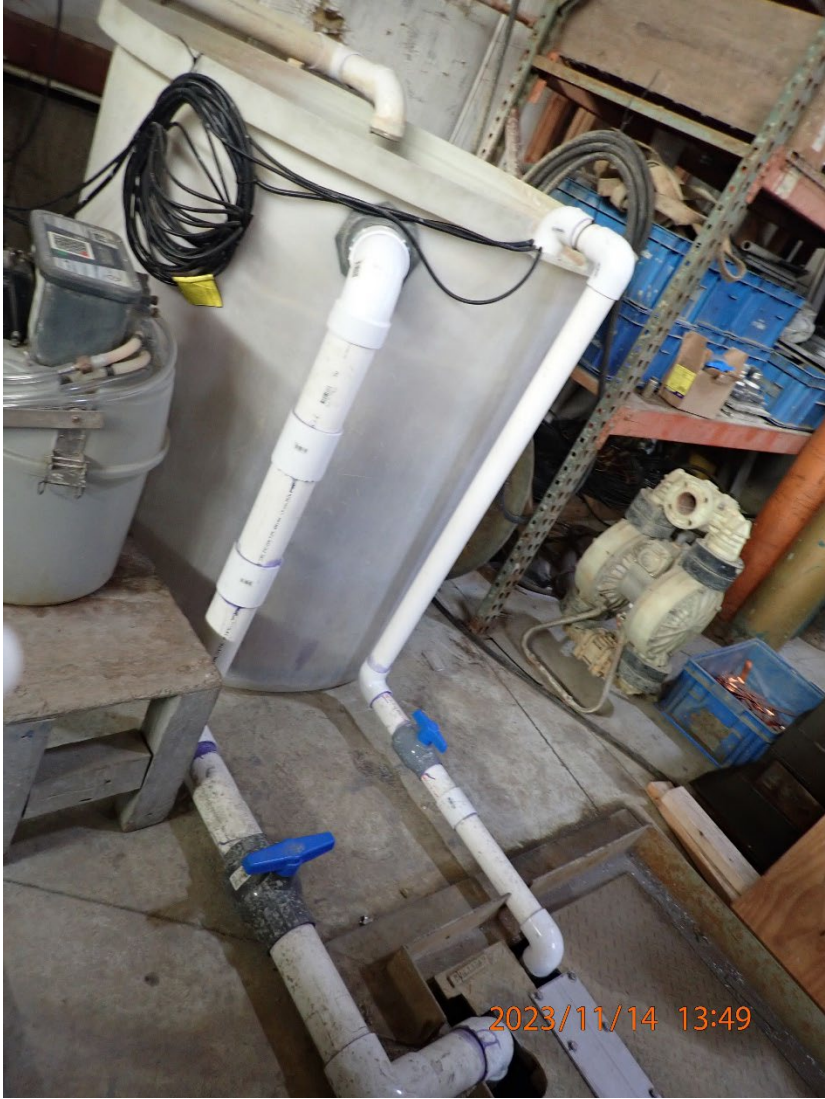
| <b>Photo No.:</b> 22 | <b>Time:</b><br>11:42 a.m. | | |

| <b>Photo Description:</b><br>Overview of holding tank with pipes to city sewer. | | | |

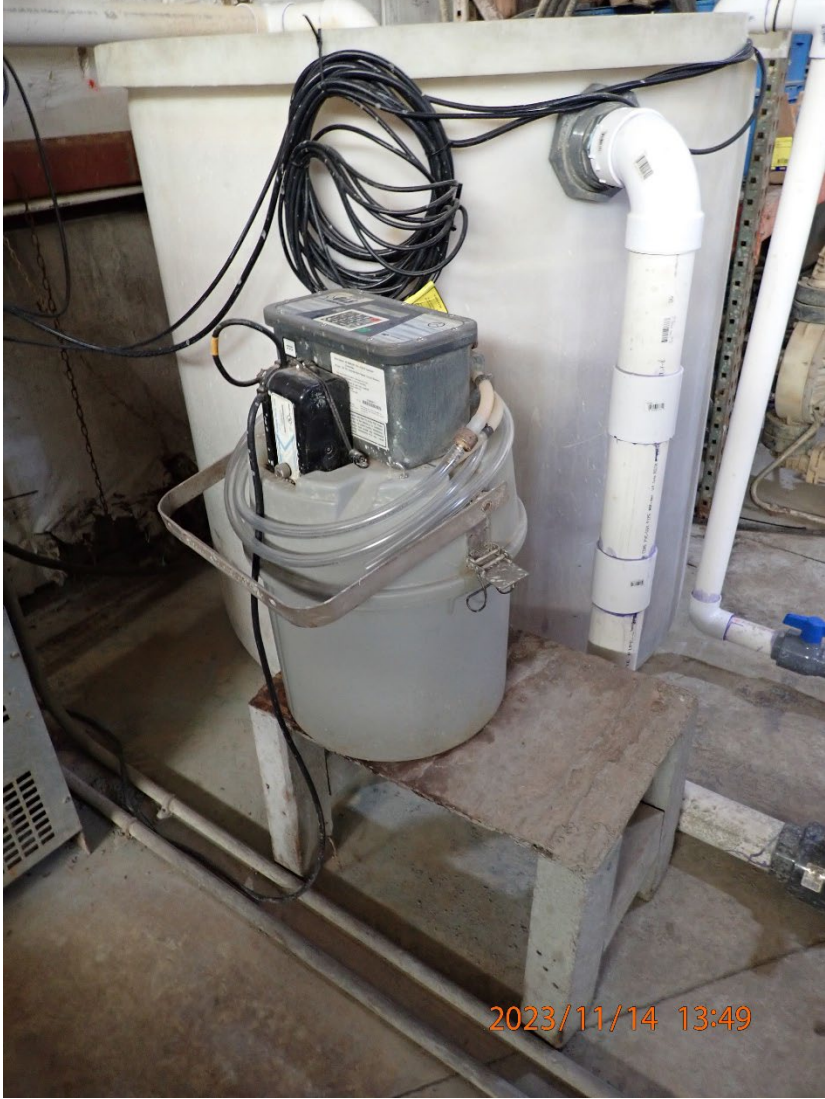
| <b>Photo No.: 23</b> | <b>Time:</b><br>11:43 a.m. | | |

| <b>Photo Description:</b><br>Composite sampler on holding tank.<br>Samples taken every 15 min. | | | |

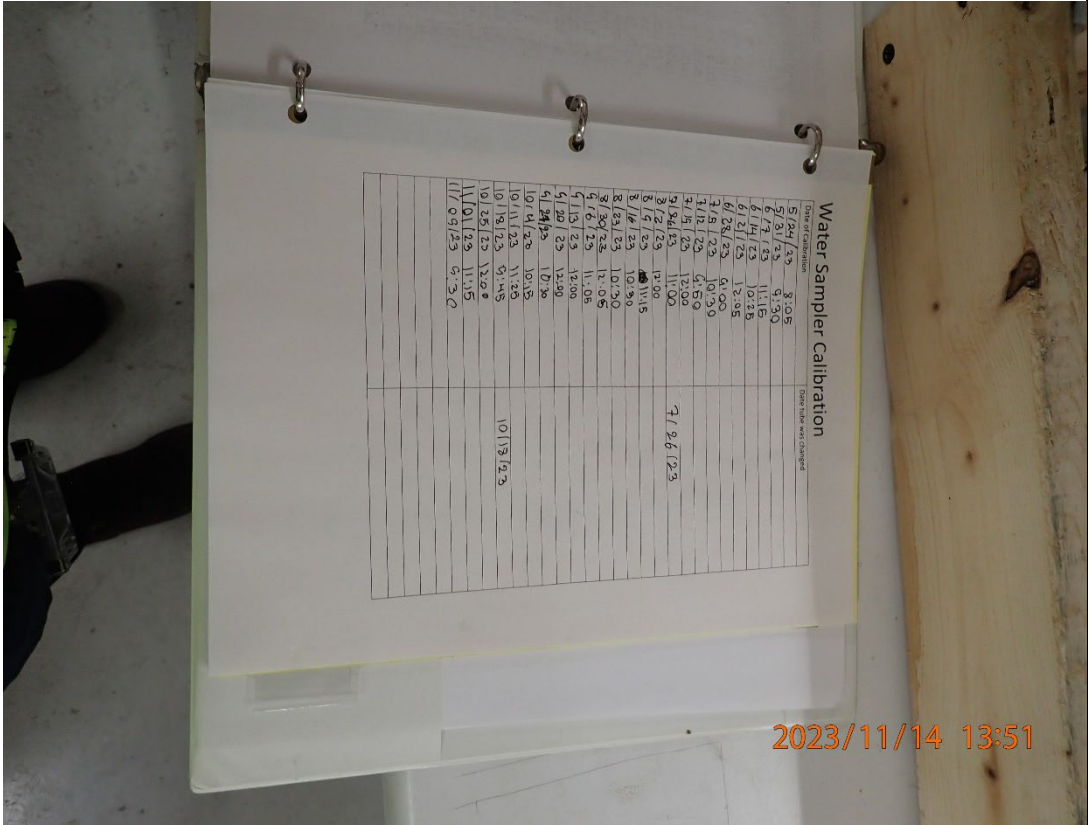
| <b>Photo No.:</b> 24 | <b>Time:</b><br>11:44 a.m. | | |

| <b>Photo Description:</b><br>Calibration records for pH in onsite lab. | | | |
