**INSPECTION REPORT**

| <b>Type of inspection:</b> | PCI – Pretreatment Compliance Inspection | |
| <b>Permittee Name:</b> | City of Joliet Eastside STP | |
| <b>Permit Number:</b> | IL0022519 | |

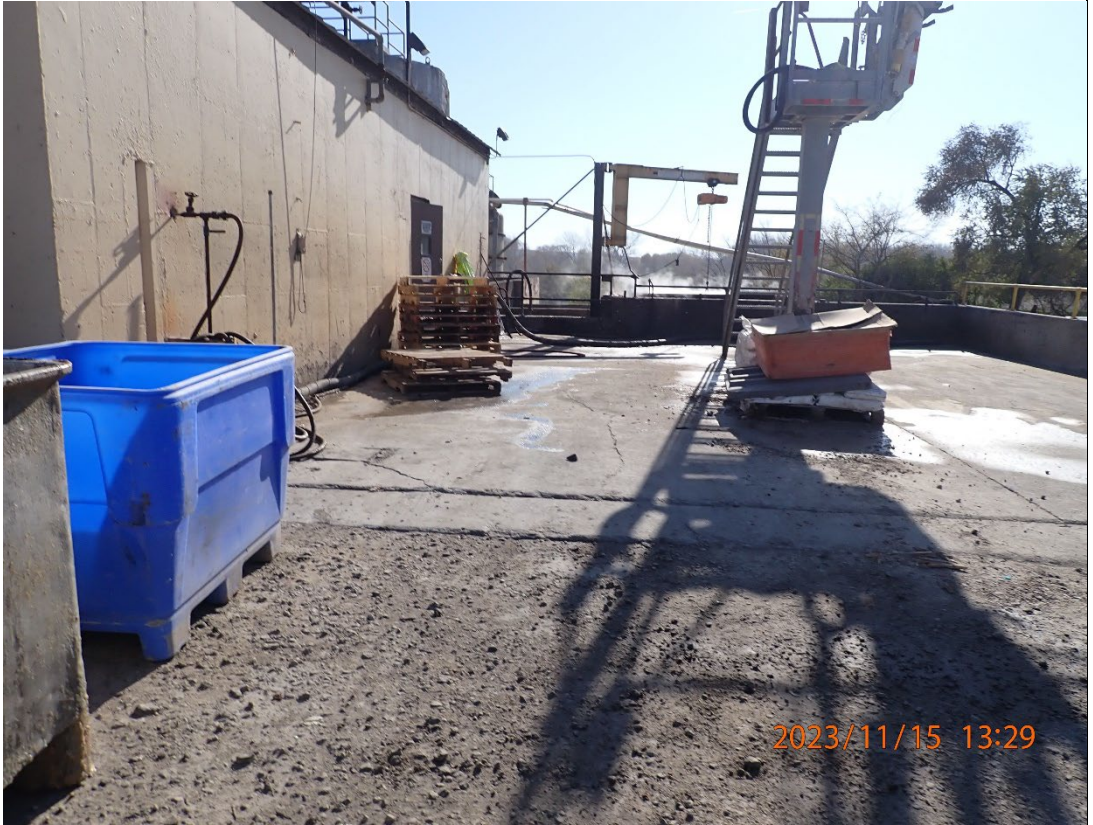
| <b>Photo No.: 25</b> | <b>Time:</b><br>11:22 a.m. | | |

| <b>Photo Description:</b><br>Tanker unloading area. | | | |

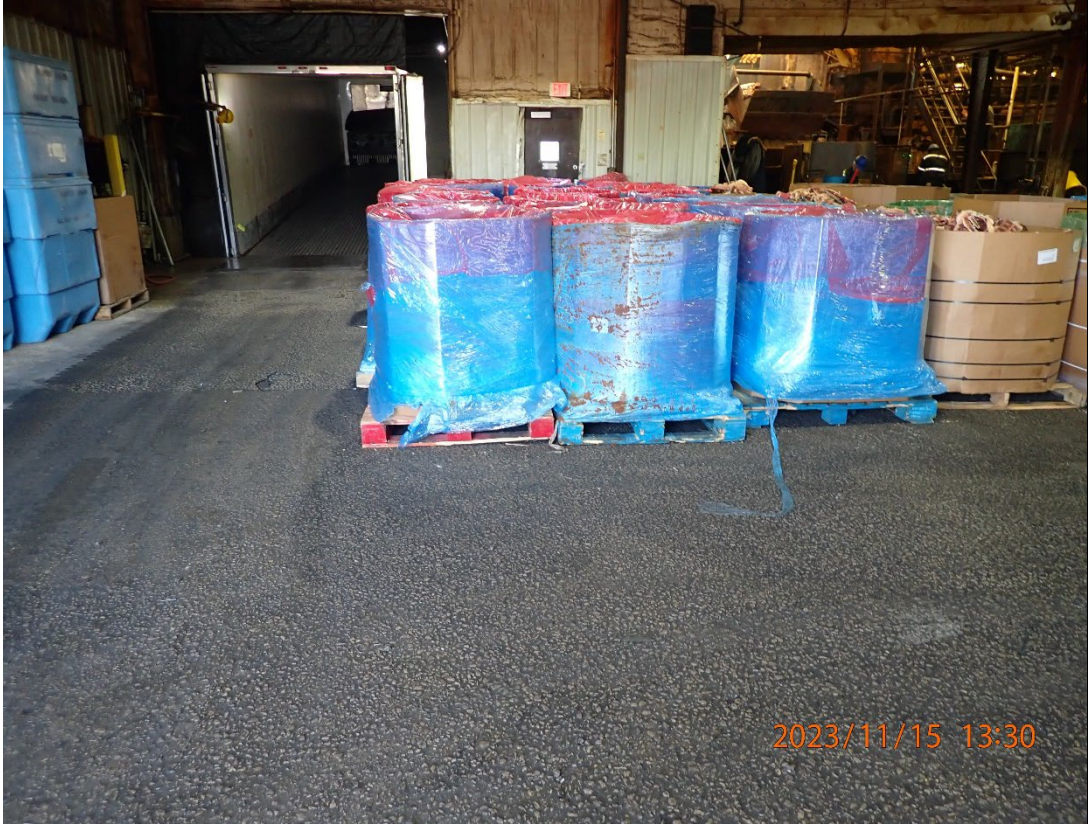
| <b>Photo No.:</b> 26 | <b>Time:</b><br>11:23 a.m. | | |

| <b>Photo Description:</b><br>Raw material receiving area. | | | |

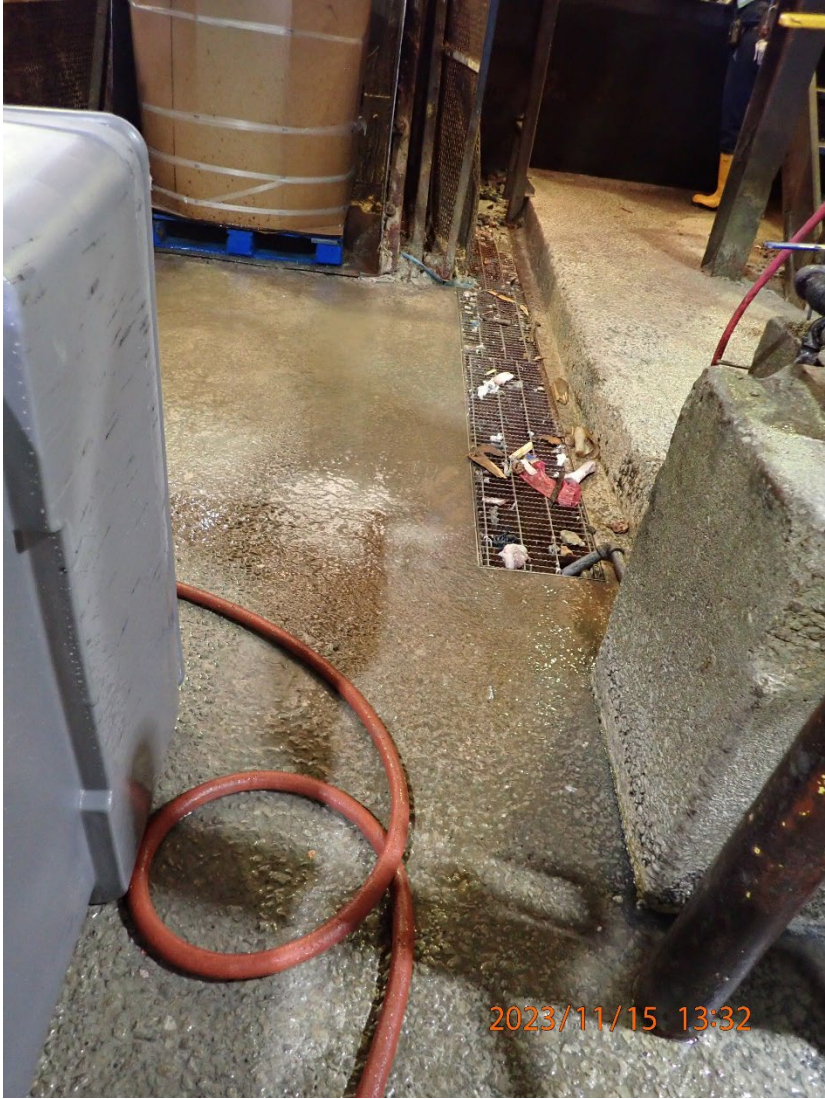
| <b>Photo No.: 27</b> | <b>Time:</b><br>11:25 a.m. | | |

| <b>Photo Description:</b><br>Tub wash station drain. Leads to wastewater treatment inside raw material handling building. | | | |

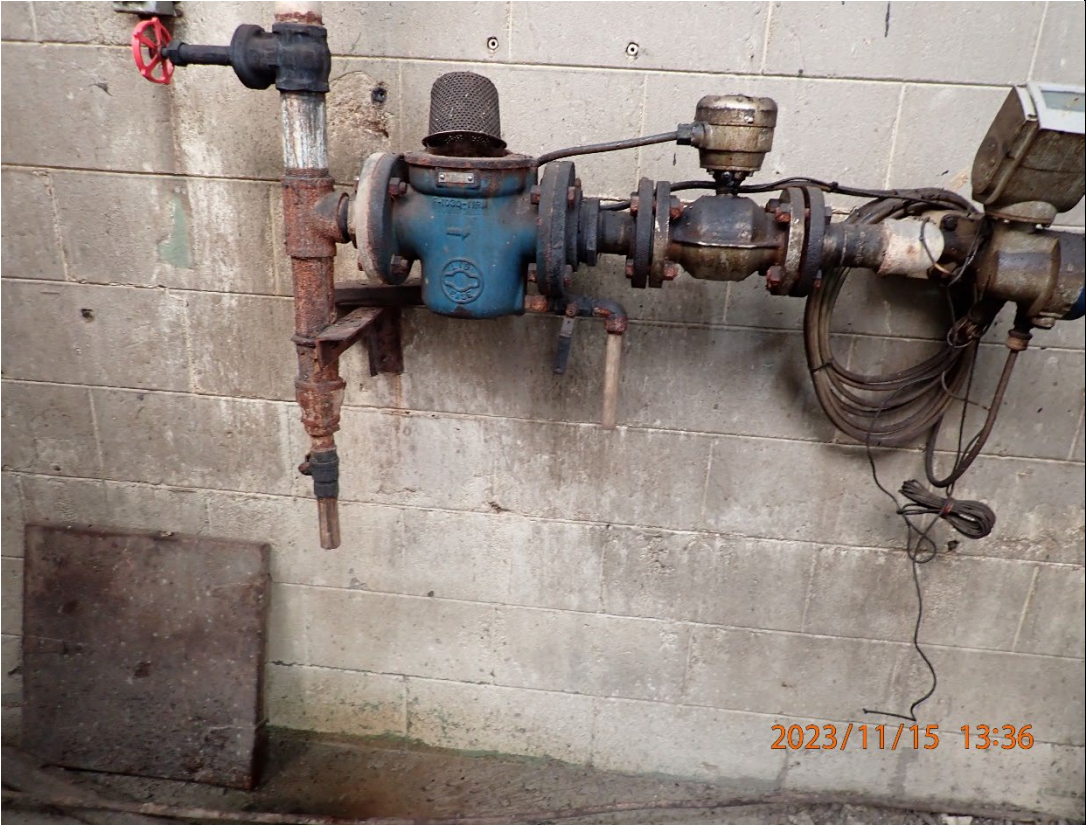
| <b>Photo No.:</b> 28 | <b>Time:</b><br>11:28 a.m. | | |

| <b>Photo Description:</b><br>Valve used for sampling point and discharge to the city. | | | |

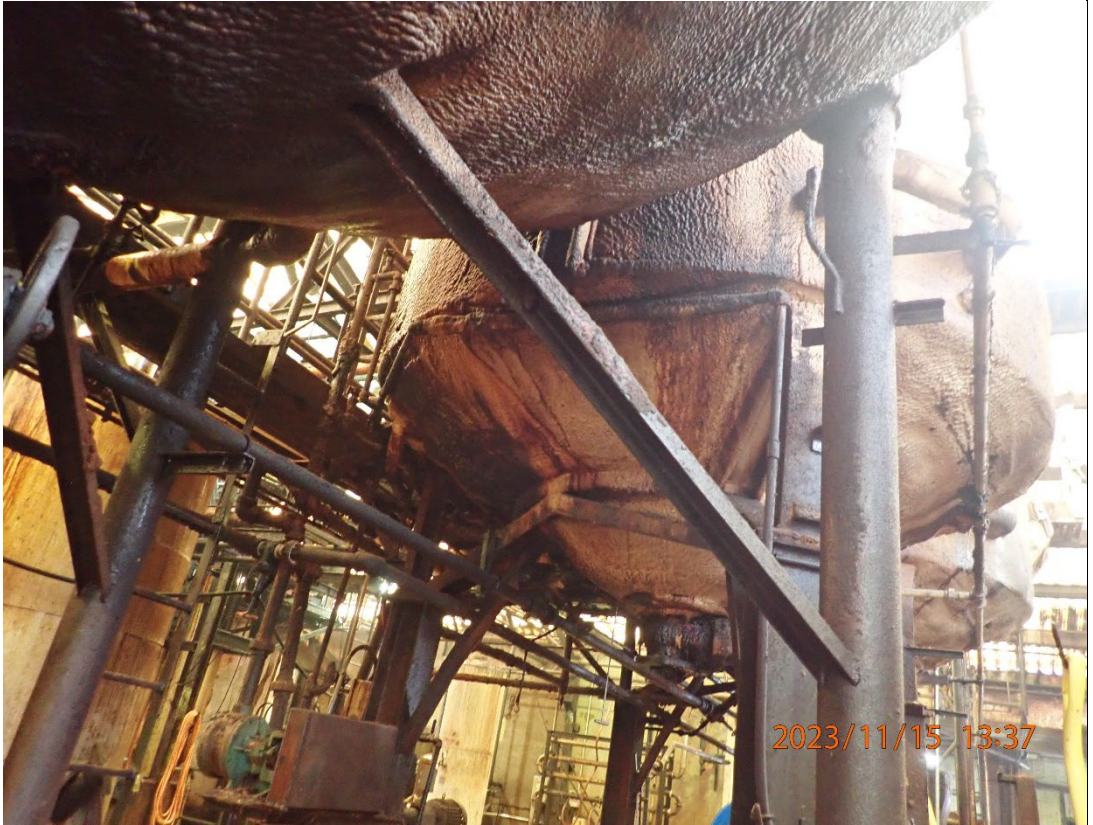
| <b>Photo No.:</b> 29 | <b>Time:</b><br>11:30 a.m. | | |

| <b>Photo Description:</b><br>Liquid fat storage tanks. | | | |

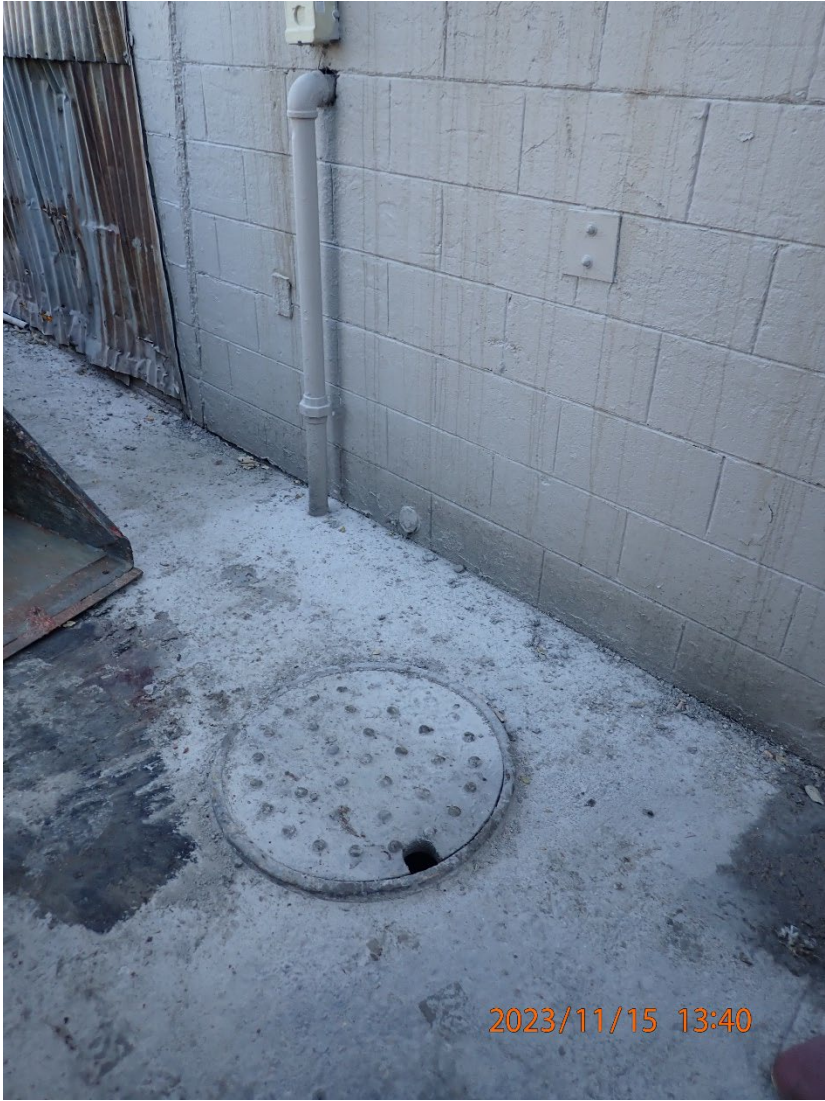
| <b>Photo No.: 30</b> | <b>Time:</b><br>11:33 a.m. | | |

| <b>Photo Description:</b><br>Composite sampler location manhole outside of material building. | | | |

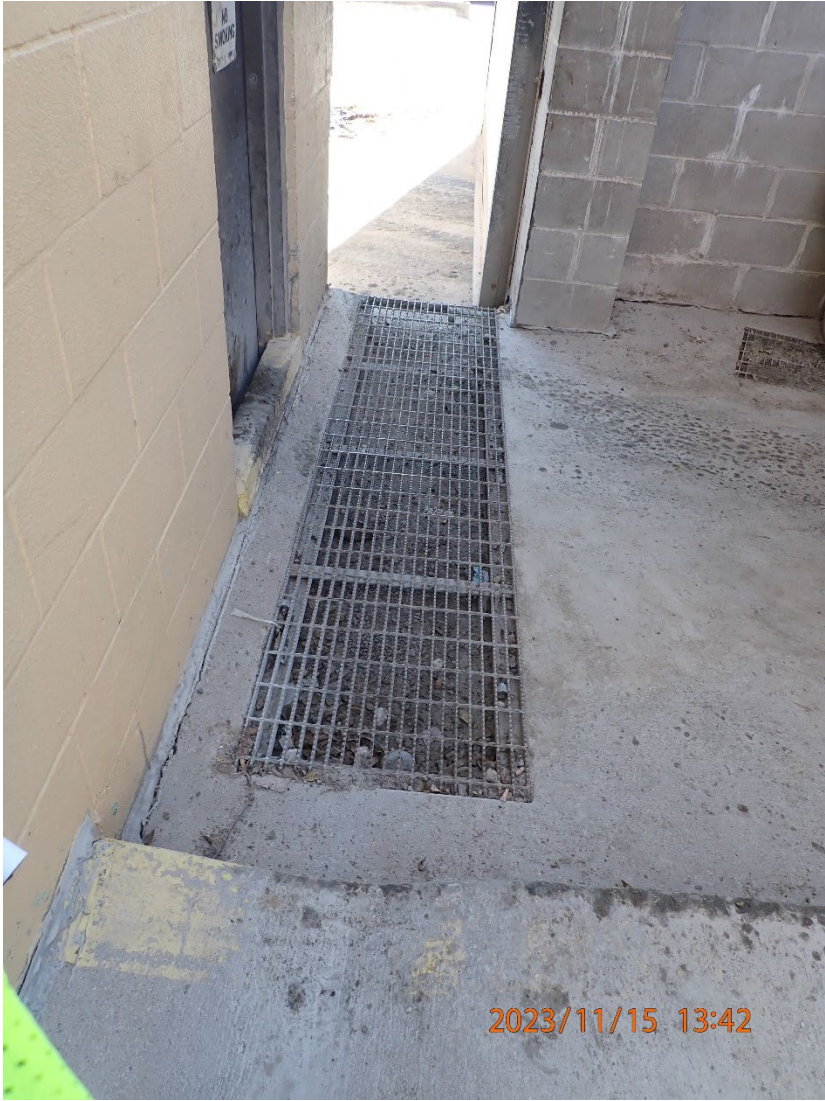
| <b>Photo No.: 31</b> | <b>Time:</b><br>11:35 a.m. | | |

| <b>Photo Description:</b><br>Stormwater drain outside of baker room. | | | |

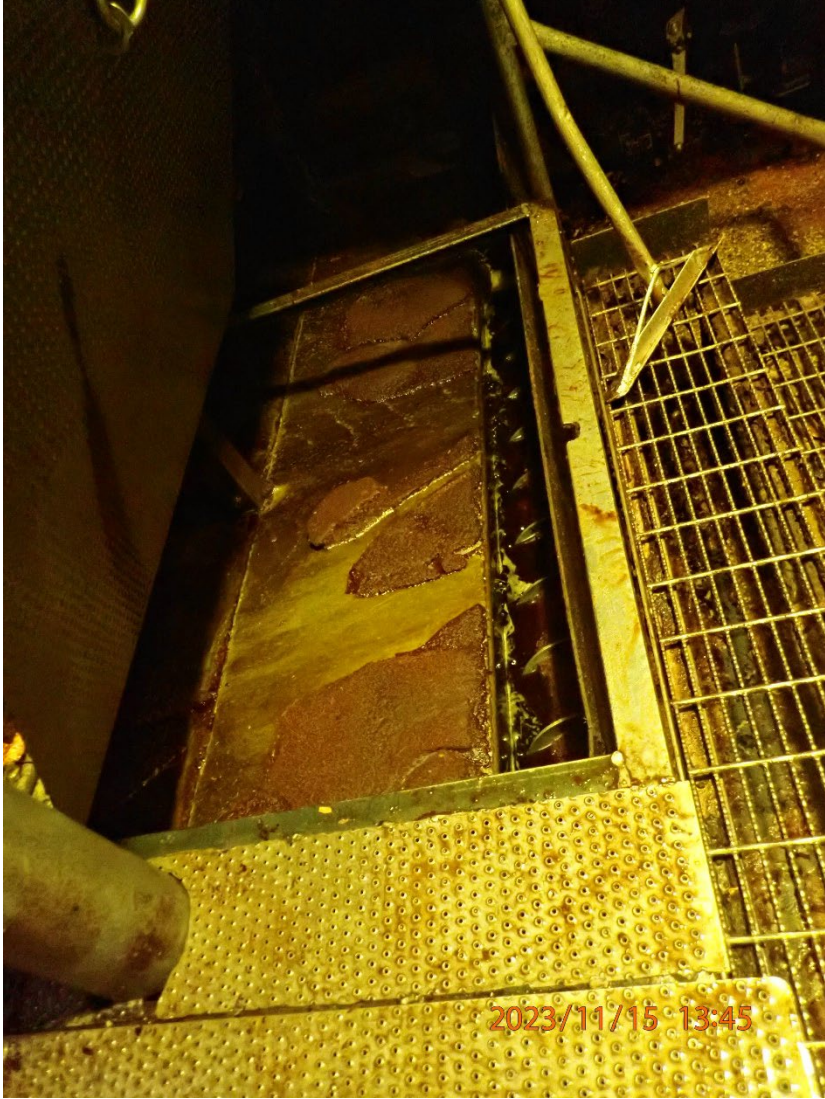
| <b>Photo No.: 33</b> | <b>Time:</b><br>11:38 a.m. | | |

| <b>Photo Description:</b><br>Liquid and fat coming off percolation tank. | | | |

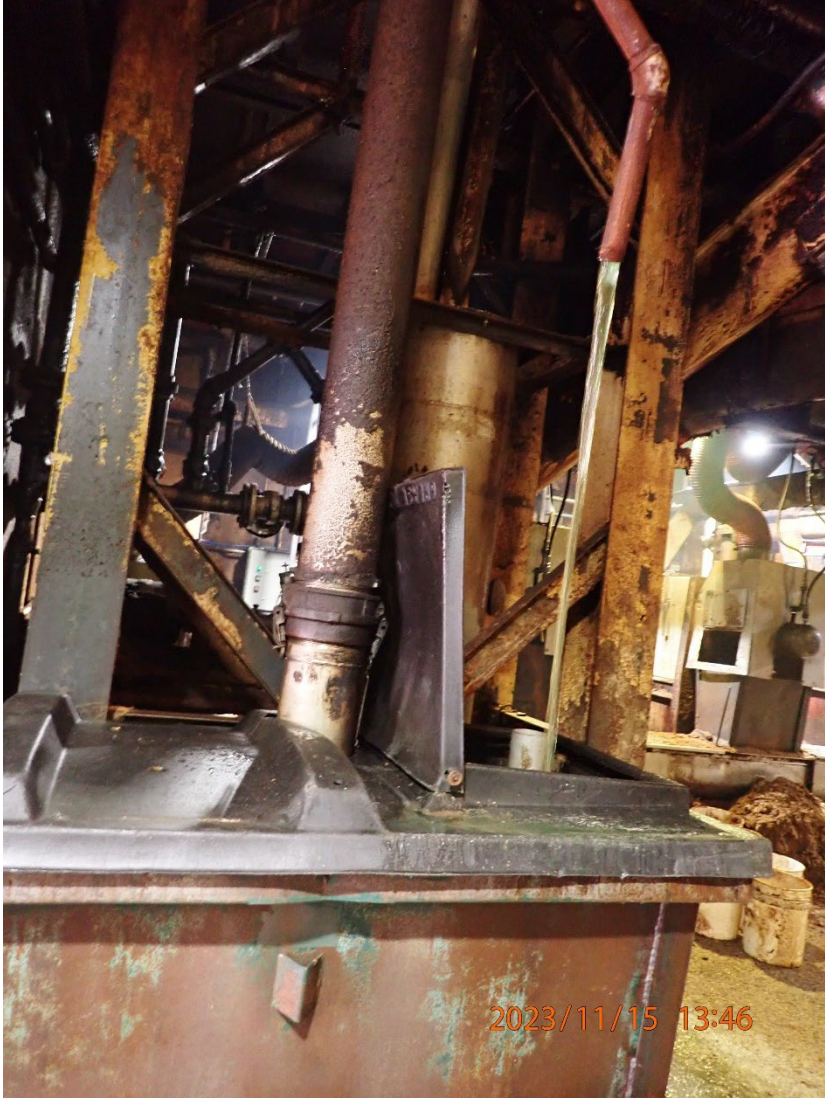
| <b>Photo No.: 34</b> | <b>Time:</b><br>11:39 a.m. | | |

| <b>Photo Description:</b><br>Hot well pond water coming in. | | | |

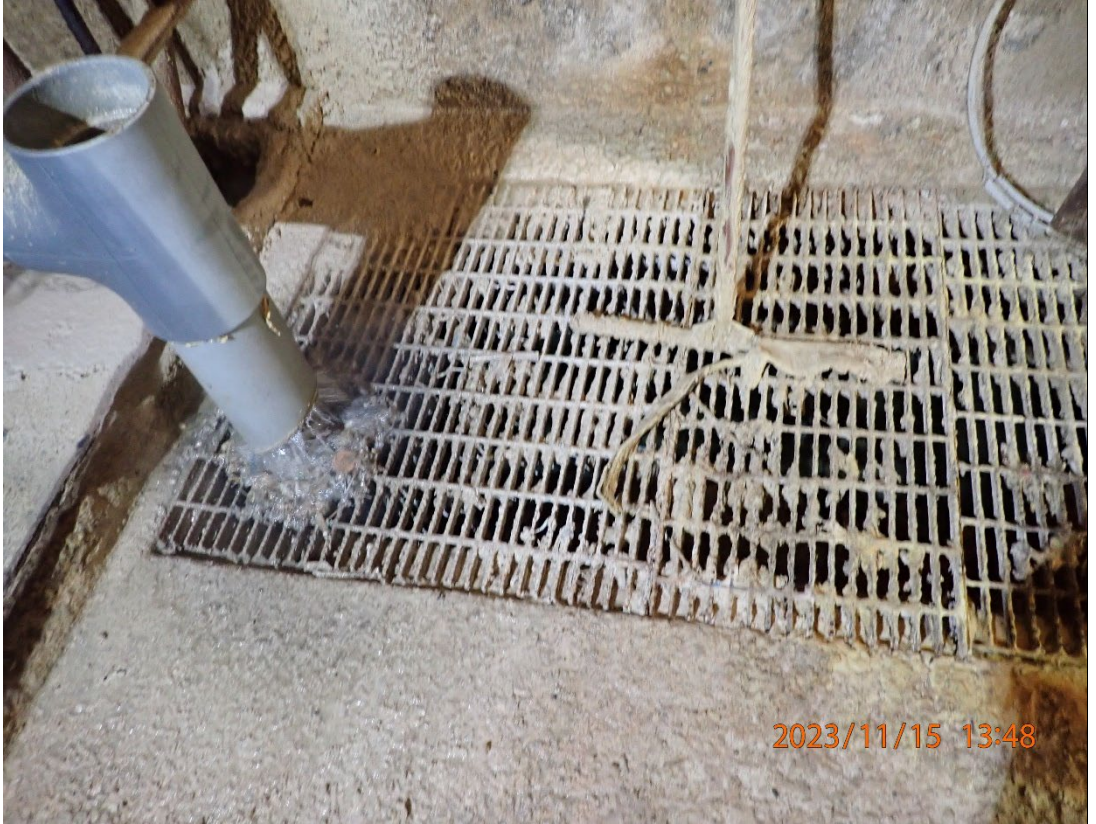
| <b>Photo No.: 35</b> | <b>Time:</b><br>11:41 a.m. | | |

| <b>Photo Description:</b><br>The pits where all water drains lead to. | | | |

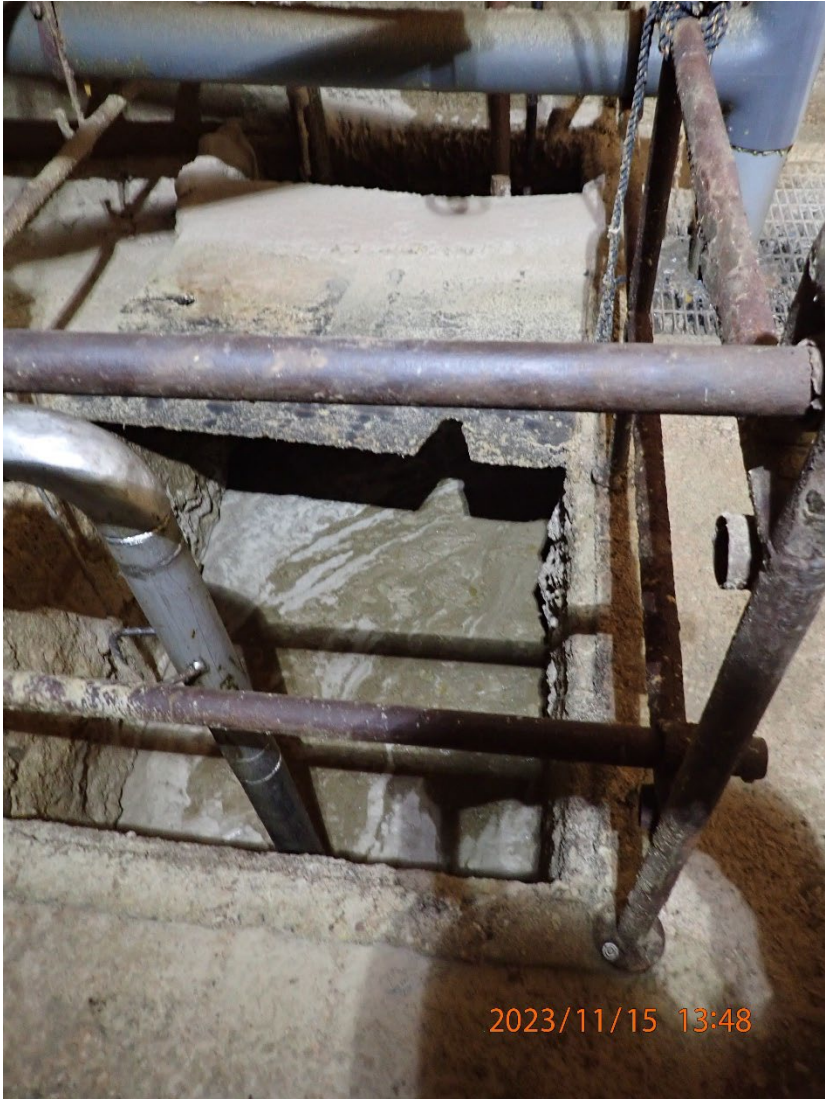
| <b>Photo No.:</b> 36 | <b>Time:</b><br>11:41 a.m. | | |

| <b>Photo Description:</b><br>Second angle of pit with drain dumping water in background. | | | |

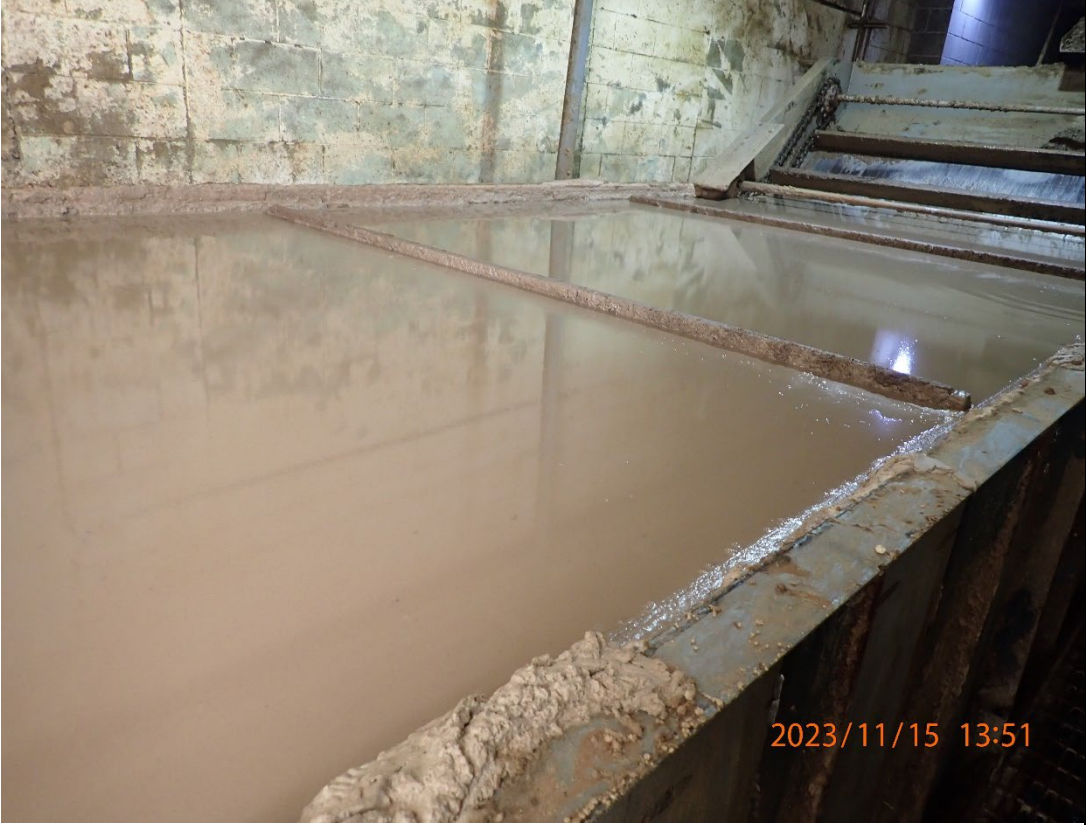
| <b>Photo No.: 38</b> | <b>Time:</b><br>11:43 a.m. | | |

| <b>Photo Description:</b><br>Skimmers. | | | |

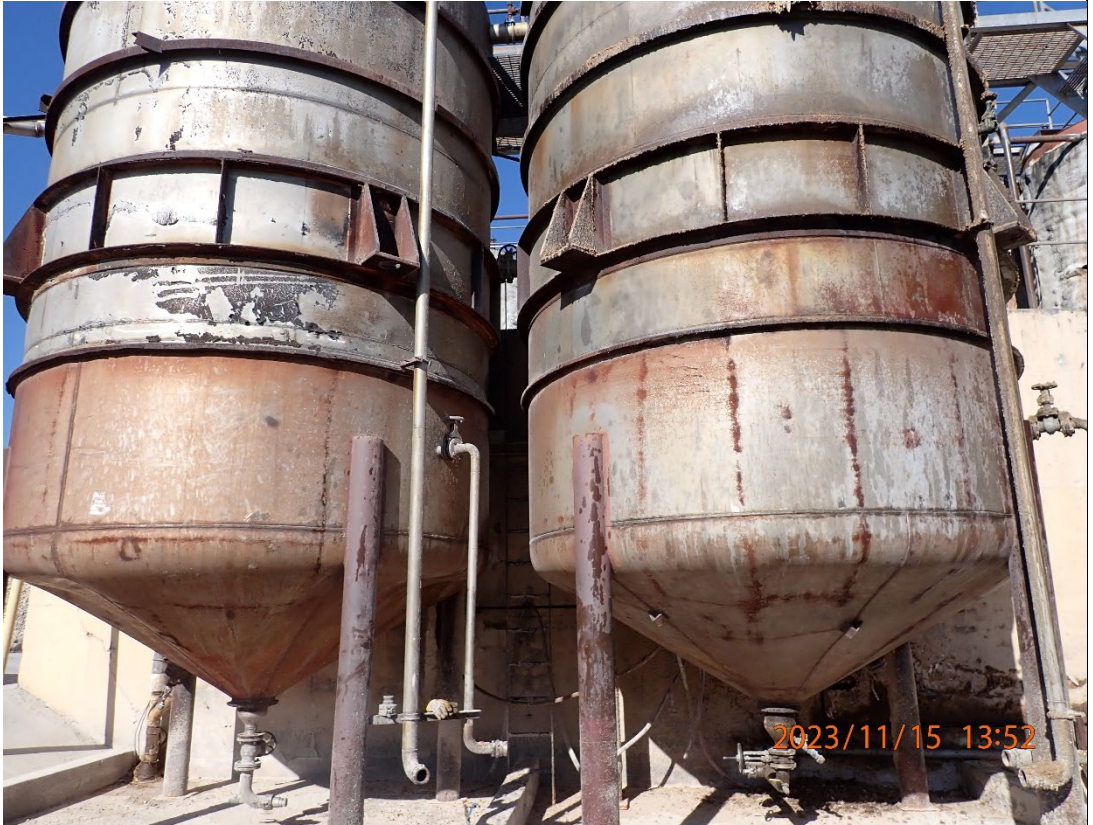
| <b>Photo No.:</b> 39 | <b>Time:</b><br>11:45 a.m. | | |

| <b>Photo Description:</b><br>Tank on the right is to the skimmer the left is after the skimmer. | | | |

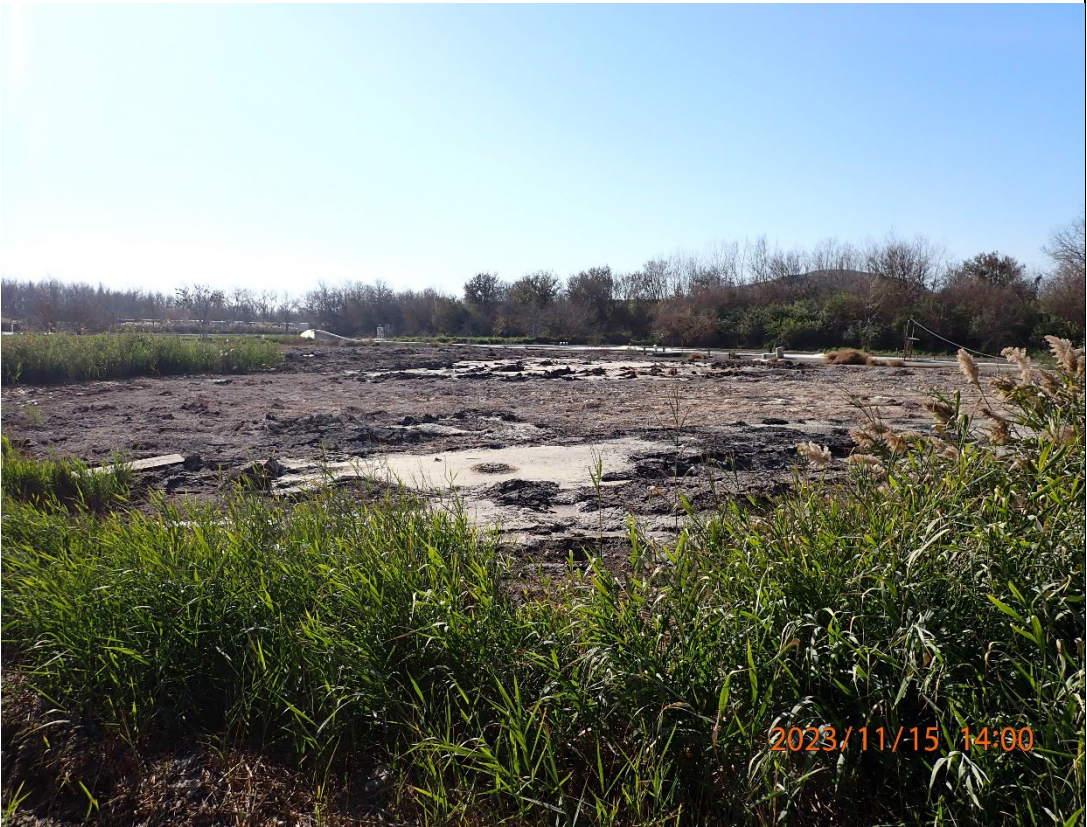
| <b>Photo No.: 40</b> | <b>Time:</b><br>11:53 a.m. | | |

| Unique Identifying No. | Observation | Area of Concern? |
|---|---|---|
| <b>MS-OB-004</b> | All water at Kaluzny Brothers, Inc. facility directed towards ponds located on the south end of the facility. No stormwater leaves the facility. (Photos: 40, 41, and 46) | No |

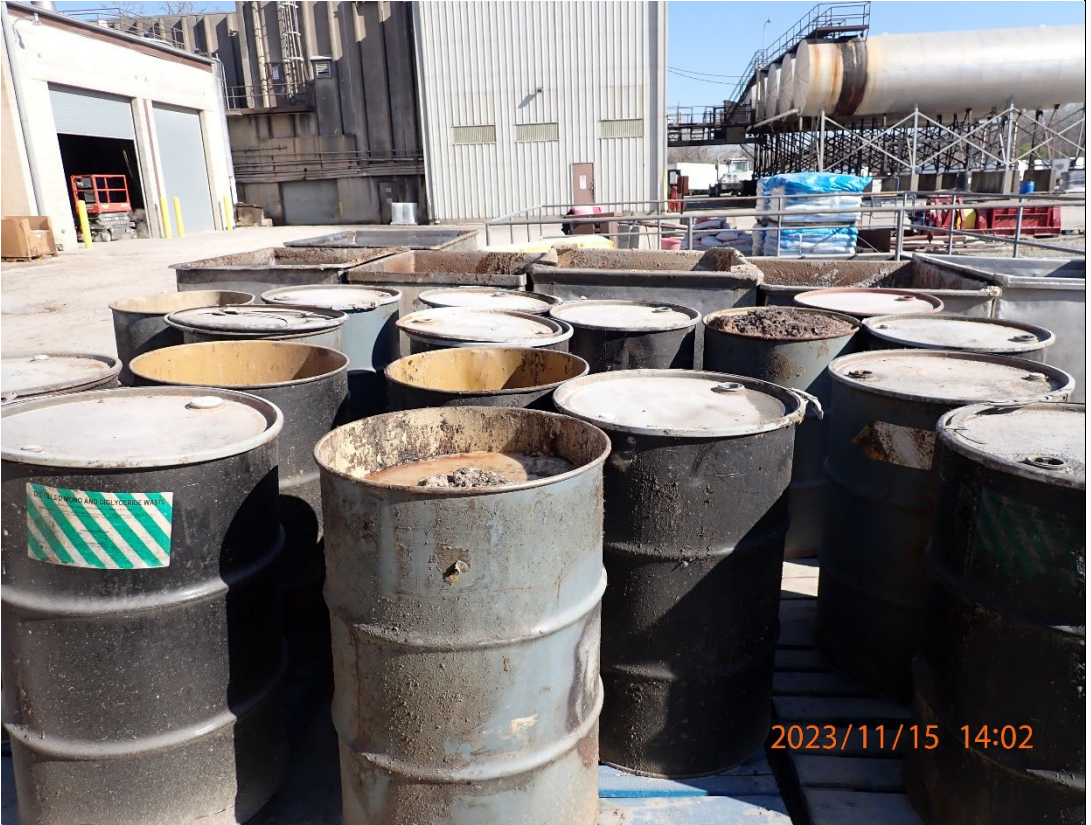
| <b>Photo Description:</b><br>Drums for storing material to be reprocessed (bones, fat, etc.). Located north of settling pond. | | | |

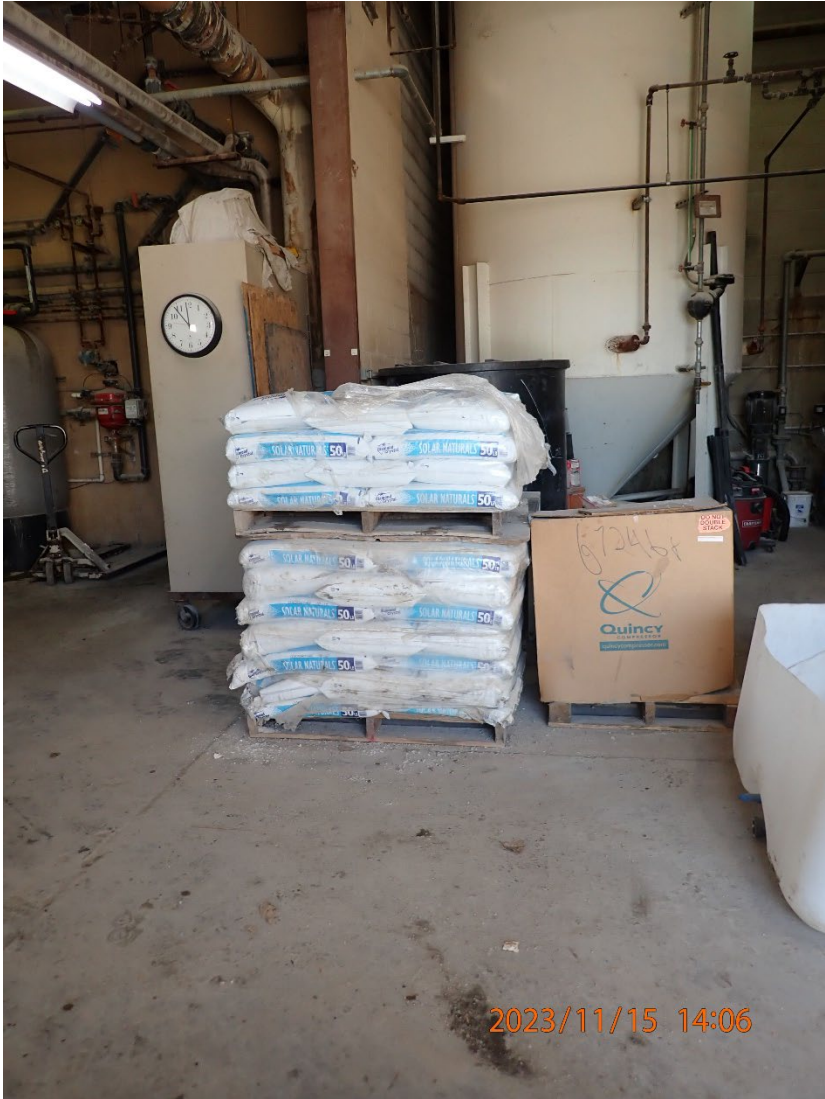
| <b>Photo No.:</b> 43 | <b>Time:</b><br>11:59 a.m. | | |

| <b>Photo Description:</b><br>Salt for softener tank<br>in boiler room. | | | |

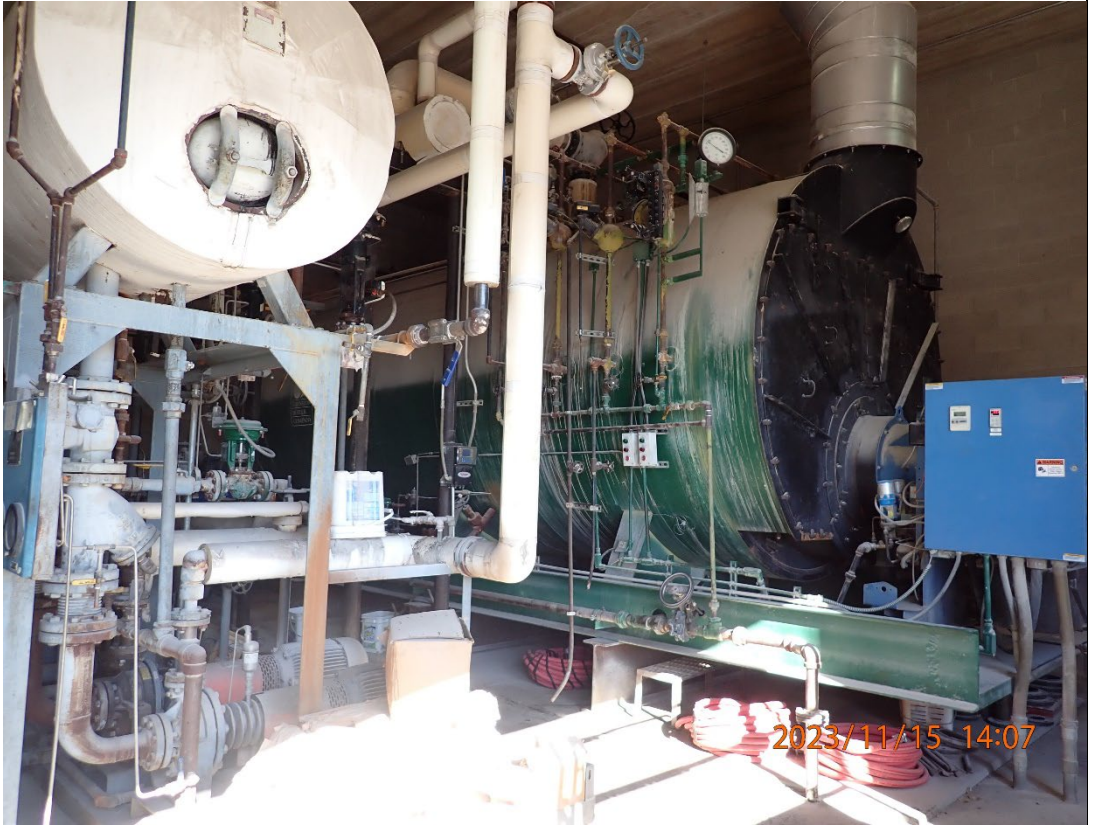
| <b>Photo No.: 44</b> | <b>Time:</b><br>11:59 a.m. | | |

| <b>Photo Description:</b><br>Boiler. | | | |

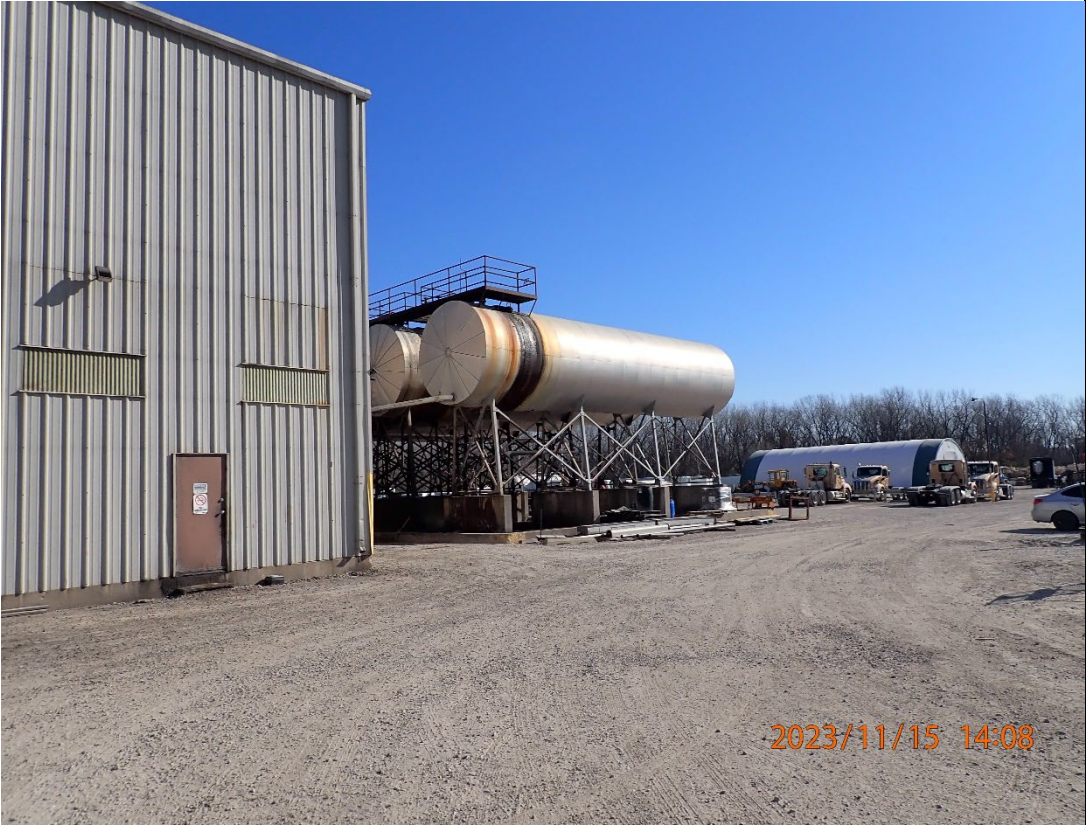
| <b>Photo No.:</b> 45 | <b>Time:</b><br>12:00 p.m. | | |

| <b>Photo Description:</b><br>Vegetable oil storage tanks. | | | |
