# Simulation and Characterization of Used Brake Friction Materials and Rotors

M. G. Jacko and R. T. DuCharme  
Research Laboratories, The Bendix Corp.

International Automotive Engineering Congress  
Detroit, Mich.  
January 8-12, 1973

730191

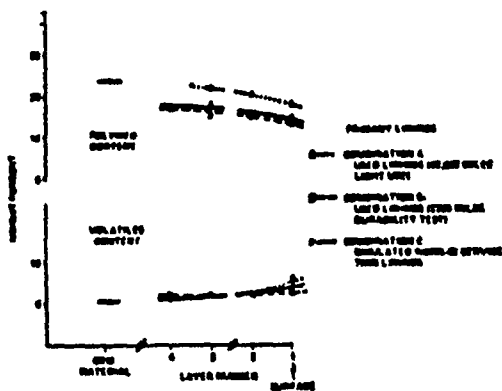
Fig. 13 - Comparison of FHAI characteristics (polymer content and volatile content) for primary linings

For the primary linings of combinations A, B, and C, Figs. 13 and 14 are plots of the data in Table 2 plus the data for the other two primaries. This is the most convenient method of comparing the state of the lining of combinations A, B, and C. Fig. 13 shows the variations of polymer content and volatiles content while Fig. 14 shows the inorganic content and asbestos dehydroxylation content as a function of thermal history (location in material). In all cases, the polymer content decreases at the rubbing surface while the low molecular

weight volatiles content increases. In all cases, the inorganic content of the rubbing surface is higher while the asbestos content is lower. The extent of indicated reaction for all of these trends is gradual from the surface (layer 1) into the depth of the FHAI (layer 4). In all cases, except for the asbestos dehydroxylation, the combination C lining is bracketed by the A and B materials.

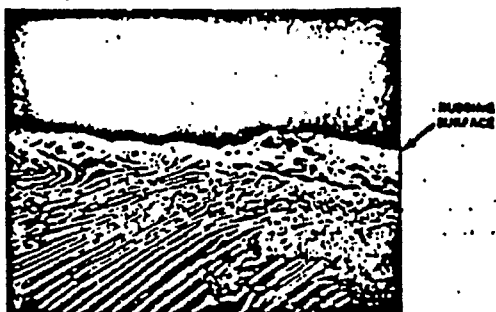
Fig. 18 - Cross-sectional microstructure of simulated worn-in-service intermediate vehicle drums (10,000X SEM reduced 63% for reproduction)

Figs. 18 and 19 show two cross-sectional photomicrographs of the used intermediate vehicle drums. The rubbing surface of the drum was approximately in the middle of both pictures. Two phenomena can be observed in these pictures. First, the graphite flakes do not continue all the way to the surface of

the drum. The graphite near the surface was removed and the void formed filled by pearlite. Second, the pearlitic structure was disturbed at the surface, the cementite platelets being broken up and dispersed in the ferrite matrix.
