## **RCRA Inspection Report**

United States Marine Corps Logistics  
Base  
Installation & Environment Division  
Environmental Branch I40300  
814 Radford Blvd. STE 20315  
Albany, Georgia 31704-0315  
Dougherty County

EPA ID#: GA7170023694  
NAICS #: 928110 – National Security

February 25-26, 2025; 8:00 am – 4: 45 pm and February 27, 2025, 7:45 am – 11:00 am.

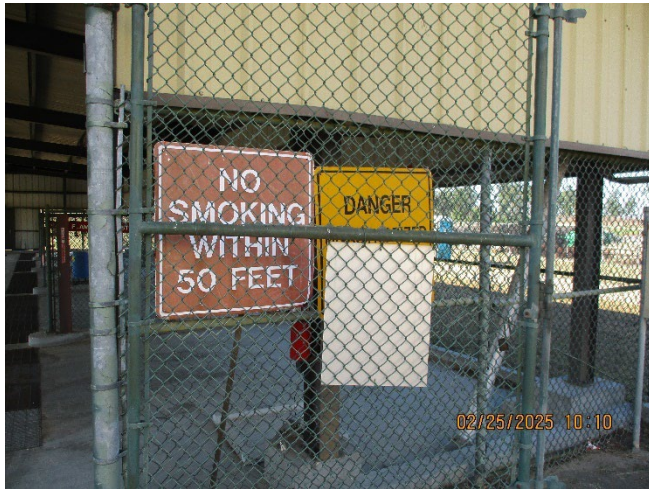
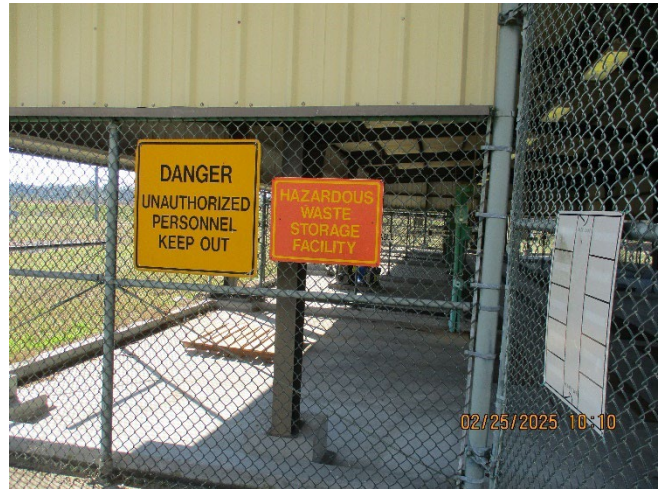
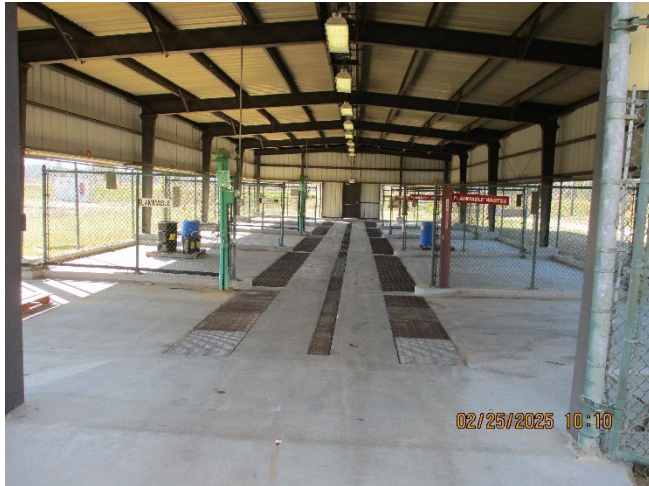
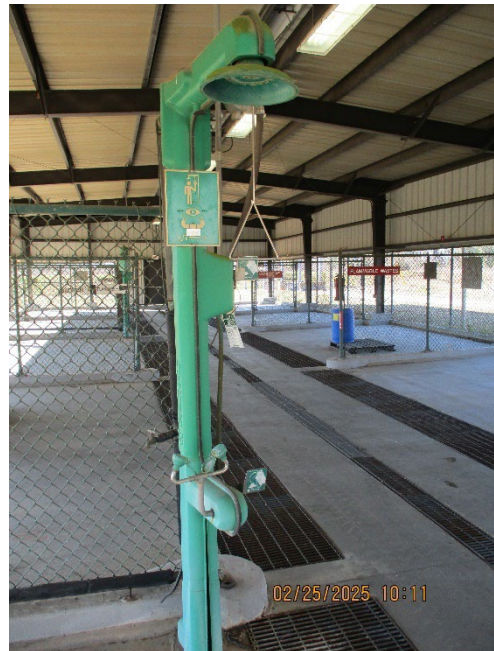
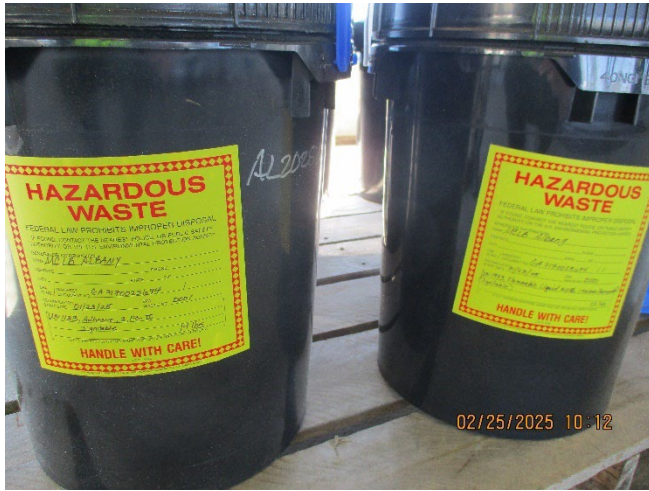
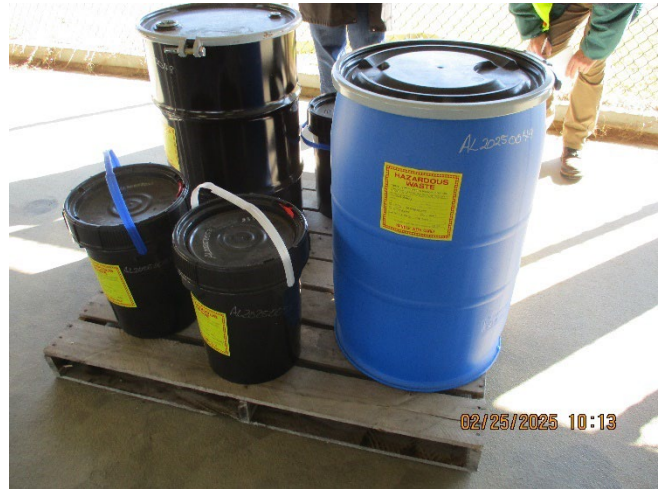
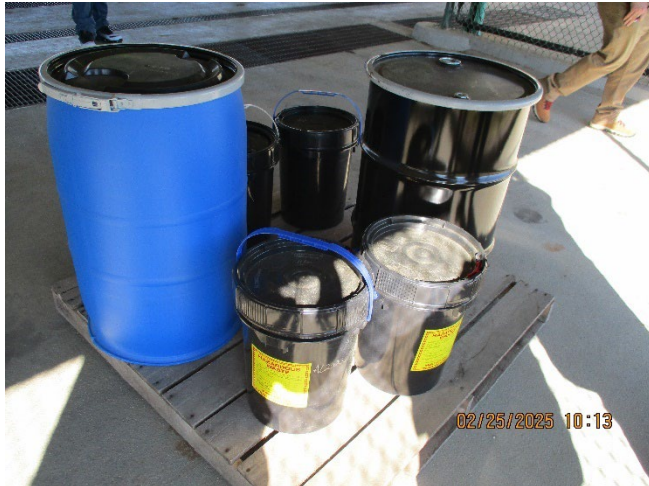
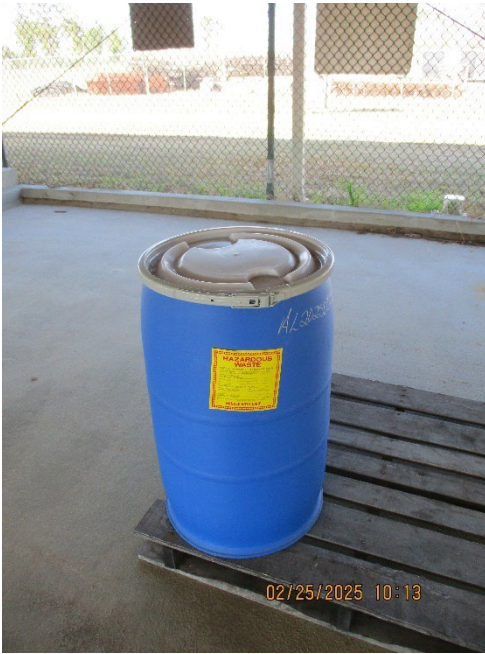
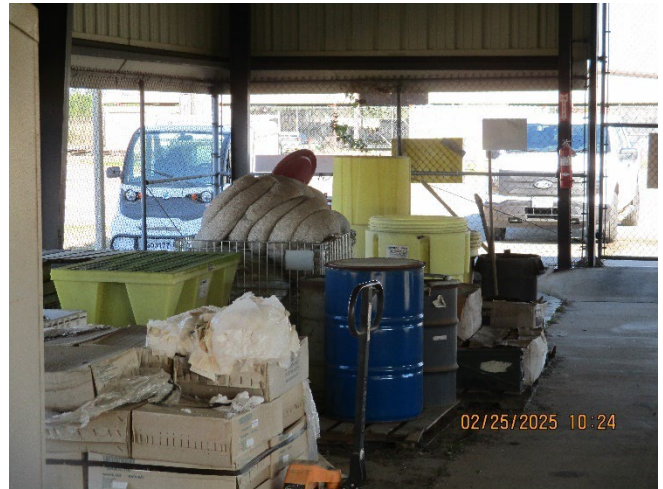
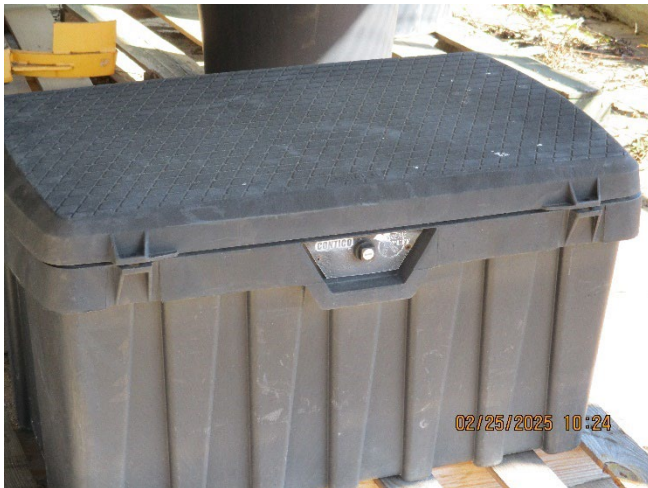
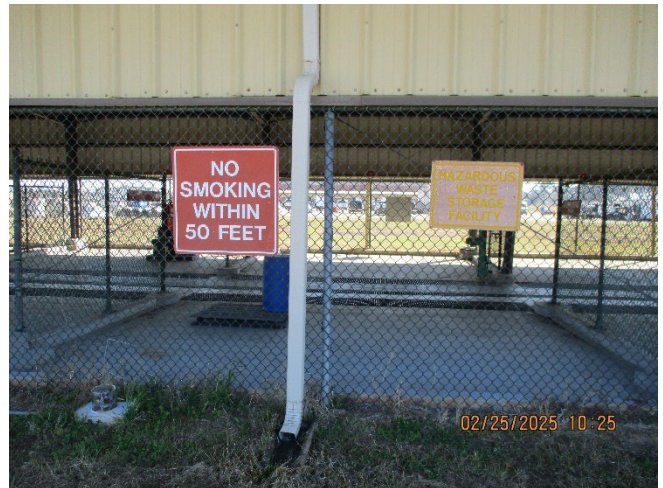
The permitted storage area consists of a roofed, concrete pad divided into ten bays surrounded by a chain-link fence; the fencing reaches from the ground to the roof. The floor consists of coated concrete; and each bay is separated by concrete curbing which runs to the edge of installed floor drains. The floor drains for each bay are separated by a concrete divider in the sump. The MCLB posted the following signs: “Hazardous Waste Storage Facility” and “No Smoking within 50 feet” on the exterior of Building 1625. Building 1625 was equipped with portable fire extinguishers, decontamination equipment, and spill equipment located within or near the building. MCLB utilizes cell phones to call the numbers for emergency response located on signage on the fence for communications from this location. MCLB operates an on-site fire department. In the permitted area, inspectors observed seven (7) HW containers; (2) 55-gallon poly, (1) 55- gallon steel, and (4) 5-gallon plastic containers. All containers were labeled “Hazardous Waste,” were compatible with the waste, were closed, and were in good condition. All containers were marked with accumulation start dates of less than one year. All containers had hazard indications written on the labels, but these were small and difficult to read. Inspectors recommended that the facility utilize DOT labels or larger words on the container that could be seen from a distance in the event of emergency (Photographs 1 – 16).

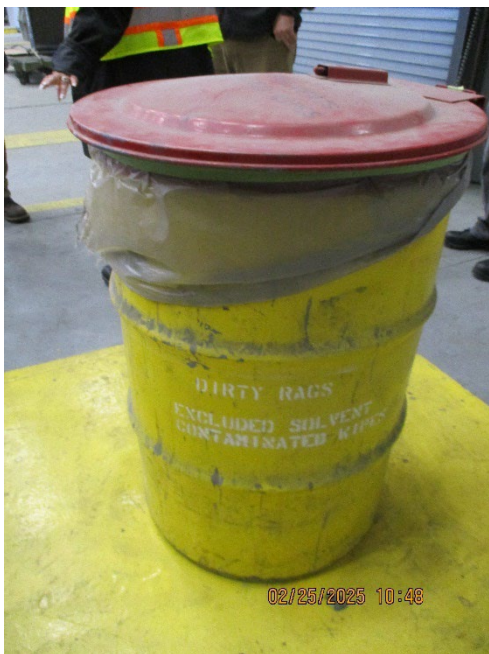
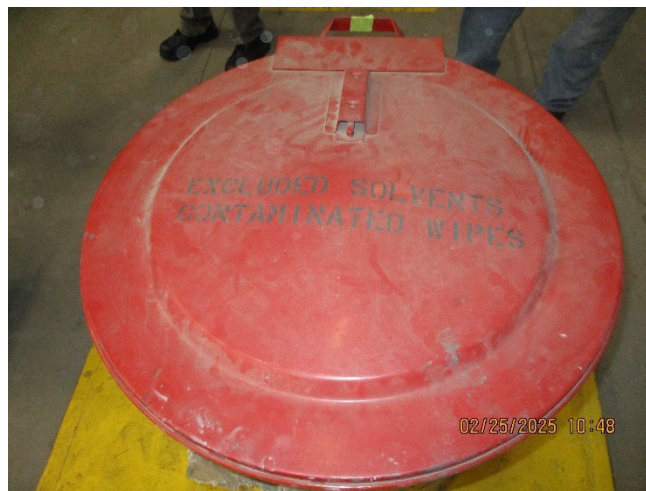
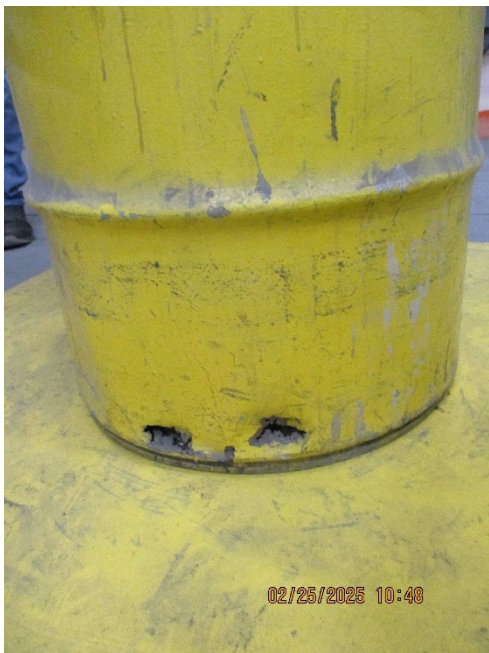
Adjacent to SC-9 inspectors observed one (1) 55-gallon steel container with a flip top lid, the container and lid were labeled “Excluded Solvent Contaminated Wipes.” The lid was closed, but the container had two holes near its base (Photographs 21-23). When asked about the management of the wipes, MCLB personnel explained that a contracted company collects and launders the ESCWs and supplies clean wipes. Facility staff explained that the individual HW coordinators for each CWC were responsible for changing full containers for empty containers and documenting this collection on the log sheet in the tool room. This log sheet was presented and only one entry was found on the log sheet for CWC 283, which represents “Big Paint” (Photograph 27). This entry was for July 16, 2024, which was more than 180 days prior to the inspection date.

**Pursuant to Ga. Comp. R. and Regs. 391-3-11-.07(1) [40 C.F.R. § 261.4(a)(26)(i)], solvent contaminated wipes that are sent for cleaning and reuse are not solid waste, and must be contained in non-leaking, closed containers that are labeled “Excluded Solvent Contaminated Wipes.” The containers must be able to contain free liquids, should free liquids occur.**

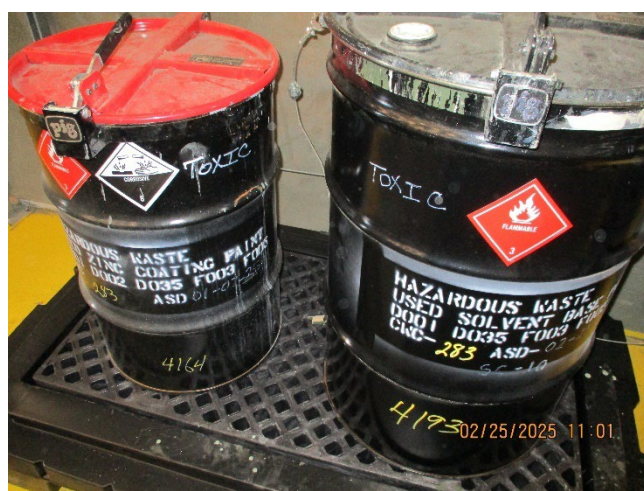
Adjacent to CWC 273, against the wall, inspectors observed one (1) 55-gallon steel container with a flip top lid marked “Excluded Solvent Contaminated Wipes.” The container was in good condition but was not closed. The log sheet for ESCWs was reviewed and documented that wipes in this workstation were less than 180 days old. MCLB personnel corrected the open container prior to departure and emailed photo documentation on February 28, 2025.

**Pursuant to Ga. Comp. R. and Regs. 391-3-11-.07(1) [40 C.F.R. § 261.4(a)(26)(i)], solvent contaminated wipes that are sent for cleaning and reuse are not solid waste, and must be contained in non-leaking, closed containers that are labeled “Excluded Solvent Contaminated Wipes.” The containers must be able to contain free liquids, should free liquids occur.**

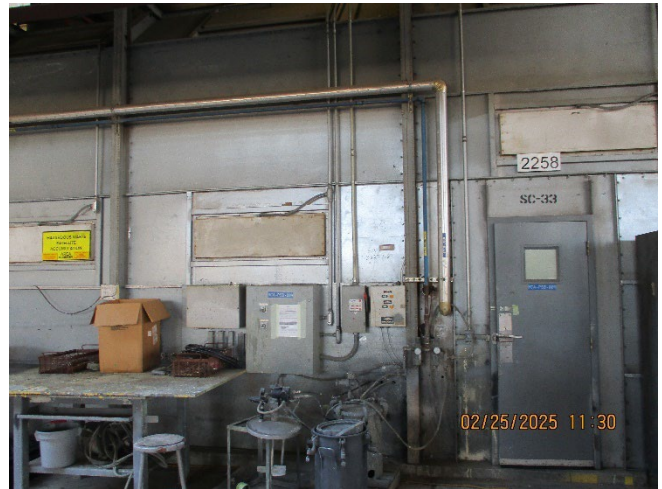
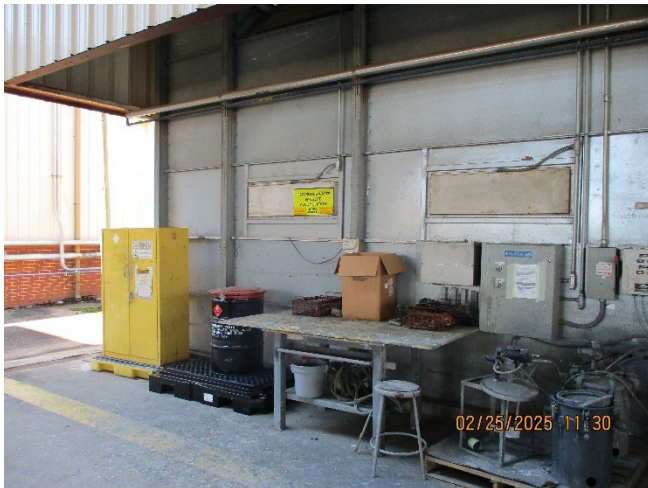
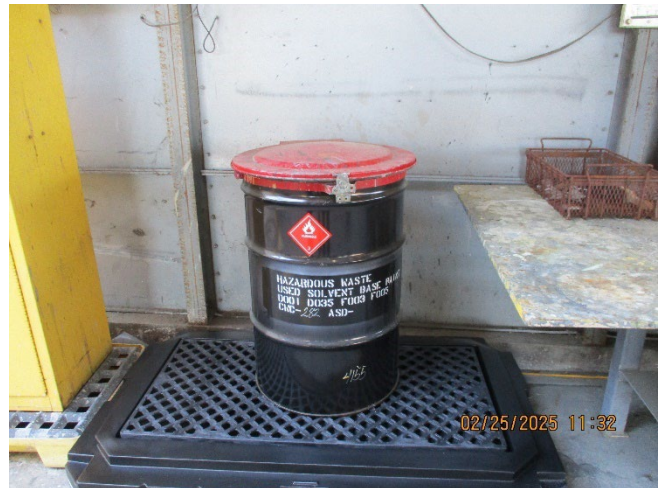
Inspectors observed that containers in three (3) SAAs were in good condition, closed, and labeled “Hazardous Waste.” Multiple SAA containers were labeled with a single hazard but failed to have included an indication of the “Toxic” hazard associated with the waste codes. These SAAs locations are listed in Table 3 (Photographs 34 – 36).

**Pursuant to Ga. Comp. R. and Regs. 391-3-11-.08(1) [40 C.F.R. § 262.15(a)(5)(ii)], which is a condition of the SAA Permit Exemption, a generator is required to mark or label its containers with an indication of the hazards of the contents.**

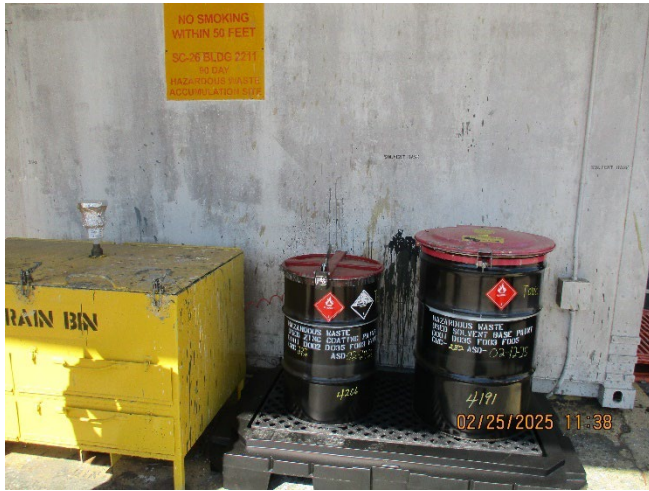
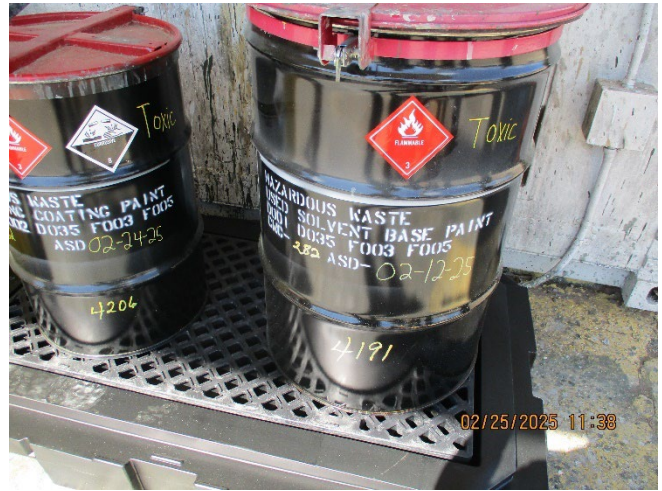
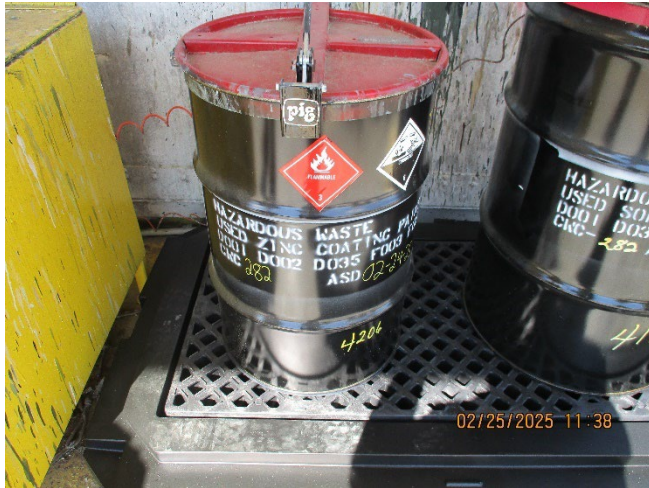
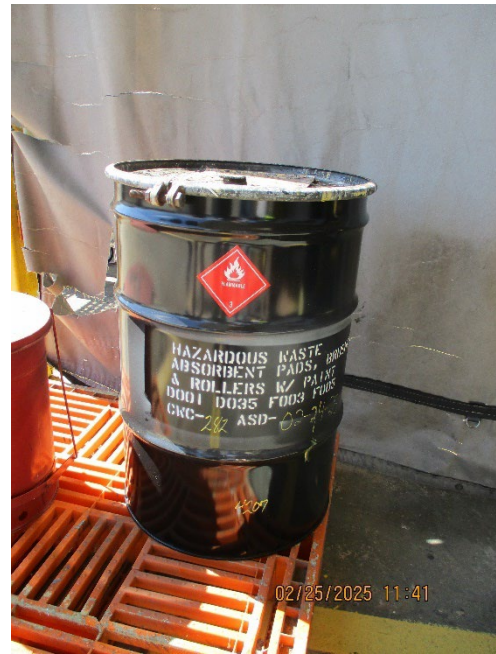
Inspectors observed two (2) 55-gallon and one (1) 30-gallon steel containers on secondary containment pallet. The location was not equipped with a portable fire extinguisher, decontamination equipment, and spill control equipment (Photographs 37-40). MCLB emailed photo documentation of the corrections on February 28, 2025.

**Pursuant to Ga. Comp. R. and Regs. 391-3-11-.08(1) [40 C.F.R. § 262.17(a)(6)], which incorporates Ga. Comp. R. and Regs. 391-3-11-.08(1) [40 C.F.R. Part 262.252(c)], and is a condition of the LQG Permit Exemption, areas of an LQG where hazardous waste is generated or accumulated must have portable fire extinguishers, fire control equipment (including any required special extinguishing equipment), spill control equipment, and decontamination equipment.**

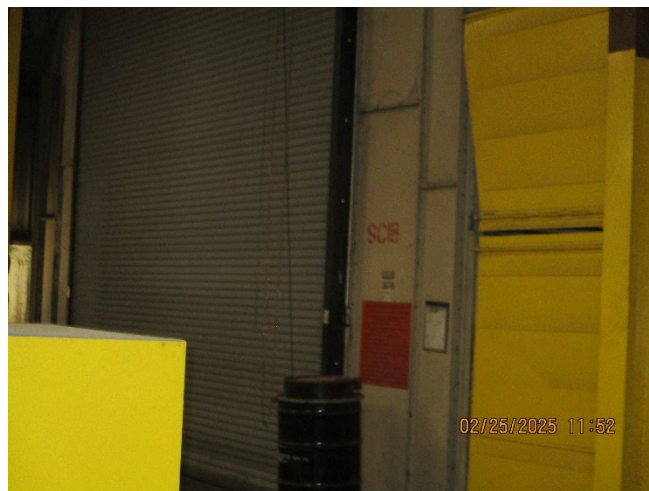
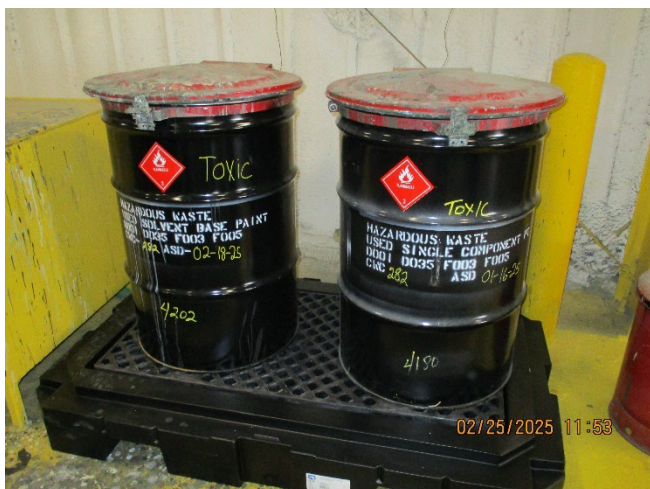
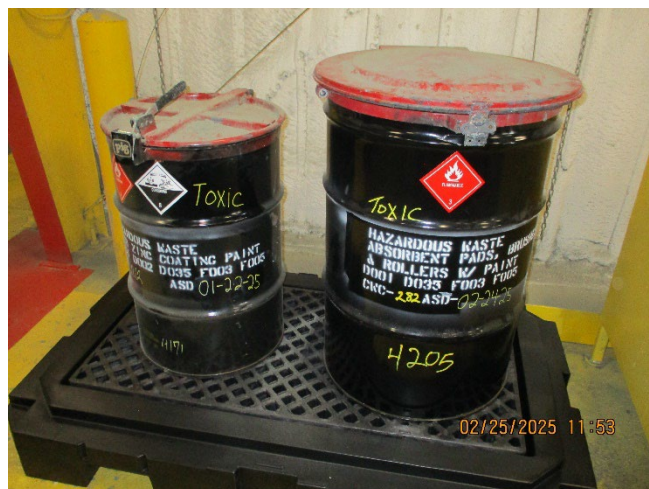
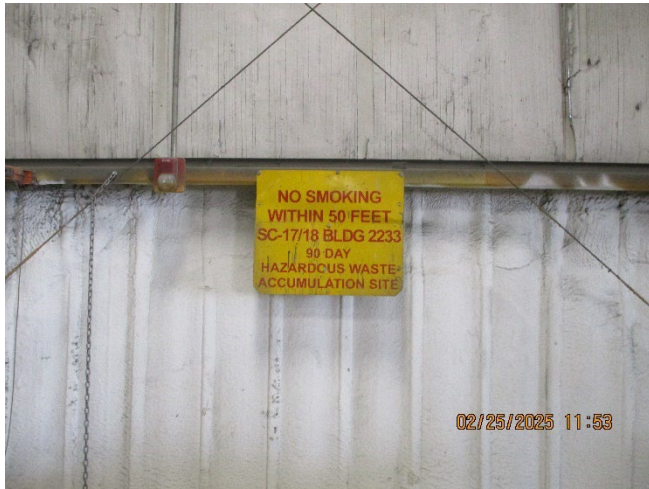
In SC-17, inspectors observed two (2) 55-gallon steel containers placed on a secondary containment pallet. In SC-18, inspectors observed one (1) 30-gallon and one (1) 55-gallon containers placed on a secondary containment device. Neither CAAs was equipped with spill control equipment (Photographs 41-45). MCLB emailed photo documentation of corrections on February 28, 2025.

**Pursuant to Ga. Comp. R. and Regs. 391-3-11-.08(1) [40 C.F.R. § 262.17(a)(6)], which incorporates Ga. Comp. R. and Regs. 391-3-11-.08(1) [40 C.F.R. Part 262.252(c)], and is a condition of the LQG Permit Exemption, areas of an LQG where hazardous waste is generated or accumulated must have portable fire extinguishers, fire control equipment (including any required special extinguishing equipment), spill control equipment, and decontamination equipment.**

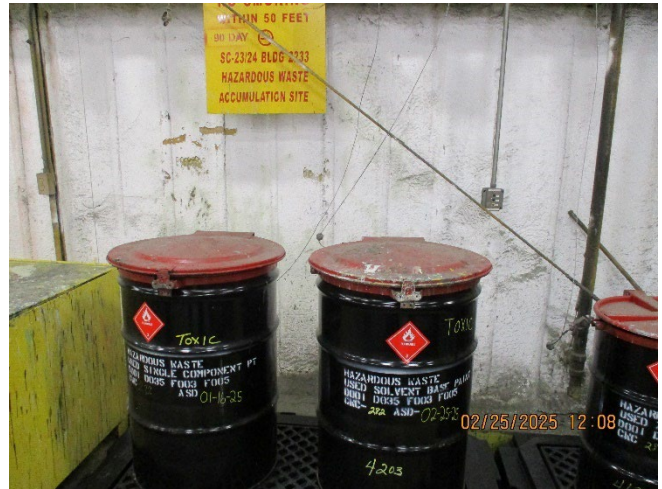
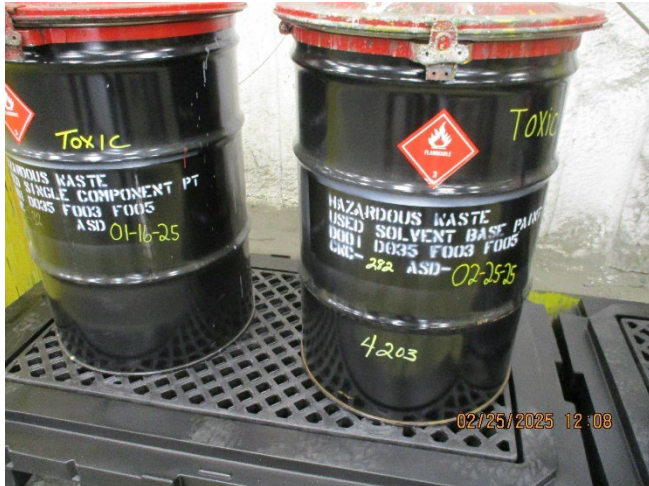
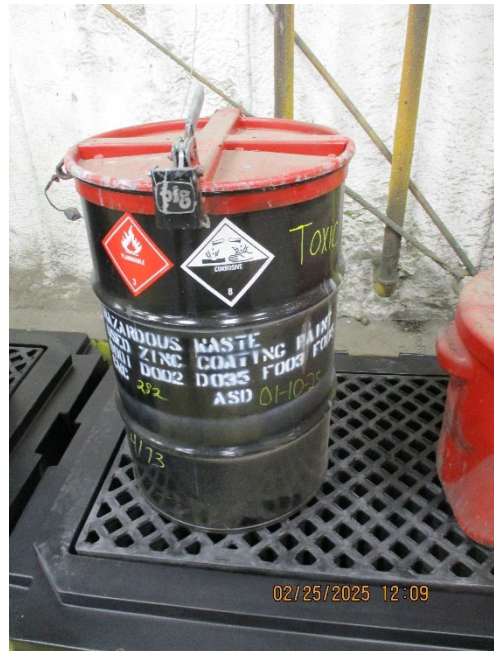
In SC-24, inspectors observed two (2) 55-gallon steel containers placed on a secondary containment pallet. In SC-23, inspectors observed one (1) 30-gallon container placed on a secondary containment device. These two CAA locations were not equipped with spill control equipment (Photographs 46-48). MCLB emailed photo documentation of corrections on February 28, 2025.

**Pursuant to Ga. Comp. R. and Regs. 391-3-11-.08(1) [40 C.F.R. § 262.17(a)(6)], which incorporates Ga. Comp. R. and Regs. 391-3-11-.08(1) [40 C.F.R. Part 262.252(c)], and is a condition of the LQG Permit Exemption, areas of an LQG where hazardous waste is generated or accumulated must have portable fire extinguishers, fire control equipment (including any required special extinguishing equipment), spill control equipment, and decontamination equipment.**

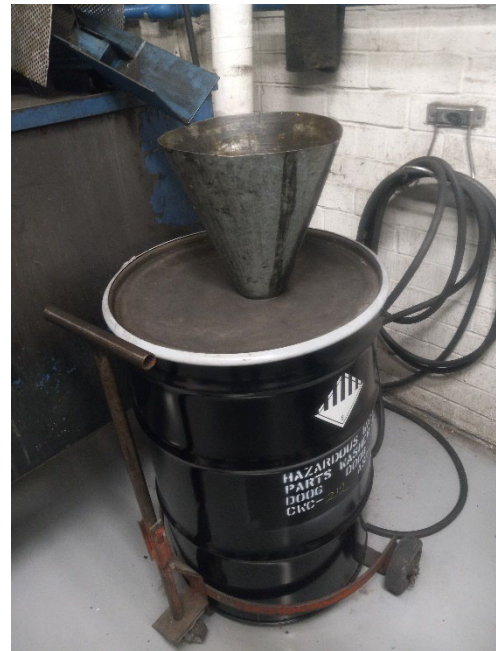
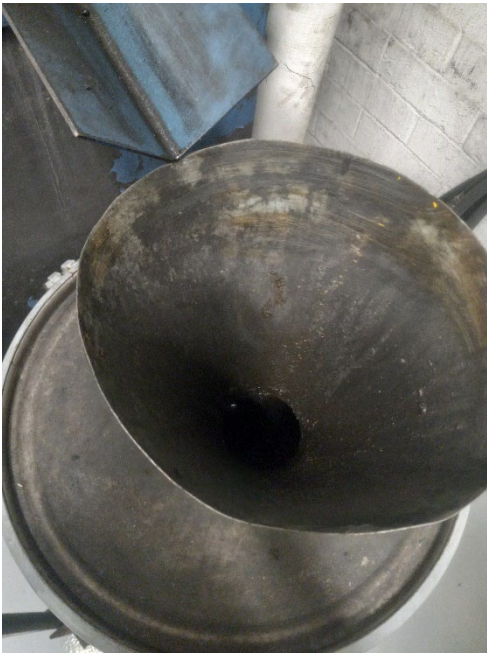
In this Cost Work Center, inspectors spoke with Emmett Williams III regarding the two large parts washer units. One of the parts washers uses “Big Red Solvent” and the other uses steam. Next to the steam washer, inspectors observed one (1) 55-gallon steel container with a lid which had a funnel welded to it. When asked about the container Emmett explained that the machine had a skimmer unit for removing the resultant waste material from the wash water. This resultant sludge then flows down a trough to the accumulation container. The waste was labeled as D006 and D008, with the words “Hazardous Waste,” and with an indication of the hazard “Toxic.” Due to the design of the welded funnel lid, the container was open. Facility personnel were notified that containers in a SAA must be kept closed unless adding or removing waste (Photographs 56-57). MCLB emailed photo documentation of correction on February 28, 2025.

**Pursuant to Ga. Comp. R. and Regs. 391-3-11-.08(1) [40 C.F.R. § 262.15(a)(4)], which is a condition of the SAA Permit Exemption, a generator is required to keep containers of hazardous waste closed at all times during accumulation, except when adding, removing, or consolidating waste; or when temporary venting of a container is necessary for the proper operation of equipment, or to prevent dangerous situations, such as build-up of extreme pressure.**

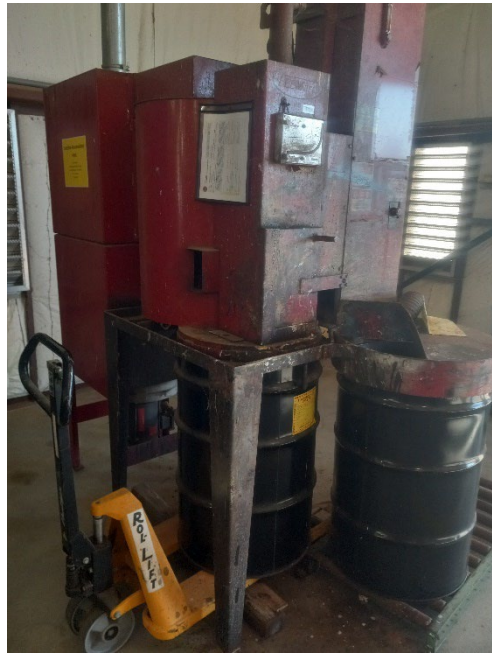
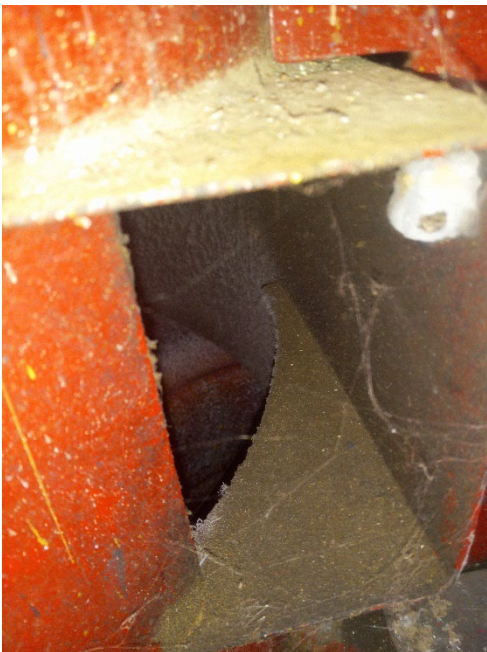
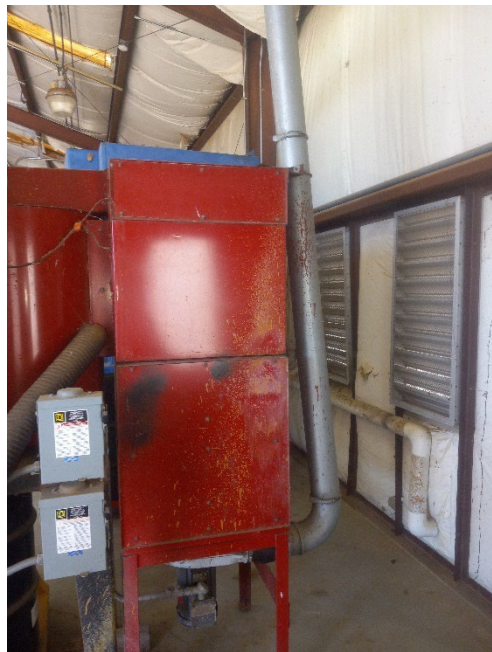
The Recycling Center operated one aerosol can crusher device. Inspectors noted that the aerosol can crusher device was designed with an opening to the environment at the back of the unit. This opening allowed inspectors to view the open container underneath the unit, constituting an open container. The inspectors also noted that the 55-gallon steel container acting as the waste container, which was labeled “Hazardous Waste,” was not labeled with an indication of the hazard (Photographs 58-60). MCLB emailed photo documentation of the hazard indication labeling on February 28, 2025. On April 30, 2025 Maria Jones provided photos of new aerosol can crushers and their schematics to illustrate that the new crushers were completely enclosed and routed all exhaust through filters.

**Pursuant to Ga. Comp. R. and Regs. 391-3-11-.08(1) [40 C.F.R. § 262.15(a)(4)], which is a condition of the SAA Permit Exemption, a generator is required to keep containers of hazardous waste closed at all times during accumulation, except when adding, removing, or consolidating waste; or when temporary venting of a container is necessary for the proper operation of equipment, or to prevent dangerous situations, such as build-up of extreme pressure.**

**Pursuant to Ga. Comp. R. and Regs. 391-3-11-.08(1) [40 C.F.R. § 262.15(a)(5)(ii)], which is a condition of the SAA Permit Exemption, a generator is required to mark or label its containers with an indication of the hazards of the contents.**

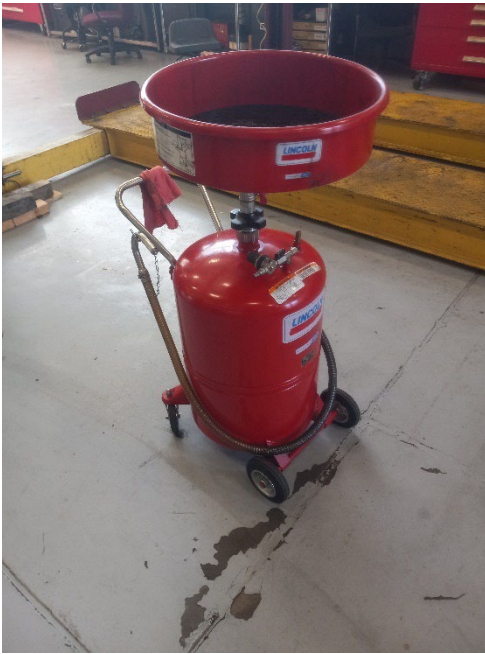
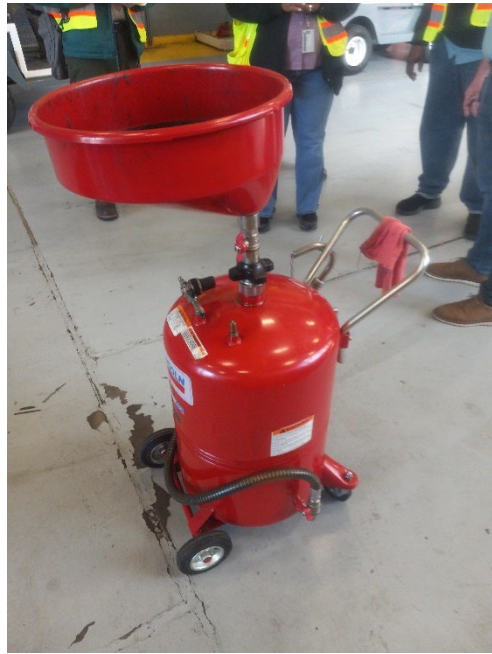
The building is divided into two large bays. In Bay 1 inspectors observed two (2) steel containers labeled “Used Oil” which were in good condition. In Bay 2 Inspectors observed three (3) 20-gallon steel rolling containers which are for collection of used oil. Additionally, inspectors observed four (4) roll-under “day pans” which are for collection of used oil. None of these containers were labeled as “Used Oil.” All were in good condition (Photographs 61-62). MCLB emailed photo documentation of correction on February 28, 2025.

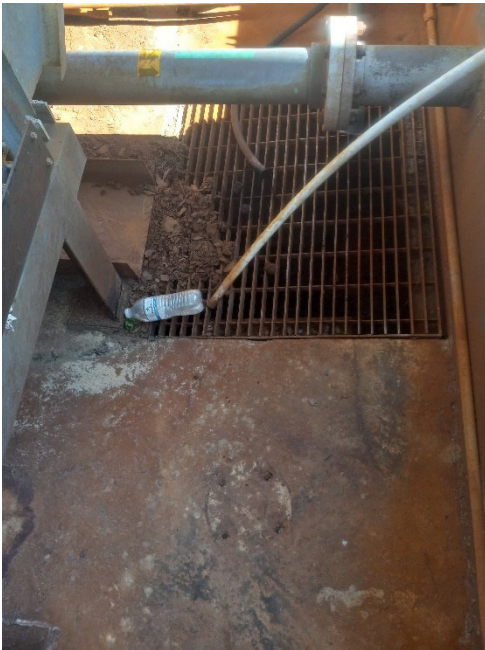
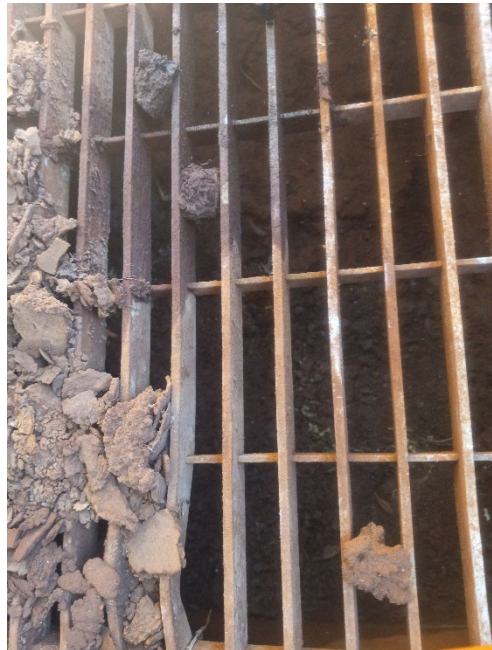
MCLB accumulates F019 hazardous waste solids from the filter press into a 40-foot roll-off container. Inspectors observed a trough below the filter press that collects liquids from the process. Inspectors observed that this trough accumulated some F019 hazardous waste solids which flow into a containment sump. At the grate of the sump there was dried F019 material,

***Pursuant to Ga. Comp. R. and Regs. 391-3-11-.08(1) [40 C.F.R. § 262.17(a)(6)], which incorporates Ga. Comp. R. and Regs. 391-3-11-.08(1) [40 C.F.R. § 262.251] and is a condition of the LQG Permit Exemption, a generator is required to maintain and operate its facility to minimize the possibility of a fire, explosion, or any unplanned sudden or non-sudden release of hazardous waste or hazardous waste constituents to air, soil, or surface water which could threaten human health or the environment.***
