**Region 6 - Enforcement & Compliance Assurance Division  
INSPECTION REPORT**

| <b>Type of Inspection</b> | RCRA Compliance Evaluation Inspection | | |
| <b>Company Name</b> | Brownsville Gulfside Warehouse, Inc. | | |

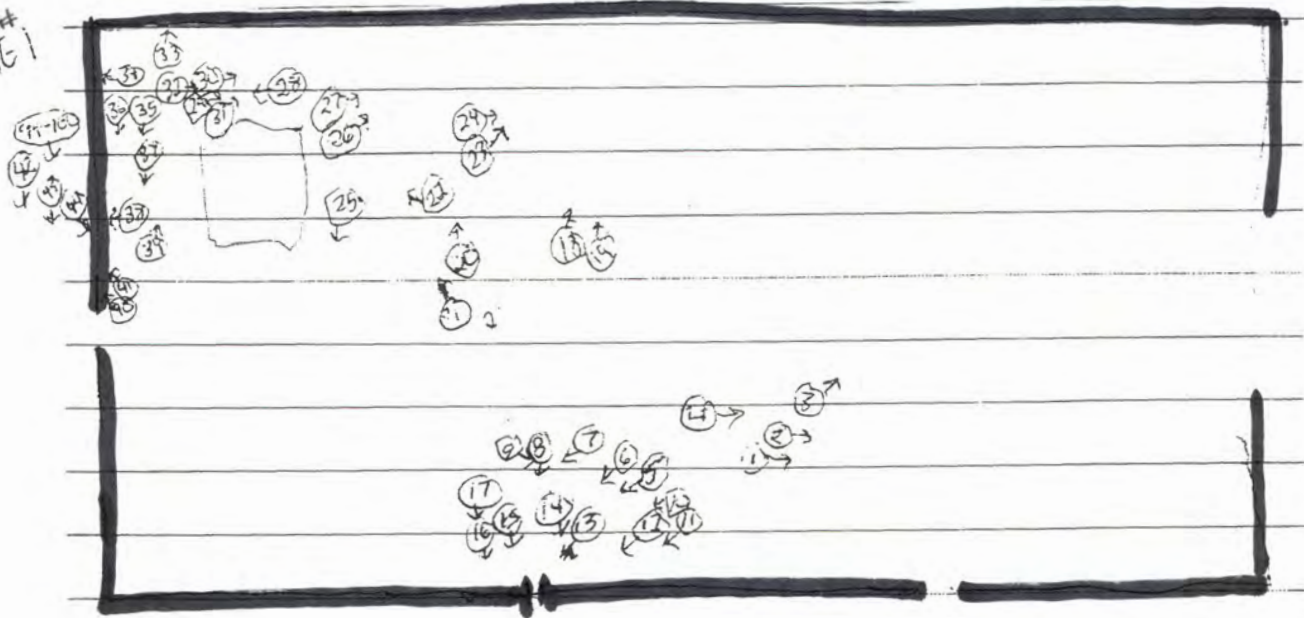
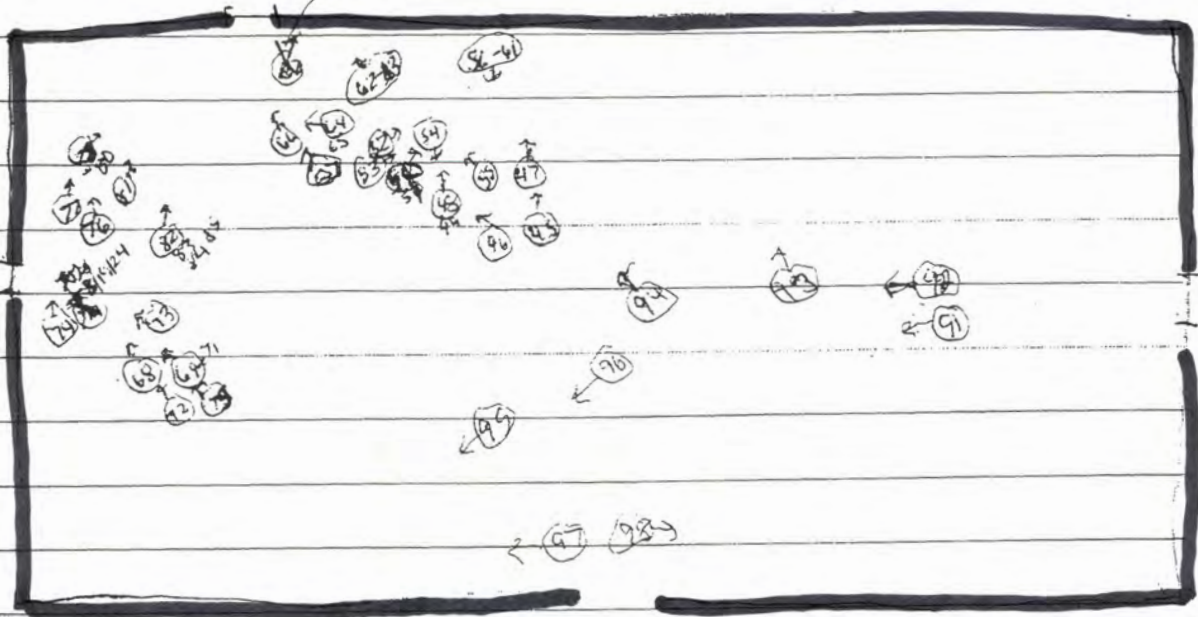
Brownsville Gulfside Warehouse, Port of Brownsville, TX -  
Warehouses #1 and #2

8/19-20/24 RCRA Inspection - Approximate locations and directions  
of photos taken.

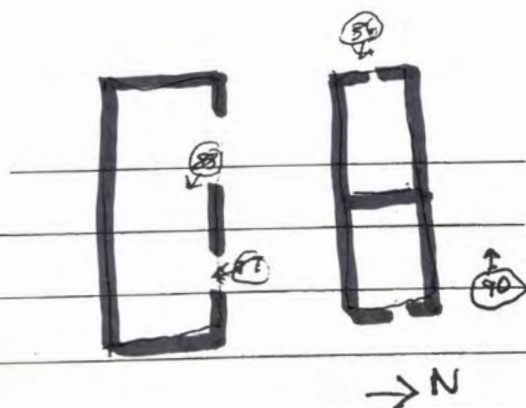
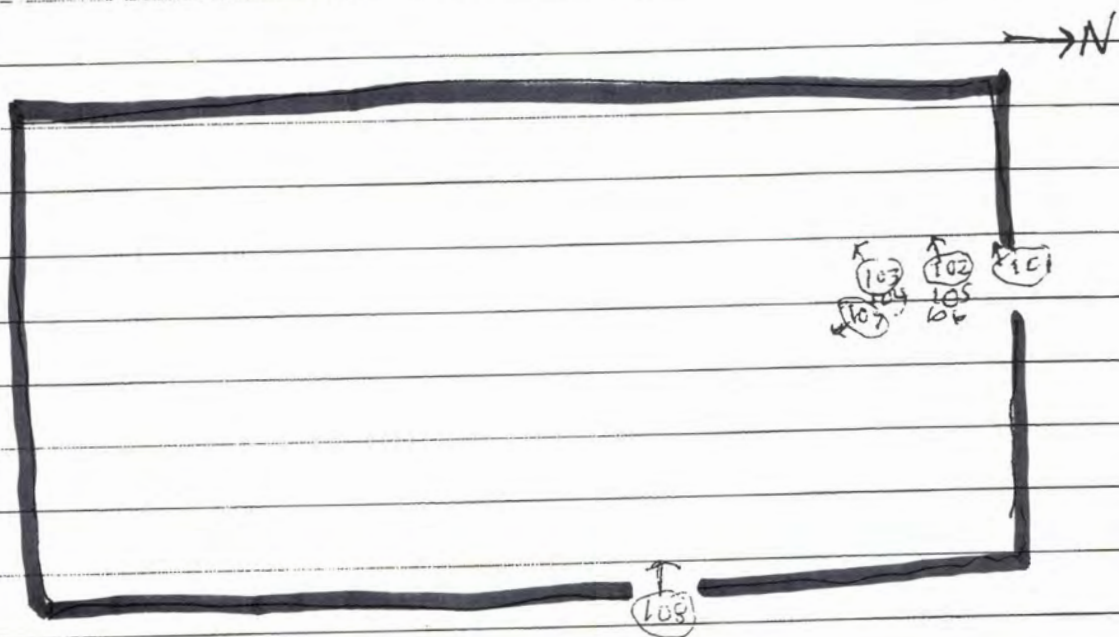
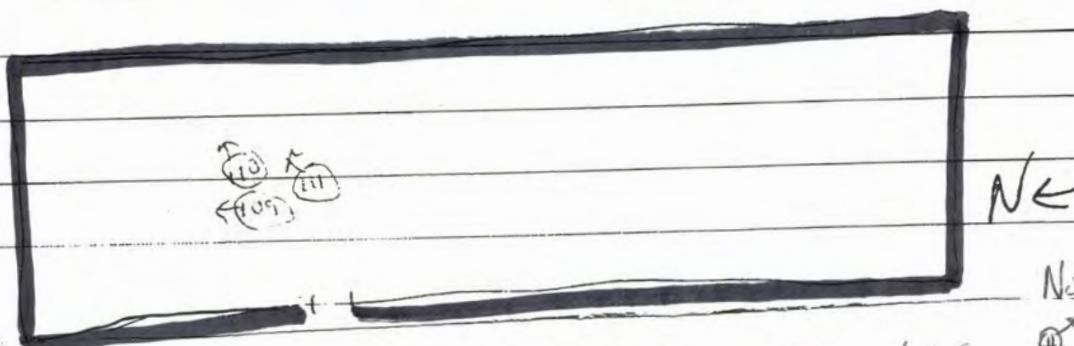
Brownsville Gulfside Warehouse, Port of Brownsville, TX - Warehouses #3 and #5,  
the Second Warehouse at 2000 N Mineral Loop Rd, and Third Warehouse located across  
from 16651 RL OStos.

8/19-20124 RCRA Inspection - Approximate locations and directions

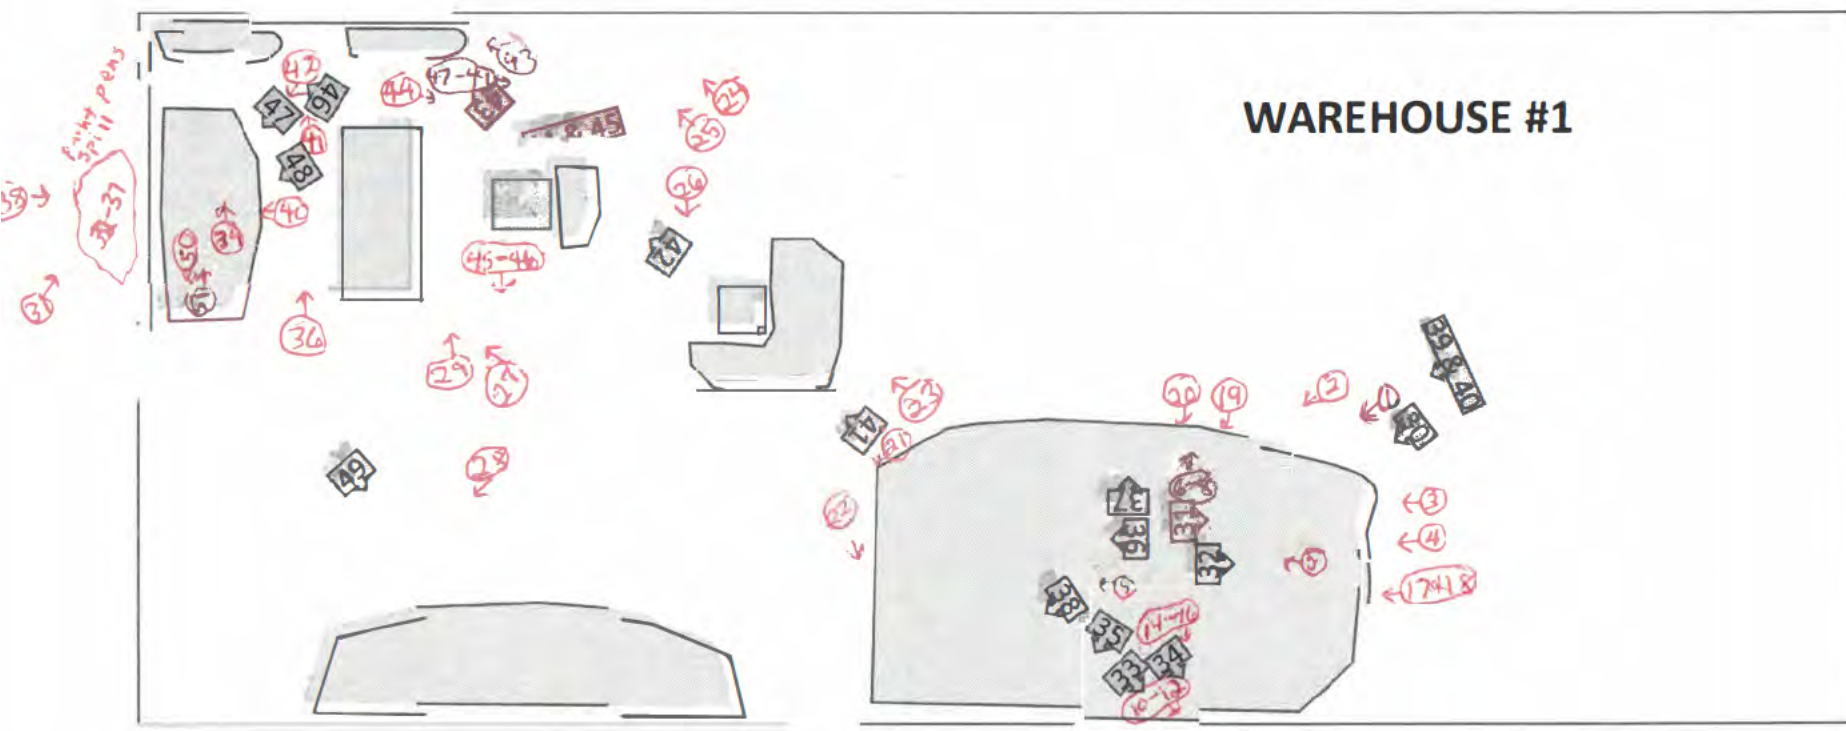
**Brownsville Gulfside Warehouse, Port of Brownsville, TX - Warehouse #1**  
 9/28/23 RCRA Inspection - Approximate locations and directions of photos taken.

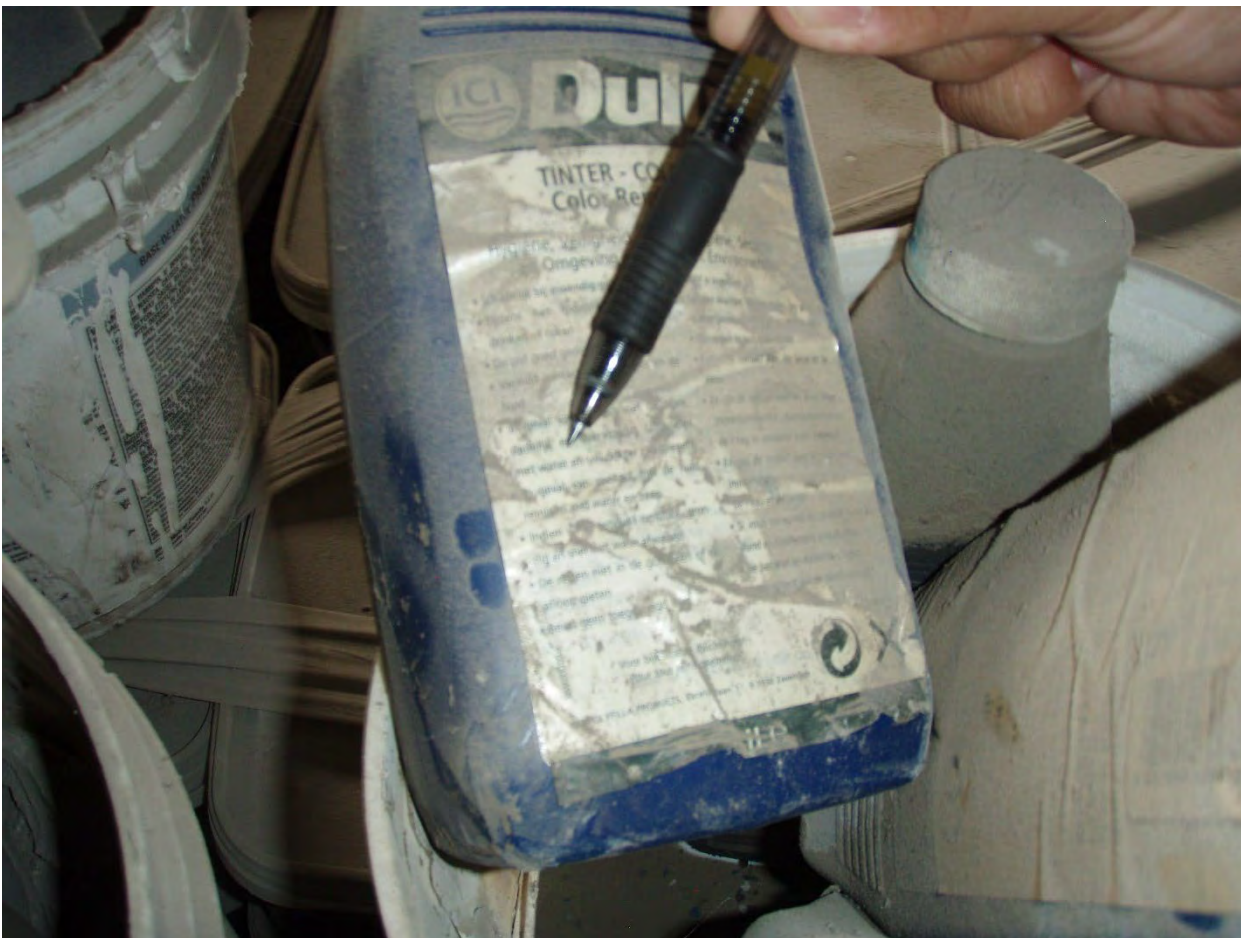
Photo File Name: P1010126

Description: Warehouse #1 – Close-up of a label on an approximately 1-quart jug labeled Dulux Tinter-Colorant Color Rendez Vous shown in Photo 6. The label was in a foreign language, but the word “water” was noted as the pen points out.

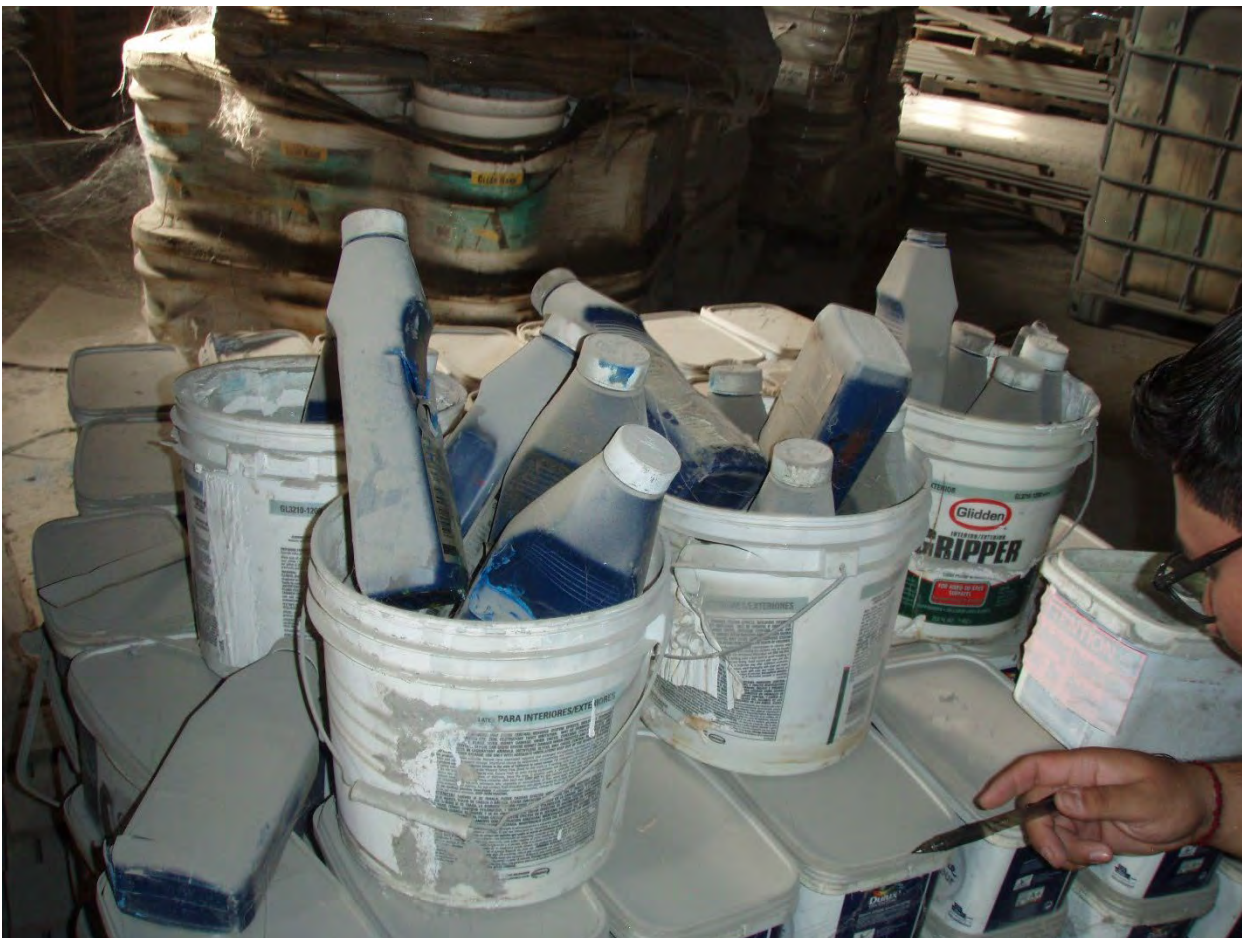
Photo File Name: P1010127

Description: Warehouse #1 - 4 pails containing approximately 13, 1-quart jugs labeled Dulux Tinter-Colorant. The label was in a foreign language, but the word "water" was noted on the label as shown in Photos 5 and 7.

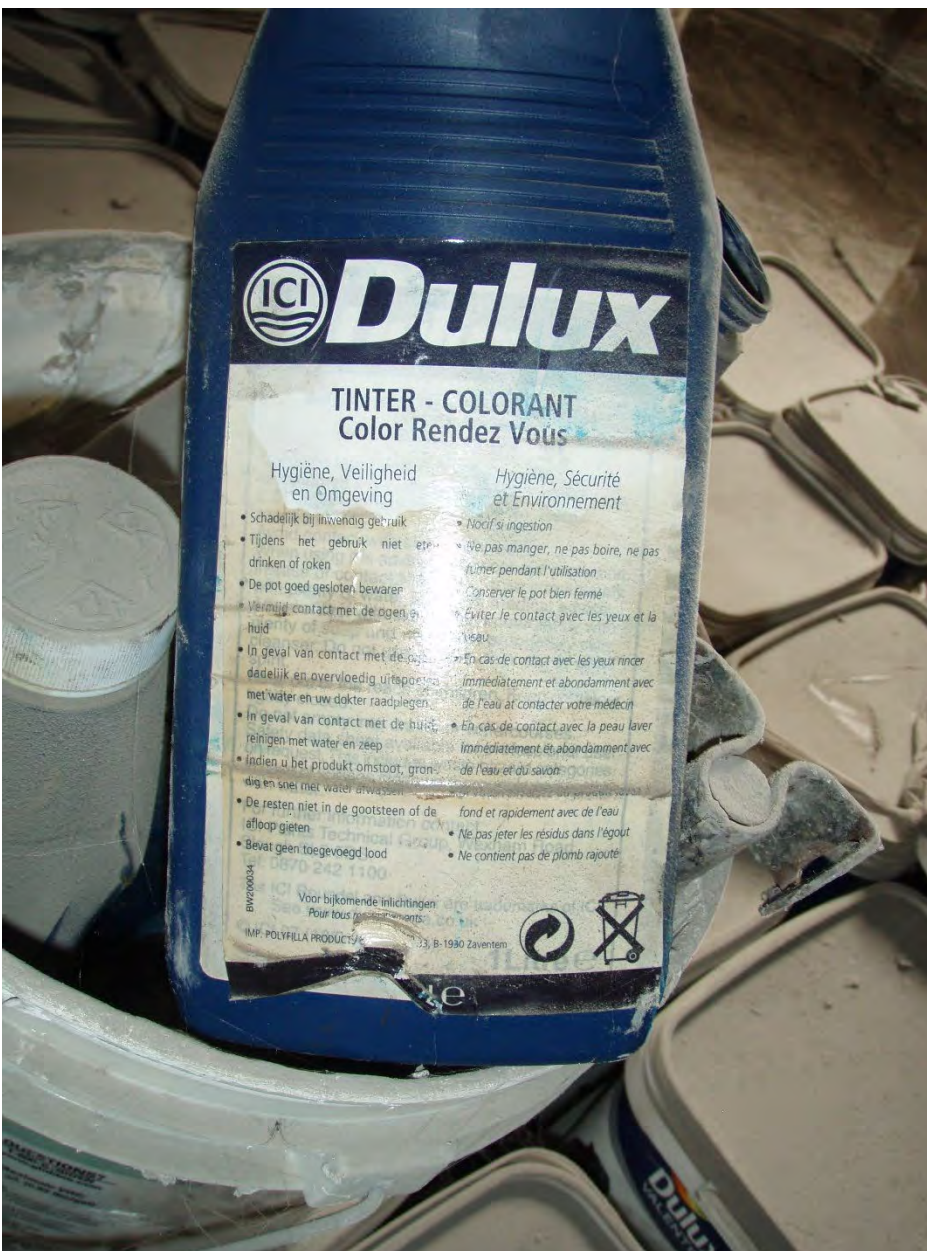
Photo File Name: P1010128

Description: Warehouse #1 – Close-up of a label on an approximately 1-quart jug labeled Dulux Tinter-Colorant Color Rendez Vous shown in Photo 6. The label was in a foreign language, but the word “water” was noted.

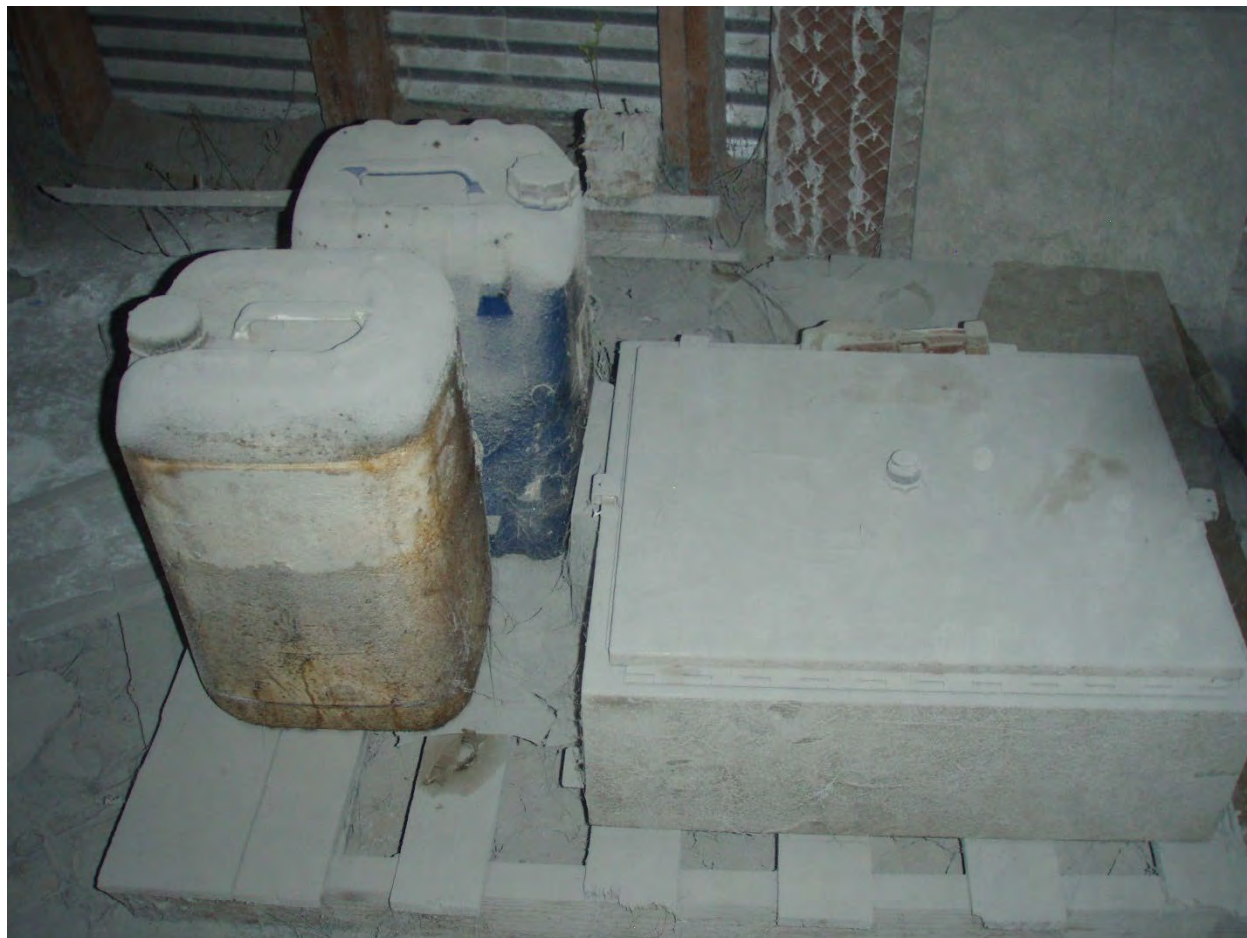
Description: Two unknown unlabeled 5-gallon plastic jugs that had a solvent type odor according to Mr. Yanez during the previous inspection. He stated that they came over with the electrical box located next to them.

- i. Also, I observed the same two full unlabeled approximately 5-gallon plastic jugs that had a solvent type of odor during the December 12, 2023, inspection (see Appendix 1, Photo 38). Mr. Yanez stated that they came over with the electrical box stored next to them and he did not know what they were. *[AOC #1a-BGW: Failure to make a hazardous waste determination on the two unknown 5-gallon plastic jugs – 40 CFR 262.11.]* However, after the inspection in a September 6, 2024, email, Ms. Vazquez stated that these containers belonged to Mr. Elizondo, and Mr. Elizondo had removed them (see (4) below for management of materials Mr. Elizondo removed).

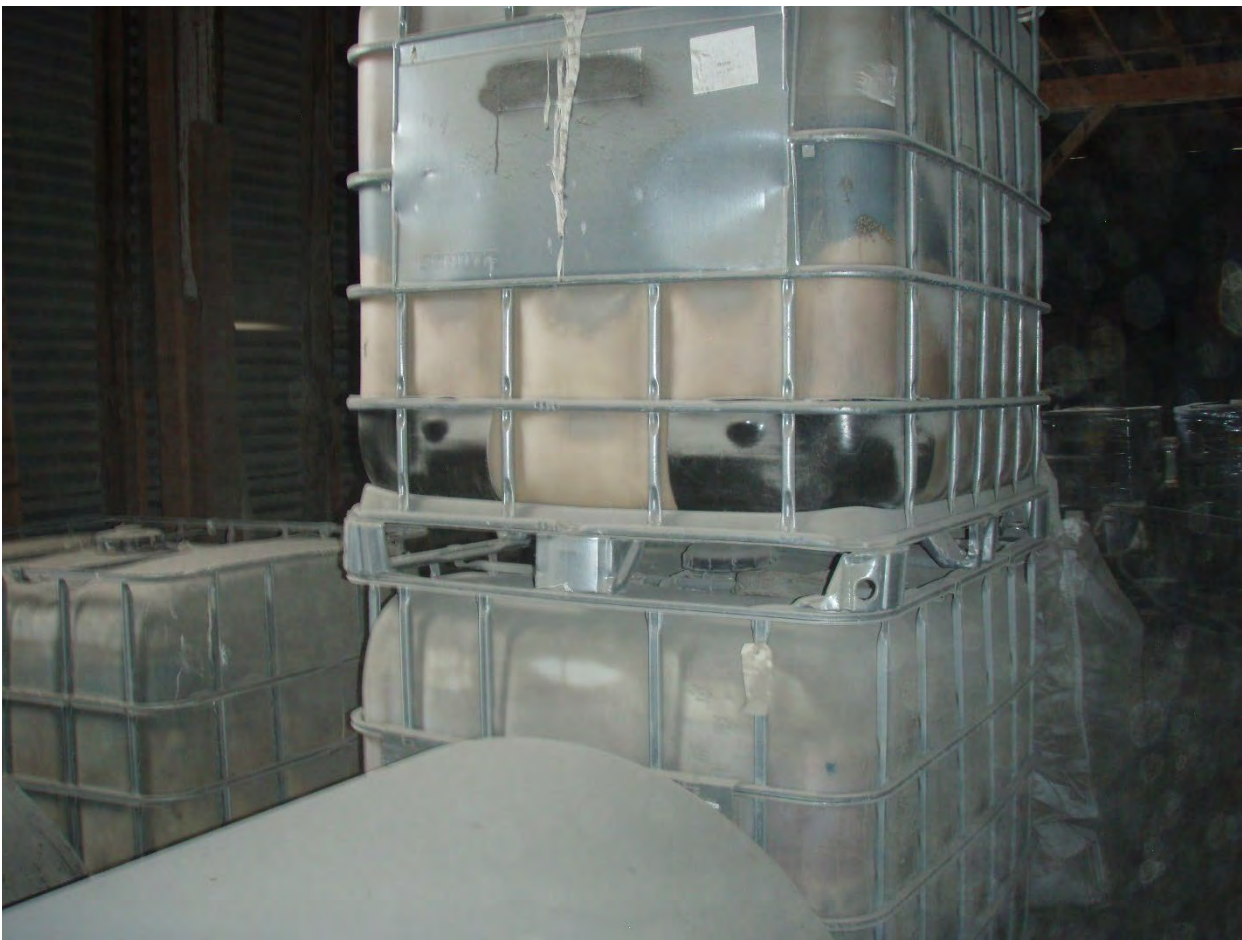
Photo No. 39

Description: Warehouse #1 – 3 totes, 2 no visible labels and one with label as shown in the photo.
