**Report Title:** Clean Water Act Compliance Inspection Report  
**Inspection Date(s):** August 7, 2023  
**Regulatory Program(s):** National Pollutant Discharge Elimination System (NPDES)  
**Type of Activity:** CAFO Inspection  
**Facility Name:** Jarred Vanderplate Farm  
**Facility Address:** 2710 Shumaker Road, Manheim, PA 17545  
**Facility Latitude:** 40.198989  
**Facility Longitude:** -76.465104  
**County/Parish:** Lancaster County  
**Permit No:** PAG123820  
**NAICS Code:** 112310  
**SIC:** 0252  
**Unique Project #:** 3E23WN108A

## PENNSYLVANIA CAFO INSPECTION REPORT

| <b>NPDES Permit No.</b> PAG123820<br><b>Facility Name:</b> Jarred Vanderplate Farm<br><b>Facility Owner:</b> Jarred Vanderplate<br><b>Facility Operator:</b> Jarred Vanderplate<br><b>Mailing Address:</b><br>2590 Shumaker Road, Manheim, PA 17545<br><b>Physical Address:</b><br>2710 Shumaker Road, Manheim, PA 17545<br><b>County:</b> Lancaster<br><b>Location (lat/long)</b><br><b>North:</b> 40.198989<br><b>West:</b> -76.465104<br><b>Contact Person:</b> Jarred Vanderplate<br><b>Phone:</b><br><b>office:</b> N/A <b>fax:</b> N/A <b>cell:</b> 717-989-8896<br><b>E-mail:</b> jandsvanderplate@yahoo.com | <b>NPDES P

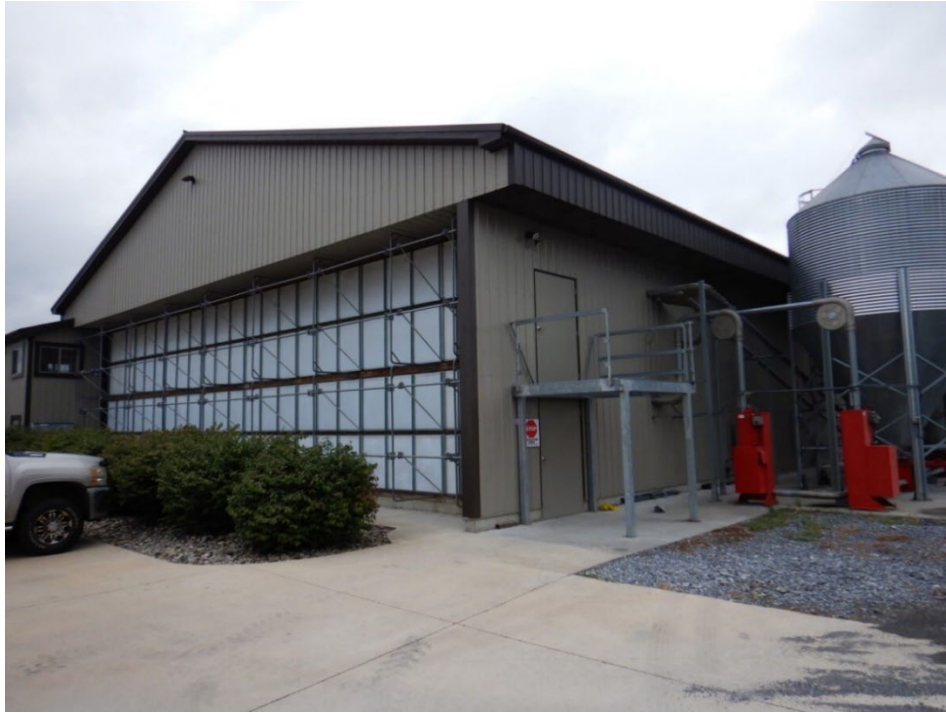
Photograph 1. View looking at the southwest corner of the poultry barn. A feed bin is visible at the right side of the photograph.

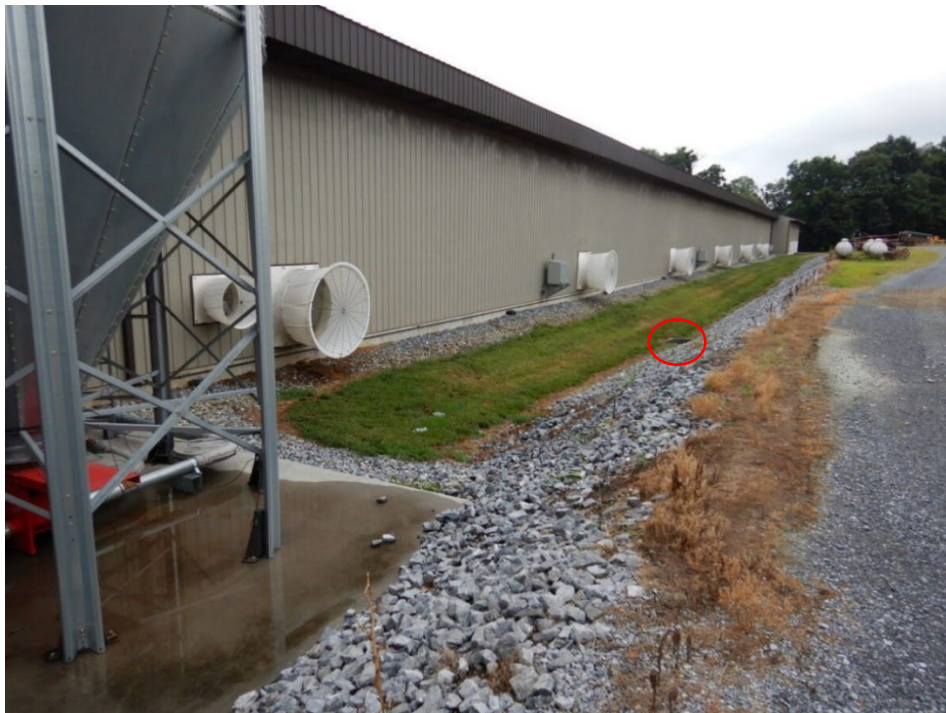
Photograph 2. View of the southern wall of the poultry barn (taken from the southwest corner of the building). The circle indicates the location of a storm drain that directs runoff to the poultry barn stormwater basin.

barn, which direct flow through pipes under the poultry barn that empty into the stormwater basin (Photographs 2, 3, 16, and 19).

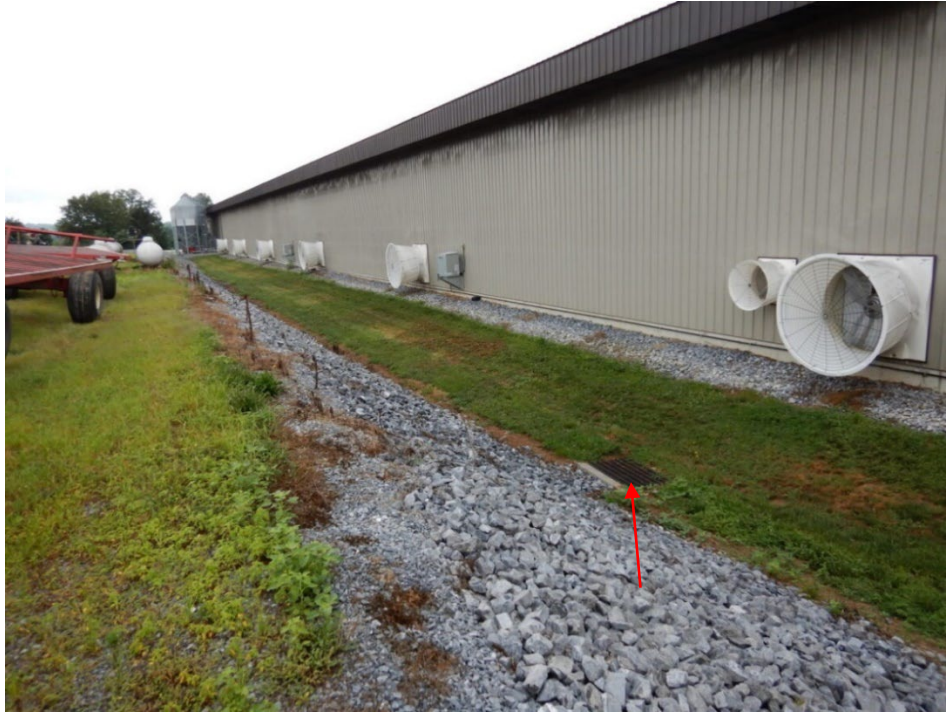
Photograph 3. Alternative view along the southern wall of the poultry barn (looking towards the feed bins shown in Photograph 2). The red arrow indicates the location of a second storm drain which directs runoff to the poultry barn stormwater basin.

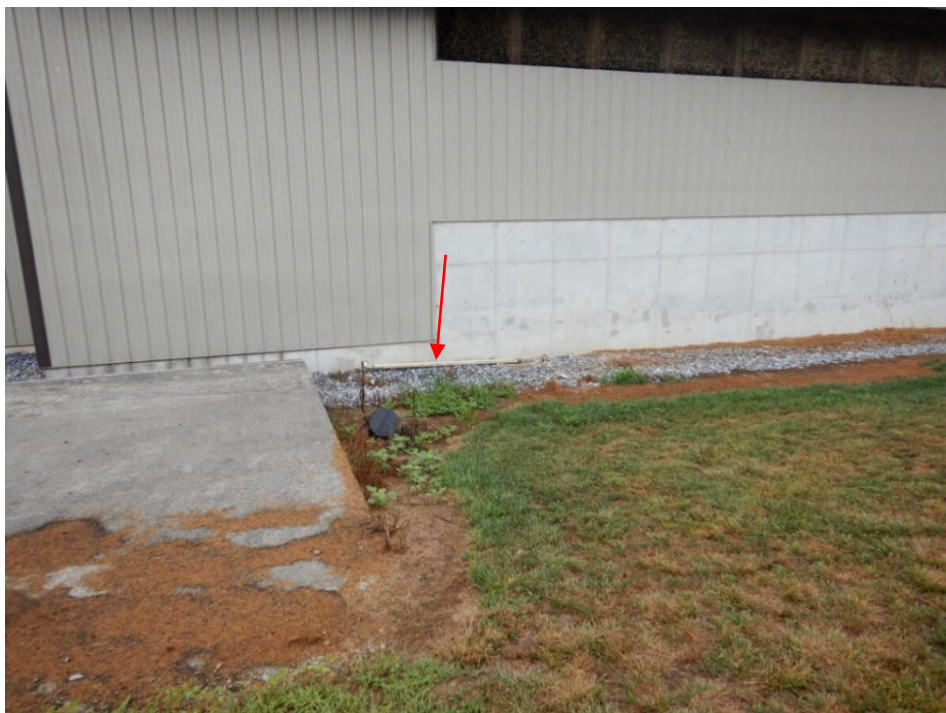
Photograph 4. The arrow indicates a PVC pipe located along the southern wall of the poultry barn. The PVC pipe conveys washdown water out of the building from the sump located beneath the concrete pad at the left side of the photo.

During the site tour, the inspection team noted a white PVC pipe on the southeast side of the poultry barn (Photographs 4 and 5). According to the operator, the facility had a fire approximately one month before the inspection. The barn was washed down after the fire. Most of the water remained in the house and evaporated. However, a small volume was pumped out of the barn through a sump located near the southeast corner of the barn, then through this PVC pipe. After discharging from the PVC pipe, the wastewater was directed into the stormwater basin via the swale (Photographs 10 – 13). The inspection team also observed a second white PVC pipe at the southeast corner of the manure storage building with a perforated end. The facility operator was unsure of the purpose of this pipe (Photographs 6 and 7).

During the site tour, the inspection team observed a white PVC pipe on the south side of the poultry barn (Photographs 4 and 5). According to the operator, the pipe was recently used to convey washwater from the adjacent sump to the swale and stormwater basin near the poultry barn. The facility had a fire approximately one month before the inspection and performed a washdown of the poultry barn after the fire. Most of the water remained in the house and evaporated. However, a small volume of washwater collected in the sump and was pumped out of the barn through this PVC pipe. According to the operator,

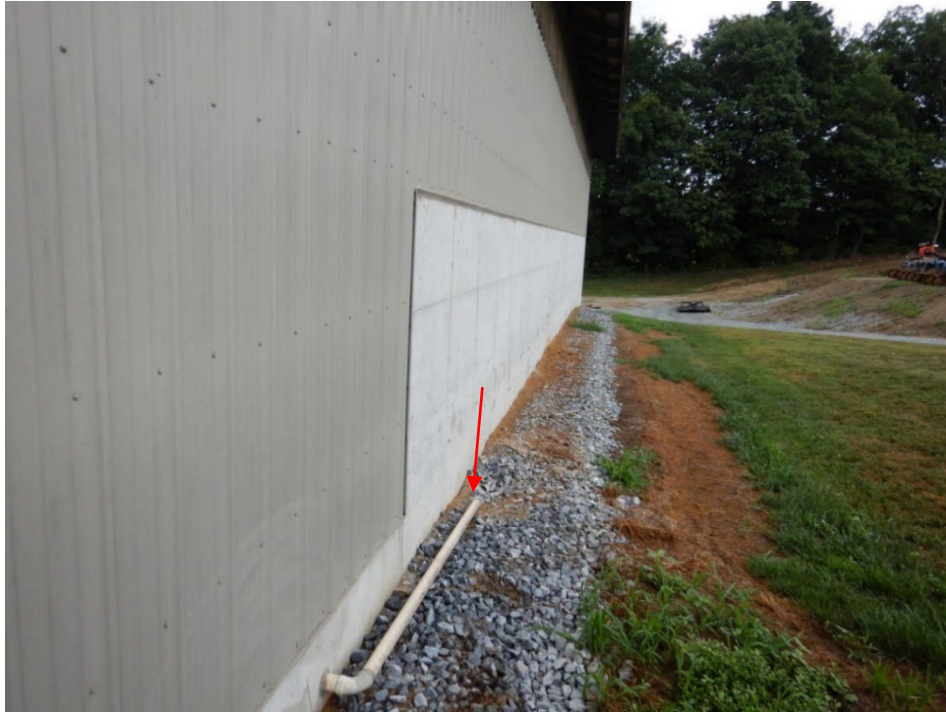
Photograph 5. Alternative view of the PVC pipe shown in Photograph 4 (downgradient view). The arrow indicates the outlet of the pipe where water would discharge into the gravel.

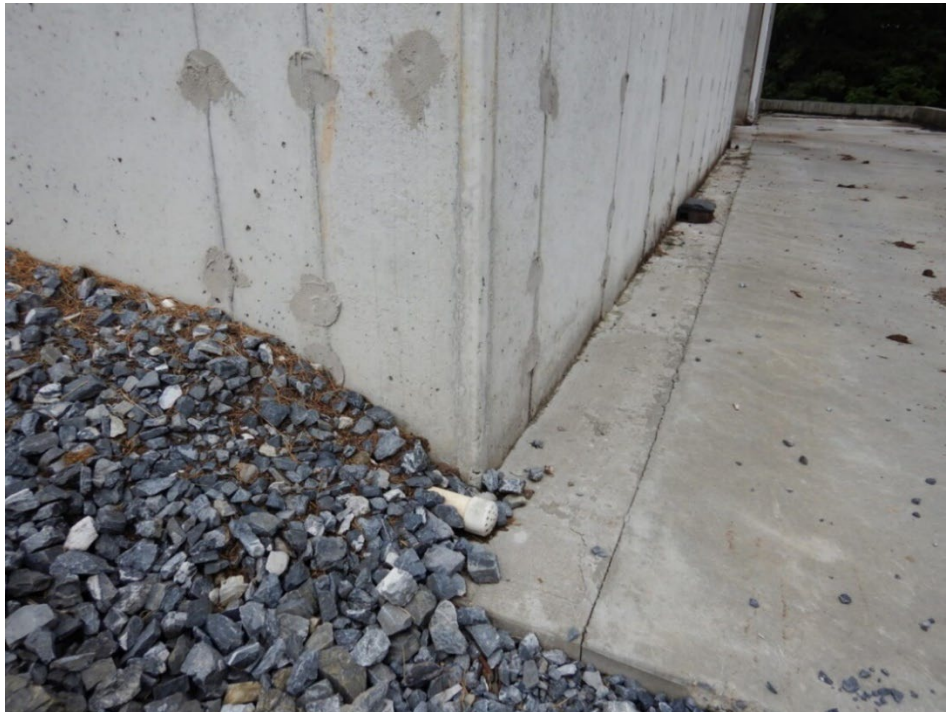
Photograph 6. View of a perforated PVC pipe with an unknown purpose located at the southeast corner of the manure storage building.

During the site tour, the facility operator could not identify the purpose of a white perforated pipe observed at the southeast corner of the manure shed (Photographs 6 and 7). It was not clear whether this pipe could discharge process-generated wastewater that might contribute to the runoff entering the poultry barn stormwater basin.

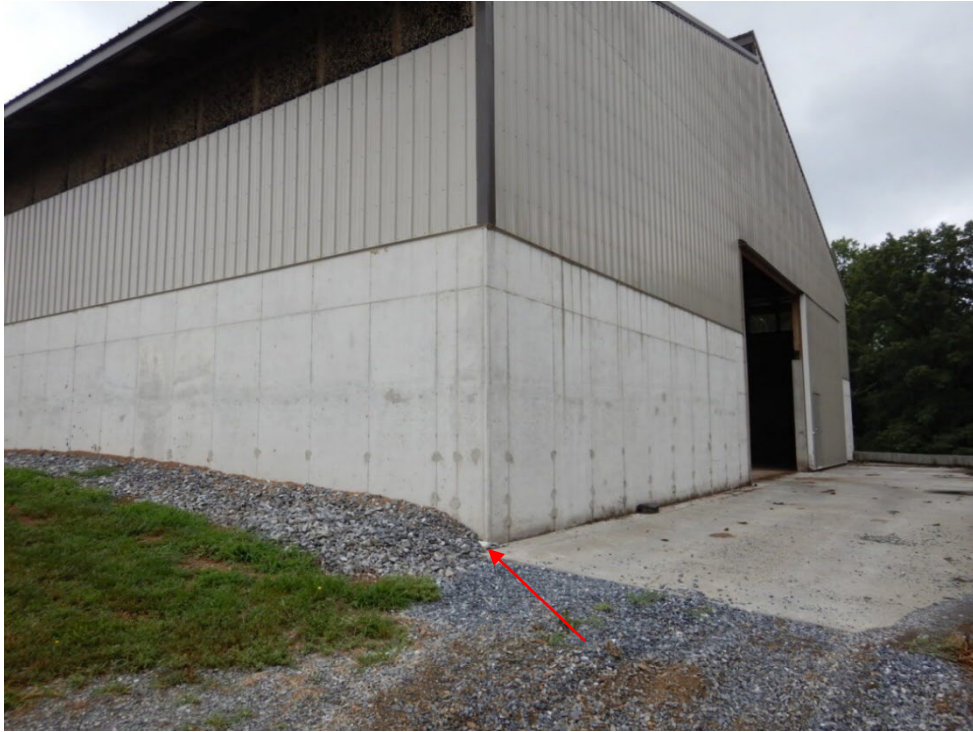
Photograph 7. Alternative view of the perforated drain with an unknown purpose (identified by the arrow) located at the southeast corner of the manure storage building.

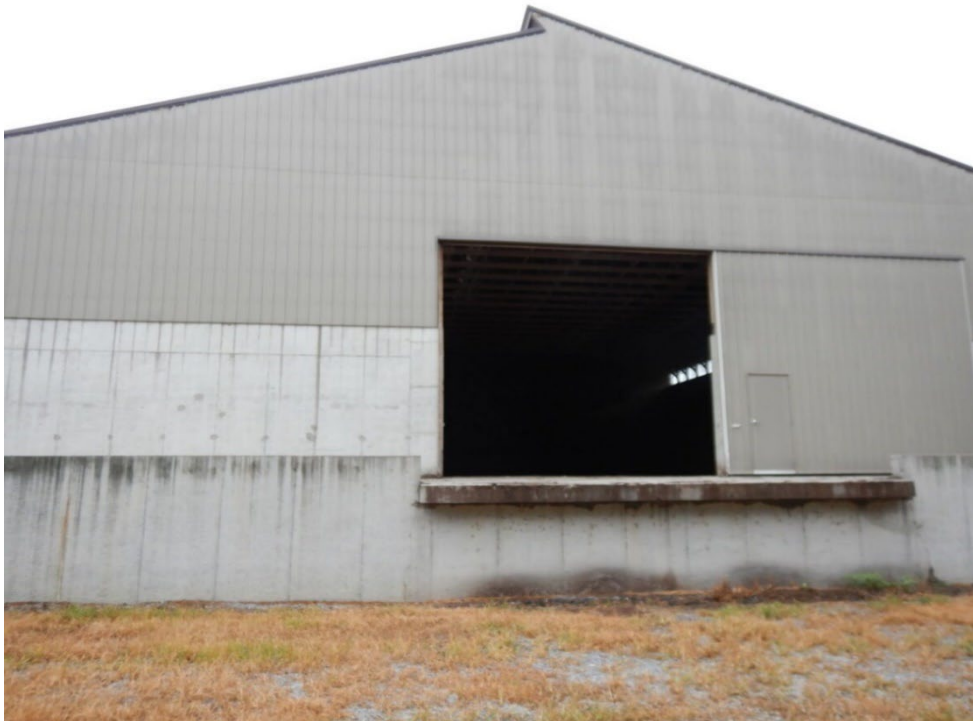
Photograph 8. View of the eastern side of the manure storage building and concrete pad.

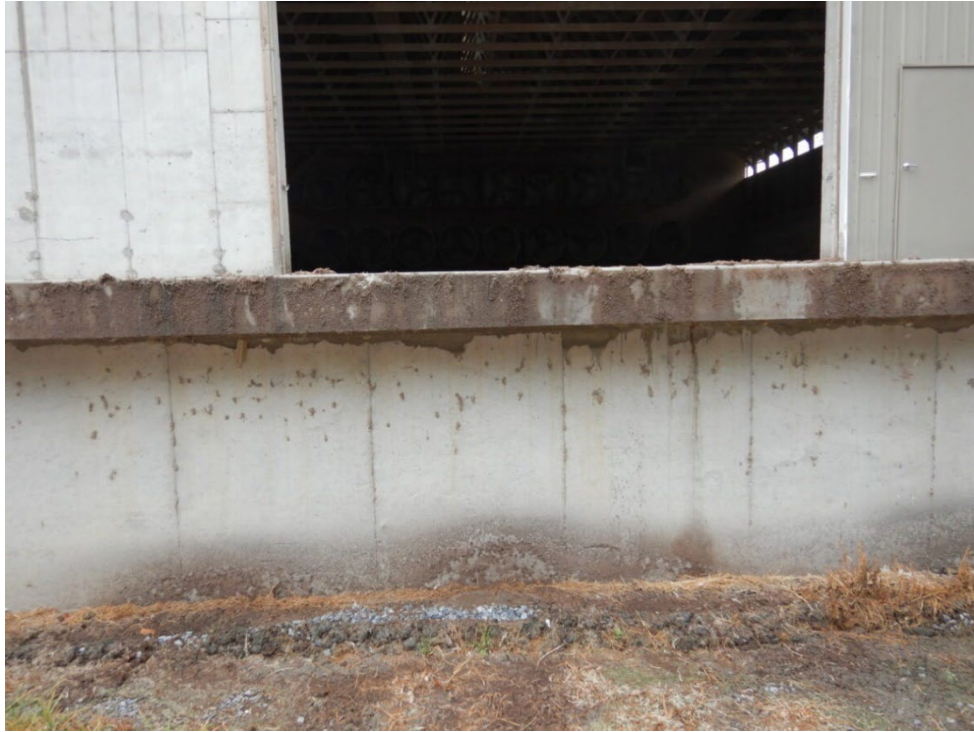
Photograph 9. Close-up view of the edge of the concrete pad on the eastern side of the manure storage building. Note the residual manure accumulated on the edge and the ground below.

- During the site tour, the inspection team observed manure on the edge of the concrete pad outside the manure storage shed (on the east end of the poultry house). Runoff from this area could potentially flow into the poultry barn stormwater basin. In addition, the inspection team observed manure on the cattle pen concrete pad. As described by the operator and observed onsite, runoff from the cattle pen could potentially flow into the cattle housing stormwater basin. The stormwater basins are not operated as manure storage facilities. See the *Inspection Overview and Facility Description* section and questions 2, 4a, 6, and 8 of the *Inspection Checklist* section.

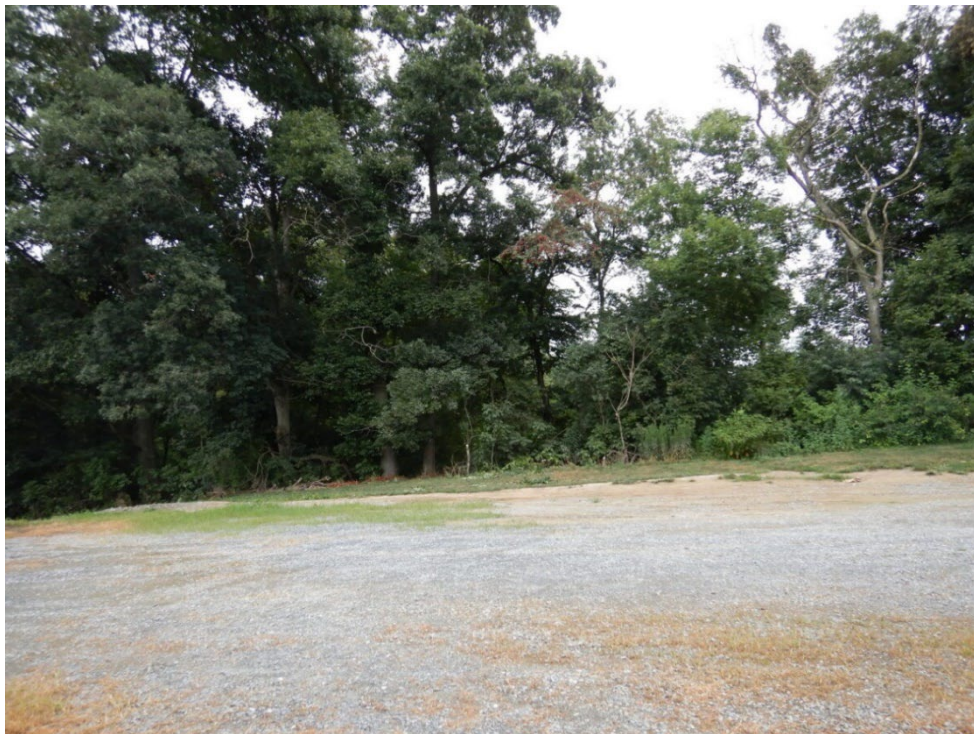
Photograph 10. Runoff from the manure storage building concrete pad and area east of the manure storage building would flow east toward the swale in front of the tree line. This photo was taken from approximately the same location as Photograph 9.

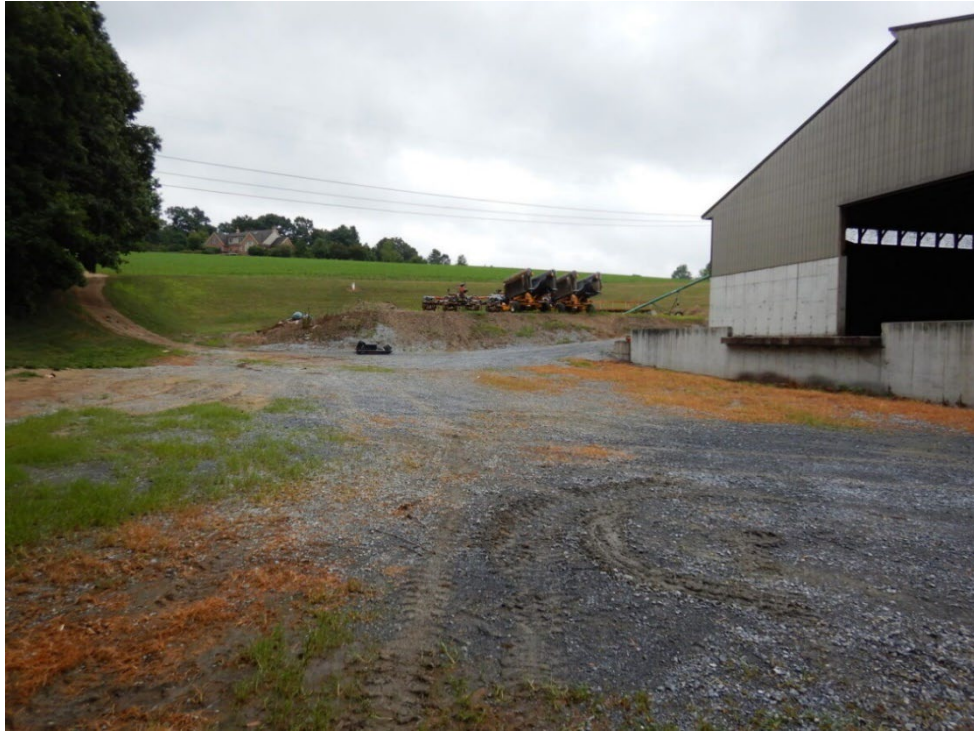
Photograph 11. View looking south at the area east of the manure storage building. Runoff from this area would flow into the swale located behind the photographer.

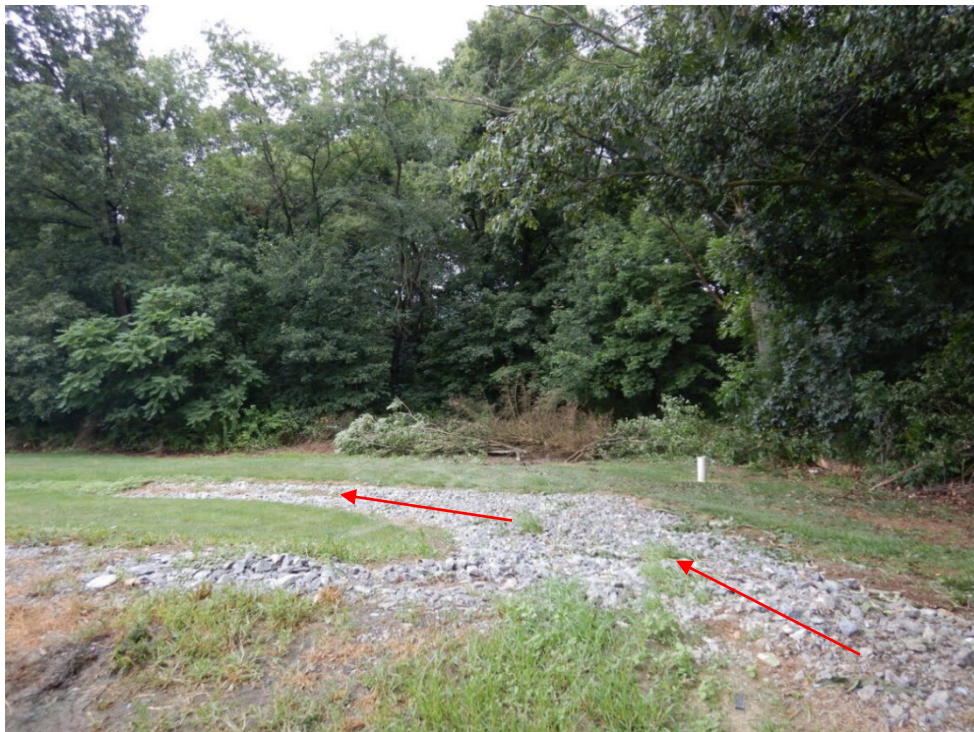
Photograph 12. Runoff from the areas shown in Photographs 10 and 11 would flow into the swale shown here (the arrows indicate the direction of flow). This photo faces north from approximately the same location as Photograph 11.

this washwater would flow east along the south side of the building and be directed into the poultry barn stormwater basin via the swale shown in Photographs 12 and 13.

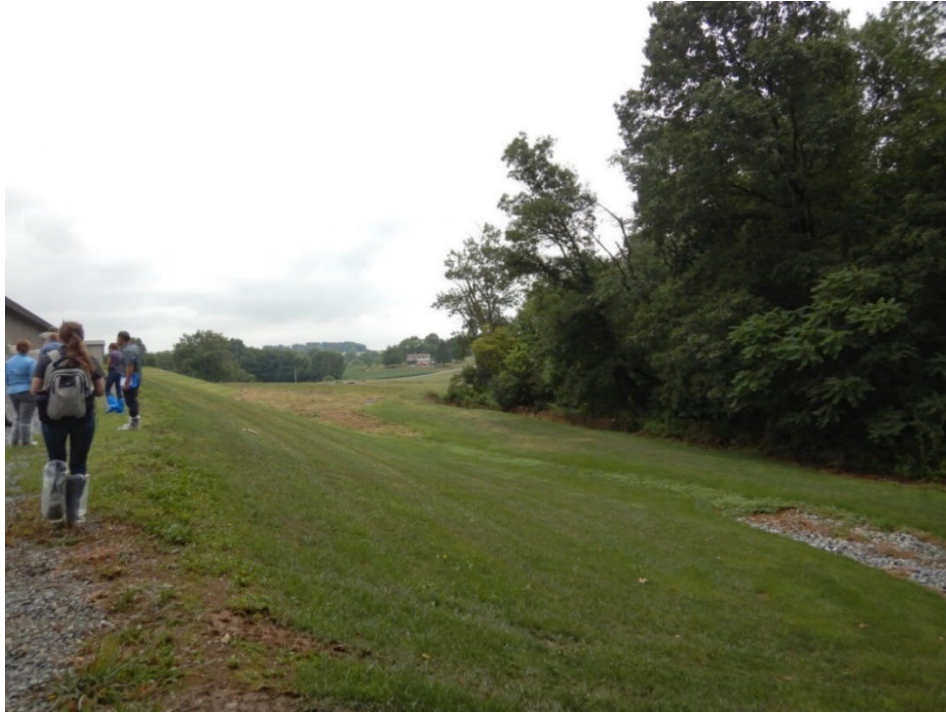
Photograph 13. View looking northwest at the stormwater basin located north of the poultry barn and manure storage building. Note the swale (shown in Photograph 12) at the right side of the photograph. This photograph was taken from approximately the same location as Photograph 12.

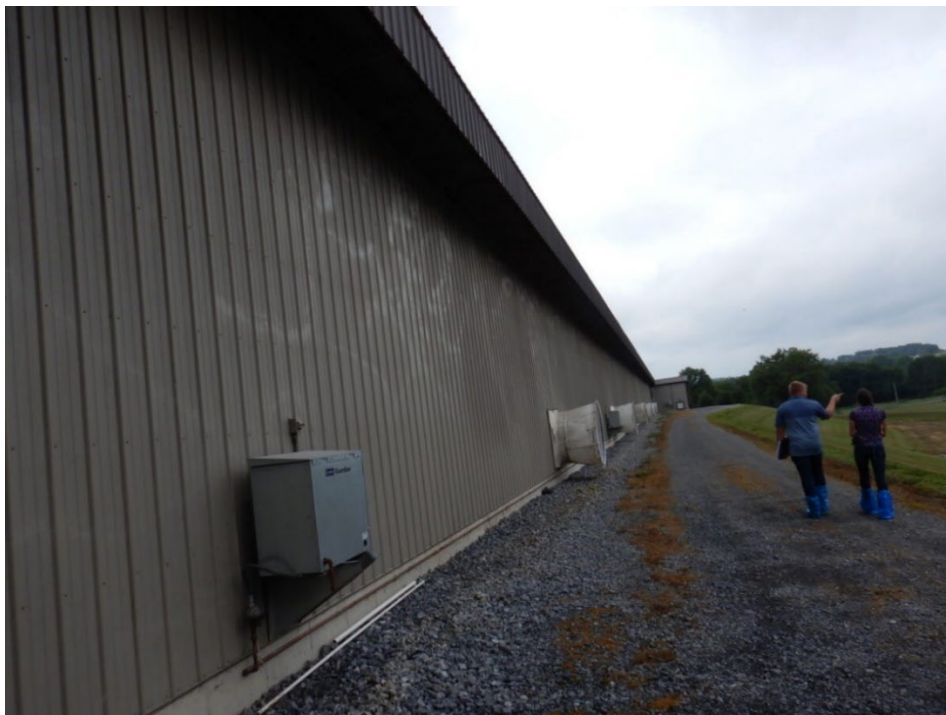
Photograph 14. View along the north side of the poultry barn (taken from the northeast corner of the building).

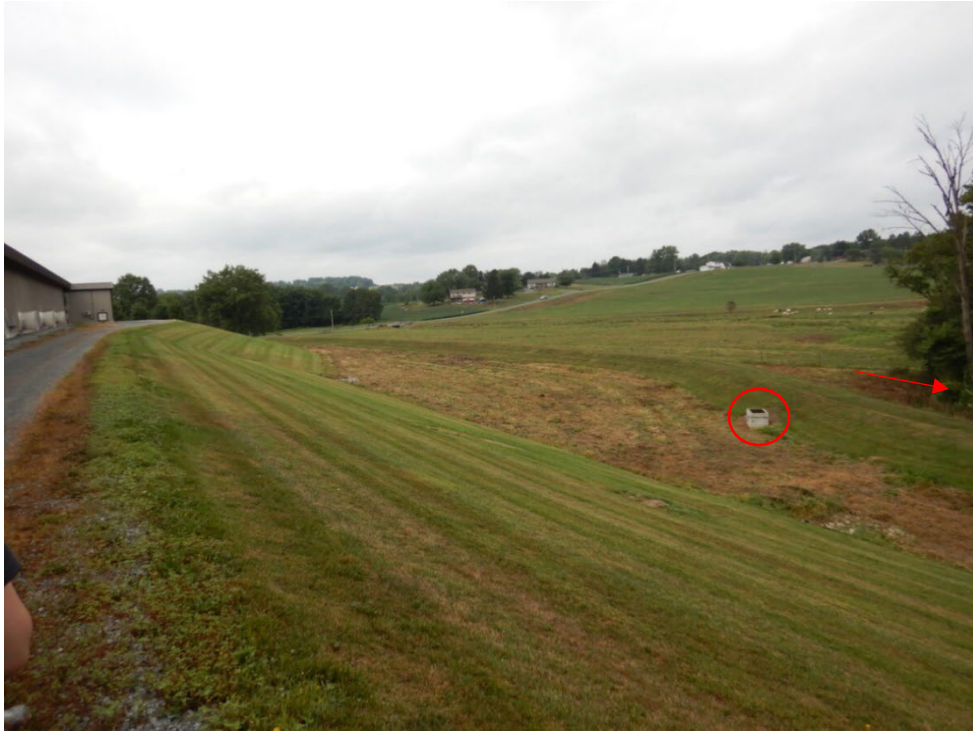
Photograph 15. View looking northwest over the poultry barn stormwater basin located north of the barn and manure storage building. The overflow drain is circled and the location of the unnamed tributary to Brubaker Run is identified by the arrow.

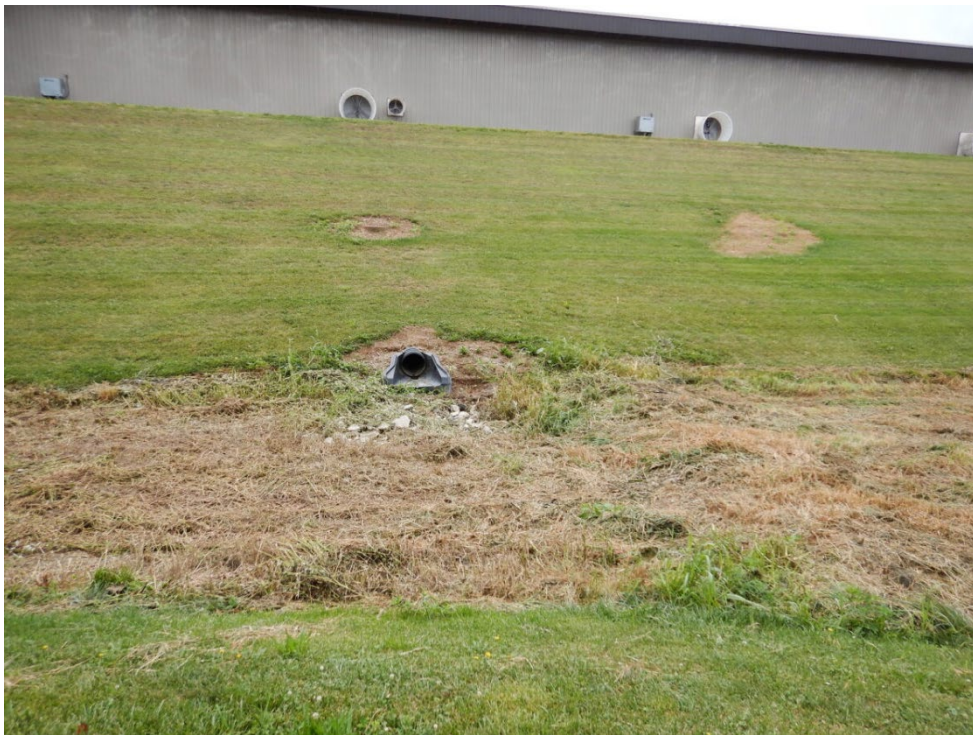
Photograph 16. View of the inlet to the poultry barn stormwater basin from the storm drain shown in Photograph 3.

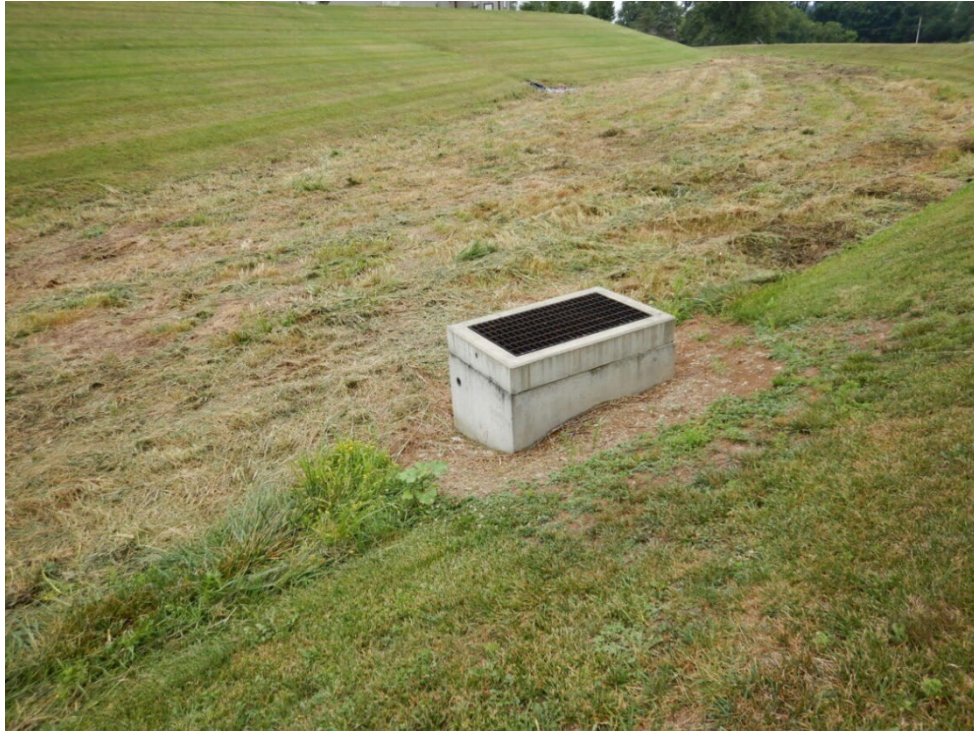
Photograph 17. Close-up view of the overflow structure located in the poultry barn stormwater basin, view looking west.

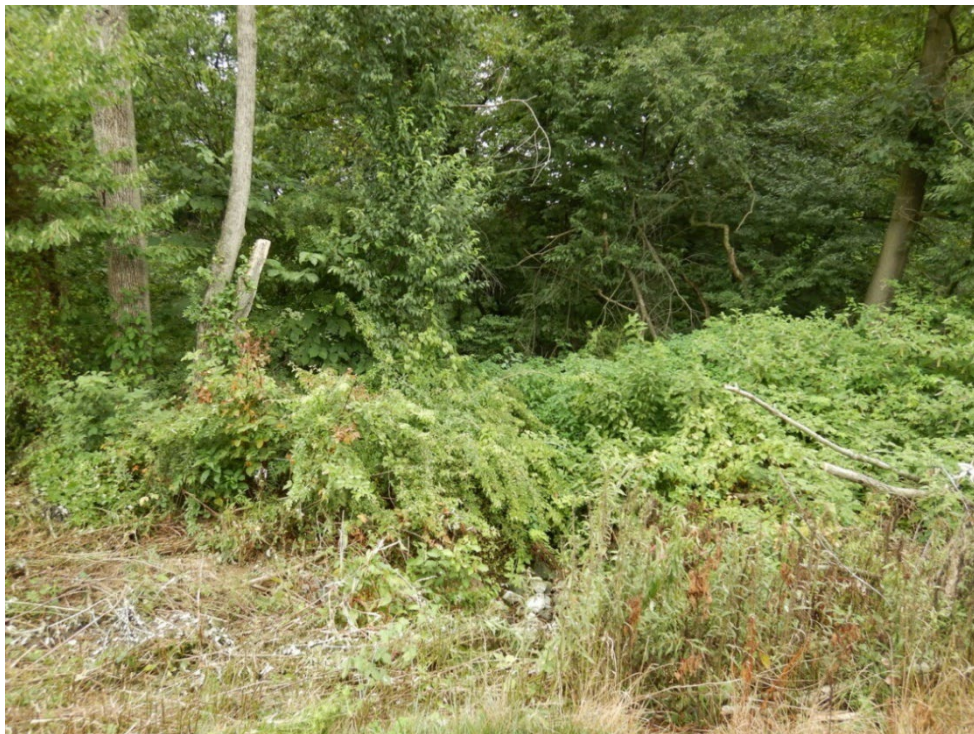
Photograph 18. View of the tree line around the unnamed tributary to Brubaker Run, which would receive discharges from the overflow drain shown in Photograph 17.

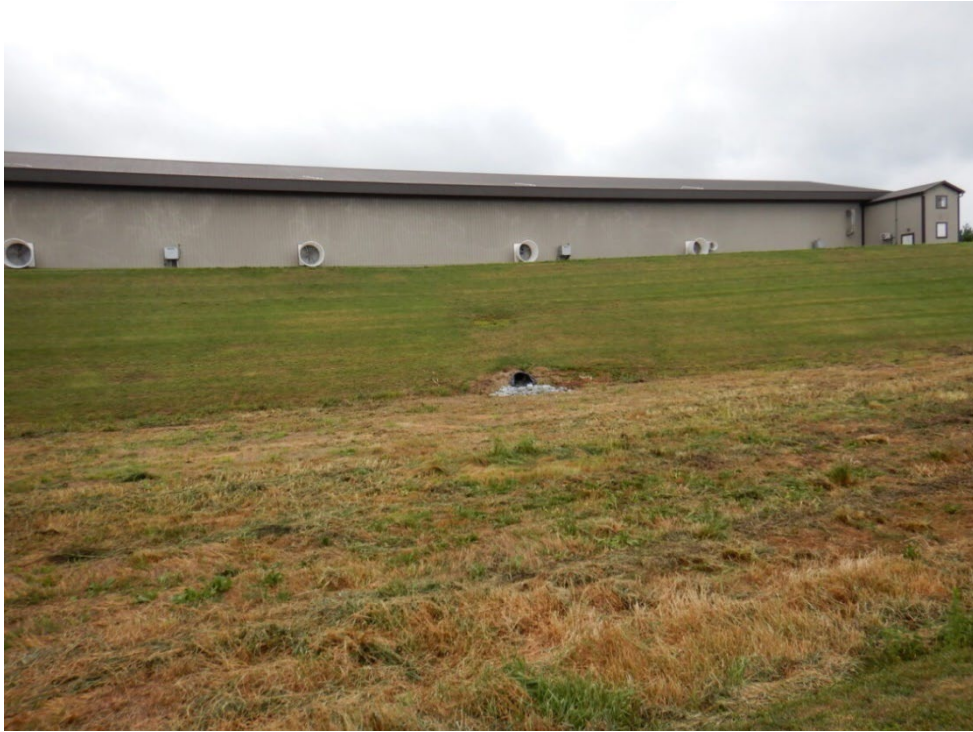
Photograph 19. View of the inlet to the poultry barn stormwater basin from the storm drain circled in Photograph 2.

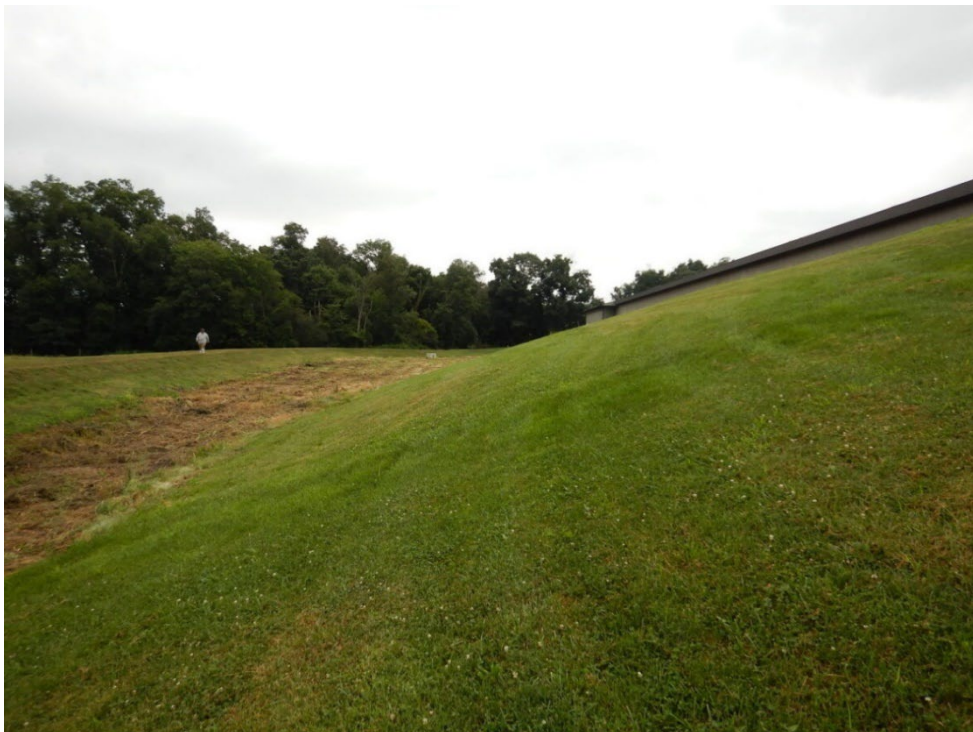
Photograph 20. Alternative view of the poultry barn stormwater basin, view looking east along the hill that forms the south side of the basin.

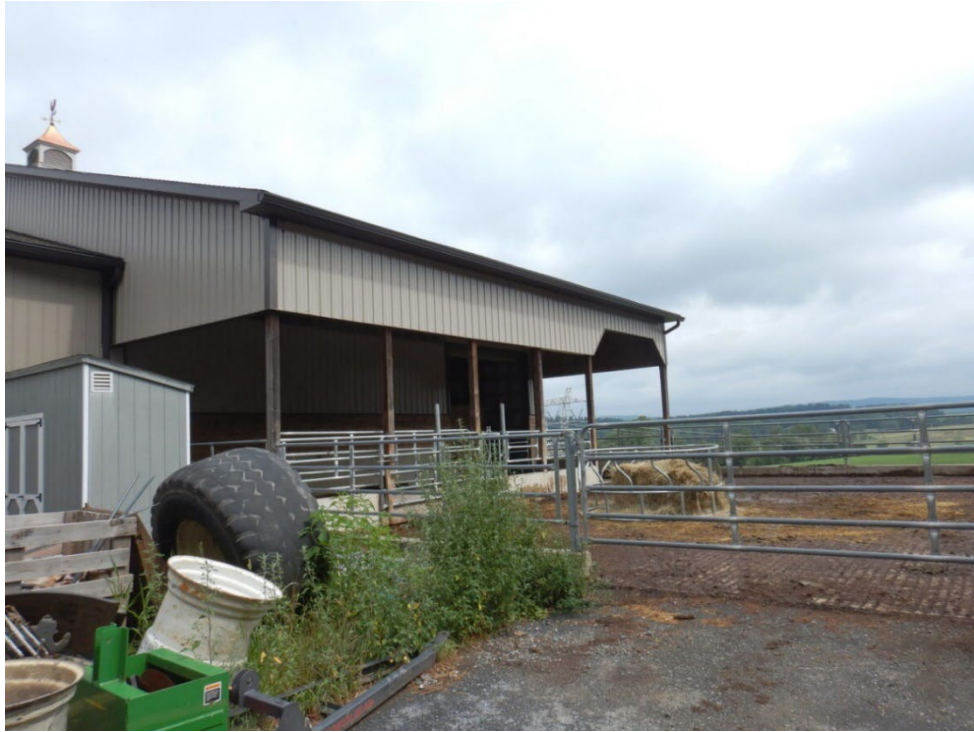
Photograph 21. View of the cattle pen and housing area. Note the manure covering the concrete pad.

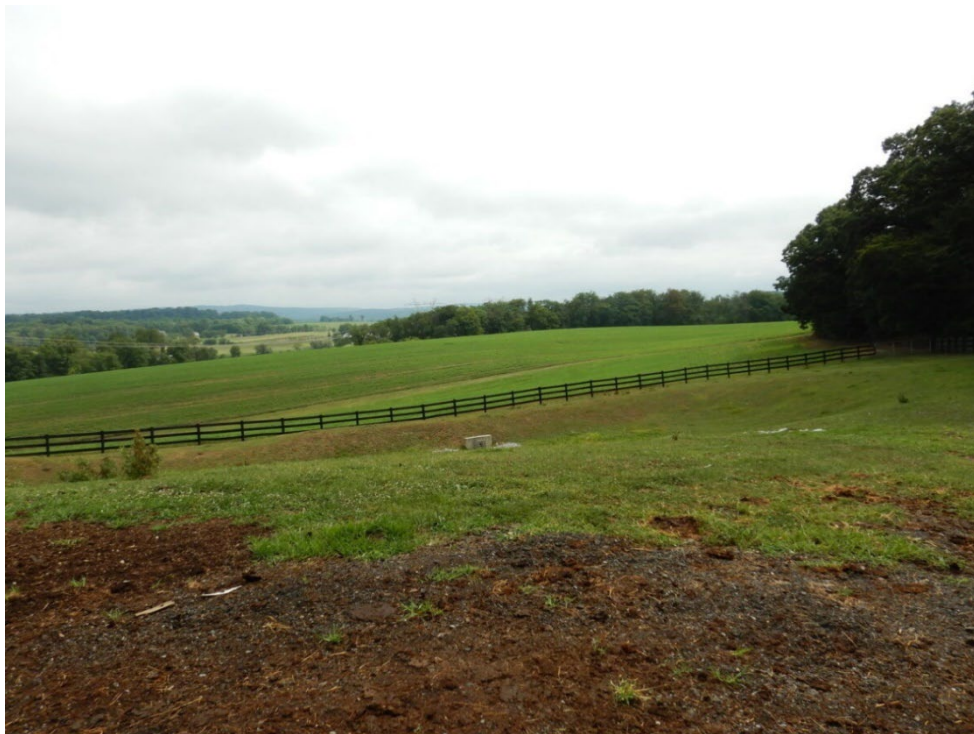
Photograph 22. View looking east over the cattle pasture and stormwater basin located to the northeast of the cattle pen.

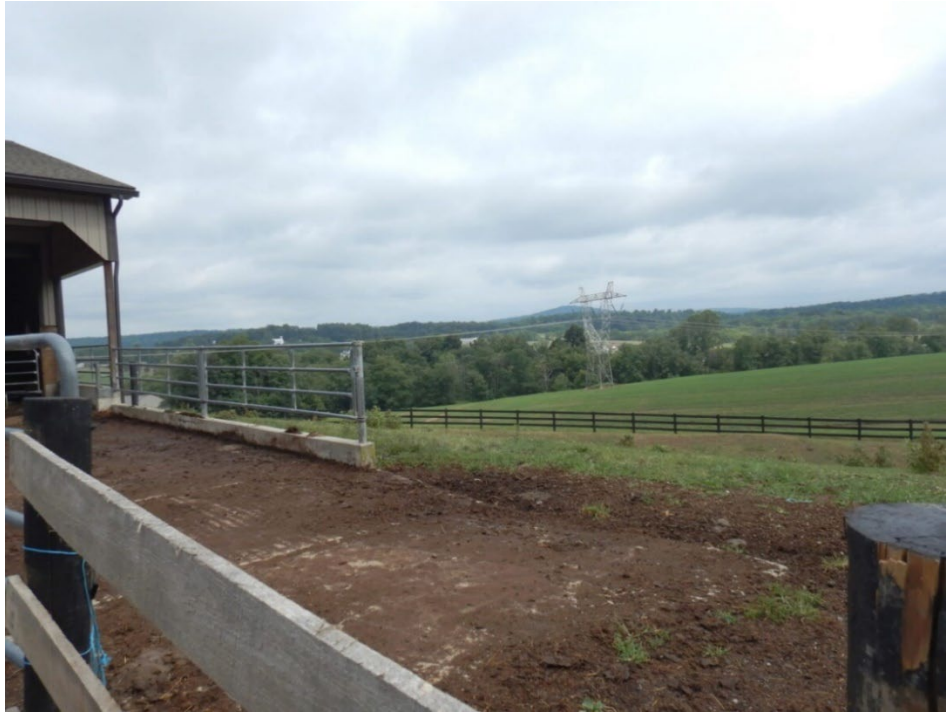
Photograph 23. View, looking north, of the southeastern corner of the cattle pen, with the crop field shown in Photograph 26 visible in the background. Note the manure covering the concrete pad.

No Manure storage areas?<sup>4</sup>  
Poultry manure is stored in the manure storage building, an enclosed structure, located at the east end of the poultry barn. The inspection team observed some manure on the edge of the concrete pad during the site tour (Photographs 8 and 9). Runoff from this area could potentially flow to the stormwater basin near the poultry barn.  
Cattle manure is scraped from the cattle pen at least once per month and transferred to the manure storage shed. The inspection team also observed manure on the cattle pen concrete pad during the site tour (Photographs 21 and 23). Runoff from this area could flow into the cattle housing stormwater basin.

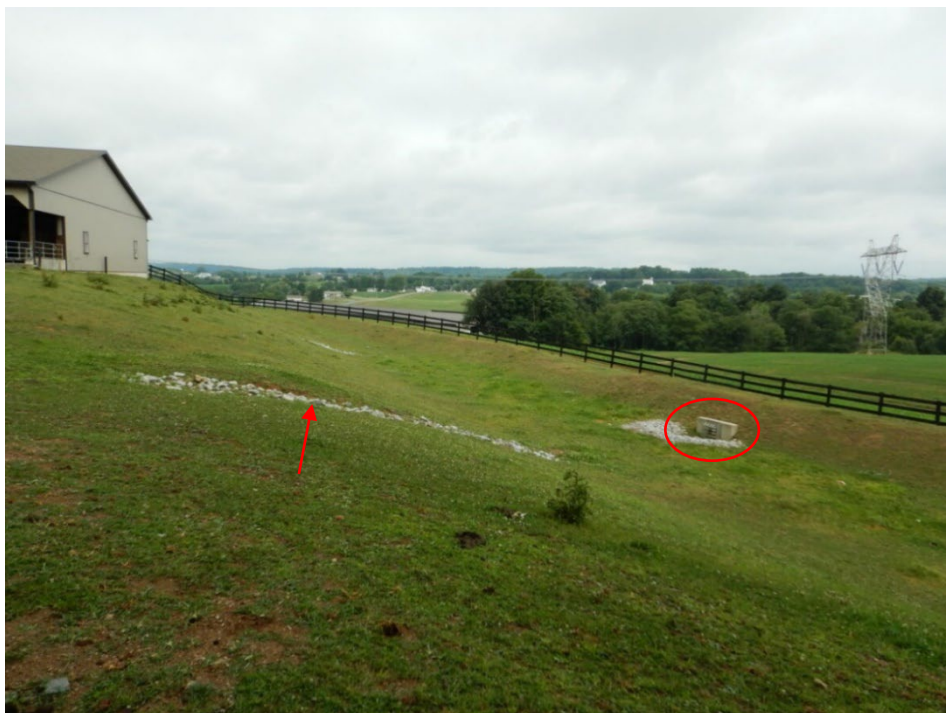
Photograph 24. View looking north over the cattle housing stormwater basin and pasture. The stormwater basin's outlet structure (circled) is located on the northeastern edge of the basin. A swale directing runoff into the basin is indicated by the arrow.

The facility also raises beef cattle onsite 365 days per year. The cattle are in confinement for 4 months and put out on pasture for 8 months of the year. At the time of the inspection, the facility had 4 beef cattle onsite, but noted that 2 of the cattle would be removed from the production area in October. The operator explained that manure is scraped from the cattle pen area at least once per month and manure is placed in the facility's manure storage building and mixed in with the poultry manure. Runoff from the cattle pen and pasture would flow east into a stormwater basin (Photographs 21-24 and 27). The cattle housing stormwater basin contains an overflow structure which would direct runoff east into the adjacent field (see Photographs 24, 25, and 28).

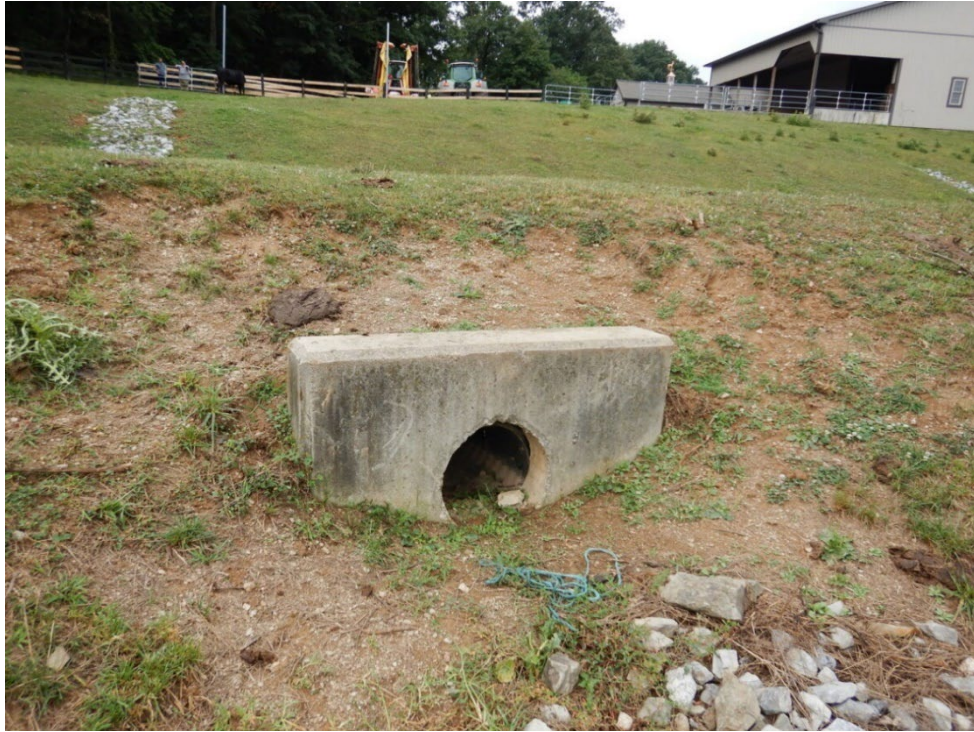
Photograph 25. Viewing looking southwest at the outlet from the cattle housing area stormwater basin with the cattle pen visible at the top right corner of the photograph.

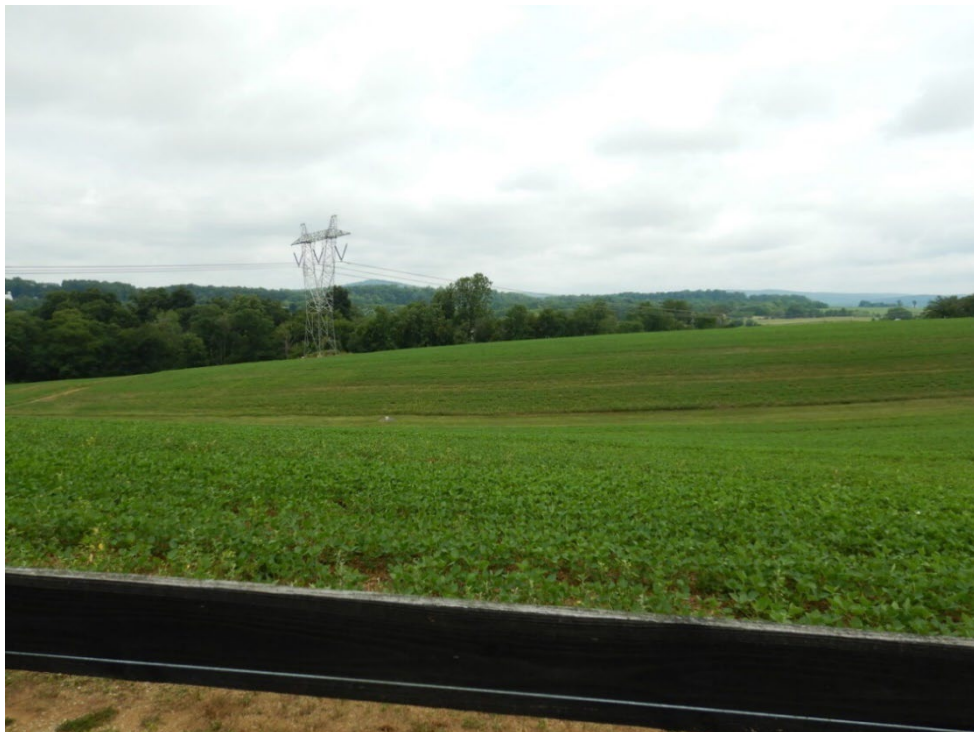
Photograph 26. View of the crop fields located northeast of the cattle barn, from the northeastern edge of the cattle pasture and stormwater basin. This photograph was taken from approximately the same location as Photograph 25.

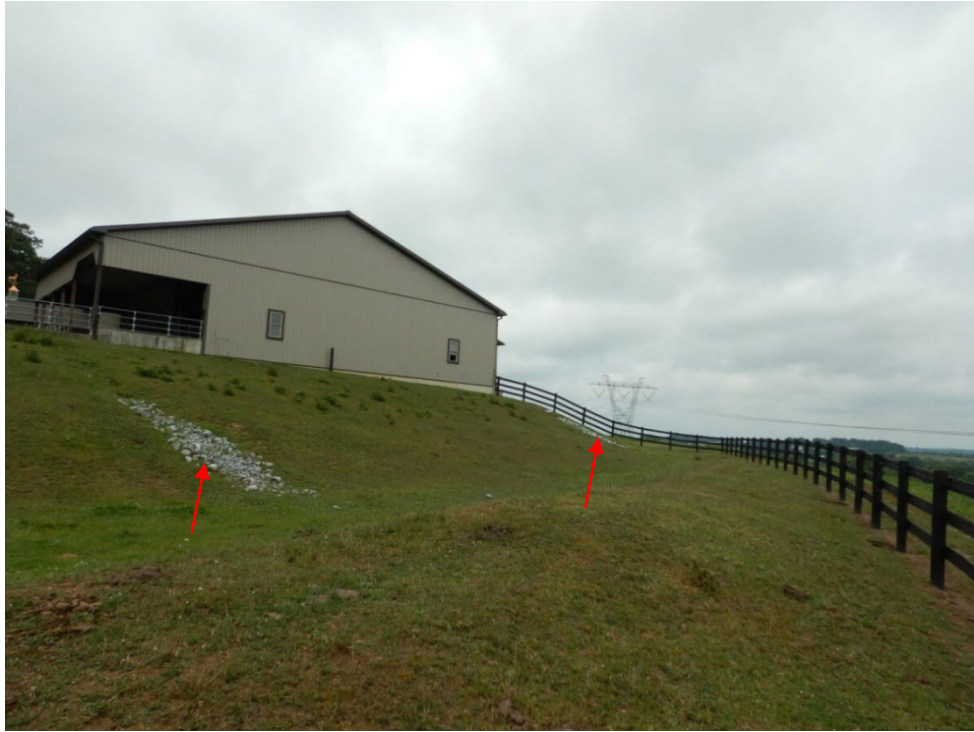
Photograph 27. View of the northern end of the cattle housing stormwater basin and swales (indicated by the arrows) feeding the basin.

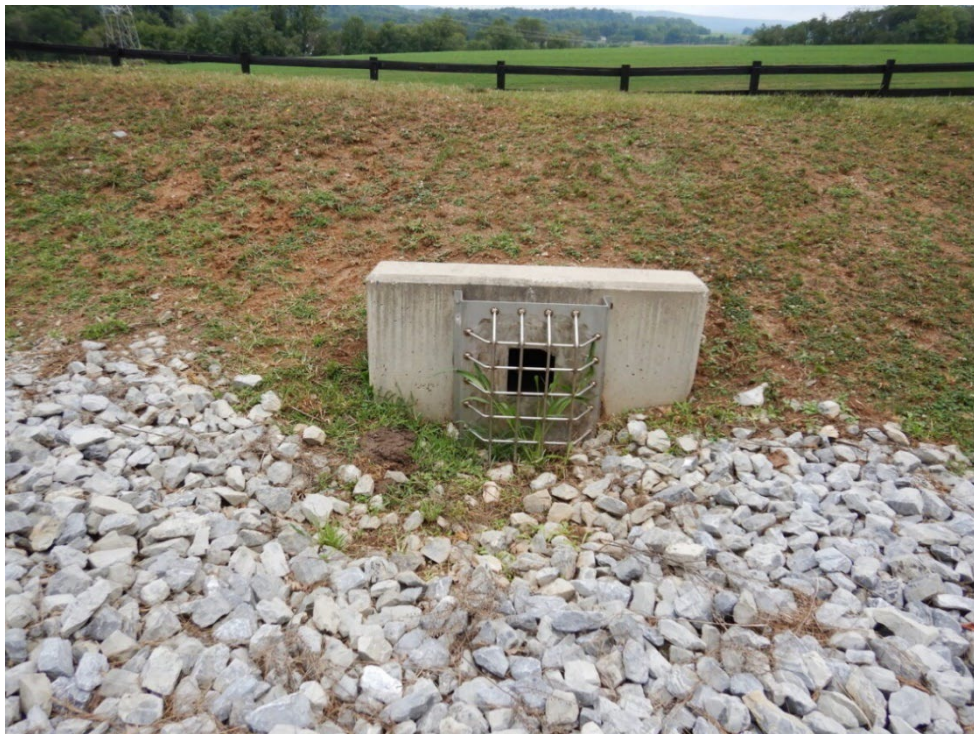
Photograph 28. Close-up view, looking northeast, of the outlet structure from the cattle housing stormwater basin located on the northeastern edge of the basin.
