# RCRA Compliance Evaluation Inspection Report

Boston Whaler Inc.  
100 Whaler Way  
Edgewater, Florida 32141-7213  
County: Volusia  
State District: Central District (Orlando)  
Latitude: 28.922814  
Longitude: -80.868248  
EPA ID Number: FLD982120024  
Primary NAICS: 336612–Boat Building

April 6, 2022 10:00 a.m.

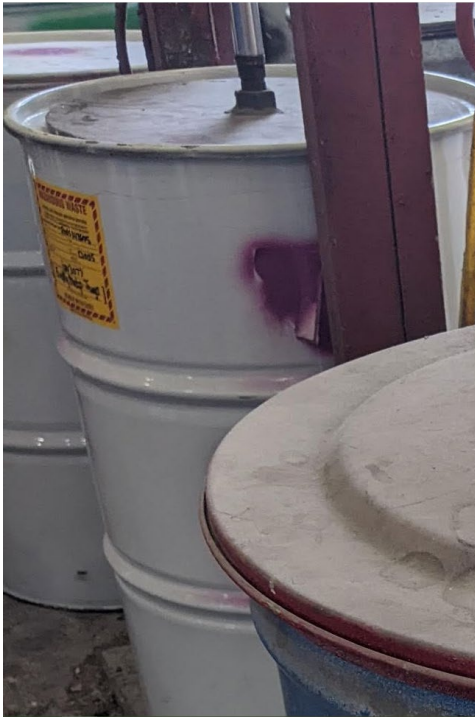
At the time of the inspection, there was a 55-gallon container labeled hazardous waste empty MEK-P jugs with EPA waste code D035. This container managing empty MEK-P jugs was fitted with a compactor used to crush and condense spent MEK-P jugs. The inspection team informed the facility that this is considered treatment of hazardous waste which can only occur in a central accumulation area (CAA). The container was closed but was missing the indication of the hazardous contents and an accumulation start date (Photograph 1). The facility submitted a photo on May 3, 2022, of the container labeled with the indication of the hazardous contents and an accumulation start date of May 6, 2022.

Photograph 1 of 17: Compacted MEK Jugs

**Pursuant to Fla. Admin. Code Ann. r. 62-730.160(1) [40 C.F.R. § 262.17(a)(5)(i)(B) and (C)], which is a condition of the LQG Permit Exemption, a generator must mark or label its containers with an indication of the hazards of the contents; and the date upon which each period of accumulation**

**begins clearly visible for inspection on each container.**

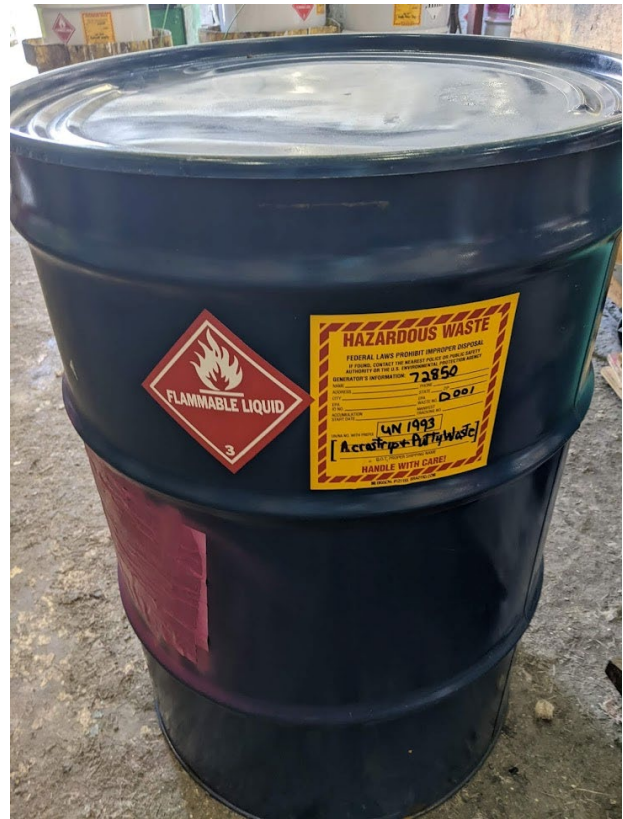
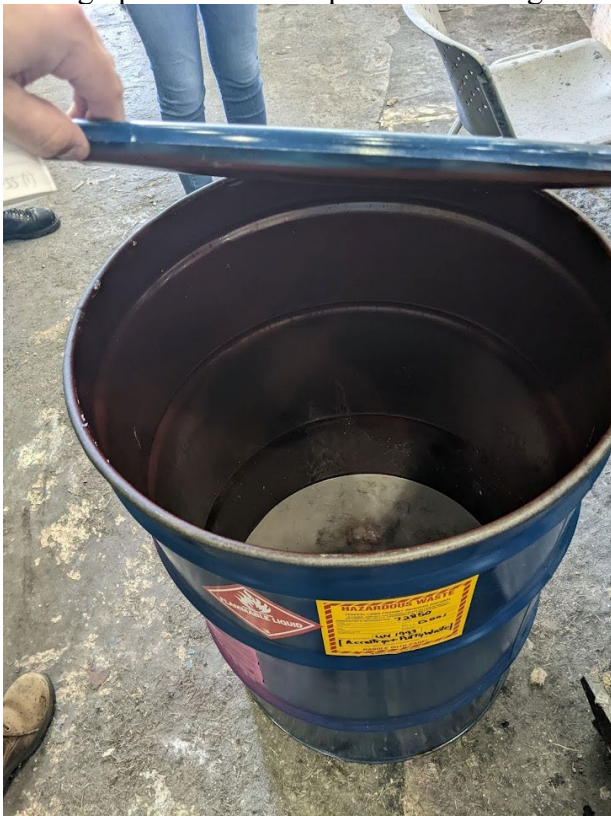
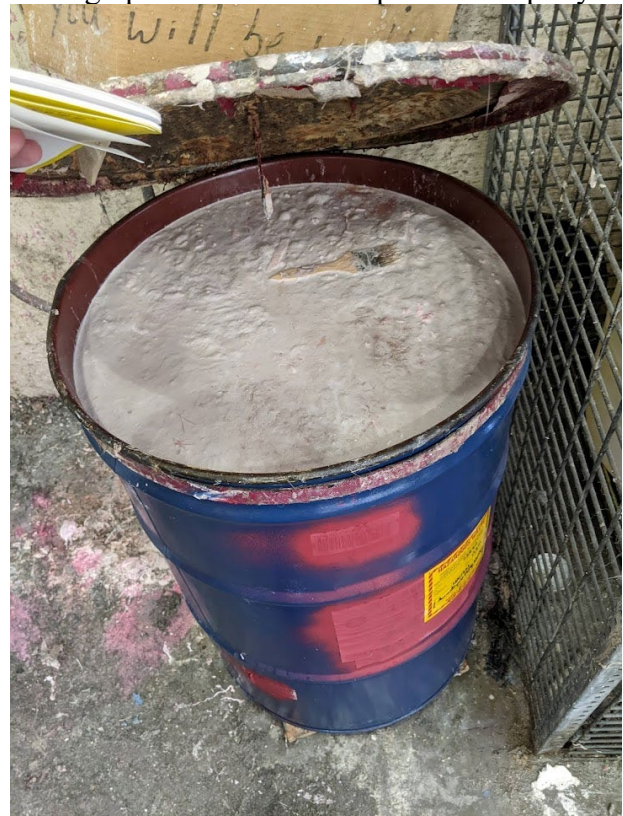
Additionally, there were two (2) 55-gallon containers labeled with the indication of the hazardous contents and labeled hazardous waste Acrastrip and B-39 putty with EPA waste code D001. One container was full, open, and missing the accumulation date, and the other container was open. The inspection team discussed dating containers in a SAA once they reach 55-gallons and to move the container to the CAA within 3 days (Photographs 2-4).

Photograph 2 of 17: AcraStrip and B-39 putty

Photograph 3 of 17: AcraStrip and B-39 putty

Photograph 4 of 17: AcraStrip and B-39 putty

**Pursuant to Fla. Admin. Code Ann. r. 62-730.160(1) [40 C.F.R. § 262.15(a)(6)(iii)], during the three-consecutive-calendar-day period, the generator must mark or label the container(s) holding the excess accumulation of hazardous waste with the date the excess amount began accumulating.**

**Pursuant to Fla. Admin. Code Ann. r. 62-730.160(1) [40 C.F.R. § 262.15(a)(4)], which is a condition of the LQG Permit Exemption, (A) a container holding hazardous waste must always be closed during accumulation, except when it is necessary to add or remove waste.**

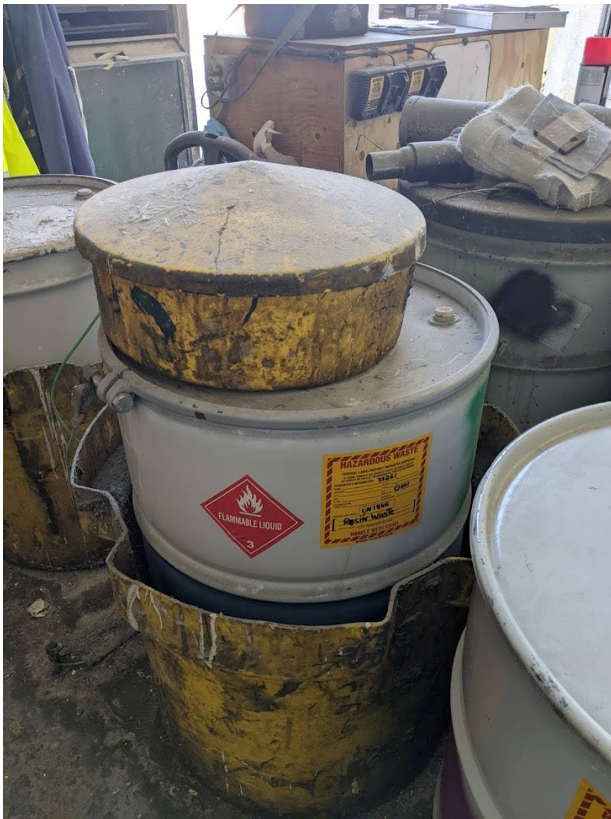
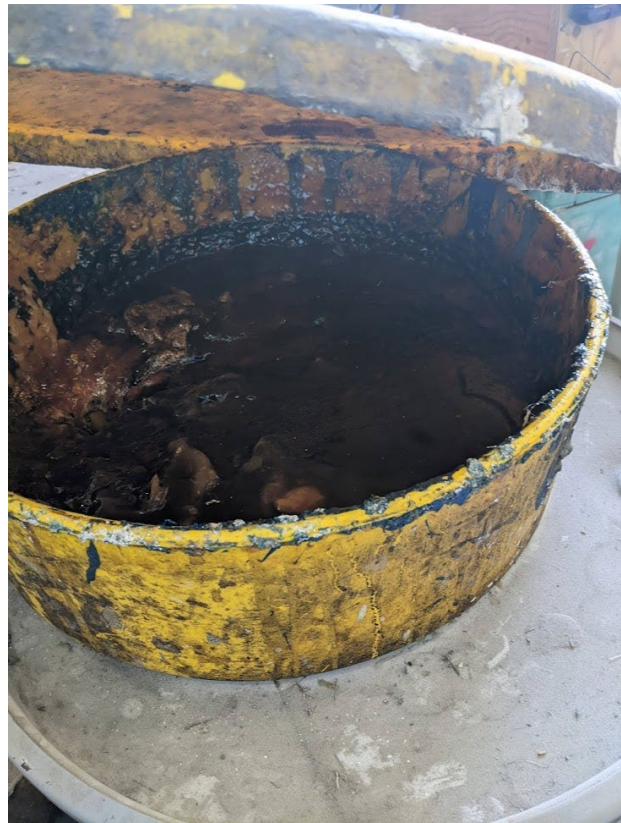
The inspection team observed a 55-gallon container labeled with the indication of the hazardous contents and labeled hazardous waste resin with EPA waste code D001. This container was affixed with a yellow funnel that did not latch and was considered open (Photographs 5-6).

Photograph 5 of 17: Waste Resin

Photograph 6 of 17: Waste Resin

**Pursuant to Fla. Admin. Code Ann. r. 62-730.160(1) [40 C.F.R. § 262.15(a)(4)], which is a condition of the LQG Permit Exemption, (A) a container holding hazardous waste must always be closed during accumulation, except when it is necessary to add or remove waste.**

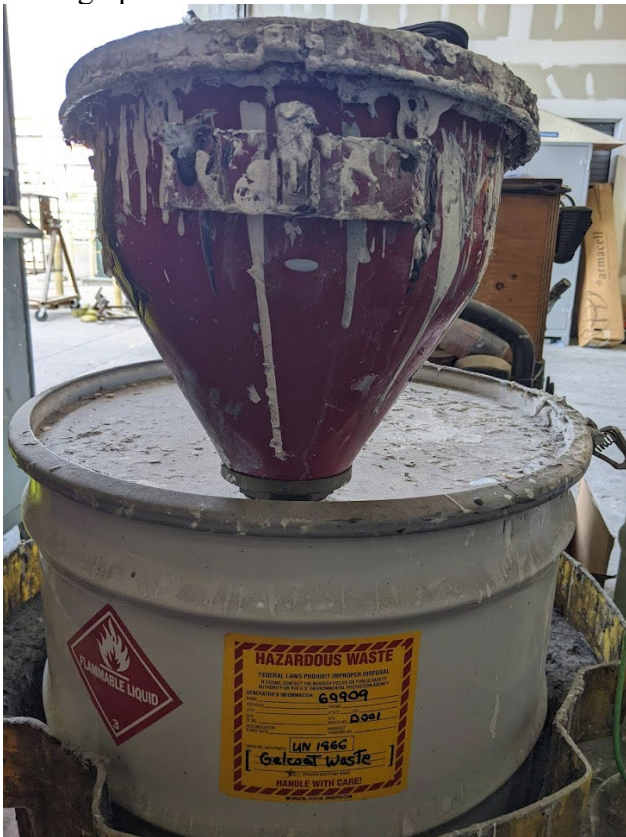
The inspection team observed a 55-gallon container labeled with the indication of the hazardous contents and hazardous Gelcoat Waste with EPA waste code D001. This container was affixed with a red funnel that was not latched and was considered open (Photograph 7).

Photograph 7 of 17: Gelcoat Waste

**Pursuant to Fla. Admin. Code Ann. r. 62-730.160(1) [40 C.F.R. § 262.15(a)(4)], which is a condition of the LQG Permit Exemption, (A) a container holding hazardous waste must always be closed during accumulation, except when it is necessary to add or remove waste.**

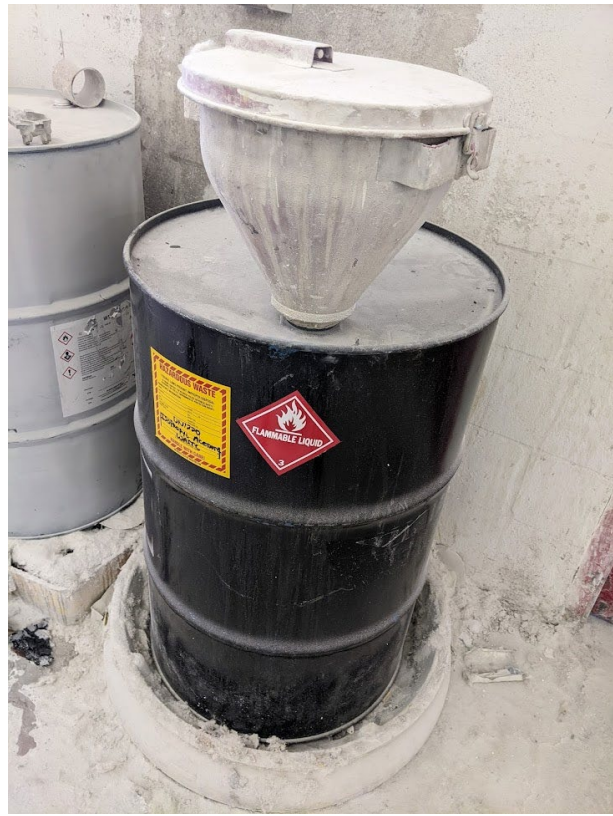
Finishing touches are made on the boat parts in this area and go through a quality control process. At the time of the inspection, a 55-gallon SAA container was labeled with the indication of the hazardous contents, labeled hazardous waste isopropyl acetate and open (Photograph 9).

Photograph 9 of 17: Finishing Isopropyl Acetate

**Pursuant to Fla. Admin. Code Ann. r. 62-730.160(1) [40 C.F.R. § 262.15(a)(4)], which is a condition of the LQG Permit Exemption, (A) a container holding hazardous waste must always be closed during accumulation, except when it is necessary to add or remove waste.**

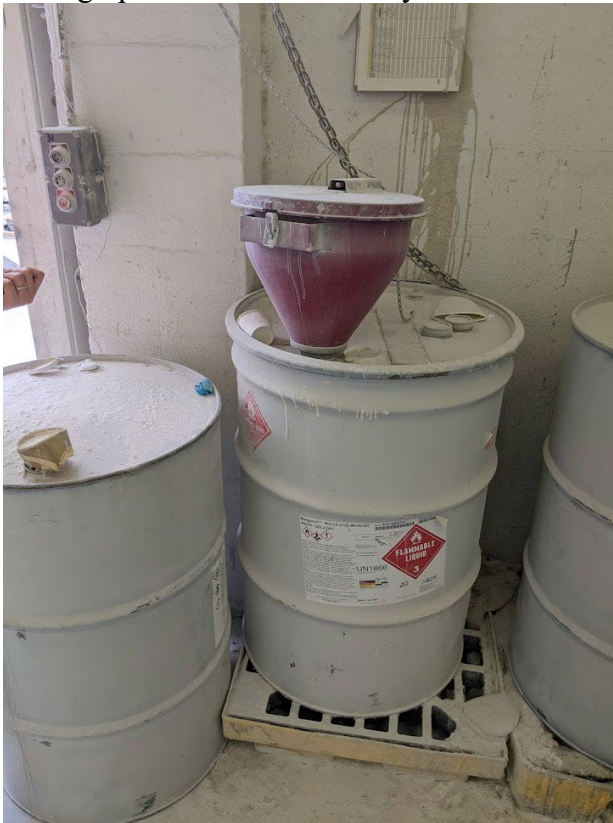
An additional closed 55-gallon SAA container was labeled with the indication of the hazardous contents, labeled hazardous waste gel coat and open (Photograph 10).

Photograph 10 of 17: Finishing Gelcoat Waste

**Pursuant to Fla. Admin. Code Ann. r. 62-730.160(1) [40 C.F.R. § 262.15(a)(4)], which is a condition of the LQG Permit Exemption, (A) a container holding hazardous waste must always be closed during accumulation, except when it is necessary to add or remove waste.**

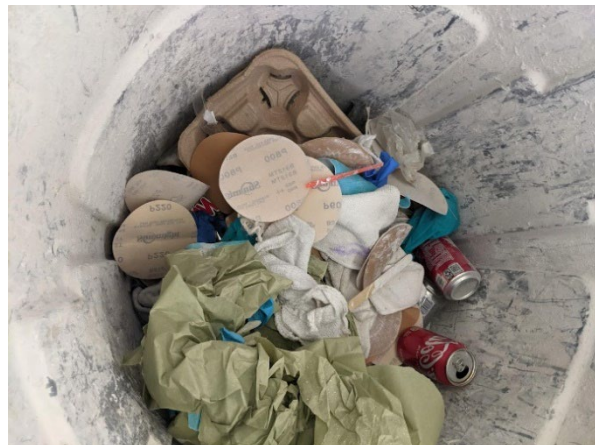
Solvent-contaminated wipes in this area were found in the municipal trash (Photograph 11).

Photograph 11 of 17: Finishing Wipes

**Pursuant to Fla. Admin. Code Ann. r. 62-730.030(1) [40 C.F.R. 261.4(a)(26)], generators accumulating, storing, and transporting solvent-contaminated wipes, must manage the wipes in non-leaking containers that are labeled “Excluded Solvent-Contaminated Wipes”.**

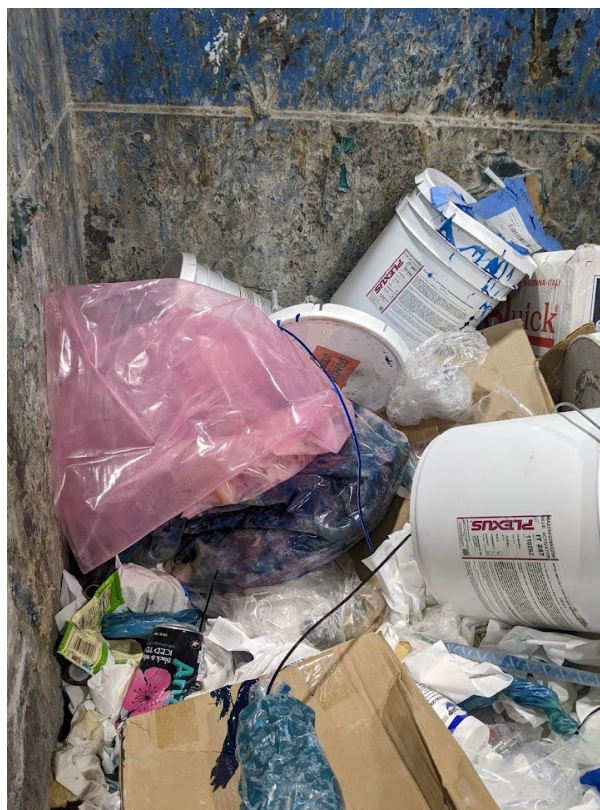
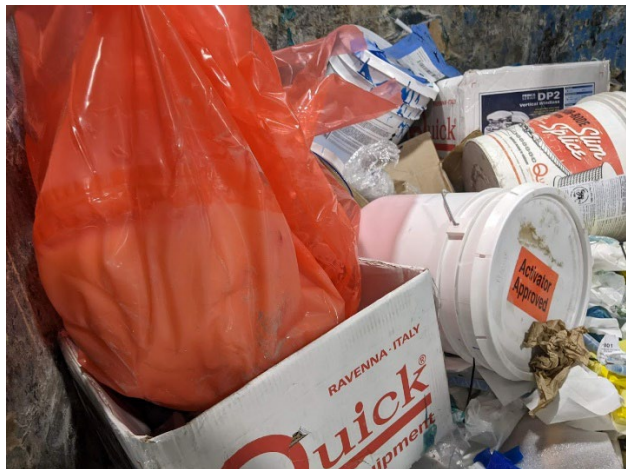
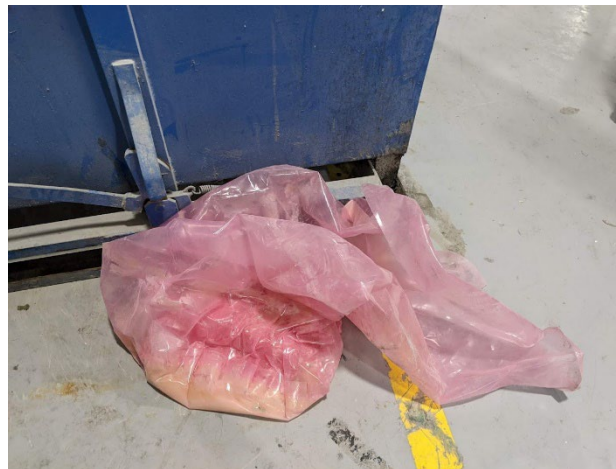
Boat parts are assembled in this area using a two-part reactive glue. IPS glue (Part A) in a lined 55-gallon drum is mixed with an activator (Part B) through a piped system that feeds from both drums into a single stream deposit into a plastic piping bag. Once hardened, the bags and tips used for application are managed as trash. In separate forms, Part A is managed as a reactive hazardous waste. Near a bay door of the assembly building, a dumpster contained two (2) Part A bag liners. Behind the dumpster was an additional bag liner on the ground. At the time of the inspection, the facility stated that they were aware of personnel throwing these bags in the trash and the maintenance team typically removes these bags from the dumpsters and transfers them to the CAA. On May 3, 2022, the facility submitted a photograph of the dumpster free of the bags, and a photograph of a container in the CAA labeled hazardous waste flammable adhesive waste dated April 11, 2022 (Photographs 12-15).

Photograph 12 of 17: Assembly Area Wastes

Photograph 13 of 17: Assembly Area Dumpster

Photograph 14 of 17: Assembly Area Dumpster

Photograph 15 of 17: Behind Assembly Area Dumpster

**Pursuant to Fla. Admin. Code Ann. r. 62-730.160(1) [40 C.F.R. § 262.20(a)(1)], a generator who transports, or offers for transport a hazardous waste for offsite treatment, storage, or disposal, must prepare a Manifest according to the instructions included in the appendix to Fla. Admin. Code Ann. r. 62-730.160(1) [40 C.F.R. Part 262].**

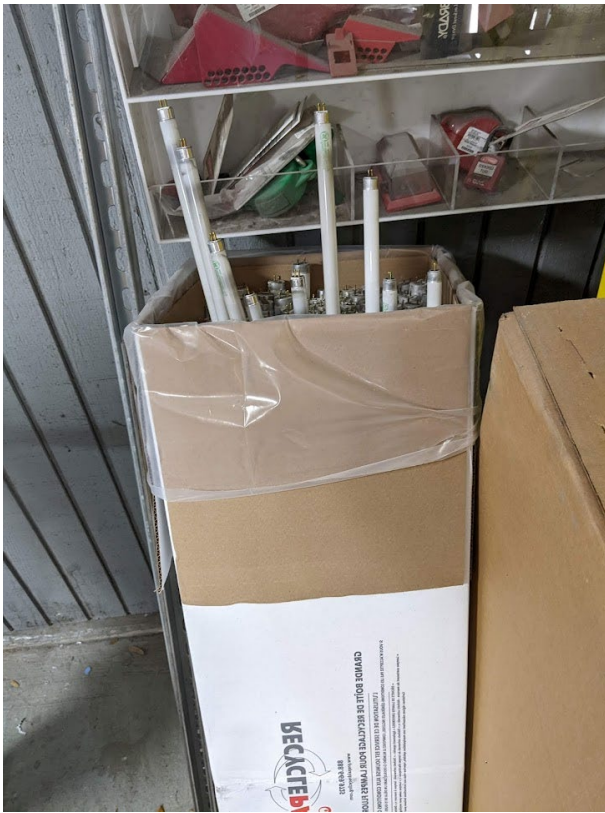
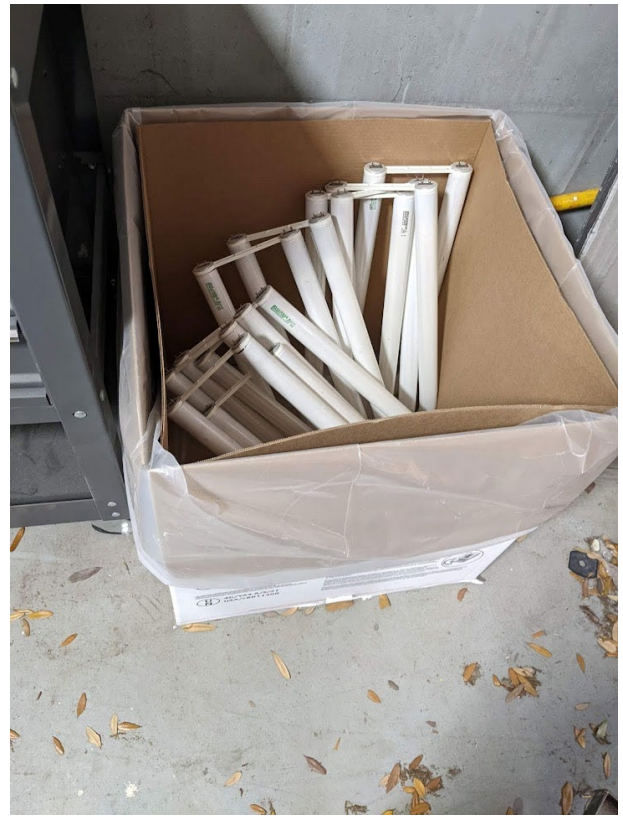
The maintenance department is a storage location for universal waste lamps and used oil. At the time of the inspection, the inspection team observed two (2) used oil container managing used oil and used oil filters. The inspection team also observed two (2) open containers of universal waste lamps that were not labeled (Photographs 16 and 17).

Photograph 16 of 17: Maintenance Area Lamps

Photograph 17 of 17: Maintenance Area Lamps

**Pursuant Fla. Admin. Code Ann. r. 62-730.185(1) [40 C.F.R. § 273.13(d)], a SQHUW must manage universal waste lamps in a way that prevents releases of any universal waste or component of a universal waste to the environment.**

**Pursuant to Fla. Admin. Code Ann. r. 62-730.185(1) [40 C.F.R. § 273.14(e)], a SQHUW must label or mark each lamp or container of lamps clearly with one of the following phrases: “Universal Waste-Lamp(s),” or “Waste Lamp(s),” or “Used Lamps.”**
