RCRA COMPLIANCE EVALUATION INSPECTION

Golden Artist Colors Inc.
188 Bell Road
New Berlin, New York

NY0000097253

September 18, 2024

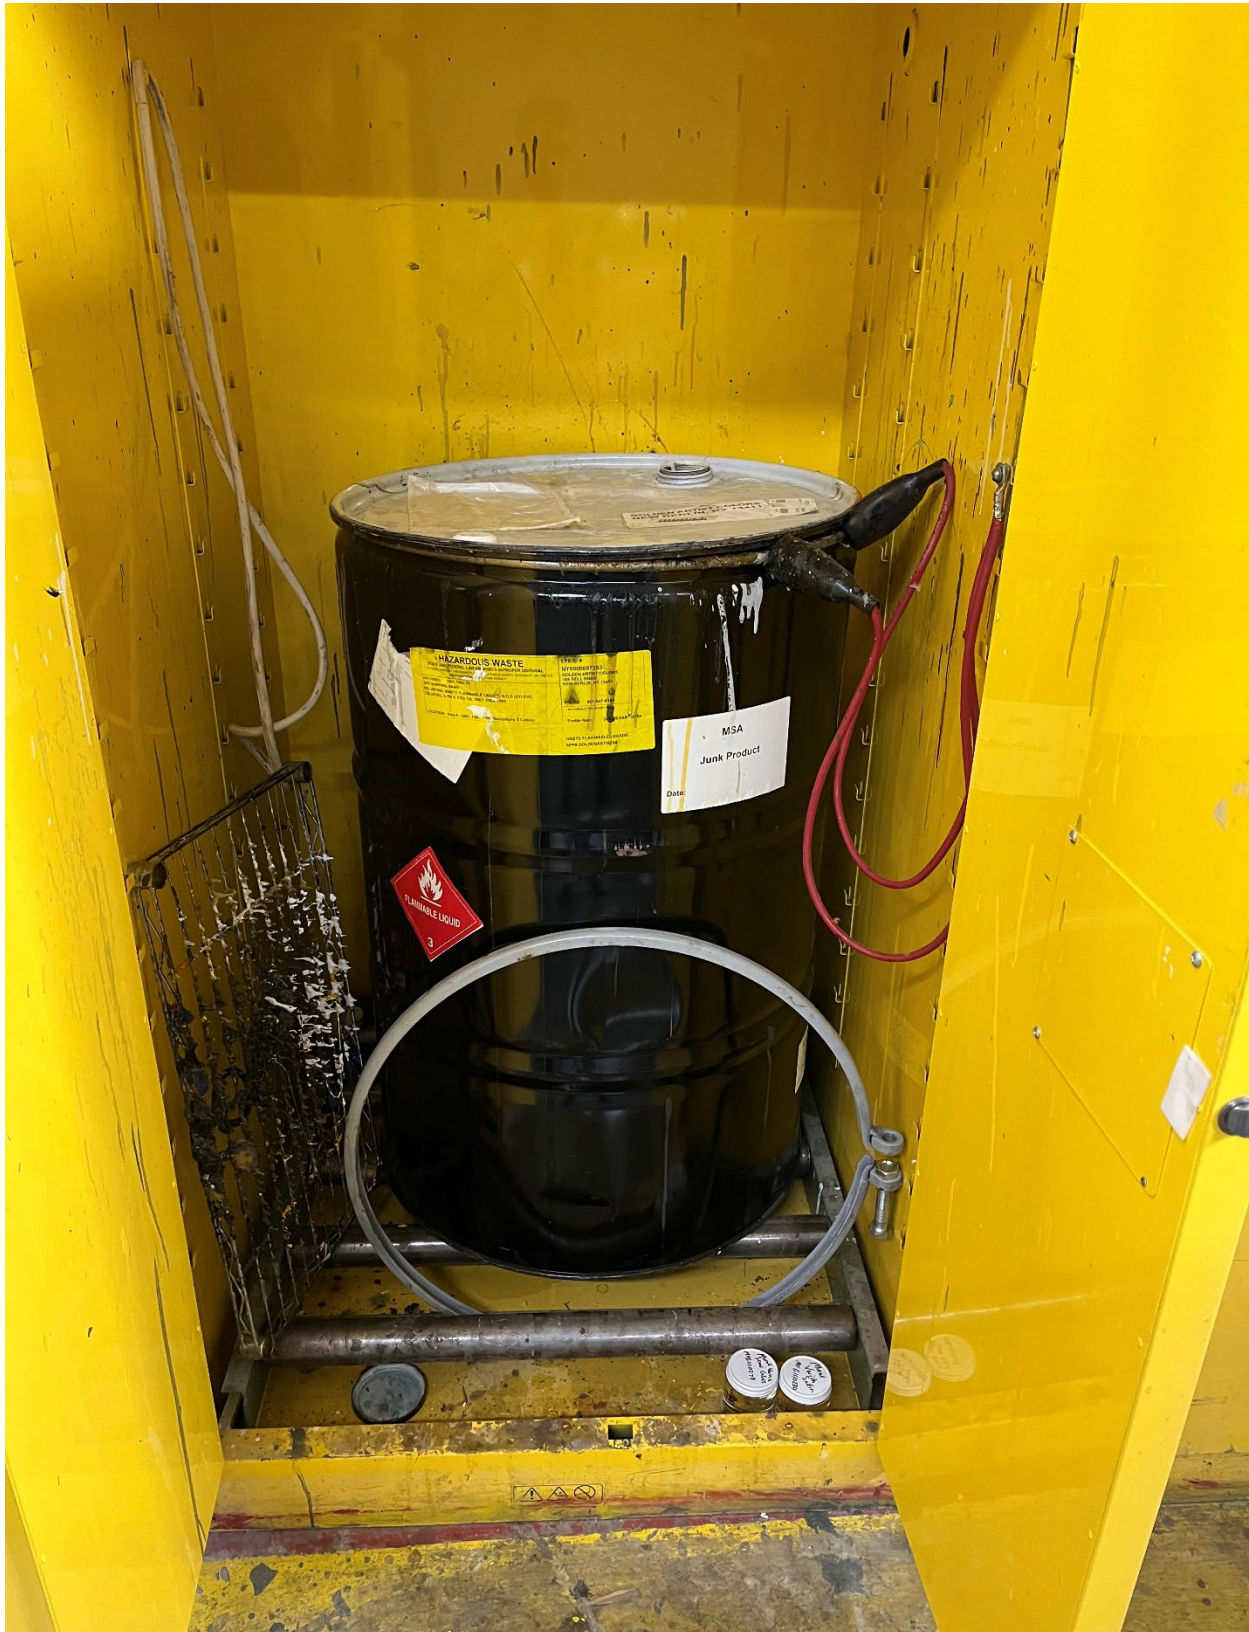
Photo #1: View of the satellite accumulation container for the liquid MSA waste.

One of the products is a mineral spirit acrylic (MSA) varnish that is flammable and contains xylene and toluene. Personal protective equipment (PPE) such as disposable gloves and wipes are generated during cleaning of equipment. The liquid MSA waste is placed in a 55-gallon satellite container. This container has a hazardous waste label and a flammable label. The PPE waste is placed in a small container and transferred to a large plastic carboy in the Hazardous Waste Storage Location. The carboy is labelled as hazardous waste containing MSA PPE with an accumulation start date. The liquid MSA waste is shipped as a waste flammable liquid (xylene, toluene) with hazardous waste codes D001, F003, and F005. The plastic carboy of MSA PPE is shipped as a waste flammable solid, organic (xylene, toluene), with hazardous waste codes D001, D035, F003, and F005.

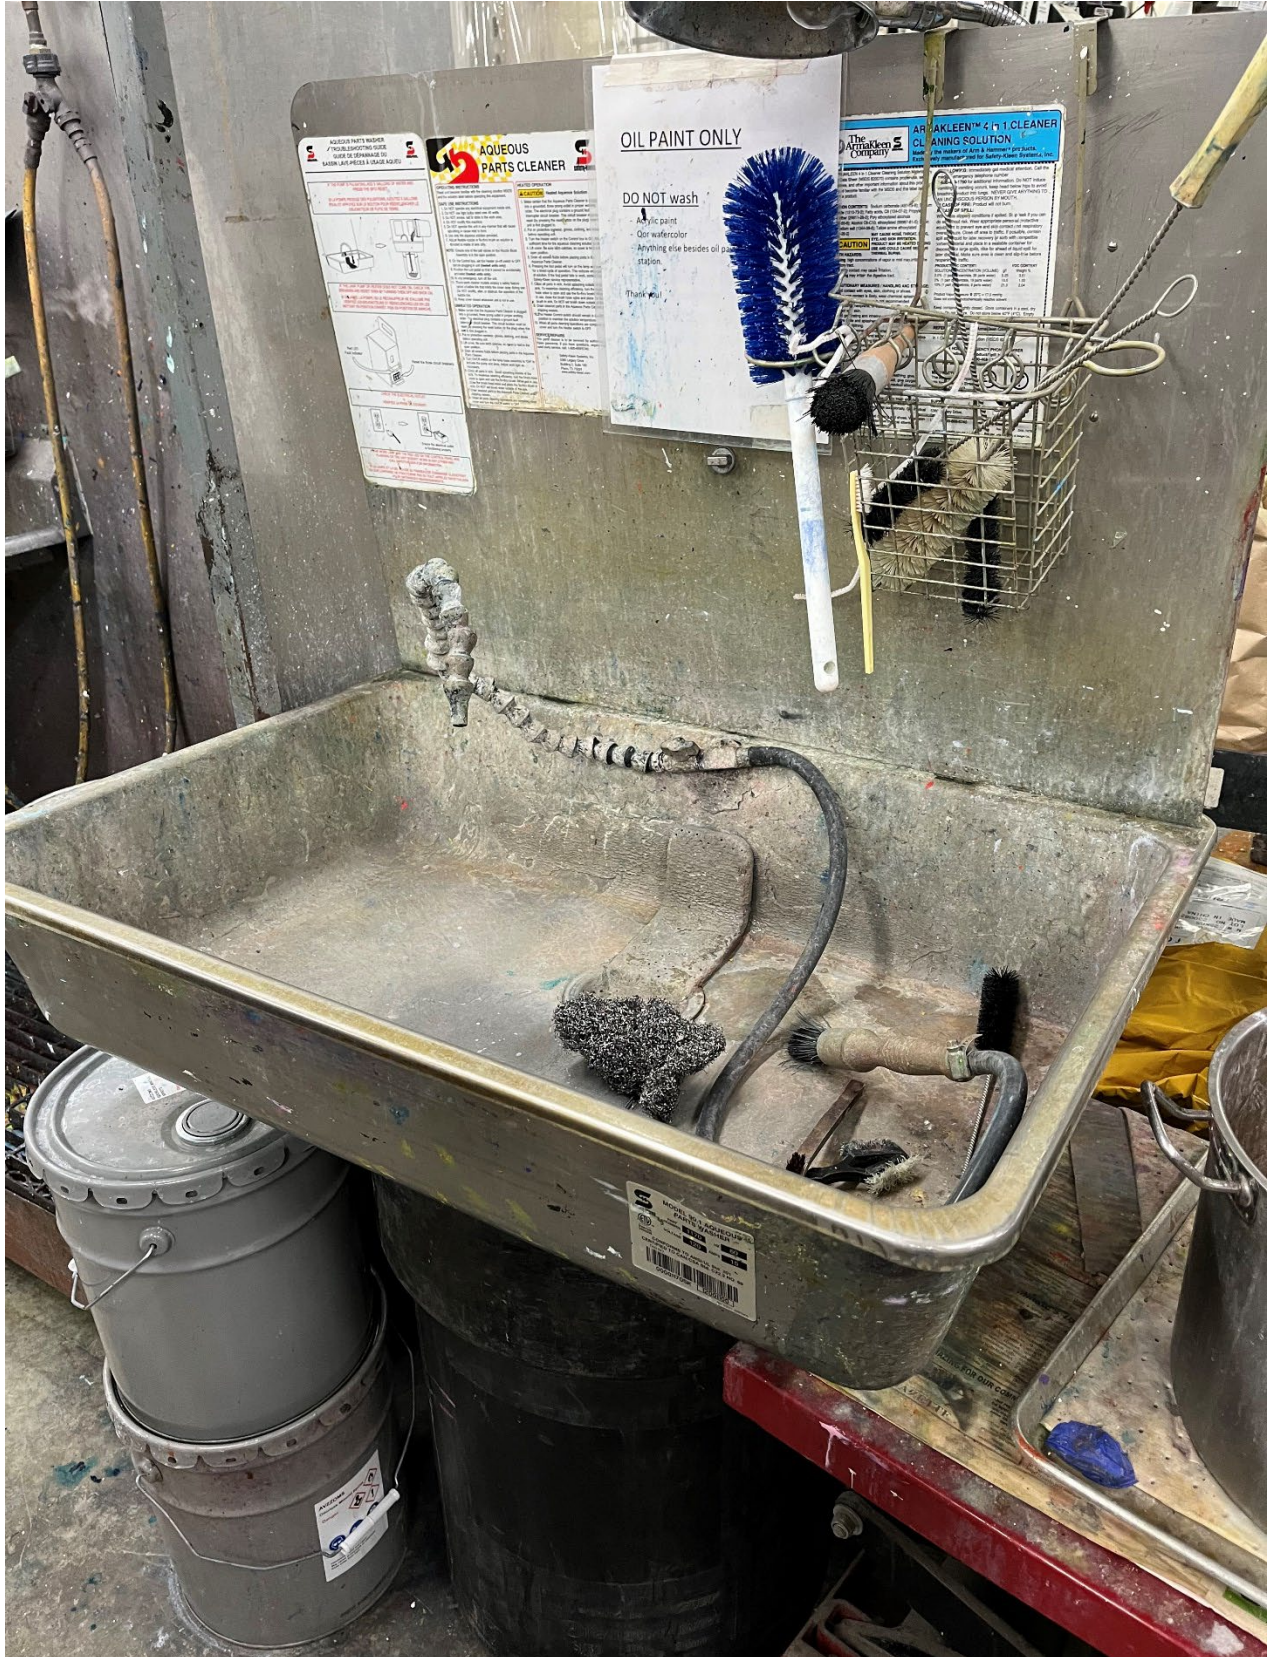
Photo #2: View of one of the aqueous parts cleaners.

There are two 20-gallon aqueous parts cleaners on-site that are used for cleaning equipment. The parts cleaner liquid is replaced approximately 3 times per year. The aqueous parts cleaner is shipped as a hazardous waste liquid with hazardous waste codes D006 and D008.

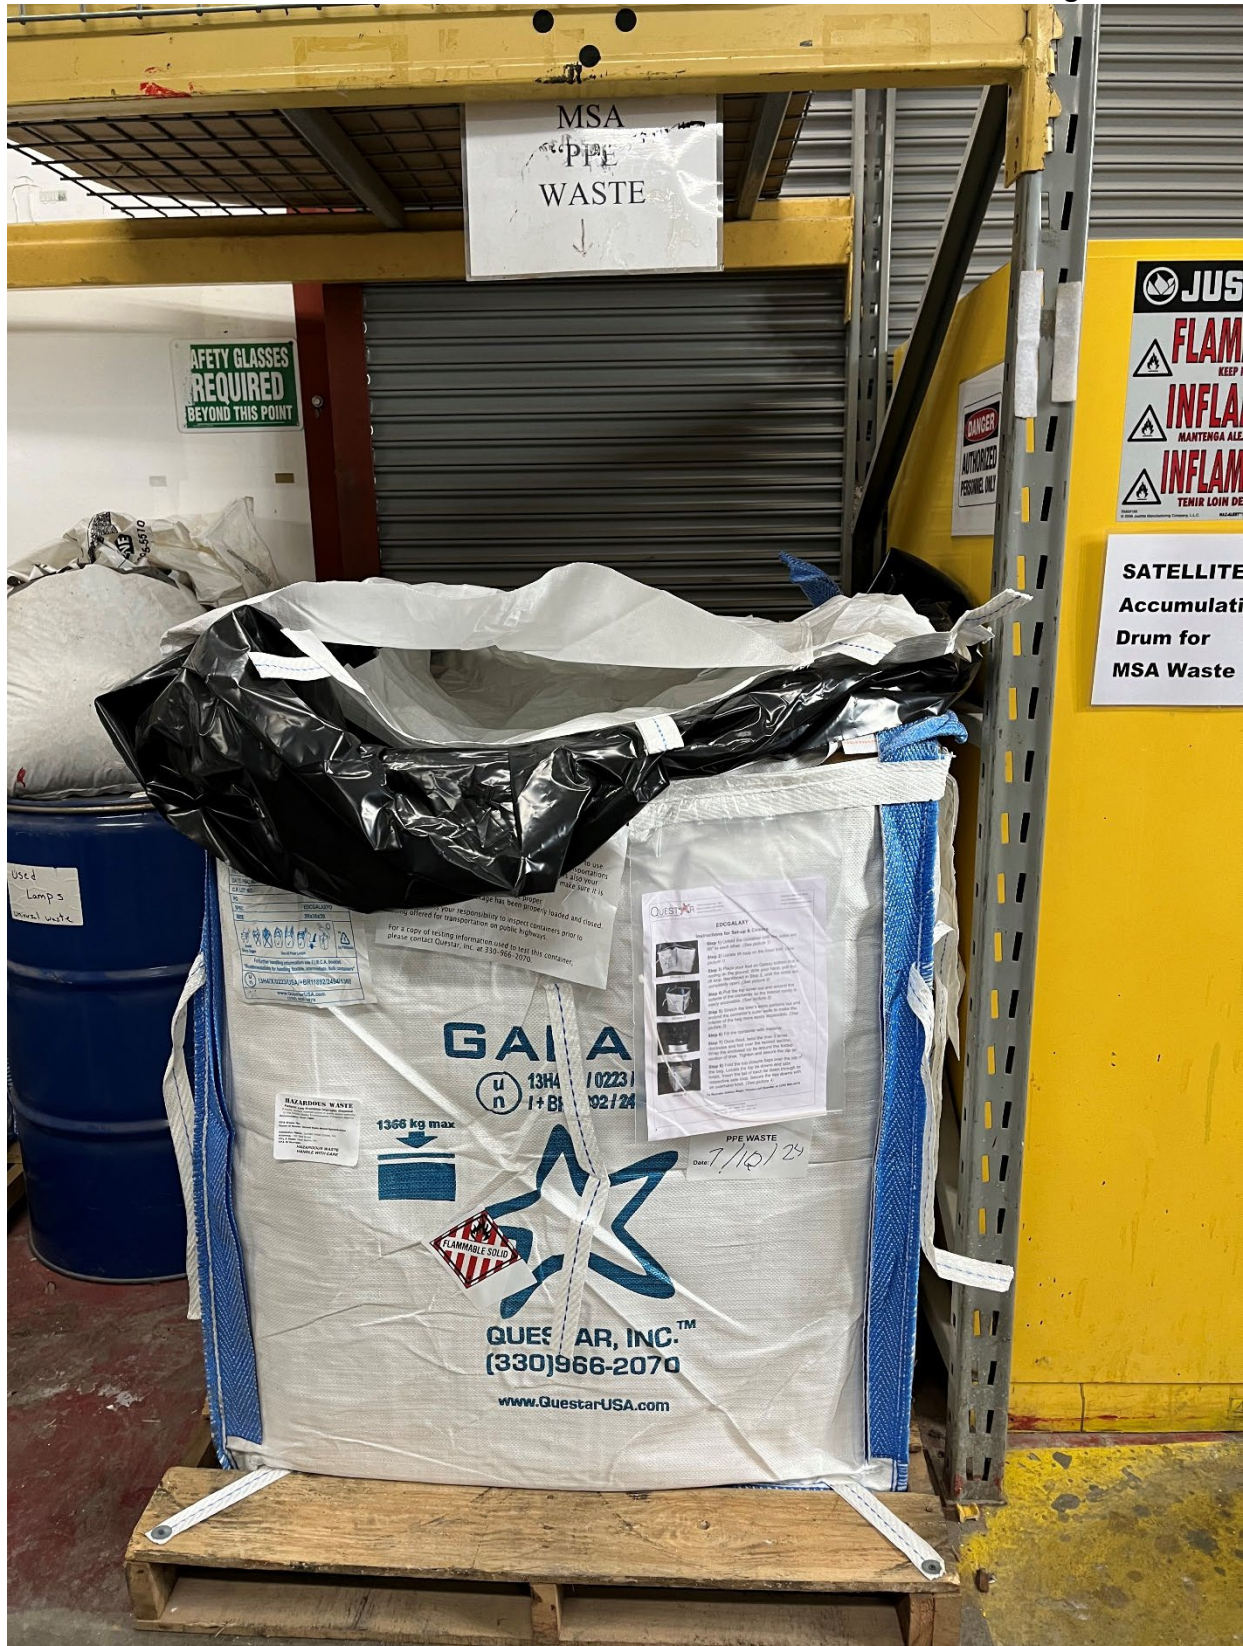
Photo #3: View of the container of MSA PPE waste in the Hazardous Waste Storage Area.

On the day of the inspection, there were two large plastic carboys of PPE waste being stored in the Hazardous Waste Storage Location. Both containers were labelled as hazardous waste containing contaminated PPE, with accumulation start dates marked on the containers.

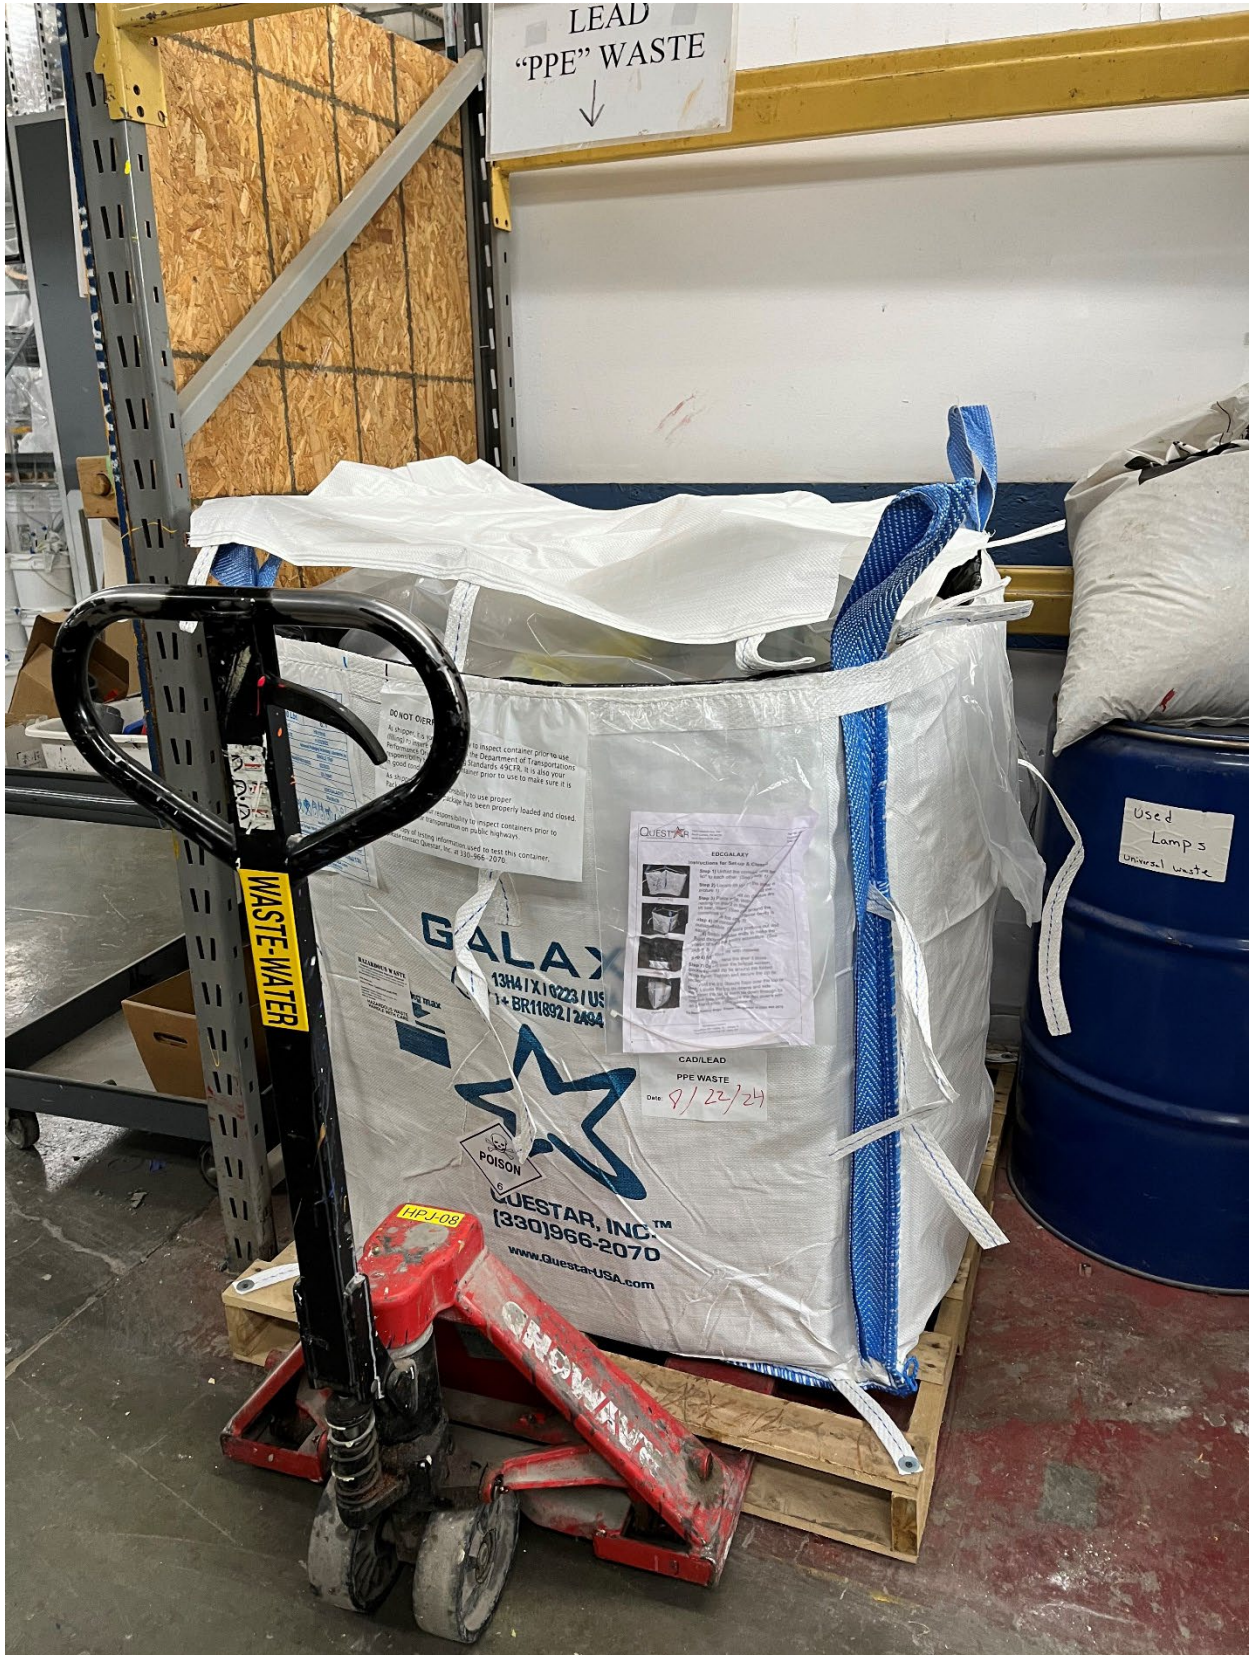
Photo #4: View of the container of lead PPE waste in the Hazardous Waste Storage Area.

The pigments used in the various paint products can be organic-based or metal-based. The paints containing pigments with cadmium, chromium, or lead are handled as hazardous materials. During cleaning operations, used disposable gloves are generated and placed in a small container. The used gloves are transferred to a large plastic carboy in the Hazardous Waste Storage Location. The carboy is labelled as hazardous waste containing cadmium/lead PPE with an accumulation start date. The plastic carboy is shipped as waste toxic solids, inorganics (cadmium, lead), with hazardous waste codes D006, D007, and D008.
