**Region 6 Compliance Assurance and Enforcement Division  
INSPECTION REPORT**

| Facility Name: | <b>Ruidoso/Ruidoso Downs WWTP</b> | | |
| Identification/Permit Number: | NM0029165 | | |

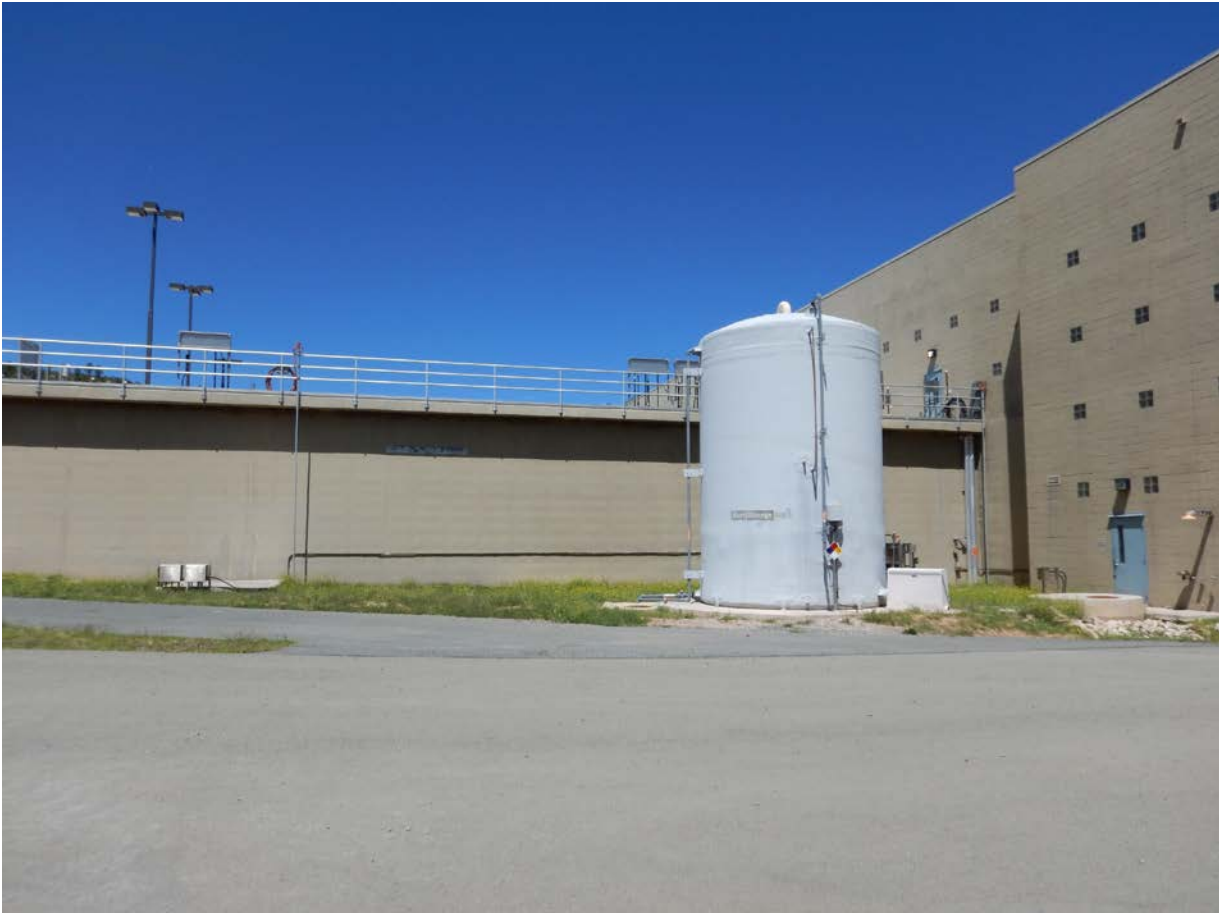
Photo No. 2

Description: Tank of aluminum sulfate (alum) used to remove phosphorus in the treatment process.

Aluminum sulfate (also called “alum”) is currently used at a rate of 500 gallons per day for phosphorus removal in the treatment process. During the tank filling process, aluminum sulfate has been spilled onto the ground repeatedly, in quantities large enough to leave a visible residue, and facility personnel report that the delivery truck drivers rinse off the tank fill pipe into a nearby storm drain. Aluminum sulfate is toxic to aquatic life, causes human health problems, and reacts with water to form sulfuric acid.

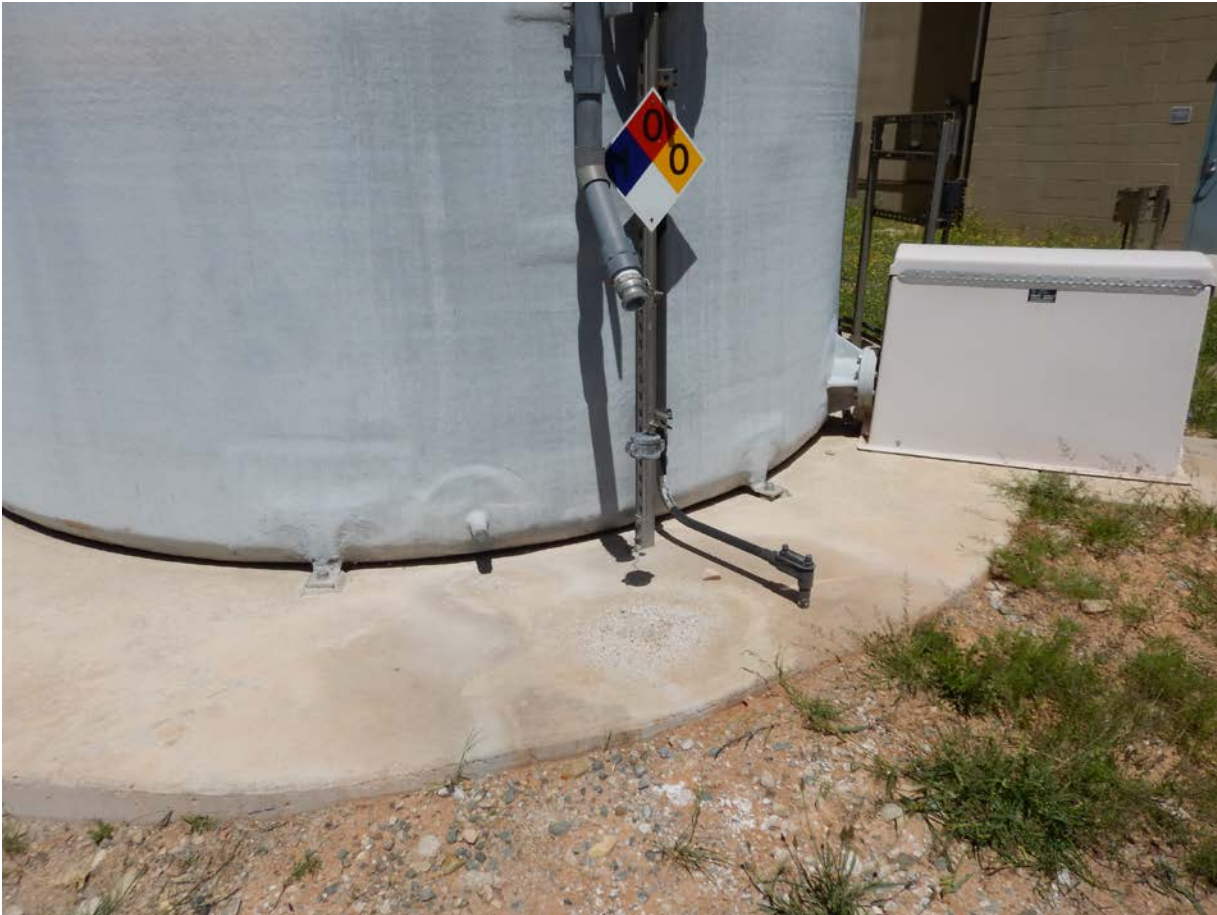
Photo No. 3

Description: Corrosion in the concrete where aluminum sulfate has been spilled

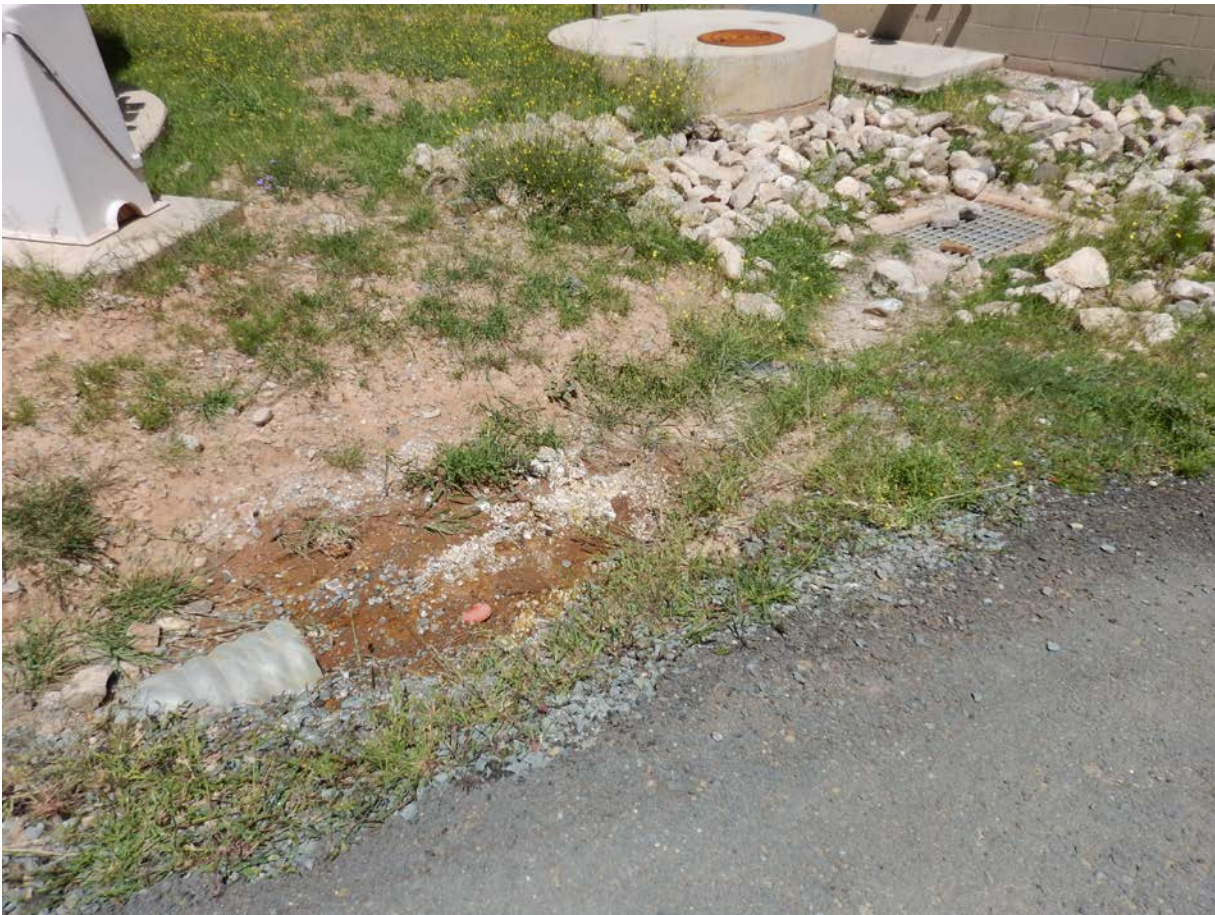
Photo No. 4

Description: Visible aluminum sulfate residue is present on the ground between the culvert and the storm drain.

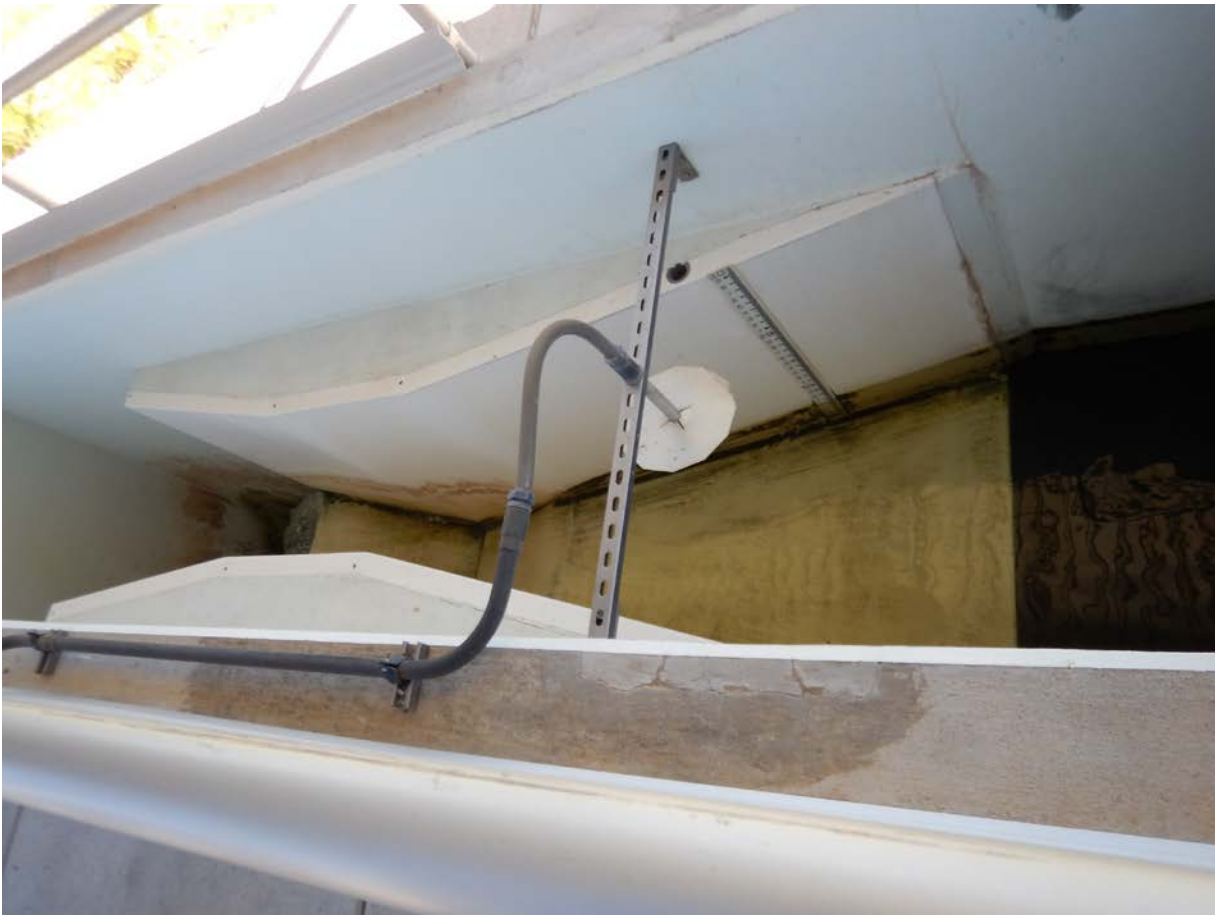
Photo No. 5

Description: Turbulence visible at the measurement point in the effluent Parshall Flume.

There was a considerable amount of turbulence inside the effluent Parshall Flume, including the location where the secondary ultrasonic flow meter was reading. Permittee indicated that regular (monthly) checks of the ultrasonic meter against the reading in the Parshall Flume are not conducted.
