**Region 6 - Enforcement & Compliance Assurance Division**  
**INSPECTION REPORT**

| Company Name: | <b>Calgary Energy, LLC</b> | |
| Facility Name: | <b>Tidal Osage 1 Lease</b> | |
| Identification/Permit Number: | OKU000893 | |

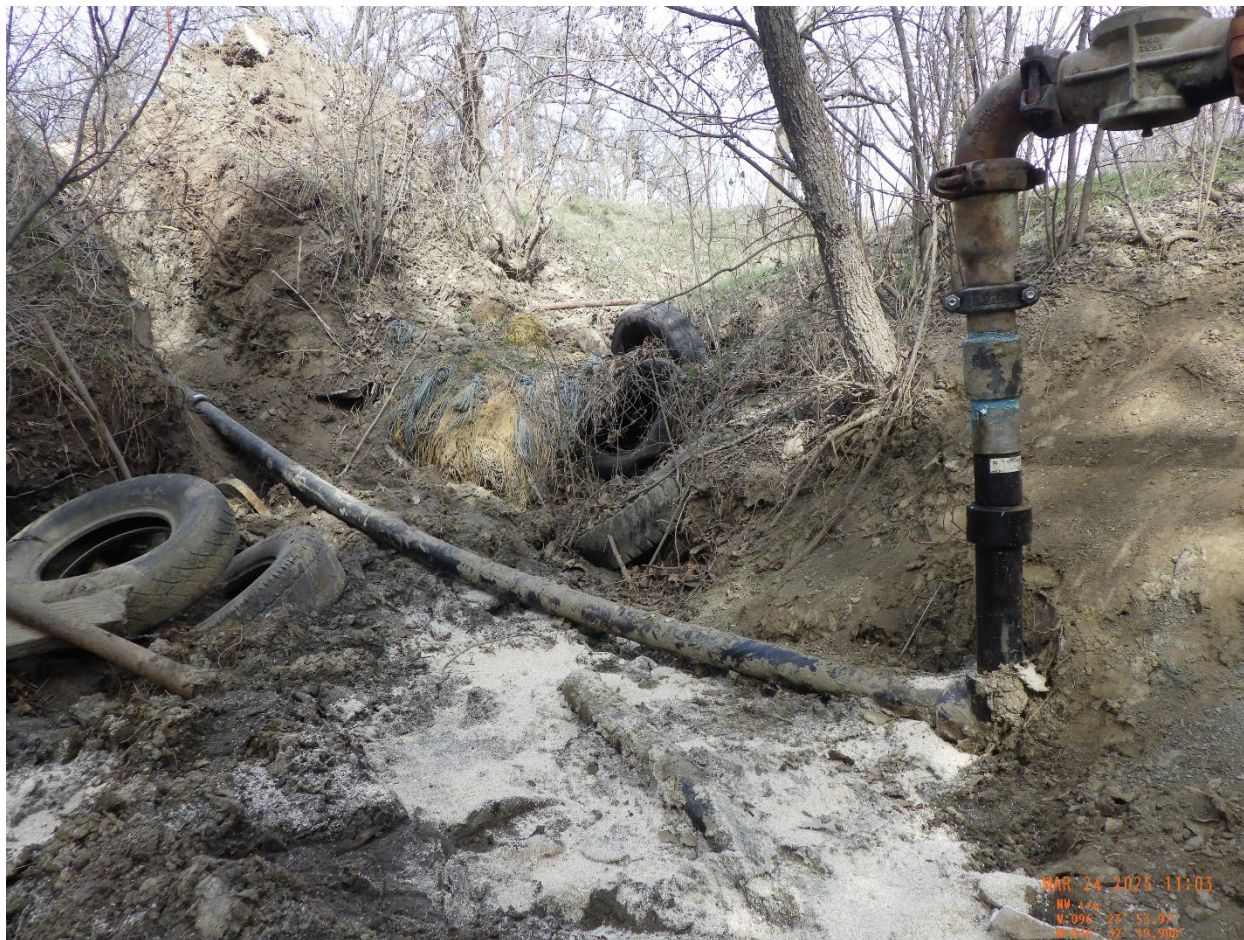
Photo No. 1

I observed the release point for the spill. At the time of the inspection the release point had been repaired through installation of a new 3" poly flowline. See photo No. 1. For additional GPS location information and photo metadata, please see Appendix 1 (photo log) attached to this report.

**Description:** This was the release point of the spill after the line was replaced.

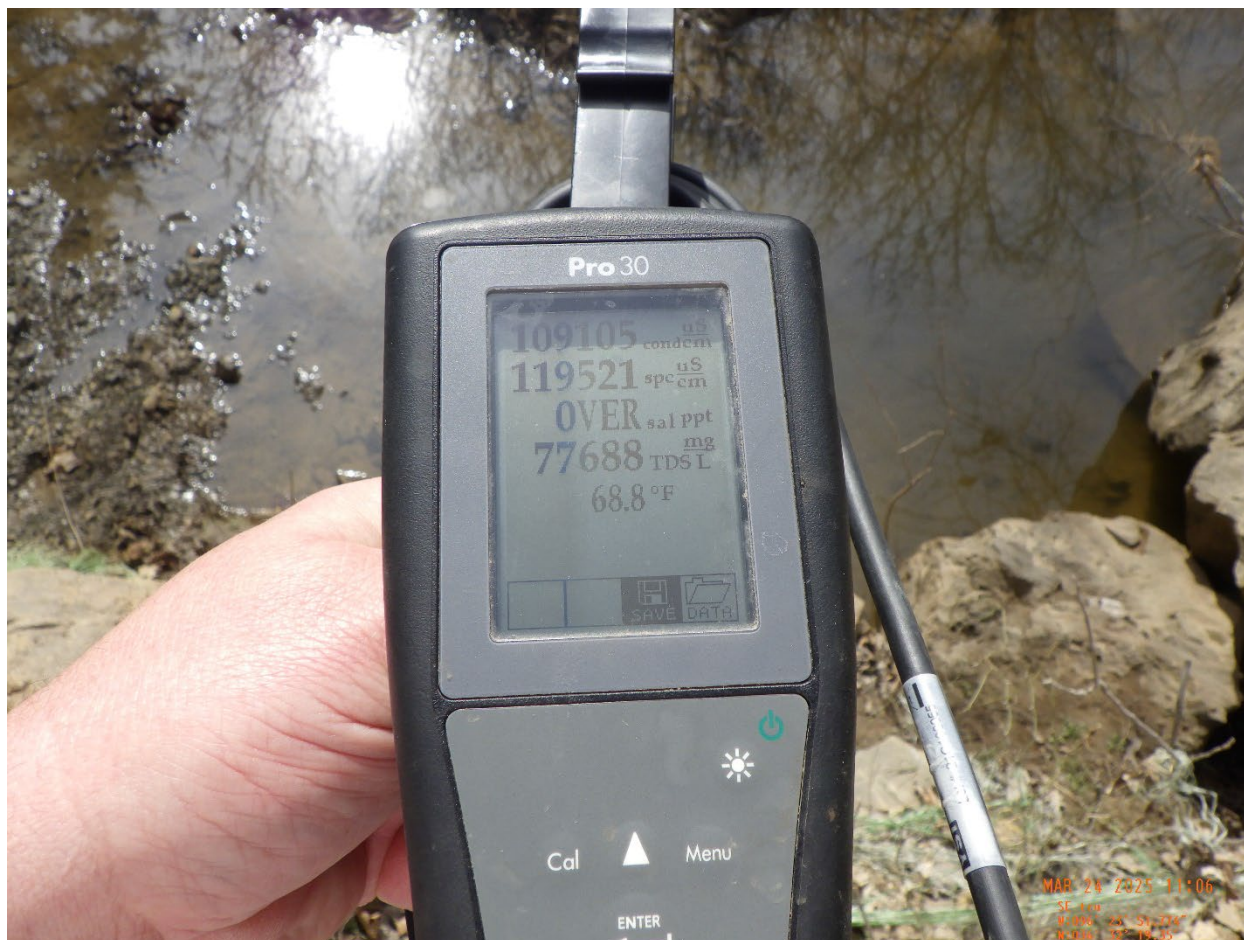
Photo No. 2

I observed a Total Dissolved Solids (TDS) field reading of 77,688 mg/L at the point of entry (POE) into the unnamed tributary of Little Hominy Creek. This was the highest TDS observation of the inspection. See photo No.2.

**Description:** This was a Total Dissolved Solids (TDS) field reading of 77,688 mg/L taken at the point of entry (POE) into the unnamed tributary of Little Hominy Creek. This was the highest TDS observation of the inspection.

The primary areas of concern included the elevated TDS waters in the unnamed tributary of Little Hominy Creek as well as the oil floating on Little Hominy Creek. Calgary Energy, LLC's representative, Connor Haag, was present during the inspection and noted the GPS location of each area where contamination should be removed from the impacted waterways.

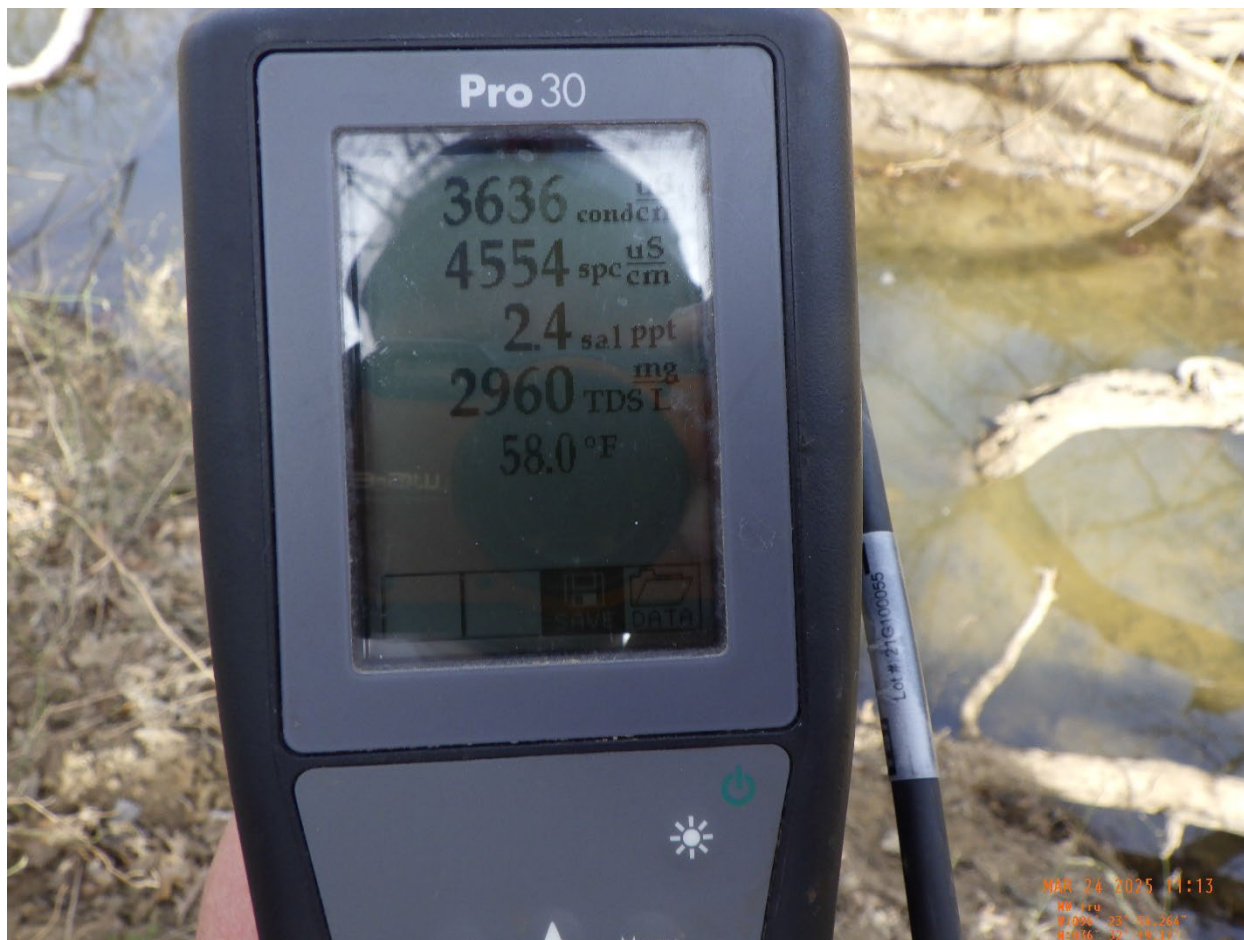
Photo No. 3

In the main channel of the impacted tributary, at the confluence with Little Hominy Creek, I observed a TDS field reading of 2,960 mg/L. See photo No. 3.

**Description:** This was a TDS field reading of 2,960 mg/L taken in the impacted tributary of Little Hominy Creek just before the confluence with Little Hominy Creek.

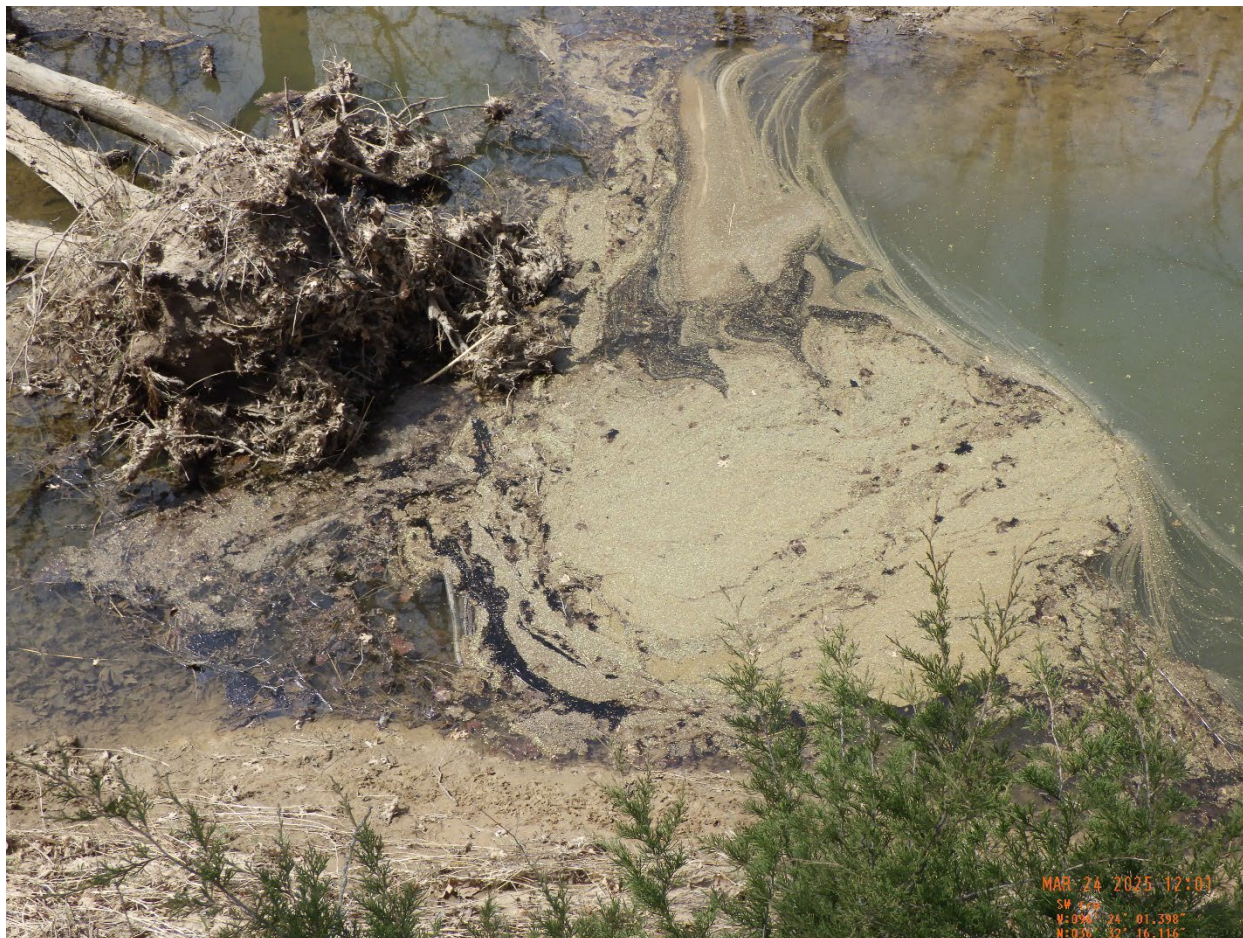
Photo No. 5

Approximately 1 mile downstream from the POE into Little Hominy Creek, I observed floating oil trapped in organic debris on the surface of the water. See photo No. 5.

**Description:** This was a photo of oil trapped in organic debris, floating on the surface of Little Hominy Creek approximately 1 mile downstream from the POE.
