Resource Conservation and Recovery Act (RCRA)
 Compliance Evaluation Inspection

Facility Name:	Alco High Tech Plastic, Inc.		
EPA ID Number:	PRR000027003		
Date of Inspection:	March 27, 2024		
Generator Status in Record:	LQG		
Generator Status at the time of inspection:	LQG		
RCRA Permitted:	No		
Basis for Inspection:	Core Program		
Corrective Action:	No		
Project ID	CEPD-RCRA-23-0441		
Facility Physical Location: (Municipality, PR, zip code)	State Road 159, km 13.5, Zona Industrial Cibuco, Corozal, Puerto Rico 00783		
Geographical Coordinates:	18°20'22.85" N, 66°19'14.87" W		
Facility Owner:	Mr. Gilberto Nieves, President/CEO	(787) 692-0297	
	gilbertonieves@alcohtgroup.com		
	Mailing address: State Road 159, km 13.5, Zona Industrial Cibuco, Corozal, Puerto Rico 00783		
Facility Operator:	Ms. Waleska Canting, Compliance Manager	(939) 599-8532	
	waleskacanting@alcohtgroup.com		
	Mailing address: State Road 159, km 13.5, Zona Industrial Cibuco, Corozal, Puerto Rico 00783		
NAICS:	326100 – Plastics Packaging Film and Sheet (Including Laminated) Manufacturing

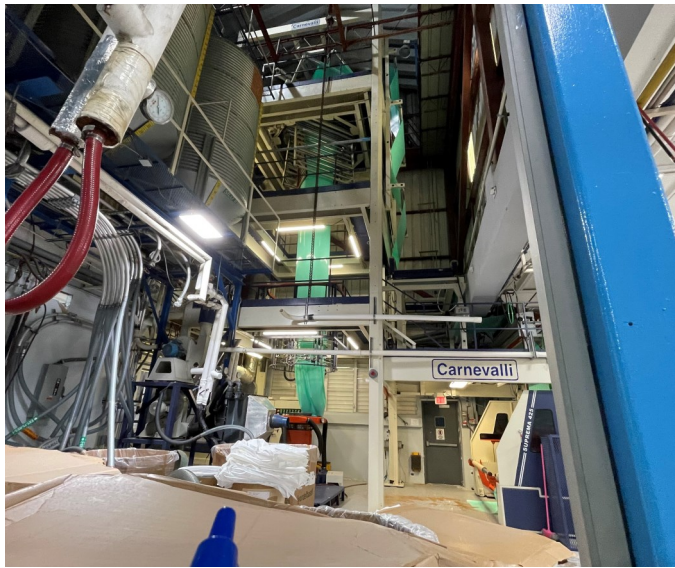
Ms. Canting escorted me to initially inspect the Plastic Extrusion area in which a high-volume manufacturing process was ongoing where raw plastic (pellets) is melted and formed into a continuous plastic layer. This process starts by feeding plastic material (pellets) from a hopper into the barrel of the extruder. The material is gradually melted by the mechanical energy generated by turning screws and by heaters arranged along the barrel (see **Pictures 1** and **2**). Most of the waste generated in this area are plastic residues or discarded plastic layers along with some cardboard boxes.

Picture 1 - ALCO HIGH TECH PLASTICS - At the Plastic Extrusion area, a high-volume manufacturing process is undertaken where raw plastic (pellets) is melted and formed into a continuous plastic layer.

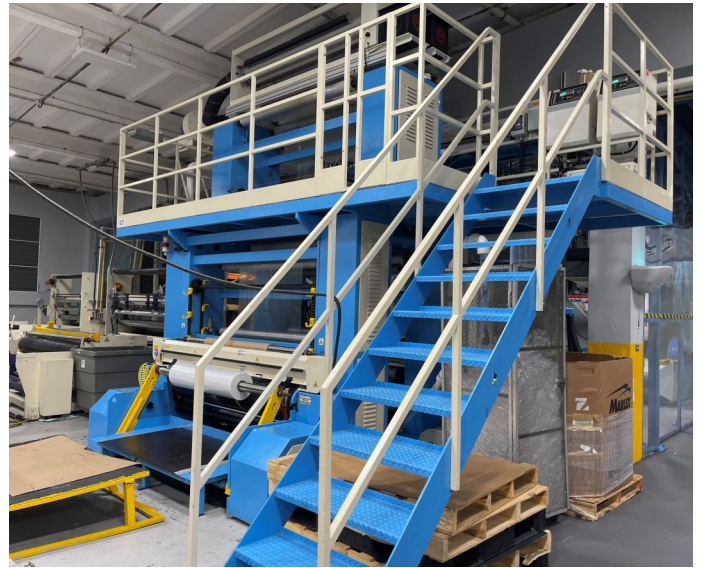
Picture 2 - ALCO HIGH TECH PLASTICS - At the Plastic Extrusion area, the material is gradually melted by the mechanical energy generated by turning screws and by heaters arranged along the barrel of the extruder.

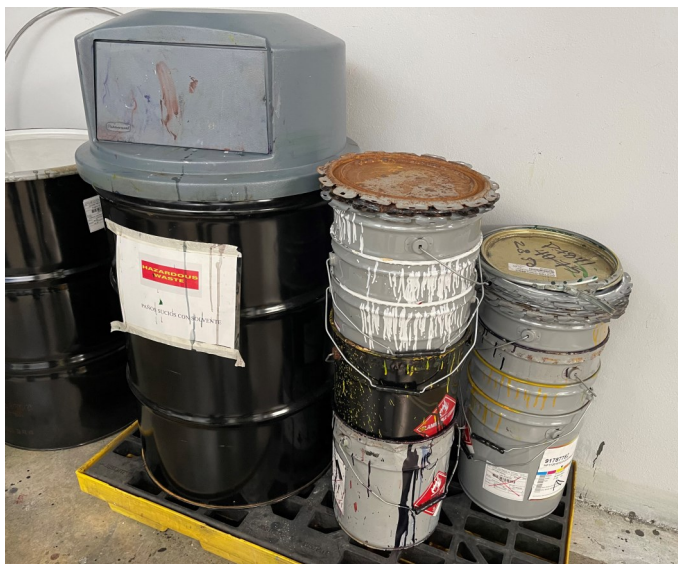
I proceeded to inspect the Plastic Extrusion Printing (SOMA) area where plastic pellets are forced through a heated nozzle, melting the material, and depositing it on a print surface roll. At the time of the Inspection, I observed one satellite area (SSA) containing one (1) 55-gallon black steel drum with impacted rags contaminated with spent liquid solvent waste of a mixture of propanol and ink, labeled as “Hazardous Waste,” and “Paños Sucios con Solventes,” and was not identified with its hazard communication pictogram as “Flammable Solids” (see **Picture 3**).

As observed by EPA Inspector, all containers were filled with spent solvents, and/or rags impacted with spent solvents which were not clearly labeled, coded, or identified with its hazard communication pictograms.

Picture 3 - ALCO HIGH TECH PLASTICS - At the Plastic Extrusion area (SOMA), there was a SSA with (1) 55-gallon black drum with impacted rags with spent liquid solvent waste containing a mixture of propanol and ink, labeled as “Hazardous Waste,” and not identified with its hazard communication pictogram as “Flammable Solids.”

I explained to Ms. Canting that pursuant to 40 CFR § 262.15(a)(5), a generator must mark or label its container with the words "Hazardous Waste," and must include an indication of the hazards of the content such as ignitable, corrosive, reactive, or toxic, a hazard communication consistent with the Department of Transportation requirements at 49 CFR Part § 172 Subpart E (labeling) or Subpart F (placarding), a hazard statement or pictogram consistent with the Occupational Safety and Health Administration Hazard Communication Standard at 29 CFR § 1910.1200; or a chemical hazard label consistent with the National Fire Protection Association code 704.

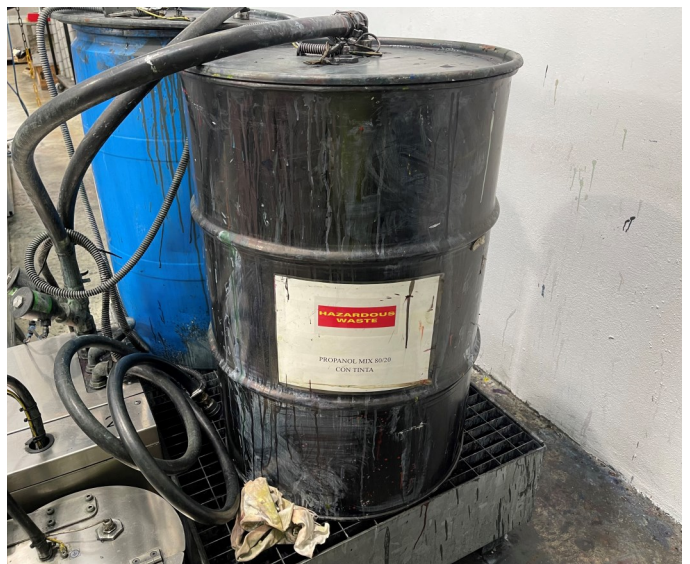
I also observed a second satellite area (SSA) containing one (1) 55-gallon black steel drum with spent liquid solvent waste containing a mixture of propanol mix 80/20 and ink waste, labeled as “Hazardous Waste,” and “Propanol Mix 80/20 Con Tinta,” and was not identified with its hazard communication pictogram as “Flammable Liquids” (see **Picture 4**). According to Ms. Canting, the mixture of propanol mix 80/20 and ink waste is generated from ink changes and cleaning of the machine after printing campaigns.

Picture 4 - ALCO HIGH TECH PLASTICS - At the Plastic Extrusion area (SOMA), there was a second SSA with one (1) 55 -gallon black drum with with spent liquid solvent waste containing a mixture of propanol and ink, labeled as “Hazardous Waste,” and not identified with its hazard communication pictogram as “Flammable Liquids.”

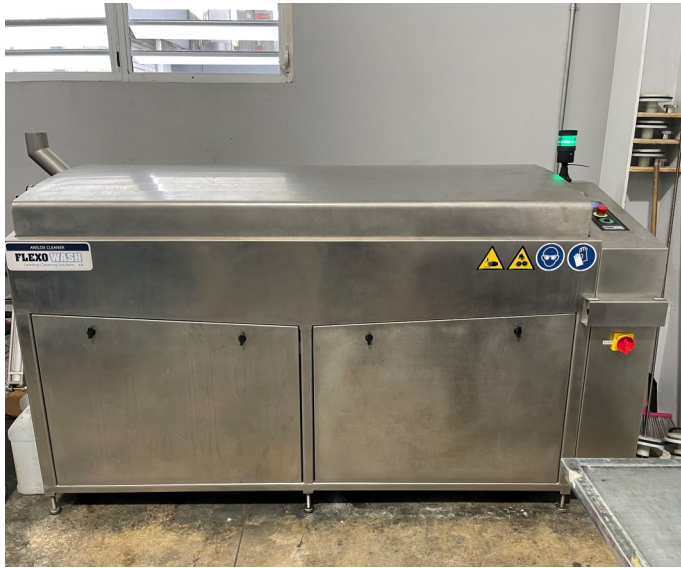
defined amount of ink during the printing process. The SSA contained one (1) 300-gallon stainless steel tank used for cleaning anilox rollers which generates spent solvents characterized as corrosive-oxidizer, and human irritant. The SSA was not labeled with the words, "Hazardous Waste," nor identified with its hazard communication pictogram as "Corrosive Liquids" (see **Picture 5**).

Picture 5 - ALCO HIGH TECH PLASTICS - At the Plastic Extrusion area (SOMA), there was a third SSA with one (1) 300-gallon stainless steel tank used to clean anilox rollers not labeled with the words, “Hazardous Waste,” nor identified with its hazard communication pictogram as “Corrosive Liquids.”

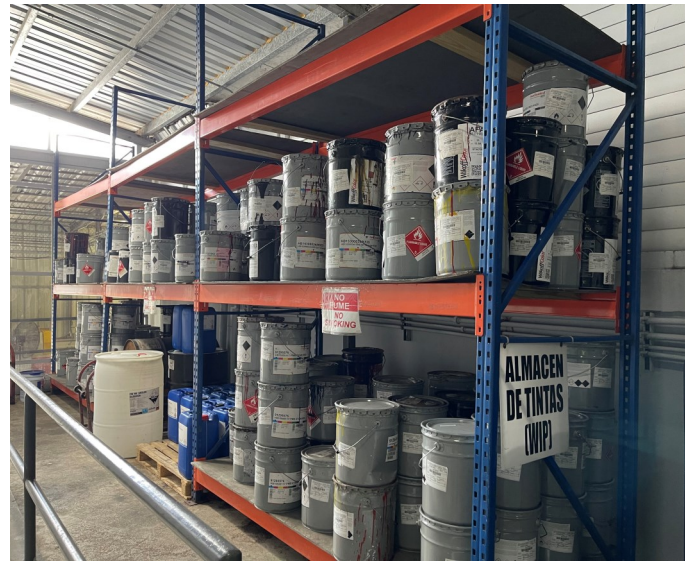
I proceeded to inspect the Ink Warehouse area where all new ink products are stored in 5-gallon pails (i.e., Cyan, Magenta, Yellow and Black) for immediate use in plastic printing machines (see **Picture 6**).

Picture 6 - ALCO HIGH TECH PLASTICS - At the Ink Warehouse area EPA Inspector observed that all new ink products are stored in 5-gallon pails (i.e., Cyan, Magenta, Yellow and Black) for immediate use in plastic printing machines.

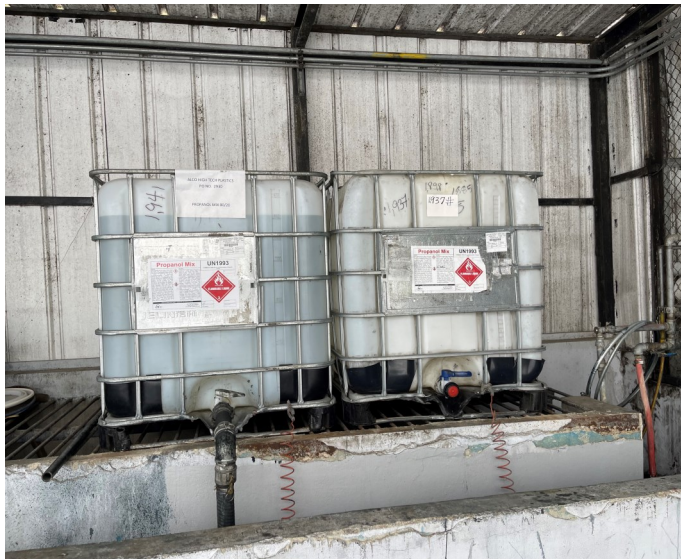
I proceeded to inspect the Alcohol Warehouse area where all Propanol Mix 80/20 solvent products (i.e., UN 1993 – Flammable Liquids) are stored in two (2) 275-gallon totes for future use in plastic printing machines (see **Picture 7**). At this area, I observed a part-washer machine that was used to clean anilox and/or plaster rollers until the new SAA Washing Machine unit was installed nearby the plastic printing machines. According to Ms. Canting, this part-washer has been discontinued and emptied over a year ago and is not currently in use (see **Picture 8**).

Picture 7 - ALCO HIGH TECH PLASTICS - At the the Alcohol Warehouse area, it was observed that all Propanol Mix 80/20 solvent products (i.e., UN 1993 – Flammable Liquids) are stored in two (2) 275-gallon totes for future use in plastic printing machines.

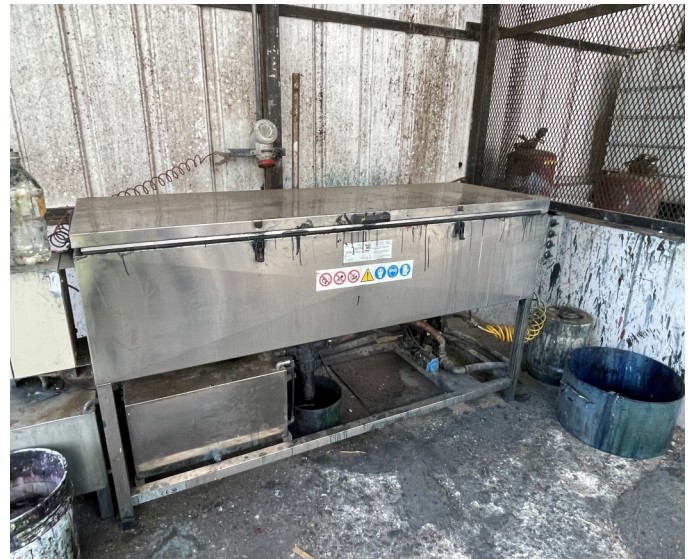
Picture 8 - ALCO HIGH TECH PLASTICS— At the Alcohol Warehouse, I observed a part-washer machine that was used to clean anilox and/or plaster rollers until the new SAA Washing Machine unit was installed nearby the plastic printing machines. This part-washer has been discontinued and emptied over a year ago and is not currently in use.

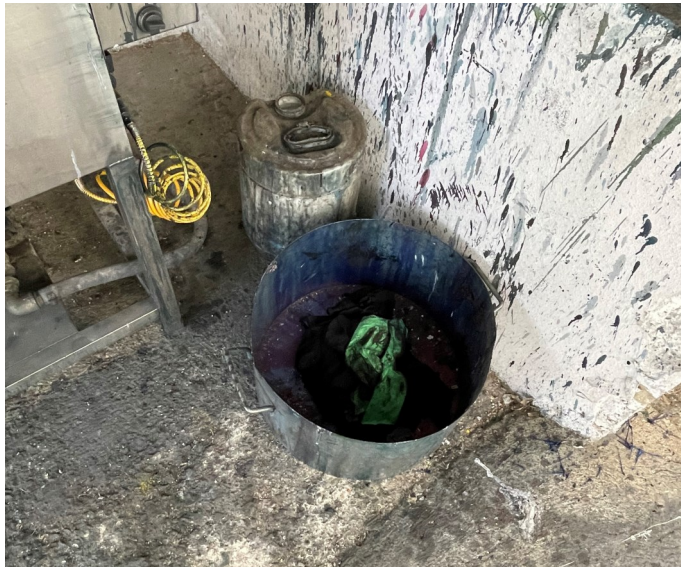
In addition, I observed one (1) ½-cut 55-gallon blue plastic drum "open" with impacted rags contaminated with spent liquid solvent waste of a mixture of propanol and ink, not labeled as "Hazardous Waste," nor identified with its hazard communication pictogram as "Flammable Solids" (see **Picture 9**). I explained to Ms. Canting that pursuant to 40 CFR § 262.15(a)(4) a container holding hazardous waste must be closed at all times during accumulation, except when adding, removing, or consolidating waste. Also, I reiterated that pursuant to 40 CFR § 262.15(a)(5), a generator must mark or label its container with the words "Hazardous Waste," and must include an indication of the hazards of the content such as ignitable, corrosive, reactive, or toxic or a hazard communication pictogram,

Picture 9 - ALCO HIGH TECH PLASTICS - At the Alcohol Warehouse, I observed one (1) ½-cut 55-gallon blue plastic drum “open” with impacted rags contaminated with spent liquid solvent waste of a mixture of propanol and ink, not labeled as “Hazardous Waste,” nor identified with its hazard communication pictogram as “Flammable Solids.”

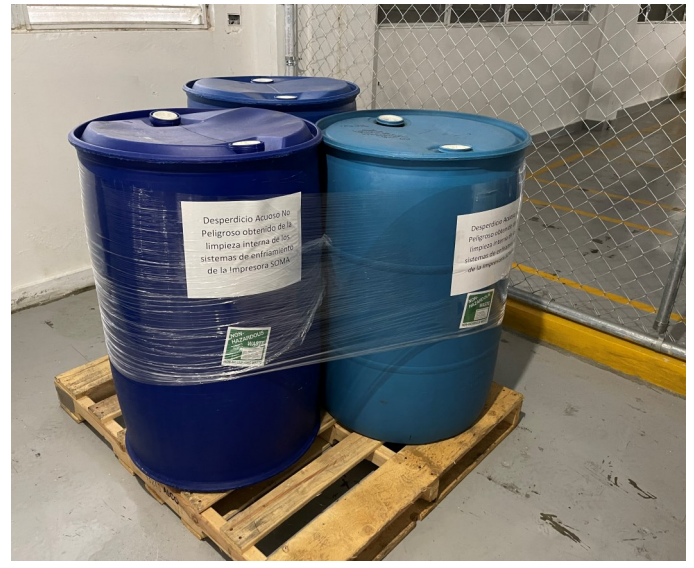
- characterized as non-hazardous and were clearly labeled with the words, “Non-Hazardous Waste,” (see **Picture 10**).
- ii. Two (2) 55-gallon drums, one steel black and the other plastic white, containing rags impacted with glue and spent acetone and methyl ethyl ketone generated from cleaning activities of the plastic lamination process. Both drums were clearly labeled with the words, “Hazardous Waste,” and dated on March 7, 2024, and March 11, 2024, respectively, coded as “D035” (MEK -methyl ethyl ketone), and one of them (steel black) identified with its hazard communication pictograms as, “Flammable.” The 55-gallon white plastic drum did not have its hazard communication pictograms (see **Picture 11**).

Picture 10 - ALCO HIGH TECH PLASTICS - At the 90-day Hazardous Waste Accumulation area, I observed three (3) 55-gallon blue plastic drums containing aqueous wastes generated from the cleaning activities of the cooling system of the SOMA Printing Machine, all clearly labeled with the words, “Non-Hazardous Waste.”

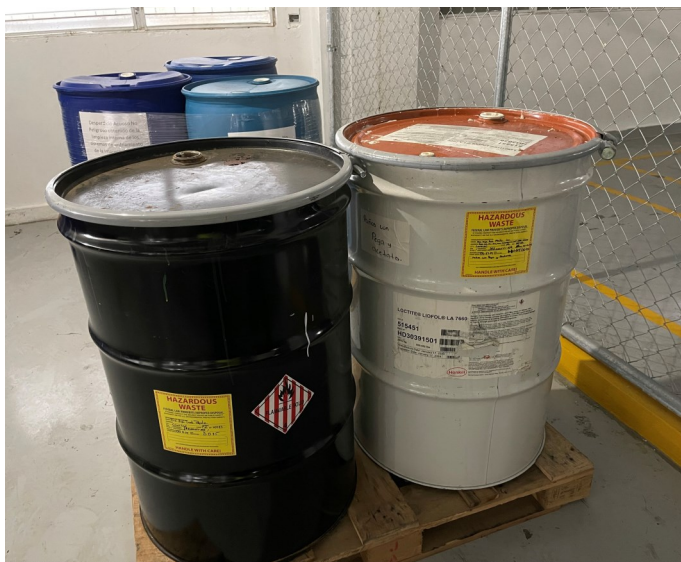
Picture 11 - ALCO HIGH TECH PLASTICS - At the 90-day Hazardous Waste Accumulation area, I observed two (2) 55-gallon drums containing rags impacted with glue and spent acetone, clearly labeled with the words, “Hazardous Waste,” and dated on March 7, 2024, and March 11, 2024, respectively.

- iii. EPA Inspector found various drums and containers located in the HWAA and SAAs that must be marked or labeled with the words "Hazardous Waste," and must include an indication of the hazards of the content such as ignitable, corrosive, reactive, or toxic or a hazard communication pictogram.

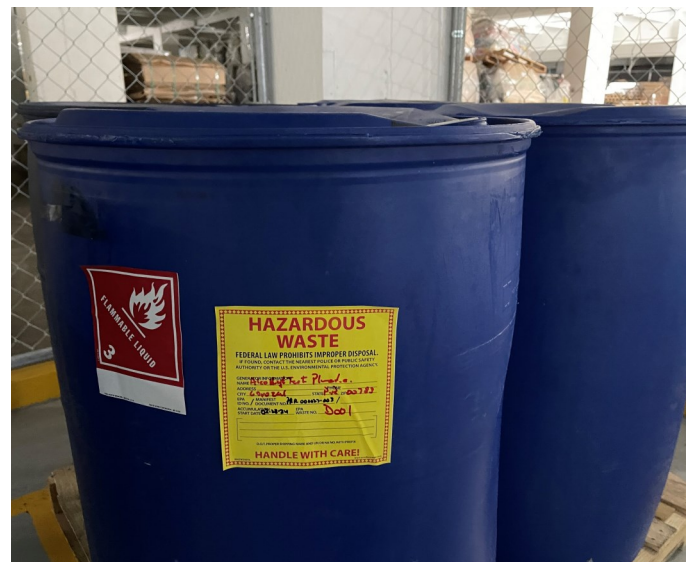
- iii. Seven (7) 55-gallon blue plastic drums containing spent liquid solvent waste made up of a mixture of propanol mix 80/20 and ink waste and coded as “D001” (Ignitable). All drums were clearly labeled with the words, “Hazardous Waste,” and dated on February 13, 2024, February 15, 2024, February 20, 2024, February 28, 2024, March 7, 2024, and two March 11, 2024, respectively. Also, all drums were identified with its hazard communication pictograms as, “Flammable Liquids” (**Picture 12**).

Picture 12 - ALCO HIGH TECH PLASTICS- At the 90-day Hazardous Waste Accumulation area, I observed seven (7) 55-gallon blue plastic drums containing with spent liquid solvent waste containing a mixture of propanol mix 80/20 and ink waste and coded as “D001” (Ignitable). All drums were clearly labeled with the words, “Hazardous Waste,” and dated Feb-Mar 2024.

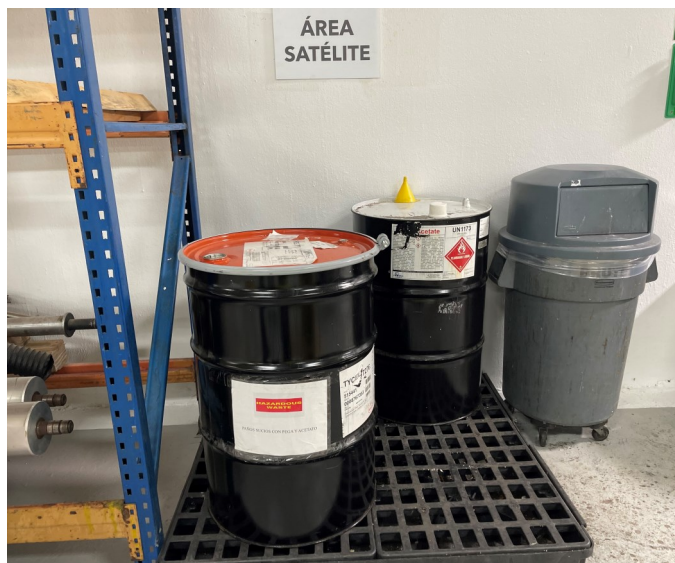
I proceeded to inspect the Plastic Lamination area where two or more layers of material are put together to create multi-layered plastic sheet. Laminating improves the physical properties of a plastic sheet, such as the impact strength, stability, and sound insulation. As part of the plastic lamination, glue is applied to plastic layers to put them together. At the time of the Inspection, I observed two satellite areas (SSAs) containing each one (1) 55-gallon black steel drum with impacted rags contaminated with glue and spent ethyl acetate, labeled as “Hazardous Waste,” and “Paños Sucios con Pega y Acetato,” and was not identified with its hazard communication pictogram as “Flammable Solids” (see **Picture 14**).

Picture 14 - ALCO HIGH TECH PLASTICS- At the Plastic Lamination one (1) 55-gallon black steel drum with impacted rags contaminated with glue and spent ethyl acetate, labeled as “Hazardous Waste,” and “Paños Sucios con Pega y Acetato,” and was not identified with its hazard communication pictogram as “Flammable Solids”

I reiterated that pursuant to 40 CFR § 262.15(a)(5), a generator must mark or label its container with the words “Hazardous Waste,” and must include an indication of the hazards of the content such as ignitable, corrosive, reactive, or toxic or a hazard communication pictogram,

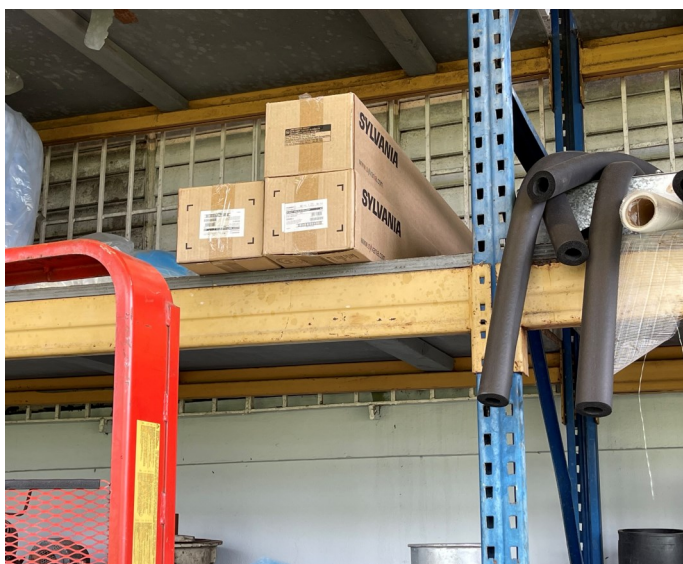
Picture 15-ALCO HIGH TECH PLASTICS- At the Universal Waste Storage area, I observed five (5) square cardboard boxes (1’x1’x 4’) packing over forty (40) 4-foot spent fluorescent lamps, some open and not labeled with the words, “Universal Waste.”

I stated that pursuant to 40 CFR 273.14(e), each lamp or a container or package in which lamps are contained must be labeled or marked clearly with the words, “Universal Waste-Lamp(s),” or “Waste Lamp(s),” or “Used Lamp(s).” I also stated that pursuant to 40 CFR § 273.13(d)(1), a small quantity handler of universal waste must contain any lamp in containers or packages that are structurally sound, adequate to prevent breakage, and compatible with the contents of the lamps. Such containers and packages must remain closed and must lack evidence of leakage, spillage or damage that could cause leakage under reasonably foreseeable conditions.

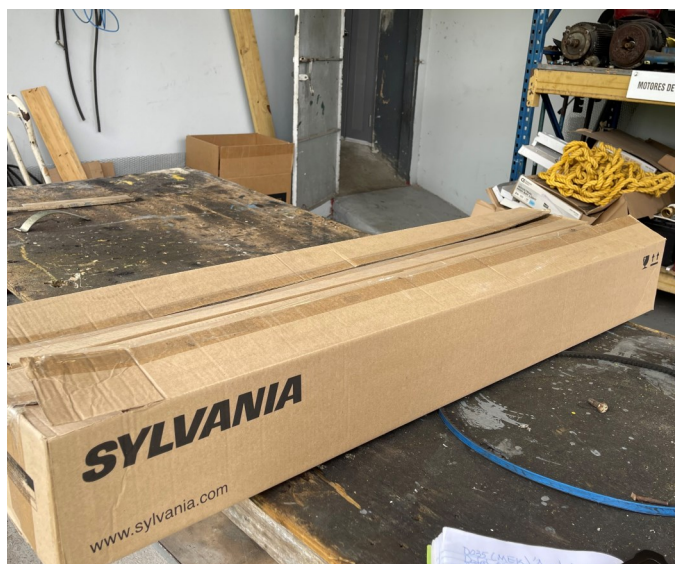
Picture 16 - ALCO HIGH TECH PLASTICS- At the Universal Waste Storage area, I also observed five (5) square cardboard boxes (1’x1’x 4’) packing over forty (40) 4-foot spent fluorescent lamps, not labeled with their accumulation start dates.

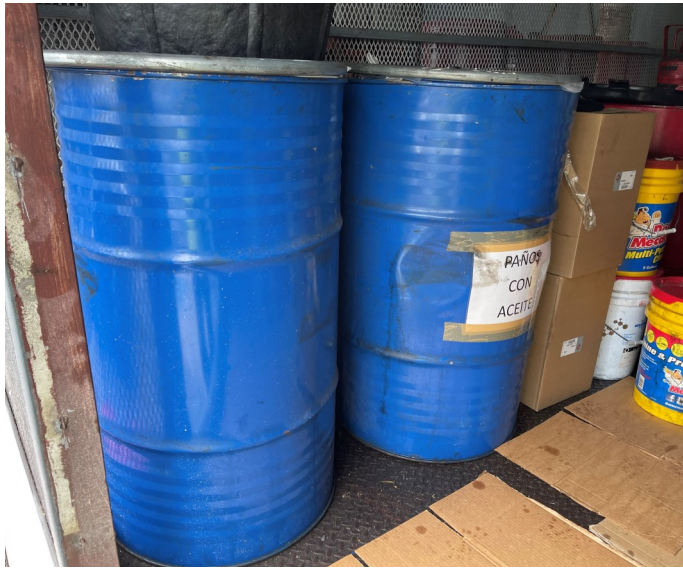
Picture 17- ALCO HIGH TECH PLASTICS— At the Used Oil Storage area, I observed one (1) 55-gallon blue steel drums with impacted rags with used oil not marked with the words, "Used Oil."

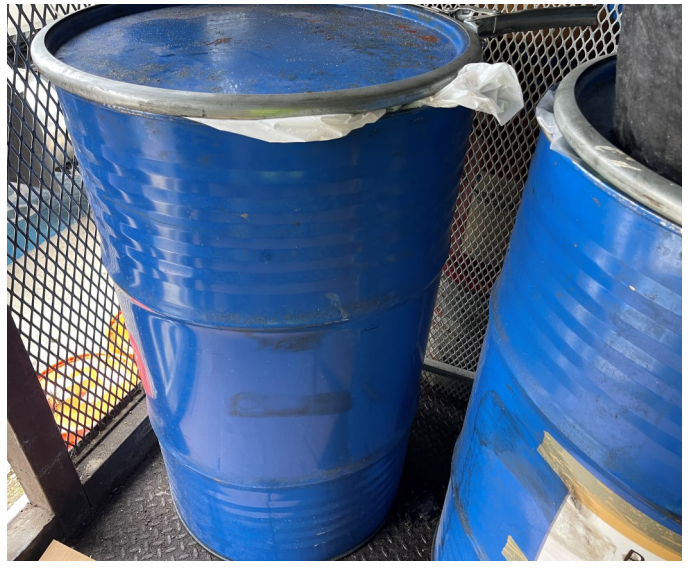
Picture 18 - ALCO HIGH TECH PLASTICS- At the Used Oil Storage area, I observed one (1) 55-gallon blue steel drums with impacted used oil filters not marked with the words, "Used Oil."

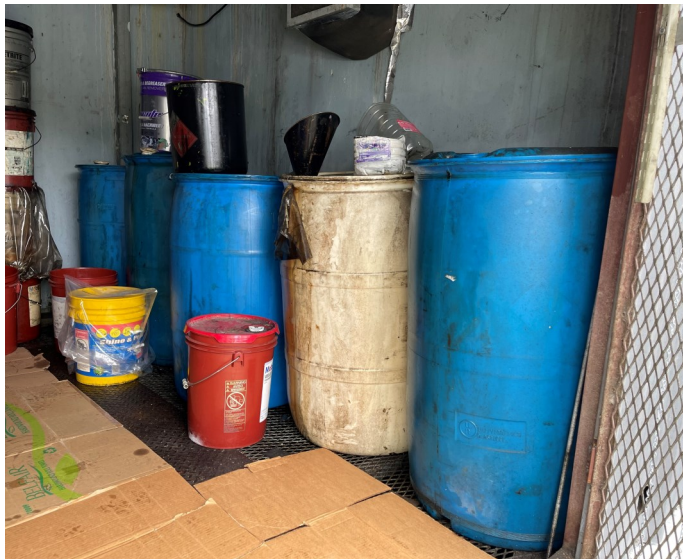
Picture 19-ALCO HIGH TECH PLASTICS- At the Used Oil Storage area, I observed five (5) 55-gallon blue/white plastic drums with used oil not marked with the words, "Used Oil."

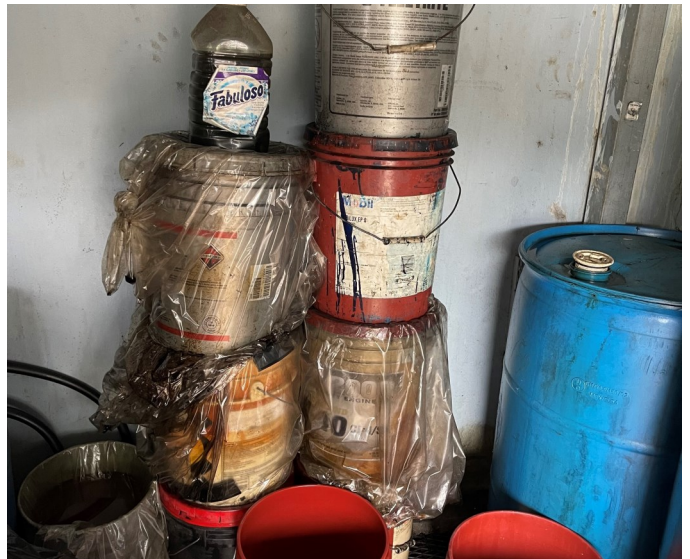
Picture 20 - ALCO HIGH TECH PLASTICS- At the Oil Storage area, I observed seven (7) 5-gallon orange/gray plastic containers with used oil not marked with the words, "Used Oil"
