## RCRA Compliance Evaluation Inspection Report

United States Naval Air Station Pensacola  
150 Hase Rd.  
Pensacola, Florida 32508  
EPA ID #: FL9170024567

March 2, 2022, 9:30 a.m.

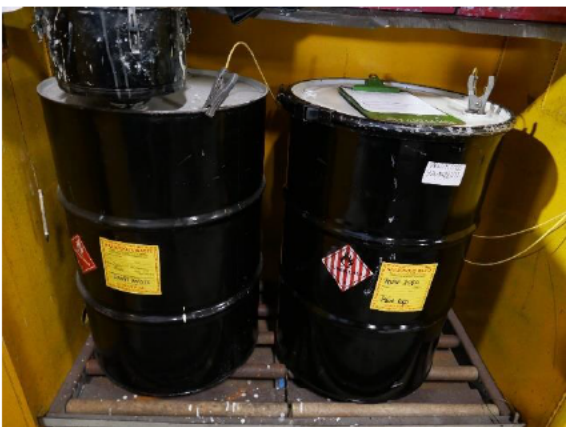
Photograph #1 - Building (b) (3) (A)

Building 3580 Corrosion Control is primarily conducting work on ground support equipment and paint operations with paint booths run by a contractor. The building has a multi-waste stream SAAs. The inspectors observed thirteen hazardous waste containers (ranging from 5-gallons to 55-gallons) of paint waste (Photograph #1), media blast, oily rags contaminated with metal, fuel rags, acid rags, parts washer sludge, paint chips and paint booth filters; five non-hazardous waste containers of oil spill debris, antifreeze, used oil filters, and silica waste; and one 30-gallon container of universal waste aerosol cans with an accumulation start date of December 25, 2021.

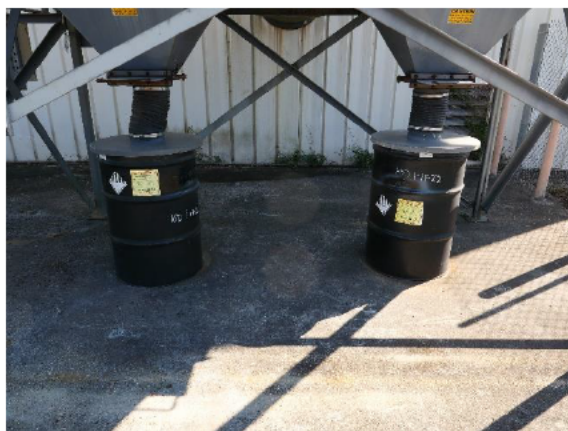
Outside the building in a fenced area were two baghouse hoppers connected to two 55-gallon containers (Photograph #2). The containers collect the spent plastic media blast (PMB) from a blasting media unit. The PMB waste (D006 and D007) containers were dated January 19, 2022. The containers were marked with a DOT class 9 diamond indicating a "Miscellaneous" hazard.

Photograph #2 - (b) (3) (A) spent plastic blast media container.

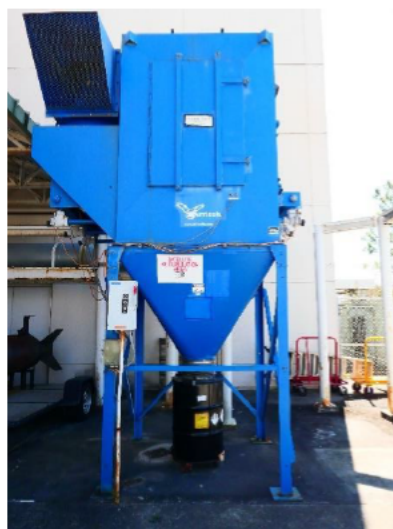
Photograph #6: (b) (3) (A)

Lab 2812-there were two small paint booths adjacent to the paint blast unit. There were two 55-gallon containers of hazardous paint waste and paint rags; and two 5-gallon containers of Alodine rags and Alodine waste. The lab staff stated that paint booth filters are removed when the paint booth meter indicates a specified air resistance on the filters. The contractor removes the paint booth filters as hazardous waste and transport them directly to the 90-day storage area. Outside Building 3460, there was a baghouse hopper connected to a 55-gallon container of hazardous spent paint chips/plastic blast media. The baghouse hopper (Photograph # 6) is connected to a paint blast media unit in Lab 2812.

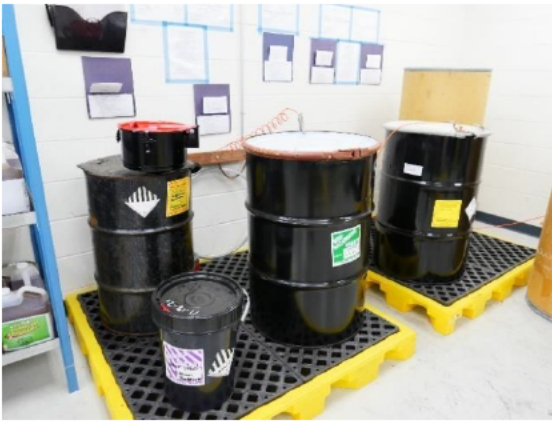
Photograph #7 – (b) (3) (A)

Lab 2651-the inspectors observed three 55-gallon containers of hazardous oil contaminated with metals, dielectric solvent waste, and test patches with metals; one 55-gallon container of non-hazardous oily rags; one 15-gallon container of hazardous aerosol cans; and a 5-gallon container of universal waste lithium batteries dated November 18, 2021 (Photograph #7).

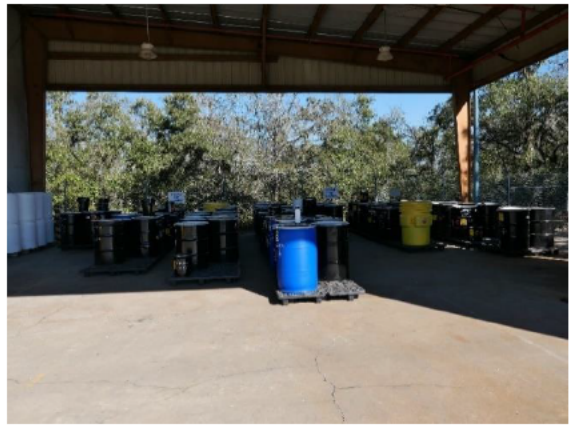
Photograph #8 – (b) (3) (A)

Building 684-A is the main less than 90-day hazardous waste storage area for the NAS Pensacola. The entire 90-day area facility is fenced in and has the appropriate signage on the gate (Photograph #8). It is a large warehouse building with an outdoor covered garage port and indoor storage space. Hazardous, non-hazardous wastes, and used oil containers are stored under the covered garage port. Hazardous, non-hazardous wastes, universal waste, and a lamp crushing unit are located inside the building. Immediately adjacent to Building 684-A is Building 684. The facility personnel described Building 684 is a specially designed hazardous materials storage building with built in divided storage aisles and spill containment trench system to prevent the release of waste to the outside environment (Photograph #9). Due to national incinerator backlog issues, NAS Pensacola began storing hazardous waste longer than 90-days in Building 684-A and Building 684. NAS Pensacola has been working with FDEP since June 2021 to ensure hazardous waste storage extension requests were submitted in accordance with 40 C.F.R. § 262.17(b).

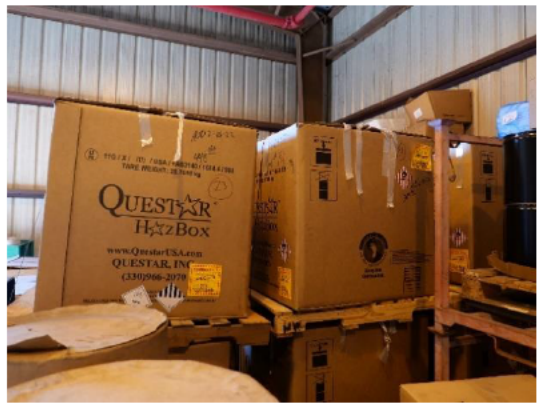
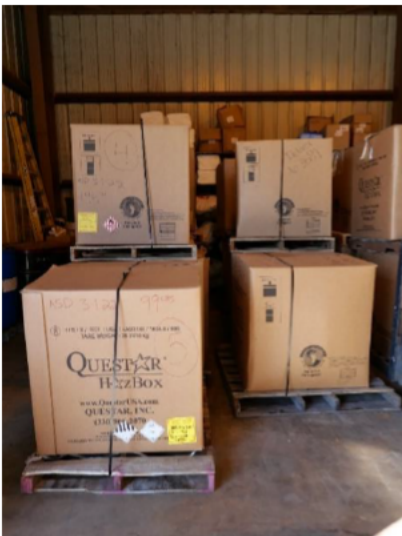
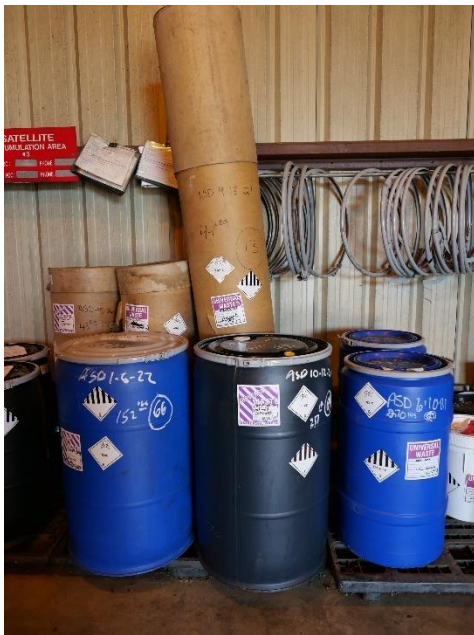
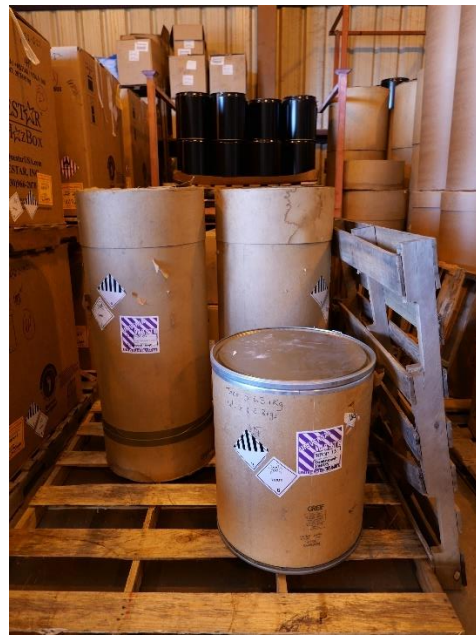
The indoor storage area was congested with containers placed closely together and some containers were also noted over the edges of the pallets (Photographs #10-11 and #13-14). Adequate aisle space was not observed in the indoor storage area. The inspector's movement was obstructed to inspect all containers due to no aisle space.

**Pursuant to Fla. Admin. Code Ann. r. 62-730.160(1) [40 C.F.R. § 262.17(a)(6)], which incorporates Fla. Admin. Code Ann. r. 62-730.160(1) [40 C.F.R. § 262.255], and is a condition of the LQG Permit Exemption, a generator must maintain aisle space to allow the unobstructed movement of personnel, fire protection equipment, spill control equipment, and decontamination equipment to any area of facility operation in an emergency, unless aisle space is not needed for any of these purposes.**
