**UNITED STATES ENVIRONMENTAL PROTECTION AGENCY**  
New England Regional Laboratory  
Laboratory Services and Applied Sciences Division  
11 Technology Drive  
North Chelmsford, MA 01863-2431

**Subject:** Reconnaissance and Sampling Inspection Report  
Clean Water Act – National Pollutant Discharge Elimination System  
Hartford, Connecticut

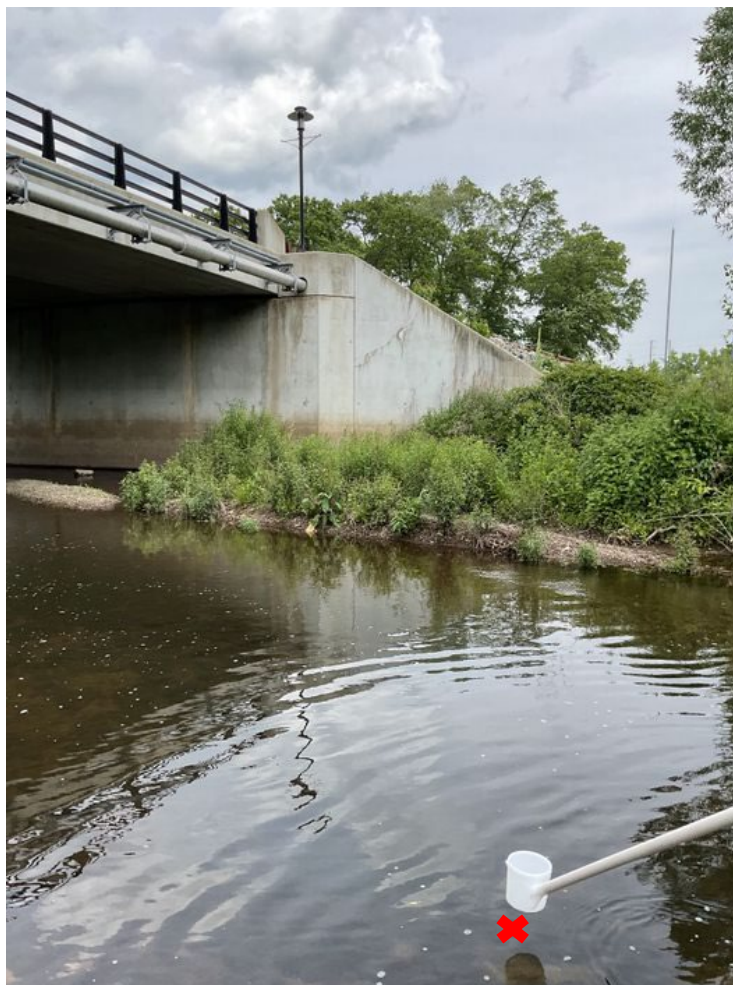
- **HartSW-A:** In-stream sample of North Branch Park River, collected by the northern end of Lot D, at the University of Hartford, approx. 25 ft downstream of the adjacent bridge and 4 feet from the bank of the stream. No odor was observed. Color and turbidity were clear. Some suds were observed on the surface of the stream. Some green filamentous algae growth was observed on the streambed. No bacteria samples were collected due to holding time constraints.

**Photo 1: HartSW-A** (photo taken 06/14/2023 at approx. 11:25) Surface water sample of North Branch Park River near 200 Bloomfield Ave. Sample points are indicated by a red X.

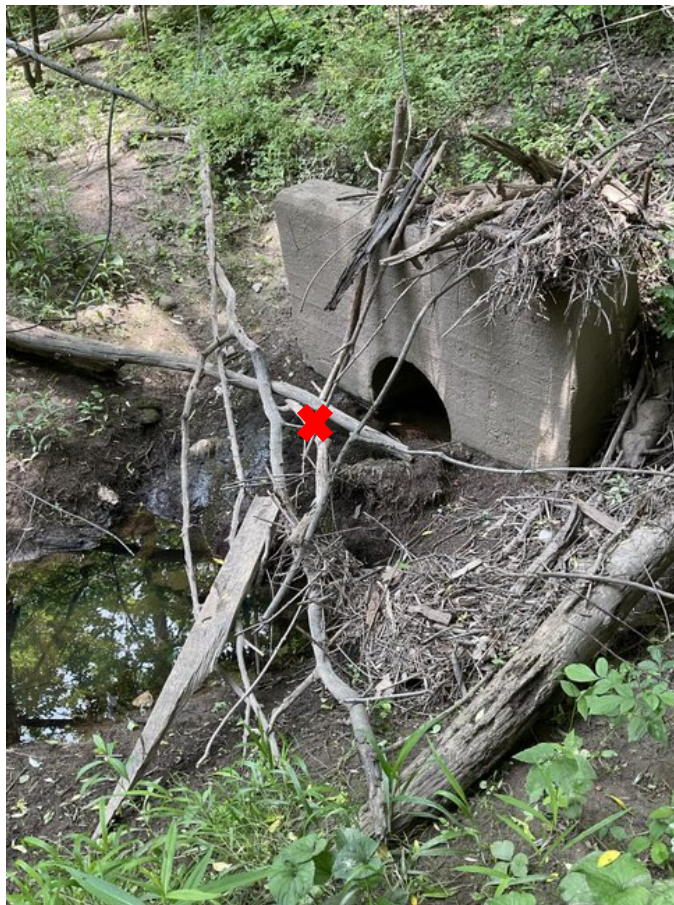
- **Hart09**: a single concrete, circular outfall, approximately 18 inches in diameter, located at 126 Mark Twain Drive. Discharge flow was approximately less than 5 gallons per minute (gpm) into North Branch Park River. Sample was collected 6 inches downstream of the mouth of the outfall. No odor was observed. Color and turbidity were clear. No floatables were observed. Some sediment build up was observed on the interior of the pipe. Algae growth was also observed inside the pipe.

**Photo 3: Hart09** (photo taken 06/15/2023 at approx. 08:19) Outfall located near 126 Mark Twain Drive, discharging into the North Branch Park River. Sample points are indicated by a red X.

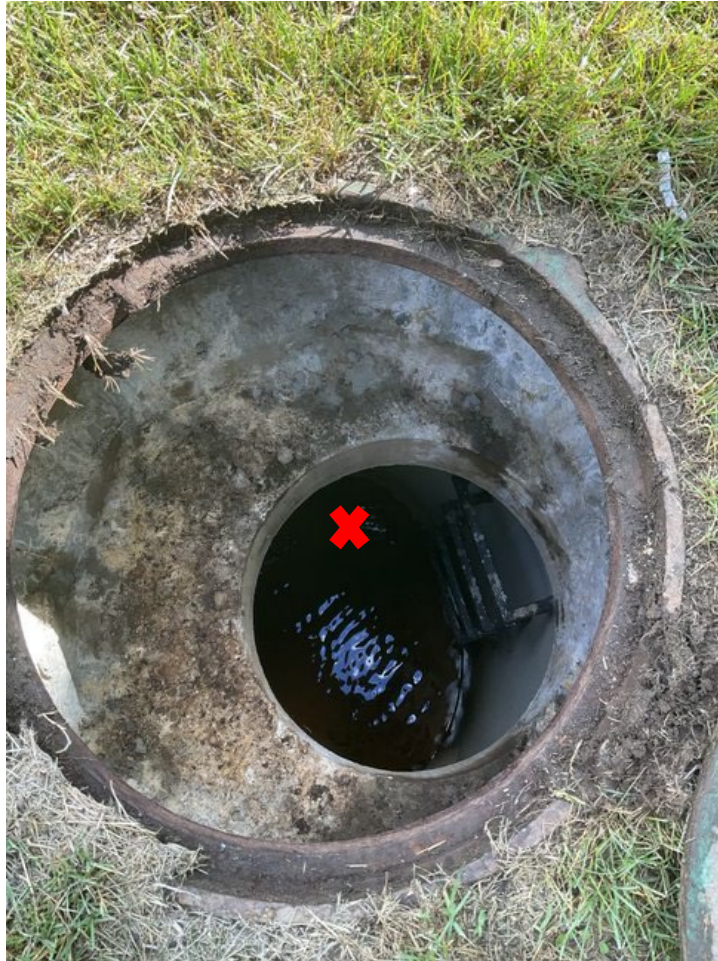
- **Hart01AG**: a single, concrete, circular outfall, in a manhole, conveying flow from the east, approximately 42 inches in diameter, located near 353 Granby Street. Discharge flow was approximately less than 5 gpm into the underground stormwater piping which flows to North Branch Park River. Sample was collected at the mouth of the outfall. No odor was detected. Color and turbidity were clear. No floatables were observed.

**Photo 5: Hart01AG** (photo taken 06/15/2023 at approx. 09:50) Outfall located near 353 Granby Street, discharging into the North Branch Park River. Sample points are indicated by a red X.
