**Region 6 - Enforcement & Compliance Assurance Division**  
**INSPECTION REPORT**

| Inspection Date(s): | 09/09/2024 to 09/12/2024 | | | |
| Regulatory Program(s) | CWA – NPDES | | | |
| Facility Name: | Los Alamos National Laboratory | | | |

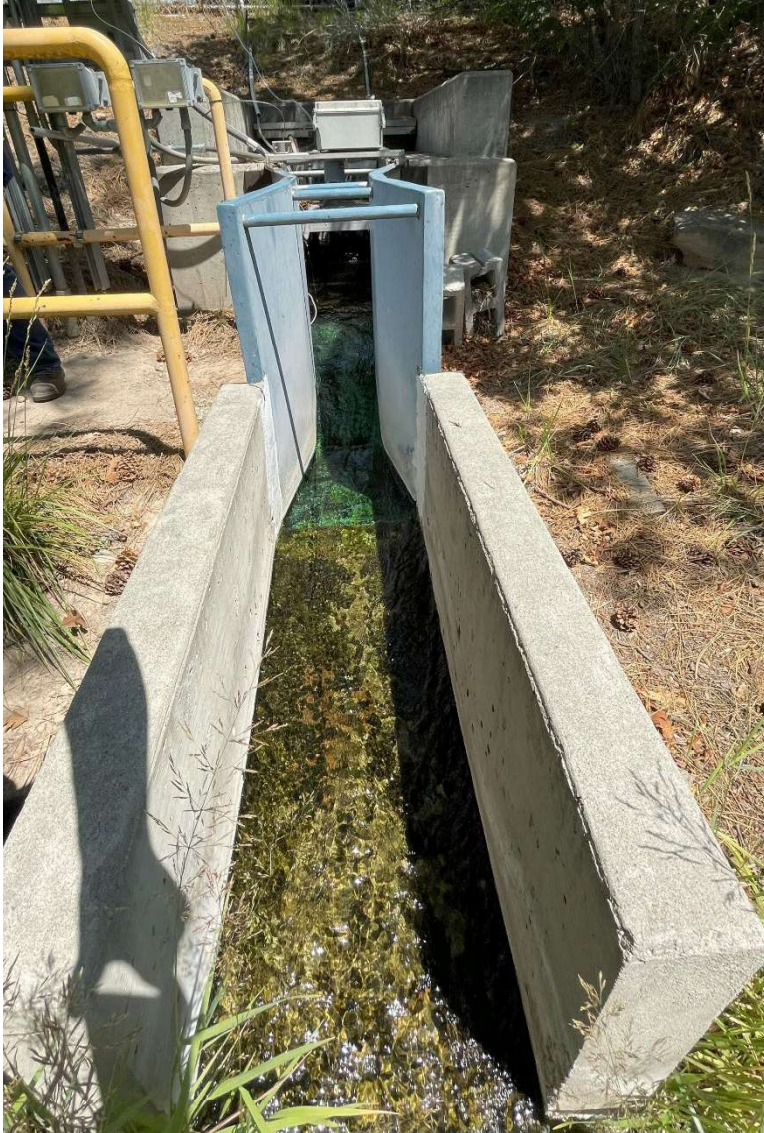
Photo File Name: Outfall 001, 20240715, 1053.PNG

- Surrounding vegetation near outfall 001 was overgrown on the date of this inspection.
- Concrete structure surrounding the outfall was deteriorating and many cracks were visible.

- The staff gauge at the effluent Parshall Flume had algae buildup and was damaged at the current flow level, making it impossible to read. Facility personnel were unable to provide documentation showing that they check the electronic flow meter against the primary flow meter on a regular basis; This verification must be done monthly.

Flow measurement device at Outfall 001 is not maintained properly and must be repaired by a qualified technician. Secondary flow meters must be confirmed and documented monthly to be within 10% of primary flow meters.

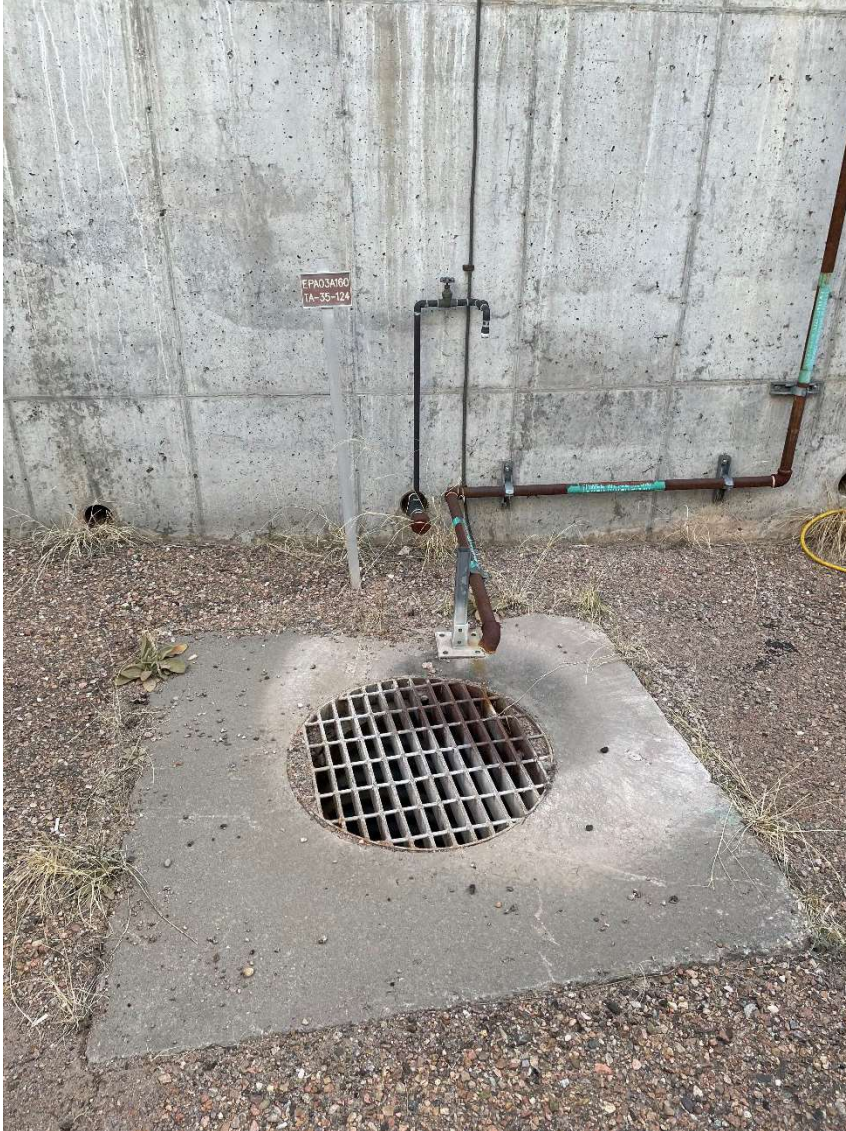
Photo File Name: Outfall 03A160, 20240226, 0919.jpg

- Outfall 03A160 is a culvert in the ground with the outfall pipe on a canyon cliff face. Due to safety hazards of scaling the cliff face, the sample location is after all treatment but prior to actual discharge location.

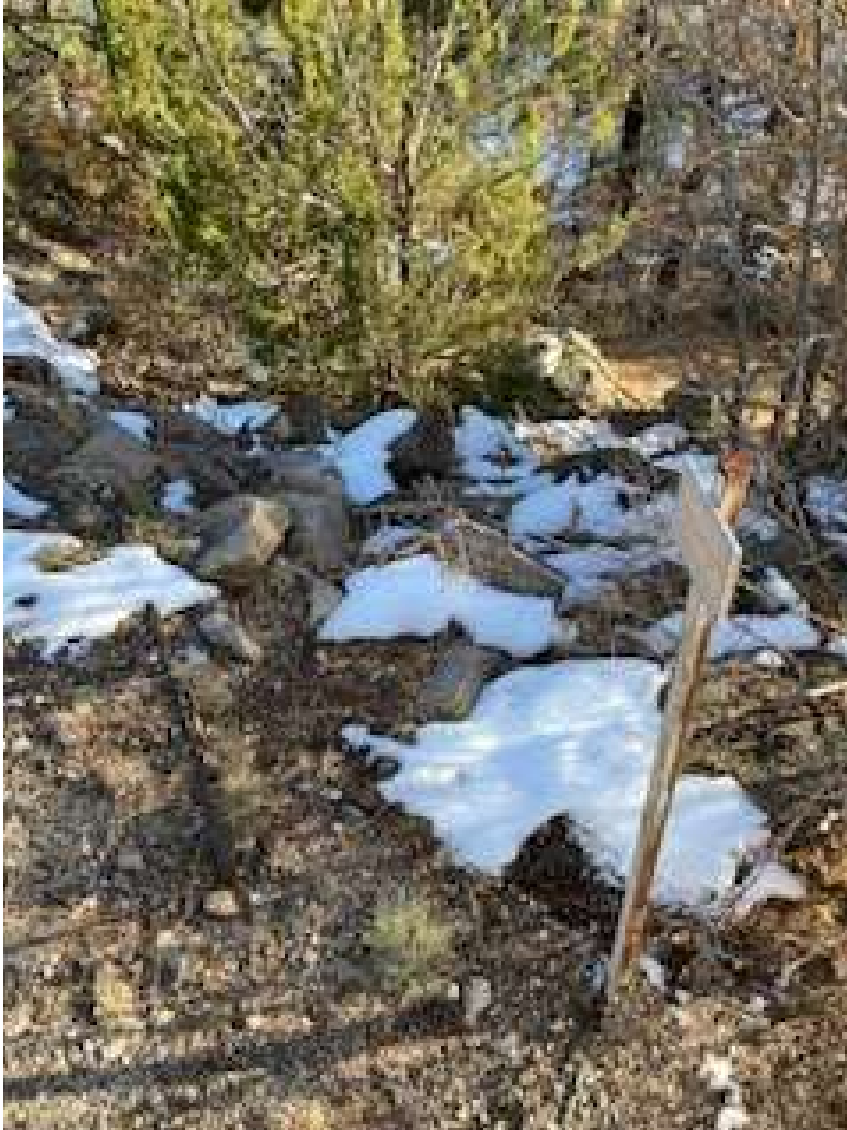
Photo File Name: Outfall 05A055, 20241119, 1114.jpg

- Outfall 05A055 hasn't discharged since 2007, effluent is almost always evaporated instead of discharging.
- The treatment system at Outfall 05A055 is prepping for a tank replacement soon to replace carbon steel tanks with stainless steel tanks and a new sand filter. The outfall may need additional discharge capacity (will notify EPA if needed). This facility is considered "Mission Critical" for LANL operations.
- The treatment system must be manually connected to a hose prior to discharge to Outfall 05A055.
