## **RCRA Inspection Report**

Formulated Solutions, LLC  
11775 Starkey Road  
Largo, Florida 33773-4799  
Pinellas County

EPA ID No.: FLR000031153

March 30, 2021, at 9:22 a.m.

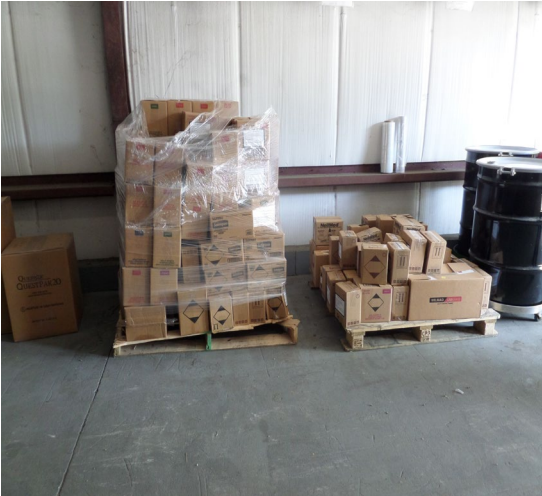
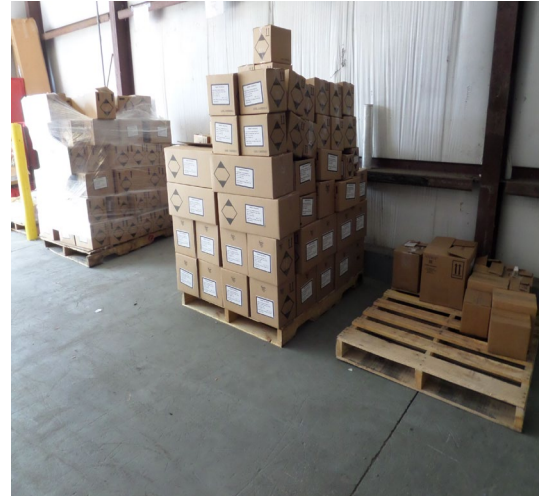
Also observed were five wooden pallets accumulating cardboard boxes of aerosol cans ranging from nine boxes to approximately 75 to 100 boxes on the pallets. The cardboard boxes contained either 12 or 36 aerosol cans per box. The boxes were not properly marked or labeled as universal waste at the time of the inspection (Photographs 1 and 2).

Formulated Solutions, LLC (Formulated). 90-Day or Less Accumulation Area. Observed five pallets each accumulating several boxes of spent aerosols. Observed the boxes were not marked or labeled with the words universal waste. Photograph 1 taken at 10:55 a.m.

Formulated. 90-Day or Less Accumulation Area. Observed five pallets each accumulating several boxes of spent aerosols. Observed the boxes were not marked or labeled with the words universal waste. Photograph 2 taken at 10:55 a.m.

Pursuant to F.A.C. Chapter 62-730.185(1), [40 C.F.R. § 273.14(f)], a SQHUW must label or mark universal waste aerosol cans (i.e. each aerosol can) or a container in which the aerosol cans are contained clearly with any of the following phrases: “Universal Waste - Aerosol Can(s)”, “Waste Aerosol Can(s),” or “Used Aerosol Can(s)”.

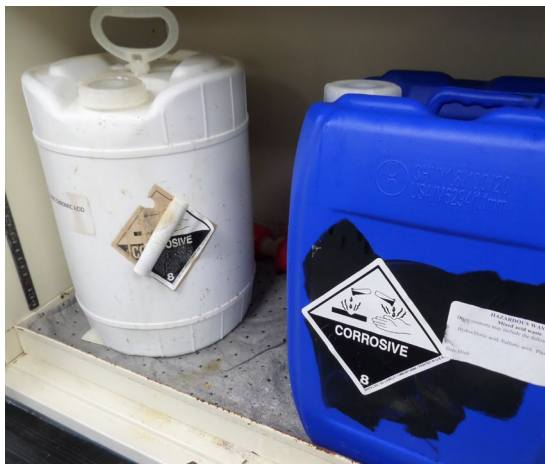
One 5-gallon container accumulating waste hydrochloric, sulfuric, and phosphoric acid and one 5-gallon container accumulating waste chromic acid was observed inside a cabinet under the fume hood. The containers were closed, in good condition, and labeled with an indication of the hazard. The container of chromic acid was marked with the words “chromic acid”, but not marked or labeled with the words hazardous waste (Photograph 3).

Formulated. QA Laboratory. Fume hood cabinet near laboratory entrance. Observed a white 5-gallon container marked with the words "spent chromic acid". The container was not marked/labeled with the words hazardous waste. The facility emailed a photograph to FDEP and EPA on April 16, 2021, showing the container marked/labeled with the words hazardous waste. Photograph 3 taken at 11:31 a.m.

Hazardous waste labels were placed on the containers. Formulated submitted photographs of the hazardous waste labels on the containers to FDEP and EPA by email on April 16, 2021.

**Pursuant to F.A.C. Chapter 62-730.160(1), [40 C.F.R. § 262.15(a)(5)], which is a condition of the SAA Permit Exemption, a generator is required to mark or label its containers with the words “Hazardous Waste”.**

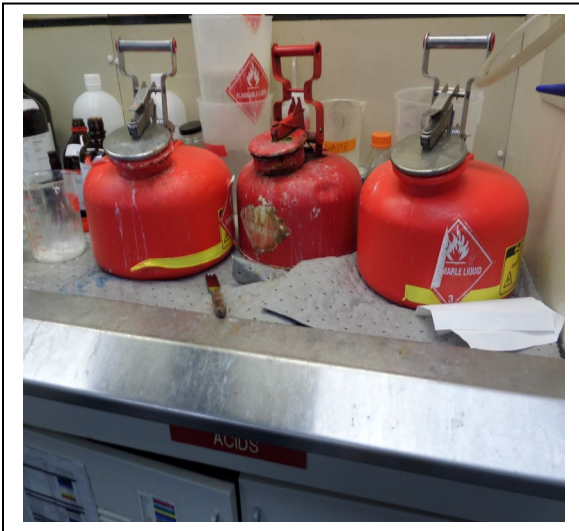
Three 1 to 2-gallon red safety containers accumulating waste IPA, methanol, ethanol and nitric acid were observed in the fume hood. The containers were closed, in good condition, and labeled with an indication of the hazard. The containers were not marked or labeled with the words hazardous waste (Photograph 5).

Formulated. QA Laboratory. Fume Hood. Observed three 1 to 2-gallon containers not marked/labeled with the words hazardous waste. The facility emailed a photograph to FDEP and EPA on April 16, 2021, showing the containers marked/labeled with the words hazardous waste. Photograph 5 taken at 11:48 a.m.
