## **RCRA Inspection Report**

Befesa Zinc US Inc. (Befesa)  
199 Truck Route  
Rockwood, Tennessee 37854  
Roane County

EPA ID#: TND982144099  
NAICS #: 331492 - Secondary smelting,  
refining, and alloying of nonferrous metal  
(except copper and aluminum)

November 29, 2023; 9:25 am – 6:00 pm and November 30, 2023; 8:30 am – 11:00 am.

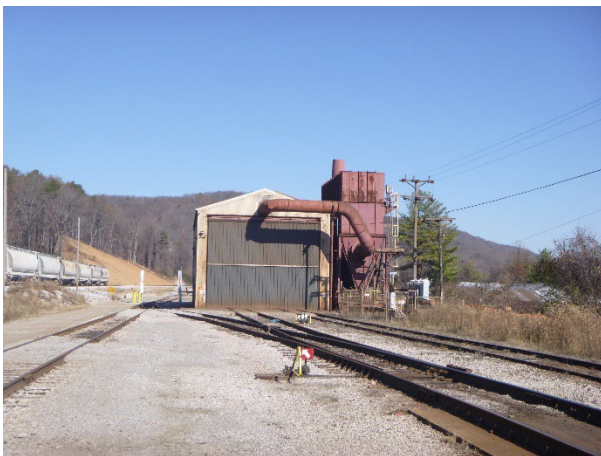
Photograph 2: Rail Yard - hopper car unloading area.

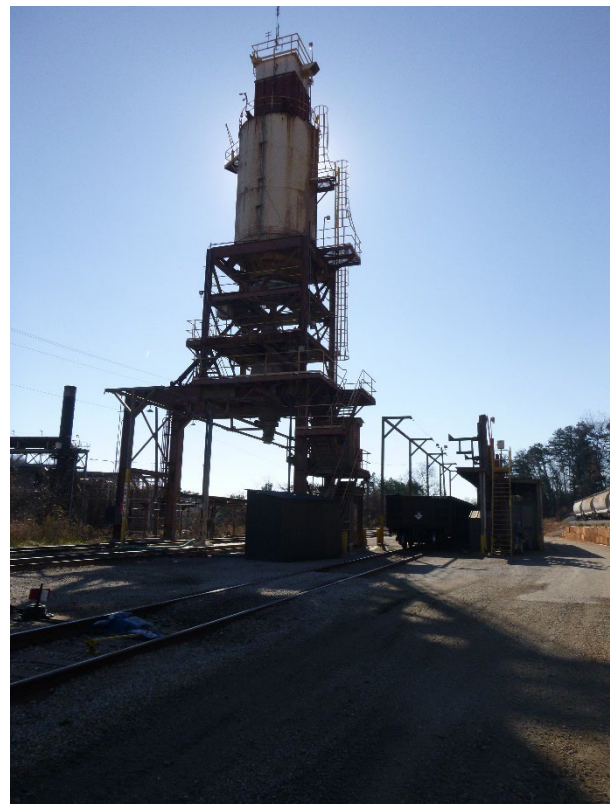
Photograph 5: Rail Yard – PD Railcar Unloading Area.

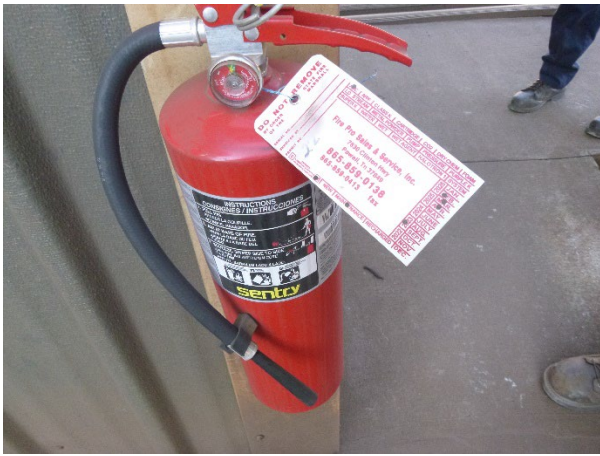
When in operation, Befesa receives EAF dust via railcar and trucks as hazardous waste (K061). Incoming railcars are stored in the rail yard until they can be off-loaded into the C & B building. This storage is permitted by the TDEC issued Permit TNHW-177. The inspection team toured the rail lines, the hopper rail car unloading building, the spike plant, and the CZO rail car loading area (Photographs 1-6). On the day of the inspection, the inspection team noted twenty-nine (29) empty rail cars being stored on the rail spur at the facility. New radiation monitors were installed to screen incoming rail cars. Hazardous waste is currently not generated or stored in these areas. The SAA containers were removed and stored for future use. The gated entrance to the railyard was closed and locked. The fire extinguisher was in good condition and recently inspected.

Photograph 6: Rail Yard fire extinguisher.

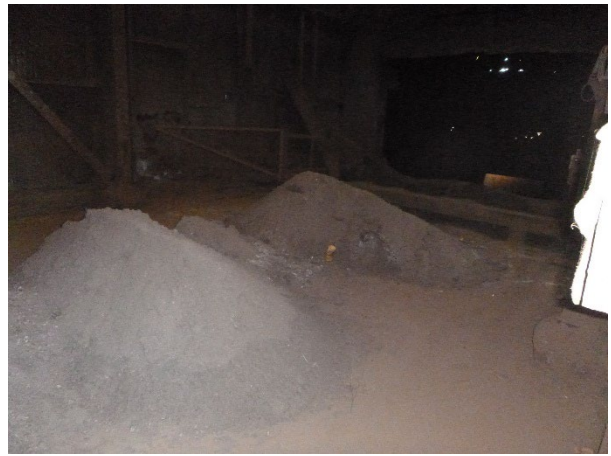
Photograph 9: C&B Building.

Typically, feed material from the rail lines is offloaded and conveyed via a covered conveyor belt to C & B Building; feed material from incoming trucks would be dumped in the truck entrance to the building. The inspection team observed from the control room that the C & B Building was predominantly cleaned out. The inspection team noted some material, several piles located in the truck dump area of the building (Photographs 7-9). Befesa needs to conduct a hazardous waste determination on this material. Facility personnel stated that this material was gathered from cleanup throughout the site.

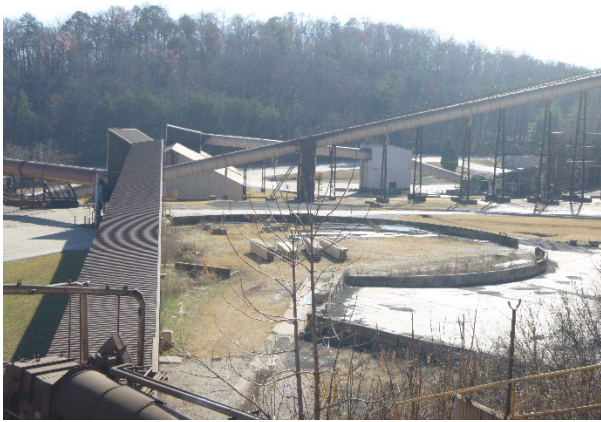
Photograph 12: Conveyor system from C&B Building to Kilns.

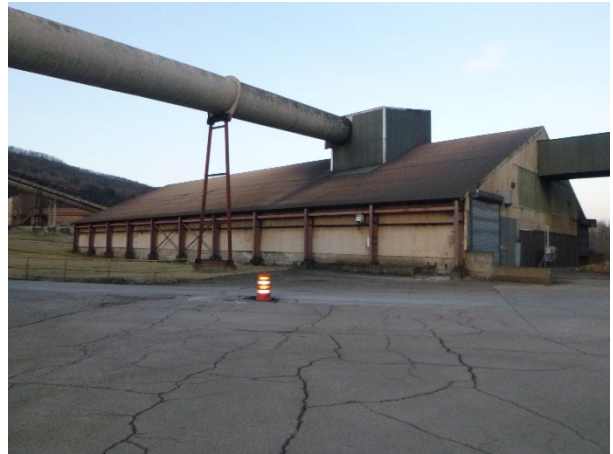
Photograph 15: IRM Building.

The other portion of the waste would be reprocessed through the kiln to recover any residual Zinc. The waste in the IRM building covered approximately 80% of the floor space at a height of 8-10 feet. The footprint of the building was estimated to be 120 feet by 300 feet. As long as the kiln was operating this material was considered to be feedstock. Facility personnel stated that the last operating day for the kilns was March 30, 2023. It appears that this waste has been stored in the IRM building for greater than 90 days. The IRM building is not included as a storage area in the hazardous waste permit.

Hazardous waste has been stored in the IRM building for greater than 90 days without a permit.

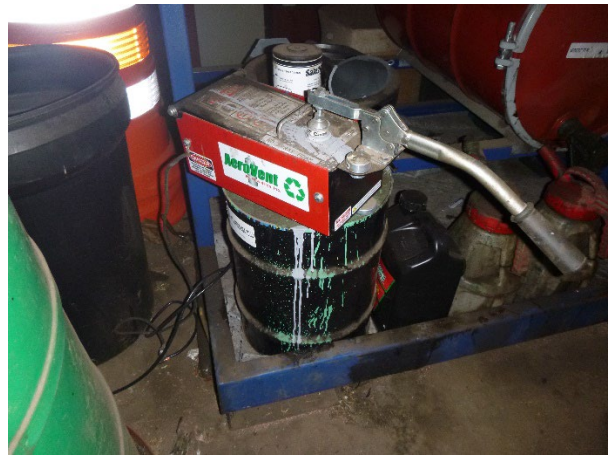
The inspection team toured the maintenance area. Befesa operates one cabinet for storing explosives used for blasting the kiln when clogged. Befesa was accumulating hazardous waste liquids generated from puncturing aerosol cans in a puncture box affixed to the bung hole of the 15-gallon SAA container (Photograph 16). The container was labeled as hazardous waste and with the indication of the hazards of toxic and flammable, in good condition, and closed.

Photograph 16: Aerosol SAA Container with puncture Device.

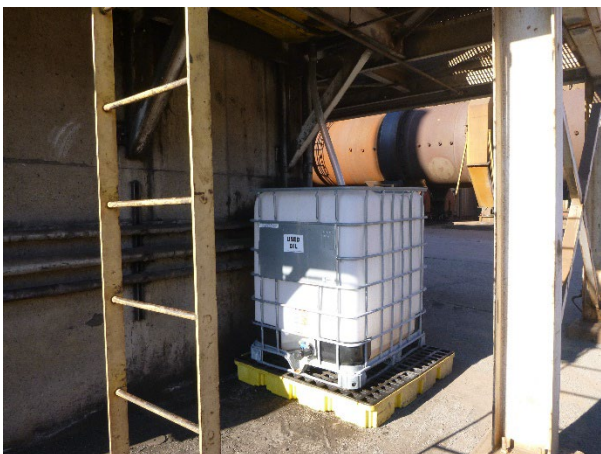
container was shipped in June 2023. The inspection team noted two 300-gallon totes containers on spill containment pallets in use collecting used oil from gear boxes (Photograph 14). Each 300-gallon tote was labeled as “Used Oil”.

Photograph 14: Used Oil near kilns.

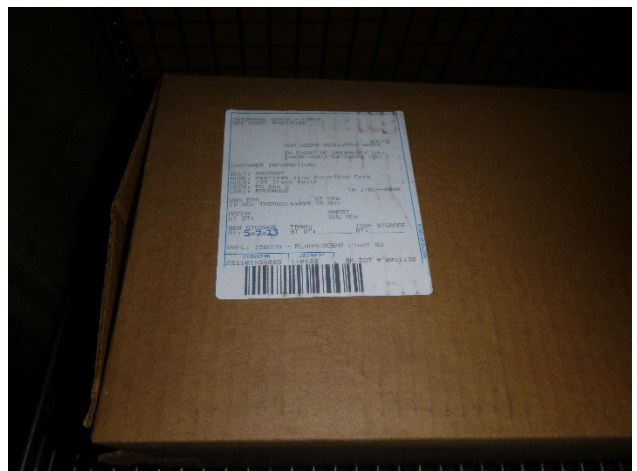
A shelf in the tool cage was used to store universal wastes generated at the facility. There was one 4-foot cardboard box labeled with an accumulation start date May 9, 2023. This box was closed and labeled as universal waste lamps (Photograph 17). There were two plastic totes used to accumulate universal waste. The first plastic tote was labeled as “Universal Waste” but failed to specify the type of universal waste (Photograph 19). This container was accumulating spent universal waste metal halide lamps. There was no date on the container and the most recent shipment of universal waste lamps was on November 2, 2022. The second plastic tote was accumulating rechargeable batteries and was dated March 24, 2023. This tote was in good condition, labeled, and closed. (Photograph 18). Befesa was operating one 500-gallon tank to store used oil. This tank was in good condition surrounded by a dike in good condition and labeled as “Used Oil.”

Photograph 17: Universal Waste Lamps.

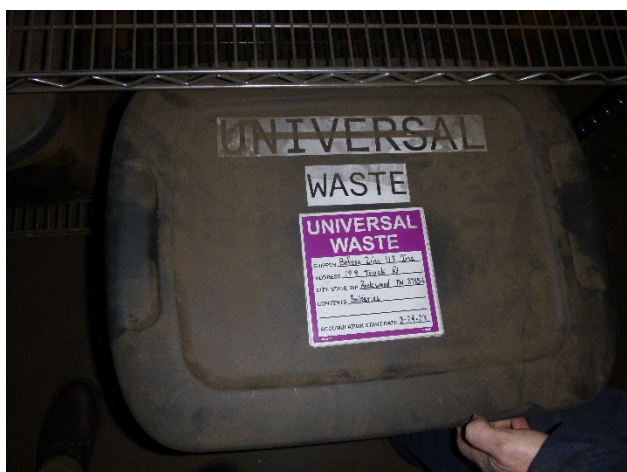
Photograph 18: Universal Waste Batteries.

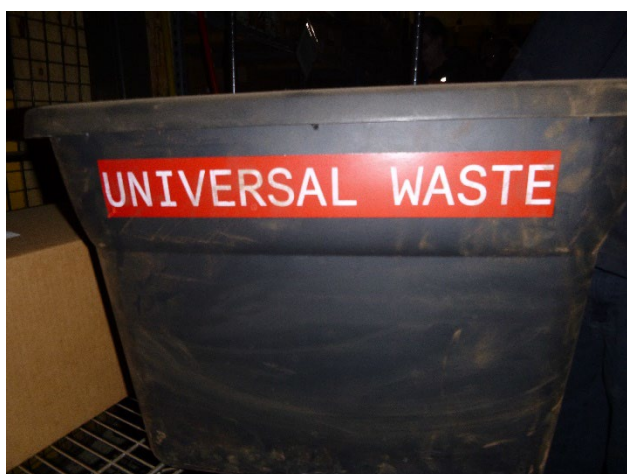
Photograph 19: Universal Waste Lamps.

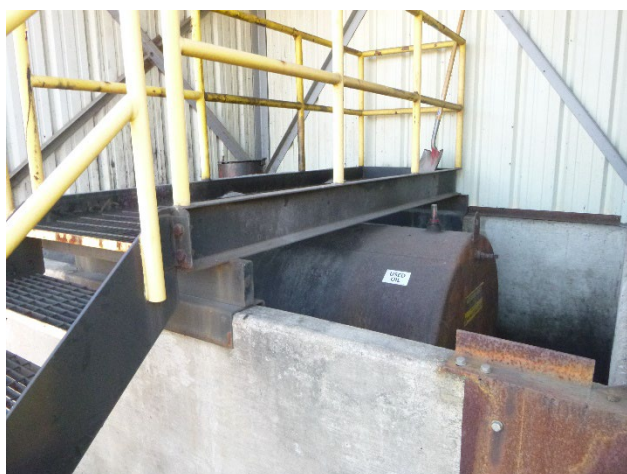
Photograph 20: Used Oil Tank.
