INSPECTION REPORT

| Statute(s)/Program(s) | Clean Water Act, NPDES, WWTP | |
| Type of Inspection | CEI - Compliance Evaluation Inspection | |
| Permittee Name | Lafayette Consolidated Government - Northeast WWTP | |

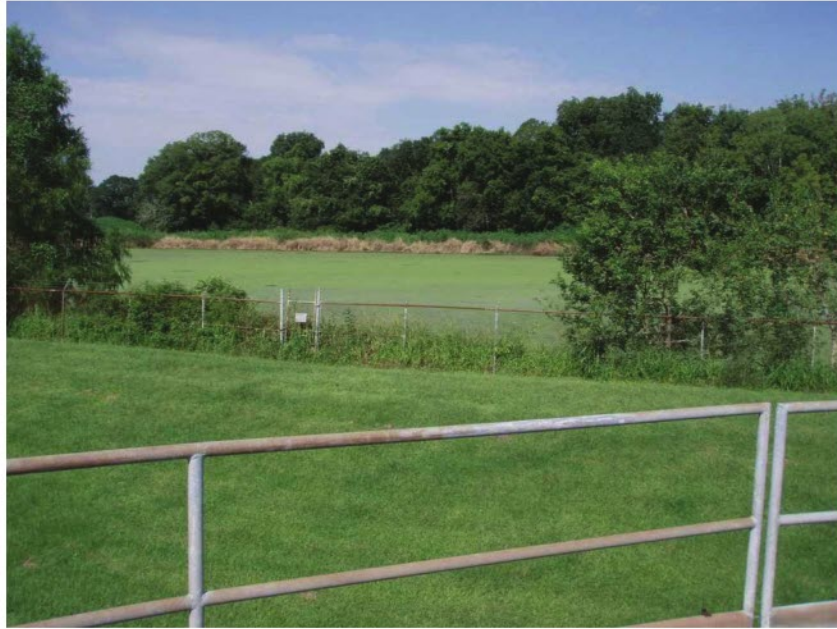
| Detention Basin | P1010003.JPG | |

| 3 Million Gallon Capacity. | | |

| 3 million gallon detention basin. | | |

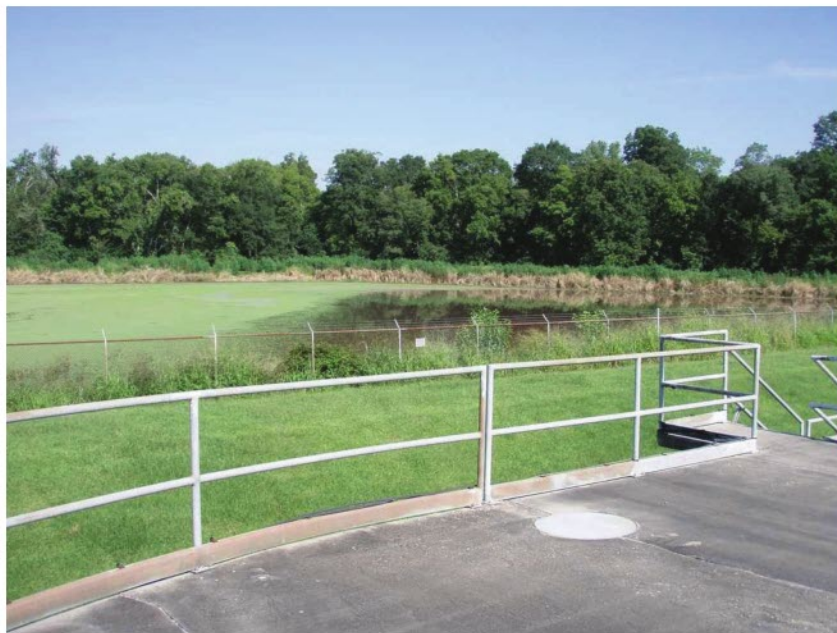
| Detention Basin | P1010004.JPG | |

| 3 million gallon detention basin | | |

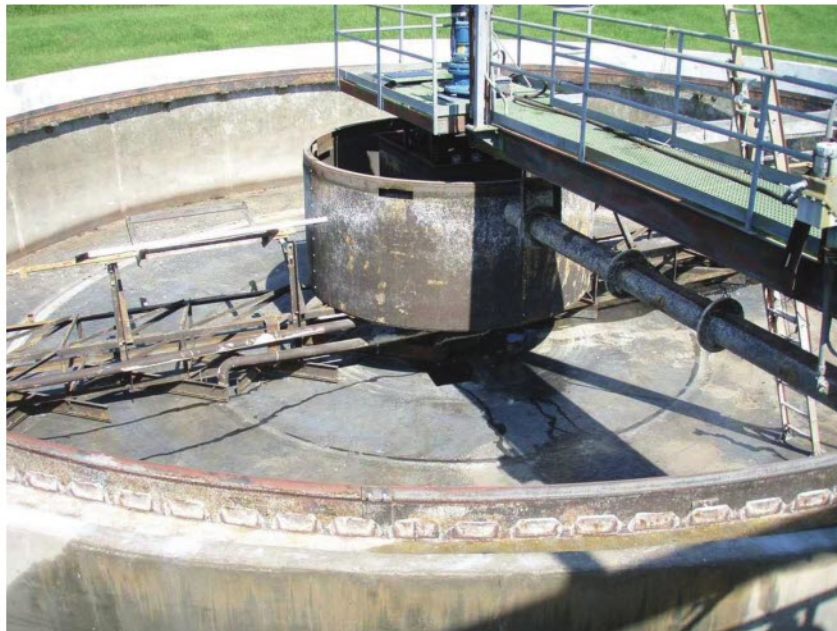
| Clarifier #1 | P1010007.JPG | |

Clarifier #1 was not in service at the time of the inspection due to normal operational maintenance. Clarifier #2 had a sludge blanket of 2 foot.

| Clarifier #1 was out of service for normal maintenance. | | |

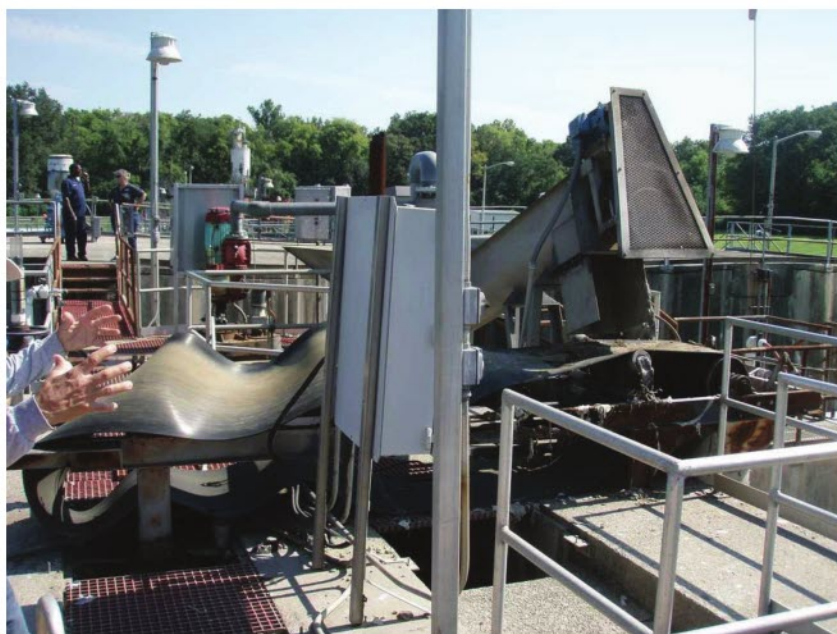
| Headworks Conveyor | P1010002.JPG | |

Head works conveyor system was inoperable at the time of the inspection. System was being rebuilt and has been inoperable for 2-4 weeks.

| Headworks conveyor system was inoperable and being rebuilt. Out of service 2-3 weeks. | | |

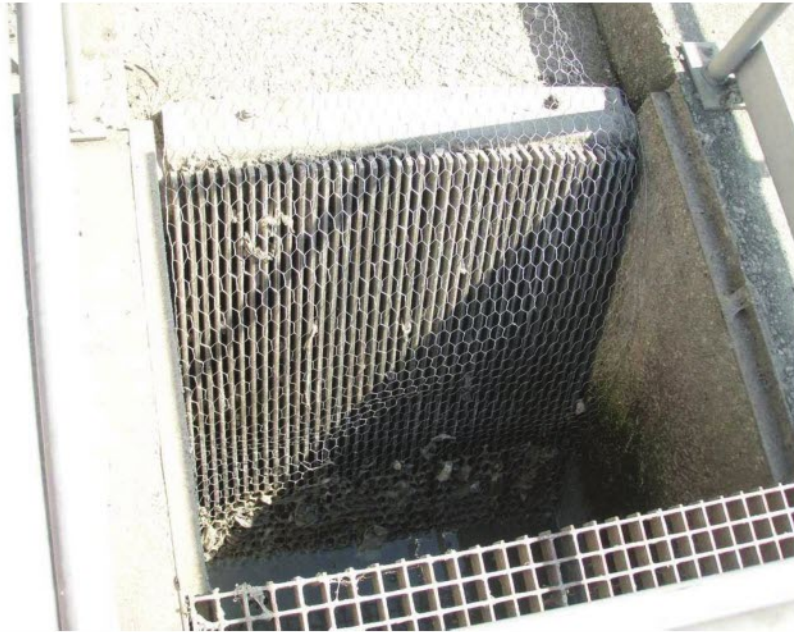
| Bar Screen | P1010001.JPG | |

| Step bar screen was inoperable at the time of the inspection. Gear box was on order from Germany but, due to Covid shipping issues step bar screen has been inoperable for 2-3 months. Facility is using chicken wire as an alternative. | | |

| Chicken wire used due to bar screen being inoperable. | | |

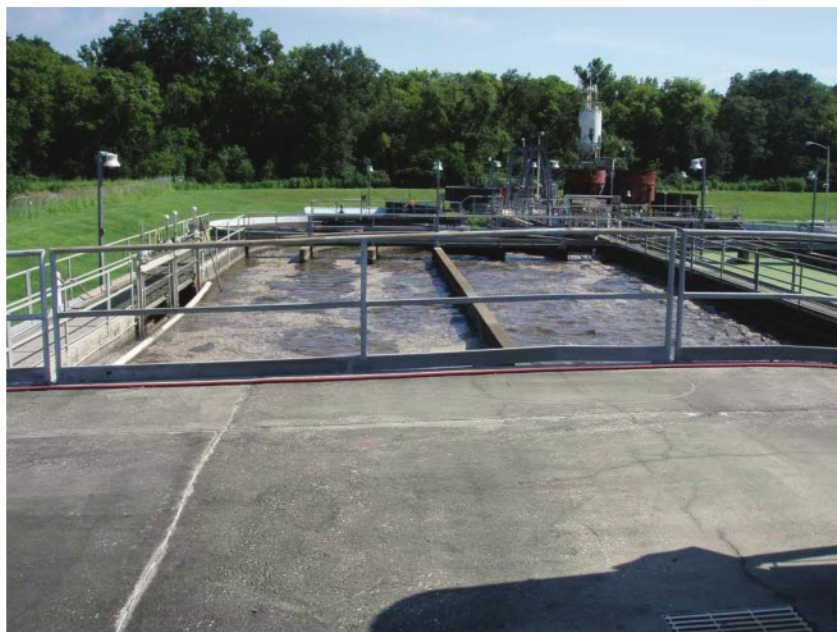
| Oxidation Ditch | P1010005.JPG | |

The facility has two operational mechanically aerated oxidation ditches. One ditch is off-line due to cleaning and standby for heavy flows.

| Mechanically aerated Oxidation Ditch | | |

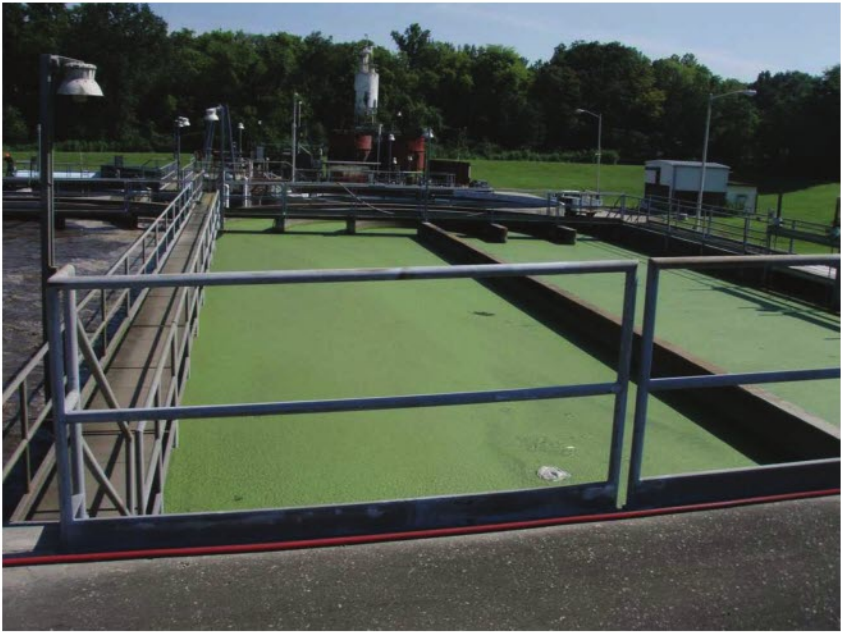
| Oxidation Ditch | P1010006.JPG | |

| Mechanically aerated oxidation ditch. | | |
