## **RCRA Inspection Report**

U.S. Department of Energy (DOE)  
Paducah Gaseous Diffusion Plant  
5501 Hobbs Road  
Kevil, Kentucky 42053

February 28 – March 2, 2023

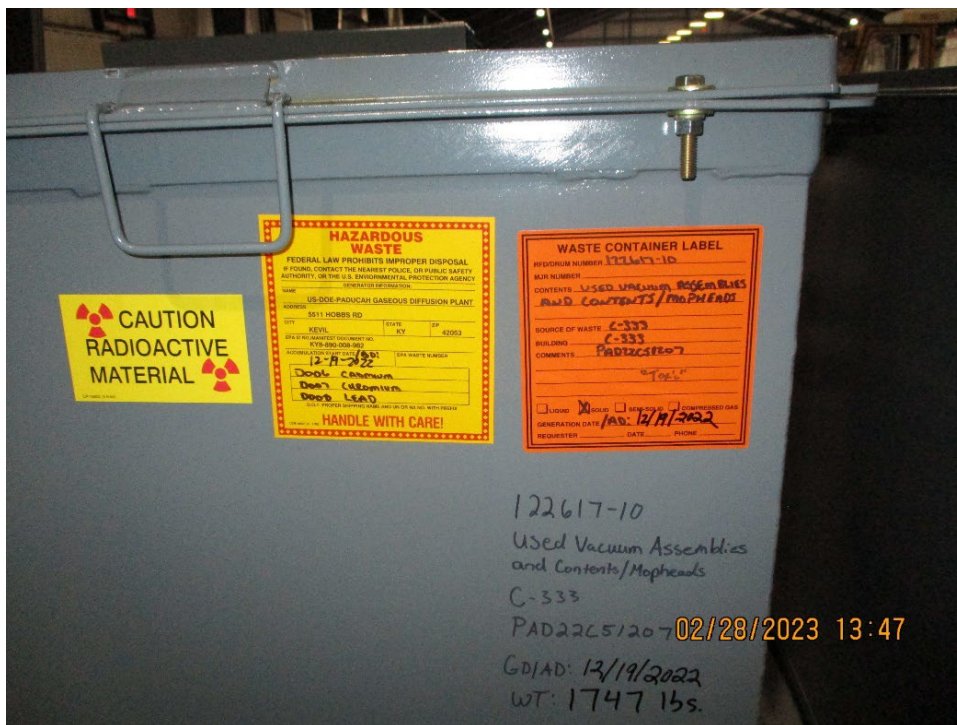
Photograph 4: Example of container in building.

The inspectors observed that containers were properly marked and labeled. Unless otherwise noted all containers were labeled, closed and dated. Supplemental secondary containment was around many of the storage areas within Building C-752-A. Wastes were observed to be stored in 55-gallon drums, tote tanks of approximately 200 gallons capacity, portable tanks of approximately 1,000 to 3,000 gallons in capacity, and square storage containers (ST-90s). Portable 1,200-gallon tanks, on trailers, were also in the building.

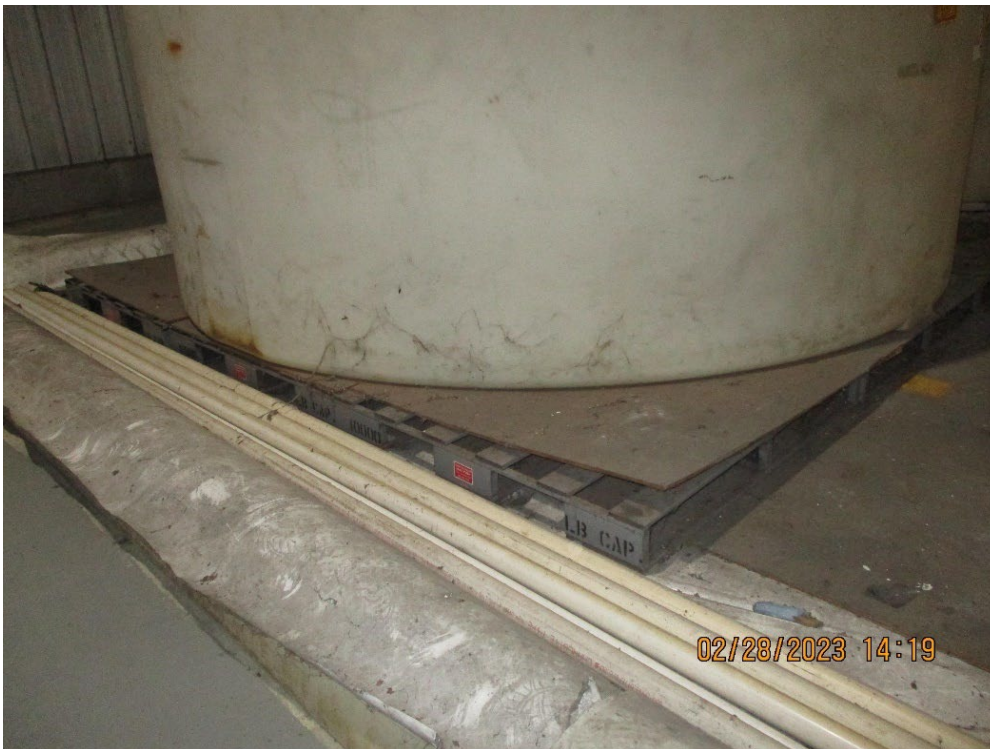
Photograph 9: Four 10,500 hazardous waste storage tank.

Building C-752-A was observed to have safety equipment and spill response equipment to include safety showers. Near the internal processing building four 10,500-gallon hazardous waste tanks were observed. These four plastic tanks were resting on metal pallets that had a label stating the capacity of the pallet was 10,000 pounds. The area was surrounded by an internal secondary containment berm. The tanks were labeled with hazardous waste codes F001, F002, and U228. The tanks were not in use at the time of the inspection and had not been utilized for several years. From observations from facility personnel, the tanks are believed to have been last in use around 2019.

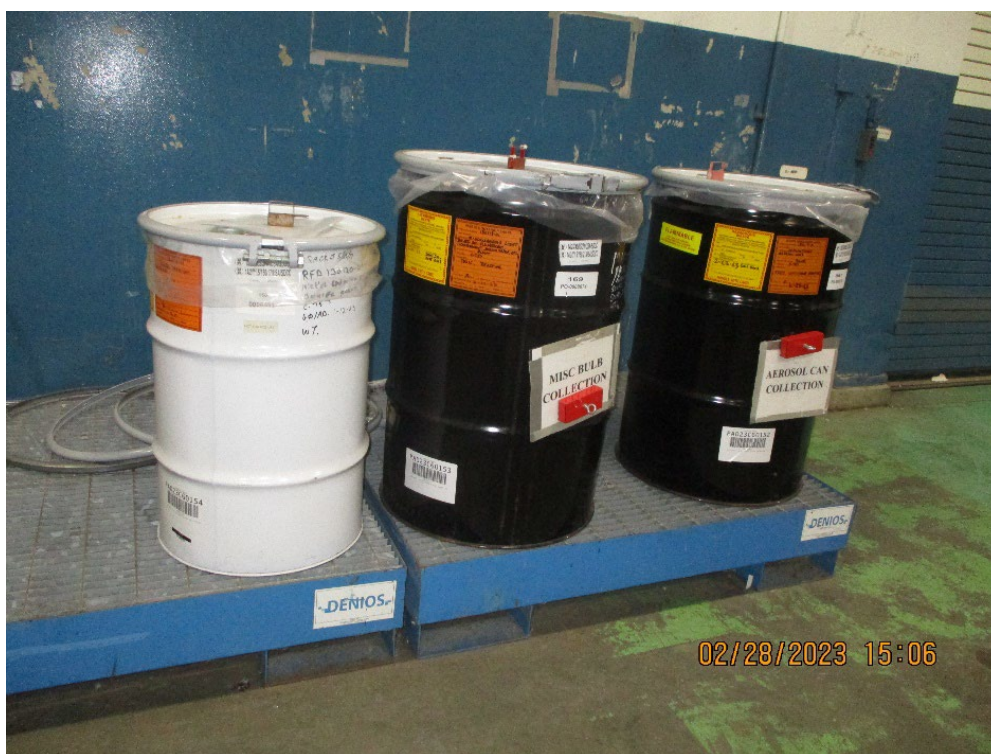
Photograph 11: SAA S-757-01

Building C-757 contained a less than 90-day hazardous waste storage area (HWSA) 90DAA-757-01 (the facility number for this area). The building appeared to be well maintained and no spills or releases were observed. This building had a SAA consisting of six red metal containers of approximately 5-gallons capacity. The containers were all closed and properly labeled with hazardous waste labels and hazards indication information. The containers segregated wastes for

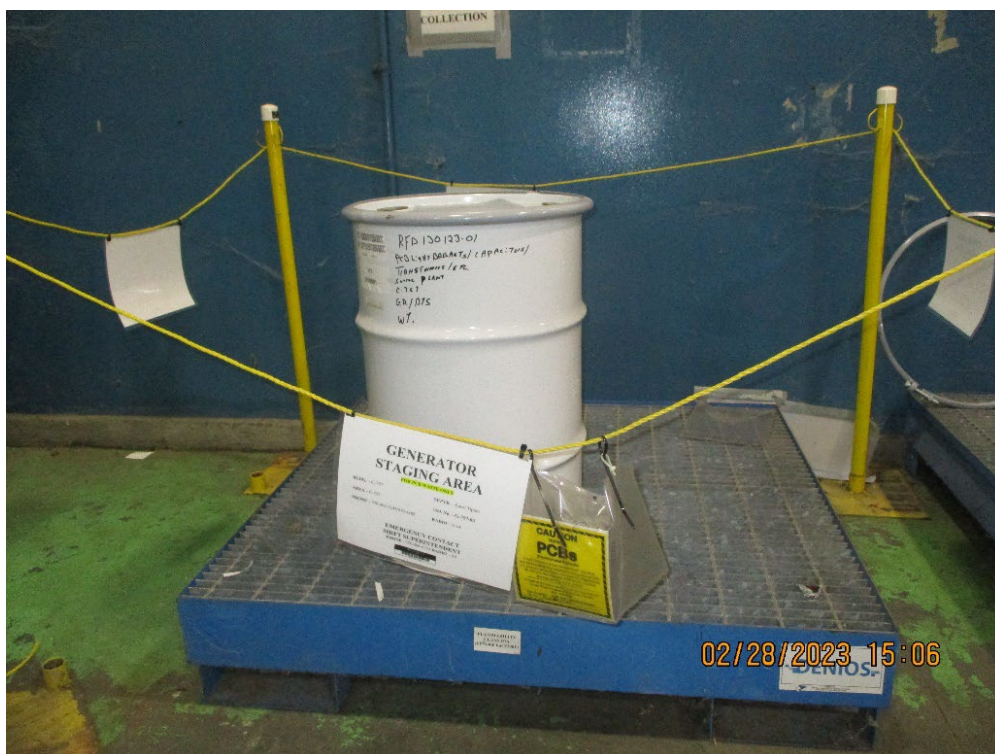
Photograph 12: Miscellaneous bulb collection and aerosol can collection.

mercury, different types of batteries, lamps, and starters and fuses. The building also had one 55-gallon drum for lamps and one 55-gallon drum for aerosol cans. A 30-gallon container of nickel-cadmium batteries and a 30-gallon container of PCB wastes. An ST-90 Container Box, containing hazardous waste (circuit boards, fuses, starters, etc.) was also in the building. Two pallets with batteries on them were also observed. All containers appeared to be properly labeled and marked, closed, and were in good condition.

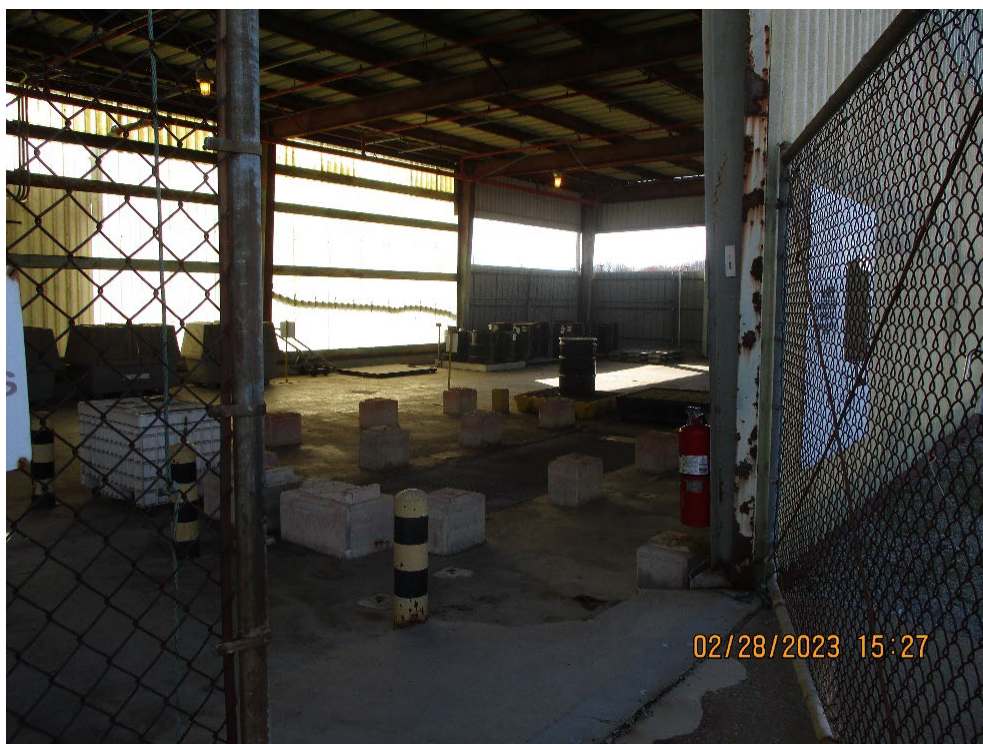
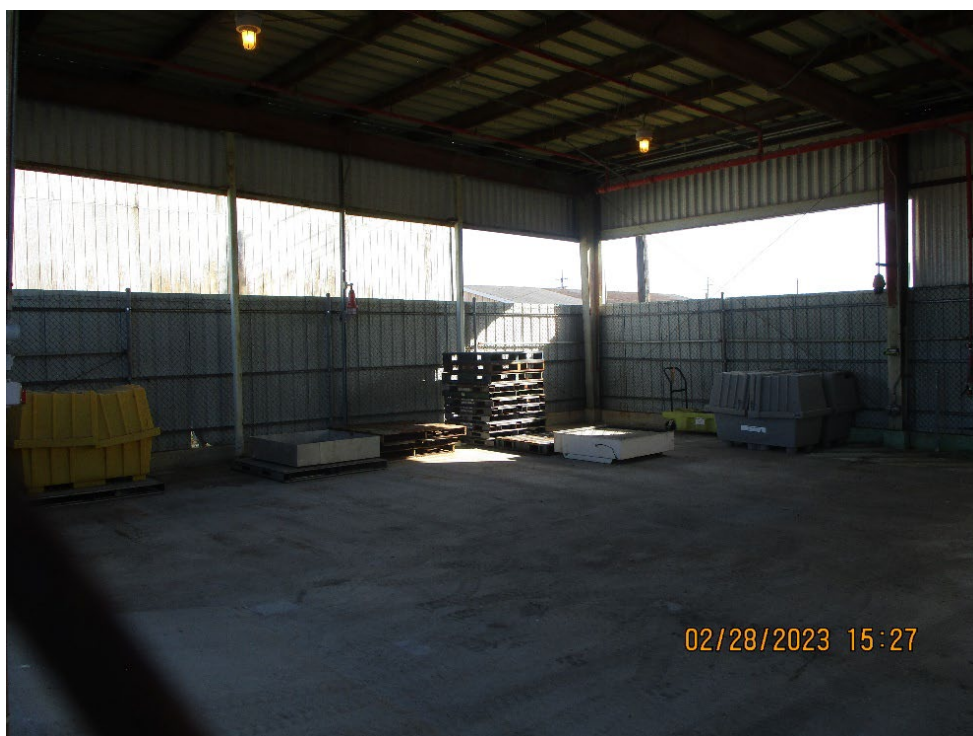
Photograph 18: Interior of mainly empty building.

The C-733 Hazardous Waste Storage and Treatment Facility is a partially sided, roofed, and diked storage area permitted to store spent solvents, paint waste, mineral spirits, containers of waste chemicals, and other miscellaneous waste materials in containers. At the time of the inspection the building was found to properly equipped with fire extinguishers, and eye wash, a spill skit, and had a sprinkler system. One 55-gallon drum of hazardous waste was present. The area was mostly empty.

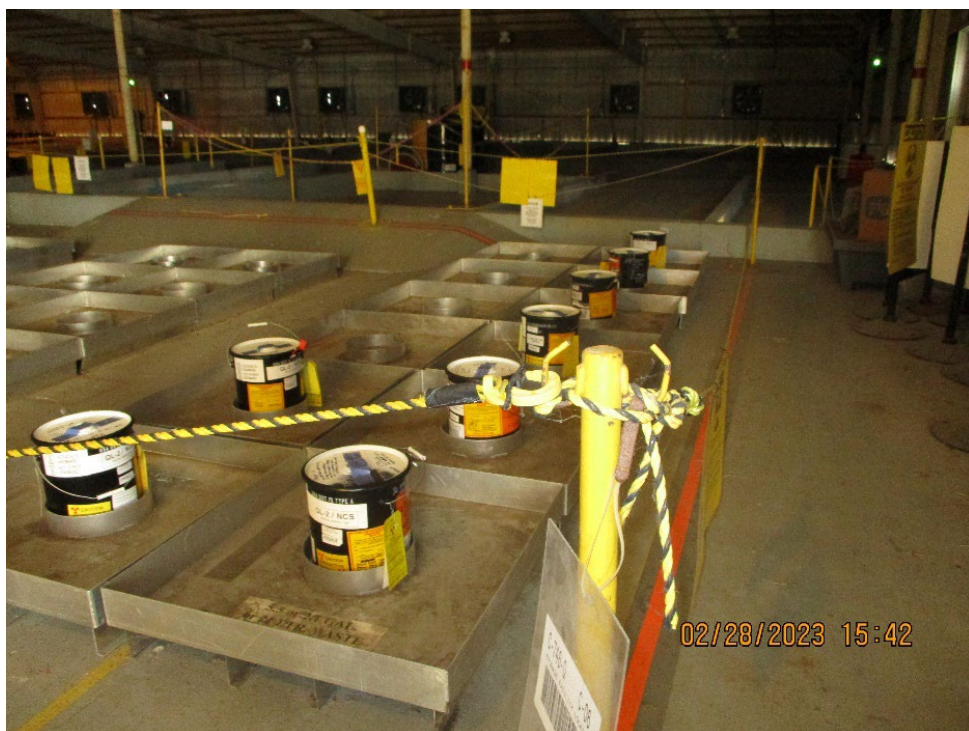
Photograph 20: Hazardous waste fissile material containers separated by metal pallet spacing.

Building C-746-Q is the third area covered in the hazardous waste permit. All waste streams (listed in the condition immediately above) may be stored in this facility except for D001. No ignitable wastes are permitted to be stored at C-746-Q. The maximum container storage capacity for this permitted area is 306,570 gallons. Potentially fissile material wastes are stored in this building. The facility has special storage units to ensure that the containers are adequately spaced. At the time of the inspection, eight 5-gallon containers of hazardous waste were in the area. The containers were in good condition, closed, and properly labeled. No maintenance issues with the building were observed. Three non-hazardous 5-gallon containers of waste were observed. The facility has the potentially fissile material areas roped off to mark the areas that should not be entered without following proper safety protocols. All containers appeared to be properly labeled and marked, closed, and were in good condition.

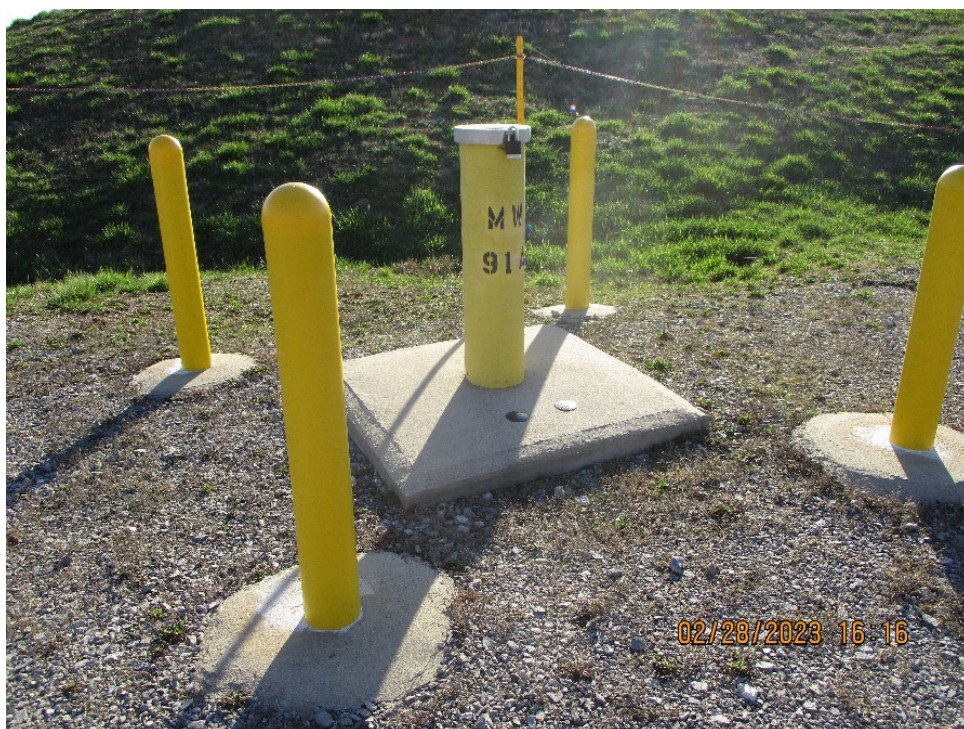
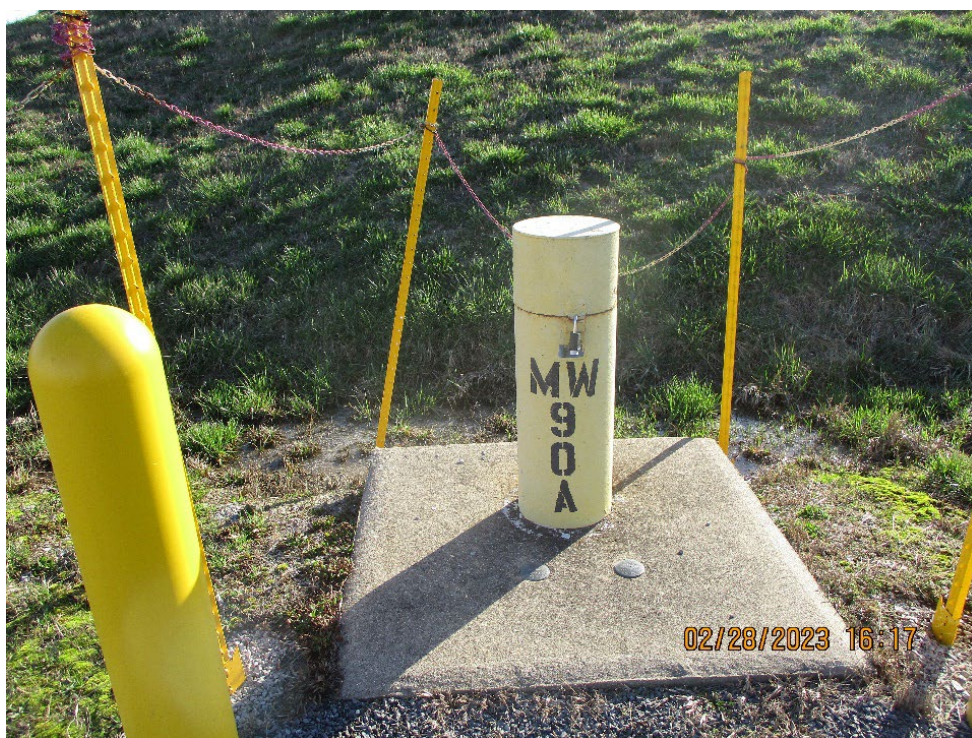
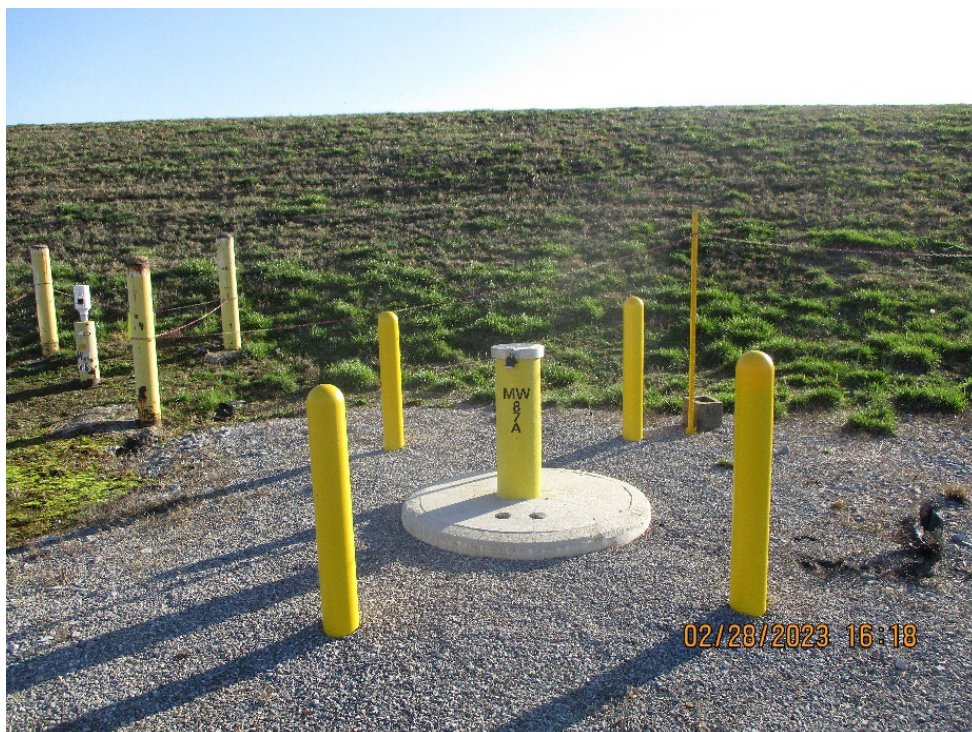
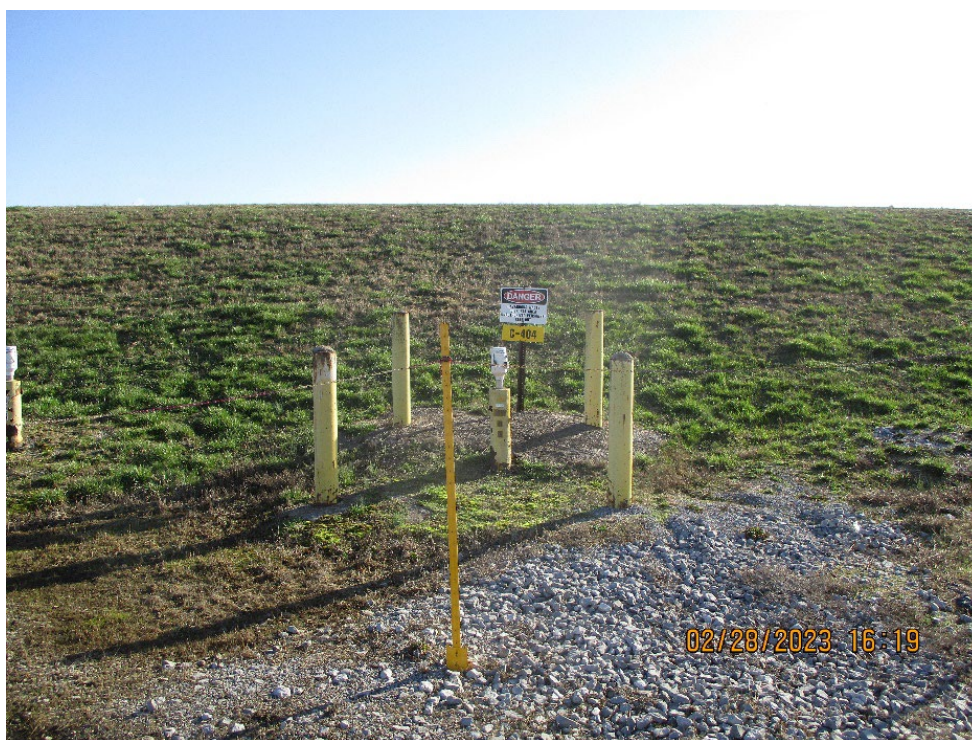
Photograph 23: Picture of a monitoring well with a locked cap.

The C-404 Landfill is a closed construction and demolition and radiological waste landfill which is currently undergoing groundwater monitoring. The landfill was observed closed off with chains and signs stating "Caution Inactive Contaminated Area. RWP Required in Area." The area appeared well kept and the grass was mowed to a short level. The inspectors observed that the wells were closed and had labeled plaques on the concrete slabs. The well caps were locked. The wells had yellow metal post around them to protect the wells.

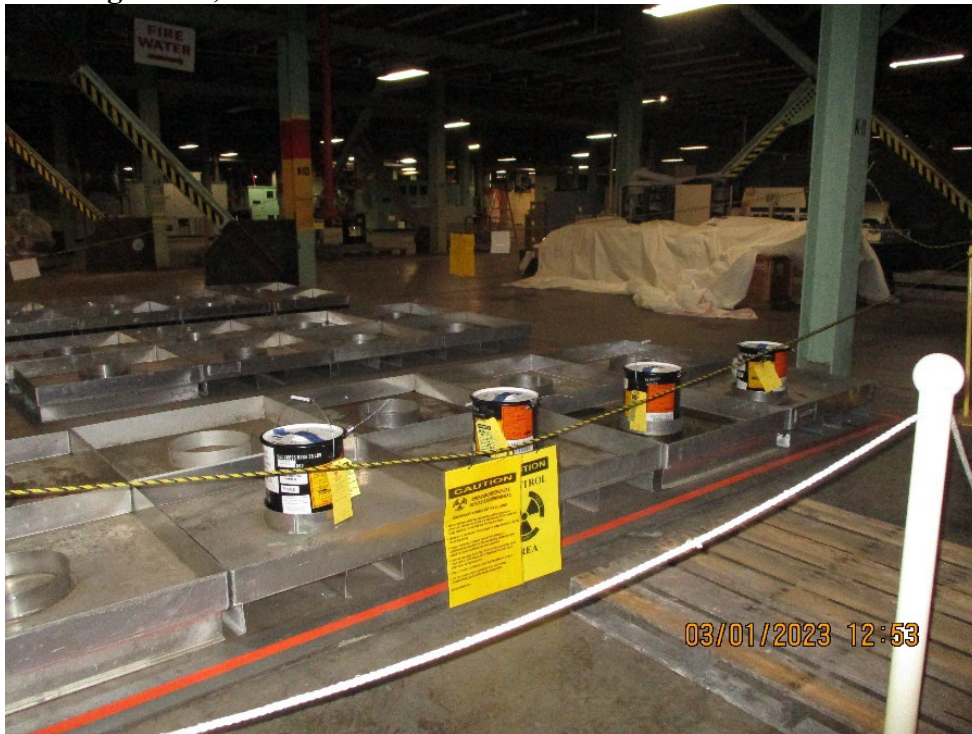
Photograph 41: Hazardous Waste Fissile 5-gallon containers. SAA S-335-03.

The 90-day accumulation area was inspected. This area had four 5-gallon containers of hazardous waste in the fissile area. The 5-gallon containers are put into specially designed metal holding areas that keep the fissile containers adequately separated. The area appeared to be well maintained and no spills, leaks, or maintenance issues were observed.

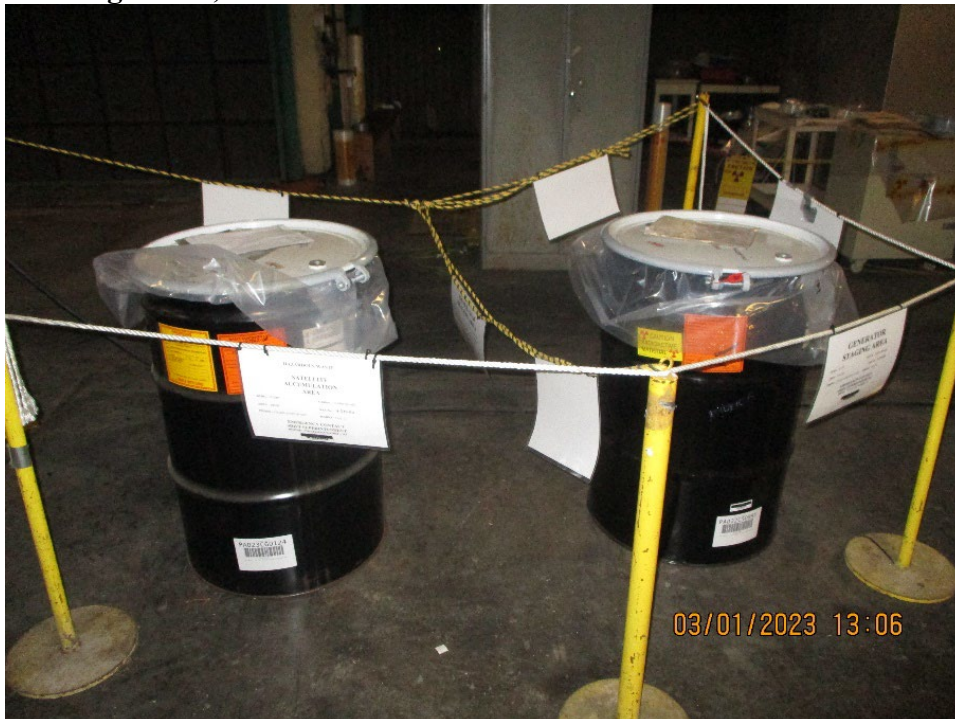
Photograph 42: Two 55-gallon drums in SAA S-335-04.

This 90-day accumulation area had two 55-gallon drums, one hazardous and one non-hazardous. The hazardous waste drum was being utilized for non-fissile vacuum waste. This drum was empty at the time of the inspection. The non-hazardous drum was utilized for storing activated aluminum waste. The area appeared to be well maintained and no spills, leaks, or maintenance issues were observed. All containers appeared to be properly labeled and marked, closed, and were in good condition.

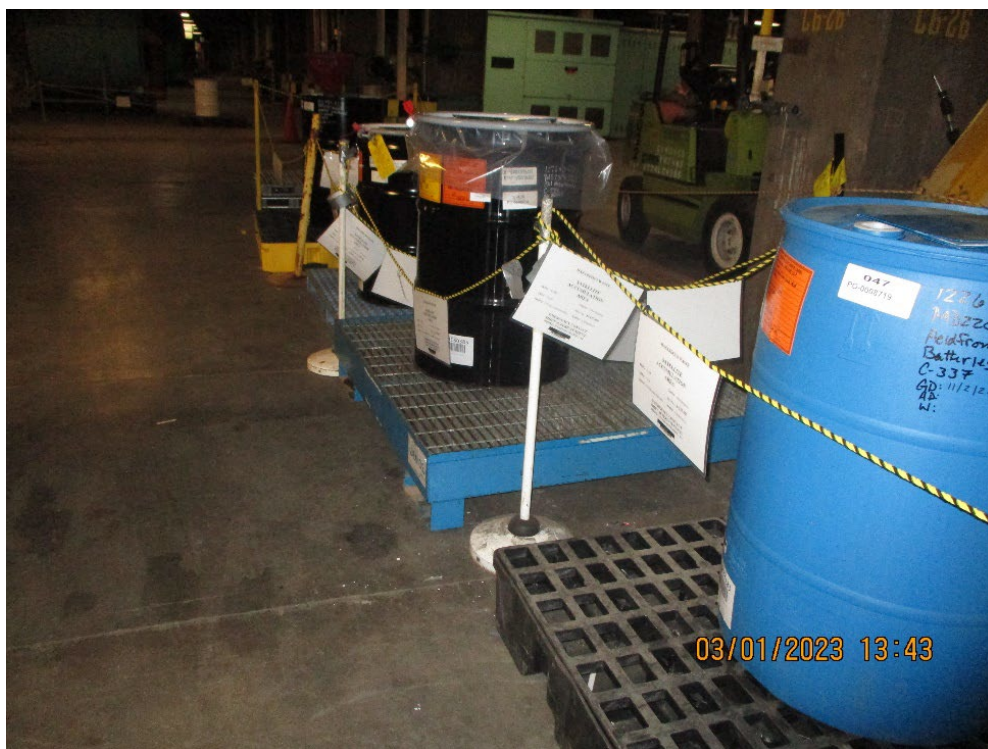
Photograph 52: Picture of the four SAAs S-337-02, 06, 08, and 09.

This area had four SAAs. These areas were for accumulating waste oil, electronic circuits and fuses, Oily absorbent rags, and acid from batteries in 55-gallon containers. A photograph was taken of each area and of the four areas together. The 55-gallon drums were on pallets that had secondary containment intrinsic to the pallet. The area appeared to be well maintained and no spills, leaks, or maintenance issues were observed. All containers appeared to be properly labeled and marked, closed, and were in good condition.

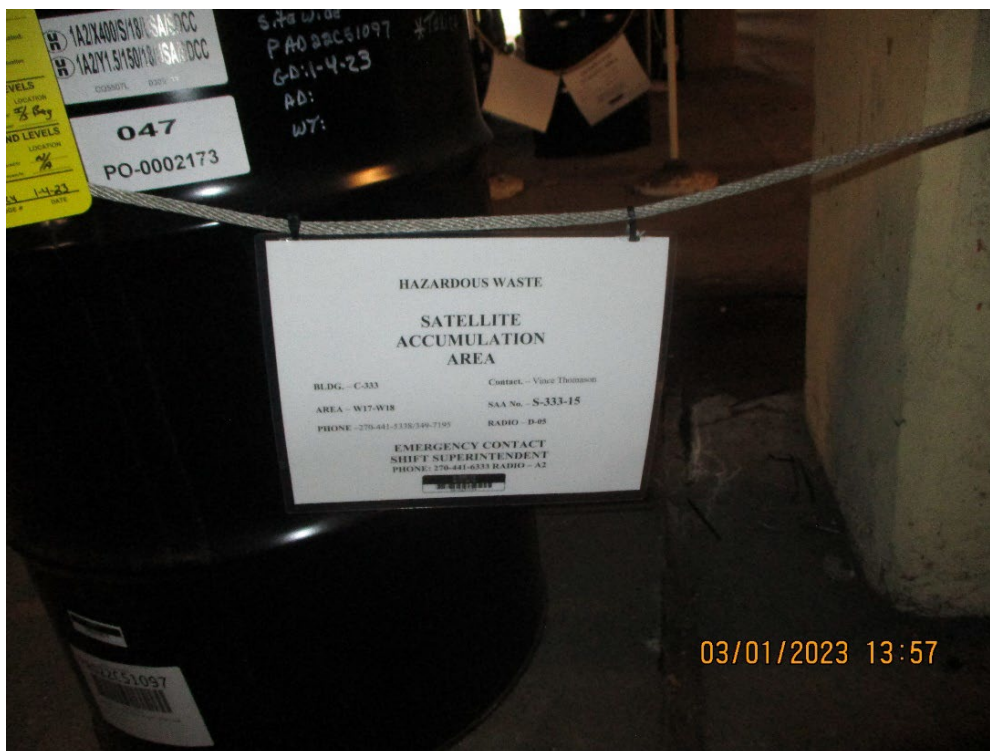
Photograph 56: 55-gallon hazardous waste drum in SAA S-333-15.

The SAAs in Building 333 were inspected. Areas 22, 18, 24, and 25 were empty at the time of the inspection. Area S-333-13 had one 55-gallon drum of lube oil with waste codes D005 and D010. Area S-333-15 had one 55-gallon drum of oily pads with waste codes D005 and D010. Area S-333-13 had one 55-gallon container of waste lube oil with waste codes D005 and D010. Area S-333-17 had one 55-gallon drum of unpunctured aerosol cans with waste codes D001 and D003. The area appeared to be well maintained and no spills, leaks, or maintenance issues were observed. No issues regarding labeling or marking were observed. All containers were closed and appeared to be in good condition.

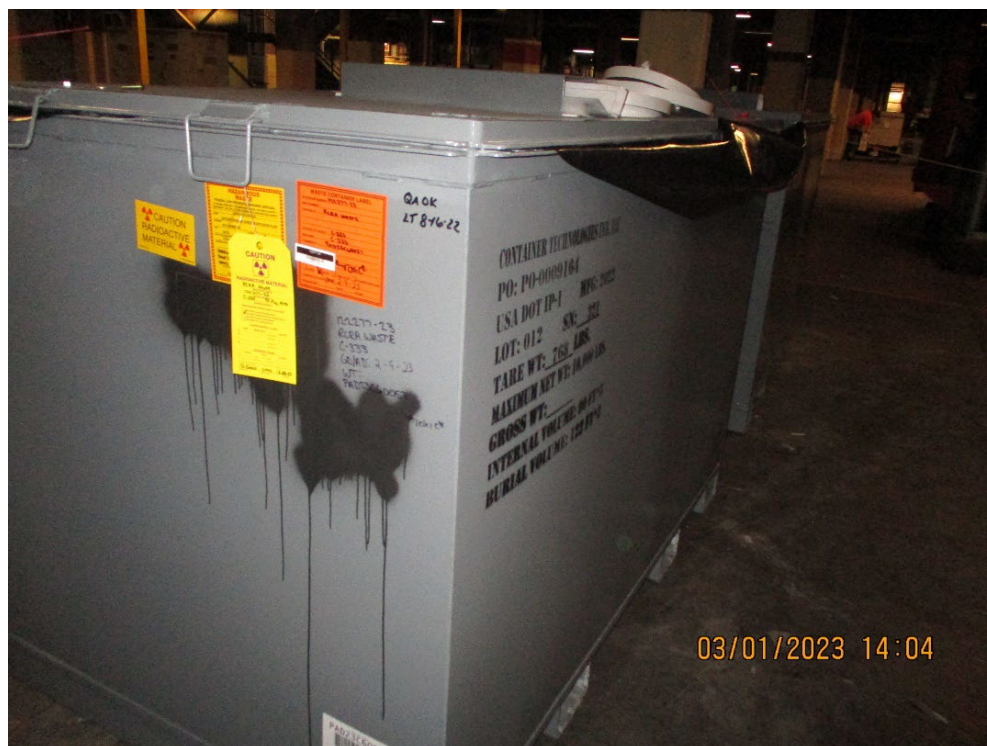
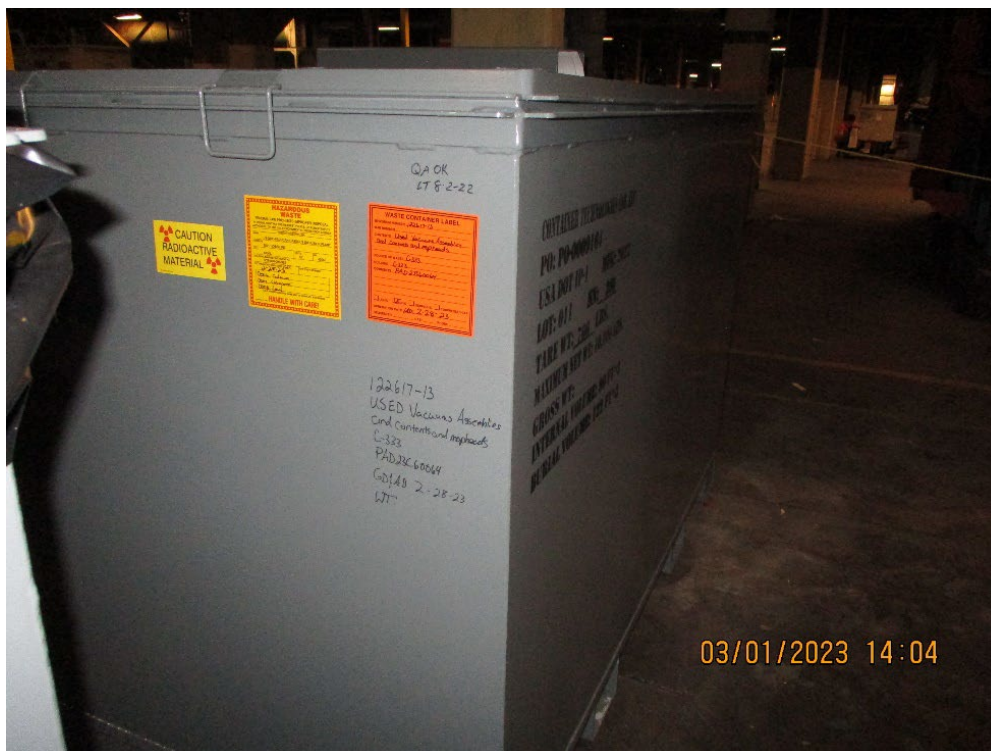
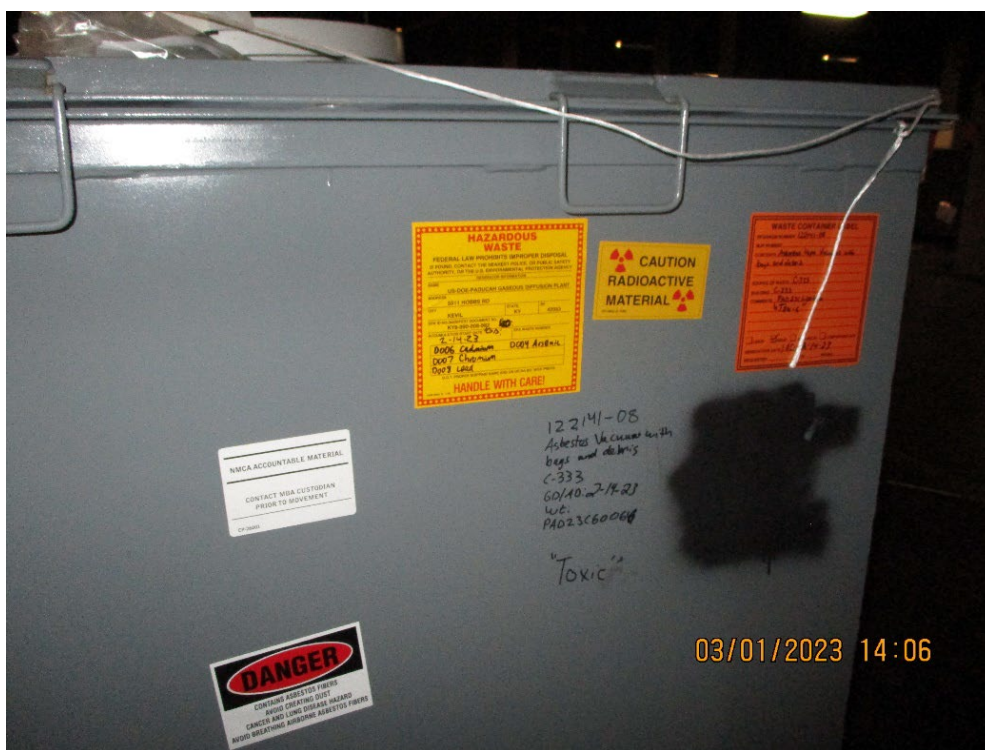
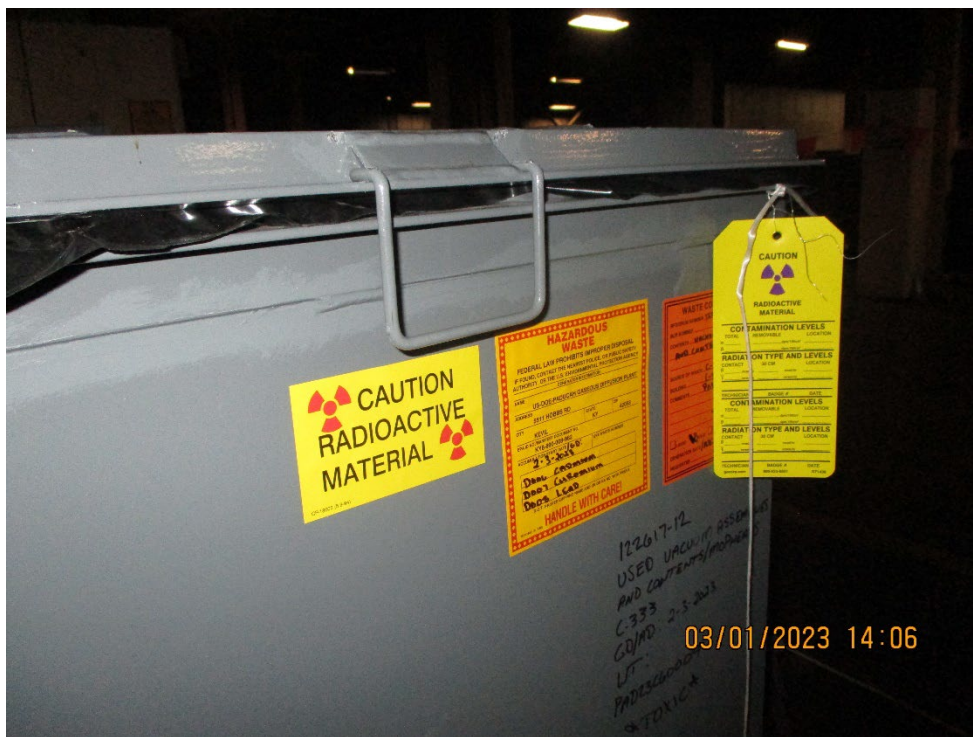
Photograph 58: First ST-90 Storage Container in 90DAA-333-01.

This 90-day area had four ST-90 box containers of hazardous waste. One box, dated 2/28/2023, had waste with waste codes D006, D007, and D008. One box, dated 2/3/2023, had waste with waste codes D006, D007, and D008. One box, dated 2/9/2023, had waste with D006, D007, D008, and D009 waste codes. The final box, dated 2/14/2023, had waste with D006, D007, D008, and D009 waste codes and also contained asbestos fibers. All containers were marked on two sides. The area appeared to be well maintained and no spills, leaks, or maintenance issues were observed. All containers appeared to be properly labeled and marked, closed, and were in good condition.

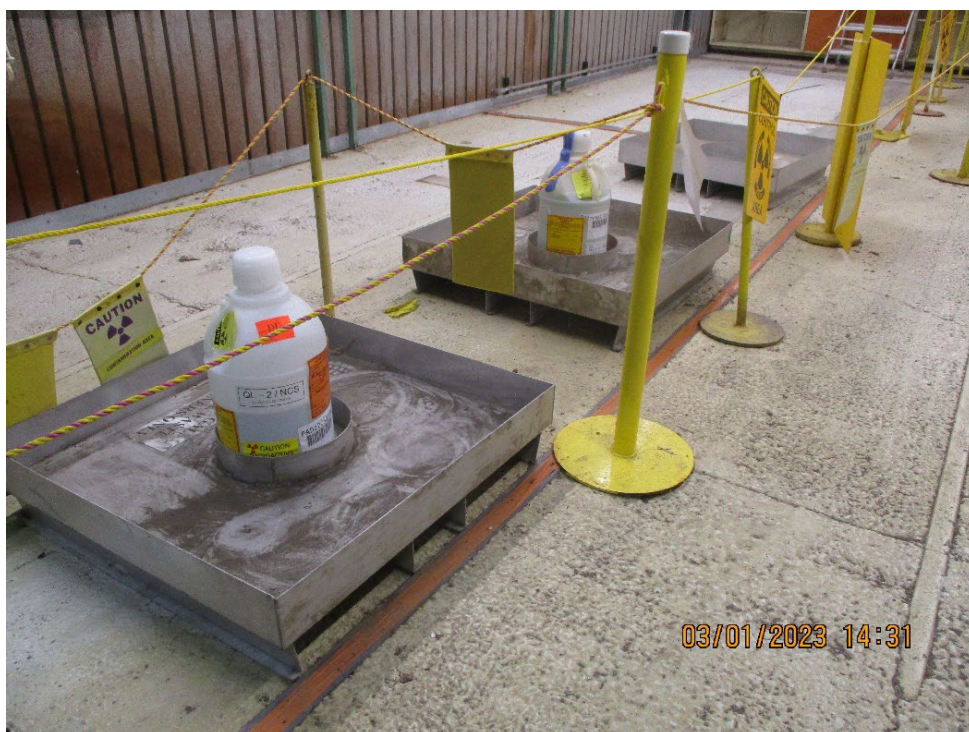
Photograph 65: Satellite Containers with fissile material.

Area S-409-02 contained one 55-gallon container for accumulating ignitable wastes. Area S-409-04 had one 55-gallon container for storing corrosive wastes. Area S-409-04 held two hazardous waste 21-gallon containers of potentially fissile material in special metal pallets. This area was

cordoned off and had radioactive caution signs. One container held aqueous oxide solutions from laboratory operations and one container held aqueous solution from laboratory operations. The area appeared to be well maintained and no spills, leaks, or maintenance issues were observed. All containers appeared to be properly labeled and marked, closed, and were in good condition.

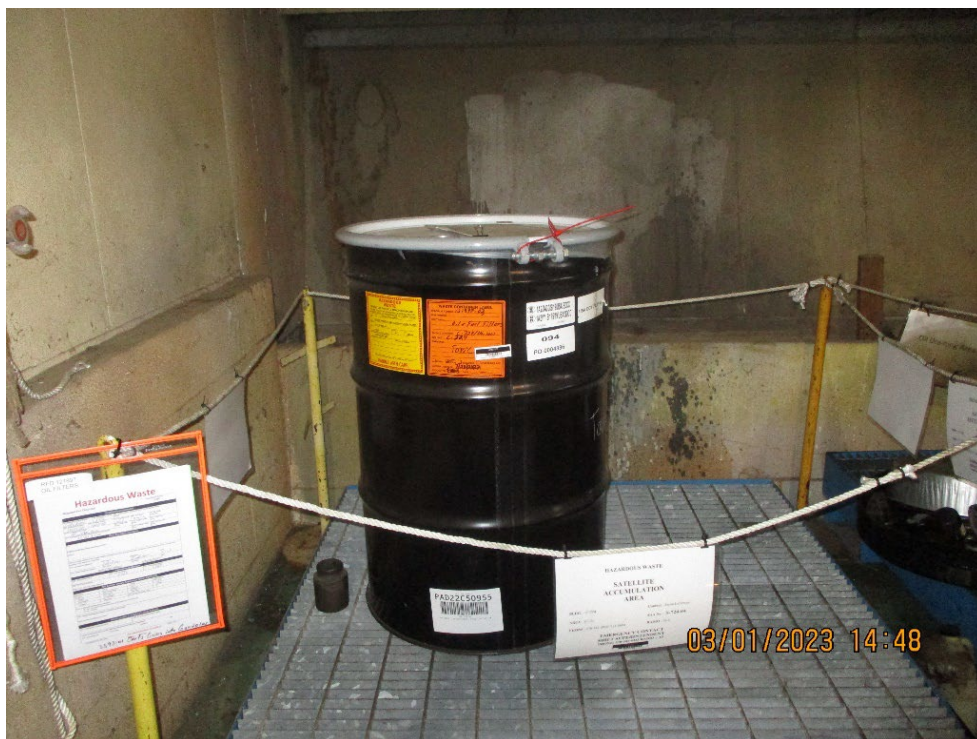
Photograph 67: 55-Gallon Hazardous Waste Container in SAA S-724-04.

The 90-day accumulation area 90DAA-724-01 was empty at the time of the inspection. This building had a battery testing area. SAA S-724-04 had one 55-gallon container for accumulating oil and fuel filters. SAA S-724-03 had one 55-gallon container for accumulating used oil that cannot be recycled. The area appeared to be well maintained and no spills, leaks, or maintenance issues were observed. All containers appeared to be properly labeled and marked, closed, and were in good condition.

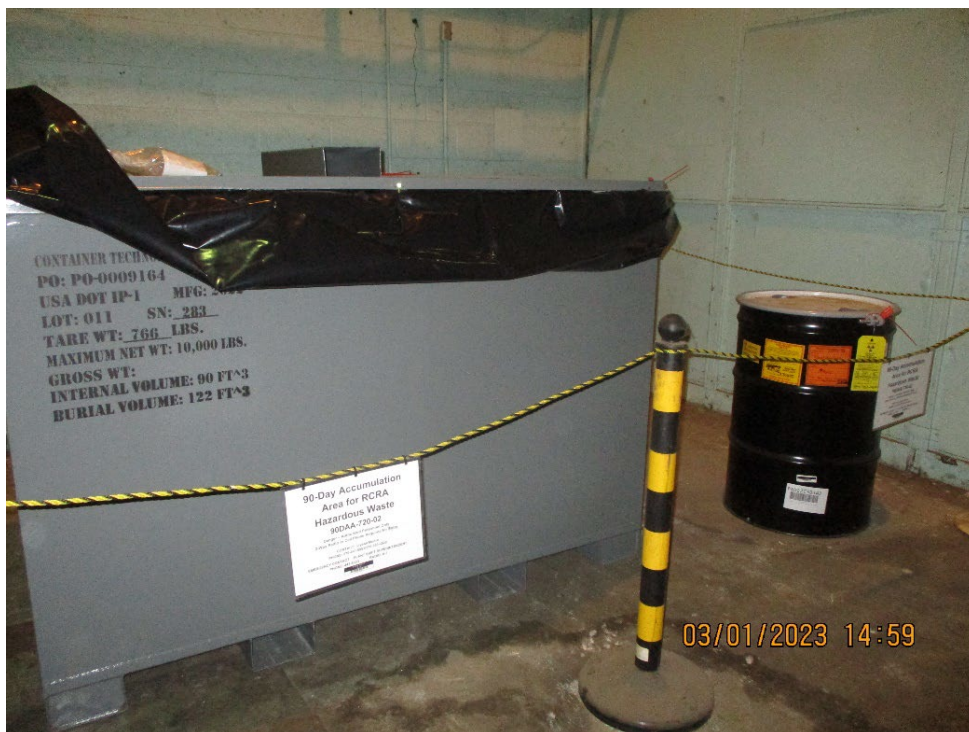
Photograph 71: ST-90 and 55-Gallon Hazardous Waste Containers in 90DAA-720-02.

SAA S-720-12, 14, and 10 were empty at the time of the inspection. One 90-day area, 90DAA-720-02 was in operation in Building 720. The 90-day area had a ST-90 box and one 55-gallon container. The 55-gallon container held hazardous waste with waste codes D006, D007, D009, and D010 containing circuit boards, etc. The ST-90 container contained “RCRA wastes” containing welding rods and various electronics and had waste codes D006, D008, D009, and D010. The area appeared to be well maintained and no spills, leaks, or maintenance issues were observed. All containers appeared to be properly labeled and marked, closed, and were in good condition.
