## RCRA COMPLIANCE EVALUATION INSPECTION REPORT

AOC Aliancys-Tennessee Plant (AOC)  
860 Highway 57 East  
Collierville, Tennessee 38017  
EPA ID: TND007037765

June 29, 2022 9:30 a.m.

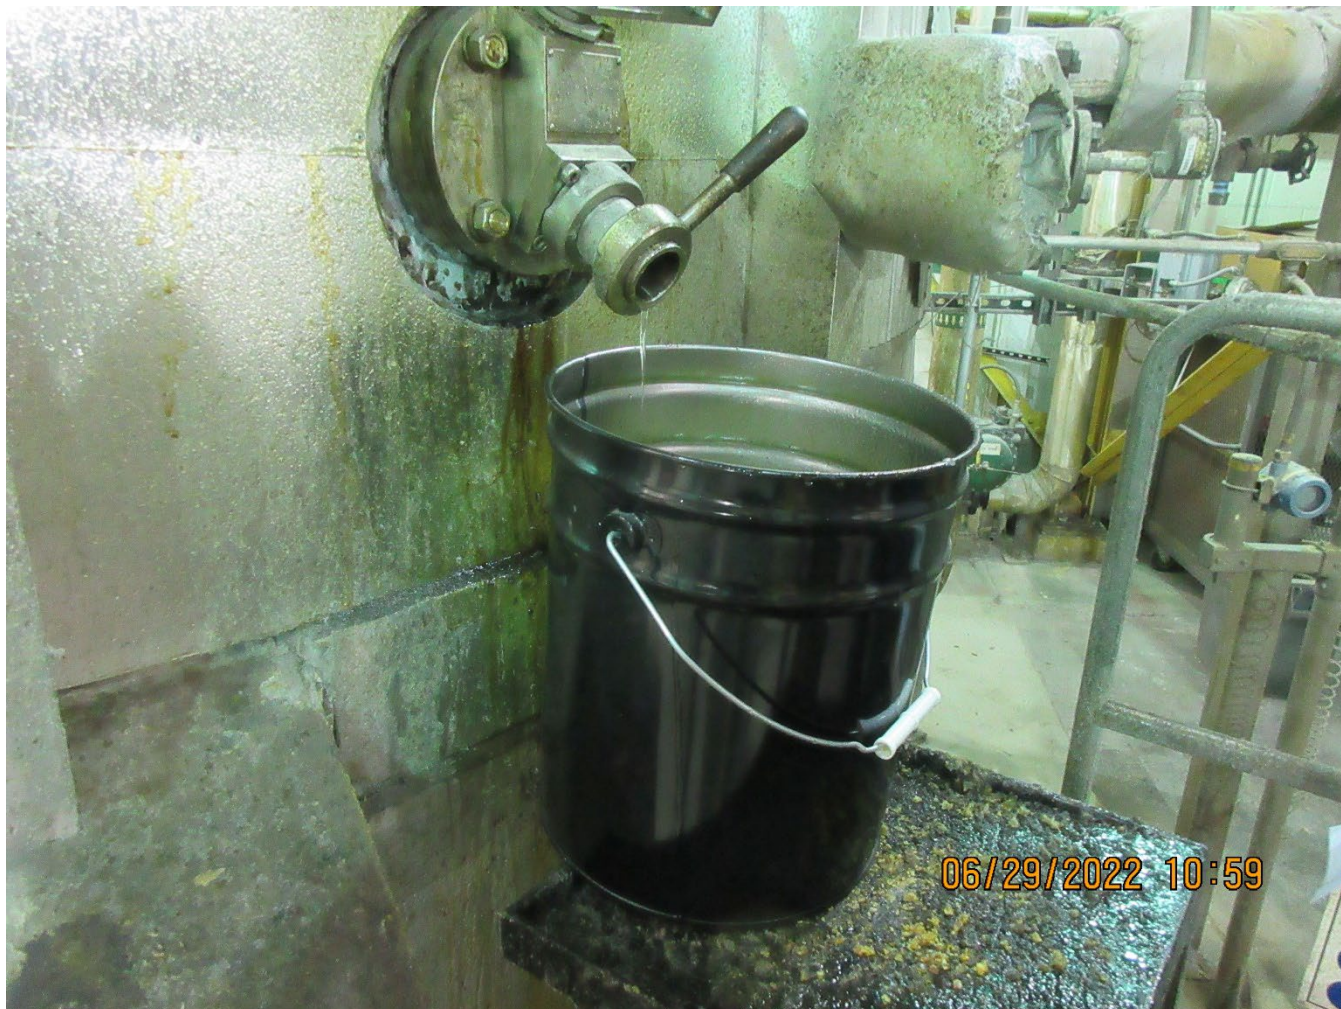
At the time of the inspection, a five-gallon container (Photo 1) which had received a small amount of waste resin solids from a port on Reactor 5 was unlabeled at the time of the inspection. Facility officials determined that the material had a flashpoint of less than 140 degrees Fahrenheit.

**Photo 1** – Five gallon container with waste resin.

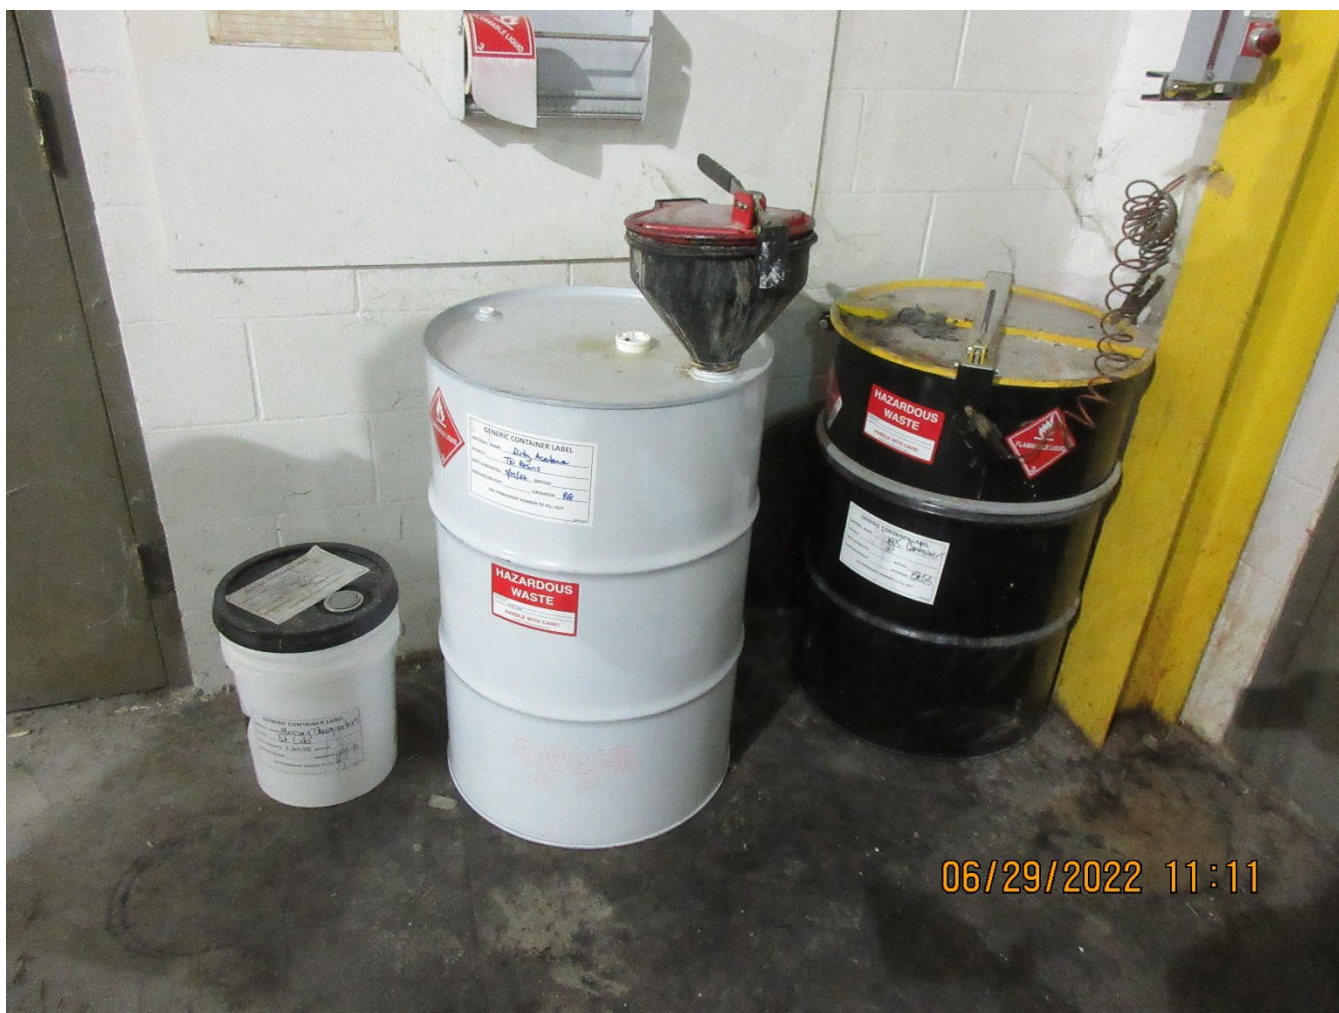
SAA #2 was the location of three separate satellite accumulation containers in the process area (Photo 2). One 55-gallon container of spent acetone, one 55-gallon container of spent sharps containing resin and one 5-gallon container of broken mercury thermometers comprised the three separate satellite accumulation areas. The 5-gallon container of broken mercury thermometers was not labeled with the words "Hazardous Waste" at the time of the inspection.

**Photo 2** - One 55-gallon container of spent acetone, one 55-gallon container of spent sharps containing resin and one 5-gallon container of broken mercury thermometers in the Process Area.

**Pursuant to Tenn. Comp. R. & Regs. 0400-12-01-.03 (1)(f)1. [40 C.F.R. § 262.15(a)], a generator may accumulate as much as 55 gallons of non-acute hazardous waste in containers at or near the point of generation where wastes initially accumulate, which is under the control of the operator of the process generating the waste, without a permit or without having interim status, as required by Section 68-212-108 of the THWMA, Tenn. Code Ann. § 68-212-108 [Section 3005 of RCRA, 42 U.S.C. § 6925], and without complying with Tenn. Comp. R. & Regs. 0400-12-01-.03(1)(g & h) [40 C.F.R. § 262.16(b) or § 262.17(a)], except as required in Tenn. Comp. R. & Regs. 0400-12-01-.03(1)(f)1.(v)(vii & viii) [40 C.F.R. § 262.15(a)(7) and (8)], provided that the generator complies with the satellite accumulation area conditions listed in Tenn. Comp. R. & Regs. 0400-12-01-.03(1)(f)1. [40 C.F.R. § 262.15(a)] (hereinafter referred to as the "SAA Permit Exemption").**

**Pursuant to Tenn. Comp. R. & Regs. 0400-12-01-.03 (1)(f)1.(v)(I)[40 C.F.R. § 262.15(a)(5)], which is a condition of the SAA Permit Exemption, a generator is required to mark or label its containers (i) with the words “Hazardous Waste.”**

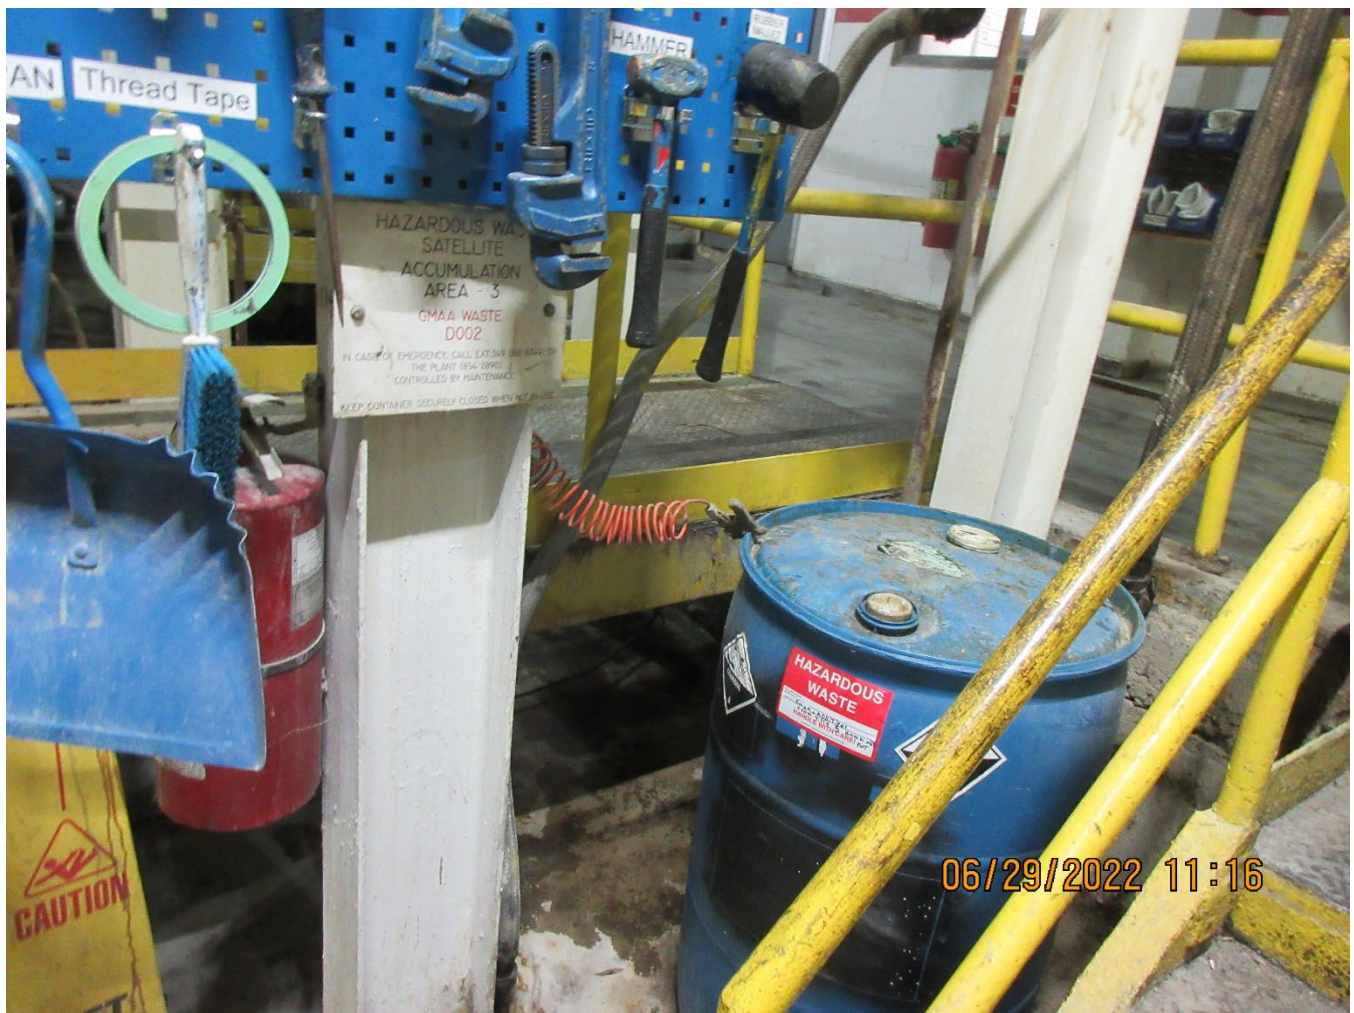
Satellite accumulation area (SAA) #3 (Photo 3) was the location of one satellite accumulation container managing a mixture of hazardous waste spent glacial methyl acrylate and GMAA additives (corrosive).

**Photo 3** - One 55-gallon container of hazardous waste spent glacial methyl acrylate and GMAA additives acetone.in SAA #2

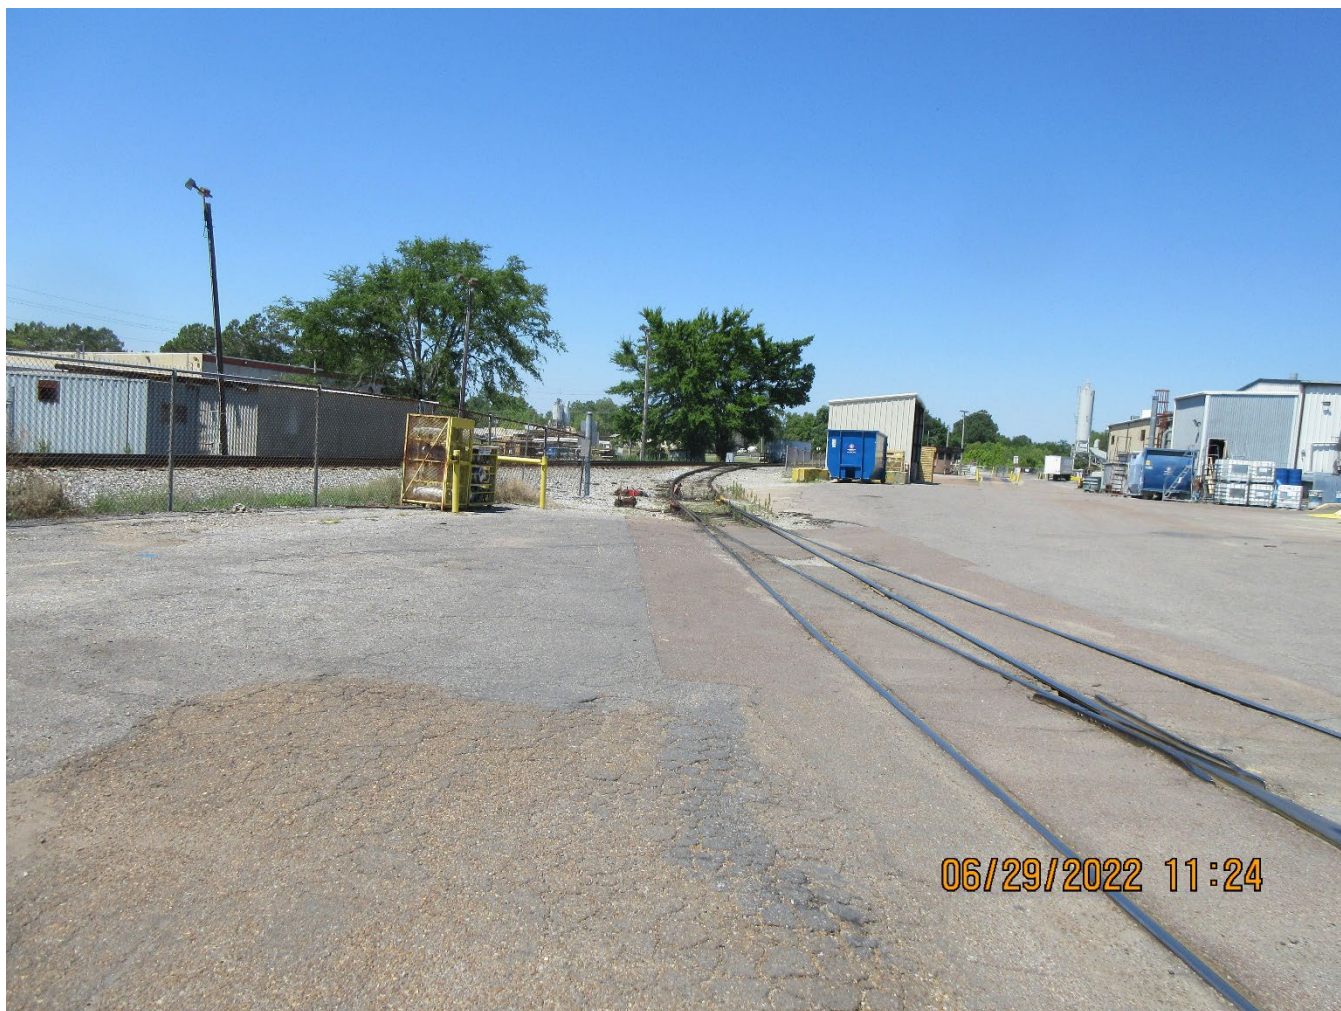
Three rail spurs (Photos 4 & 5) break off from the rail line that dissects the facility into an off-loading area in the southeastern area of the property to the north of the rail line. No hazardous wastes were observed in any of the loading/offloading areas associated with the rail spurs.

**Photo 4** - Rail Spur shown (facing ESE) from rail line which dissects facility property

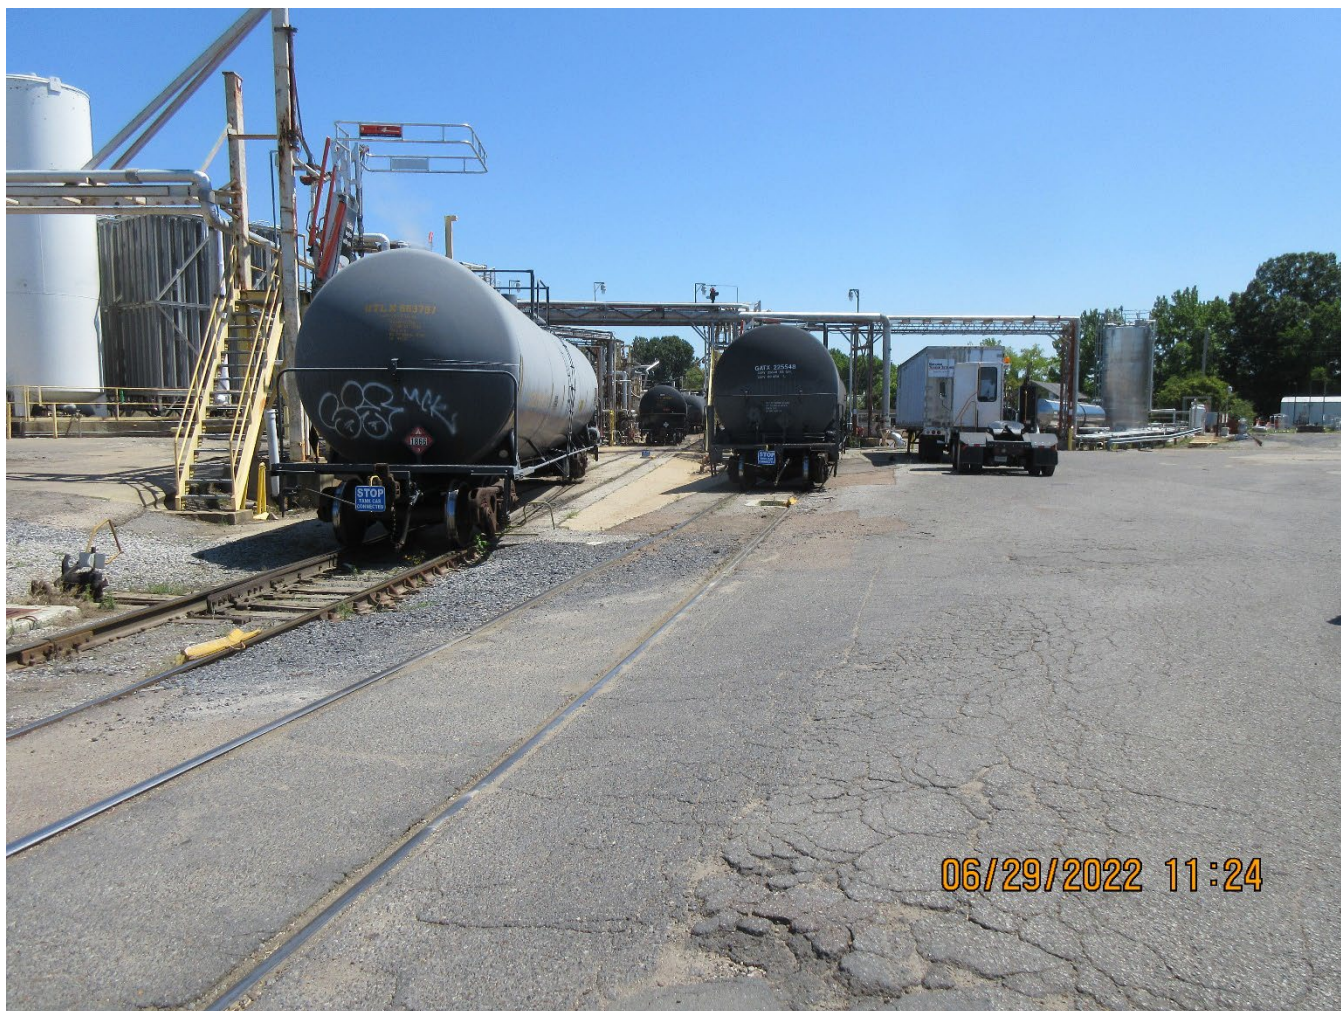
**Photo 5** - Rail Spurs shown facility property in an off-loading area

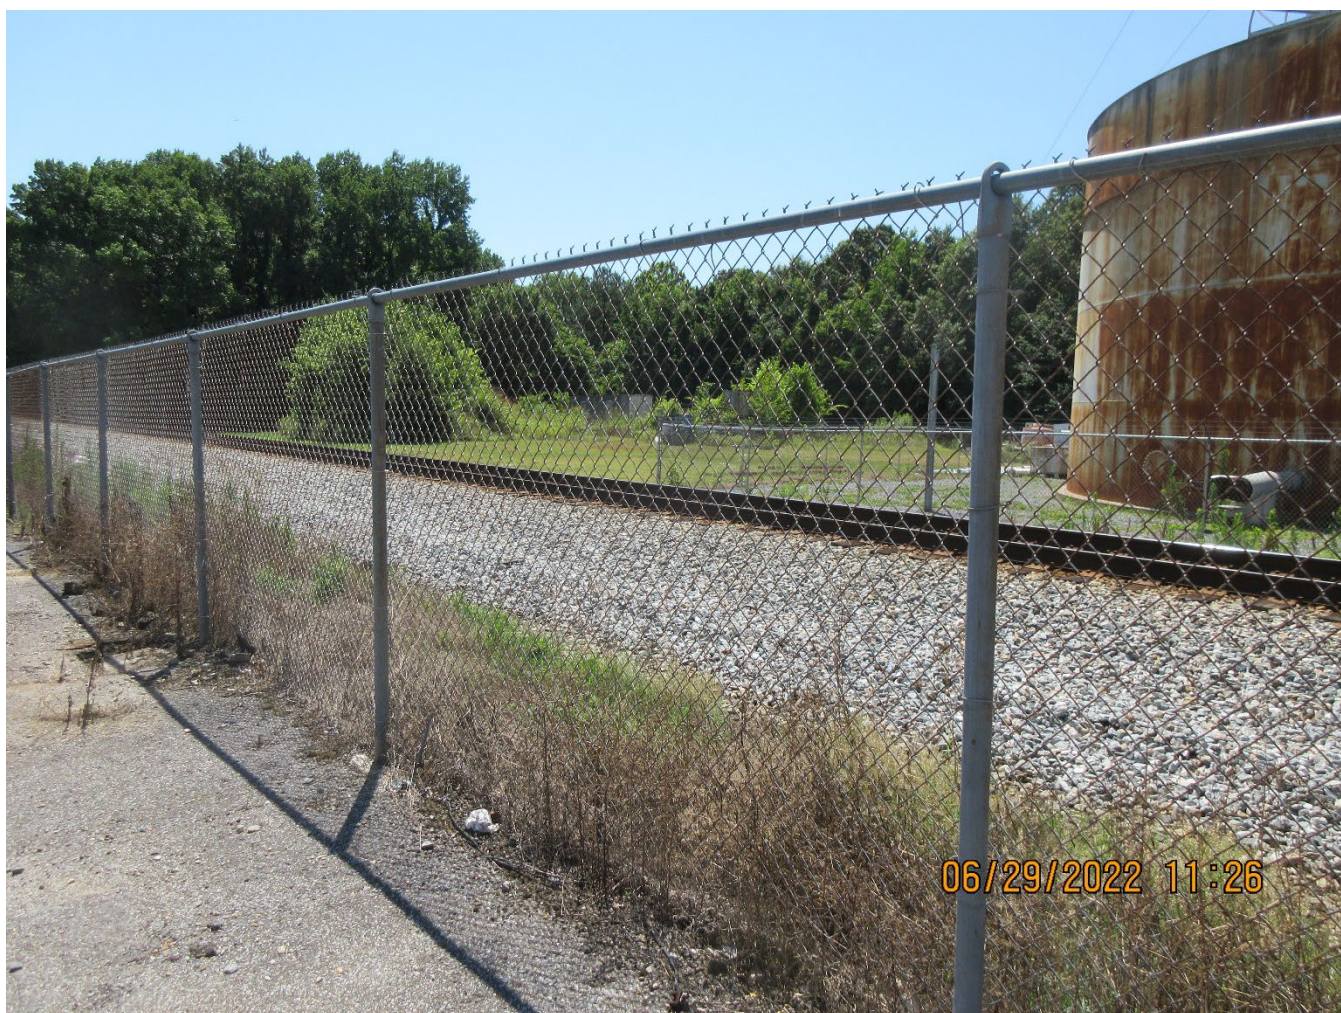
The property which encompasses the facility is bordered on the northern edge by Highway 57 and on the western edge by Commerce Road. A rail line runs east/west through the property dividing it into northern and southern parts. The facility's chemical operations take place in buildings on the north side of the rail line. Building #5, located on the south side of the rail line is comprised of office and warehouse space. Immediately to the south of Building #5 is a metal roofed structure on a bermed concrete pad used for the accumulation of hazardous waste generated by facility operations on the north side of the rail line.

**Photo 6** - Rail line running east/west through property

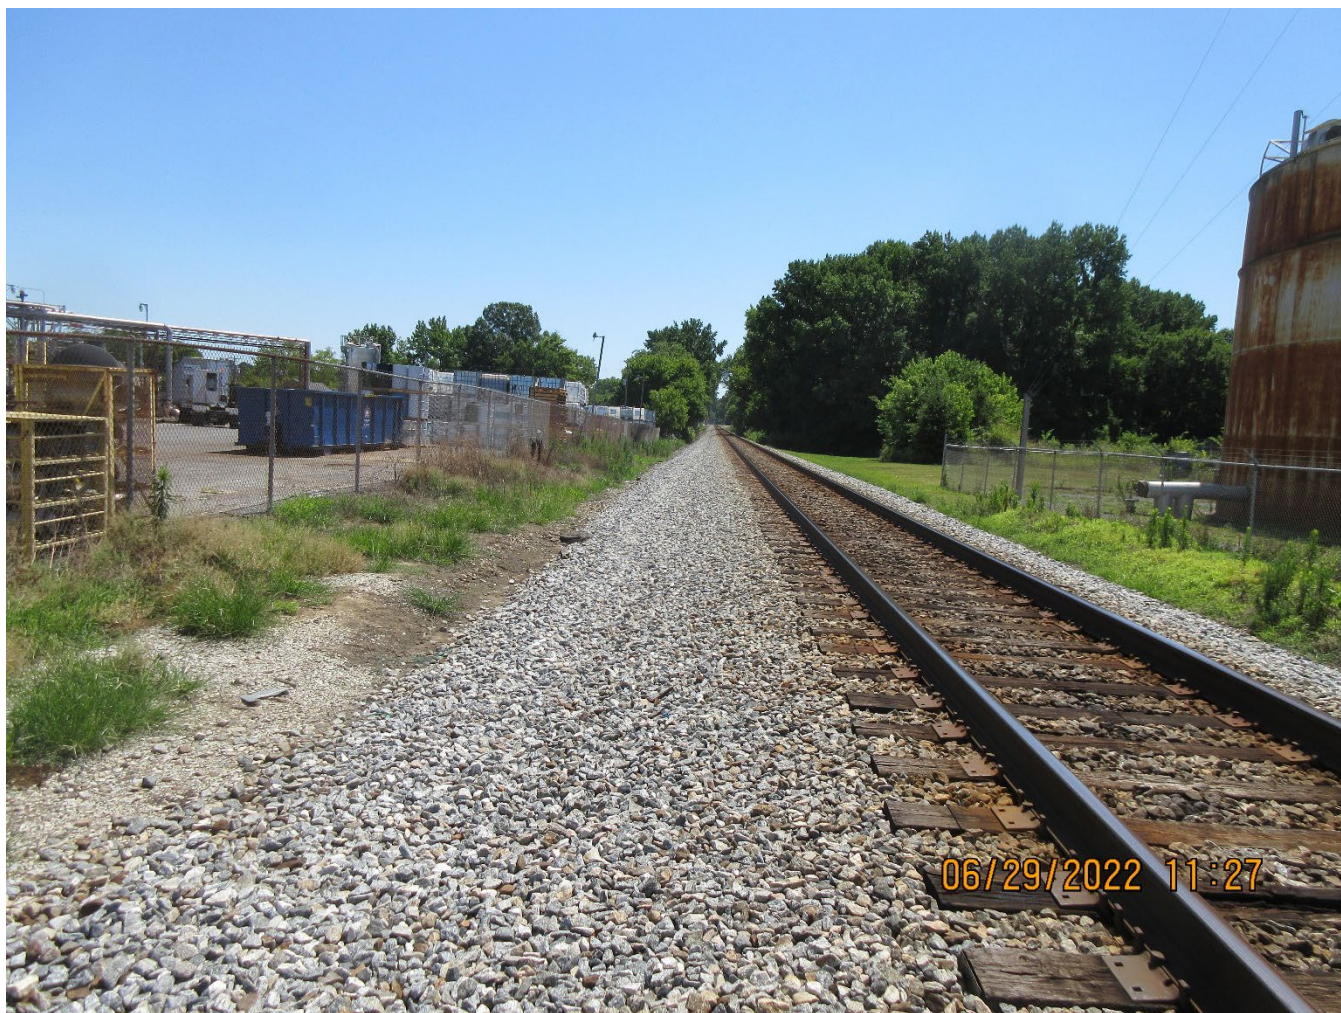
**Photo 7** - Rail line running east/west through property

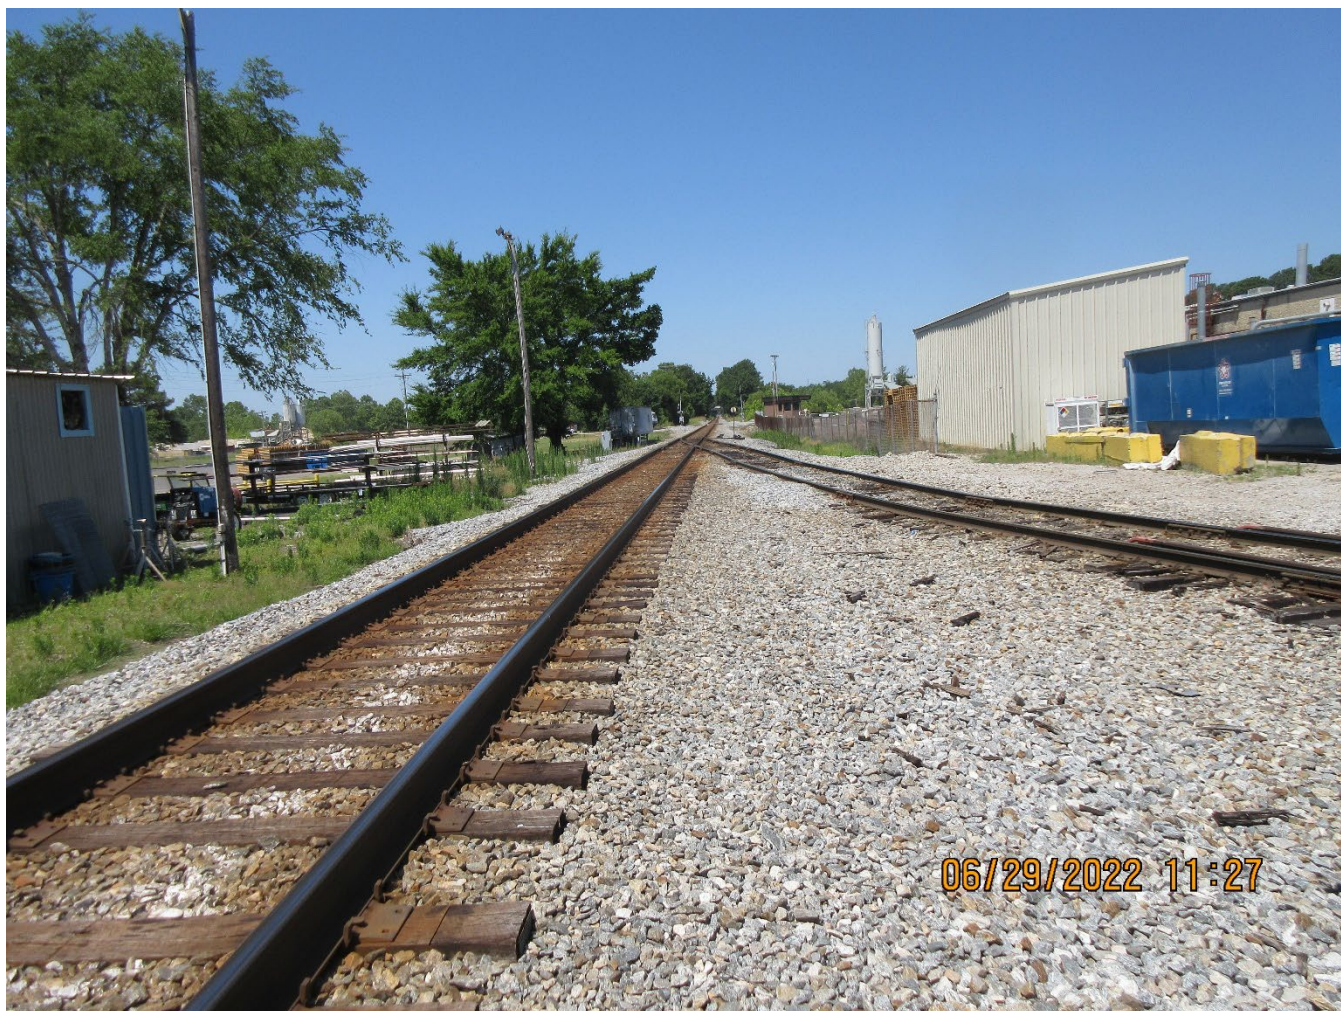
**Photo 8** - Rail line running east/west through property with spur to AOC property

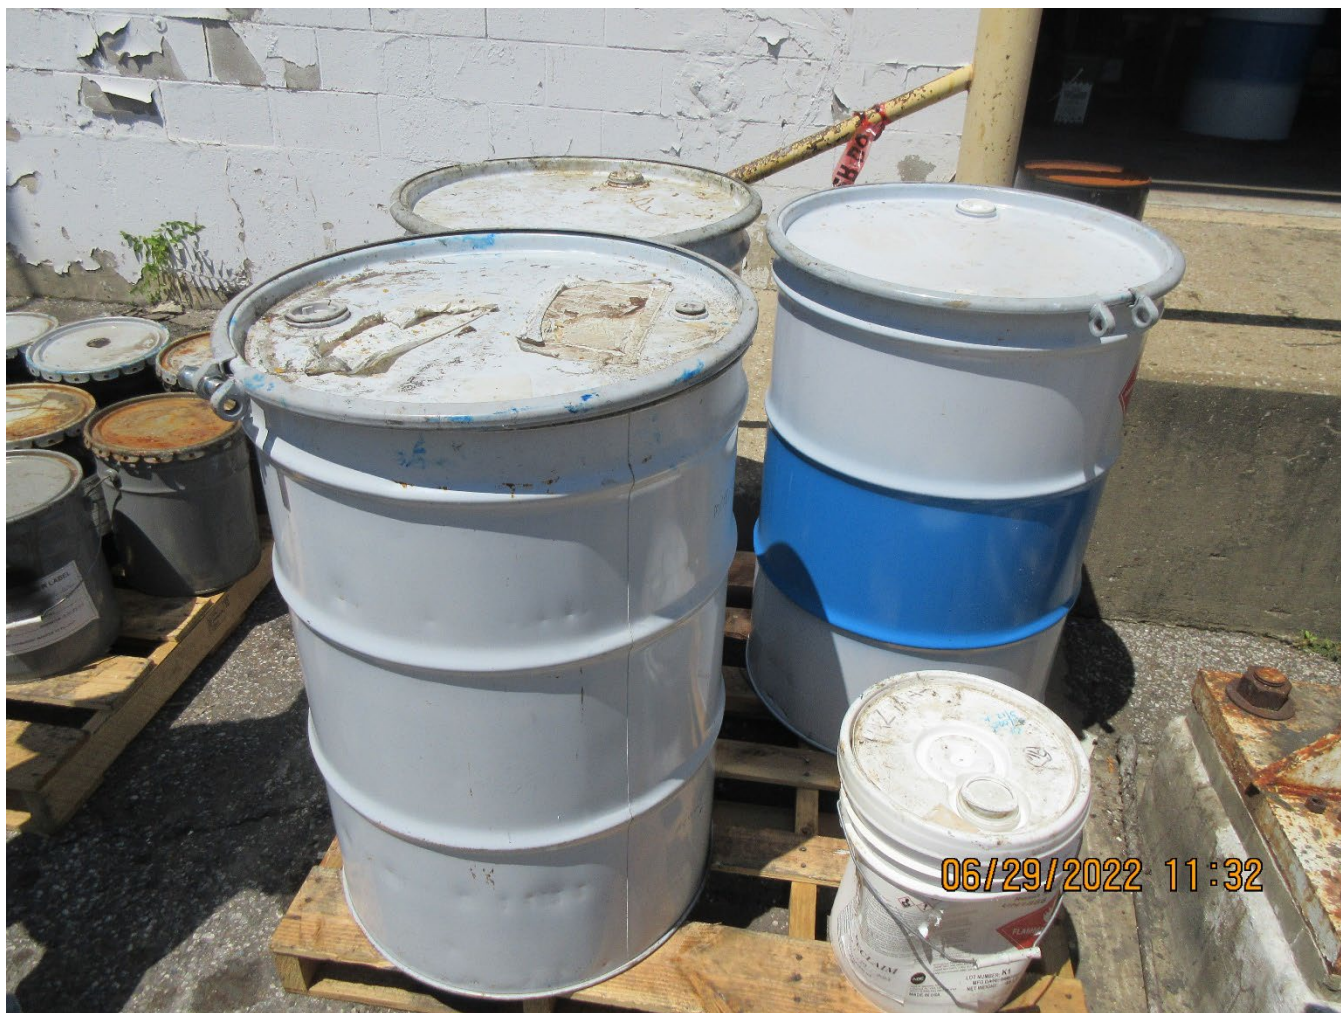
Hazardous wastes resins and other liquid wastes were observed within three 55-gallon drums on a pallet outside of Building 1 in an area where materials are reclaimed.

While designated as a SAA, none of the containers were marked with accumulation start dates. One of the containers was not labeled with the words “Hazardous Waste” or an indication of the hazard contents of the container and one was open (missing bolt in lid fastener) at the time of the inspection.

**Photo 9** – Reclaim Area outside Building 1

**Pursuant to Tenn. Comp. R. & Regs. 0400-12-01-.03(1)(f)1.(vi)(III)[40 C.F.R. § 262.15(a)(6)(iii)], which is a condition of the SAA Permit Exemption, a generator is required, during the three-consecutive-calendar-day period in which the SAA exceeds 1 kilogram of acute or 55-gallons of characteristic or listed hazardous wastes, comply with paragraphs (a)(1) through (5) of this section. The generator must mark or label the container(s) holding the excess accumulation of hazardous waste with the date the excess amount began accumulating.**

**Pursuant to Tenn. Comp. R. & Regs. 0400-12-01-.03(1)(f)1.(iv) [40 C.F.R. § 262.15(a)(4)], which is a condition of the SAA Permit Exemption, a generator is required to keep containers of hazardous waste closed at all times during accumulation, except when adding, removing, or consolidating waste; or when temporary venting of a container is necessary for the proper operation of equipment, or to prevent dangerous situations, such as build-up of extreme pressure.**

**Pursuant to Tenn. Comp. R. & Regs. 0400-12-01-.03(1)(f)1.(v) [40 C.F.R. § 262.15(a)(5)], which is a condition of the SAA Permit Exemption, a generator is required to mark or label its containers (i) with the words “Hazardous Waste” and (ii) with an indication of the hazards of the contents.**

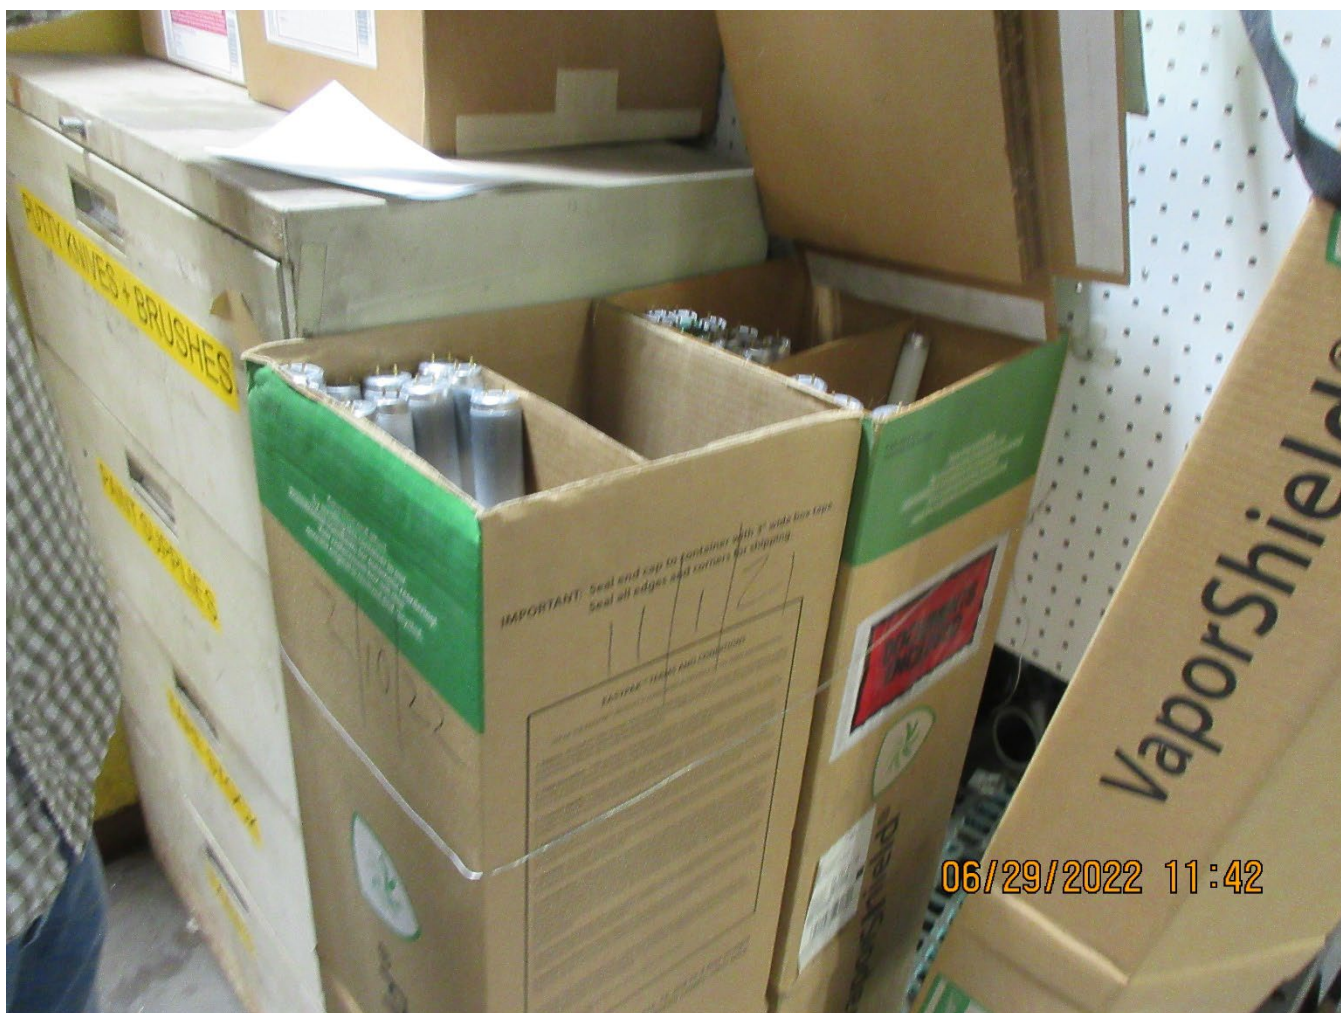
Maintenance operations for the facility are performed in this area. Universal wastes generated within the facility are brought to a collection area in this location (Photo 12). At the time of the inspection, the inspection team observed two four-foot boxes of universal waste fluorescent tubes (Photo 11). Ten bulbs were observed in one box, 24 bulbs were observed in the other. Each box was open at the time of the inspection. One 10-foot box of Universal Waste fluorescent bulbs was also observed to be open in this area (Photo 10).

**Photo 11** – Four-foot boxes of universal waste fluorescent tubes in Maintenance Area

**Pursuant Tenn. Comp. R. & Regs. 0400-12-01-.12(2)(d)4 [40 C.F.R. § 273.13(d)], a SQHUW must manage universal waste lamps in a way that prevents releases of any universal waste or component of a universal waste to the environment.**

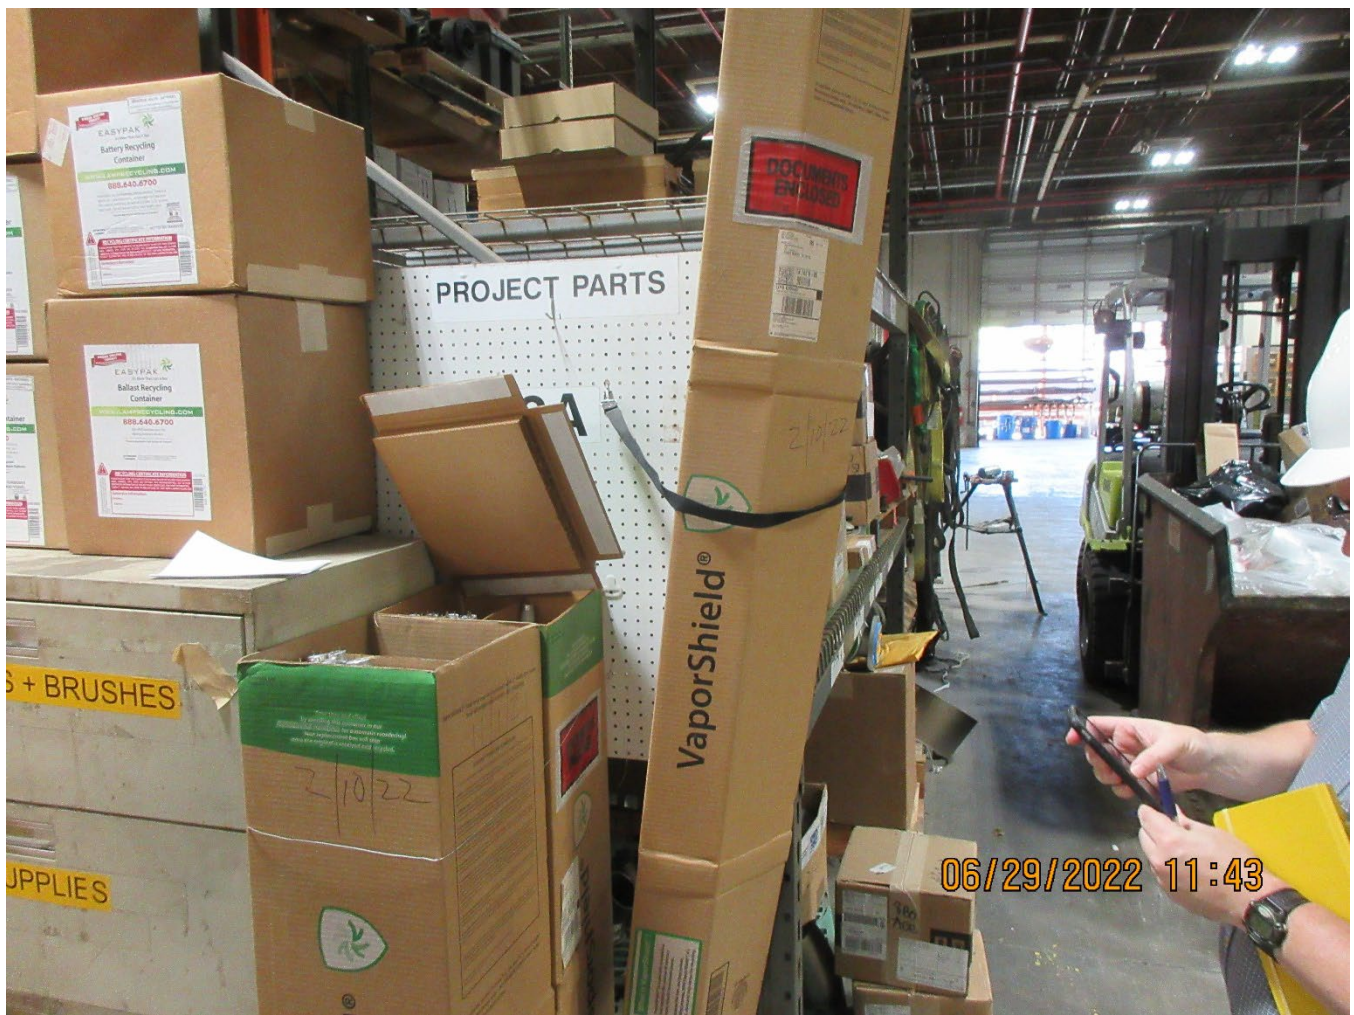
**Photo 12 - Universal Waste accumulation area in Maintenance Area**

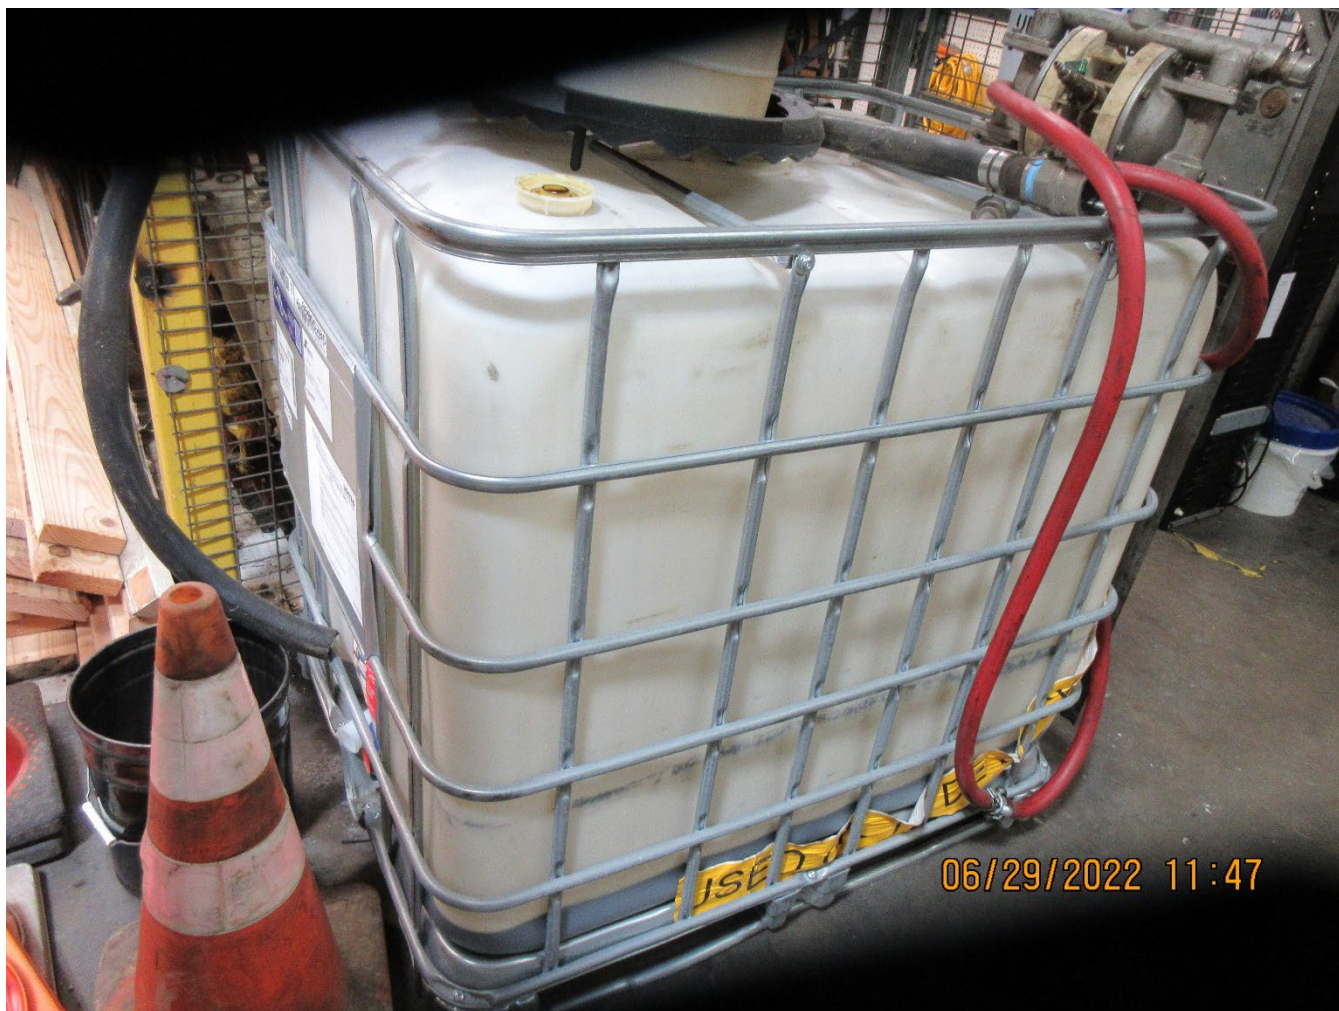
One 275-gallon plastic tote of used oil was also observed in this area (Photo 13). The tote was closed and labeled with the words “Used Oil.”

**Photo 13** – Tote containing used oil in Maintenance Area

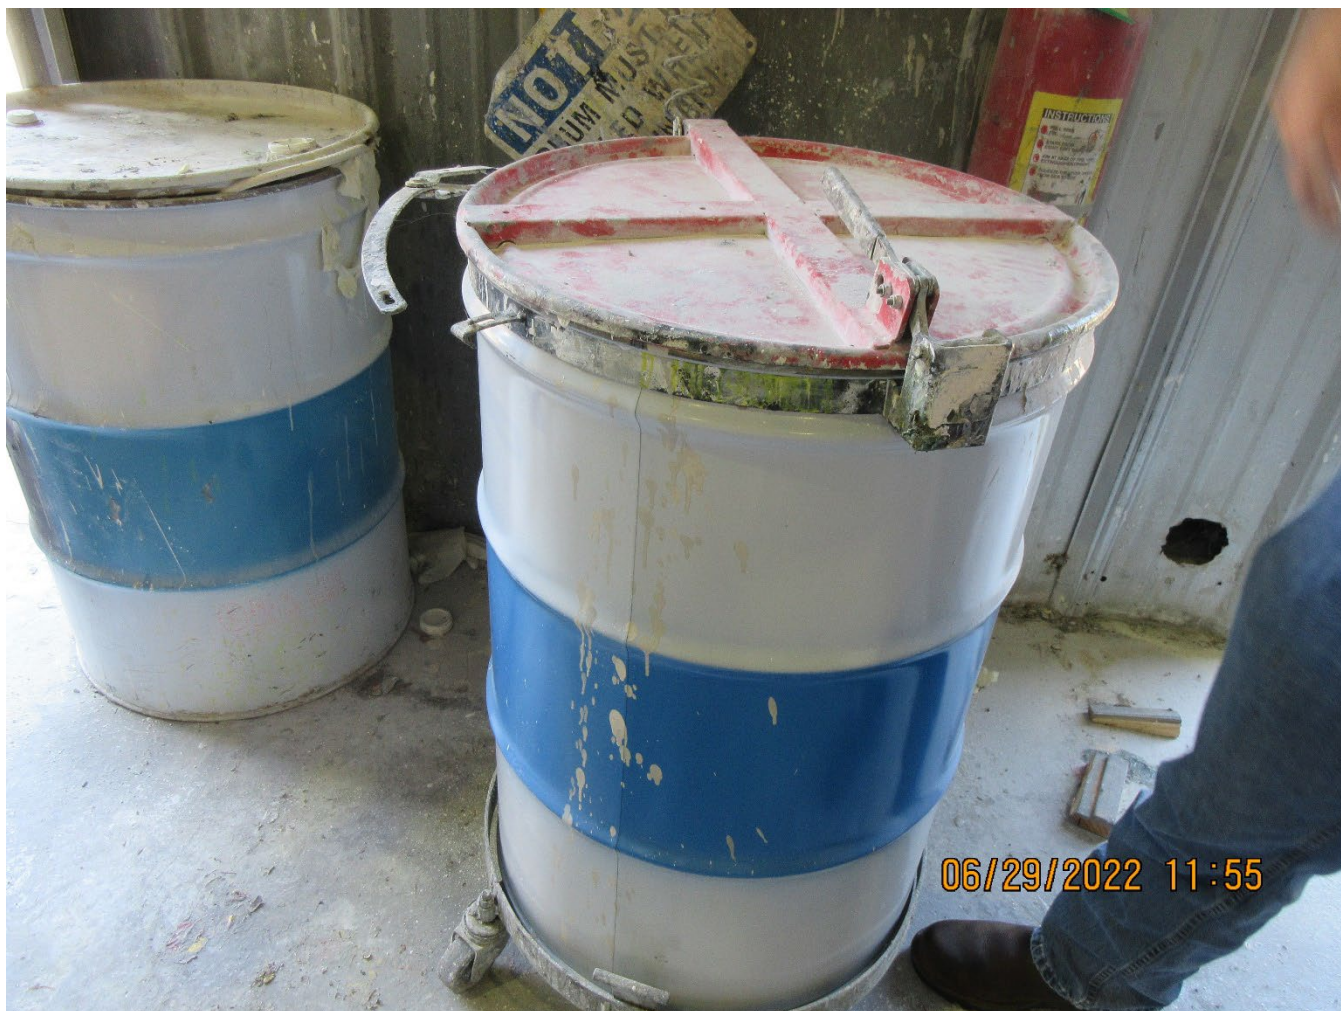
**Photo 14 – SAA # 7 in Building 4 Colorants Area**

One 55-gallon container of hazardous waste (ignitable) spent gel coat filter bags was observed within SAA #7 in this area (Photo 14). The container was not labeled with the words “Hazardous Waste” or with an indication of the hazard associated with the waste at the time of the inspection.

**Pursuant to Tenn. Comp. R. & Regs. 0400-12-01-.03 (1)(f)1.(v)(I & II)[40 C.F.R. § 262.15(a)(5), which is a condition of the SAA Permit Exemption, a generator is required to mark or label its containers (i) with the words “Hazardous Waste” and (ii) an indication of the hazards of the contents of the container.**

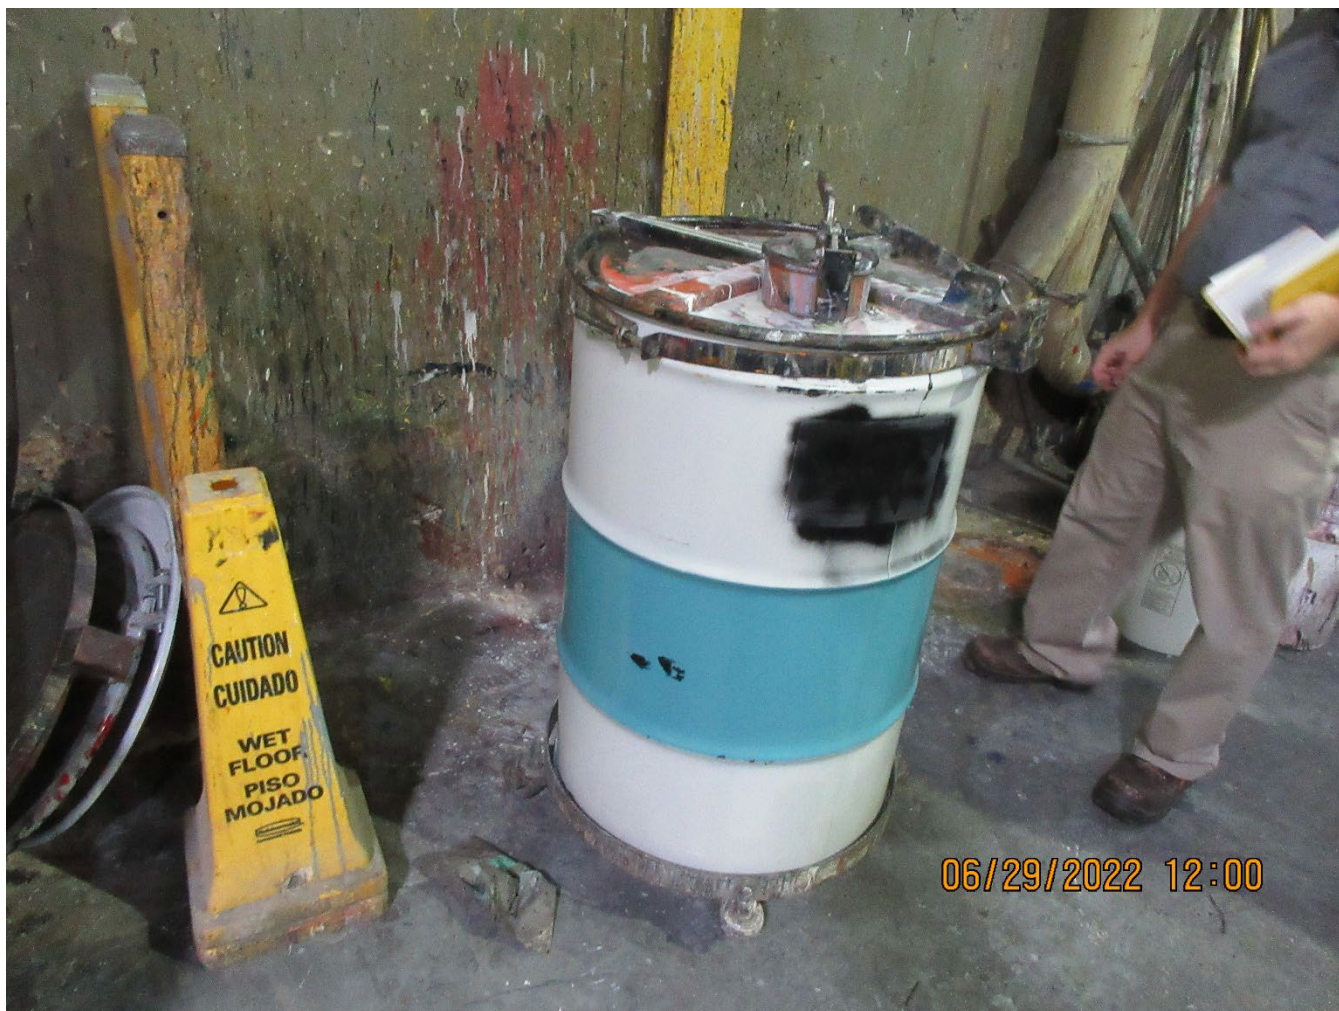
**Photo 15 - SAA # 9 in Building 4 Colorants Area**

One 55-gallon container of hazardous waste (ignitable) gel coat colorants was observed within SAA #9 in this area (Photo 15). The container was not labeled with the words “Hazardous Waste” at the time of the inspection.

**Pursuant to Tenn. Comp. R. & Regs. 0400-12-01-.03 (1)(f)1.(v)(I)[40 C.F.R. § 262.15(a)(5), which is a condition of the SAA Permit Exemption, a generator is required to mark or label its containers (i) with the words “Hazardous Waste.”**

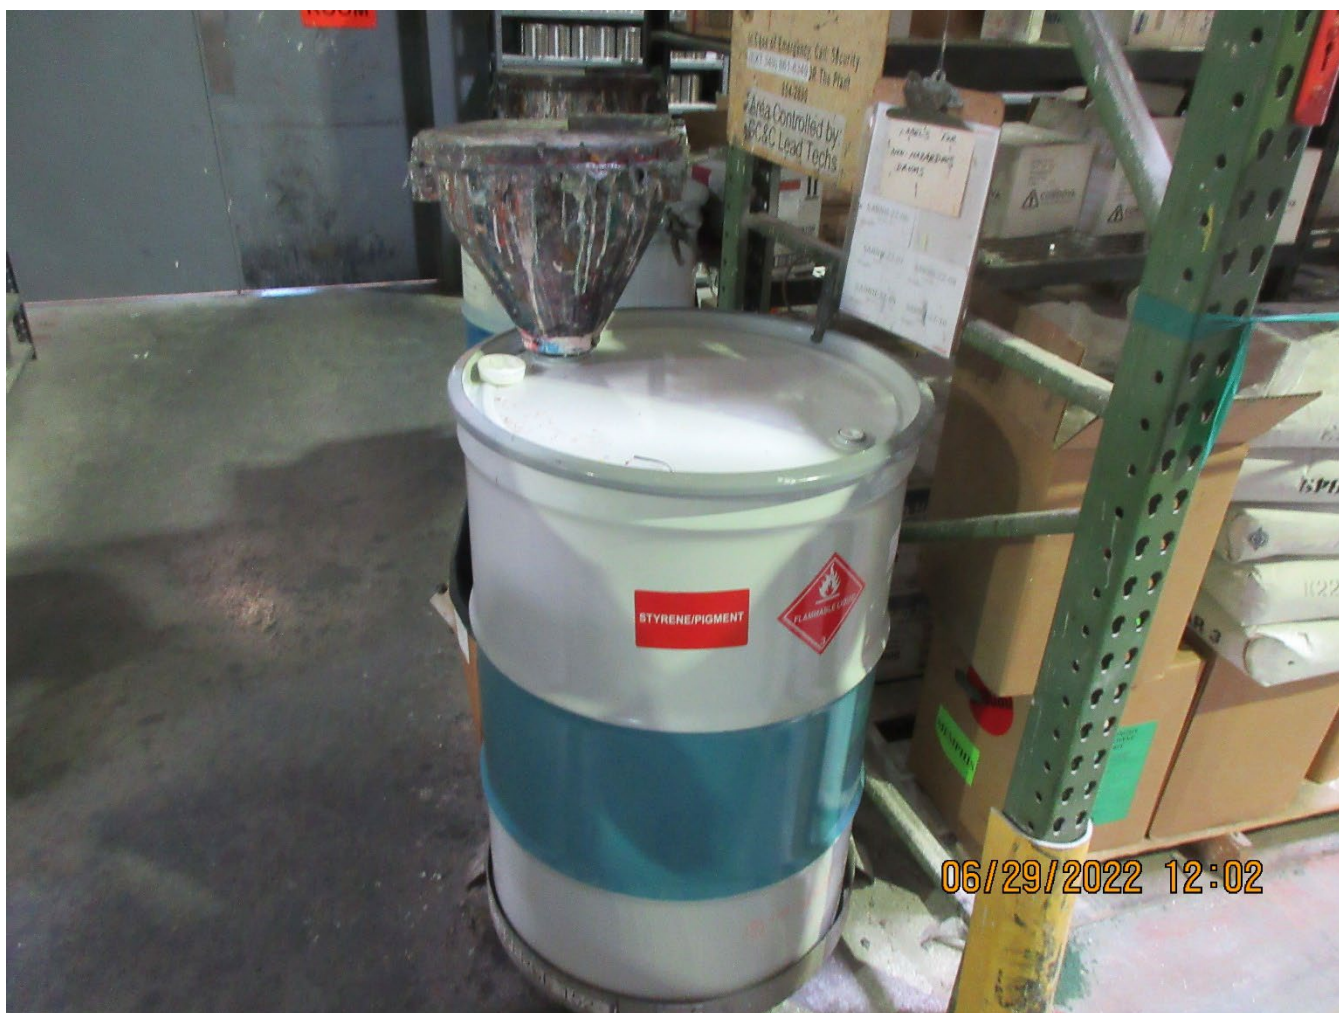
**Photo 16 - SAA # 8 in Building 4 Colorants Area**

One 55-gallon container of hazardous waste (ignitable) pigment materials was observed within SAA #8 in this area (Photo 16). The container was open (Photo 17) and not labeled with the words “Hazardous Waste” at the time of the inspection. Facility personnel closed this container during the inspection.

**Pursuant to Tenn. Comp. R. & Regs. 0400-12-01-.03 (1)(f)1.(v)(I)[40 C.F.R. § 262.15(a)(5), which is a condition of the SAA Permit Exemption, a generator is required to mark or label its containers (i) with the words “Hazardous Waste.”**

**Pursuant to Tenn. Comp. R. & Regs. 0400-12-01-.03(1)(f)1.(iv) [40 C.F.R. § 262.15(a)(4)], which is a condition of the SAA Permit Exemption, a generator is required to keep containers of hazardous waste closed at all times during accumulation, except when adding, removing, or consolidating waste; or when temporary venting of a container is necessary for the proper operation of equipment, or to prevent dangerous situations, such as build-up of extreme pressure.**
