## RCRA COMPLIANCE EVALUATION INSPECTION REPORT

AOC Aliancys-Tennessee Plant (AOC)  
860 Highway 57 East  
Collierville, Tennessee 38017  
EPA ID: TND007037765

June 29, 2022 9:30 a.m.

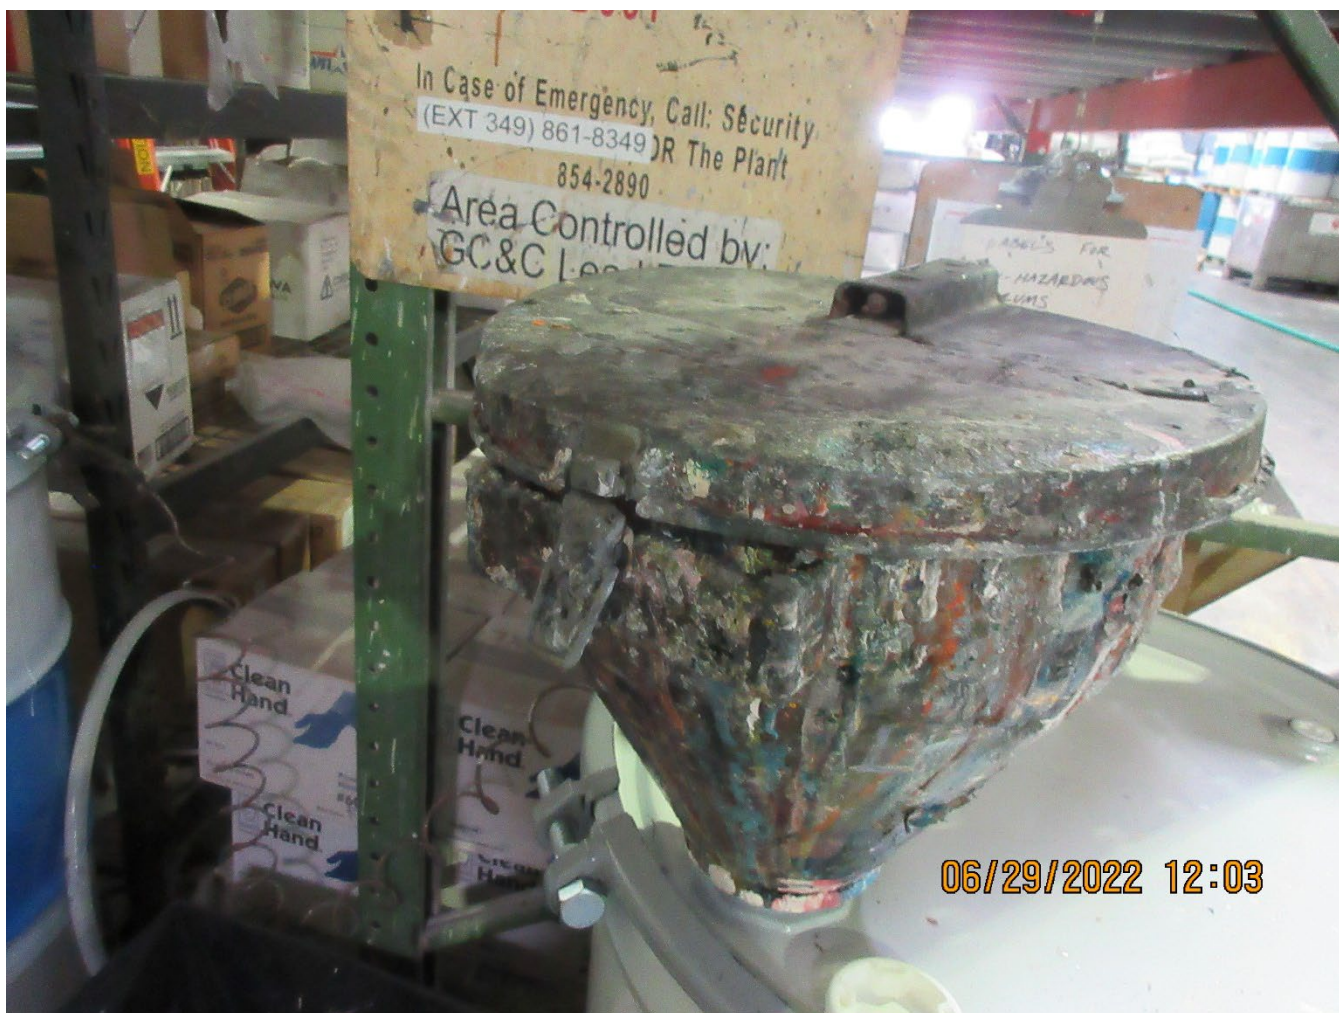
One 55-gallon container of hazardous waste (ignitable) pigment materials was observed within SAA #8 in this area (Photo 16). The container was open (Photo 17) and not labeled with the words “Hazardous Waste” at the time of the inspection. Facility personnel closed this container during the inspection.

**Photo 17 - Open latch on SAA # 8 in Building 4 Colorants Area**

**Pursuant to Tenn. Comp. R. & Regs. 0400-12-01-.03(1)(f)1.(iv) [40 C.F.R. § 262.15(a)(4)], which is a condition of the SAA Permit Exemption, a generator is required to keep containers of hazardous waste closed at all times during accumulation, except when adding, removing, or consolidating waste; or when temporary venting of a container is necessary for the proper operation of equipment, or to prevent dangerous situations, such as build-up of extreme pressure.**

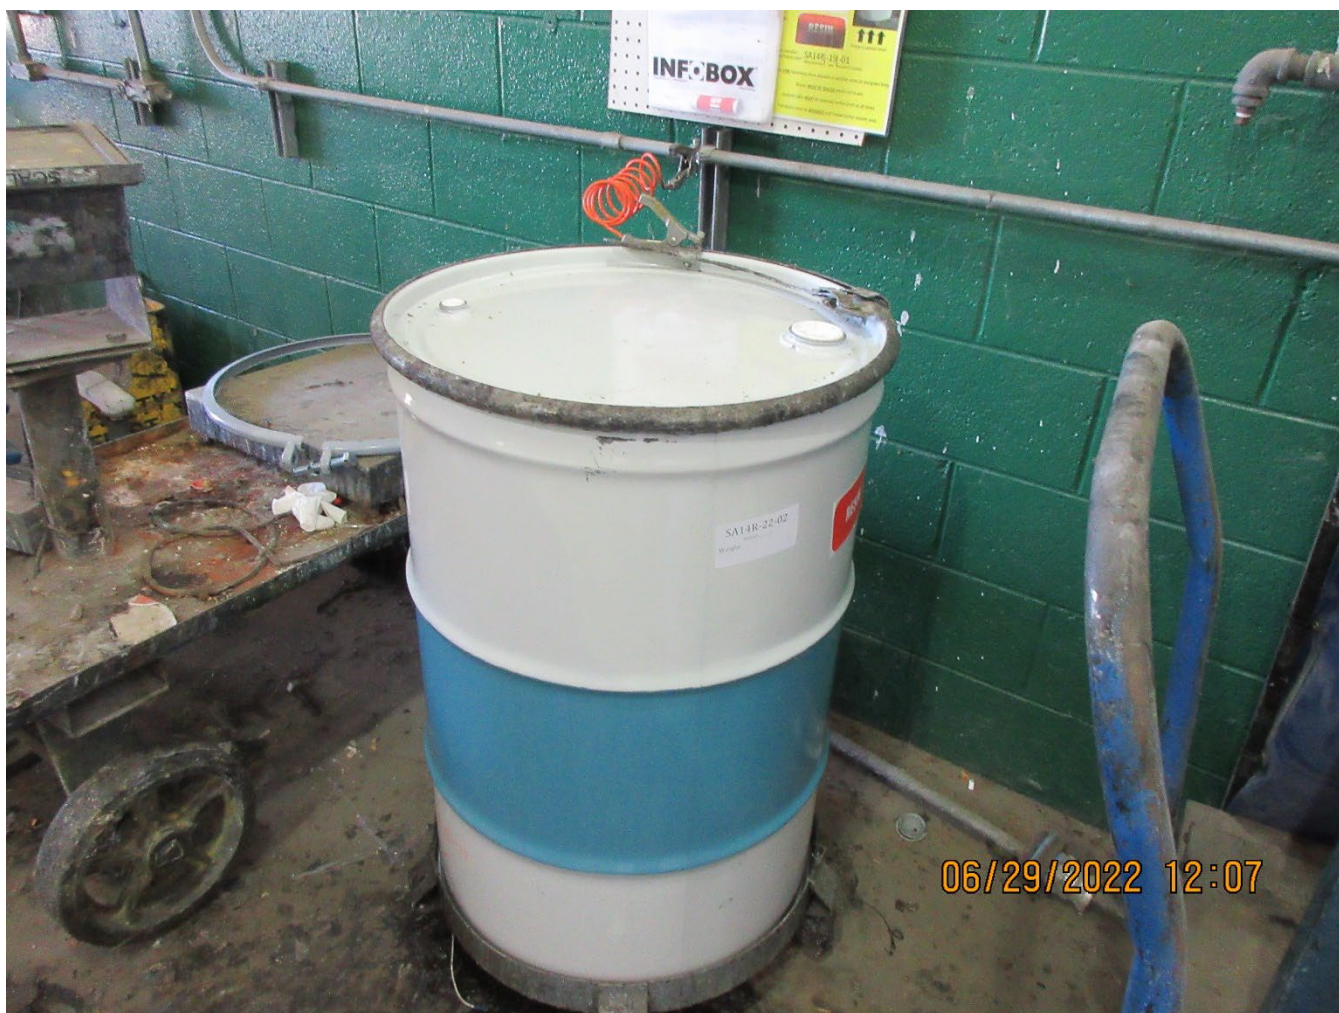
**Photo 18 - SAA #14 in a loading bay within Building 4**

One 55-gallon container of hazardous waste (ignitable) resin materials was observed within SAA #14 in a loading bay within this area (Photo 18). The container was and not labeled with the words “Hazardous Waste” or an indication of the hazard contents of the container at the time of the inspection.

**Pursuant to Tenn. Comp. R. & Regs. 0400-12-01-.03 (1)(f)1. (v)(I & II) [40 C.F.R. § 262.15(a)(5)], which is a condition of the SAA Permit Exemption, a generator is required to mark or label its containers (i) with the words “Hazardous Waste” or (ii) with an indication of the hazard contents of the container.**

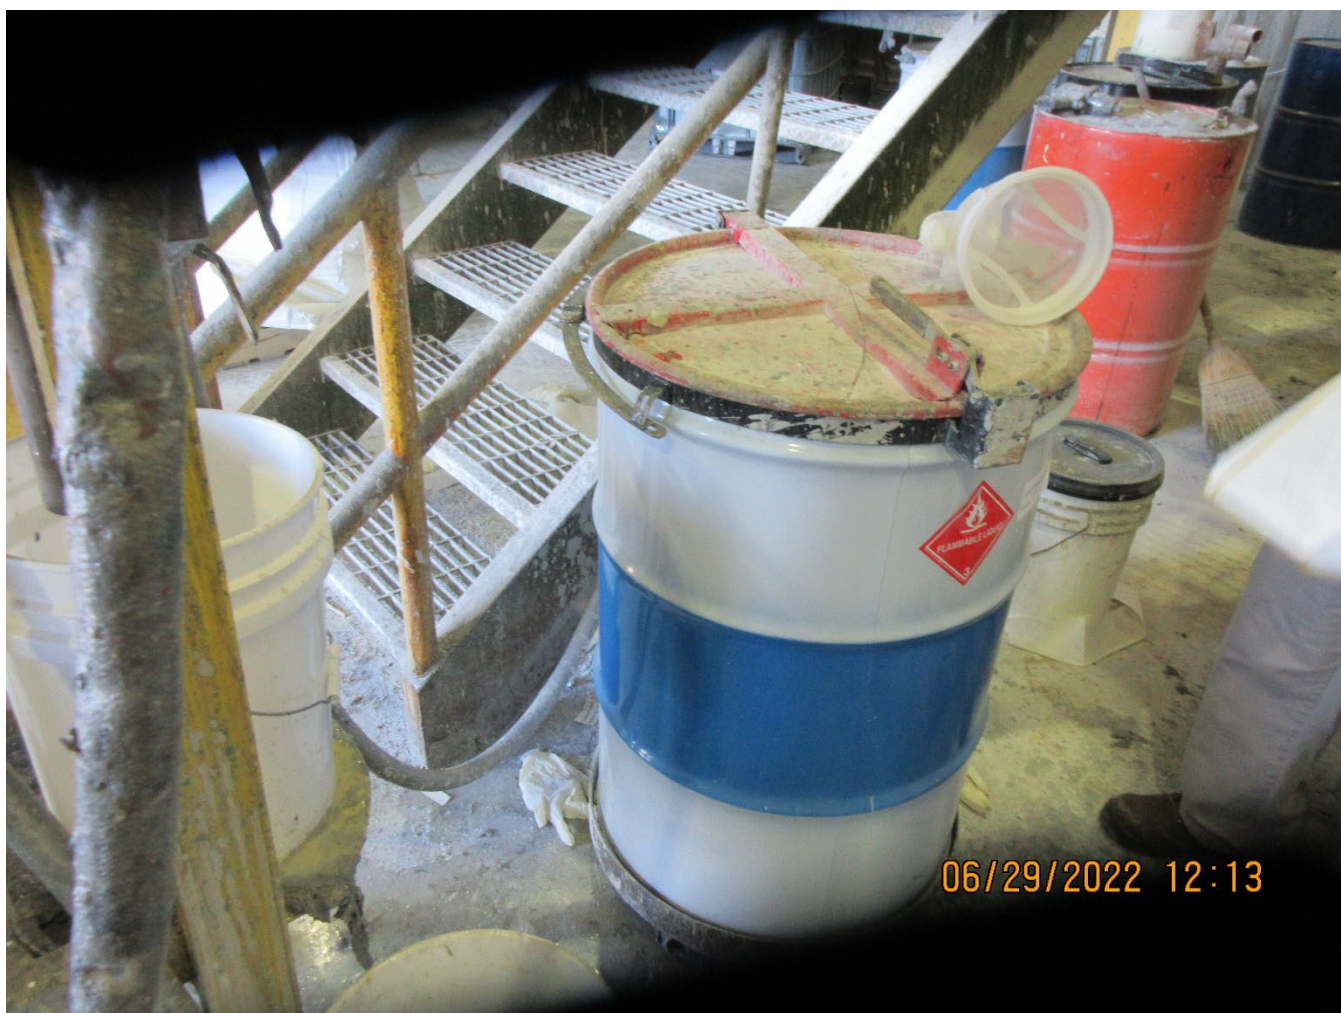
**Photo 19 - SAA #10 in Building 4**

One 55-gallon container of hazardous waste (ignitable) used materials was observed within SAA #10 in Building 4 (Photo 19). The container was not labeled with the words “Hazardous Waste” at the time of the inspection.

**Pursuant to Tenn. Comp. R. & Regs. 0400-12-01-.03 (1)(f)1.(v)(I)[40 C.F.R. § 262.15(a)(5), which is a condition of the SAA Permit Exemption, a generator is required to mark or label its containers (i) with the words “Hazardous Waste.”**

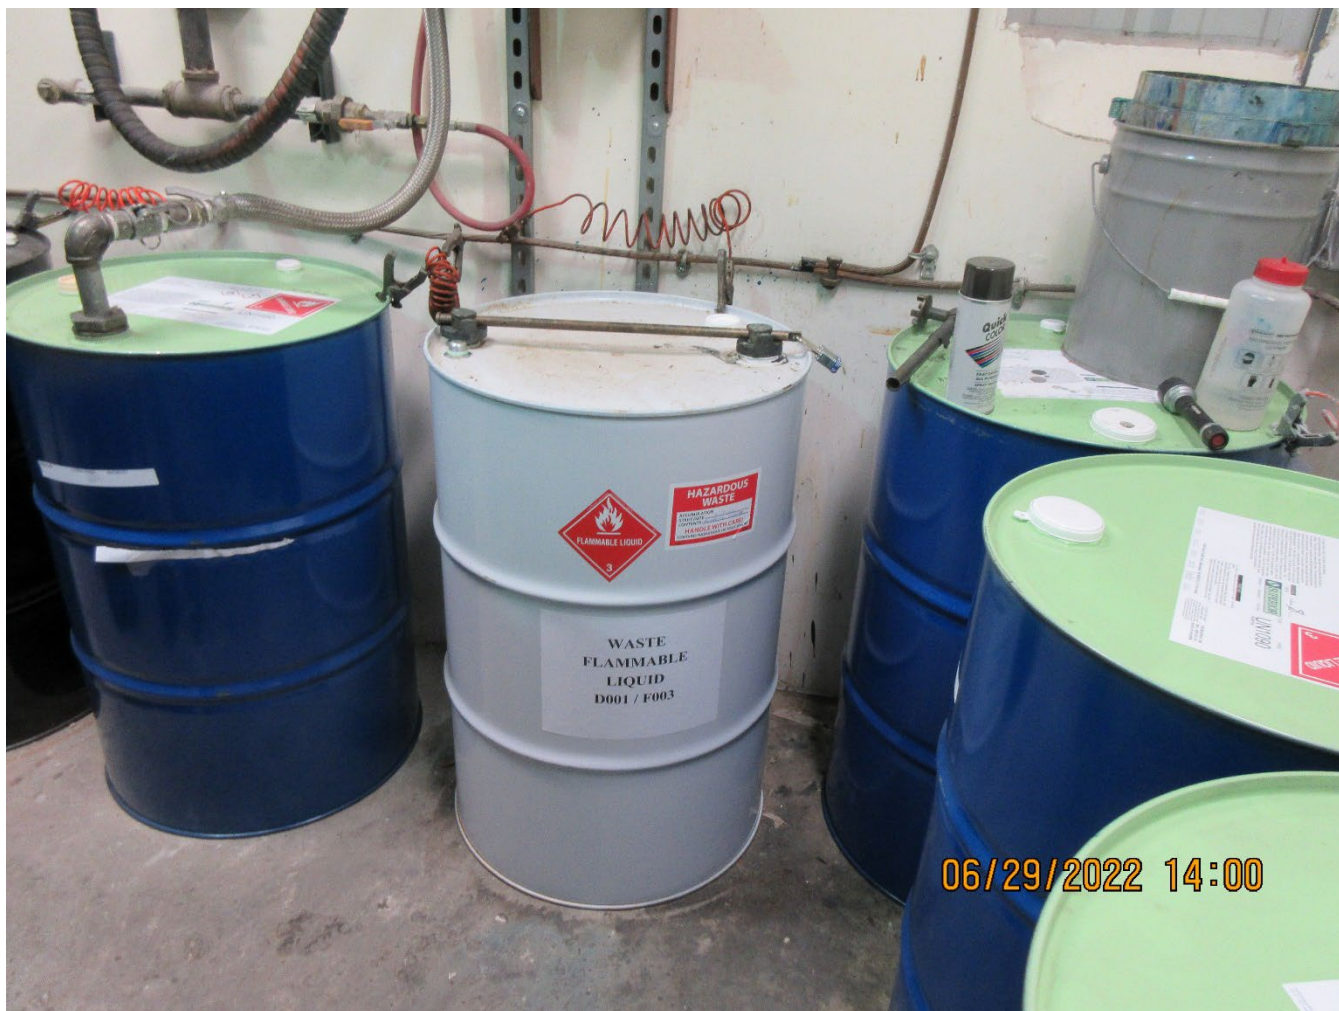
One 55-gallon container of hazardous waste acetone (ignitable) was observed within SAA #1 in a chemical shed outside of the Research and Development Building (Photo 20).

**Photo 20** - SAA #1 in a chemical shed near the Research and Development Building

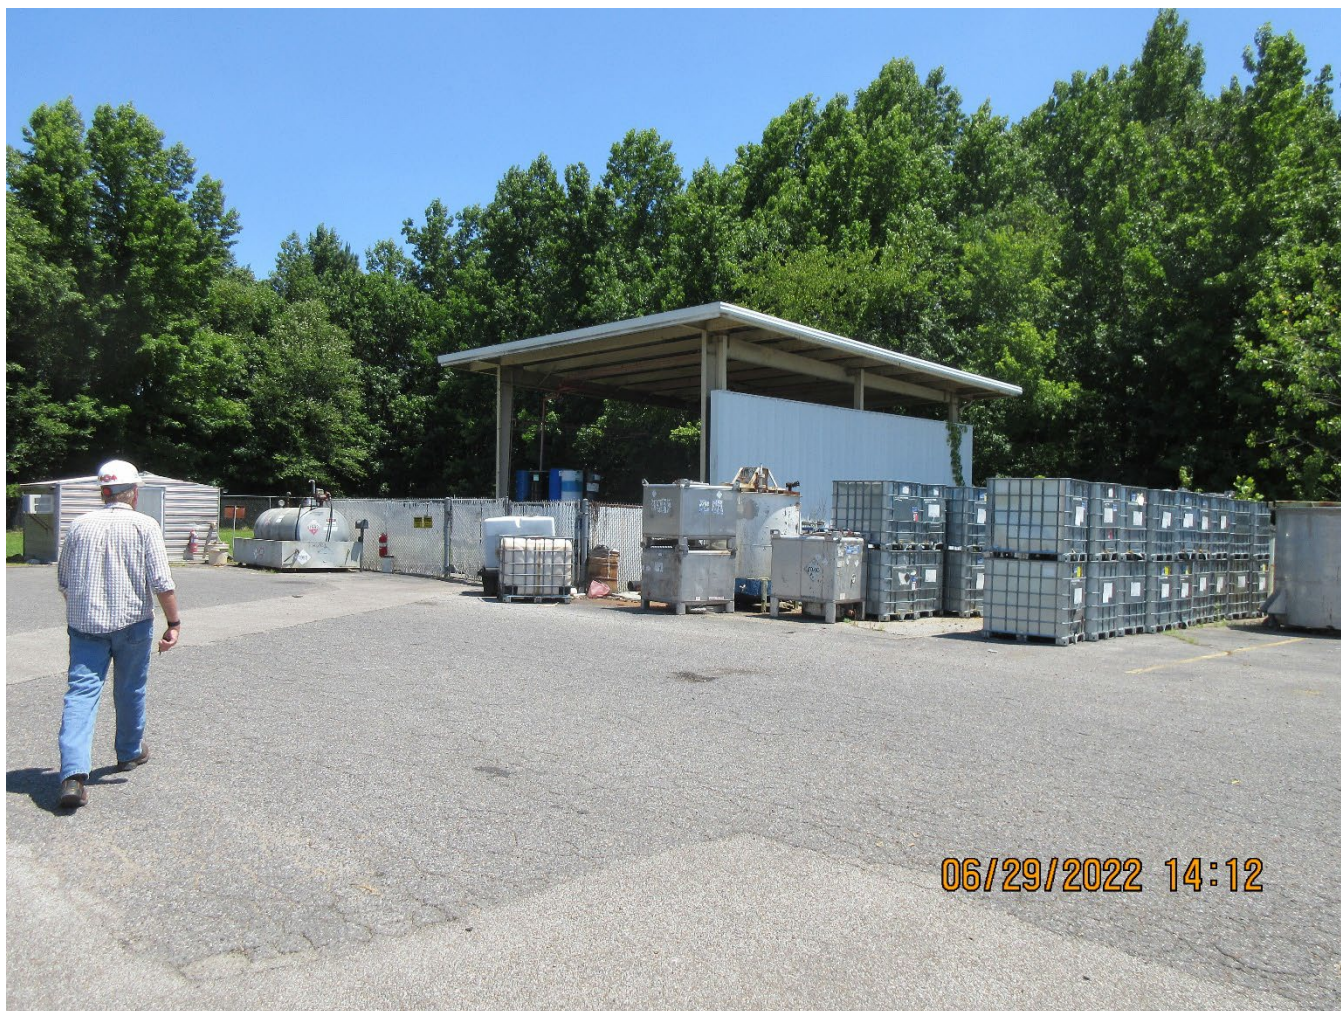
**Photo 21** – Central Accumulation Area

This building (Photo 21) consisted of a metal roof constructed on a concrete pad located just south of Building 5 which is located on the property south side of the rail line. The area was equipped with a fire extinguisher and spill equipment.

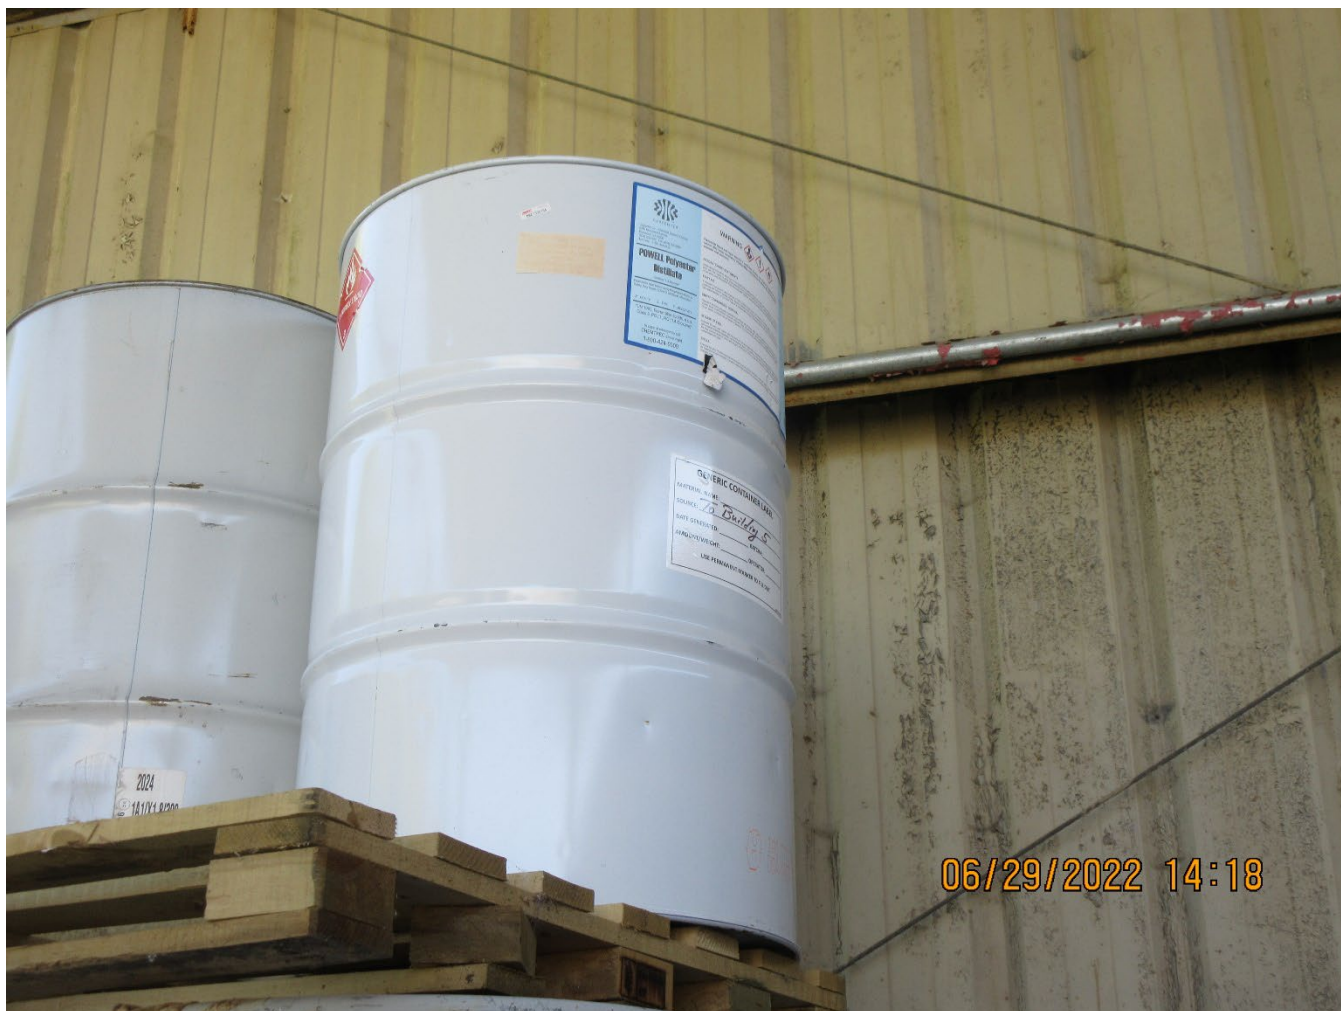
Sixty-nine 55-gallon containers, two 80-gallon overpack containers, and twelve 5-gallon containers of hazardous waste were observed on pallets in this area (Photo 23). One 55-gallon container of hazardous waste was observed to be without a label with the words “Hazardous Waste” and an accumulation start date (Photo 22).

**Photo 22** – Unlabeled container in 90-day accumulation area.

**Pursuant to Tenn. Comp. R. & Regs. 0400-12-01-.03 (1)(h)1.(v)(I)I. & III [40 C.F.R. § 262.17(a)(5)(i)], which is a condition of the LQG Permit Exemption, a generator must mark or label its containers with the following: the words “Hazardous Waste”; an indication of the hazards of the contents; and the date upon which each period of accumulation begins clearly visible for inspection on each container.**
