**Well Inspection**  
**Osage DNR / Environmental Protection Agency**  
**1201 Elm Street, Suite 500**  
**Dallas, Texas 75270**

| | | <b>Lease Name</b> | Blackland | | |
| | | <b>Well ID</b> | 10 | | |
| <b>Location</b> | NW 01 27N 07E | <b>Status</b> | Active | <b>Well Type</b> | Disposal |

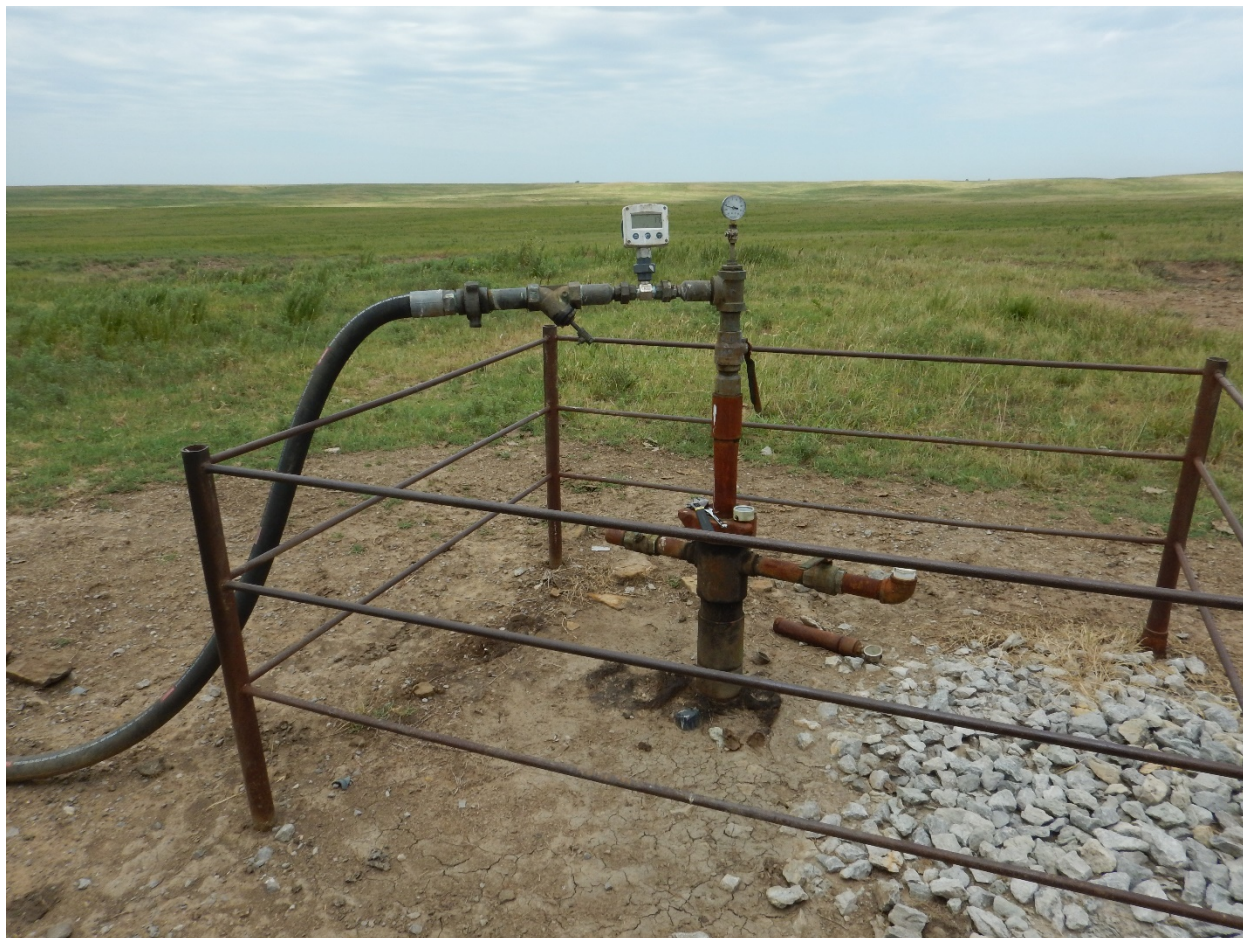
Photo No. 1

**Description:** This was the Blackland No. 10 well (OS6222000). At the time of inspection, the well was connected and injecting with a rate of 212 barrels per day and displayed a cumulative volume of 17 barrels on the barrel meter. There was no well sign present on the well location. The operator should install an appropriate well sign displaying the EPA inventory ID for the well.

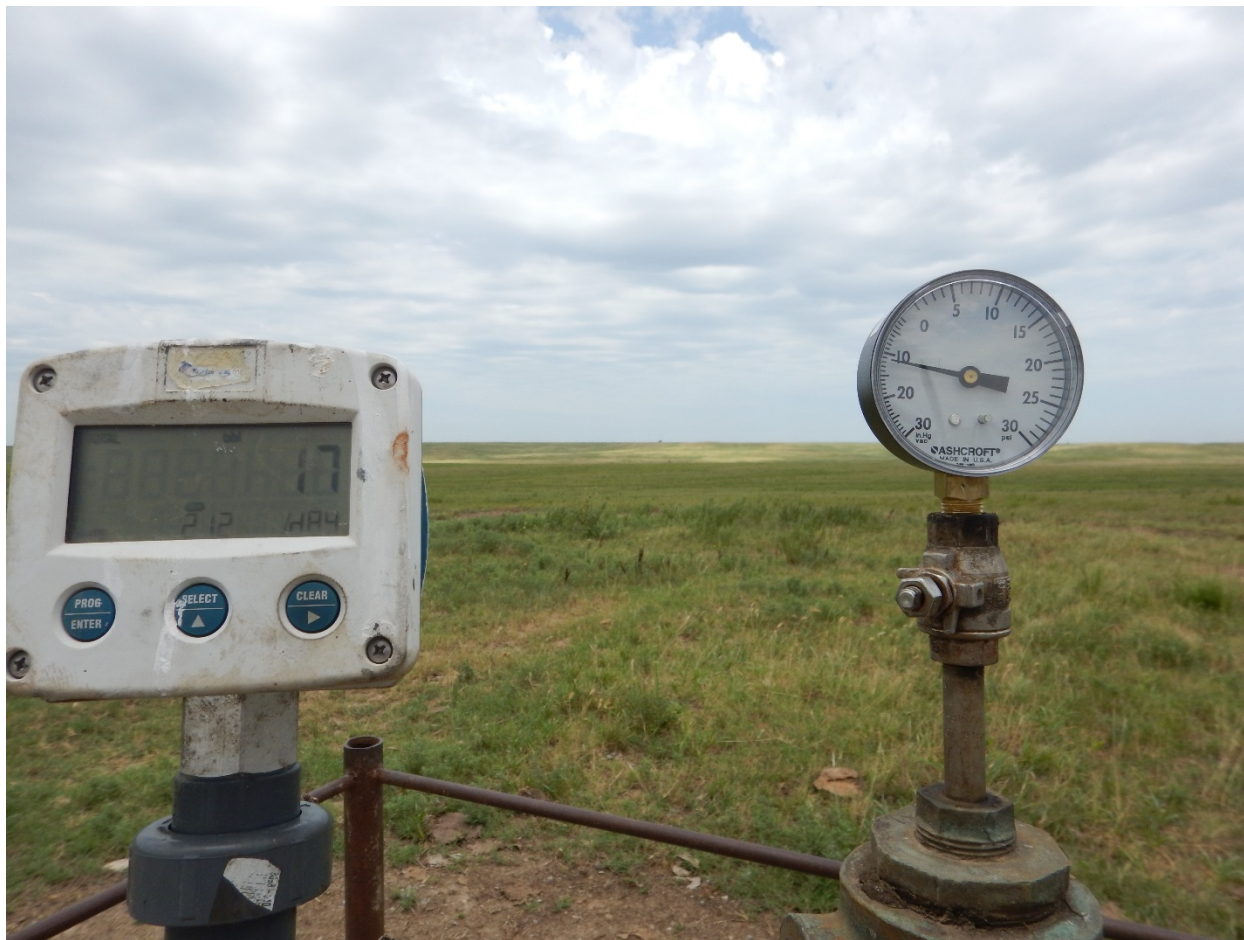
Photo No. 2

**Description:** This was the barrel meter (rate 212 BPD) (total 17 barrels) and tubing pressure gauge (12 in.Hg vacuum) readings which were observed at the time of the inspection.
