INSPECTION REPORT

| Type of Inspection | Compliance Evaluation Inspection (CEI) | | |
| Facility or Site Name | Westport Orange Shipyard | | |
| Type of Operation | Westport Orange Shipyard (WOS) performs repairs and maintenance of barges, performs degas operations and cleaning of barges. | | |

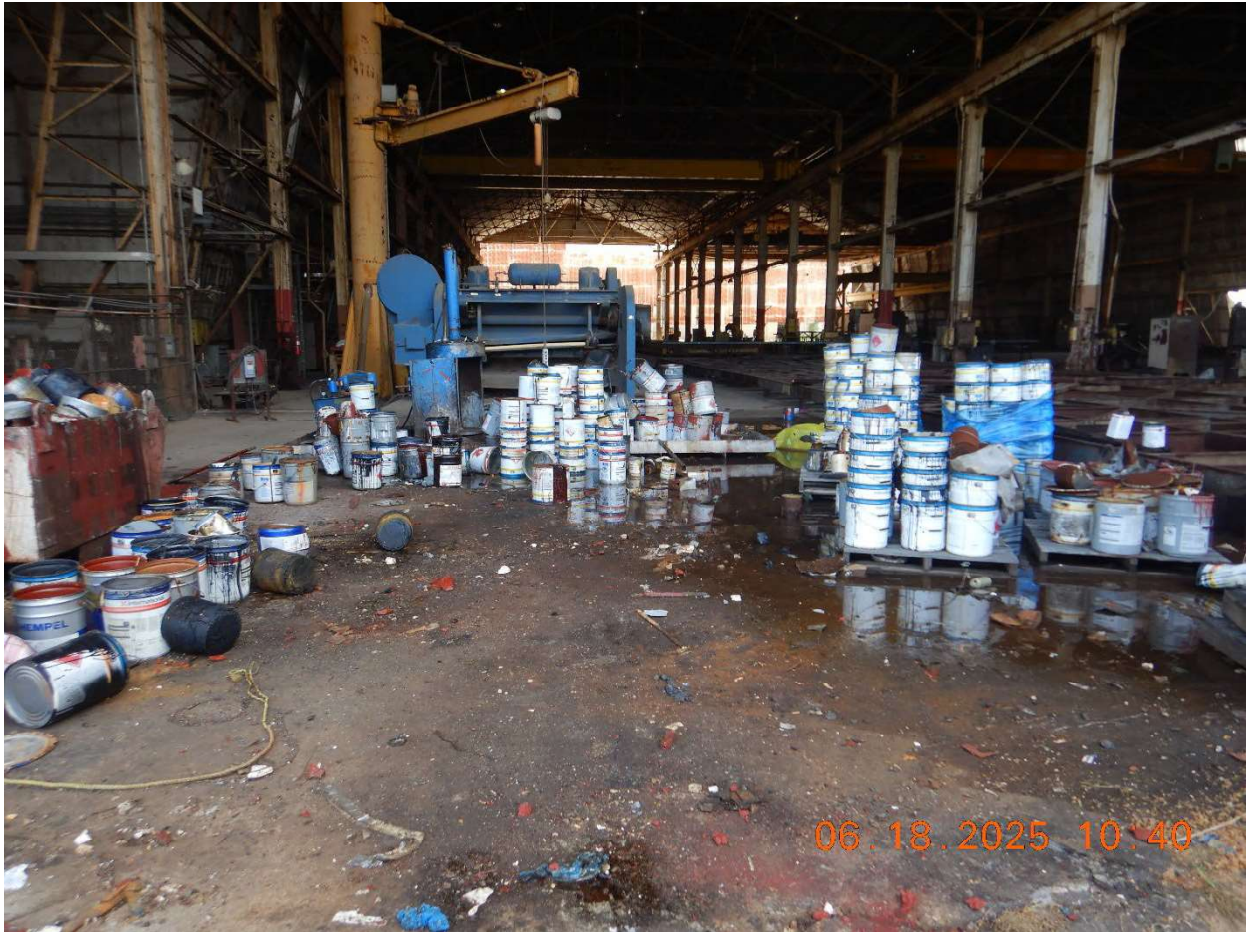
**Photo No. 1**

Description: View of paint can storage area. Mr. Chacin claimed that the paint used for barge painting would dry in a closed container. Once paint cans are brought to this area, they would be sorted for disposal. It was unclear how long paint cans have been accumulating in this area. There were various chunks of paint solids on the ground as shown in the photo.

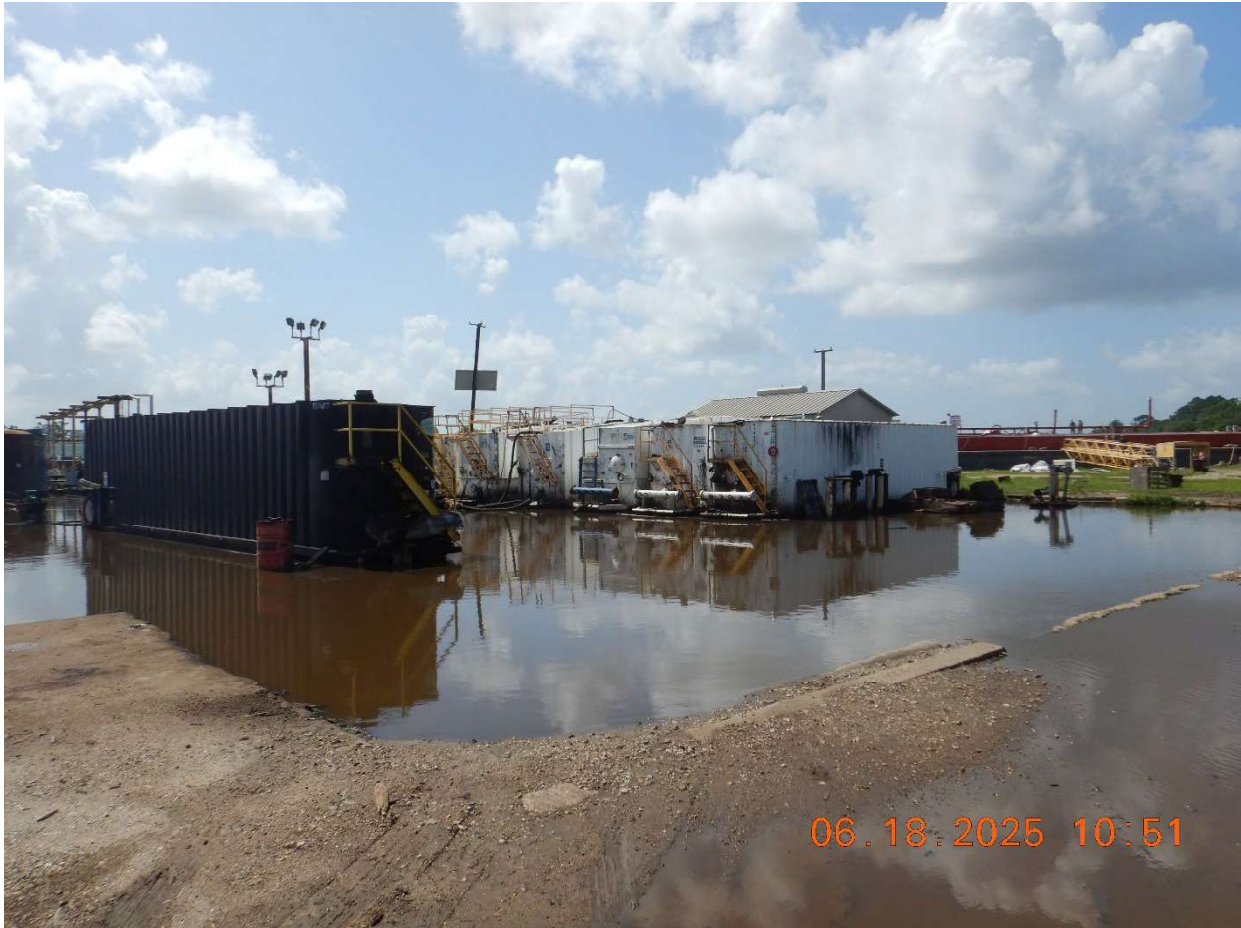
**Photo No. 2**

Description: View of frac tanks present on site. The liquid present across the ground is rainwater due to the recent storms in the area.

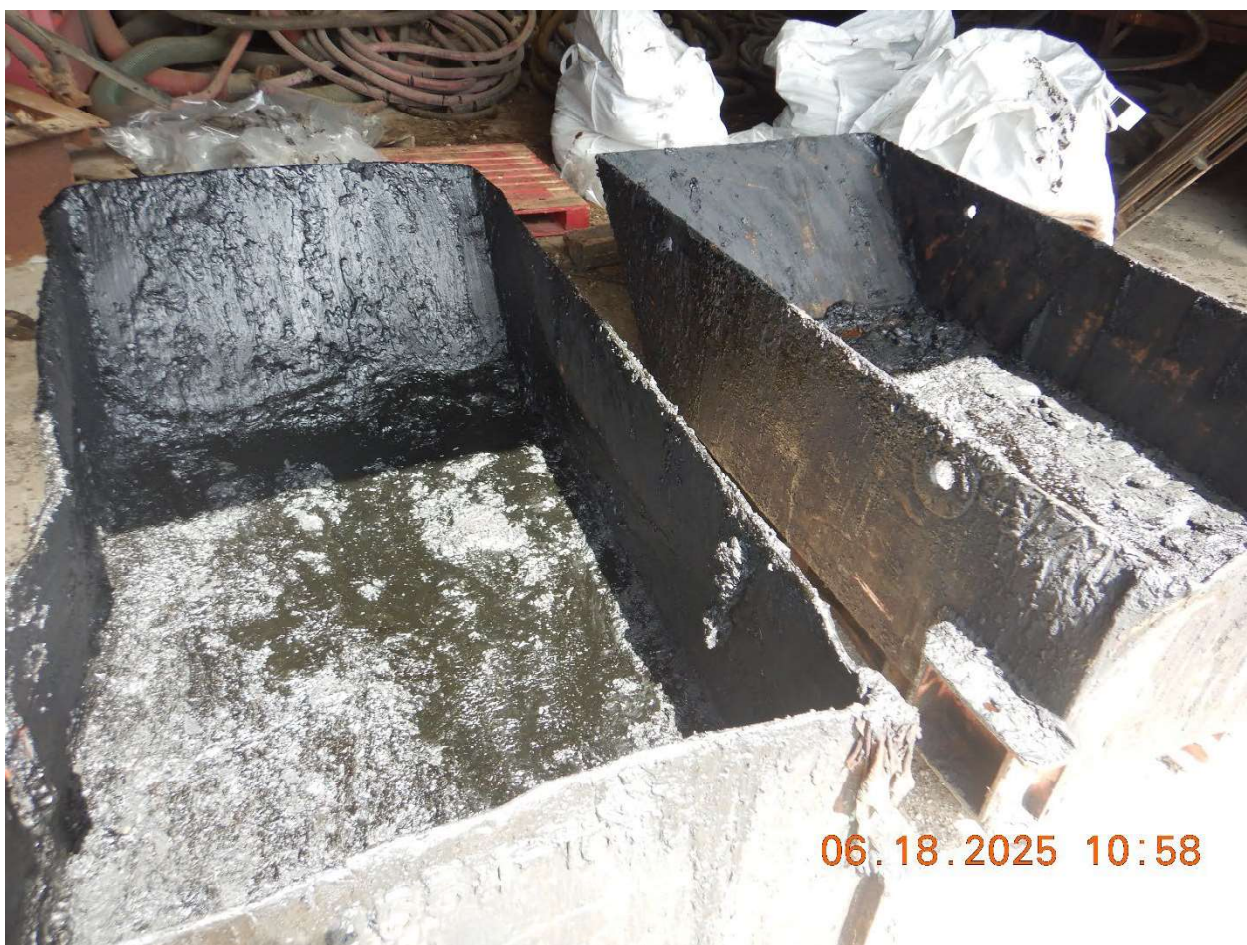
**Photo No. 3**

inspection, Mr. Chacin could not provide the inspection team with analytical results. WOS uses methyl ethyl ketone (MEK) for cleaning paint guns and stores the spent MEK in 5-gallon containers. Mr. Chacin was unsure if the spent MEK was managed as hazardous or nonhazardous waste. Therefore, the inspection team explained it appears WOS has not made adequate waste determinations on the MEK waste stream and sludge bottoms [**AOC #1** – WOS did not make a hazardous waste determination. - 40 CFR 262.11].

Description: Sludge from tank bottoms accumulated from recent barges. Claimed as a nonhazardous waste for disposal.

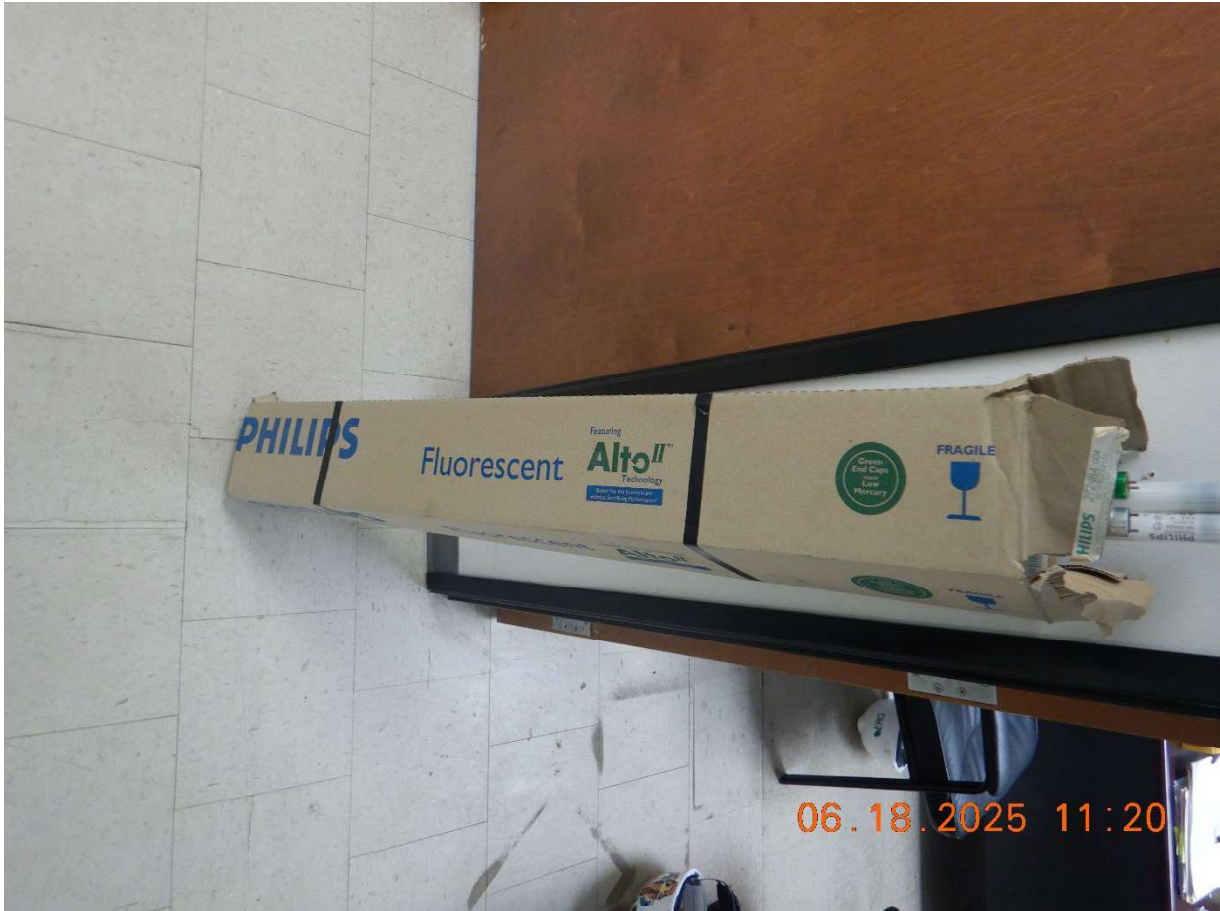
**Photo No. 4**

Next, the inspection team observed the facility's universal waste (Appendix 1 - Photo 4) storage area. The universal waste storage area contained one four-foot box of universal waste lamps. The container was not labeled, did not have an accumulation start date, and was open. [**AOC #2** – WOS did not label a container or package in which lamps with one of the following phrases: "Universal Waste—Lamp(s)," or "Waste Lamp(s)," or "Used Lamp(s)". – 40 CFR 273.14(e)], [**AOC #3** – WOS did not demonstrate the length of time that the universal waste has been accumulated from the date it becomes waste – 40 CFR 273.15(c)], and [**AOC #4** – Tidewater did not contain lamps in a container that was closed and able to prevent damage– 40 CFR 273.13(d)(1)].

| Facility: Westport Orange Shipyard | | |
|---|---|---|
| <b>AOC #2</b> – WOS did not label a container or package in which lamps with one of the following phrases: "Universal Waste—Lamp(s)," or "Waste Lamp(s)," or "Used Lamp(s)". | <b>Citation:</b> 40 CFR 273.14(e) | Section: 2.1 |
| <b>AOC #3</b> – WOS did not demonstrate the length of time that the universal waste has been accumulated from the date it becomes waste. | <b>Citation:</b> 40 CFR 273.15(c) | Section: 2.1 |
| <b>AOC #4</b> – WOS did not contain lamps in a container that was closed and able to prevent damage. | <b>Citation:</b> 40 CFR 273.13(d)(1) | Section: 2.1 |

Description: Universal Waste container accumulating universal waste lamps was not labeled, did not have an accumulation start date, and was open.
