**Region 6 - Enforcement & Compliance Assurance Division**  
**INSPECTION REPORT**

| Inspection Date(s): | 09/29/2022 | |
| Facility Name: | <b>Tucumcari Wastewater Treatment Plant</b> | |
| Identification/Permit Number: | NM0020711 | |

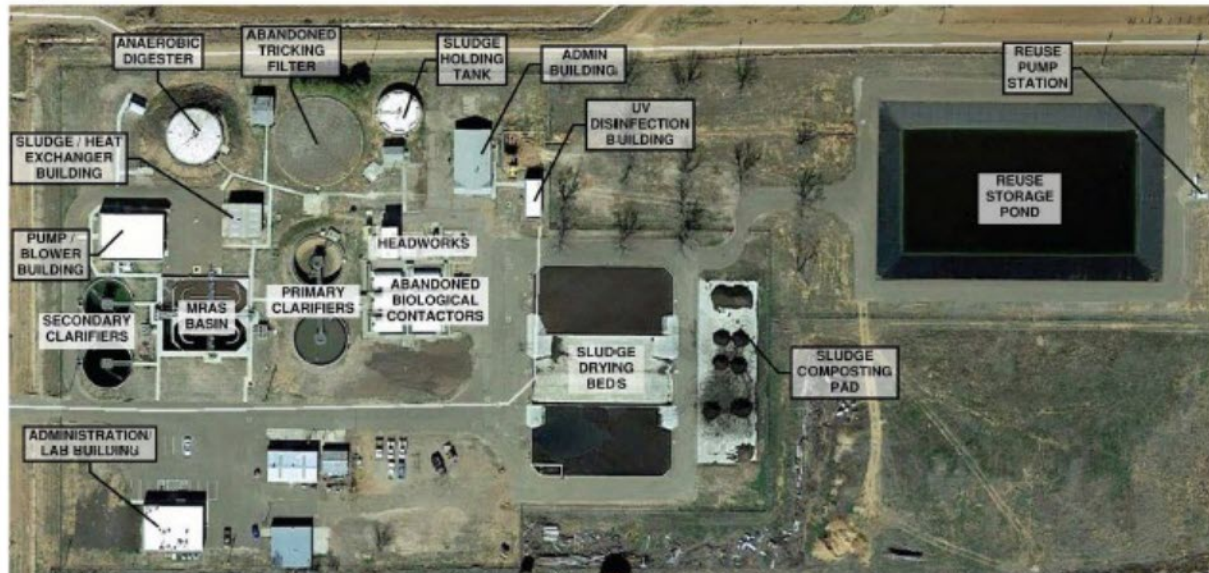
**Aerial Site Image #1:** Overall view of the City of Tucumcari Wastewater Treatment Plant

The WWTP is a major discharger with a design flow capacity of 1.2 MGD (million gallons per day) and an average influent flow of 0.4 MGD. The facility is located at 1700 North Rock Island Street, Tucumcari, Quay County, New Mexico (depicted in **Aerial Site Image #1** below). The WWTP also accepts approximately 3,500-gallons per day of septage from permitted waste haulers. The facility serves a population of approximately 5,000 residents and is operated by staff within the Public Works Department consisting of 5 full-time equivalent (FTE) positions, during the hours of 7:00 AM to 4:00 PM five (5) days during the regular work week and 1 FTE on weekends. On-call staff is available on an as needed basis.

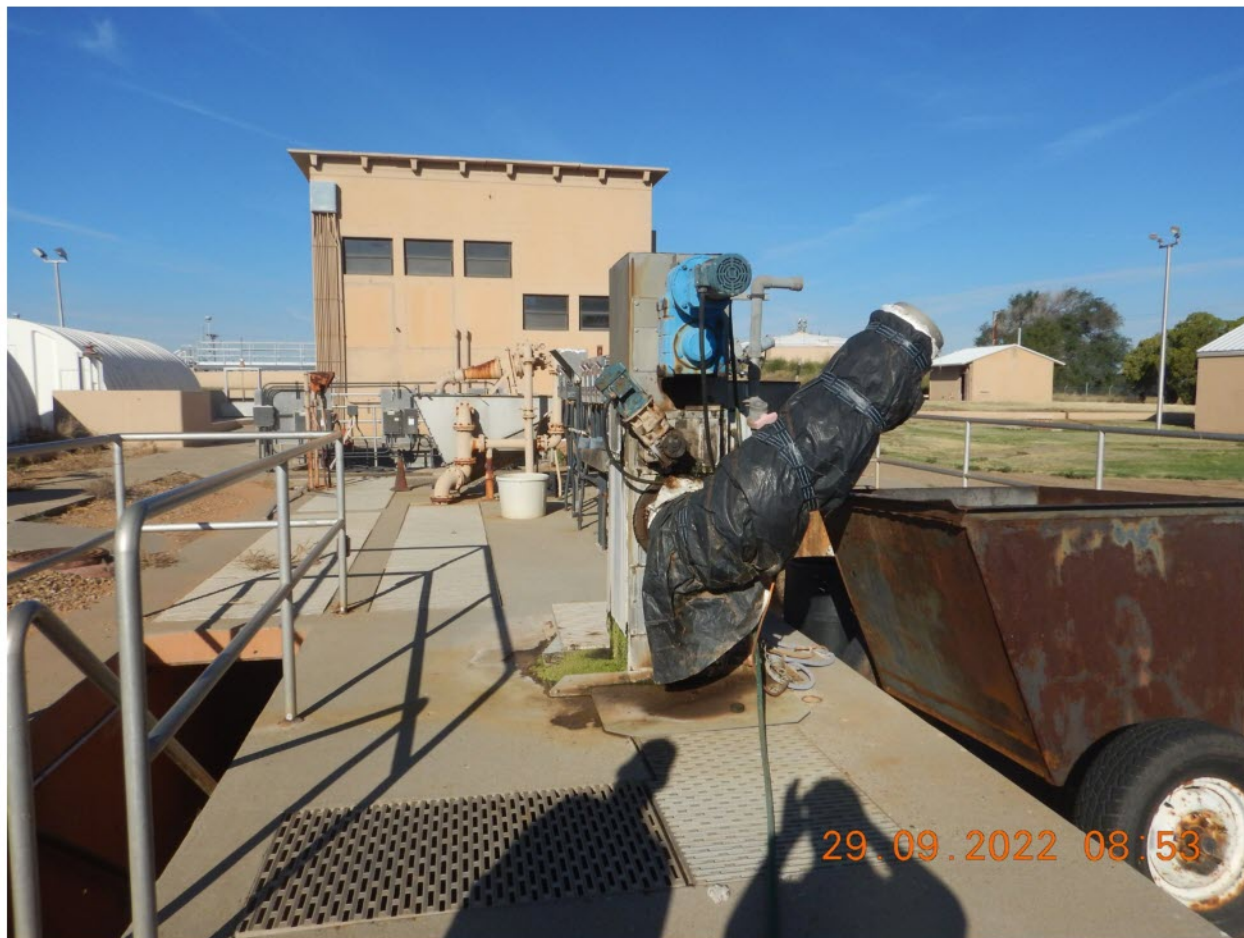
Photo No. 1

View of the WWTP's Headworks. The WWTP Supervisor stated that locating replacement parts for the existing facility equipment in general was getting extremely difficult. (DSCN2348) Photographed by D. Esparza

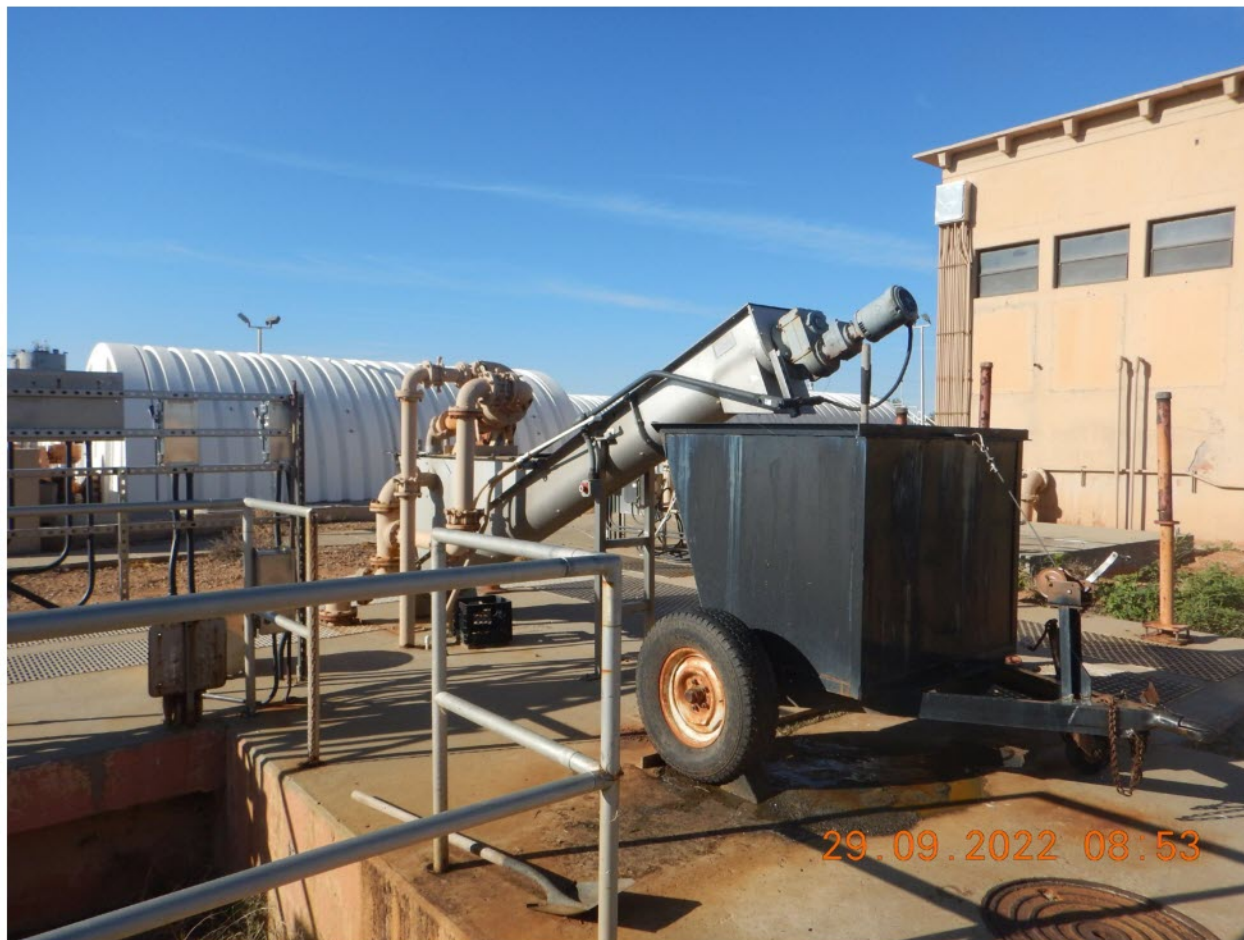
Photo No. 2

View of the grit screen removal equipment. (DSCN2349) Photographed by D. Esparza

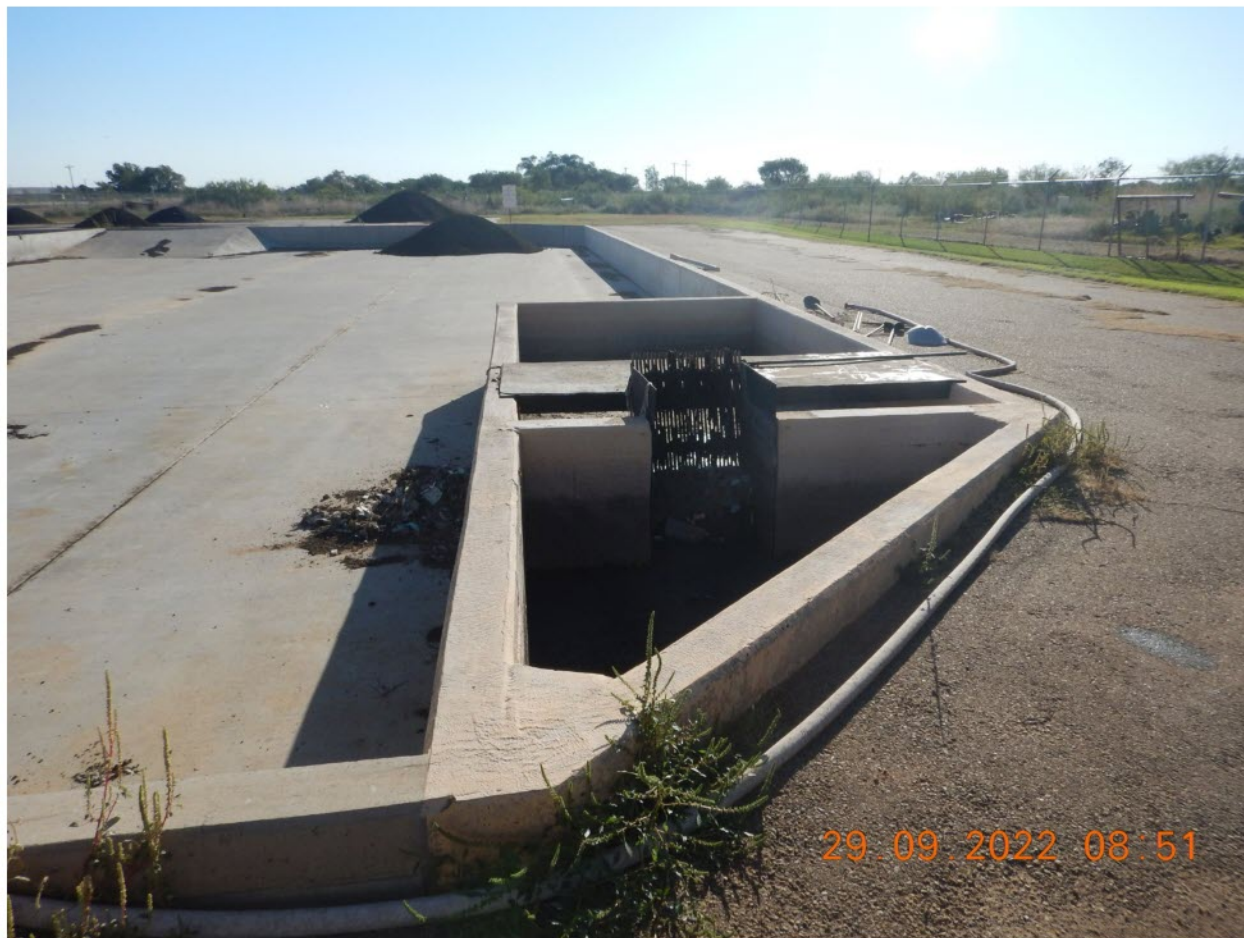
Photo No. 3

View of one (1) the three (3) sludge drying beds (located approximately at the southeast end of the facility) for composting into Class A sludge for land application and/or local agricultural purposes. These beds were originally constructed with underdrains to collect excess wastewater; thus, creating the ability to pump and/or return excess wastewater to the headworks. (DSCN2346) Photographed D. Esparza

To address their sludge management, the WWTP has and/or maintains three (3) concrete sludge drying beds (located approximately at the southeast end of the facility) for composting into Class A sludge for land application and/or local agricultural purposes. These beds were originally constructed with underdrains to collect excess wastewater; thus, creating the ability to pump and/or return excess wastewater to the headworks.

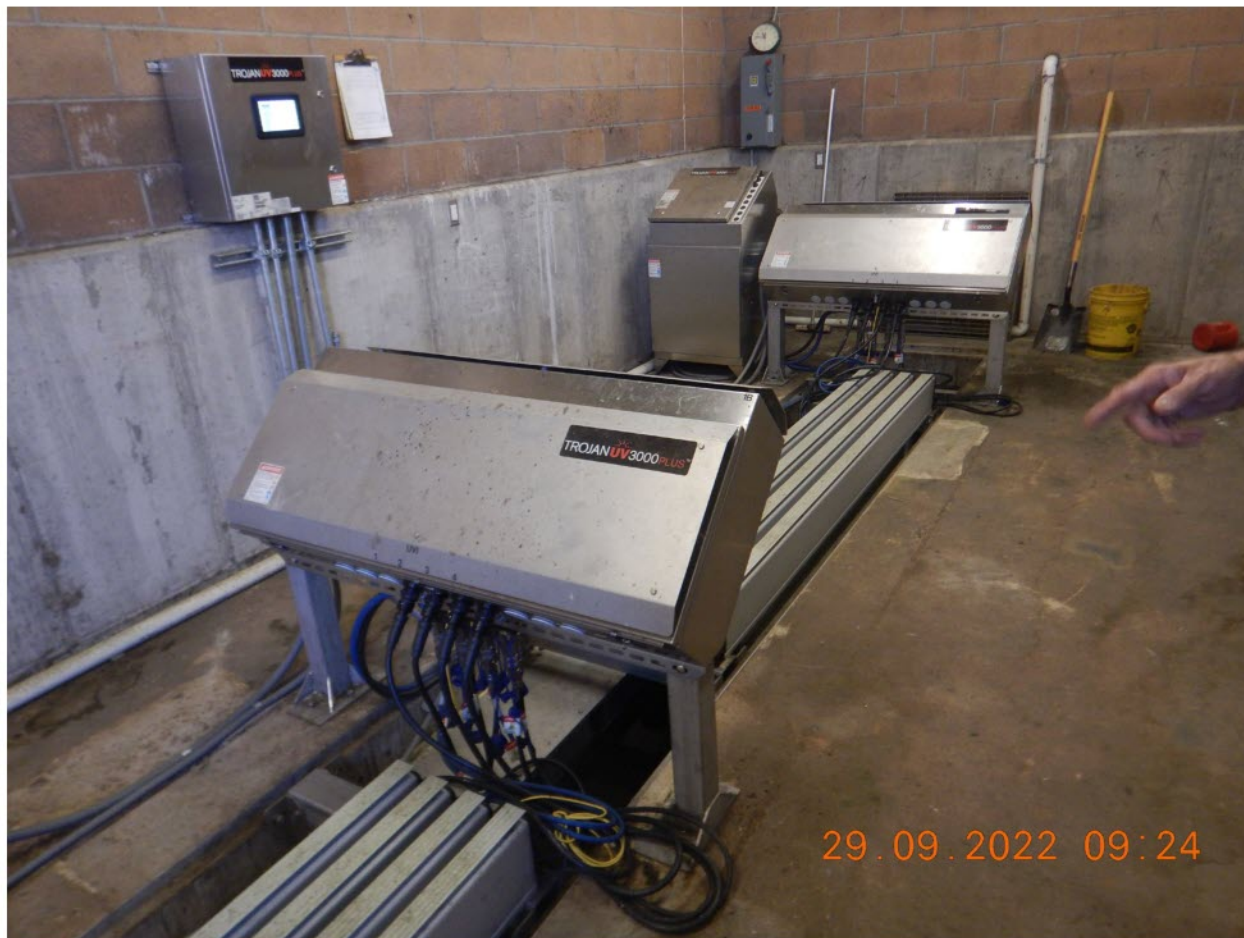
Photo No. 4

View of the two (2) banks of Trojan ultraviolet (UV) disinfection units included in the 2011 WWTP upgrades. (DSCN2350) Photographed by D. Esparza
