INSPECTION REPORT

| Regulatory Program | RCRA | | | |
| Type of Inspection | Focused Compliance Inspection (FCI) | | | |
| Facility or Site Name | Martin Energy | | | |

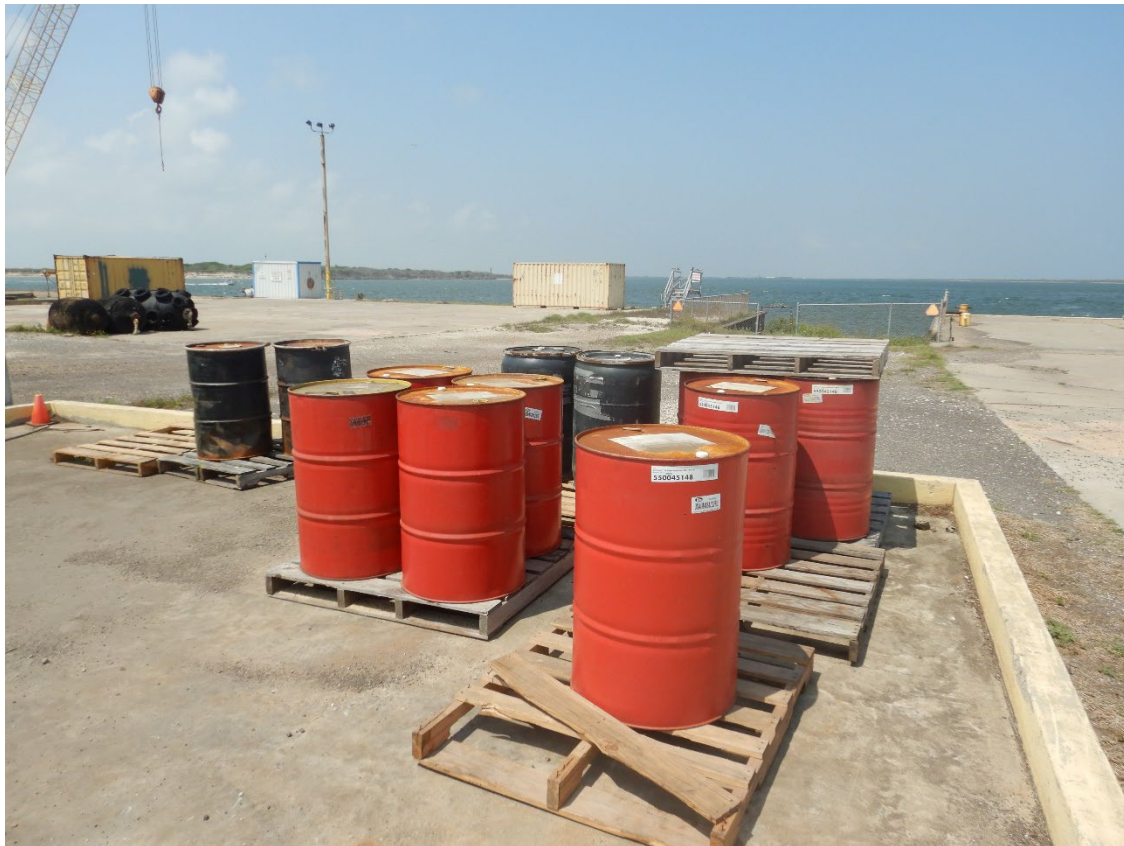
**Photo No. 1**

Description: View of four red 55-gallon drums full used oil and four black 55-gallon drums full of oil contaminated filters that were not labeled, along with five empty red 55-gallon drums in the containment area in Martin's yard.

- 1 Four red 55-gallon steel drums of used oil generated by your customers in the containment area in the yard. **(Martin generated from containment pump outs and maintenance) (See Attachment C)**

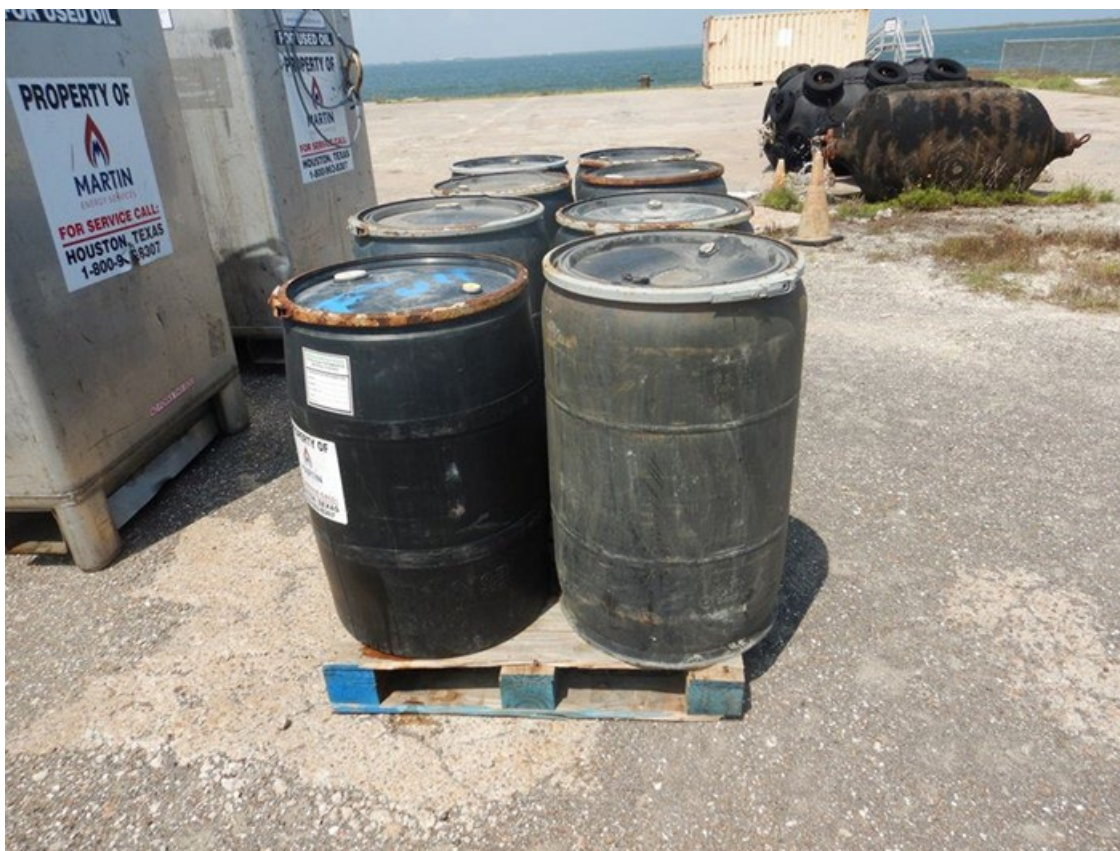
Photo No. 2

Description: View of eight 55-gallon plastic drums partially filled with oily rags and debris in Martin's general yard area. One of these drums was unlabeled (observed).

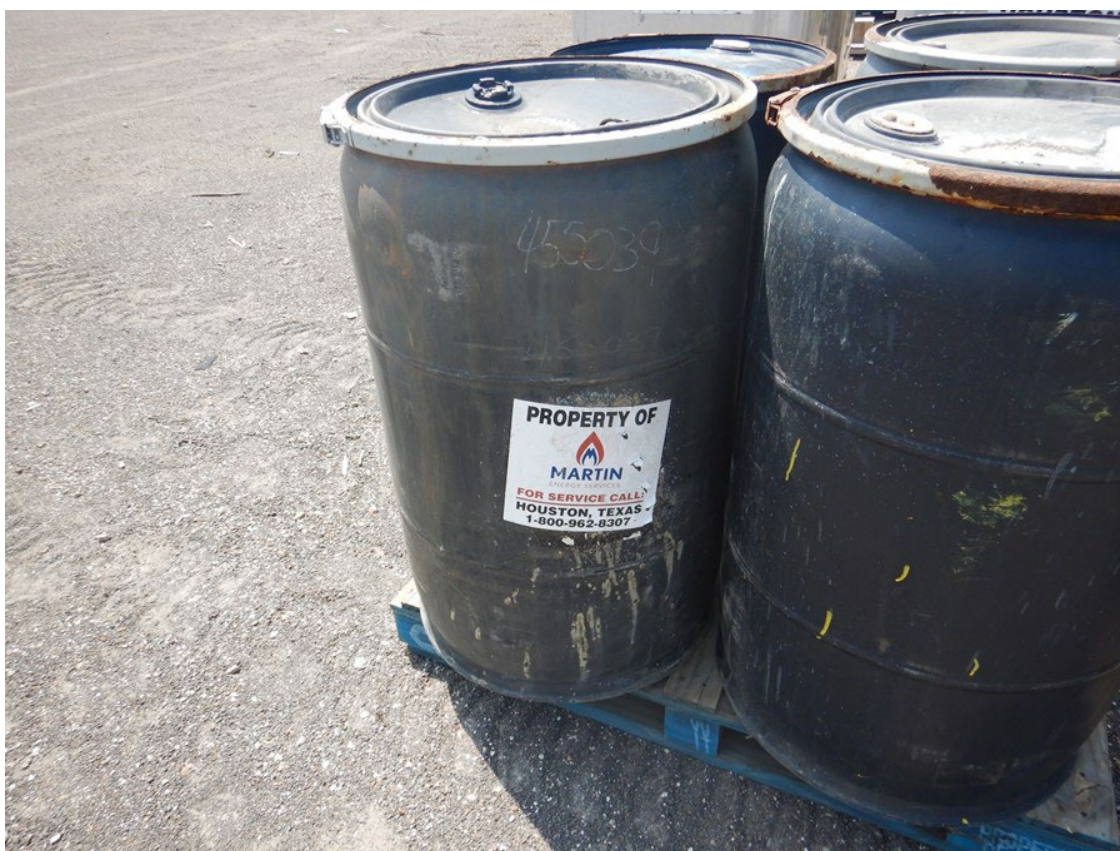
Photo No. 3

Description: Close-up view of the unlabeled 55-gallon plastic drum in the general yard area shown in Photo No. 2 (observed).

- 2 One black 55-gallon plastic drum that contained spent oily filters/rags generated by your customers. This was staged with seven other 55-gallon black plastic drums, each of which were labeled. **(Drum containing oily filters/rags was generate by Martin personnel from maintenance tasks throughout the yard.) (See Attachment D)**

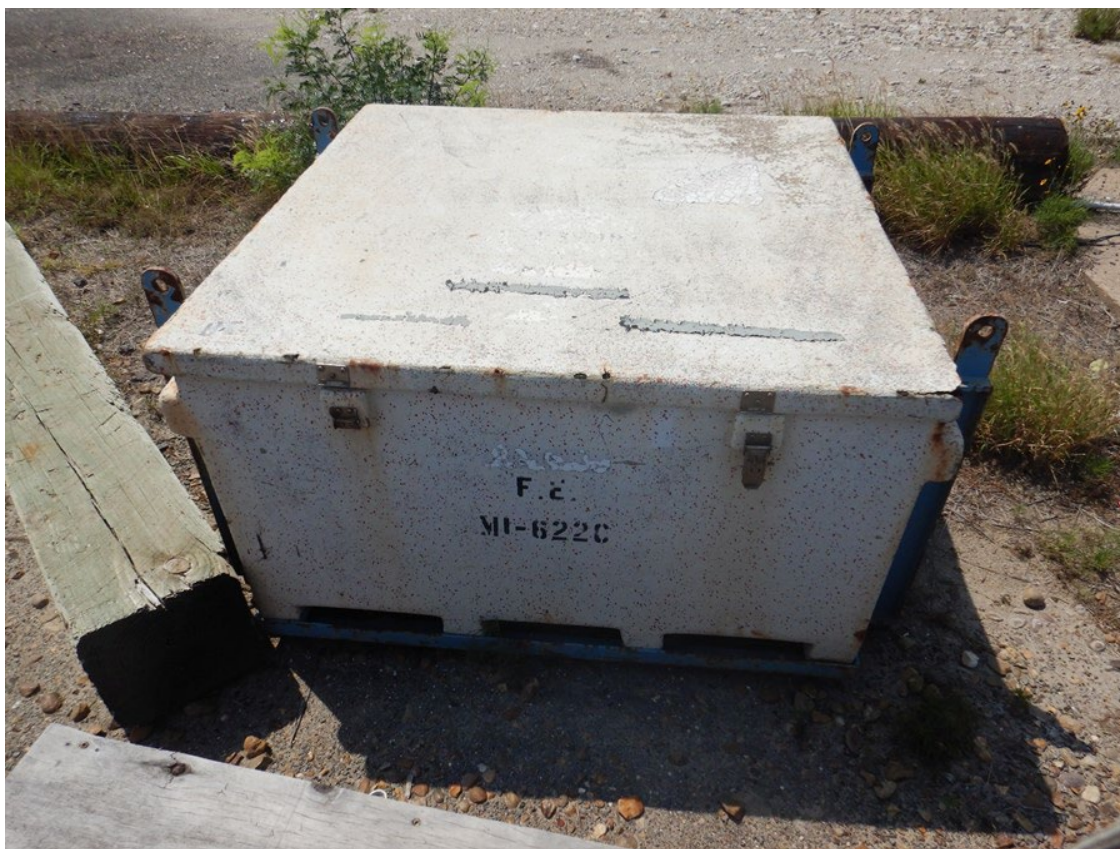
Photo No. 4

Description: View of unlabeled box used to store used lead-acid batteries in Martin's general yard area.

- 3 A box used to store lead-acid batteries, generated by your customers. **(Customer batteries for reclamation, these batteries are picked up by supplier and replaced with new batteries. This is a recycle program from supplier to client for reuse) Client has contacted vendor for removal/swap out of batteries that will be completed NLT 6/5/2024.**

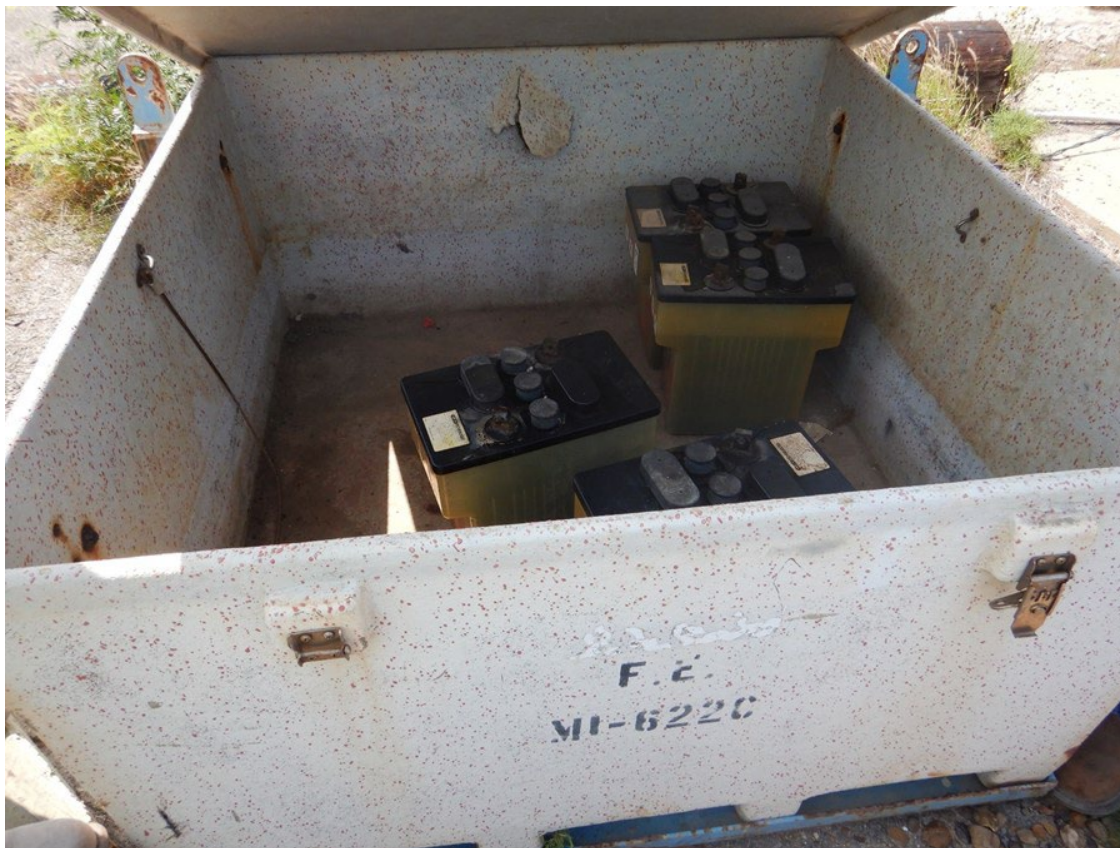
Photo No. 5

Description: View of the inside of the unlabeled box used to store used lead-acid batteries in Martin's general yard area.

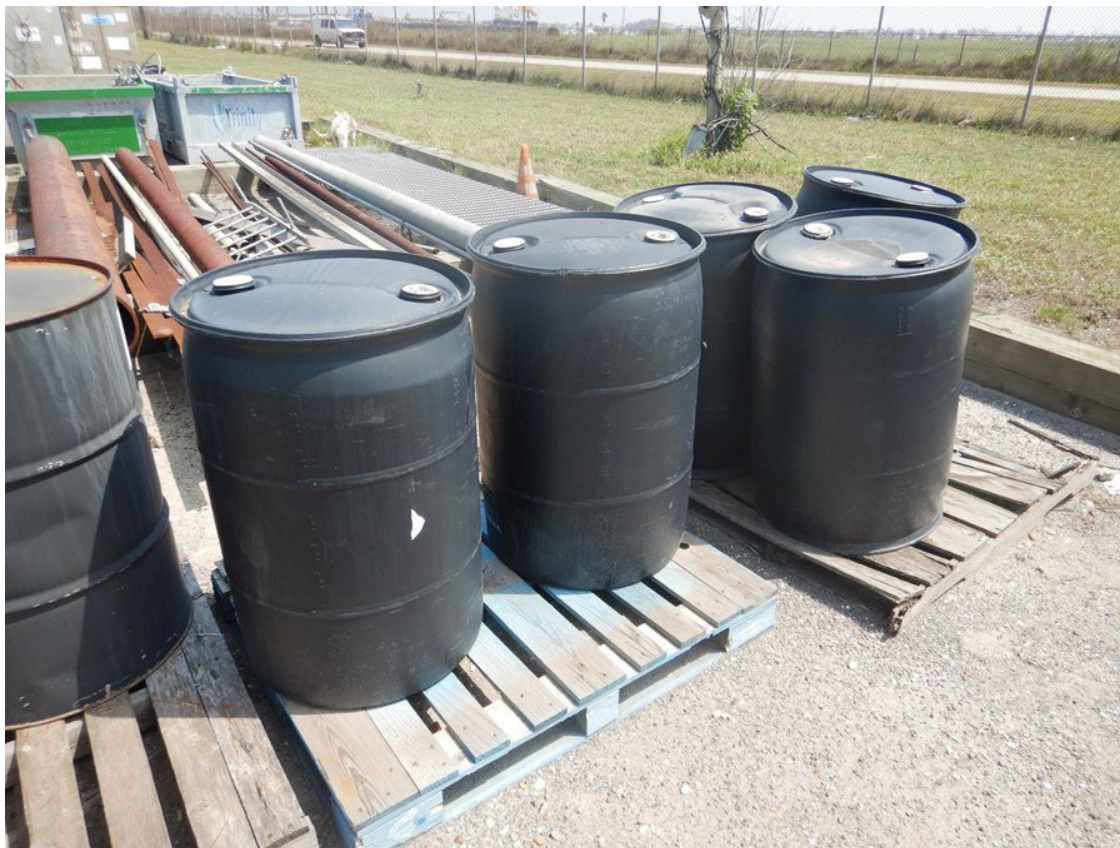
Photo No. 6

Description: View of five unlabeled black 55-gallon plastic drums in Martin's general yard area (observed).

- 1 Please provide a copy of the facility's MARPOL Certificate of Adequacy **(See Attachment A)**
- 2 During the inspection we observed five unlabeled black 55-gallon plastic drums, for these containers, could you please provide: **(See Attachment B)**

Documentation of the contents of the containers. **(Customer Product "Corrosion Inhibitor")**
- 5 **see areas of concern #1** During the inspection we observed four red 55-gallon steel drums which reportedly contained used oil. For these drums, can you please provide the date the used oil drums were transferred to the site from your customer's vessel and documentation of the date they are transferred off-site (if the pick-up occurs within the next two weeks). **(Martin Generated from facility maintenance tasks) (See Attachment C)**

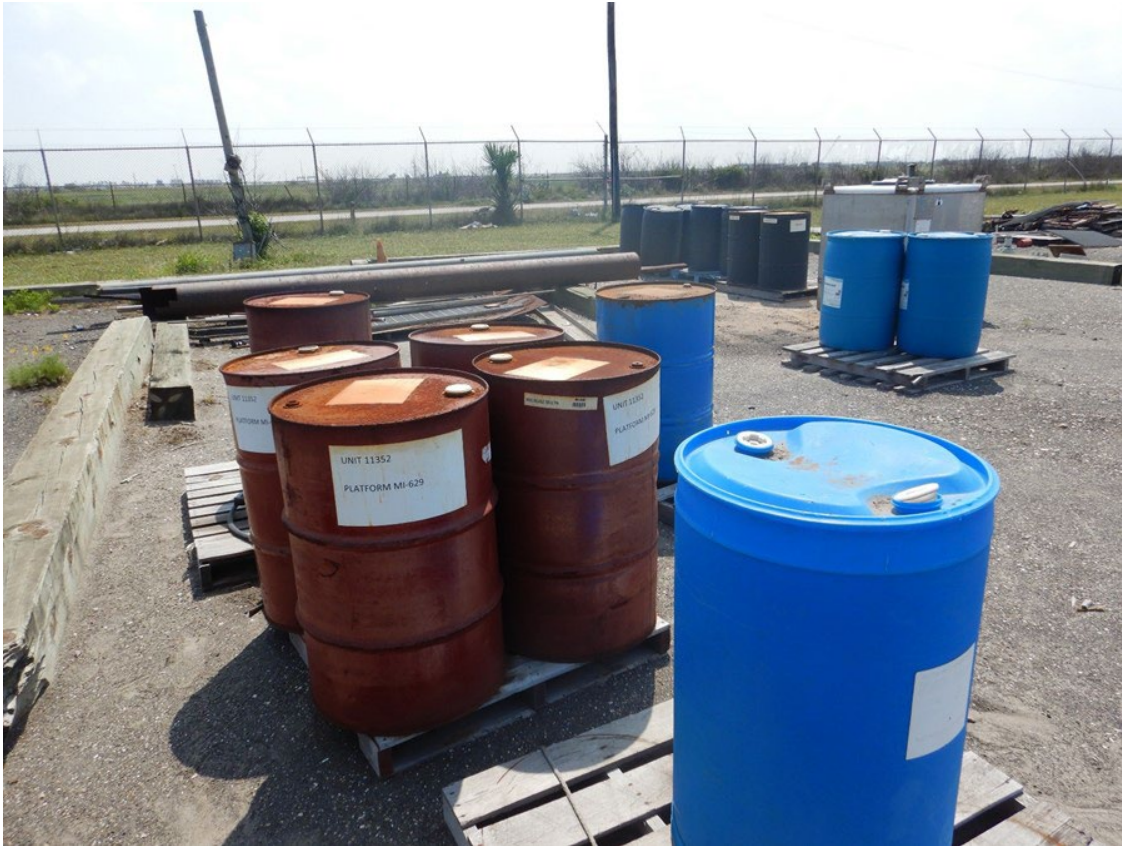
**Photo No. 7**

Description: Overview of the area in the general yard area where the drums shown in Photo No. 7 were located (observed).

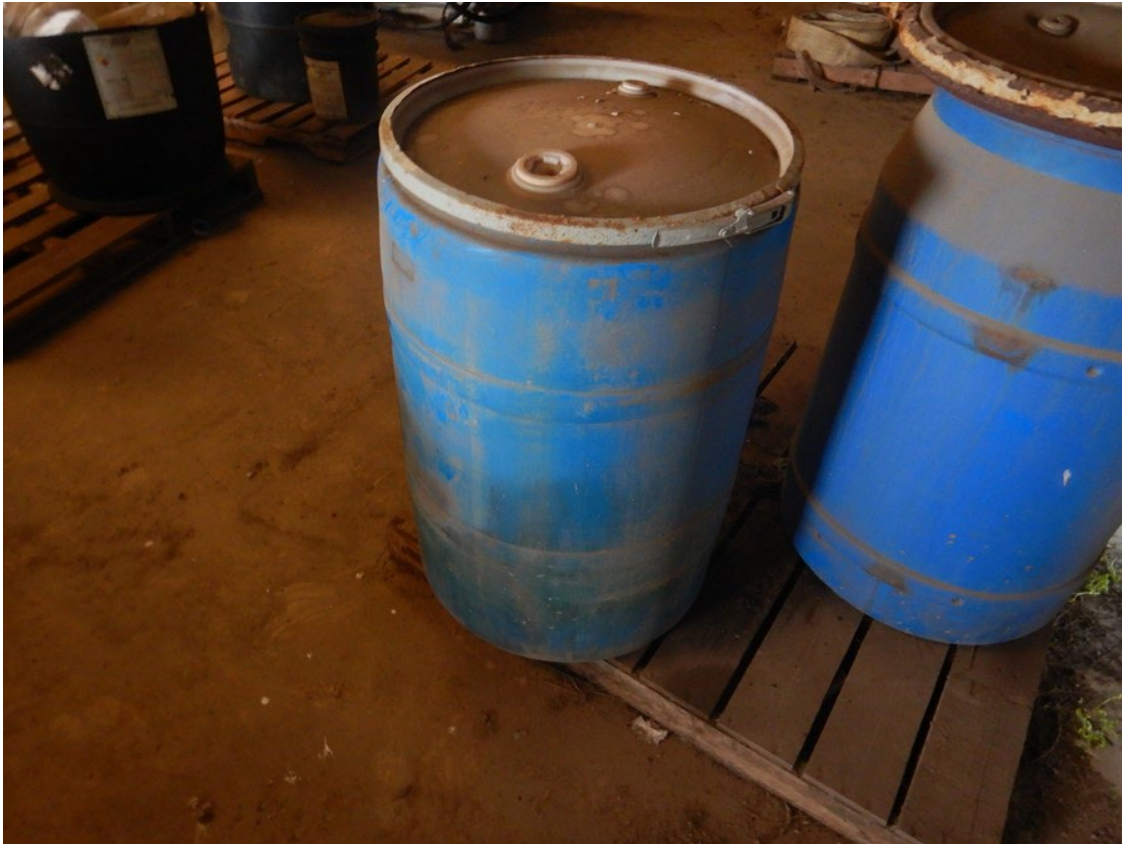
Photo No. 8

The inspection team also observed two drums of oily rags, pads, and filters with no label (see Appendix 1 – Photos 8 and 9). Mr. DiMario explained in his follow-up document that the oily rags, pads, and filters in this container were generated by Martin personnel from maintenance tasks at various locations on the facility, and he included an image of the drums with visible non-hazardous waste labels as Attachment E (see Appendix 2). The inspection team observed an empty tote that Martin uses to store generated used oil that was not properly labeled (see Appendix 1 – Photos 10 and 11).

Description: View of a drum containing oily rags, pads, and filters with no label in Martin's warehouse (observed).

- 4 Two 55-gallon drums containing oily filters/rags, generated by Martin Operating Terminal, located in the warehouse. **(Maintenance is performed at various locations within the confines of the facility on pumps and PIT equipment. Once maintenance tasks are completed the drums are moved to the "Used Oil laydown area.) (See Attachment E)**

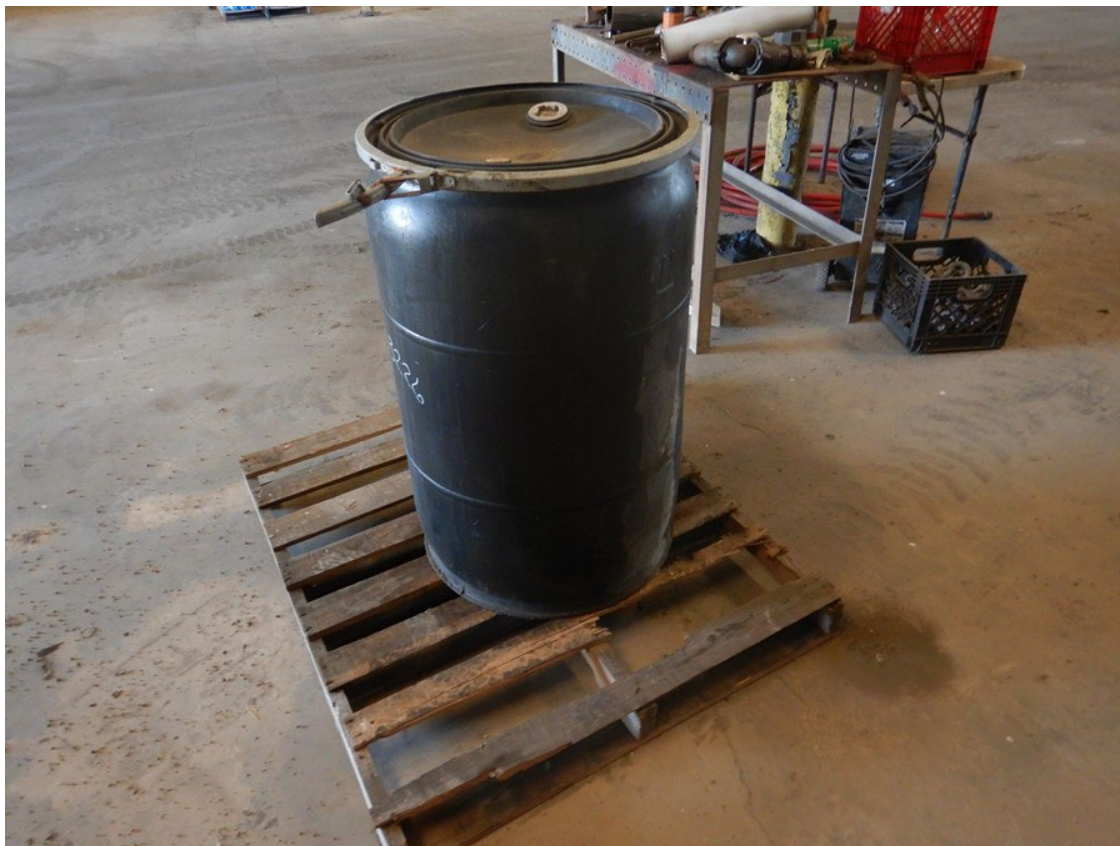
Photo No. 9

Description: View of a drum containing oily rags, pads, and filters with no label in Martin's warehouse (observed).

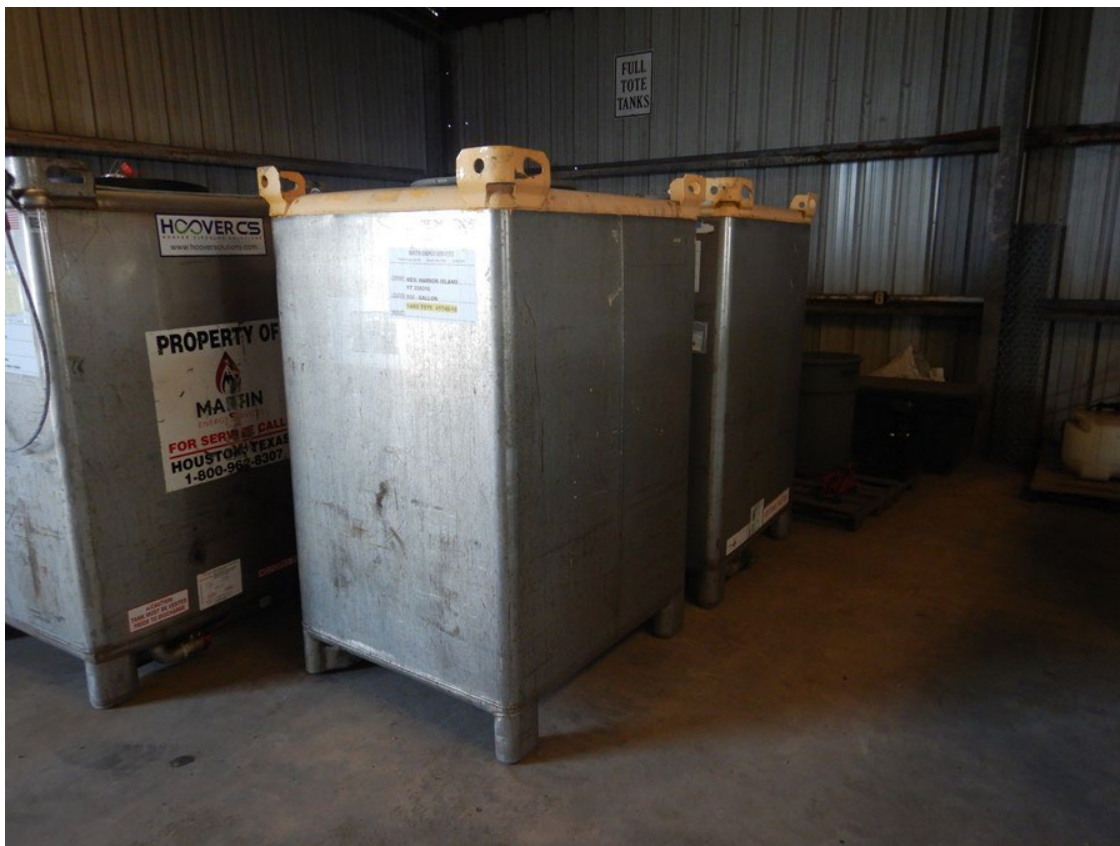
Photo No. 10

Description: View of an empty used oil tote in Martin's warehouse that was not properly labeled (observed).
