## **RCRA Inspection Report**

Bona US EPA ID# NCR000010215  
4275 Corporate Center  
Monroe, North Carolina 28110

February 15, 2022

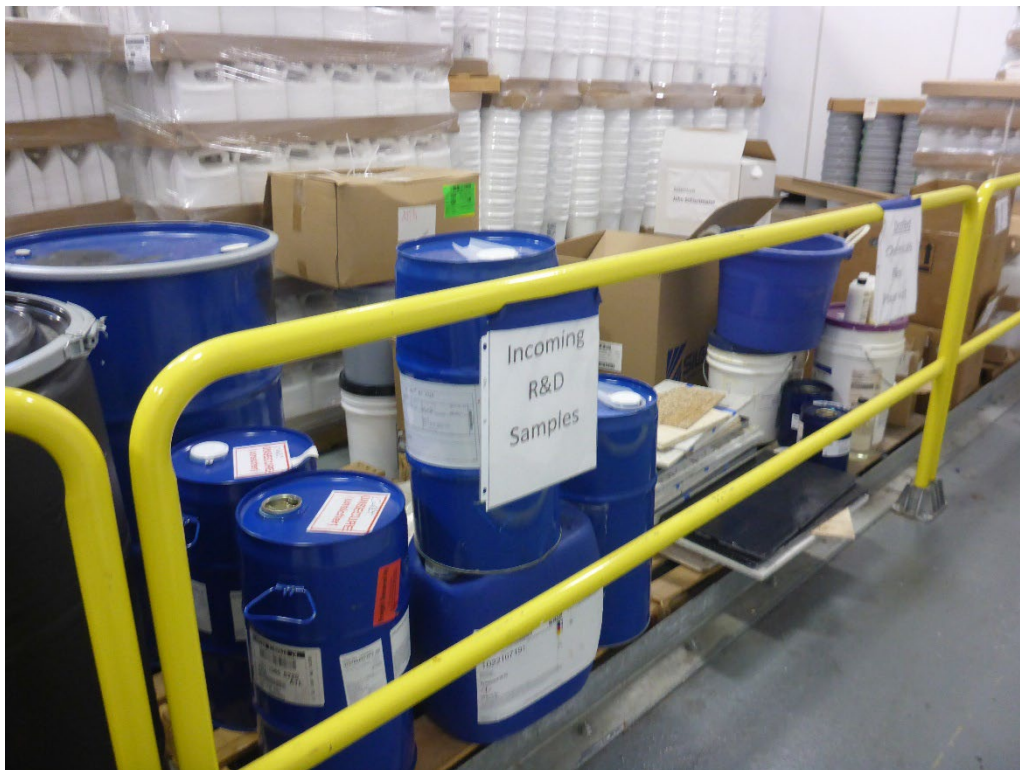
Filling Area CAA: The inspection tour began in the Filling Area, where the participants observed a number of containers staged next to a metal handrail outside of the Laboratory (Photo 1). Mr. Schmitt explained that personnel test products for potential use in the manufacturing process in the R & D Laboratory, and this area is used to stage incoming R & D samples and outgoing laboratory wastes such as expired chemicals or R & D products that have failed testing for potential use on-site. Mr. Schmitt explained that the SHE Specialist evaluates materials that are staged in this area when the staging pallet is filled. The SHE Specialist identifies waste containers with a color-coded dot to indicate the designated waste profile. After the containers are marked by the color-coded dot, they are transferred to the hazardous waste primary CAA in the 30,000 square foot outbuilding. Some containers observed in this area included:

**Photo 1:** Miscellaneous materials located along a metal handrail outside of the Laboratory in the Filling Area. This area is used to stage incoming R & D samples and outgoing laboratory wastes such as expired chemicals or R & D products that have failed testing for potential use on-site.

This area did not appear to be near the point where wastes initially accumulate or under the control of the laboratory personnel generating the waste. Bona does not ensure that the wastes are properly managed according to applicable RCRA regulations between the time the material becomes a waste and the time that the hazardous waste determination is performed. None of the containers observed in this area were labeled as hazardous waste or marked with an accumulation start date, and many were not identified with an indication of the hazards of their contents.

**Pursuant to 15A NCAC 13A .0107(a) [40 C.F.R. § 262.11], a person who generates a solid waste, as defined in 15A NCAC 13A .0106 [40 C.F.R. § 261.2], must use the steps articulated in 15A NCAC 13A .0107(a) [40 C.F.R. § 262.11] to make an accurate determination as to whether that waste is a hazardous waste in order to ensure wastes are properly managed according to applicable RCRA regulations.**

**Pursuant to 15A NCAC 13A .0107 [40 C.F.R. § 262.17(a)(5)(i)], which is a condition of the LQG Permit Exemption, a generator is required to mark or label containers with the words “hazardous waste”; with an indication of the hazards of the contents; and with the date upon which each period of accumulation begins.**

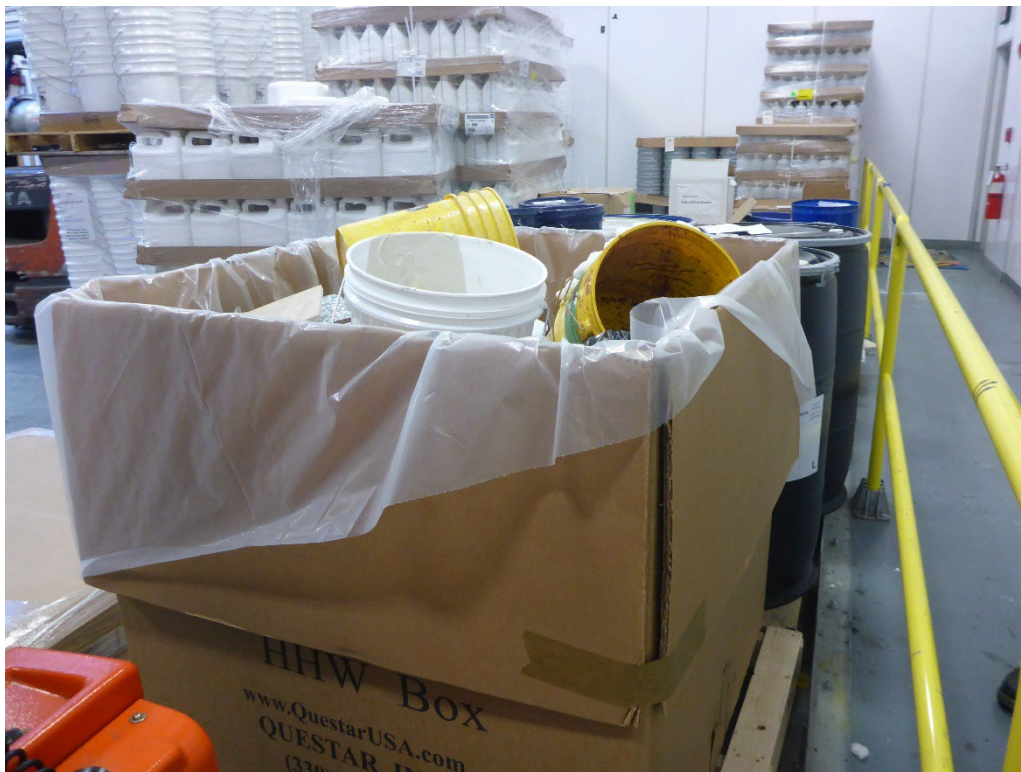
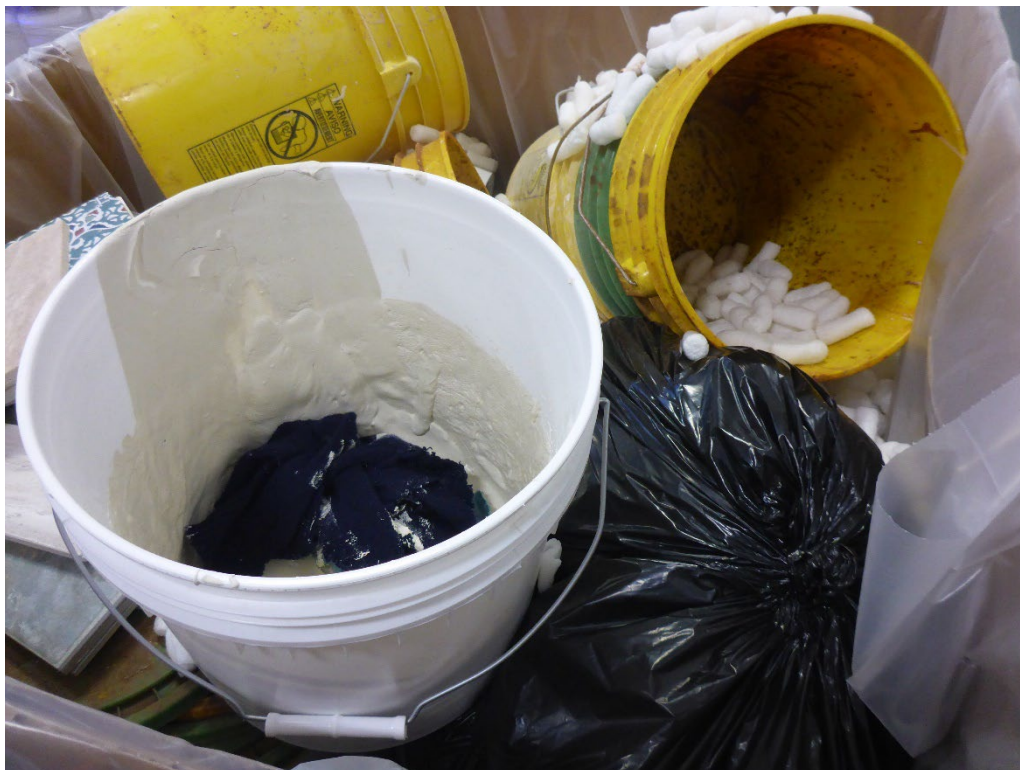
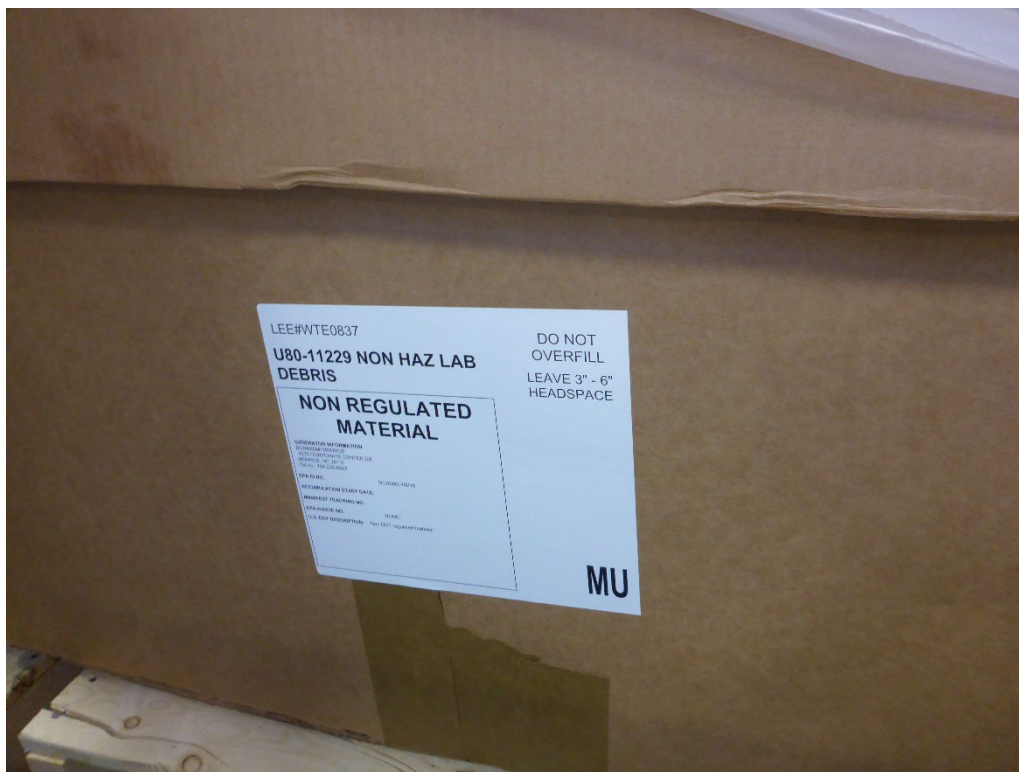
- One gaylord box labeled nonhazardous waste and containing 5-gallon pails and a black trash bag of laboratory generated wastes (Photos 2-4);
- Two 55-gallon poly drums labeled nonhazardous liquid products (profile: LEE #WTE0564);
- One 55-gallon steel drum labeled nonhazardous concrete silane adhesive (profile: WTE0560);
- One 55-gallon steel drum labeled nonhazardous spill cleanup (profile: 23754);
- One 55-gallon steel drum with no label, no date, and no indication of hazards;
- Three ½-gallon buckets labeled Bona Pigmented control 617121 (Photo 5);
- One ½-gallon bucket labeled Bona Pigmented textured 170 grit (Photo 5);
- Three boxes of Bona Natural finish (414-100A, WE417946000), with each box containing three 2-liter bottles;
- Two 1-gallon blue containers of corrosive material (Photos 6 and 7);
- One glass jar of Ancarez 2364 curing agent (Photo 8);

**Photo 2:** Cubic yard box containing 5-gallon pails and a black trash bag of laboratory generated wastes. The box, which is located next to a metal handrail outside of the Laboratory in the Filling Area, is labeled nonhazardous waste.

**Photo 3:** 5-gallon pails and a black trash bag of laboratory generated wastes observed in a cubic yard box, which was labeled nonhazardous waste and staged in an area next to a metal handrail outside of the Laboratory in the Filling Area.

**Photo 4:** Nonhazardous waste label observed on the cubic yard box, which was staged in an area next to a metal handrail outside of the Laboratory in the Filling Area.

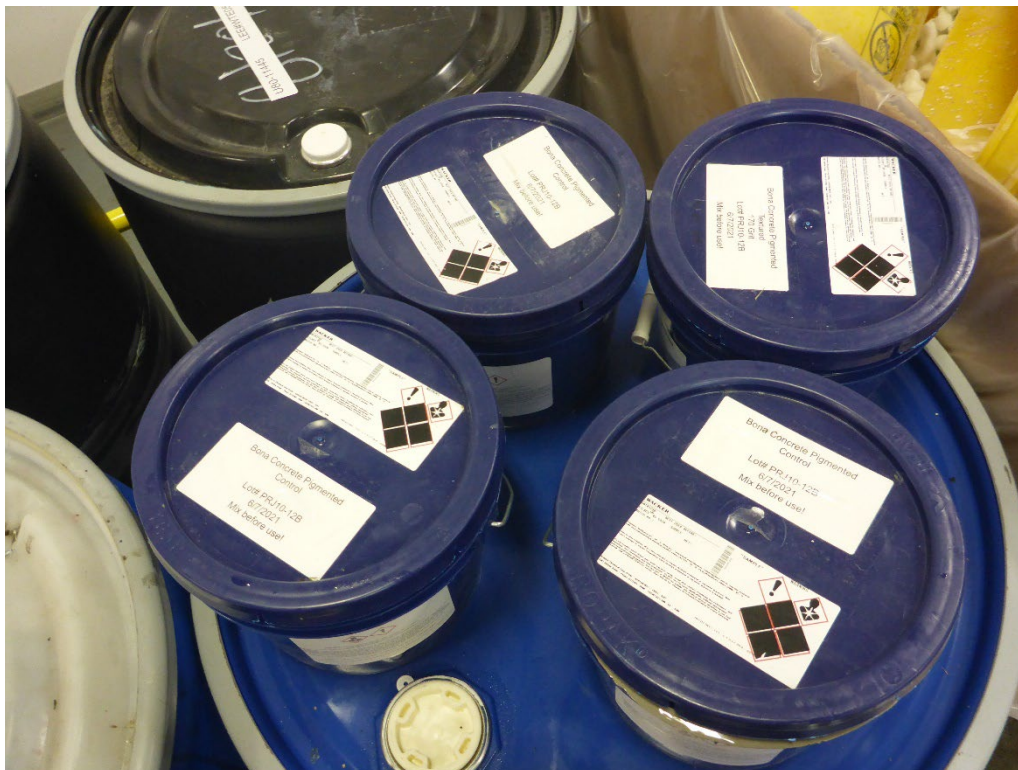
**Photo 5:** Three ½-gallon buckets labeled Bona Pigmented control and one ½-gallon bucket labeled Bona Pigmented textured, which were among the miscellaneous materials observed in an area next to a metal handrail outside of the Laboratory in the Filling Area.

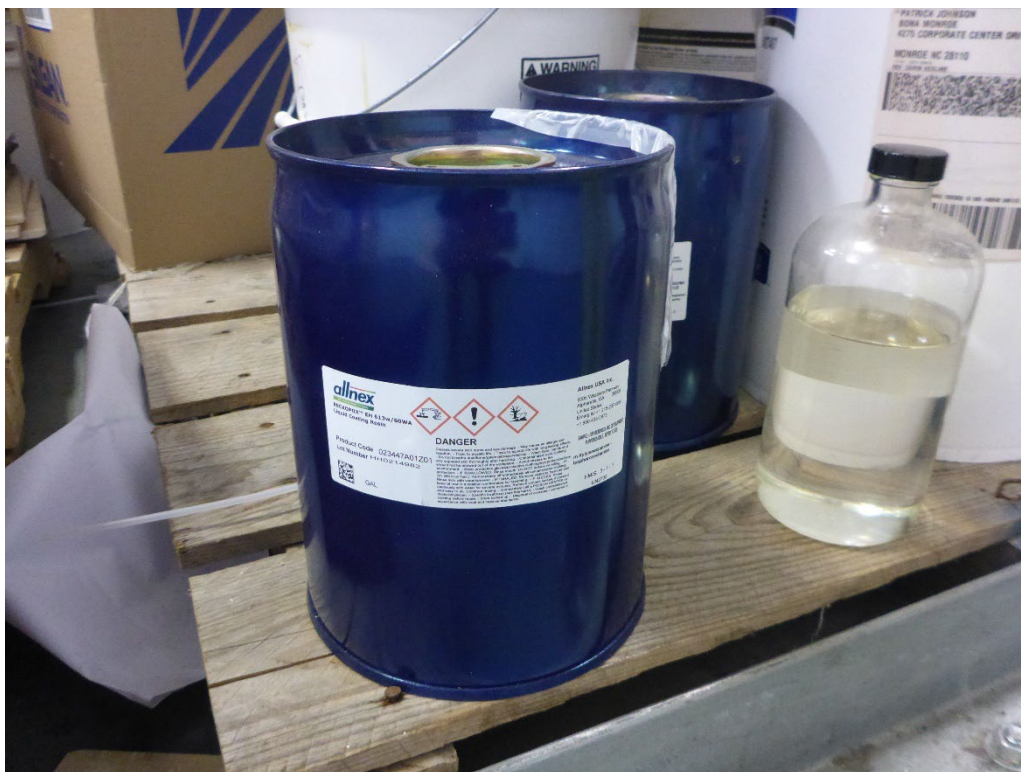
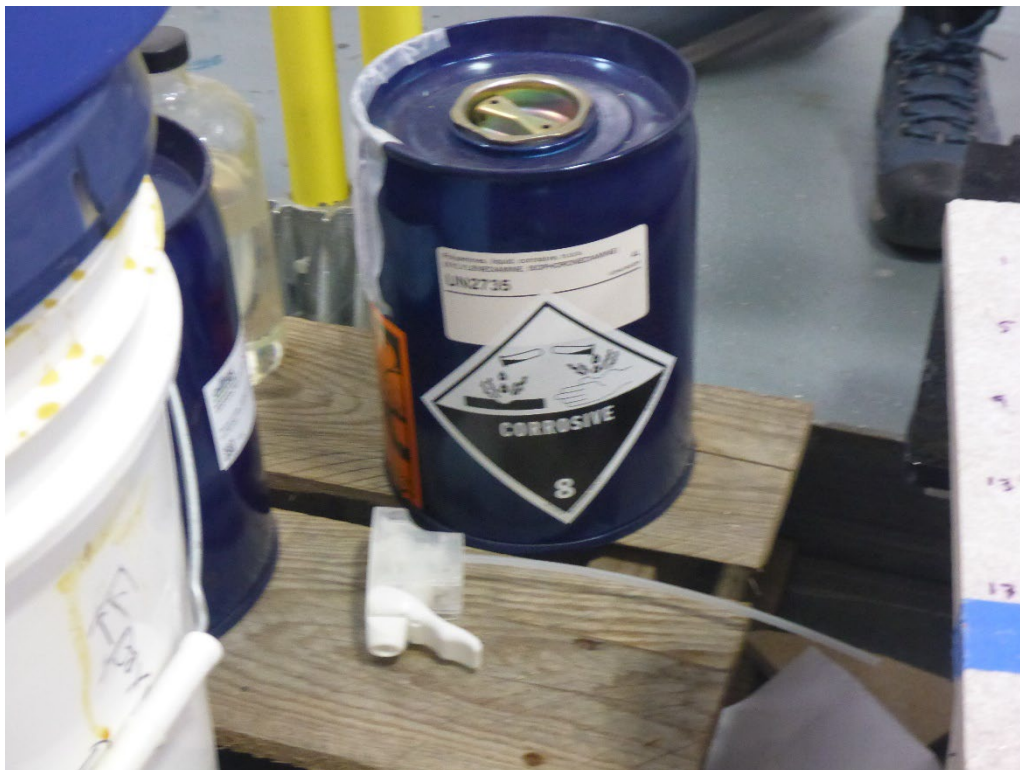
**Photo 6:** One of two 1-gallon blue containers of corrosive material which were among the miscellaneous materials observed in an area next to a metal handrail outside of the Laboratory in the Filling Area.

**Photo 7:** One of two 1-gallon blue containers of corrosive material which were among the miscellaneous materials observed in an area next to a metal handrail outside of the Laboratory in the Filling Area.

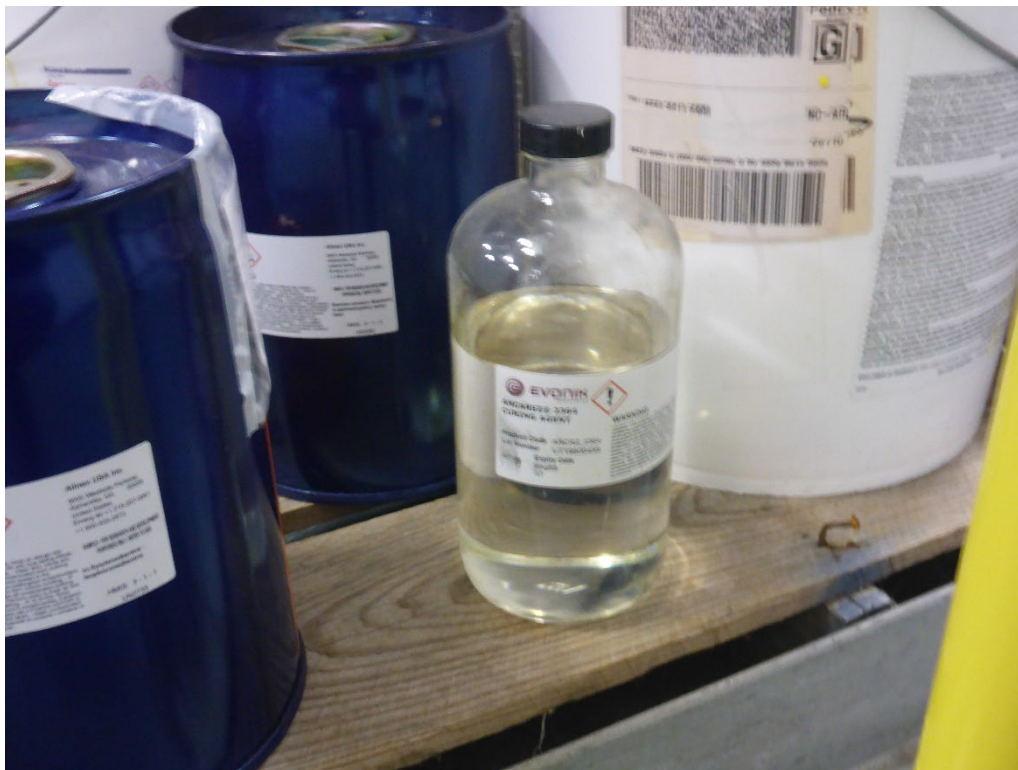
**Photo 8:** One glass jar of Ancarez 2364 curing agent, which was among the miscellaneous materials observed in an area next to a metal handrail outside of the Laboratory in the Filling Area.

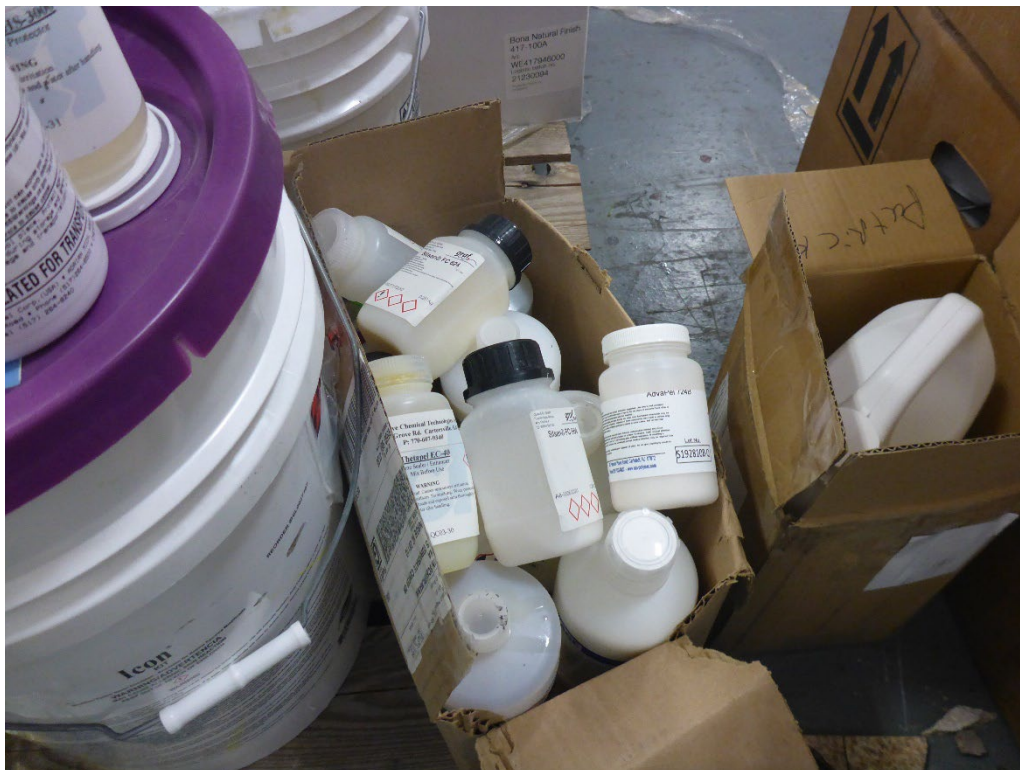
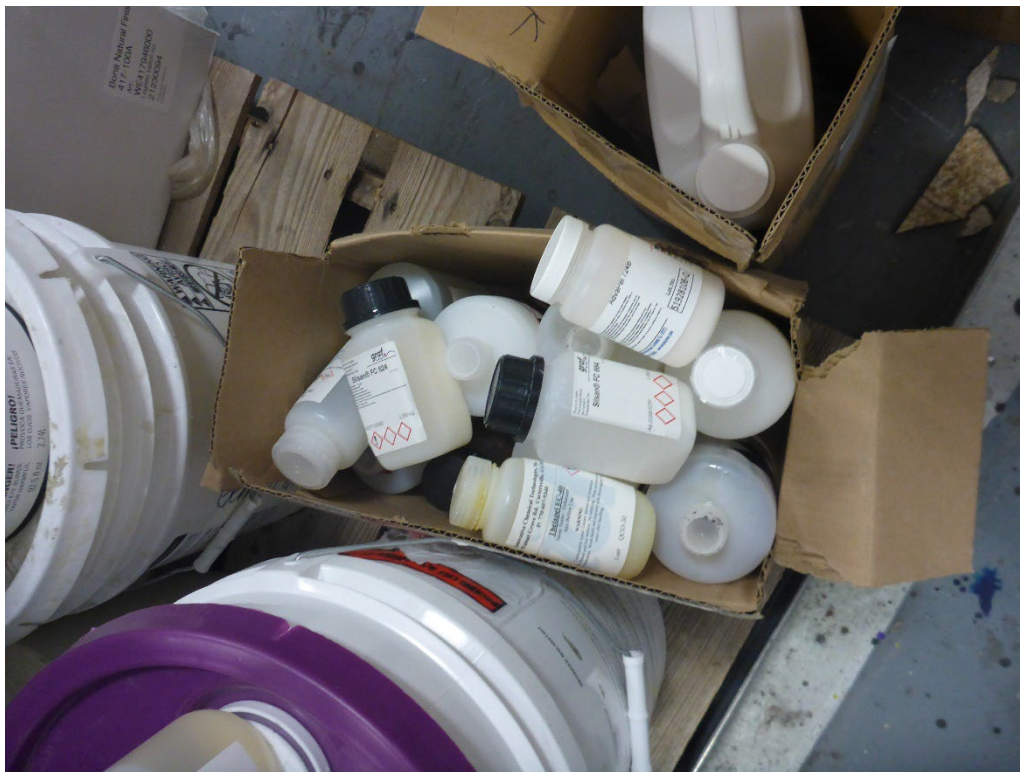
**Photo 9:** One box of R & D samples, which was among the miscellaneous materials observed in an area next to a metal handrail outside of the Laboratory in the Filling Area.

**Photo 10:** One box of R & D samples, which was among the miscellaneous materials observed in an area next to a metal handrail outside of the Laboratory in the Filling Area.

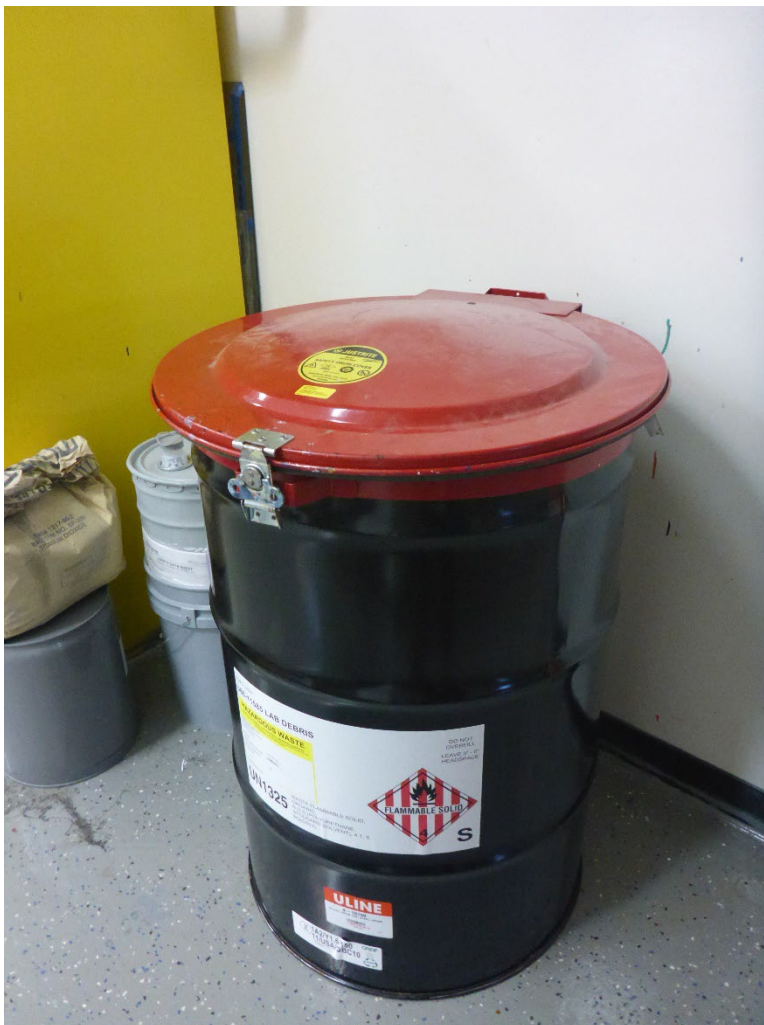
Laboratory SAAs: Bona US manages one SAA in the Laboratory for managing hazardous waste lab debris. The inspectors observed one 55-gallon drum in this SAA (Photo 12). The drum was located in the laboratory, and it was equipped with a latched, red flip-top lid. The drum was marked as U80-11585 lab debris, labeled D001 hazardous waste flammable solid (polyurethane Stoddard solvent), and identified with a flammable solid DOT hazard placard.

**Photo 12:** One 55-gallon drum observed in the Laboratory SAA for managing hazardous waste lab debris. The drum was identified as U80-11585 lab debris, labeled D001 hazardous waste flammable solid (polyurethane Stoddard solvent), and marked with a flammable solid DOT hazard placard.

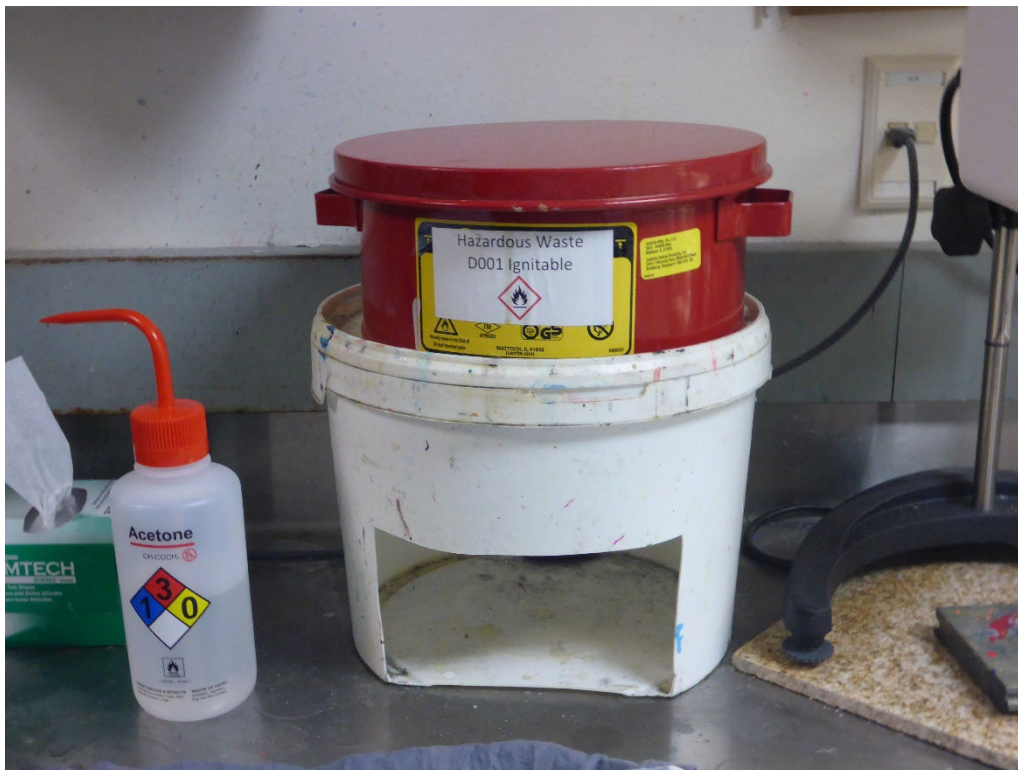
Bona US manages a second SAA in the Laboratory for managing hazardous waste flammable liquid that is generated in the Laboratory. The inspectors observed one ½-gallon red flammable can (Photo 13), one 1-gallon paint can (Photo 14), and one 1-gallon plastic jug in this SAA. The ½-gallon and 1-gallon cans were each labeled D001 hazardous waste ignitable liquid. The 1-gallon plastic jug, which was located next to the density meter, was empty. Personnel stated that the jug will be used to accumulate acetone waste, so a hazardous waste label and flammable liquid DOT hazard placard were added to the container during the inspection.

**Photo 13:** One ½-gallon flammable can, which was observed in the Laboratory SAA for managing hazardous waste flammable liquids. The container was labeled D001 hazardous waste flammable liquid and marked with a flammable pictogram.

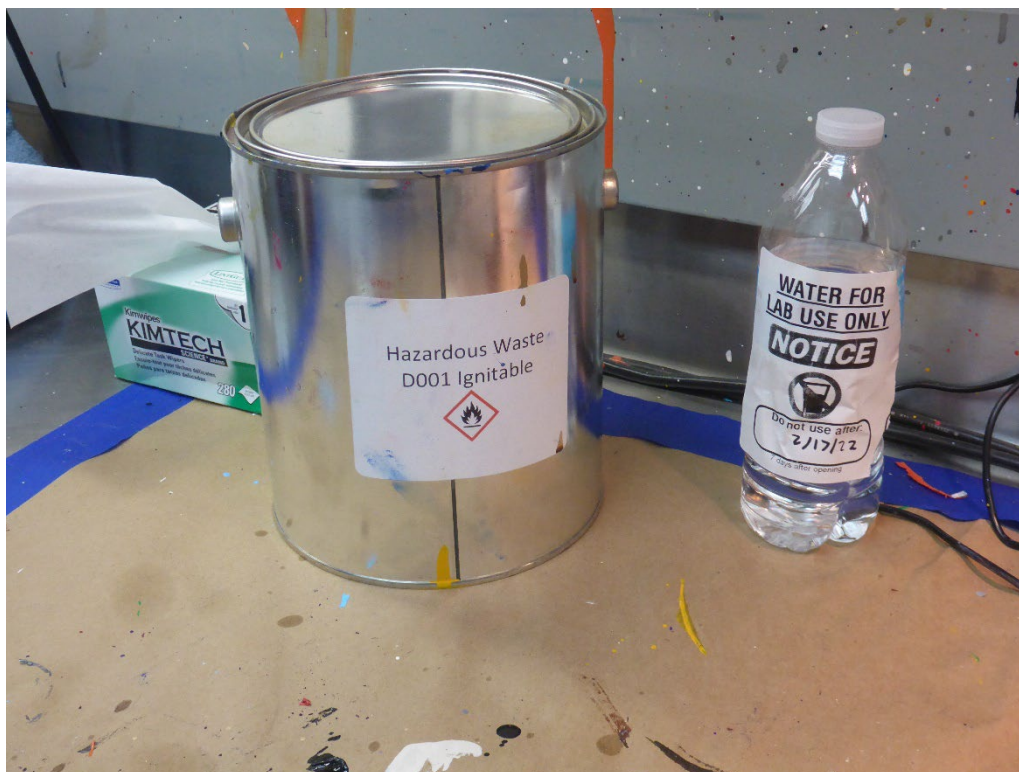
**Photo 14:** One 1-gallon paint can, which was observed in the Laboratory SAA for managing hazardous waste flammable liquids. The container was labeled D001 hazardous waste flammable liquid and marked with a flammable pictogram.

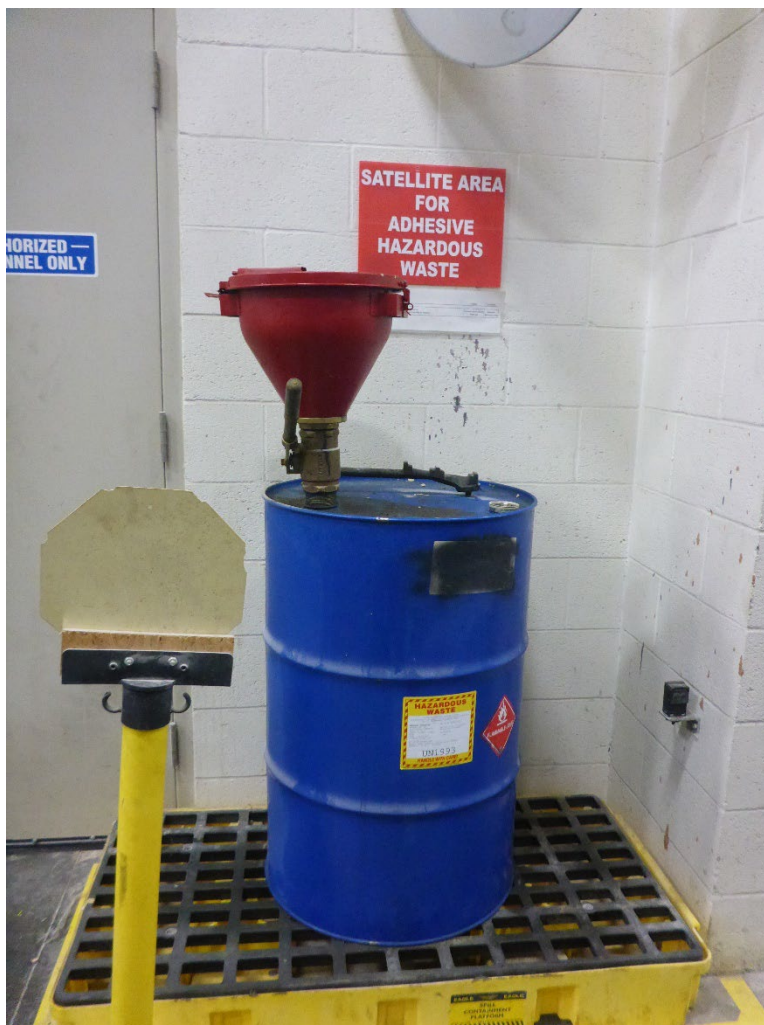
Bona US manages a third SAA for managing adhesive solvent titrant hazardous waste and excess cleaning solvents just outside of the Laboratory door in the Adhesives Area of the facility. The inspectors observed one 55-gallon drum on a secondary containment pallet in this SAA (Photo 15). The drum was equipped with a funnel lid. It was labeled D001 hazardous waste adhesive solvent titrant (ethanol / methanol), and it was identified with a flammable liquid DOT hazard placard.

**Photo 15:** One 55-gallon drum, which was observed in the Laboratory SAA for managing hazardous waste excess cleaning solvents. The container was labeled D001 hazardous waste adhesive solvent titrant (ethanol / methanol) and marked with a flammable liquid DOT hazard placard.

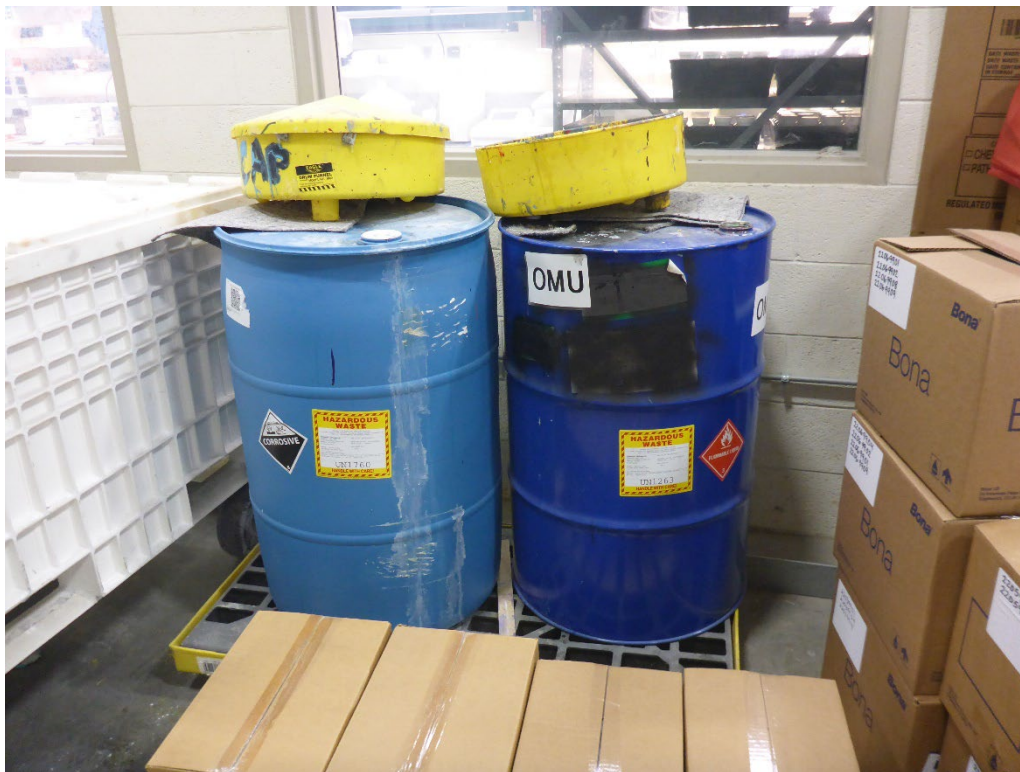
laboratory waste on the same secondary containment pallet located outside the Laboratory far door in the Adhesives Area. The inspectors observed one 55-gallon steel drum in the hazardous waste paint SAA (Photo 16). This drum was labeled D001 hazardous waste paint waste (polyurethane / Stoddard solvent) and identified with a flammable liquid DOT hazard placard. The inspectors observed another 55-gallon poly drum in the laboratory waste SAA (Photo 16). This drum was labeled D002 hazardous waste titration waste (sulfuric acid / hydrogen peroxide) and identified with a corrosive DOT hazard placard.

**Photo 16:** One 55-gallon steel drum, which was observed in the Laboratory SAA for managing hazardous waste paint waste. The container was labeled D001 hazardous waste paint waste (polyurethane / Stoddard solvent) and marked with a flammable liquid DOT hazard placard. One 55-gallon poly drum, which was observed in the Laboratory SAA for managing hazardous waste titration waste. The container was labeled D002 hazardous waste titration waste (sulfuric acid / hydrogen peroxide) and identified with a corrosive DOT hazard placard.

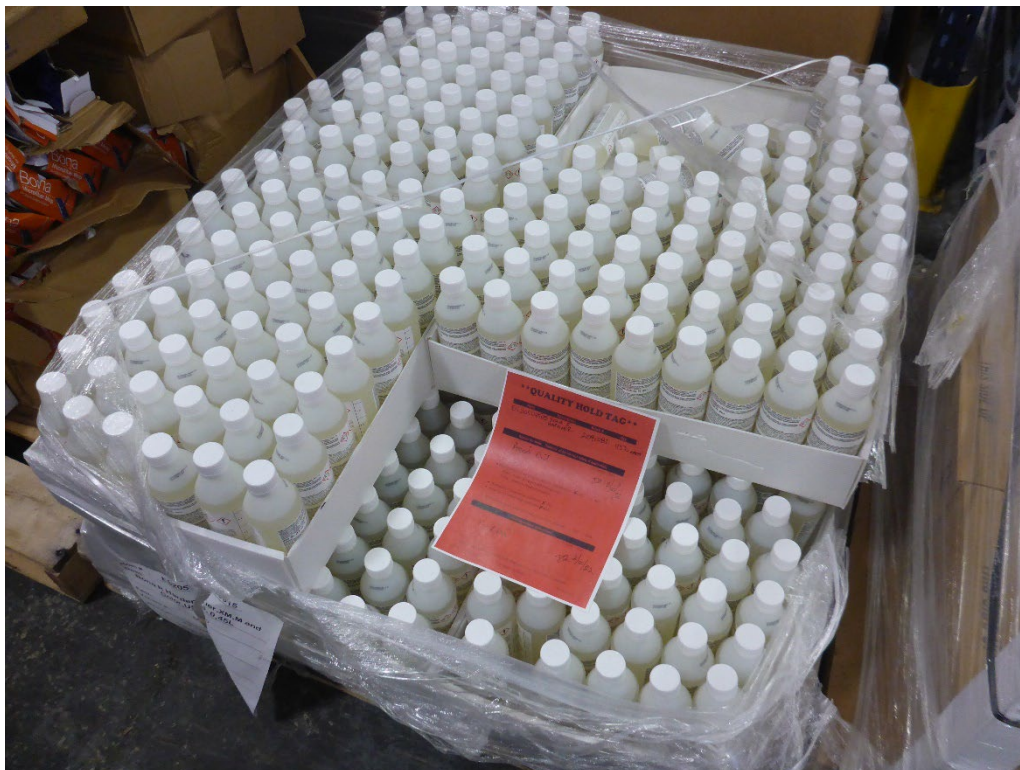
The inspectors observed a variety of materials in this area, but the only material that had been apparently tagged for disposal was one wooden pallet of Bona Hardener. This pallet was marked with a sign which read “aged out, scrap February 10, 2022” (Photo 17). It appears that hazardous wastes identified in this area are not properly managed according to applicable RCRA regulations between the time that employees determine that the material is a waste and the time that containers of hazardous waste are prepared for transport in the main CAA. Before wastes are transferred to the CAA, those materials are identified in the Return SAA with a color-coded dot, but containers of hazardous wastes are not labeled as hazardous waste, marked with an accumulation start date, or identified with an indication of the hazards of their contents.

**Photo 17:** One pallet of Bona Hardener, which was marked with a sign reading “aged out, scrap 02/10/2022,” observed in the Returns SAA.

**Pursuant to 15A NCAC 13A .0107(a) [40 C.F.R. § 262.11], a person who generates a solid waste, as defined in 15A NCAC 13A .0106 [40 C.F.R. § 261.2], must use the steps articulated in 15A NCAC 13A .0107(a) [40 C.F.R. § 262.11] to make an accurate determination as to whether that waste is a hazardous waste in order to ensure wastes are properly managed according to applicable RCRA regulations.**

**Pursuant to 15A NCAC 13A .0107 [40 C.F.R. § 262.17(a)(5)(i)], which is a condition of the LQG Permit Exemption, a generator is required to mark or label containers with the words “hazardous waste”; with an indication of the hazards of the**

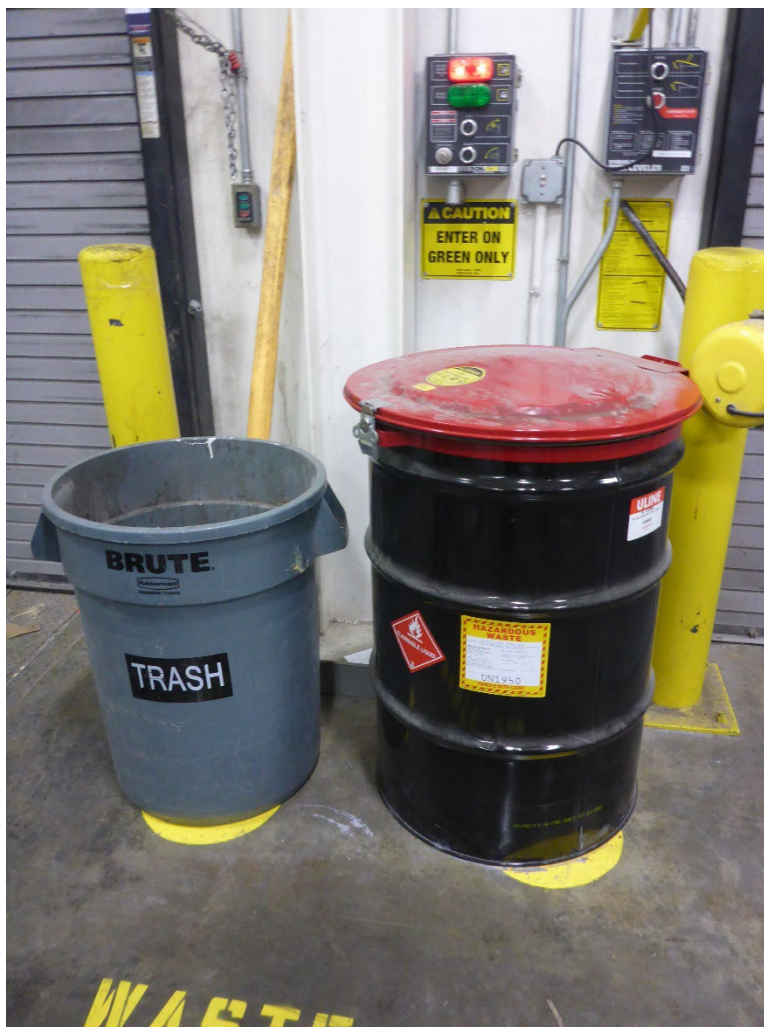
Shipping and Receiving SAA: Bona US manages one SAA in the Shipping and Receiving Area for managing hazardous waste aerosol cans. The inspectors observed one 55-gallon drum in this SAA (Photo 18). The drum was equipped with a red, flip-top lid. The drum was labeled D001 / D005 / D035 hazardous waste aerosols and identified with a flammable liquid DOT hazard placard, but it was not marked with an indication that the contents are toxic.

**Photo 18:** One 55-gallon drum, which was observed in the Shipping and Receiving SAA for managing hazardous waste aerosol cans. The container was labeled D001 / D005 / D035 hazardous waste aerosols and marked with a flammable liquid DOT hazard placard. The container was not marked with an indication that the contents are toxic.

**Pursuant to 15A NCAC 13A .0107(a) [40 C.F.R. § 262.15(a)(5)(ii)], which is a condition of the SAA Permit Exemption, a generator is required to mark or label its containers with an indication of the hazards of the contents.**

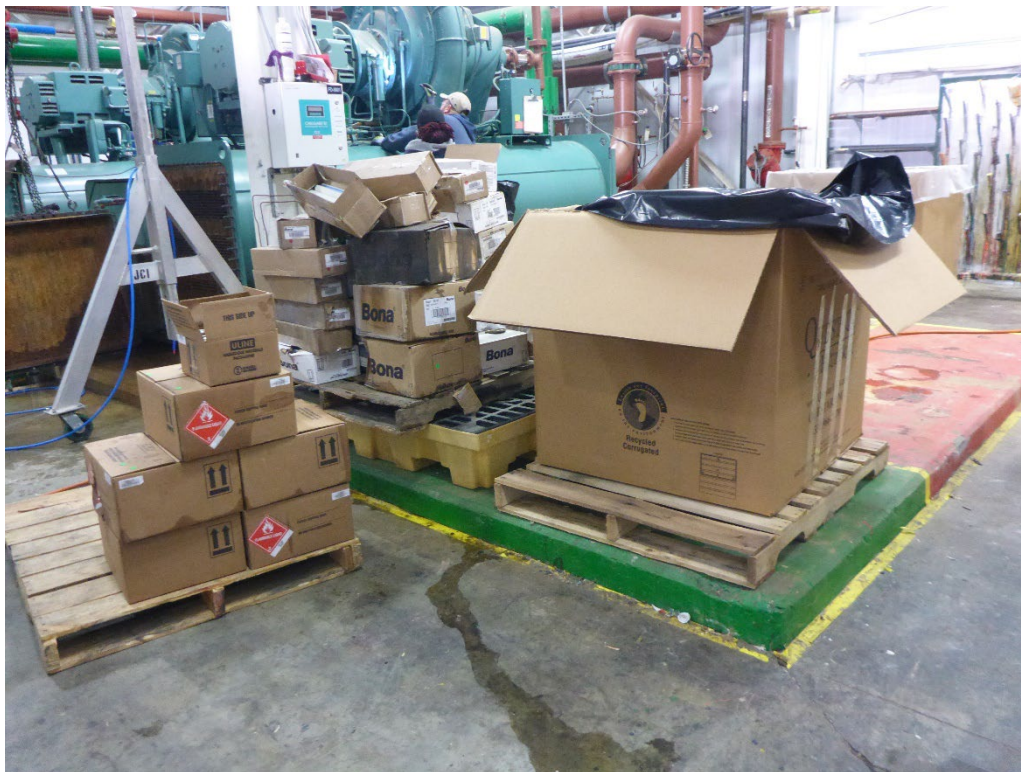
containers that are marked with a given color-coded identification dot are packaged together into totes or cubic yard boxes in the designated area with the corresponding color-coded identification floor. The larger tote or cubic yard box used to consolidate the waste is also marked with the same color-coded identification dot. When the container is full, it is closed and prepared for transport. The inspectors observed open, unlabeled containers of hazardous waste in this area.

**Photo 19:** Area within Main CAA where wastes are consolidated according to color-coding system. The cubic yard box and some smaller containers are open. None of the containers are labeled as hazardous waste, marked with an accumulation start date, or identified with an indication of the hazards of their contents.

**Pursuant to 15A NCAC 13A .0107 [40 C.F.R. § 262.17(a)(1)(iv)(A)], which is a condition of the LQG Permit Exemption, a container holding hazardous waste must always be closed during accumulation, except when it is necessary to add or remove waste.**

**Pursuant to 15A NCAC 13A .0107 [40 C.F.R. § 262.17(a)(5)(i)], which is a condition of the LQG Permit Exemption, a generator is required to mark or label containers with the words “hazardous waste”; with an indication of the hazards of the contents; and with the date upon which each period of accumulation begins.**

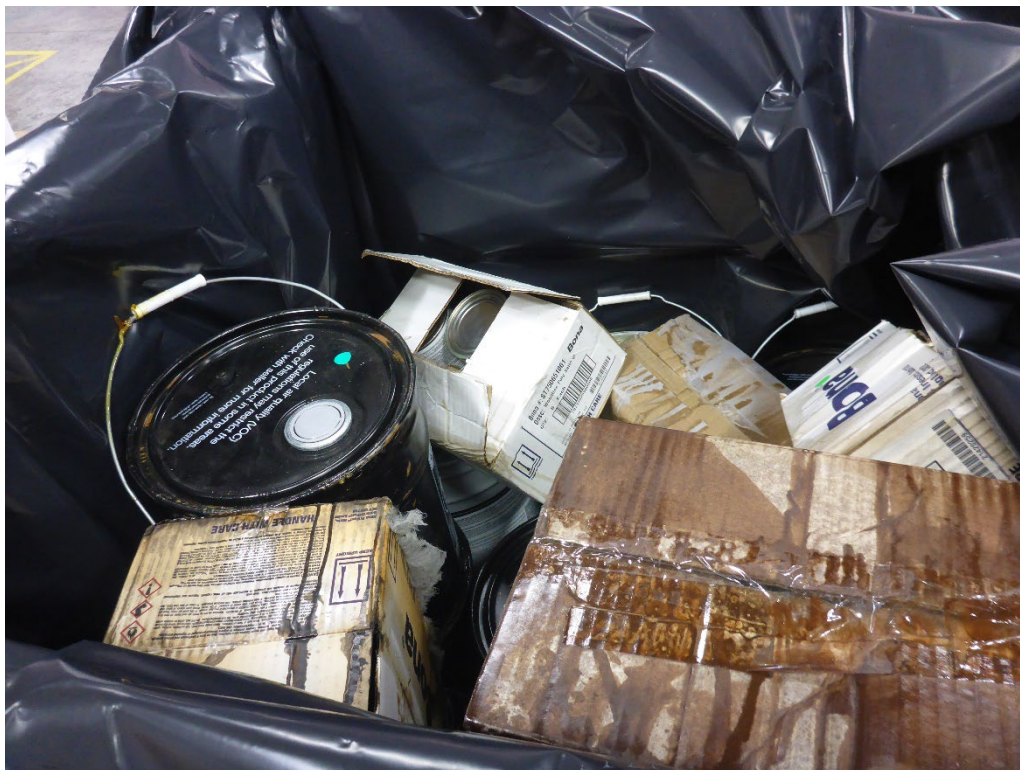
**Photo 21:** Smaller containers that have been consolidated into a cubic yard box in the Main CAA. The cubic yard box is open, not labeled as hazardous waste, not marked with an accumulation start date, and not identified with an indication of the hazards of its contents.

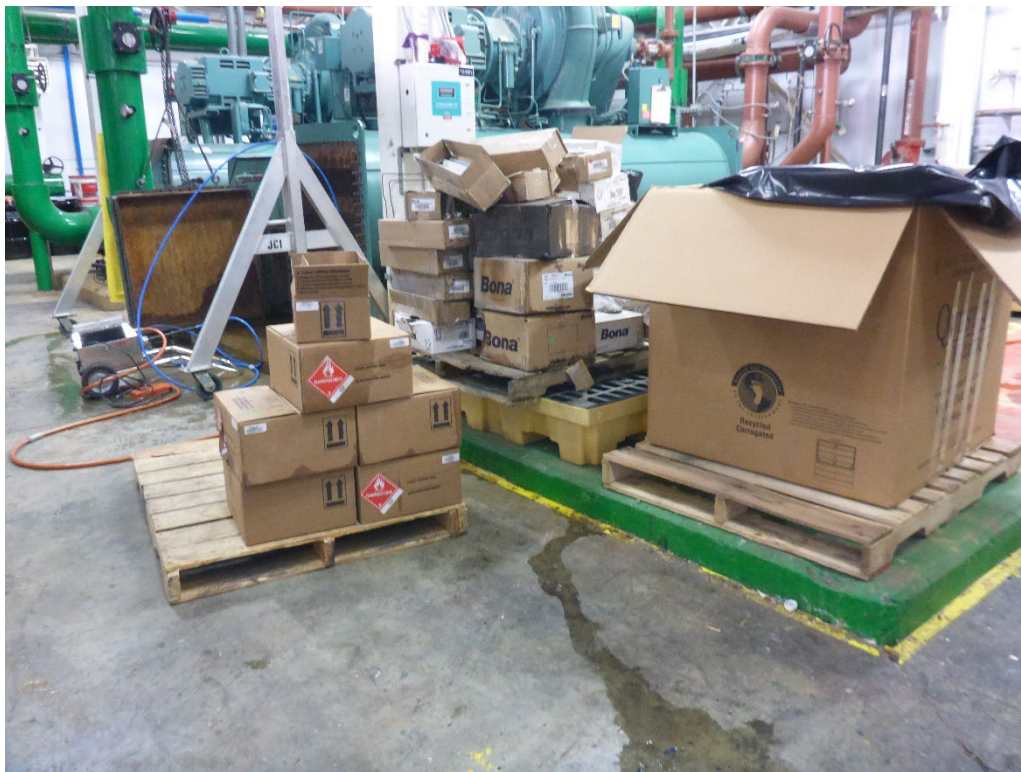
**Photo 22:** Area within Main CAA where wastes are consolidated according to color-coding system. The cubic yard box and some smaller containers are open. None of the containers are labeled as hazardous waste, marked with an accumulation start date, or identified with an indication of the hazards of their contents.

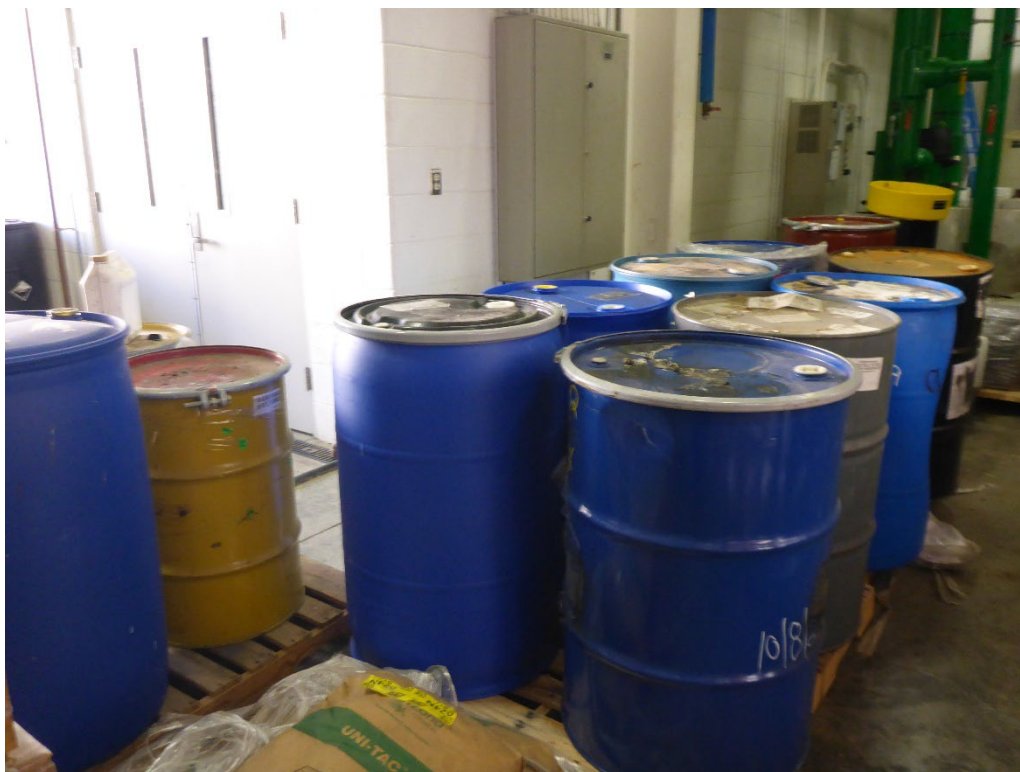
The inspectors also observed approximately twenty 55-gallon drums staged in this area (Photo 23). Bona was not ensuring that the wastes in this area are properly managed according to applicable RCRA regulations. None of the containers observed in this area were labeled as hazardous waste, and many were not marked with an accumulation start date or identified with an indication of the hazards of their contents. The observed drums included:

**Photo 23:** Approximately twenty 55-gallon drums staged in the area designated for waste-pickup. None of the containers were labeled as hazardous waste, and many were not marked with an accumulation start date or identified with an indication of the hazards of their contents.

**Pursuant to 15A NCAC 13A .0107(a) [40 C.F.R. § 262.11], a person who generates a solid waste, as defined in 15A NCAC 13A .0106 [40 C.F.R. § 261.2], must use the steps articulated in 15A NCAC 13A .0107(a) [40 C.F.R. § 262.11] to make an accurate determination as to whether that waste is a hazardous waste in order to ensure wastes are properly managed according to applicable RCRA regulations.**

**Pursuant to 15A NCAC 13A .0107 [40 C.F.R. § 262.17(a)(5)(i)], which is a condition of the LQG Permit Exemption, a generator is required to mark or label containers with the words “hazardous waste”; with an indication of the hazards of the contents; and with the date upon which each period of accumulation begins.**

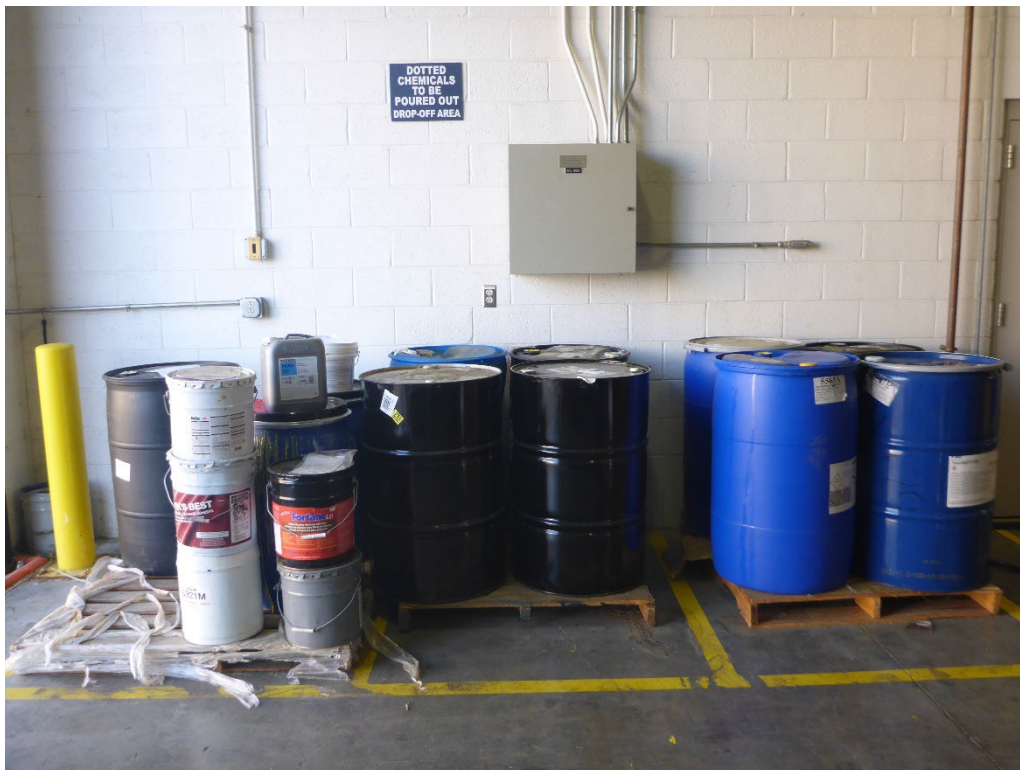
The inspectors also observed a row of pallets along the wall just to the left when entering this outbuilding (Photo 24). Bona was not ensuring that the wastes in this area are properly managed according to applicable RCRA regulations. None of the containers observed in this area were labeled as hazardous waste, and many were not marked with an accumulation start date or identified with an indication of the hazards of their contents. Some containers observed on these pallets include:

- One 55-gallon drum with no visible label, which was dated October 8, 2020;
- One 55-gallon drum, which was identified with a corrosive DOT hazard placard, but not labeled as hazardous waste or marked with an accumulation start date;

**Photo 24:** Row of containers along the wall just to the left when entering the Main CAA. None of the containers were labeled as hazardous waste, and many were not marked with an accumulation start date or identified with an indication of the hazards of their contents.

**Pursuant to 15A NCAC 13A .0107(a) [40 C.F.R. § 262.11], a person who generates a solid waste, as defined in 15A NCAC 13A .0106 [40 C.F.R. § 261.2], must use the steps articulated in 15A NCAC 13A .0107(a) [40 C.F.R. § 262.11] to make an accurate determination as to whether that waste is a hazardous waste in order to ensure wastes are properly managed according to applicable RCRA regulations.**

**Pursuant to 15A NCAC 13A .0107 [40 C.F.R. § 262.17(a)(5)(i)], which is a condition of the LQG Permit Exemption, a generator is required to mark or label containers with the words “hazardous waste”; with an indication of the hazards of the**
