## **RCRA Inspection Report**

Bona US EPA ID# NCR000010215  
4275 Corporate Center  
Monroe, North Carolina 28110

February 15, 2022

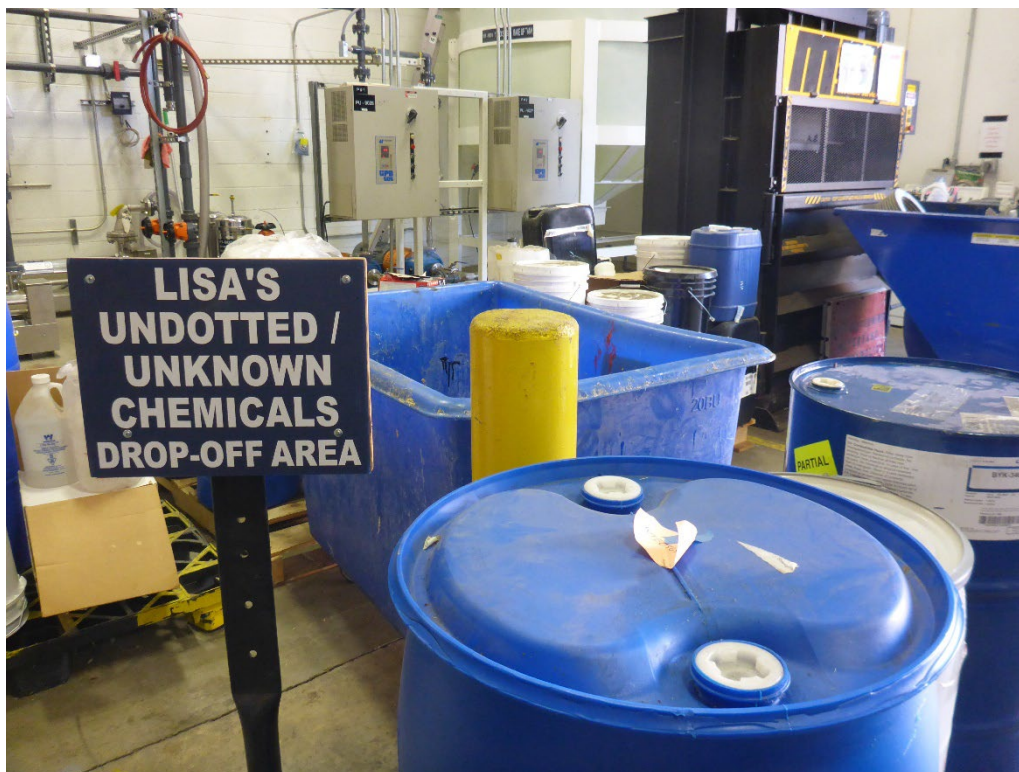
Wastes that are transferred to this area from on-site SAAs may be staged in an area just to the right when entering the outbuilding (Photos 25-31). The inspectors observed containers of waste on two portable secondary containment pallets in this area. Some of those observed containers included:

**Photo 25:** Area for staging wastes that are transferred to the Main CAA from SAAs or staging unknown materials that are included with customer returns.

**Pursuant to 15A NCAC 13A .0107(a) [40 C.F.R. § 262.11], a person who generates a solid waste, as defined in 15A NCAC 13A .0106 [40 C.F.R. § 261.2], must use the steps articulated in 15A NCAC 13A .0107(a) [40 C.F.R. § 262.11] to make an accurate determination as to whether that waste is a hazardous waste in order to ensure wastes are properly managed according to applicable RCRA regulations.**

**Pursuant to 15A NCAC 13A .0107 [40 C.F.R. § 262.17(a)(5)(i)], which is a condition of the LQG Permit Exemption, a generator is required to mark or label containers with the words “hazardous waste”; with an indication of the hazards of the contents; and with the date upon which each period of accumulation begins.**

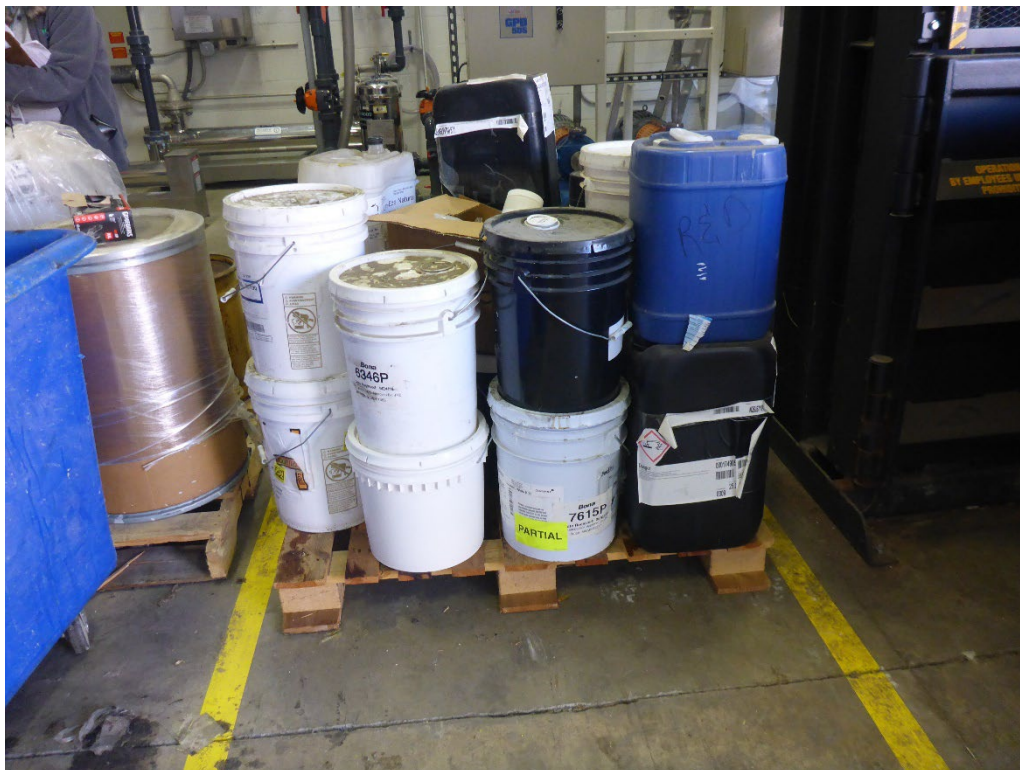
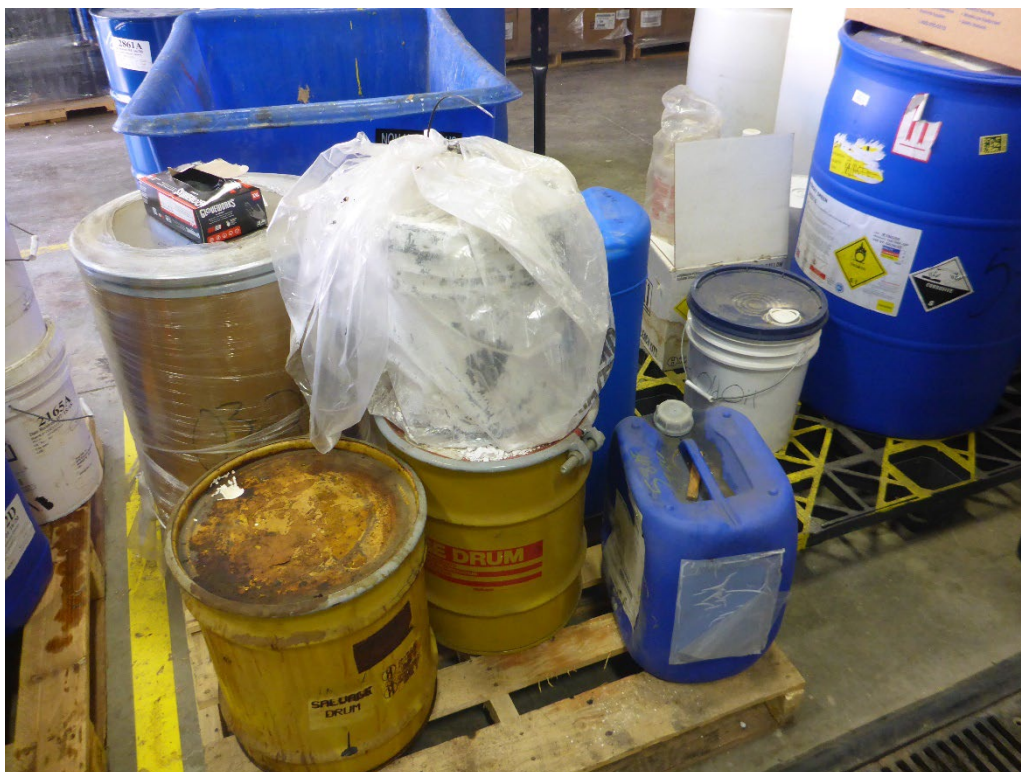
**Photo 26:** Unknown materials that are included with customer returns that are staged in the Main CAA to be characterized.

**Photo 27:** Unknown materials that are included with customer returns that are staged in the Main CAA to be characterized.

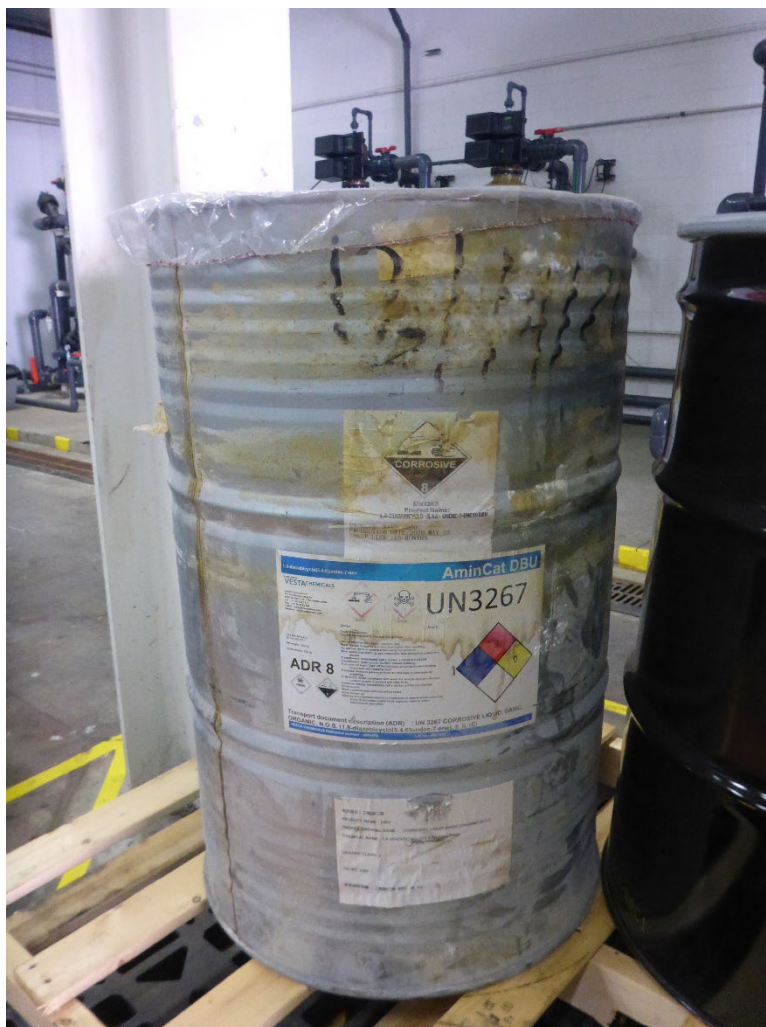
**Photo 28:** One 55-gallon drum, which was observed in the area used to stage unknown materials that are included with customer returns. The drum was labeled profile pending and dated 08/12/2021.

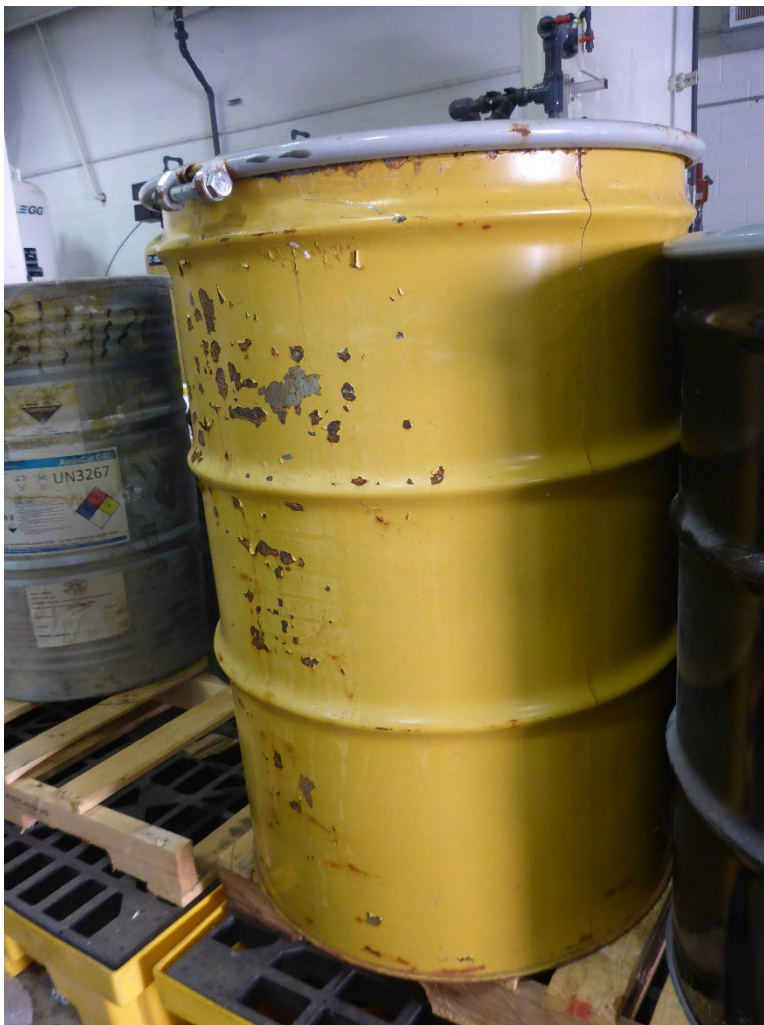
**Photo 29:** One overpack drum, which was observed in the area used to stage unknown materials that are included with customer returns. The drum was labeled profile pending and dated 01/18/2022.

**Photo 30:** Close-up of the profile pending label, dated 01/18/2022, which was observed on an overpack drum in the area used to stage unknown materials that are included with customer returns.

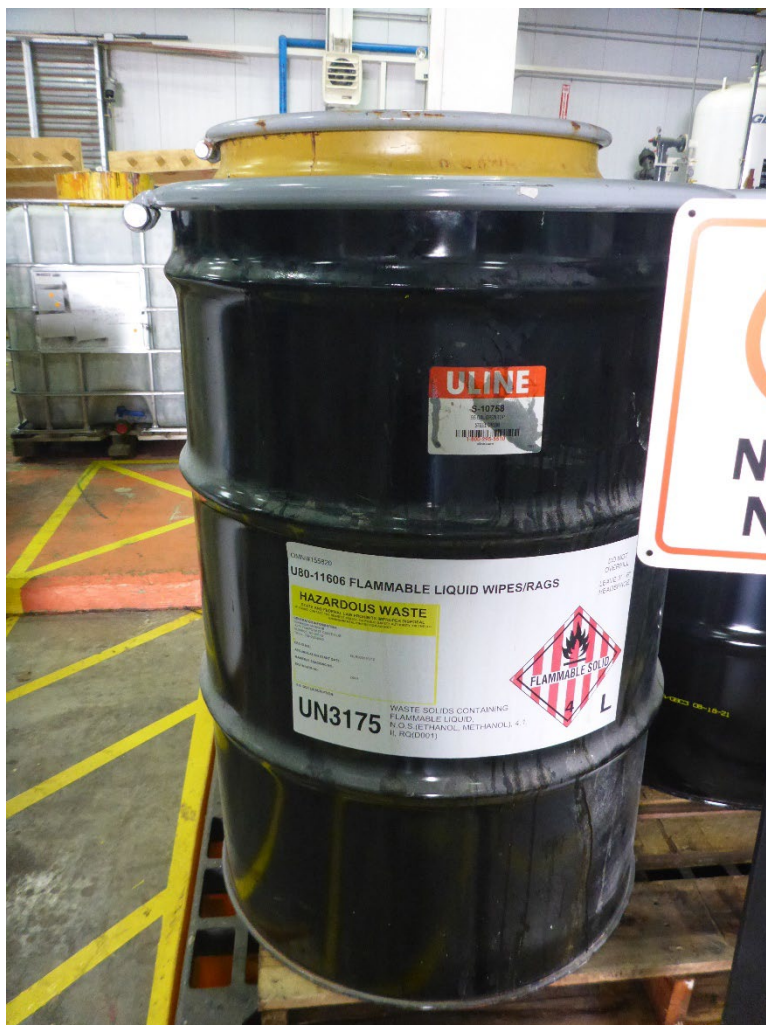
- One 55-gallon drum, which was labeled hazardous waste lab debris (polyurethane, Stoddard solvent), identified with a flammable solid DOT hazard placard, and dated November 23, 2021 (84 days);
- One 55-gallon drum, which was labeled hazardous waste lab debris (polyurethane, Stoddard solvent), identified with a flammable solid DOT hazard placard, and dated October 6, 2021 (132 days);
- One 55-gallon drum (Photo 28), which was labeled profile pending and dated August 12, 2021 (187 days);
- One salvage drum (Photos 29-30), which was labeled profile pending and dated January 18, 2022 (28 days); and
- One 55-gallon drum (Photo 31), which was labeled hazardous waste flammable liquid cups / rags (ethanol / methanol), identified with a flammable solid DOT hazard placard, but not marked with an accumulation start date.

**Photo 31:** One 55-gallon drum labeled hazardous waste flammable liquid cups / rags (ethanol / methanol) and identified with a flammable solid DOT hazard placard. The drum was not marked with an accumulation start date.

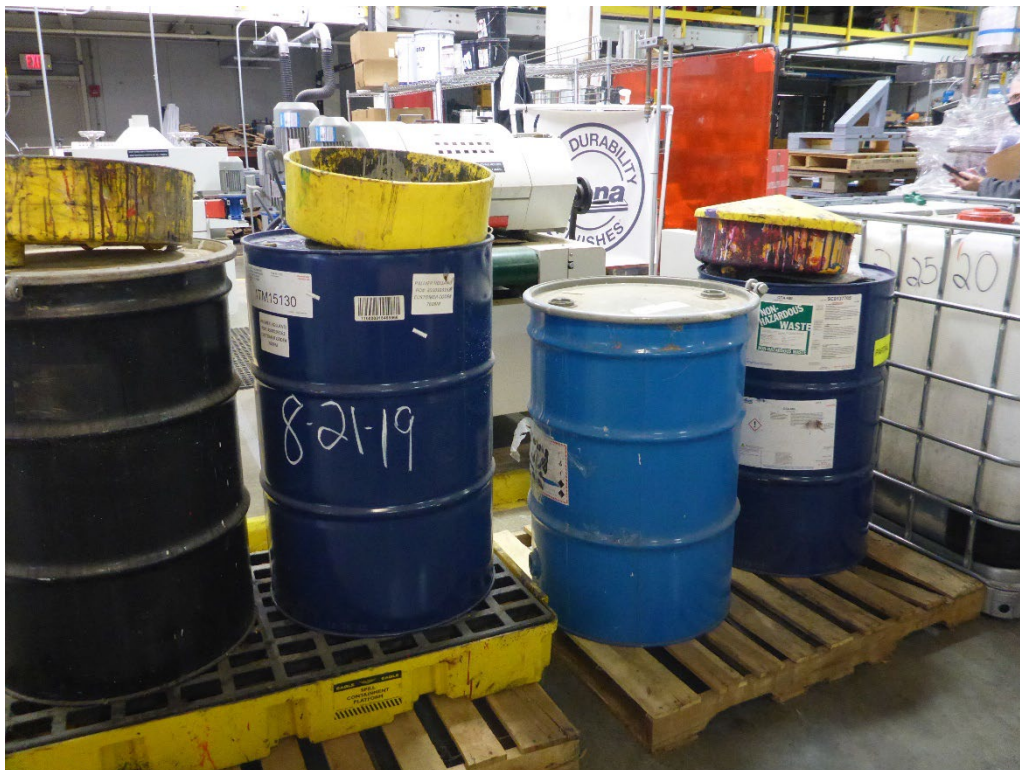
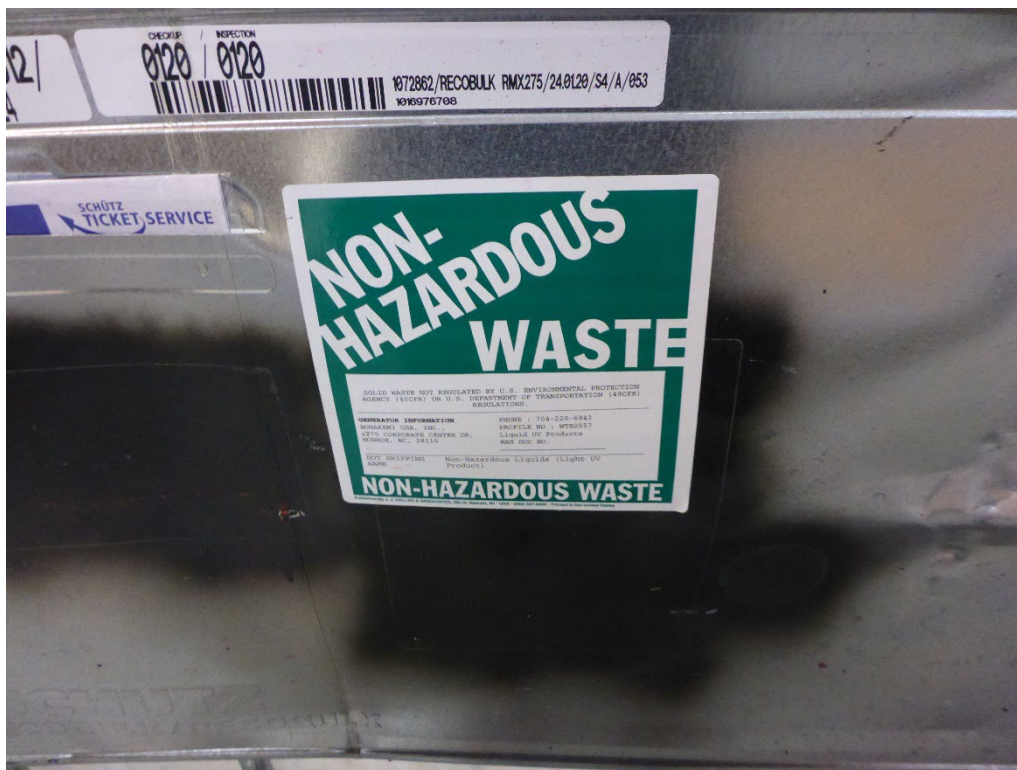
**Photo 32:** Four 55-gallon drums used to accumulate wastes generated in the UV Area.

**Photo 33:** Close-up of a label observed on one of four 55-gallon drums used to accumulate wastes generated in the UV Area.

**Photo 34:** Close-up of a label observed on another of four 55-gallon drums used to accumulate wastes generated in the UV Area.

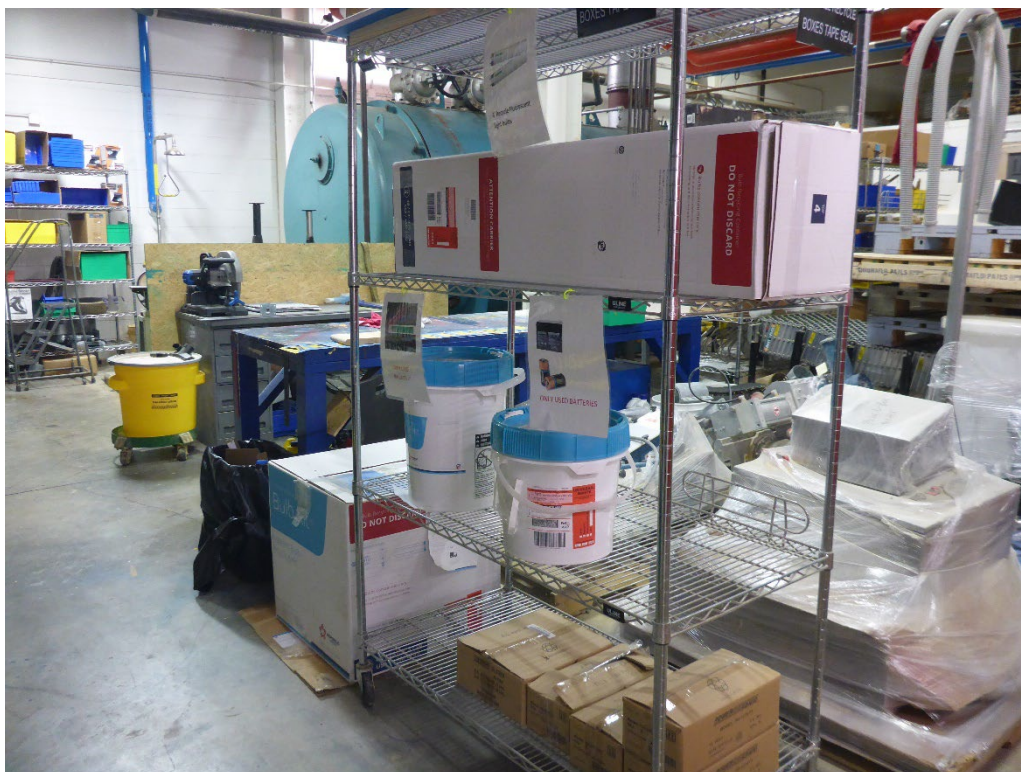
**Photo 35:** Shelving unit used to manage universal waste near the UV Area.

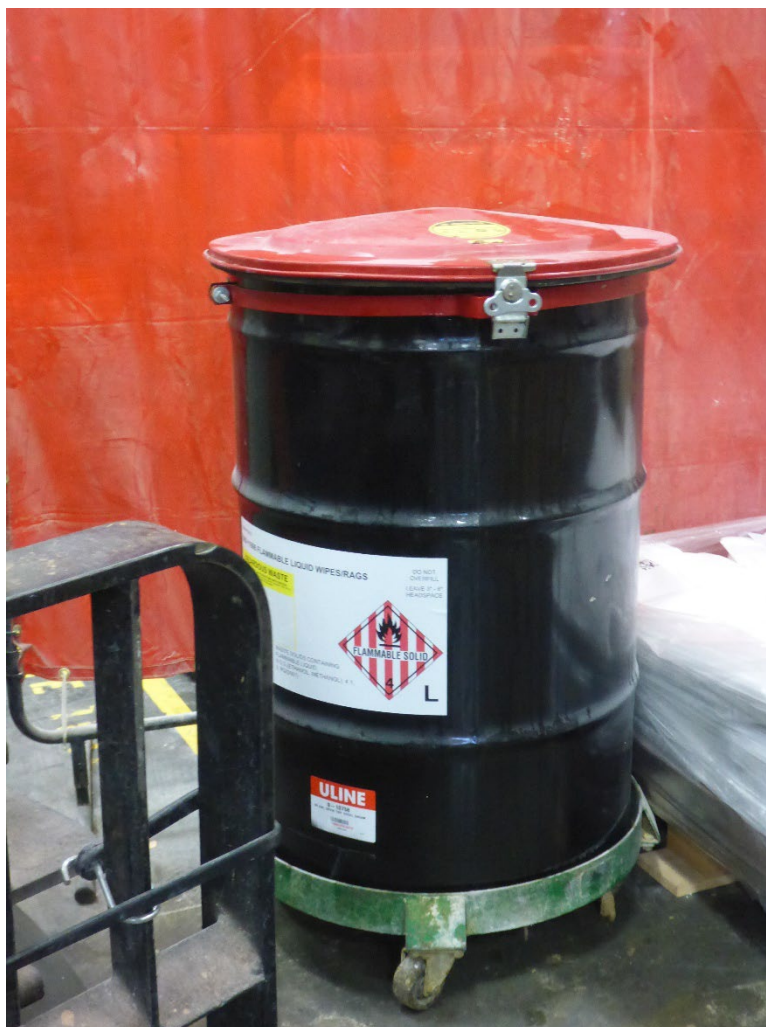
**Photo 36:** One 55-gallon drum observed in the Adhesives Area SAA for managing hazardous waste flammable solids. The drum was labeled D001 hazardous waste flammable liquid cups / rags (ethanol / methanol) and marked with a flammable solid DOT hazard placard.
