## **RCRA Inspection Report**

Core Molding Technologies, Inc. EPA ID# SCR000005629  
24 Commerce Drive  
Meadowcreek Industrial Park  
Gaffney, South Carolina 29340

September 17, 2020

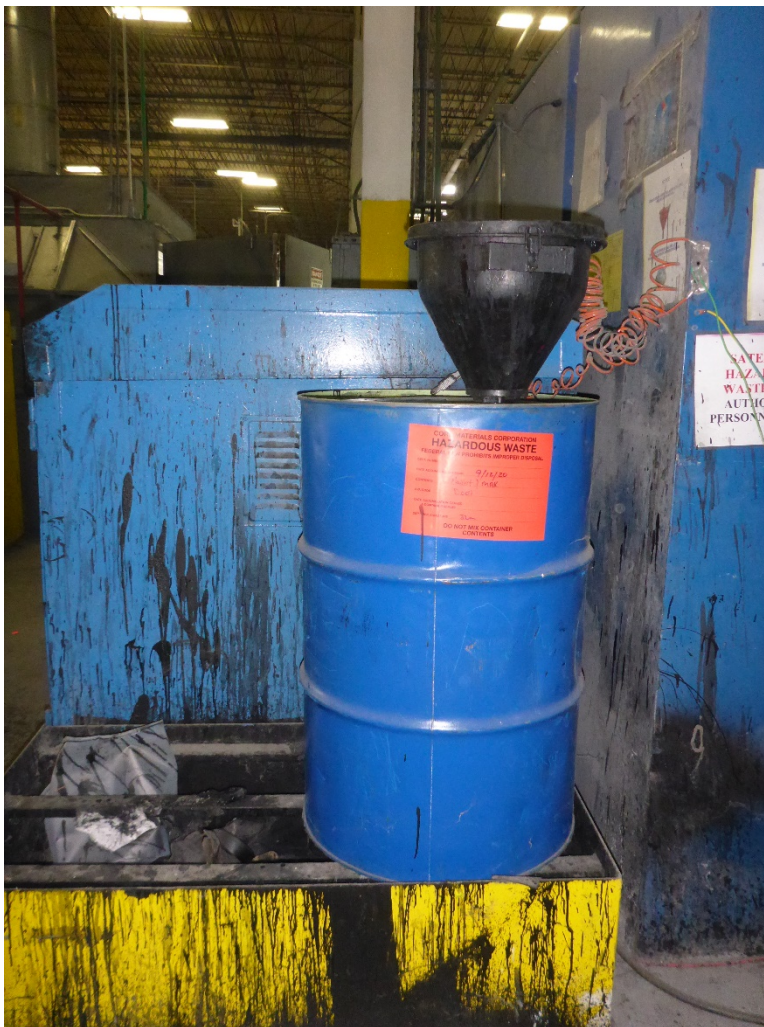
Paint Booth Satellite Accumulation Area (SAA): Paint is applied to certain Core molded parts in a paint booth near the assembly area. Core manages a hazardous waste SAA next to the paint booth for accumulating D001 hazardous waste paint solvent and MAK (Photo 1), which is generated during paint gun cleaning activities. The inspectors observed one 55-gallon drum in this SAA. The drum was closed with a latched funnel lid, and it was located on a portable secondary containment pallet. The drum labeled as D001 hazardous waste paint MAK from

**Photo 1:** One 55-gallon drum located in the SAA next to the paint booth for accumulating D001 hazardous waste paint solvent and MAK. This drum was not marked with an indication of the hazards of its contents.

On September 17, 2020, Ms. Belue sent an email to the inspectors which included an attached photograph documenting that a flammable liquid hazard placard had been affixed to the 55-gallon drum.

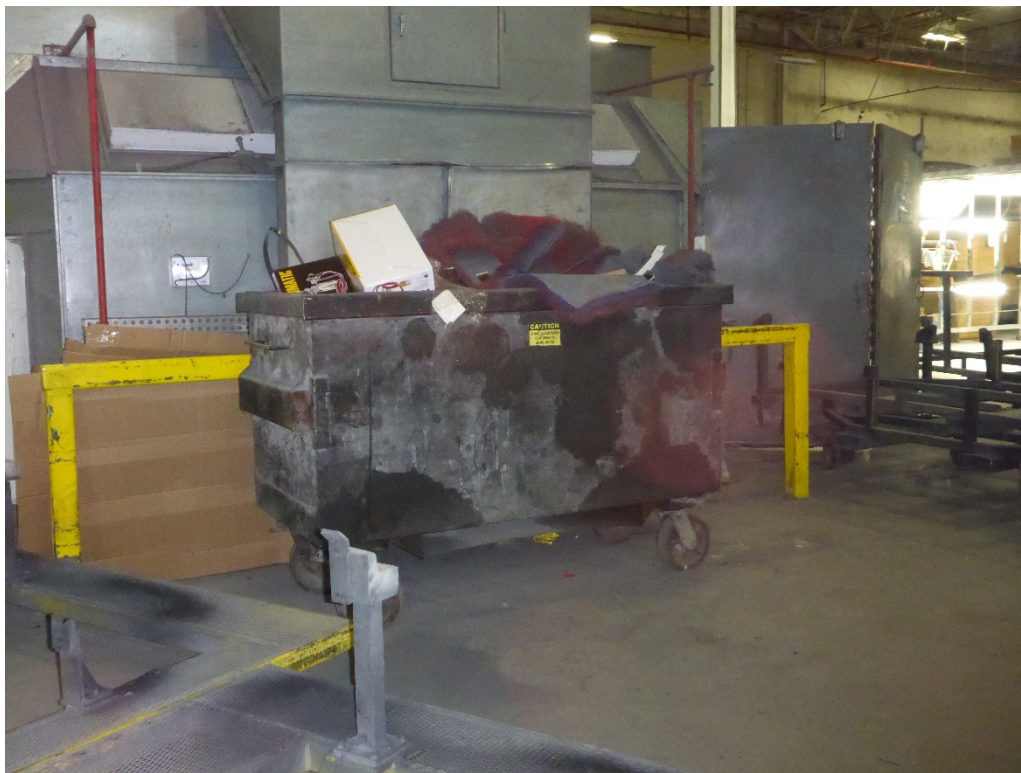
The inspectors also observed an open bin where used paint booth filters had been accumulated for disposal (Photo 3). Employees stated that the paint booth filters are changed out approximately once each month. On September 17, 2020, Ms. Belue sent an email to the

inspectors which included TCLP test results from samples of the paint booth filters taken on April 17, 2019 and April 23, 2019. The April 17, 2019 sample was analyzed for TCLP volatile organics, and the April 23, 2019 sample was analyzed for TCLP semi-volatile organics and TCLP metals. The analytical results indicated that the used paint booth filters do not exhibit the characteristic of toxicity due to the concentration of volatiles, semi-volatiles or metals. The used filters are sent to Republic Services for disposal in the municipal solid waste landfill.

**Photo 3:** Open bin accumulating used paint booth filters.

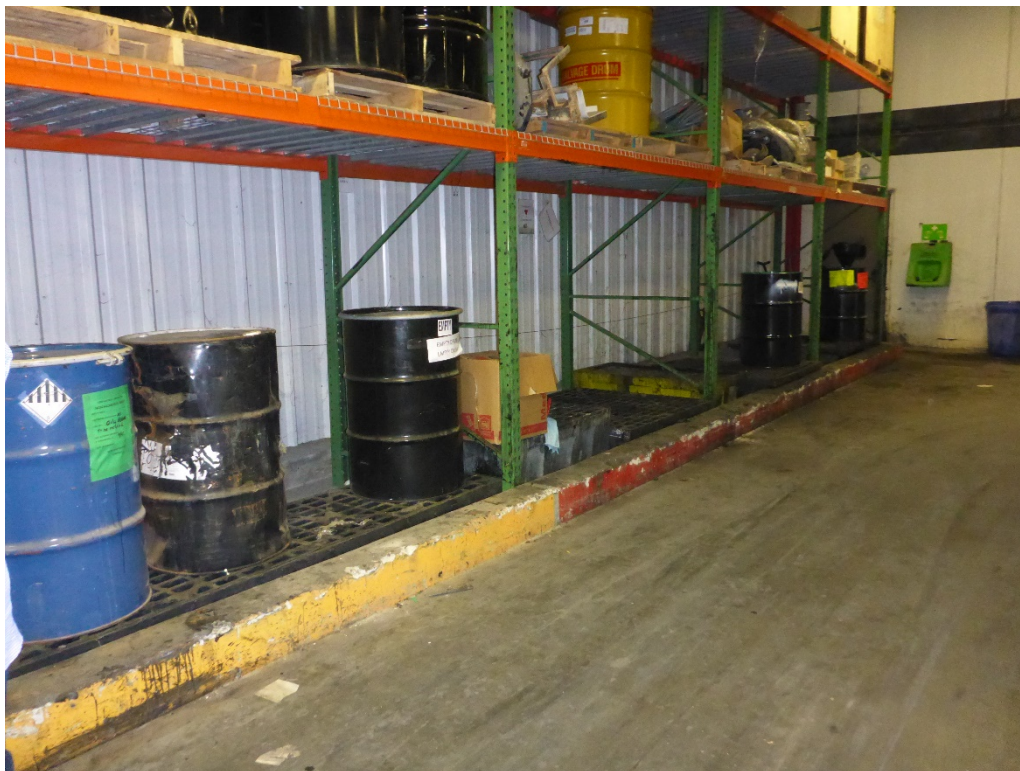
Central Accumulation Area (CAA): Core manages a hazardous waste CAA in a covered area just outside of, and adjacent to the manufacturing building (Photo 4). This area is equipped with an emergency eye wash station, a fire extinguisher, spill control equipment, and an overpack drum. Ms. Belue stated that employees carry hand-held radios for emergency communication in the CAA.

**Photo 4:** Part of the CAA located in the covered area just outside of and adjacent to the manufacturing building.

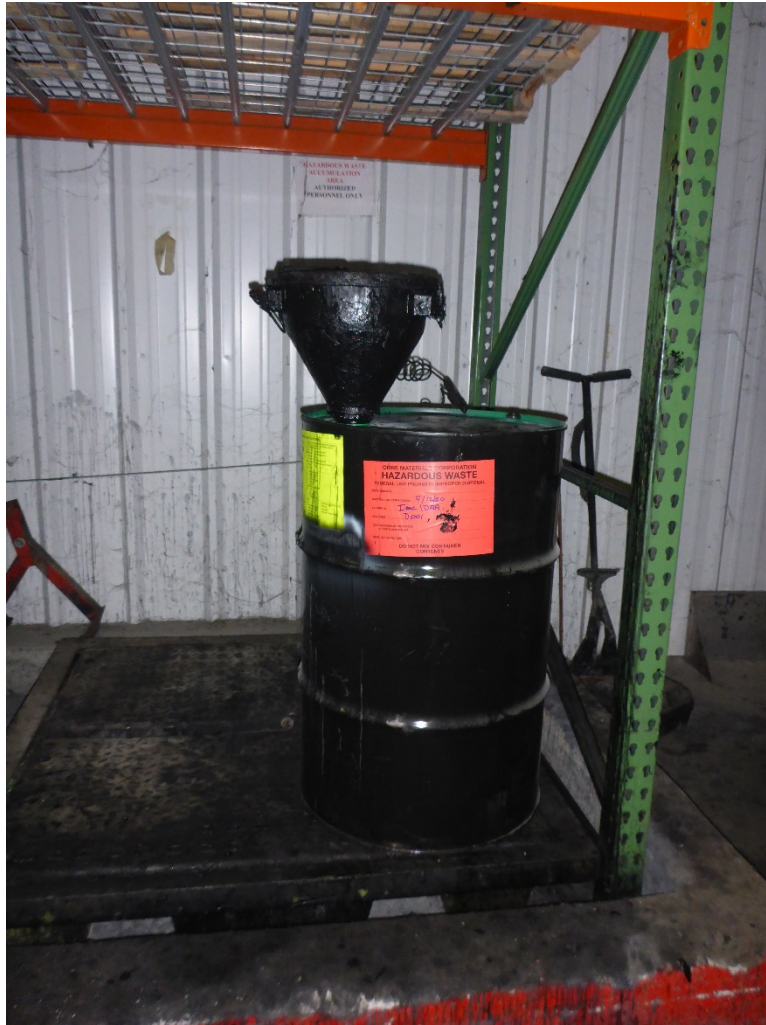
The inspectors observed one 55-gallon drum labeled D001 hazardous waste IMC / DAA on the bottom shelf along the wall in this area (Photo 5). Employees explained that IMC is used to clean the molds in the press room, and used IMC is flushed from the lines and accumulated in a 5-gallon bucket at the press line. The buckets are immediately brought to this area, and the contents are poured into the 55-gallon drum. The drum was located on a portable secondary containment pallet and it was closed with a latched funnel in the lid. The drum marked with an accumulation start date of September 12, 2020, but it was not marked with an indication of the hazards of its contents. The inspectors observed accumulated liquids and material inside the secondary containment pallets.

**Photo 5:** 55-gallon hazardous waste storage drum accumulating and storing hazardous waste IMC / DAA generated at the press lines. Drum observed in the CAA located in the covered area just outside of and adjacent to the manufacturing building. Drum was not marked with an indication of the hazards of its contents.

On September 17, 2020, Ms. Belue sent an email to the inspectors which included a photograph documenting that a flammable liquid hazard placard had been affixed to the 55-gallon drum.

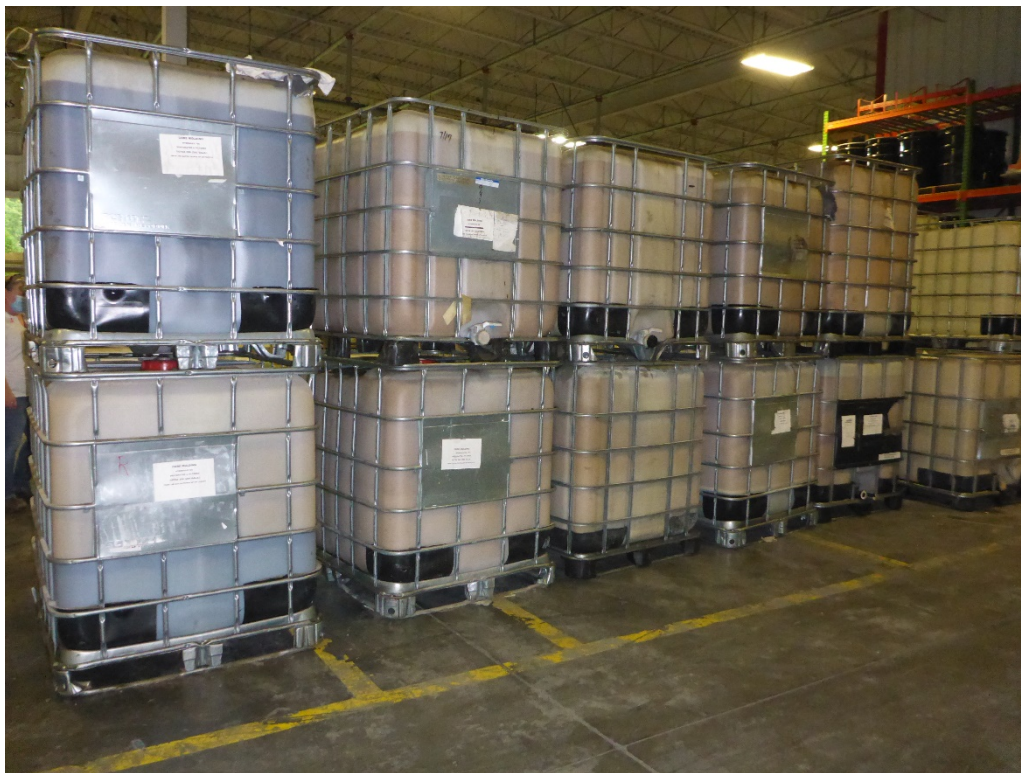
**Photo 6:** Some of approximately fourteen totes of used oil on the floor near the shelving unit in the CAA.

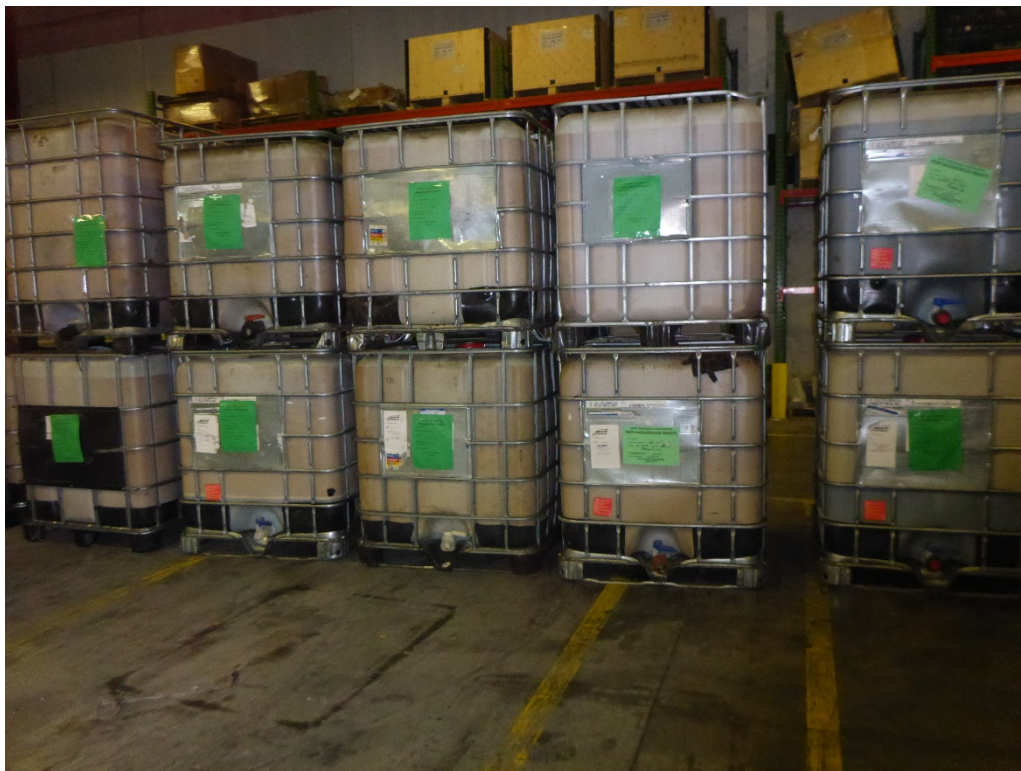
**Photo 7:** Opposite side of totes shown in Photo 6. Each tote labeled as “used oil.”

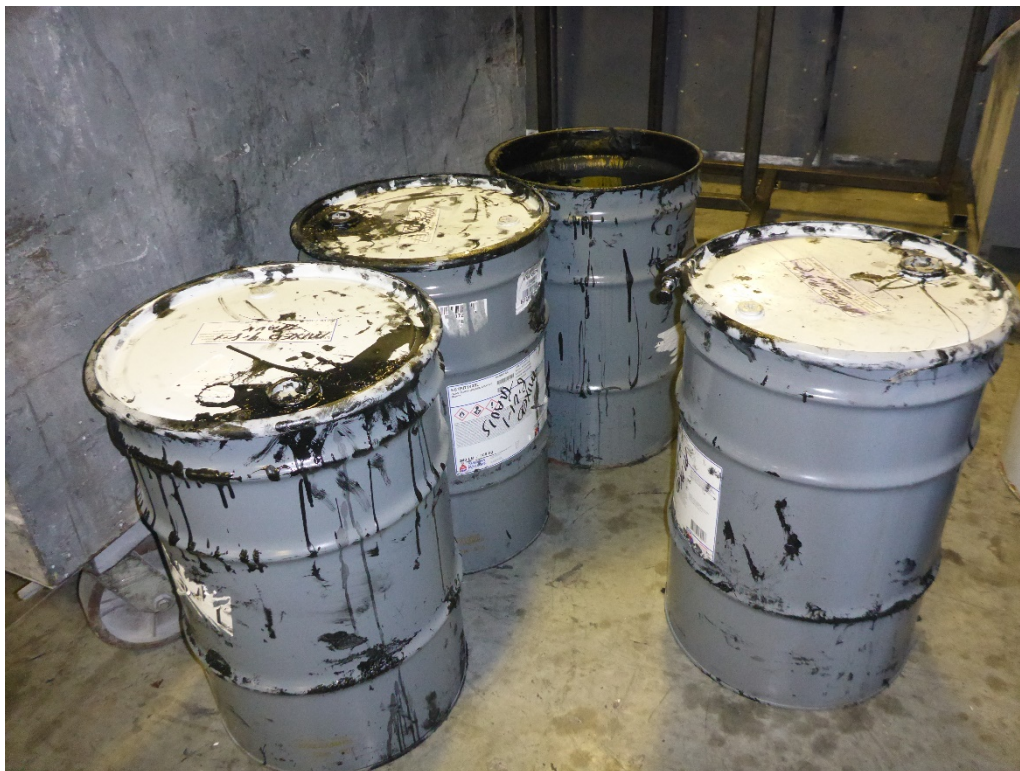
Employees spray a mixture of DAA / IMC onto molds in the press room to prevent the SMC from adhering to the mold. A small batch of this mixture is generated in the SMC room and transported to the press room in a 30-gallon drum. The residual DAA / IMC mixture inside the 30-gallon drums is brought back to the CAA where it is scraped from the inside of the container and accumulated as D001 hazardous waste. Scraped, empty 30-gallon drums are identified with an “empty” label and sent off-site for recycling. In the area near the door to the SMC room, the inspectors observed four 30-gallon drums of the DAA / IMC mixture which were staged for scraping and consolidation (Photo 9). One of the drums, which was approximately 1/3 full, did not have a lid (Photo 10). None of the drums were labeled as hazardous waste, marked with an indication of the hazards of the contents, or marked with an accumulation start date.

**Photo 9:** Four 30-gallon drums of hazardous waste DAA / IMC mixture staged for scraping and consolidation. One drum had no lid. None of the drums were labeled or marked with an indication of the hazards of the contents.

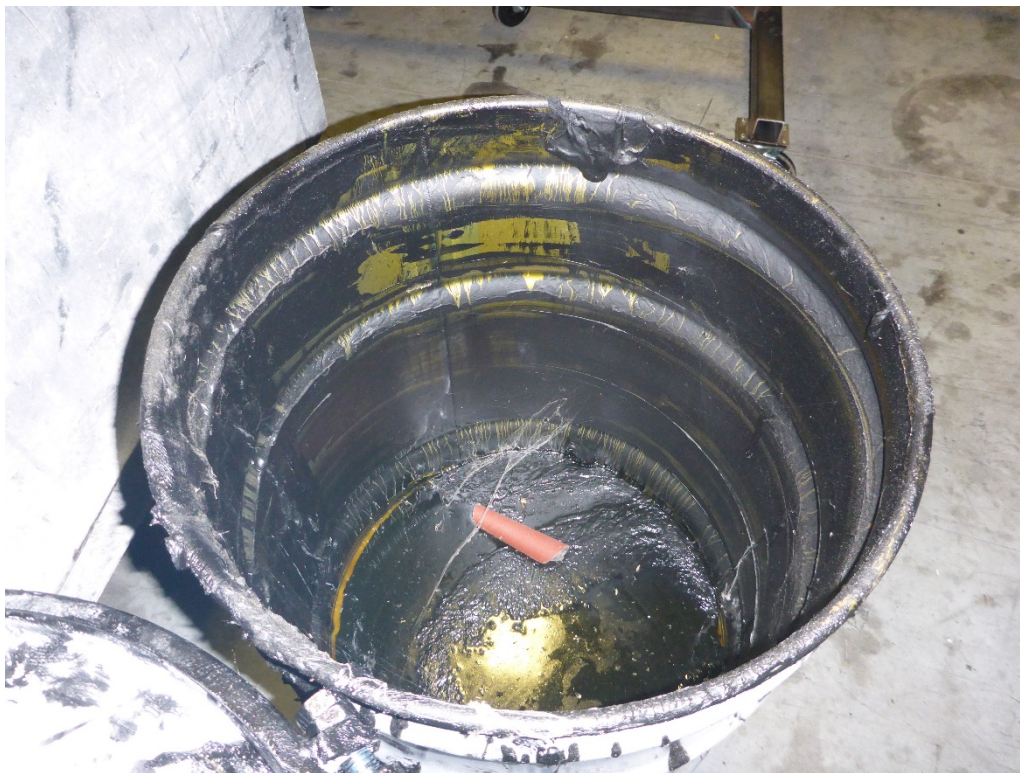
**Photo 10:** One of four 30-gallon drums of hazardous waste DAA / IMC mixture staged for scraping and consolidation. Drum has no lid and is approximately 1/3 full. Drum was not labeled or marked with an indication of the hazards of the contents.
