**Region 6 - Enforcement & Compliance Assurance Division**  
**INSPECTION REPORT**

| Company Name: | <b>Nevada Oil, LLC</b> | |
| Facility Name: | <b>Irma Nacatoch (Sand) Unit Tank Battery</b> | |

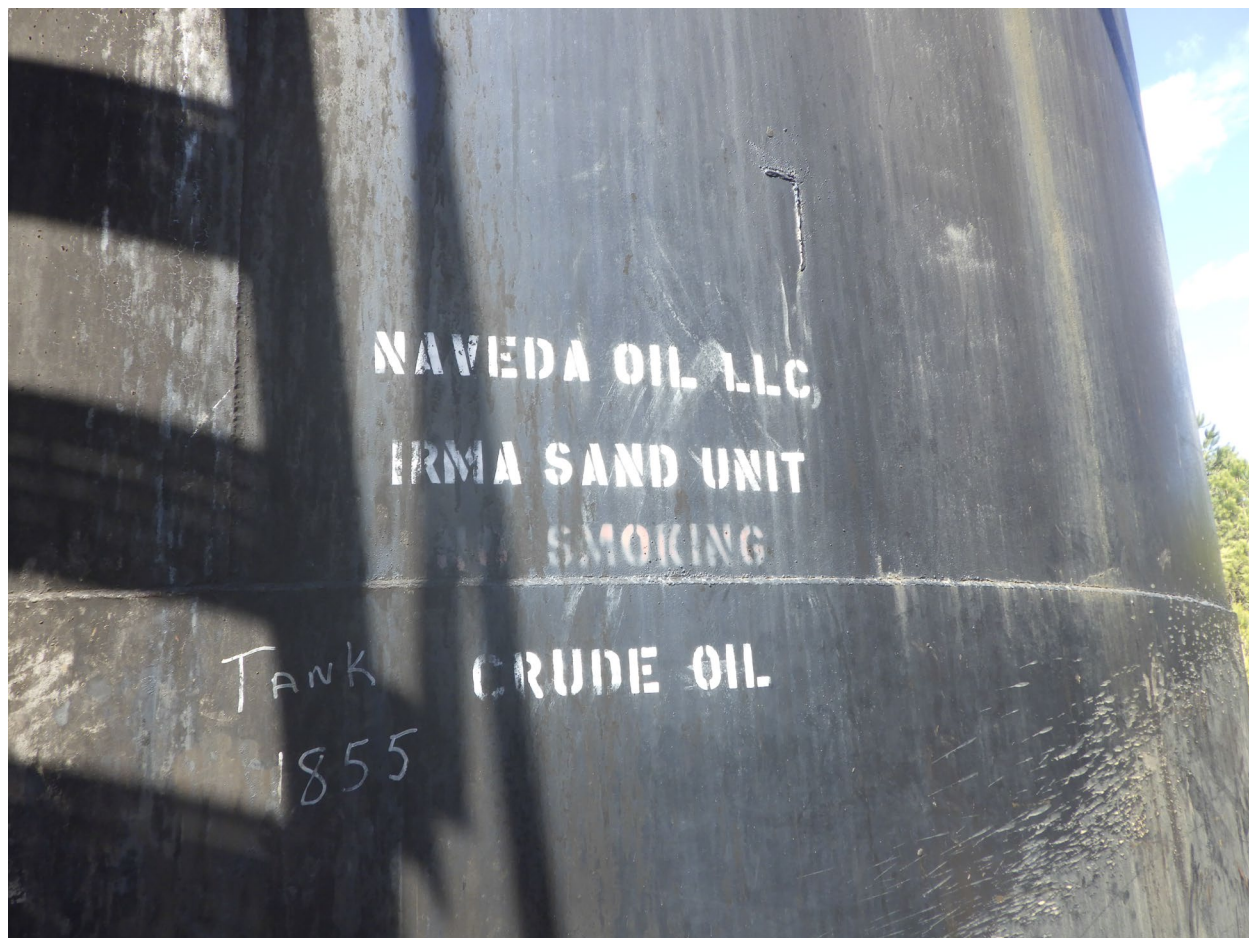
Photo No. 1

**Description:** Looking NE, this photo shows identification for the Irma Nacatoch (Sand) Unit Tank Battery ("facility").

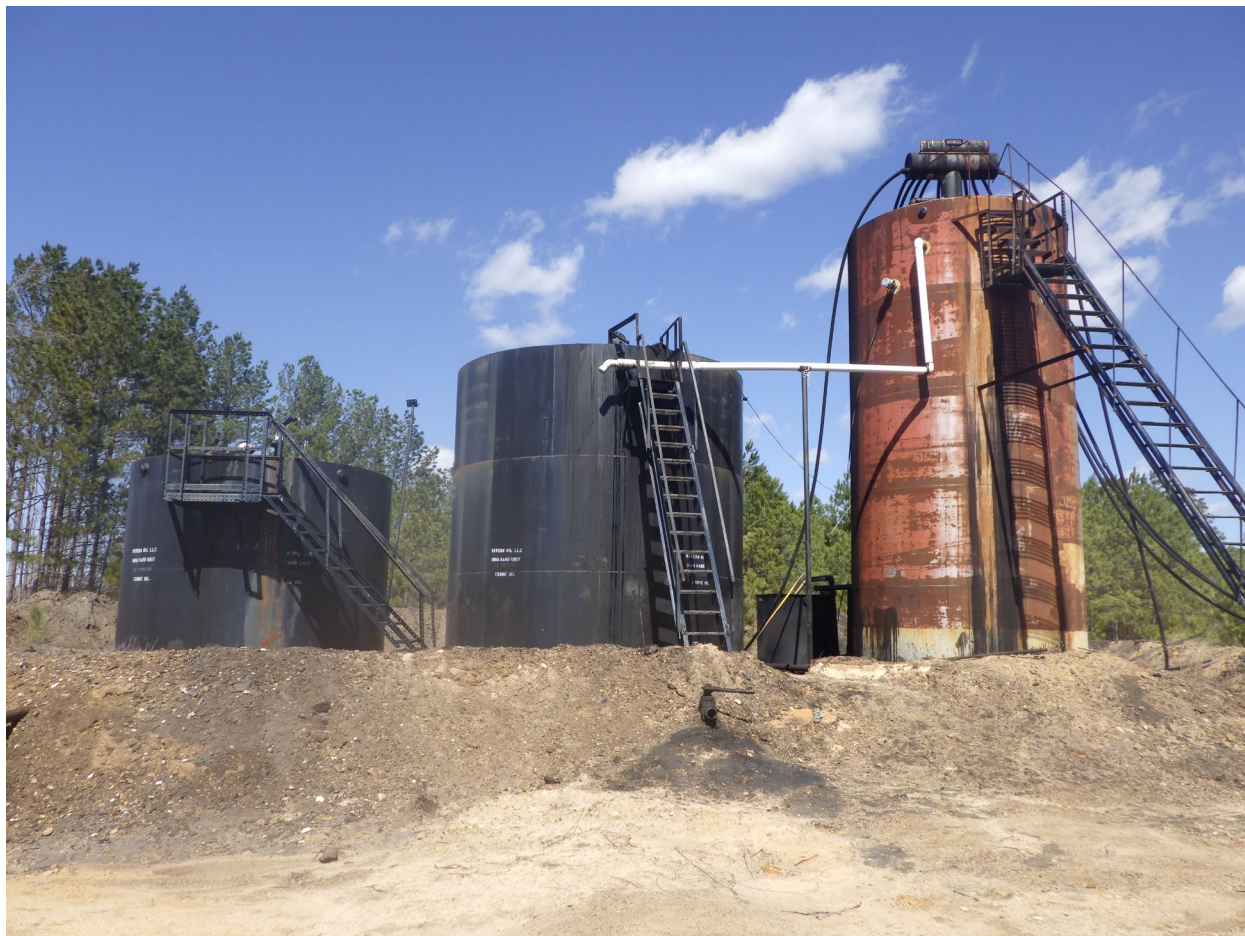
Photo No. 2

I observed product transfer lines without catchment buckets outside secondary containment, see Photos No. 2 and No. 3.

**Description:** Looking ENE, this photo shows an overview of the facility.

Inspector will conduct follow-up phone calls with the company representative(s) over the coming weeks and months to ensure areas of concern are properly addressed.

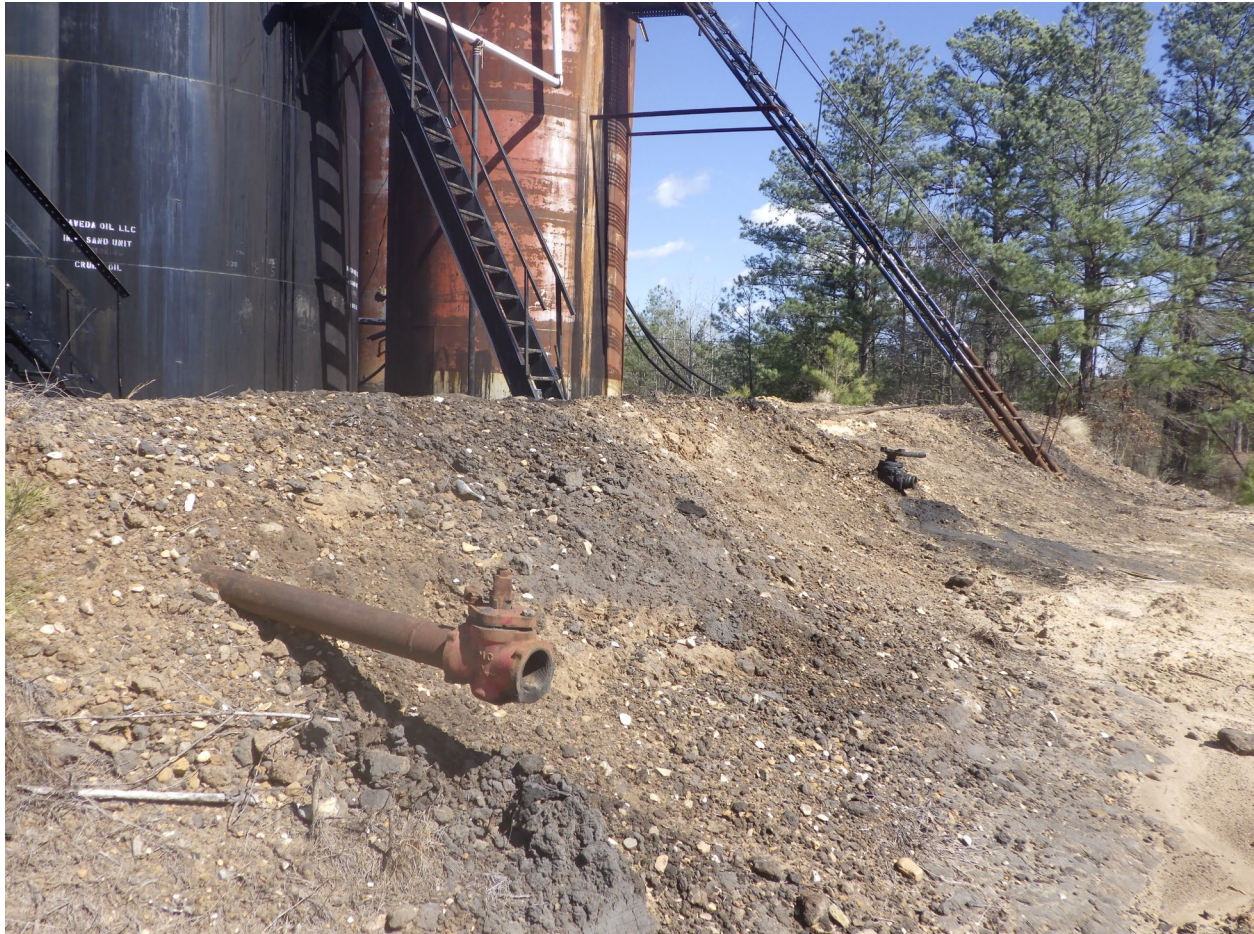
Photo No. 3

**Description:** Looking E, this photo shows a front view of the outside of the secondary containment with transfer lines through the berm.

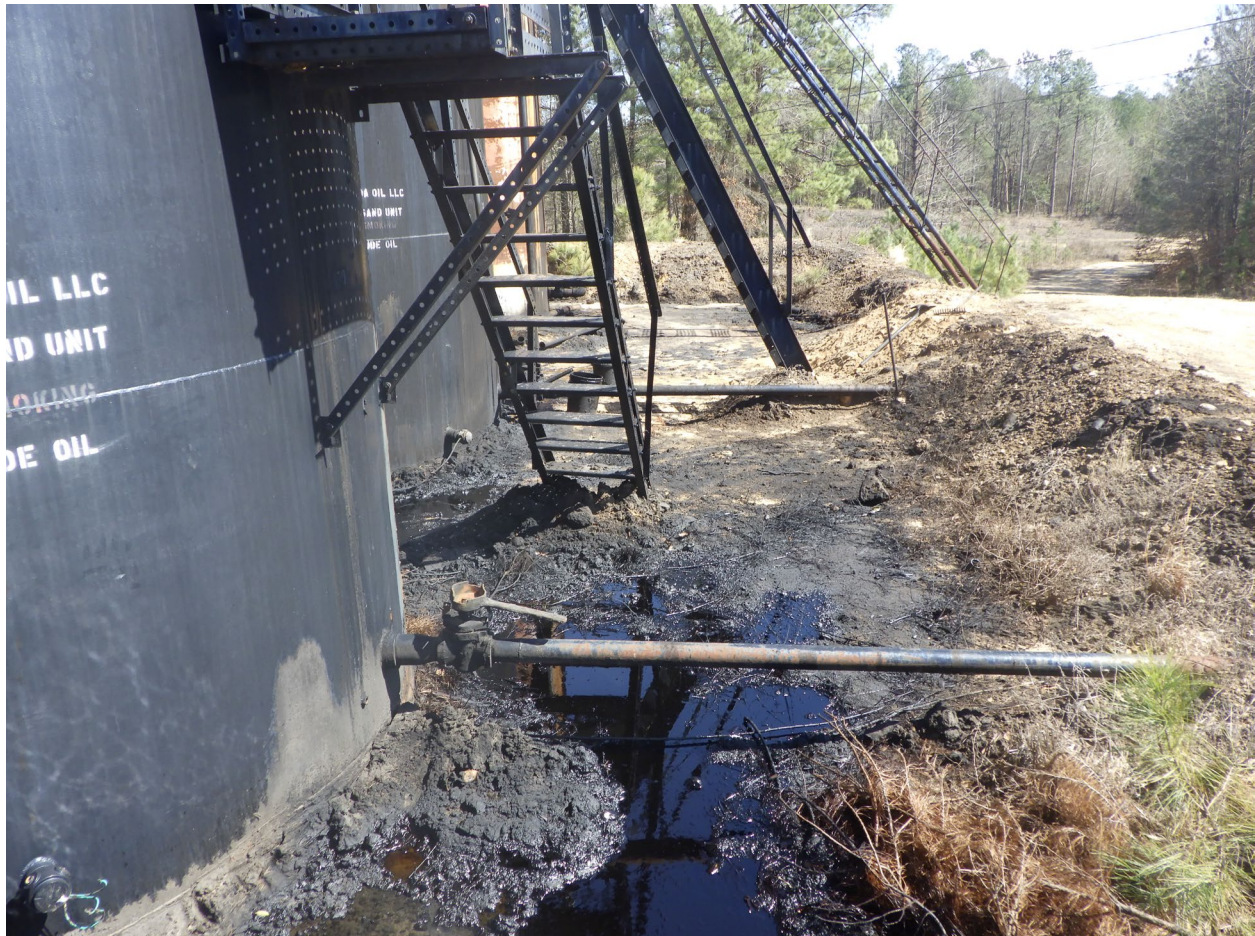
Photo No. 4

I observed loose crude oil and saltwater inside secondary containment, see Photos No. 4 through No. 7 and Photo No. 11.

**Description:** Looking E, this photo shows a front view of the inside of the secondary containment with loose crude oil present.

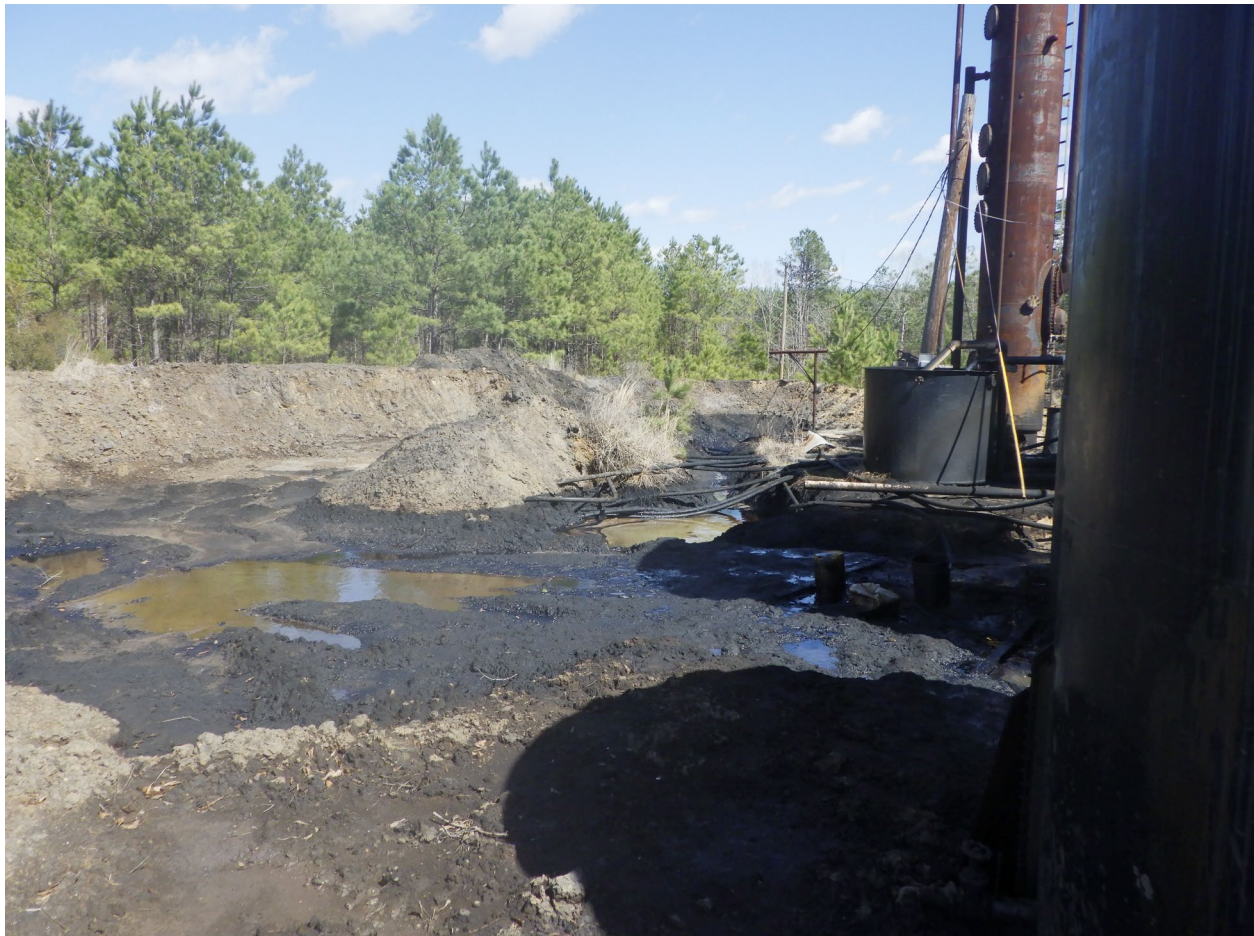
Photo No. 5

I observed an open-top tank used to skim or separate crude oil from saltwater, see Photos No. 5 and No. 6 and Photos No. 8 and No. 9.

**Description:** Looking ENE, this photo shows a sideview of the inside of the secondary containment with loose crude oil and saltwater present.

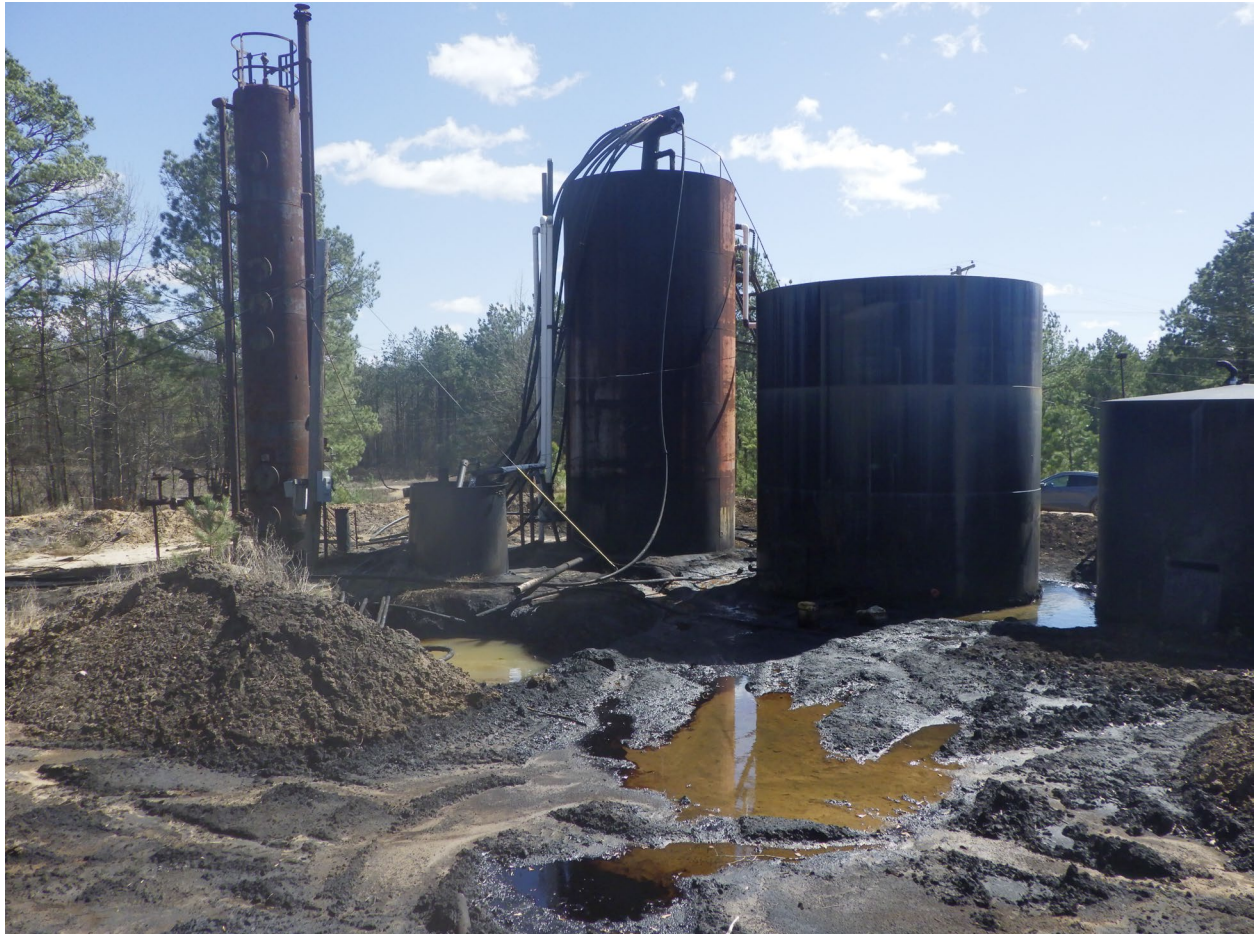
Photo No. 6

**Description:** Looking SE, this photo shows a view of the backside of the inside of the secondary containment with loose crude oil and saltwater present.

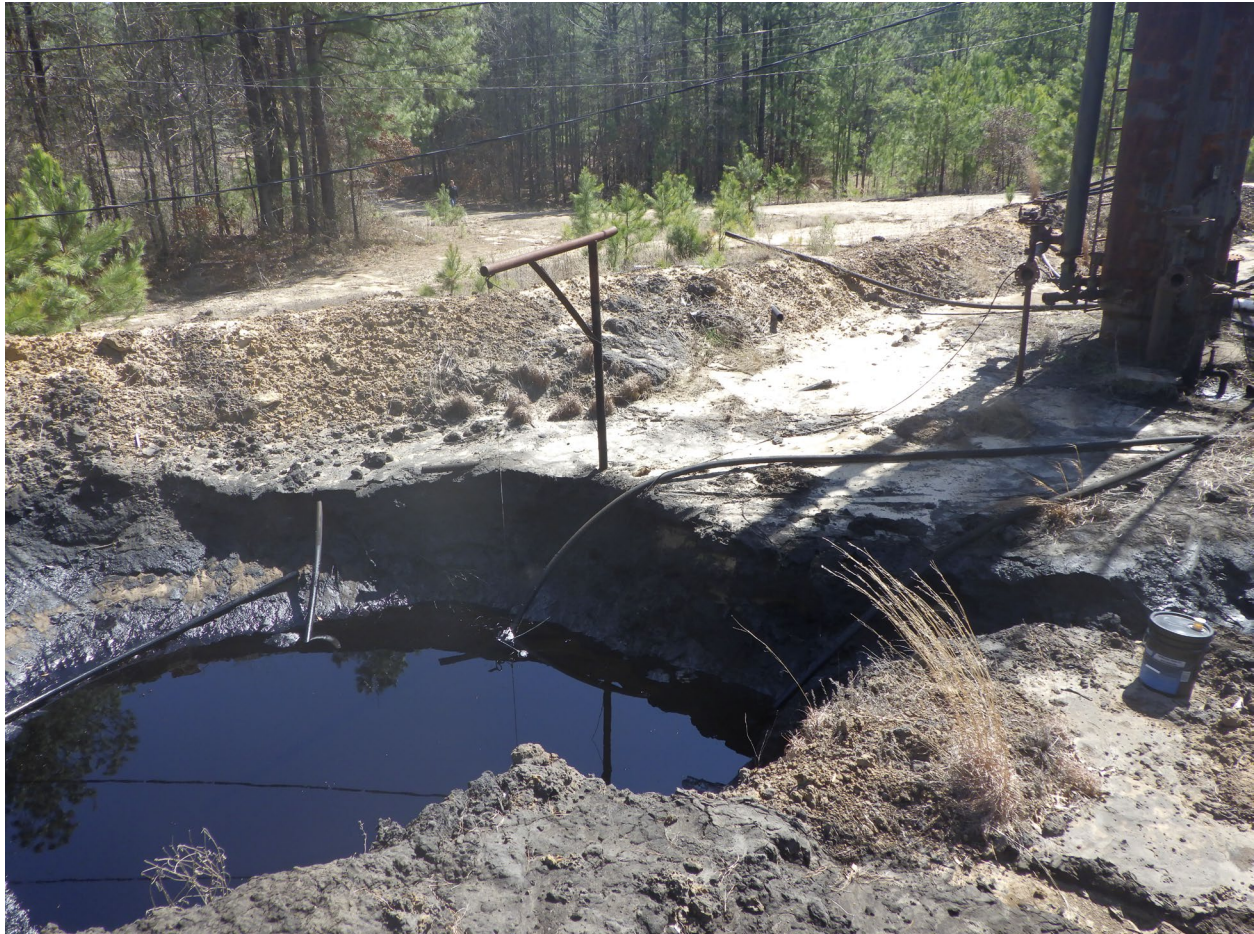
Photo No. 7

I observed pits and a drainage channel excavated inside secondary containment, see Photos No. 7 and No. 8.

**Description:** Looking ESE, this photo shows a pit or sump area excavated inside the secondary containment holding crude oil.

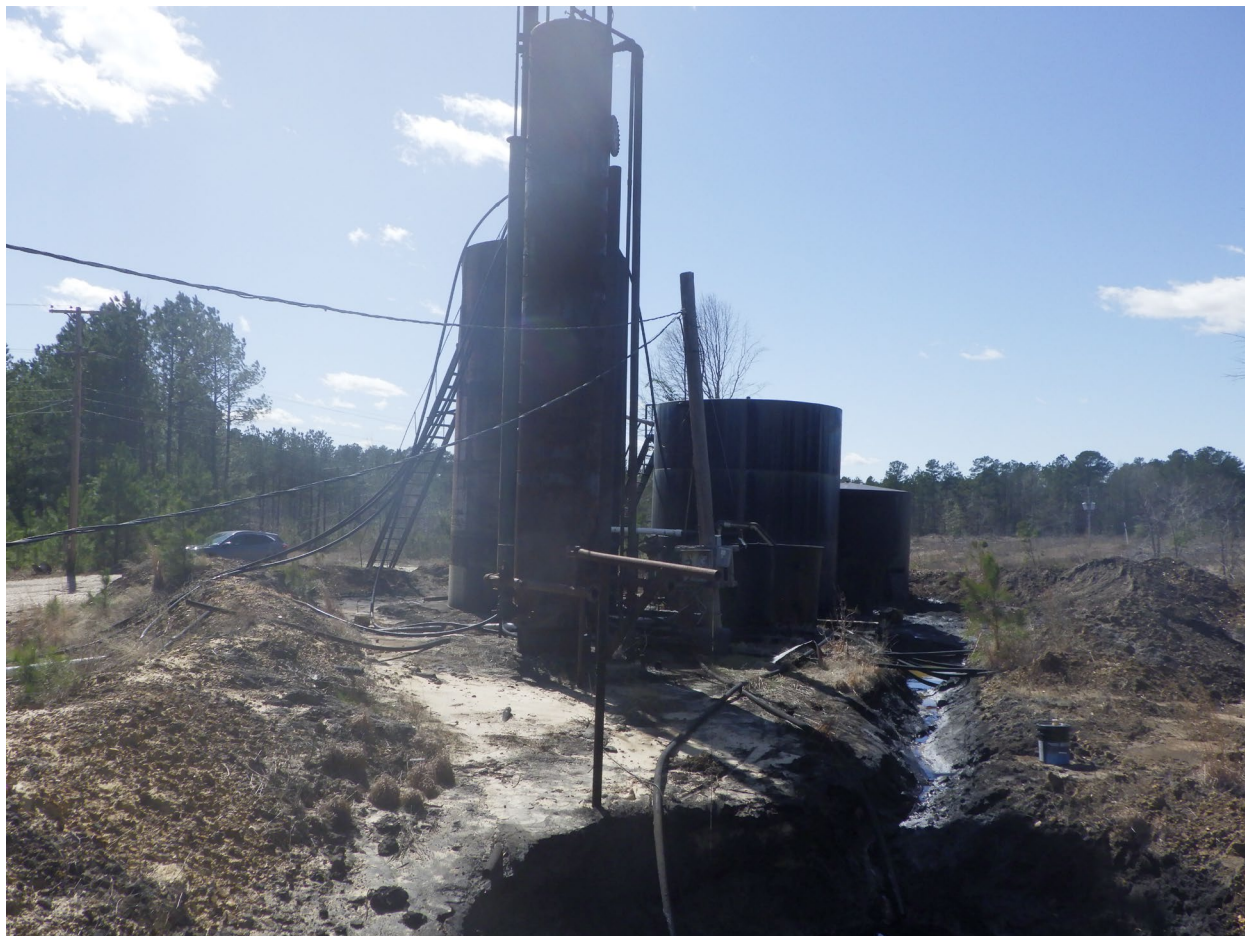
Photo No. 8

**Description:** Looking S, this photo shows an excavated drainage for the pit or sump area inside the secondary containment.

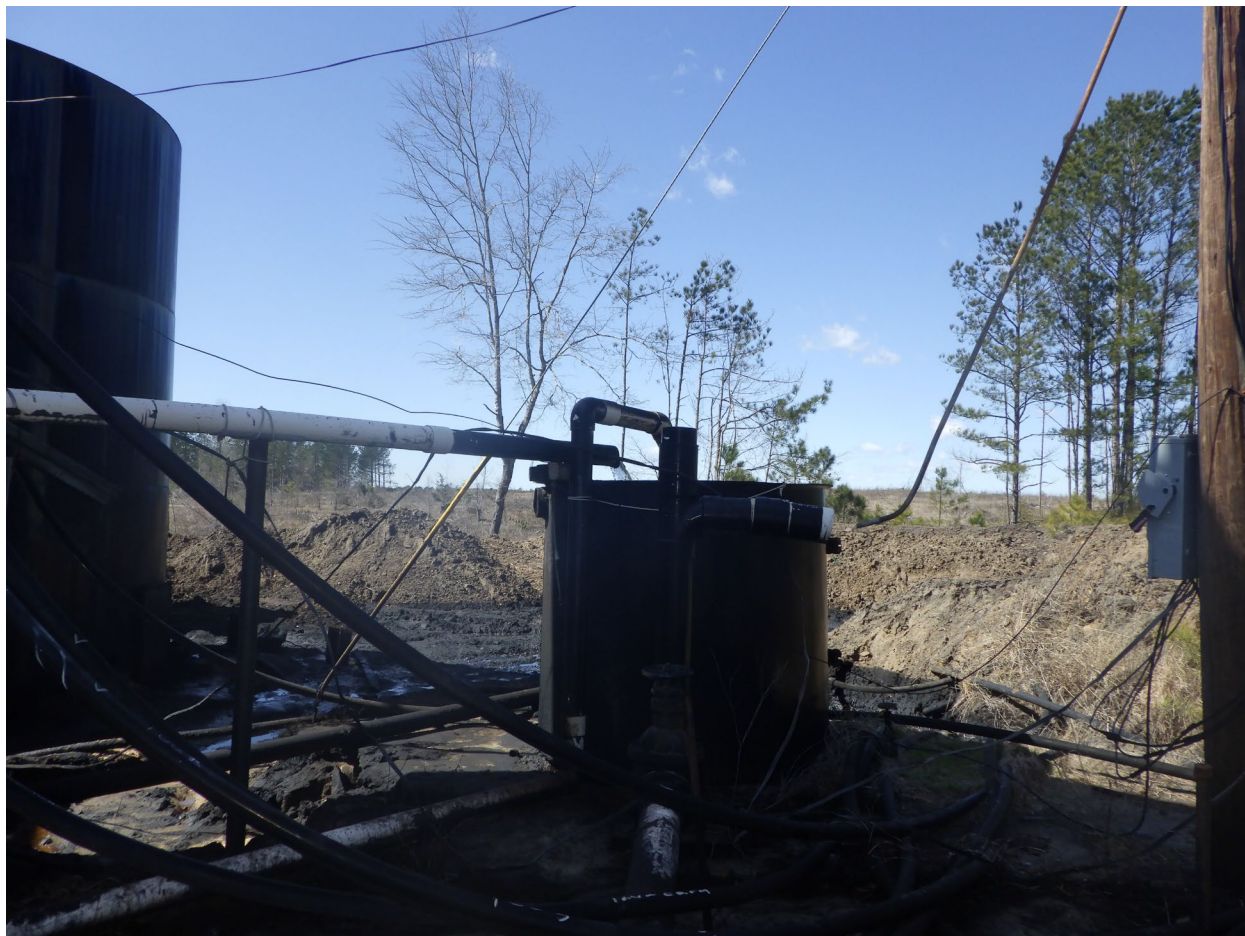
Photo No. 9

I observed PVC piping connected to the open-top tank passing through the berm of the secondary containment directed towards the offsite saltwater disposal (SWD) injection well, see Photos No. 9 and No. 10.

**Description:** Looking ENE, this photo shows an open-top tank used as skimmer inside secondary containment. The white PVC piping is directed towards the Irma Nacatoch Unit saltwater disposal (SWD) inject well or an Enhanced Oil Recovery (EOR) well.

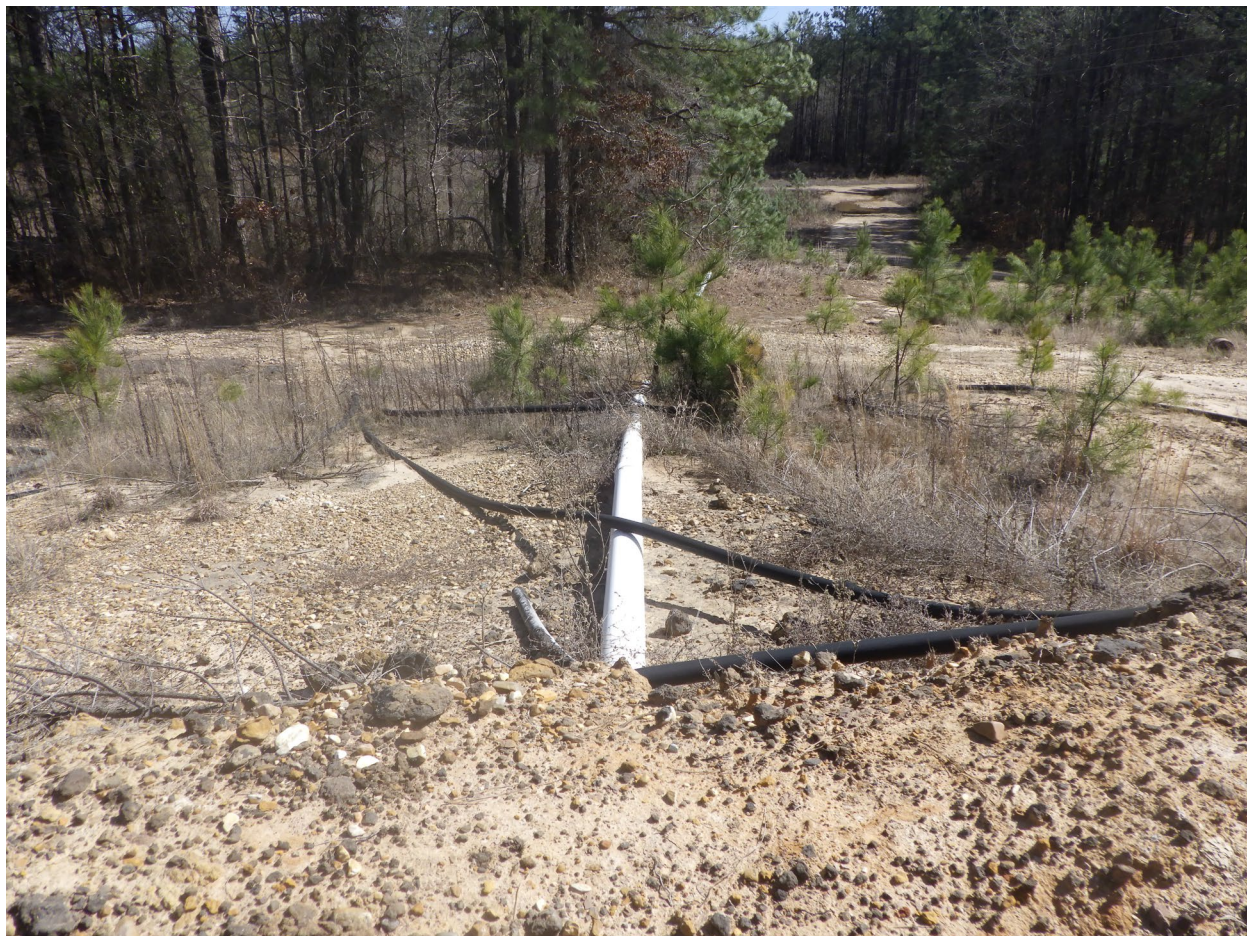
Photo No. 10

**Description:** Looking E, this photo shows the white PVC piping from Photo No. 9 directed towards the Irma Nacatoch Unit SWD/EOR well downgradient.

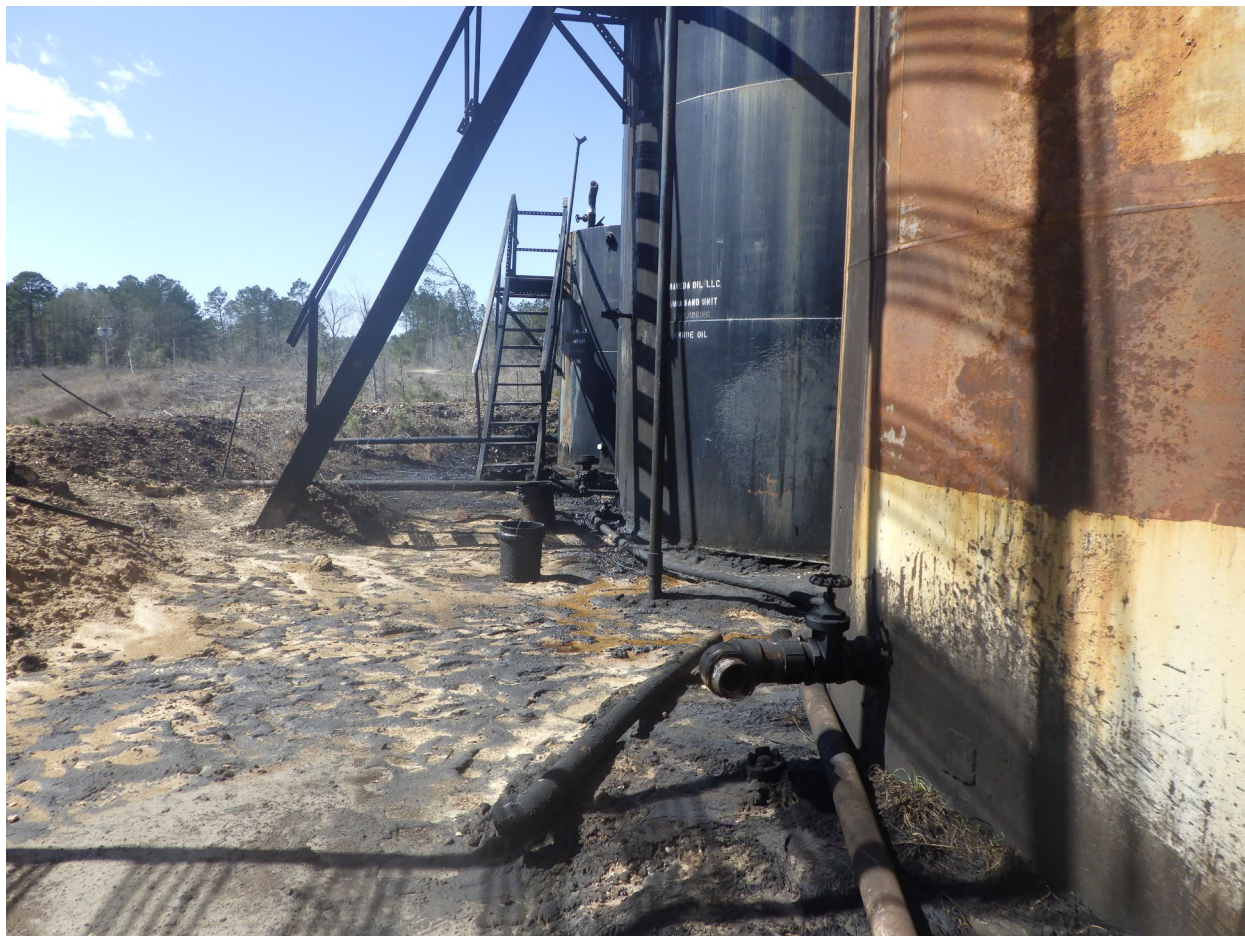
Photo No. 11

**Description:** Looking NW, this photo shows a front view of the inside of the secondary containment with loose crude oil and saltwater present.
