**Battelle Field Sampling Procedures Review  
Columbus Georgia City Survey  
regarding  
Empirical Human Exposure Assessment  
Multi-City Study**

**August 3, 1999**

### Review Objective

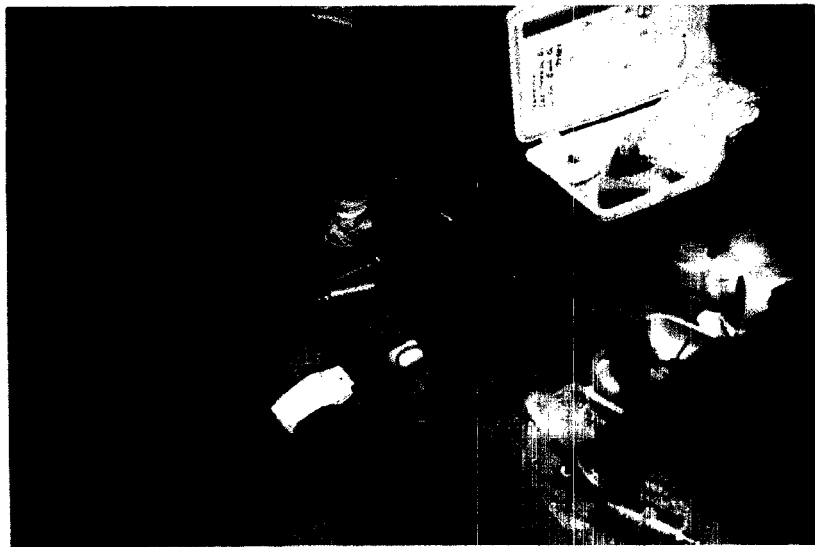
**Urban Air Sampler  
Day 1, Set-Up**

After traveling to Columbus and meeting Chief Schmidt, the Ambient Urban Air Sampler was set up. The sampler was set up on the ground near a wash area behind Fire Station #1 located at 201 10<sup>th</sup> Street. See the scanned images of the sampling location in the photograph section. Initially there was trouble getting the unit to operate; improper power connection. No timer switch was shipped with the sampler therefore one had to be purchased. After a switch was purchased they went ahead with the set-up. According to the QAPP, the sampler was set up at 15:00 hours ● three hours (start time 16:20 hours), an initial totalizer reading was recorded, and the sampler was set to run 12 hours. The coordinates of the sampler location were recorded based on a hand held Global Positioning System (GPS).

Several specific sampling set-up requirements were not followed (section 11.3 in TO-13). The sampler was not set-up at least 2 meters from any obstacle (11.3.2). The sampler was placed approximately one foot away from a wall which could cause a flow obstruction. The sampler was not equipped with an exhaust hose to prevent recycling of air into the sample head (11.3.2). A single point flow check was not performed as described in section 11.2.3 of TO-13. Flow rates were varied from 55, 50, 40, 30, and 20 inches of water using the voltage variator during set-up which is incorrect. It appeared that the five point flow variator adjustments were somehow thought to be the calibration procedure described in section 11.2 of TO-13. A thorough review of TO-13 and TO-13A are recommended prior to conducting any further ambient air testing relative to this study.

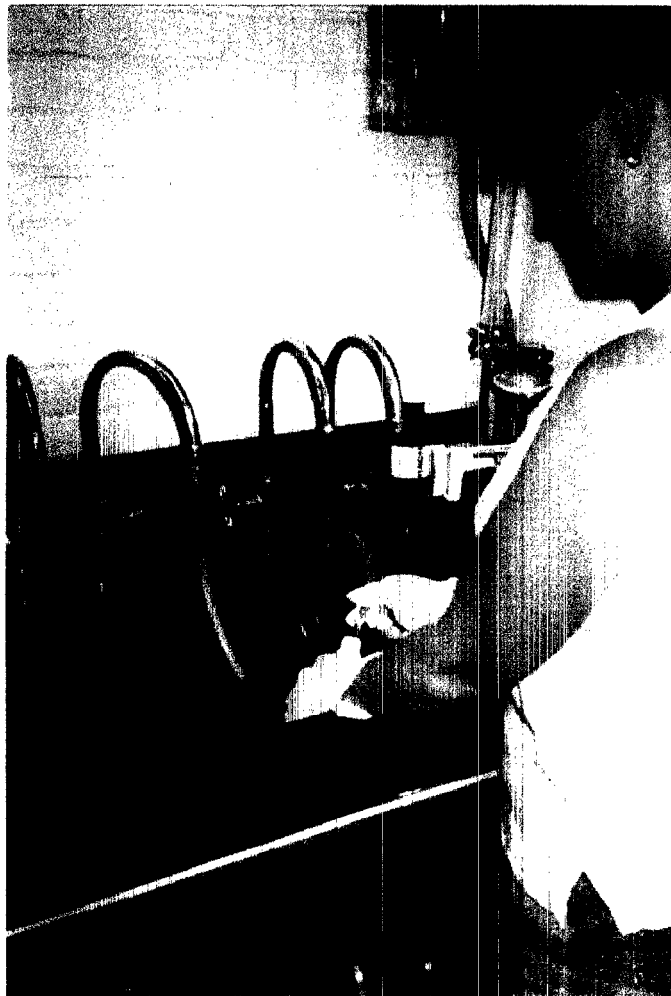
**Water Treatment Plant Outlet Day 2 Event # 3**

**Event # 3 - Water Treatment Plant Outlet:** A tap water sample was collected at 09:42 hours from the final treated water. According to the QAPP; replicate samples of the final treated water were collected in pre-cleaned one liter polyethylene bottles, labeled, and sampling information recorded on data sheets. The coordinates of the sampling location were recorded based on a hand held GPS. See the scanned images of the sampling location in the photograph section.

**Reviewer Comments:** Field data documentation was thorough, and personnel wore disposable gloves while handling the samples. There was a short piece of flexible tubing attached to the faucet where the samples were collected. Water runs continually into the sink located in the test lab from several different treatment steps. There is concern about possible residual accumulation of FC's onto the surface of the flexible tubing. Some discussions regarding this concern are warranted. For future reference, it may be advisable to remove any such tubing before sampling.

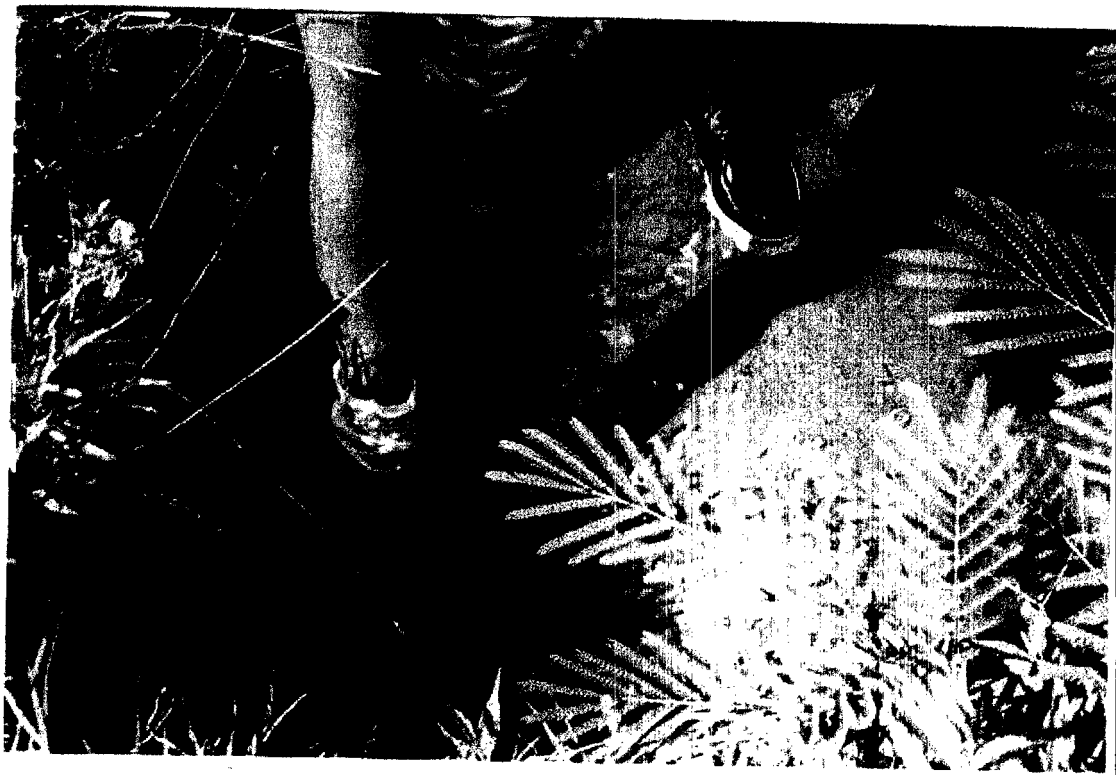
**Drinking Water Source Day 2 Event # 9 and # 10**  
**Oliver Lake, Chattahoochee River**

**Event # 9 and # 10 – Oliver Lake Surface Water:** Surface water and sediment samples were collected at 11:15 and 11:20 hours respectively from a bay area near Roaring Branch River north of the Municipal Marina. Sediment samples were collected near the water/shore boundary using a pre-cleaned stainless steel spoon. According to the QAPP; replicate samples of the surface water and sediment were collected in pre-cleaned polyethylene bottles, labeled, and sampling information recorded on data sheets. The coordinates of the sampling location were recorded based on a hand held GPS. See the scanned images of the sampling location in the photograph section.

**Reviewer Comments:** Field data documentation was thorough, and personnel wore disposable gloves while handling the samples. The water source is Oliver Lake that has formed behind Oliver Dam located on the Chattahoochee River. The surface water and sediment samples were collected by wading into the shallows near shore. The water samples were collected while remaining still so as not to stir sediment from the bottom.

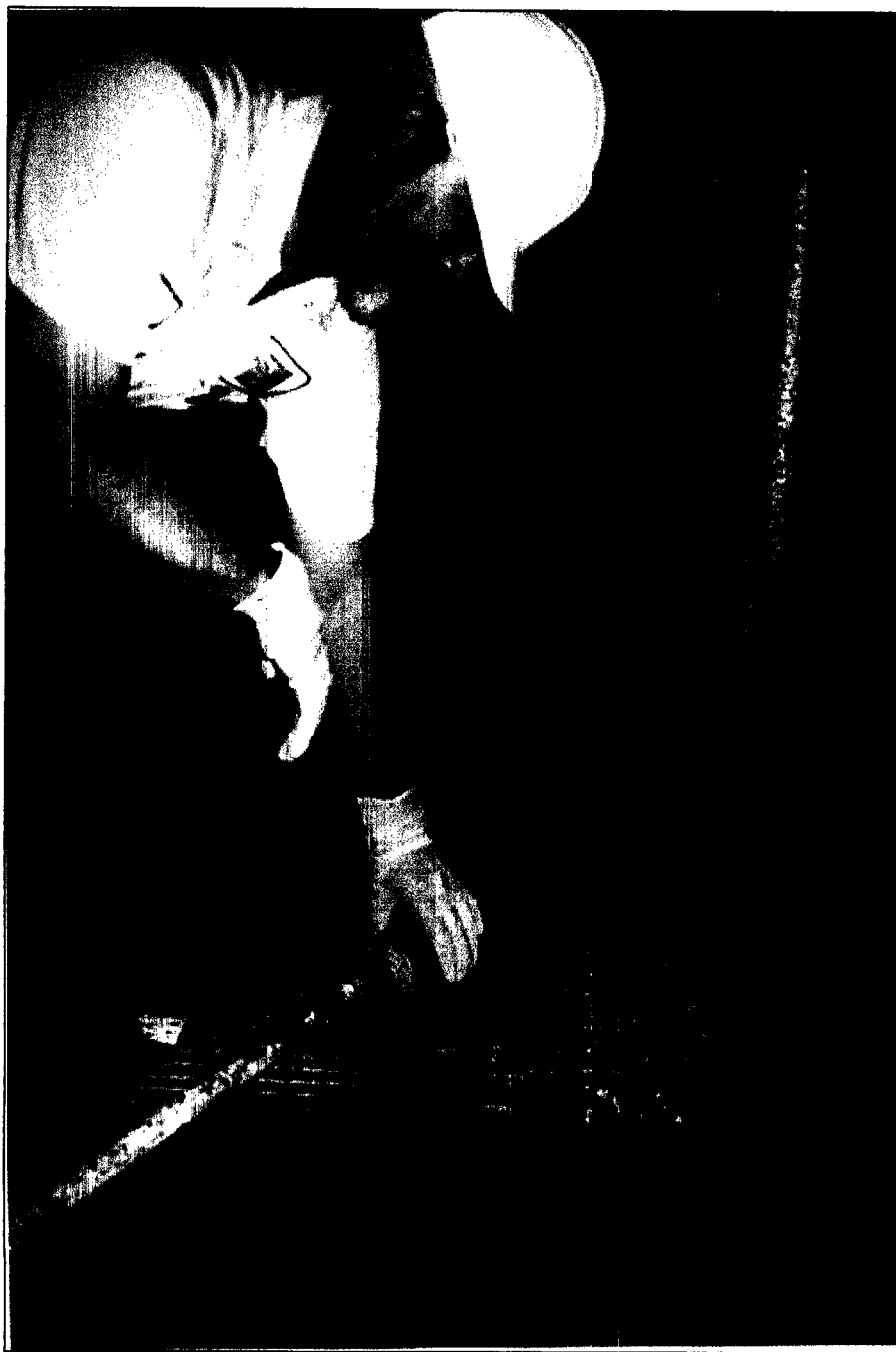
**POTW Final Sludge Day 2 Event # 15**

**Event # 15 – POTW Final Sludge Sample:** A sludge sample was collected by one of the POTW operators at 16:10 hours from the discharge line from the anaerobic digesters. According to the QAPP; replicate samples were collected in pre-cleaned polyethylene bottles, labeled, and sampling information recorded on the data sheets. The coordinates of the sampling location were recorded based on a hand held GPS. See the scanned image of the sampling location in the photograph section.

**Reviewer Comments:** The sludge sample was collected from the main discharge line by one of the operators and given directly to Chris. Field data documentation was thorough, and personnel wore disposable gloves while handling the samples.

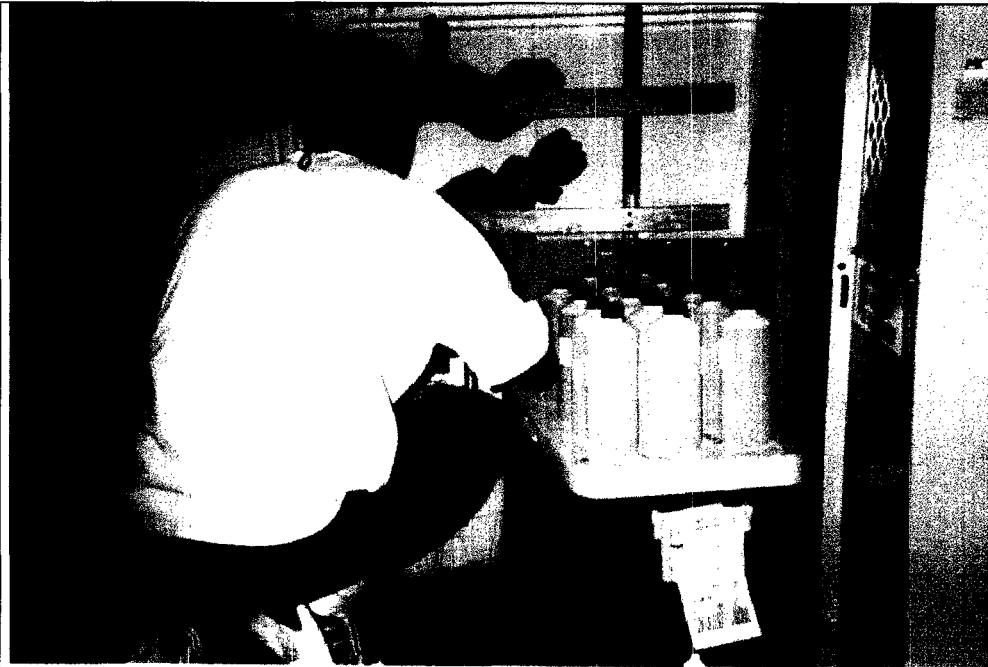
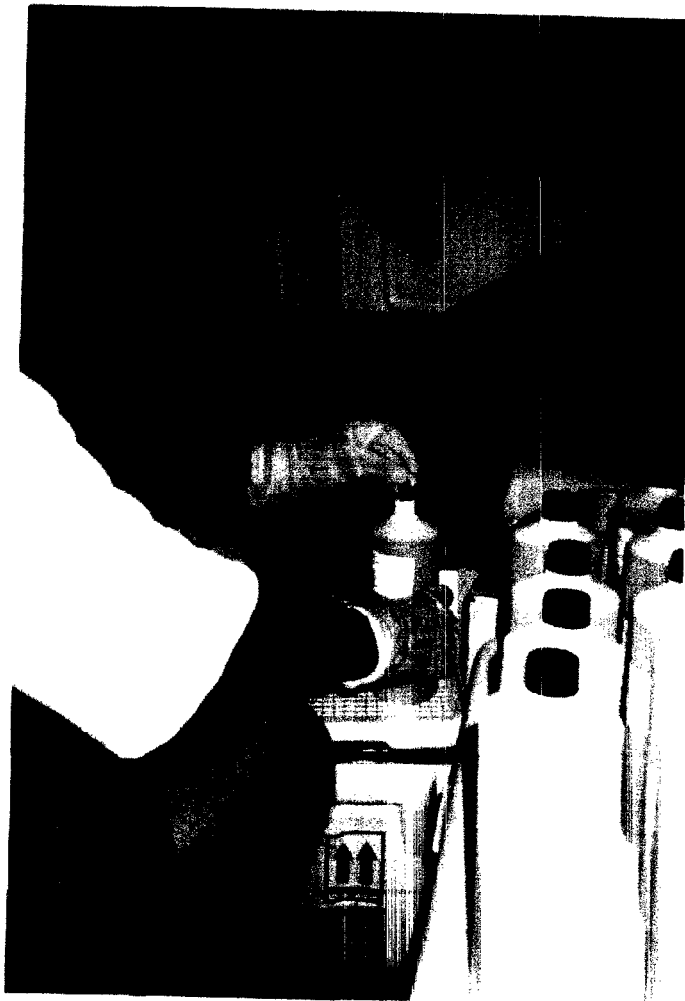
**Field Spiking Day 2 Event # 17**

**Event # 17 – Field Spiking:** A set of samples collected throughout the day were field spiked. Glass ampules containing the analytes of interest were emptied into the sample bottles. After an ampule was emptied, it was dropped into the sample bottle that was spiked.

**Reviewer Comments:** The addition of the empty vial to the sample raises concern. This procedure follows the QAPP but poses a potential contamination source, that being the outside surfaces of the vial. The QAPP specifies the vial be methanol rinsed and wiped dry with a ChemWipe. What are the precautions that the external surfaces are kept from potential contamination? Field data documentation was thorough, and personnel wore disposable gloves while handling the samples.
