INSPECTION REPORT

| Type of Inspection | CEI - Compliance Evaluation Inspection, SSO - Sanitary Sewer Overflow Inspection | | |
| Facility or Site Name | DCDPW - Nordic Park STP | | |
| Permit Number(s) (If Applicable) | IL0028398 | | |

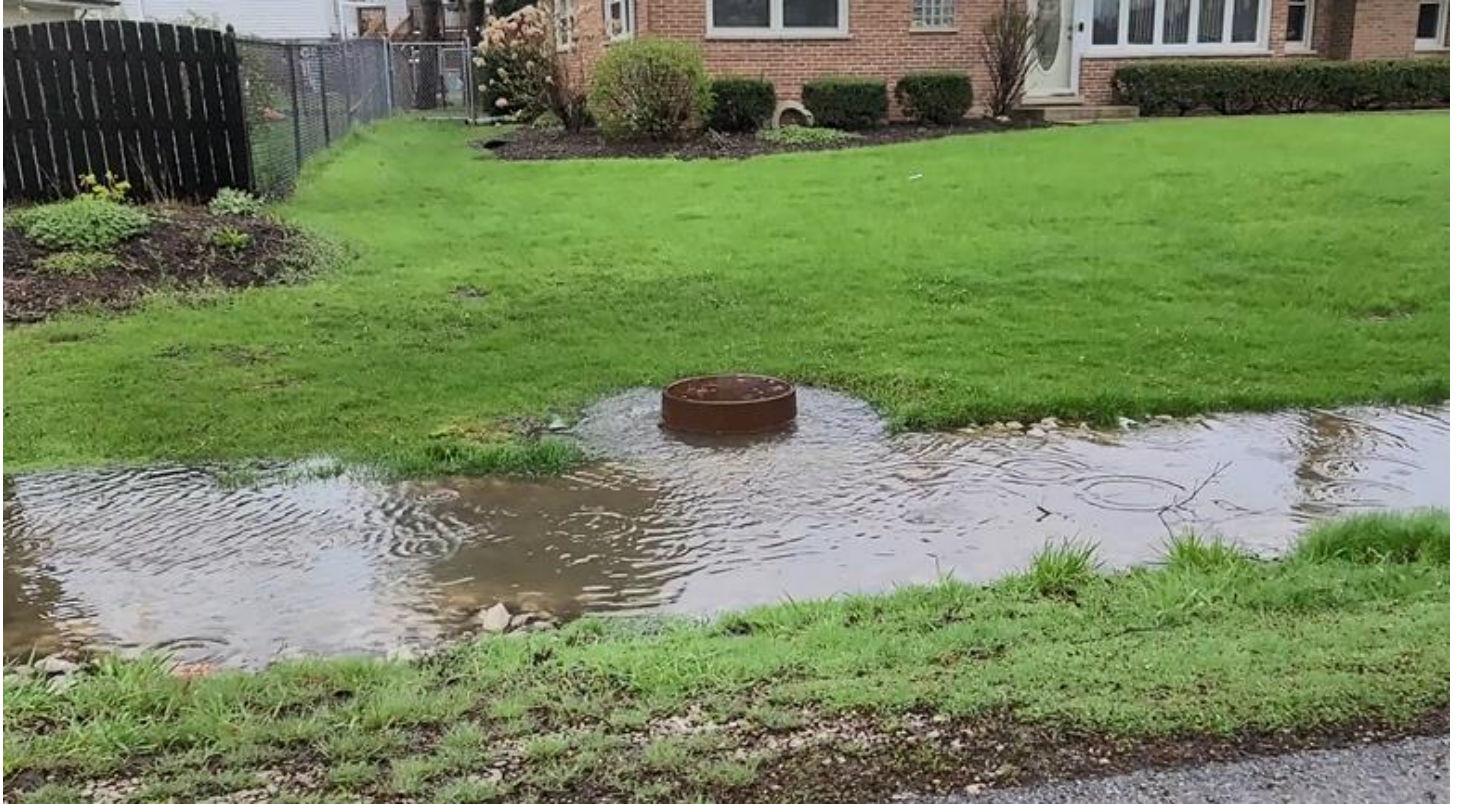
***Image of video file name 20220503\_101405.mp4 – SSO on Eagle Terrace on May 3, 2022***

The SSO occurring on May 3, 2022, was captured in the video (file name 20220503\_101405.mp4, image of the video captured below) presented to the DuPage County representatives. The SSO occurred at a manhole on Eagle Terrace, believe to be manhole 163 or 164 (see Photo Log, Photos NPST12-13), DuPage County representatives were not sure, and said they would confirm.

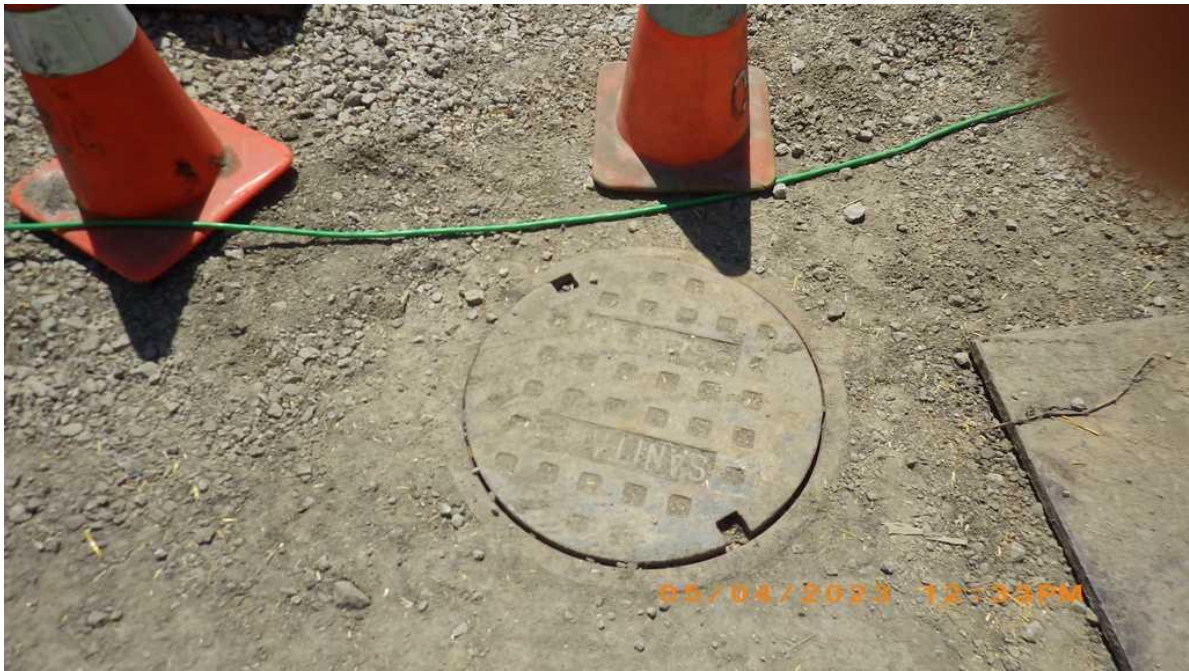
| Influent Manhole | NPST01.JPG | |

| Last manhole before headworks. | | |

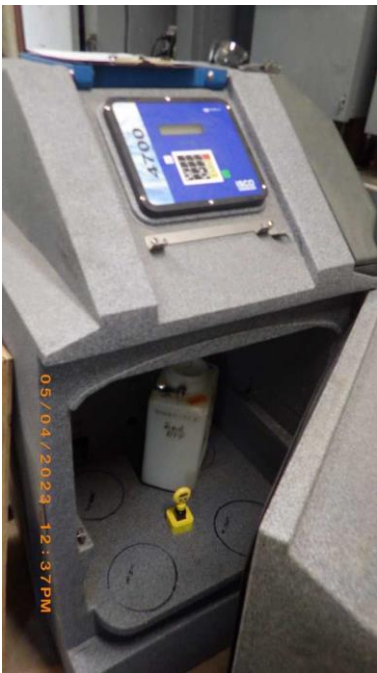
| ISCO Composite sampler (Influent) | NPST04.JPG | |

| Note thermometer in ISCO refrigerated sample chamber. | | |

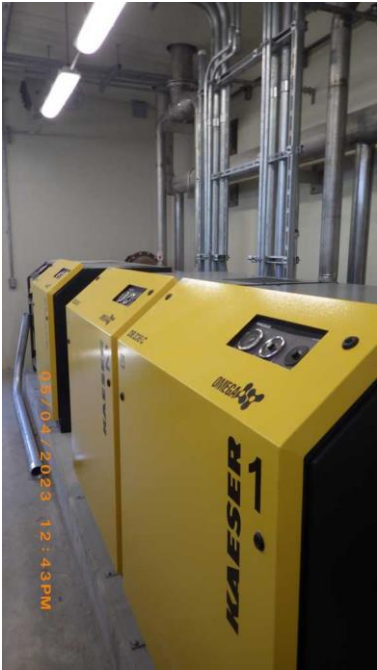
| New aeration blowers (4) | NPST06.JPG | |

| New blowers are online. | | |

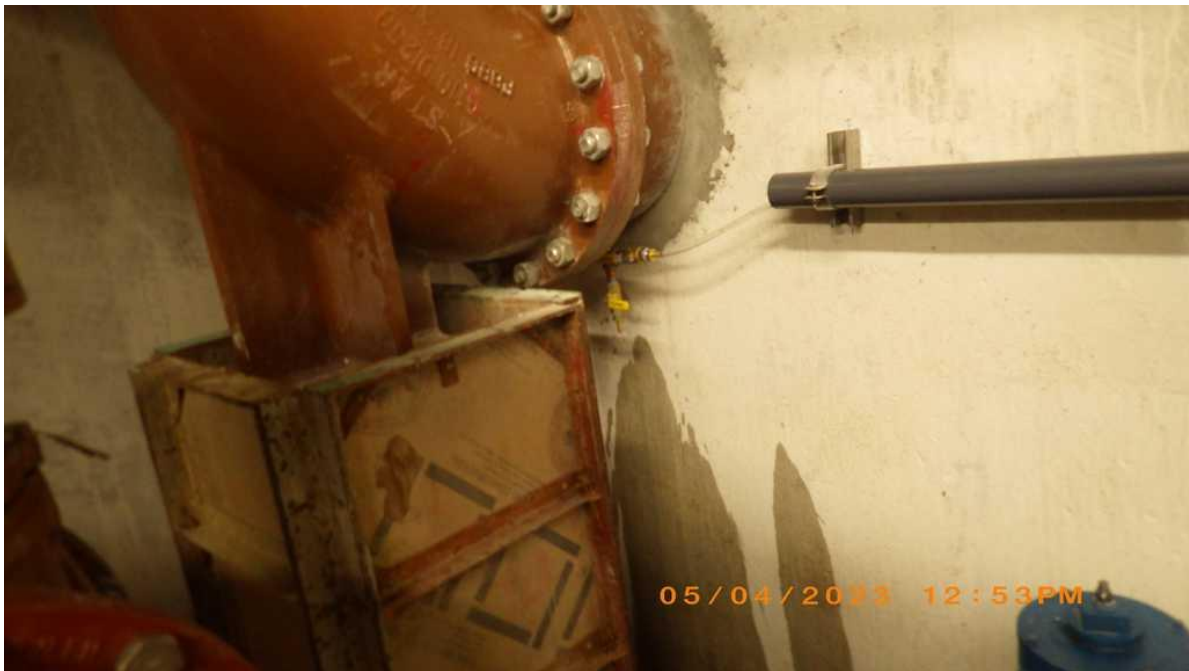
| Final effluent sample port | NPST08.JPG | |

| Dave Vogel collected sample from effluent port and measured for pH using calibrated pH probe (result 7.05, at 12:57 PM). | | |

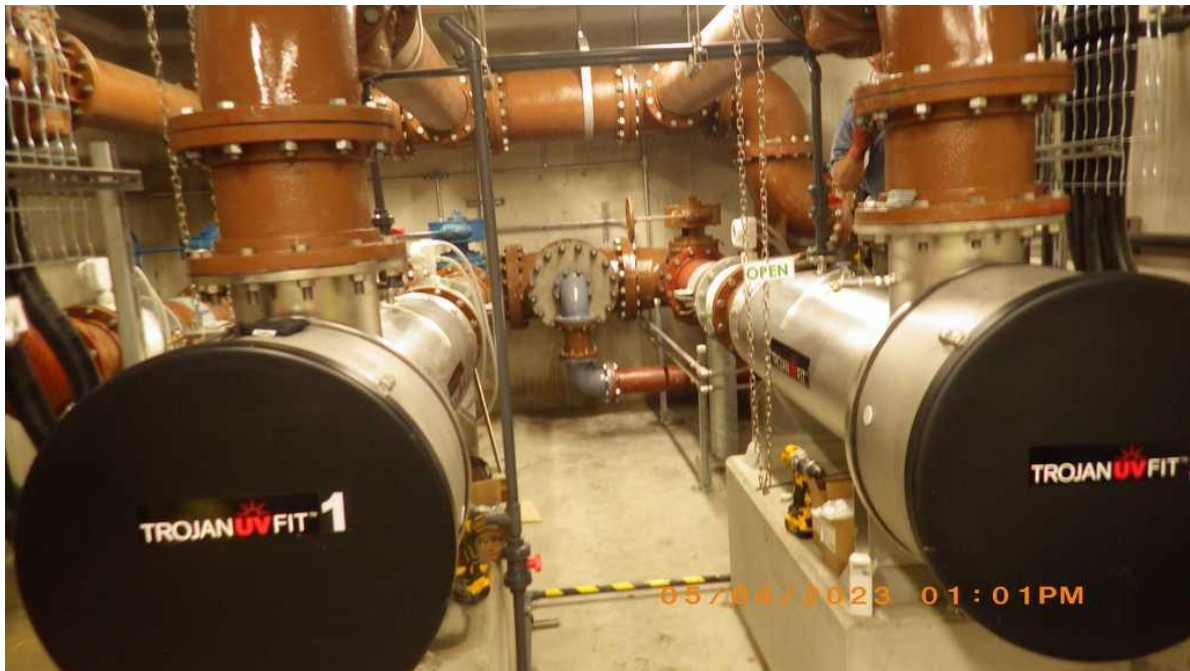
| New Twin UV banks (now online) | NPST10.JPG | |

| <b>AOC Reference #: DM1-OB-001</b> | <b>Location: Interview/O&amp;M</b> |
|---|---|
| <b>AOC:</b> Fecal coliform exceedances in summer 2022 and 2021 were due to “old UV equipment”. | |

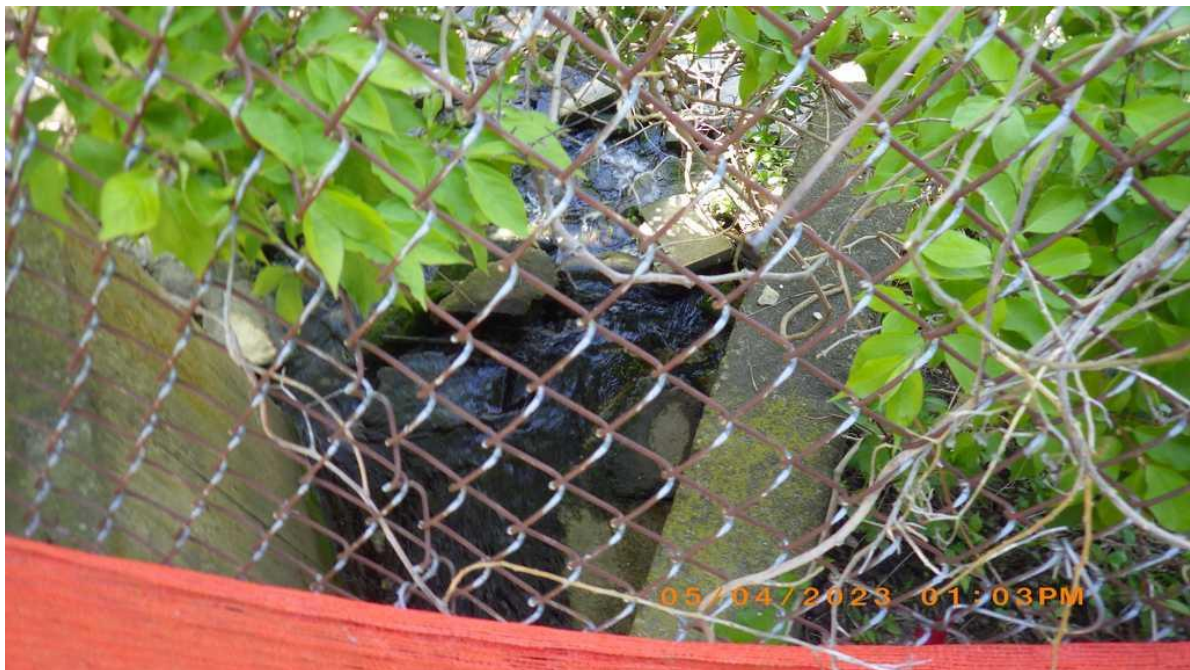
| Final Outfall 001 | NPST11.JPG | |

| Discharge appeared clear and free of debris or foam. Dave Vogel measure DO at this location using calibrated YSI probe (result 10.53, at 1:05 PM). | | |

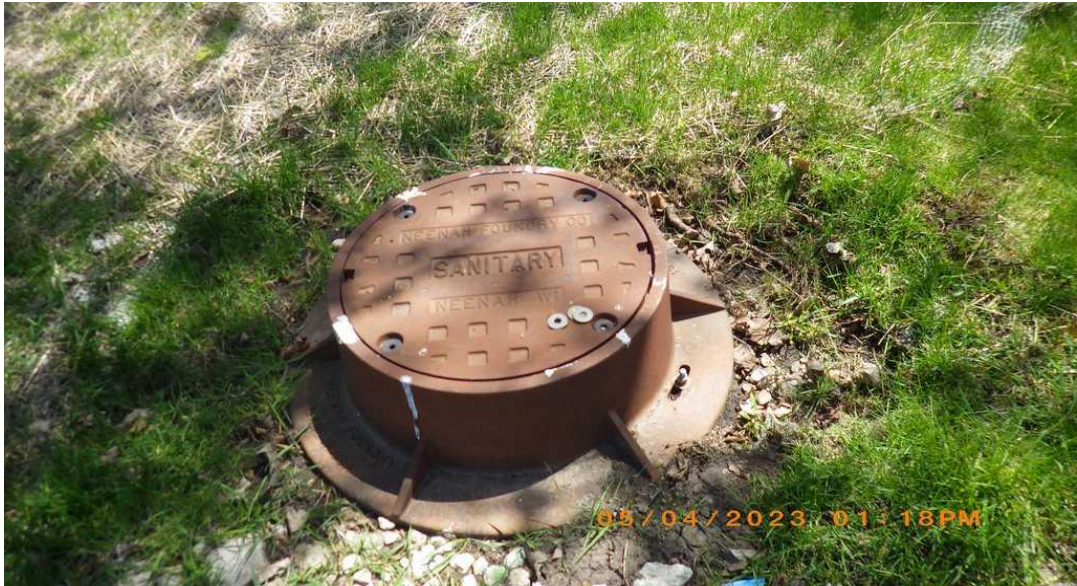
| <b>AOC:</b> EPA inspectors observed an unsecured sanitary sewer manhole cover on Eagle Terrace, believed to be manhole 163 or 164 (see Photo Log, Photos NPST12-13). The cover was not bolted. | |

| Believed to be manhole 163 or 164, DuPage County representatives were not sure. Note the cover is not bolted and unsecured. This was the manhole captured in the video (file name 20220503_101405.mp4) presented to the DuPage County representatives earlier during the interview portion of the inspection showing a flowing sanitary sewer overflow from this manhole on May 3, 2022. | | |

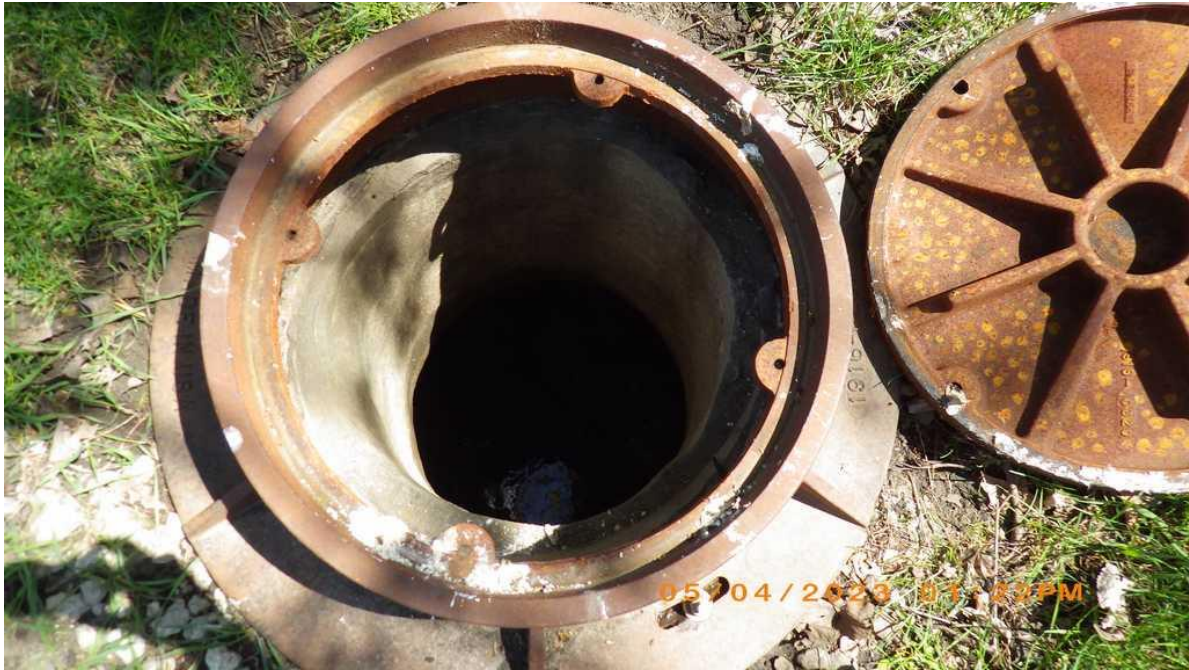
| Sanitary sewer collection system manhole on Eagle Terrace | NPST13.JPG | |

| Believed to be manhole 163 or 164, DuPage County representatives were not sure. Same manhole captured in Photo NPST12. Flow level low. | | |

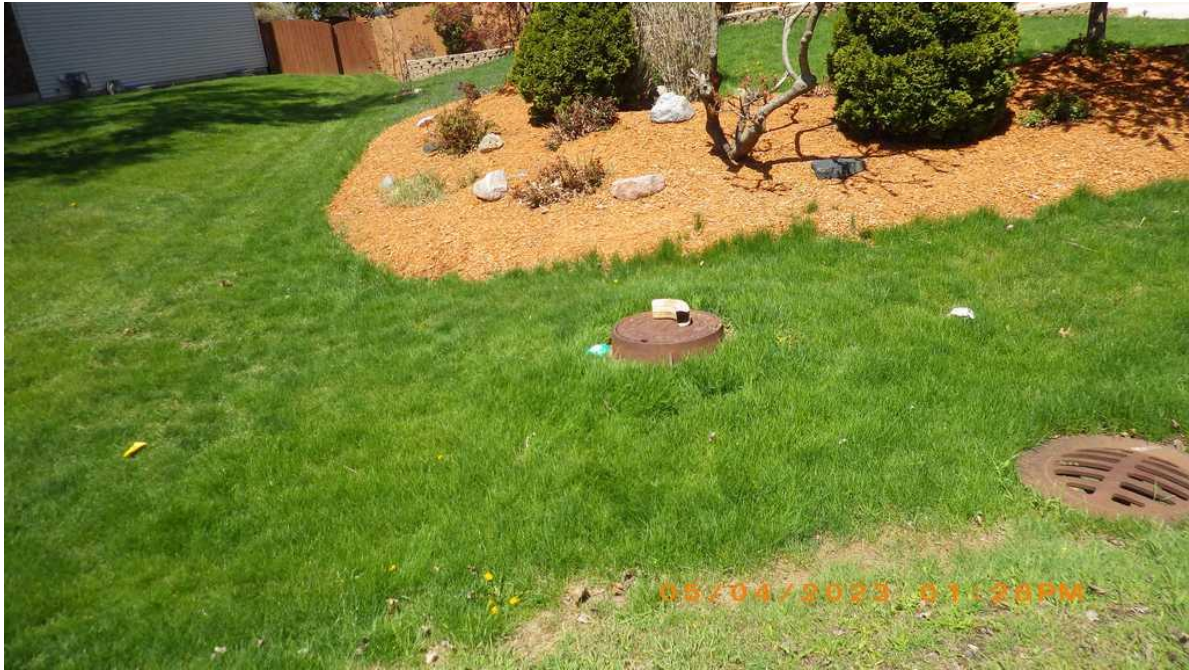
| Sanitary sewer collection system manhole on Eagle Terrace | NPST14.JPG | |

| Believed to be manhole 163 or 164, DuPage County representatives were not sure. Across the street (to the north) of the manholes captured in Photos NPST12-13. | | |

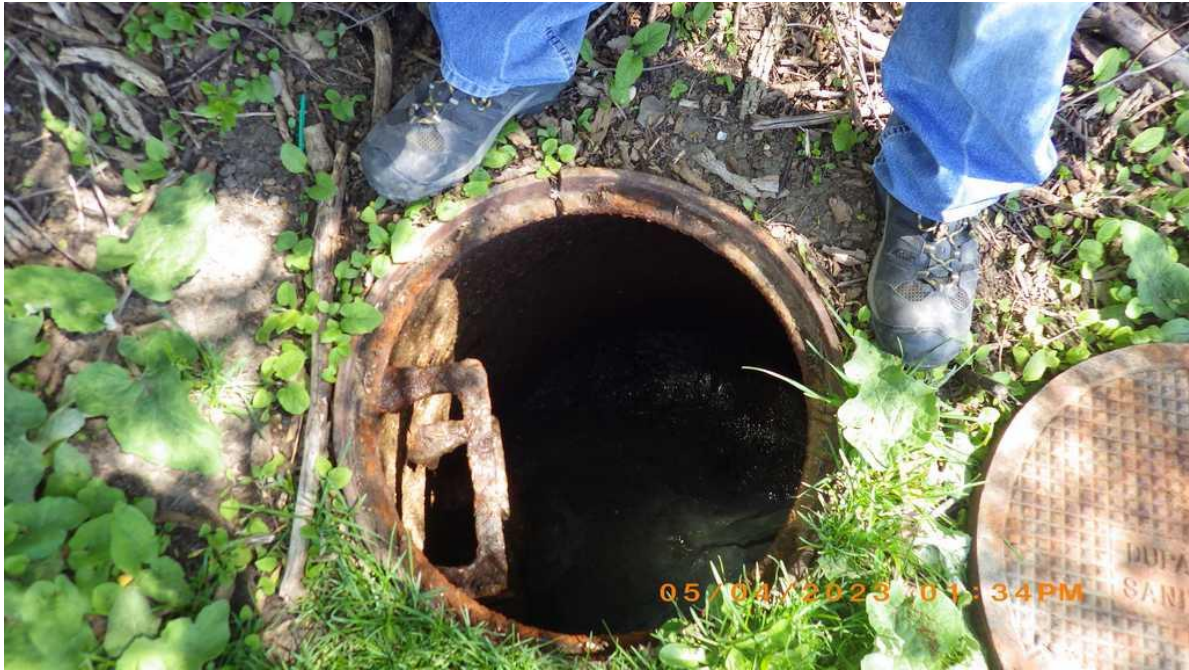
| Sanitary sewer collection system manhole in easement east of the golf course. | NPST15.JPG | |

| Manhole 134. Flow low. | | |

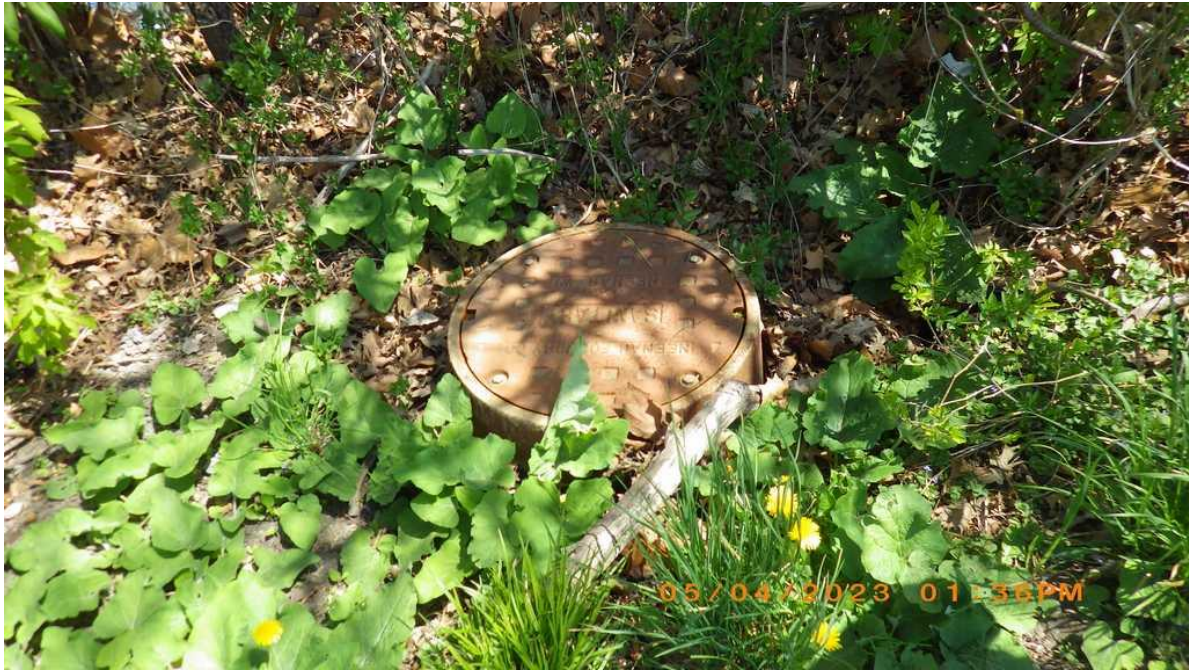
| Sanitary sewer collection system manhole in easement east of the golf course. | NPST16.JPG | |

| Manhole 133. Bolted closed. | | |

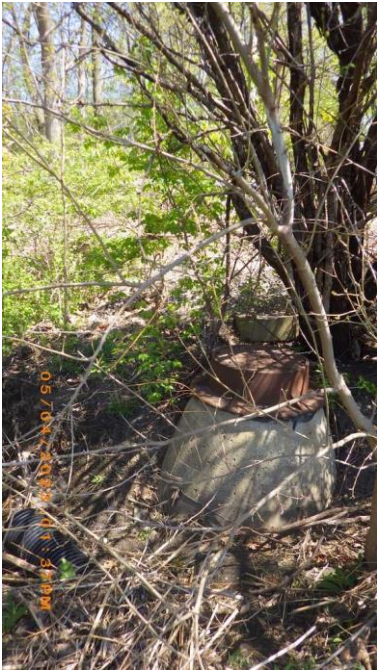
| Sanitary sewer collection system manhole in easement east of golf course. | | NPST17.JPG | |

| Manhole 132 in foreground, manhole 131 in background. | | | |

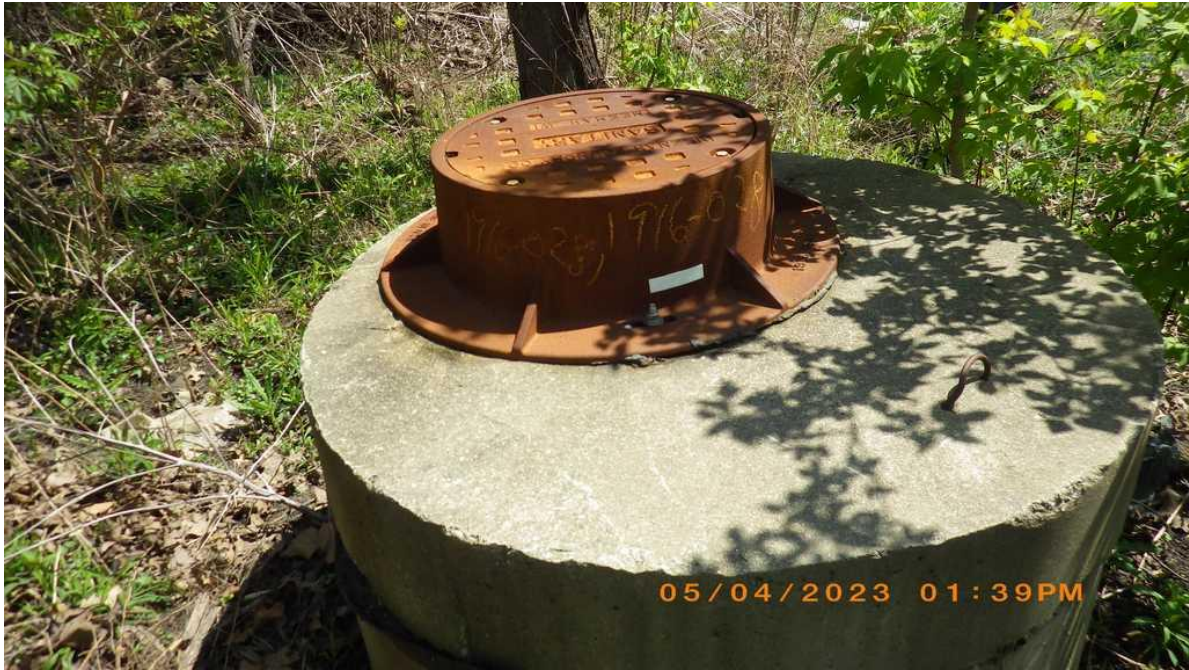
| Sanitary sewer collection system manhole in easement east of the golf course. | NPST18.JPG | |

| Manhole 130. This was the manhole captured in the video presented to the DuPage County representatives earlier during the interview portion of the inspection, showing a flowing sanitary sewer overflow from this manhole on October 25, 2021. | | |

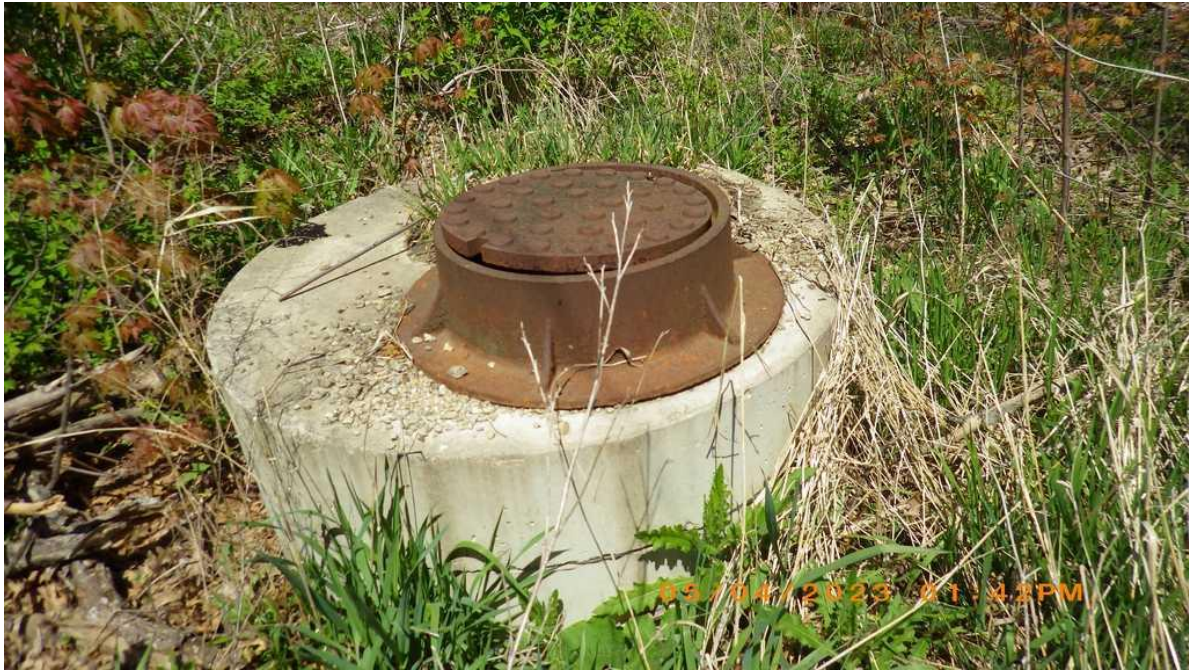
| Sanitary sewer collection system manhole in easement east of golf course. | NPST19.JPG | |

| Manhole 129. Note cover is unseated. | | |
