**CWA COMPLIANCE EVALUATION INSPECTION REPORT  
U.S. ENVIRONMENTAL PROTECTION AGENCY, REGION 5**

Compliance Evaluation Sampling Inspection

Richter Dairy Farm  
14113 St. Rose Road  
Breese, Illinois 62230  
Clinton County, Illinois  
38.62797657159176, -89.55355561706052

**Date of Inspection:** Site Inspection - September 14<sup>th</sup>, 2022  
Operator Interview – September 27<sup>th</sup>, 2022

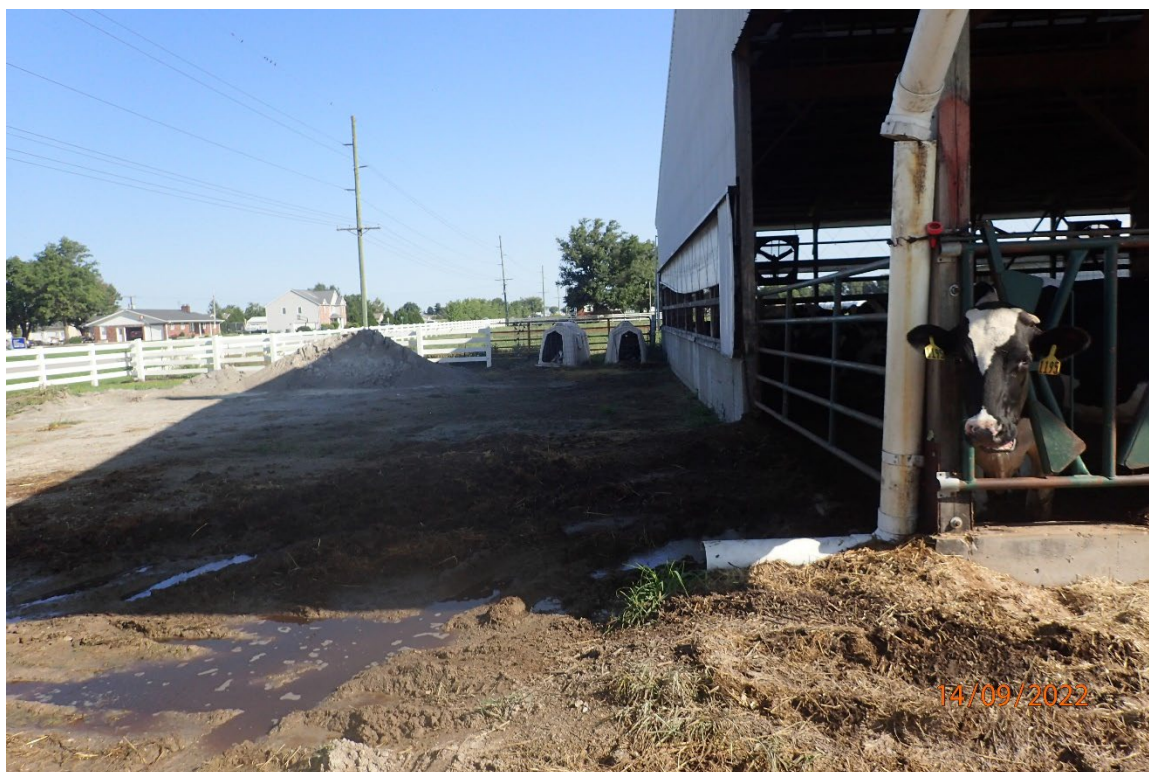
1: P9140092

The walkthrough began on the west side of the Dry Cow Barn. The Inspectors observed manure solids and dark brown liquid around the exterior of the gate located in the southwest corner of the Dry Cow Barn. The Inspectors also observed that the roof gutter downspout outlet was located in the same area (photo 1). The Inspectors noted that if stormwater were to come into contact with manure and discharge that it would be violation of the CWA.

Description: Looking north along the west side of the Dry Cow Barn. Note there are manure solids around the gate to the animal area as well a downspout outlet in the same area.

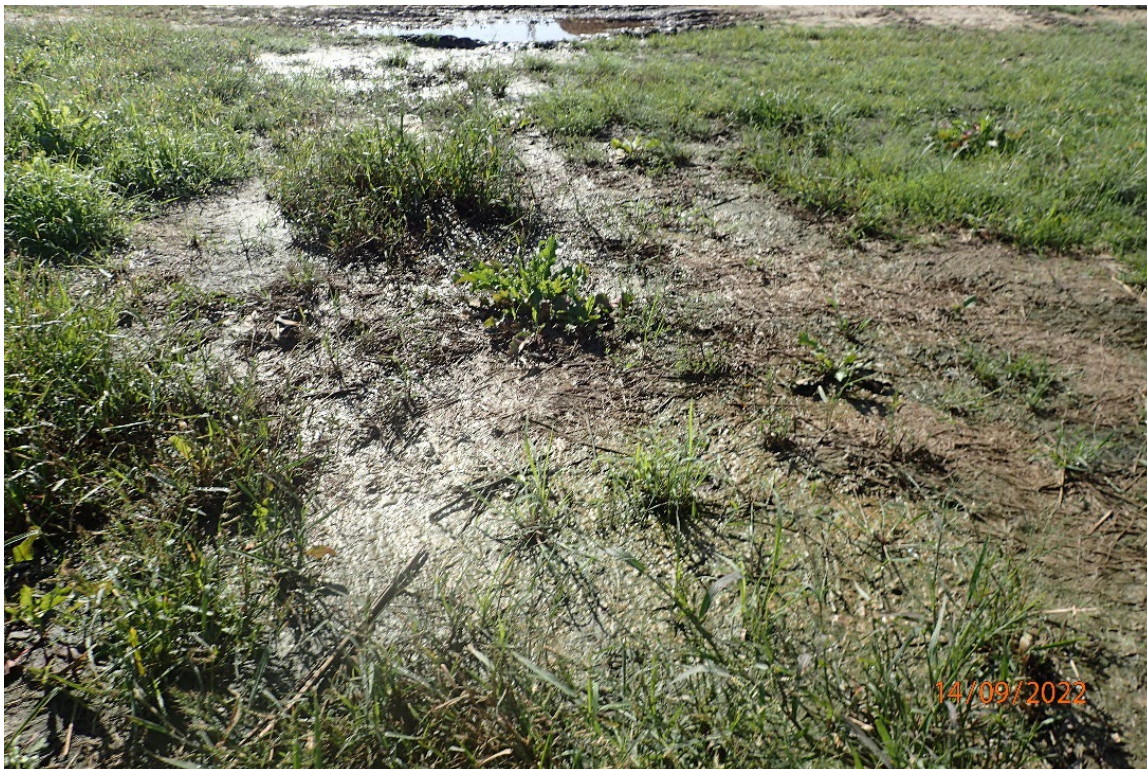
13: P9140104

The Inspectors walked north along the east side of the Heifer barn to the north side of the facility. The Inspectors observed an apparent flow path from the north end of the feed bags toward the north end of the property (photos 12-14). The Inspectors did not observe the flow path continuing into the field to the north.

Description: Close up of the flow path noted in photo 12.

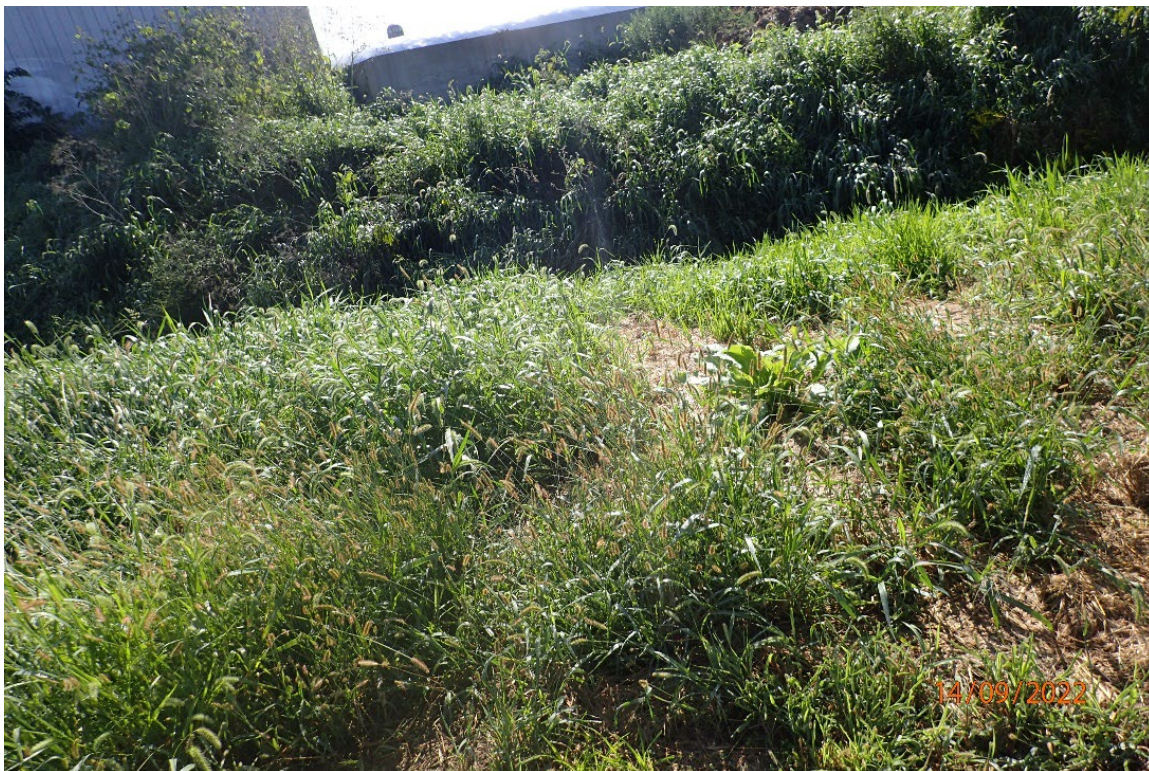
26: P9140117

Description: Solids deposited in grass along the west bank of Bull Branch.

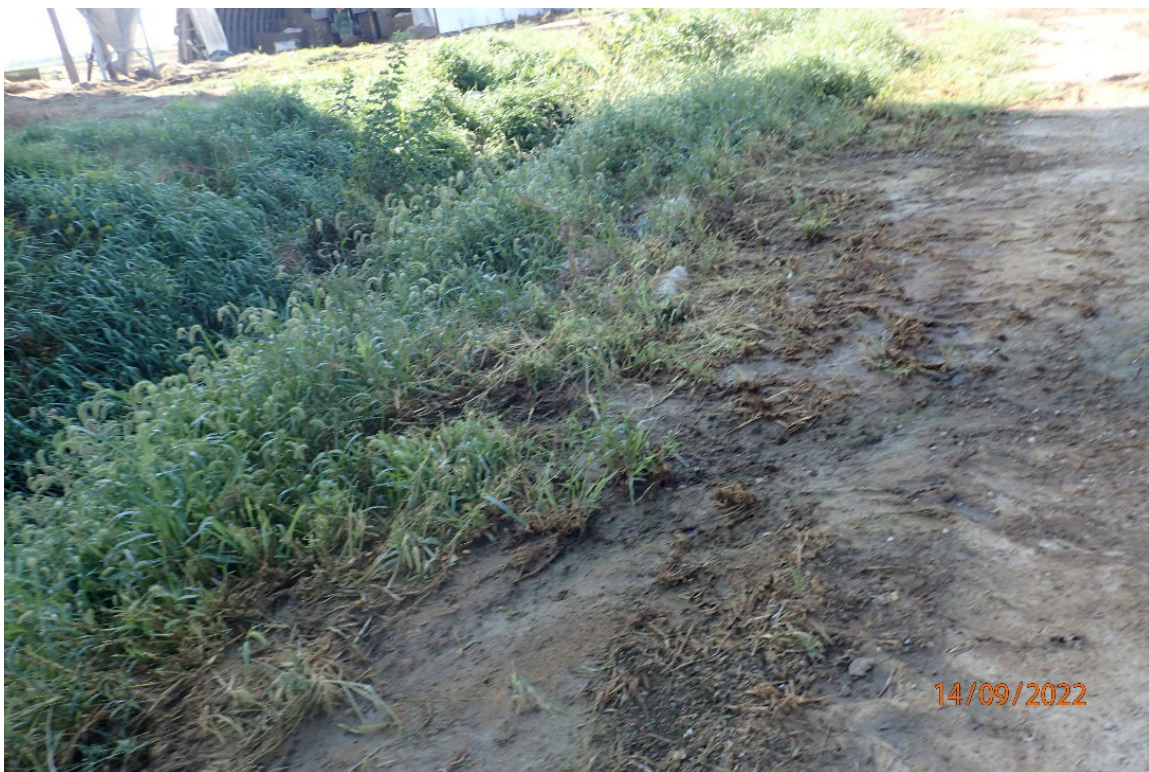
27: P9140118

Description: Manure solids deposited on access road east of the Hospital Barn.

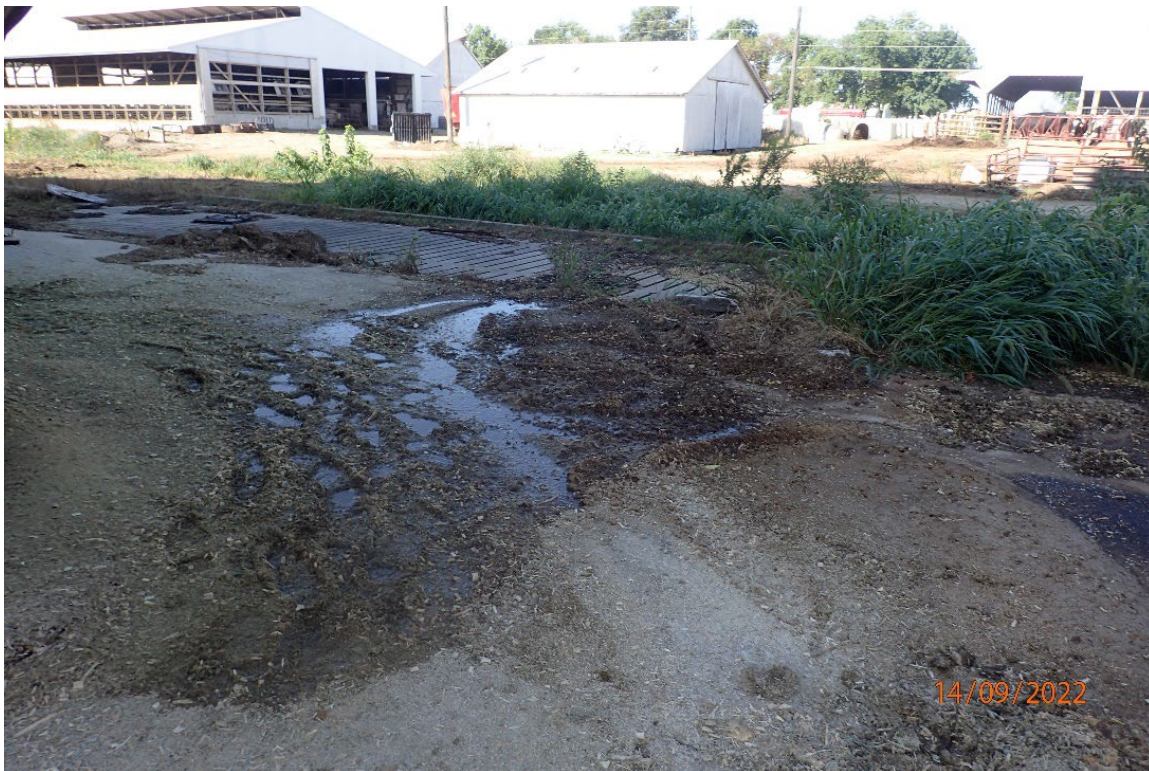
40: P9140131

Description: Looking southwest along the runoff pathways (blue arrows) from the solid manure stacked northwest of the silos to Pit 2.

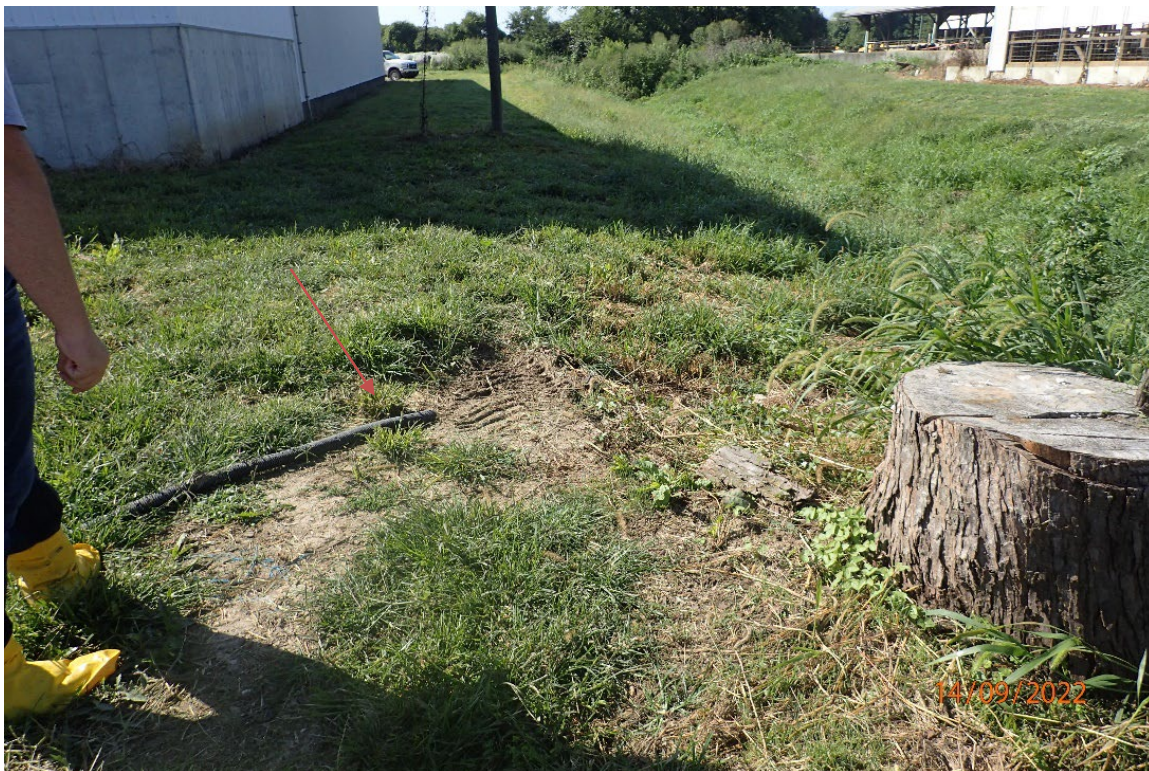
54: P9140145

The Inspectors walked south on the east side of the silos and then west to the Hay Barn. The Inspectors observed Pit 3 (photos 49-51). The Inspectors walked south to the south end of Pit 3 and observed a hose attached to a pump sitting at the south end of Pit 3. The opposite end of the hose was lying on the ground and oriented toward Bull Branch (photos 52-56). When asked what the pump was for, the Operator stated that he did not know why it was there and that his father had been put it there. At the Inspectors request, the hose was moved onto the Pit 3 area so it could not discharge to Bull Branch (photo 57).

Description: Area southwest of Pit 3. Note the black hose (red arrow). One end of the black hose is connected to a pump and other end is toward Bull Branch.

| <b>Were any deficiencies or areas of concern addressed or fixed during the inspection? If so, list what was done.</b> | During the Inspection, the Operator moved the hose from the pump in Pit 3 so that it could not discharge. Additionally, the Operator took steps to stop the flow of manure to Bull Branch. Following the site visit, the Operator notified EPA that he had blocked Bull Branch, flushed the channel with fresh water, and used a vacuum truck to remove the manure which was then placed in Pit 5. |

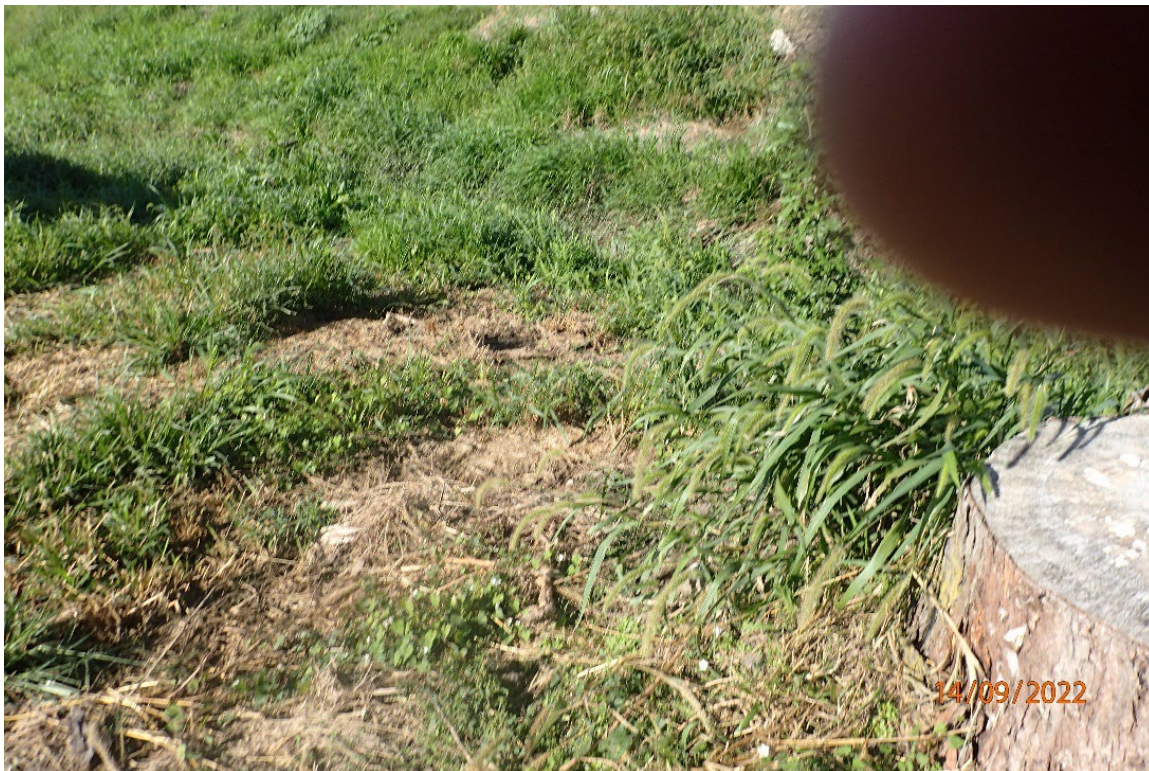
55: P9140146

Description: Potential flow paths on the east bank of Bull Branch west of the the black hose attached to the pump. Location: Southwest corner of Pit 3.

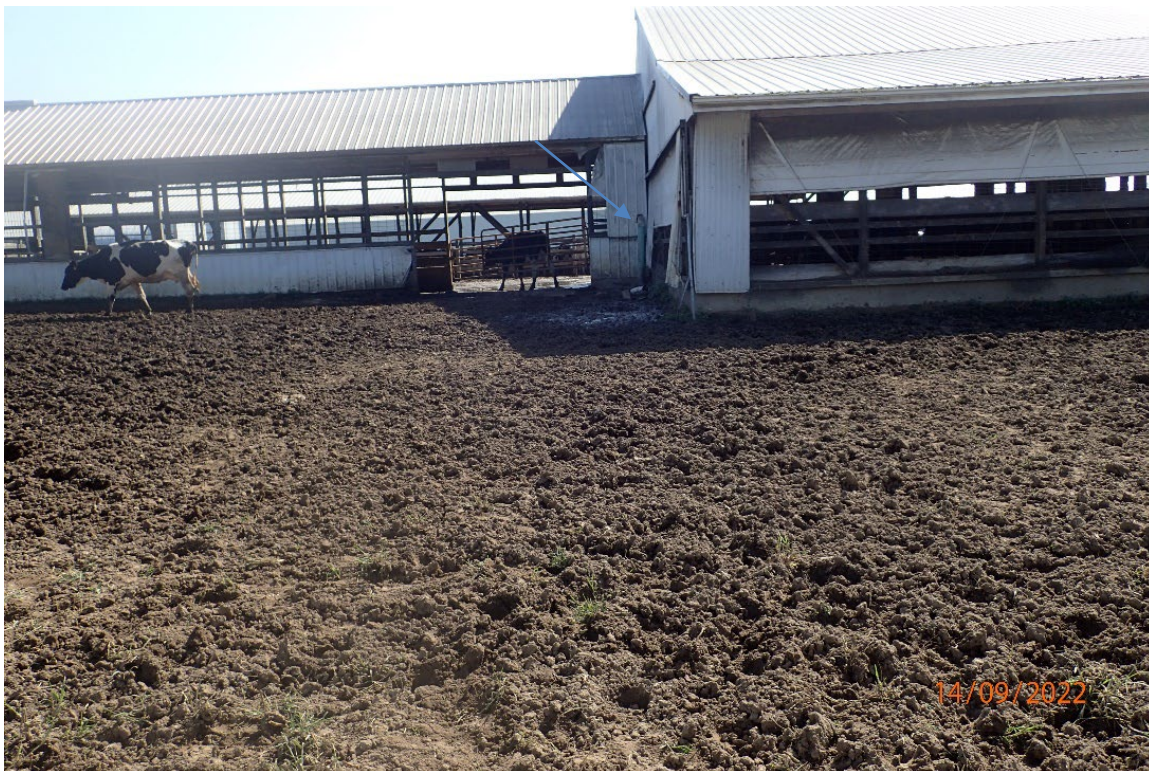
66: P9140157

10. The denuded earthen lot west of the West Milk Cow Barn lacked containment.
11. Manure was observed outside of the gate to the Dry Cow Barn in close proximity to the roadside ditch and a roof gutter downspout.

Description: Looking east toward the West Milk Cow Barn across the denuded outdoor lot. Note the blue pipe receiving roof gutter water (blue arrow).

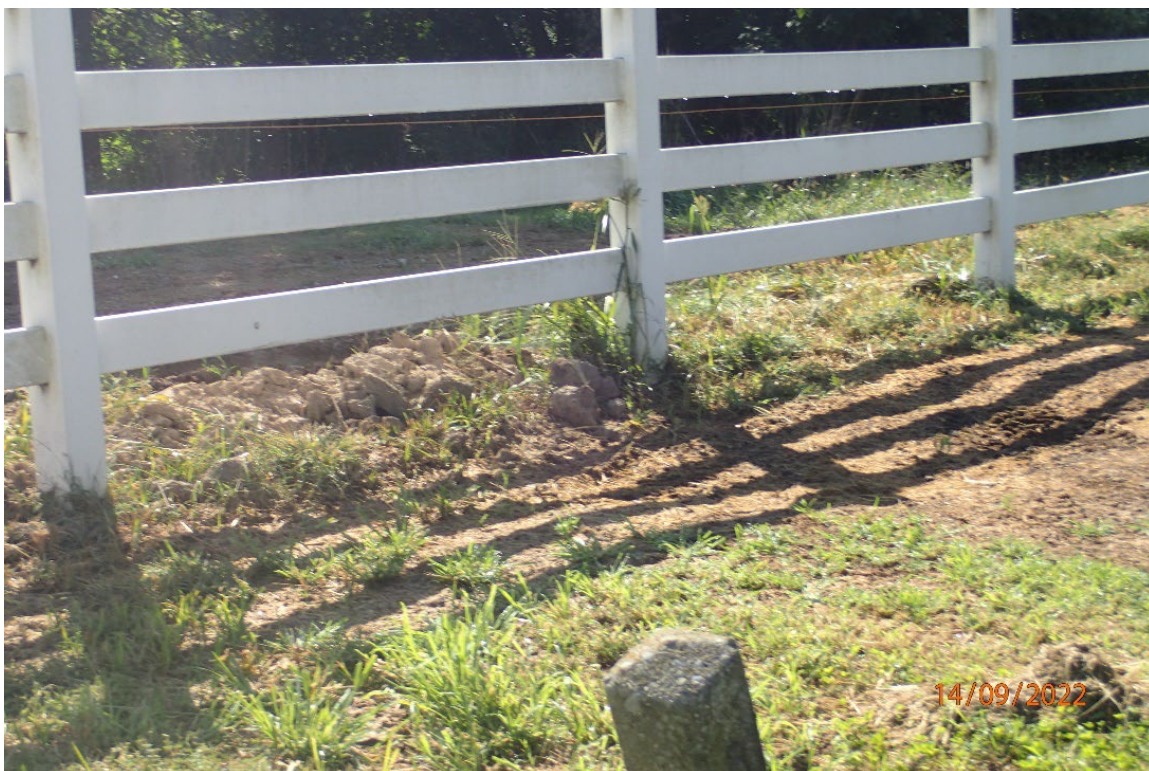
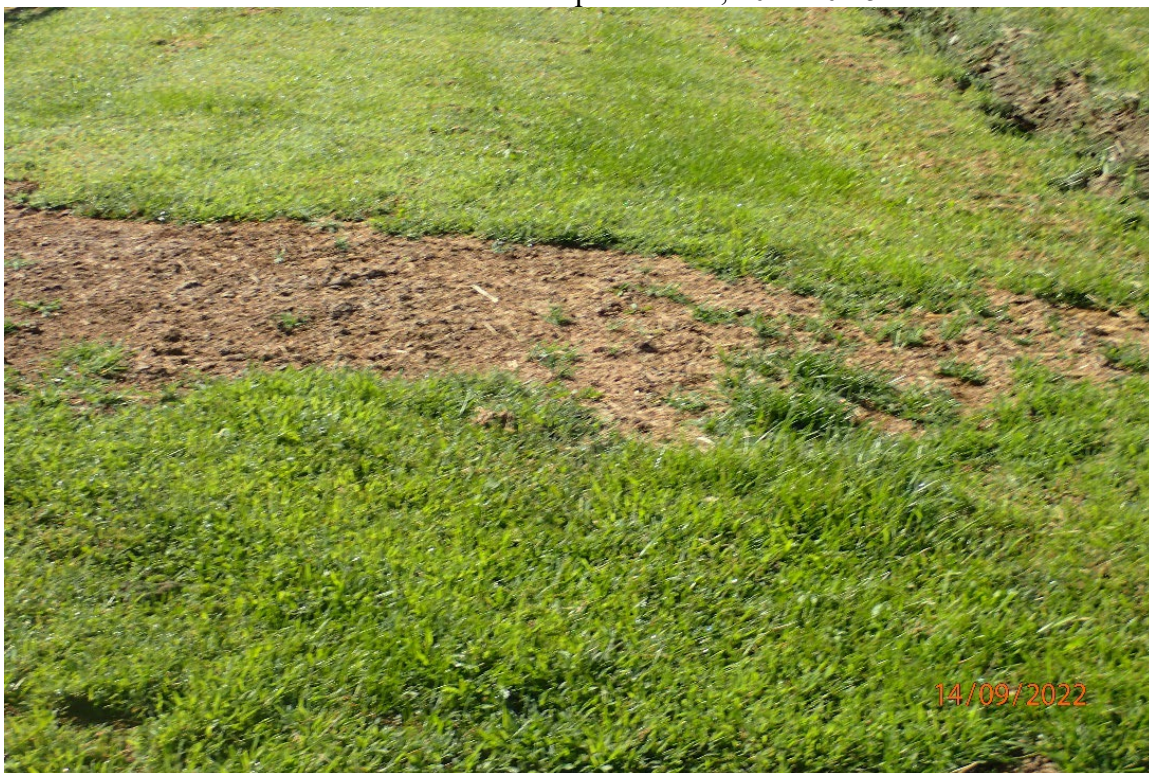
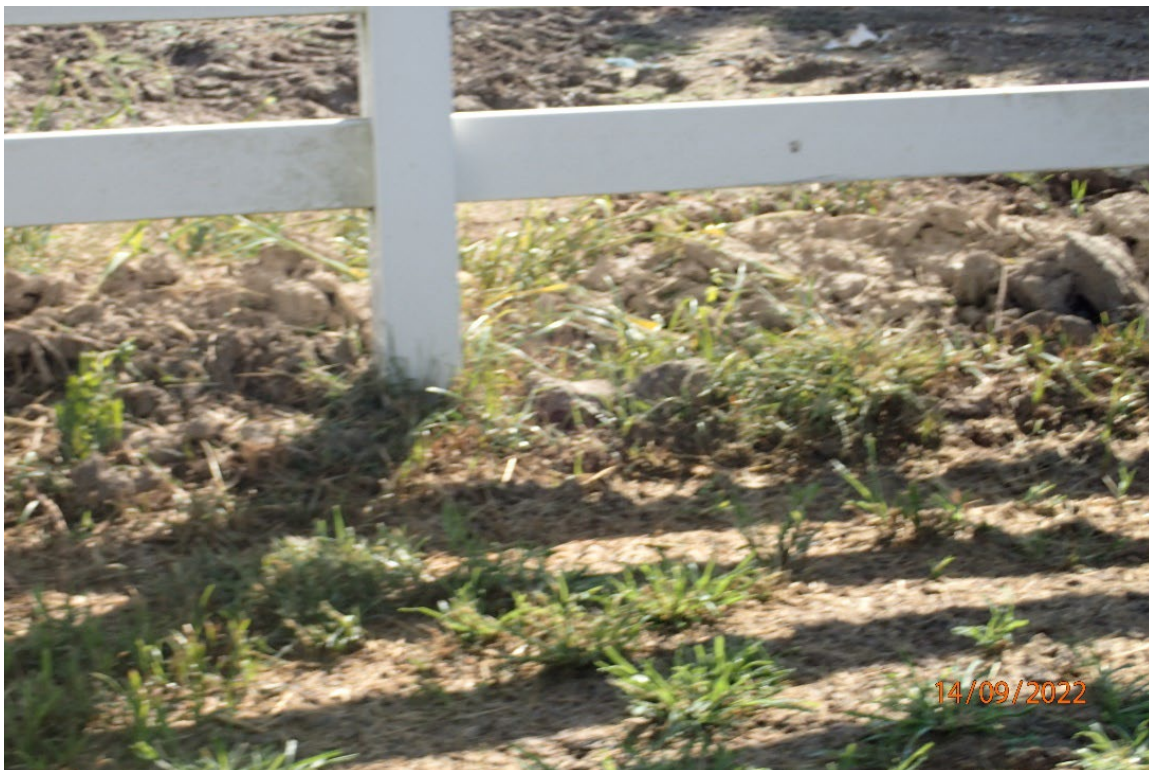
70: P9140161

The Inspectors continued walking south along the west fence and observed burnt vegetation and manure solids in a path from the area west of the Pit 4 ramp down to the roadside ditch (photos 70 – 77).

3. A path of burnt vegetation and organic material was observed from the area west of the Pit 4 ramp to the roadside ditch.
4. A path of burnt vegetation and organic material was observed from the area south of the Pit 4 ramp toward the Bull Branch.

Description: Burnt vegetation and organic solids on ground in path on west side of fence west of Pit 4 ramp.

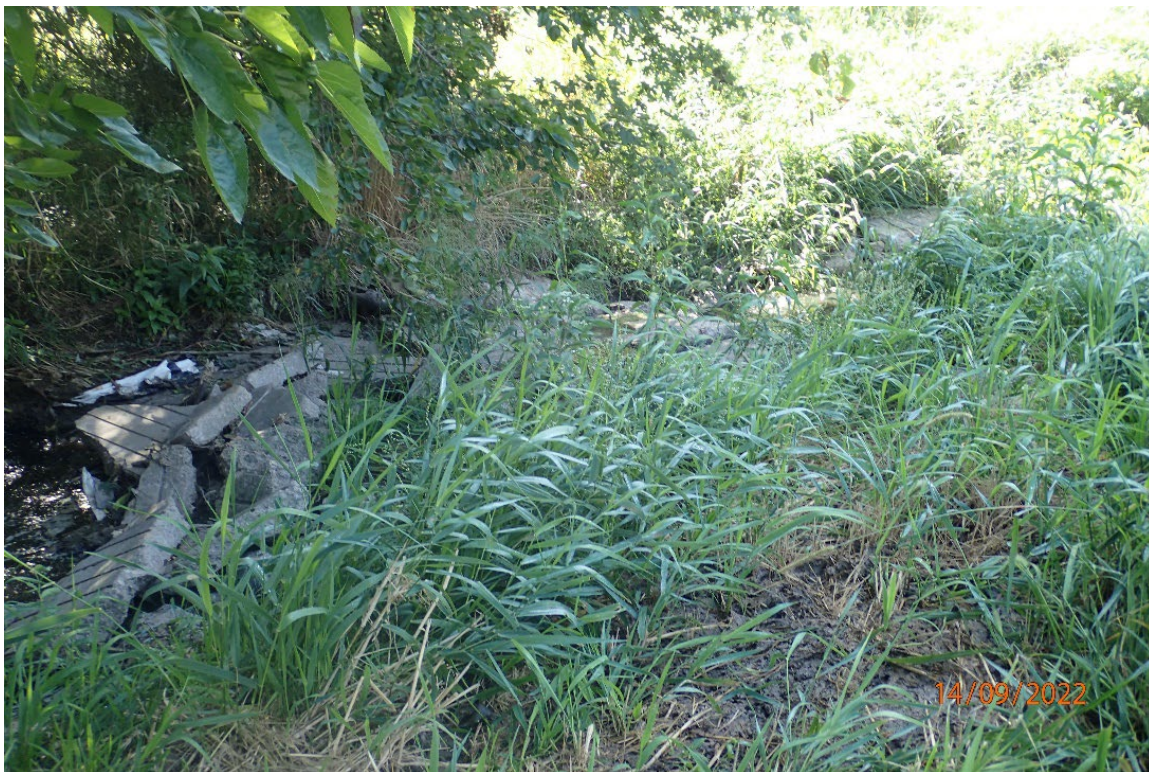
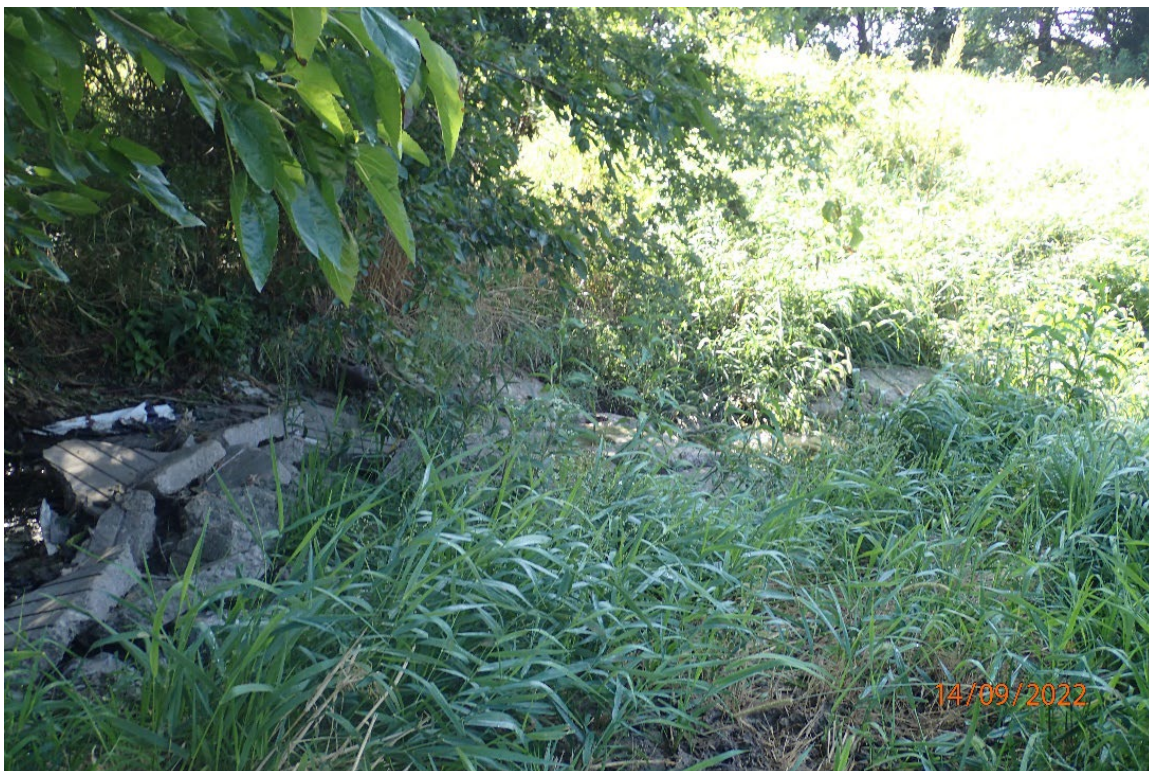
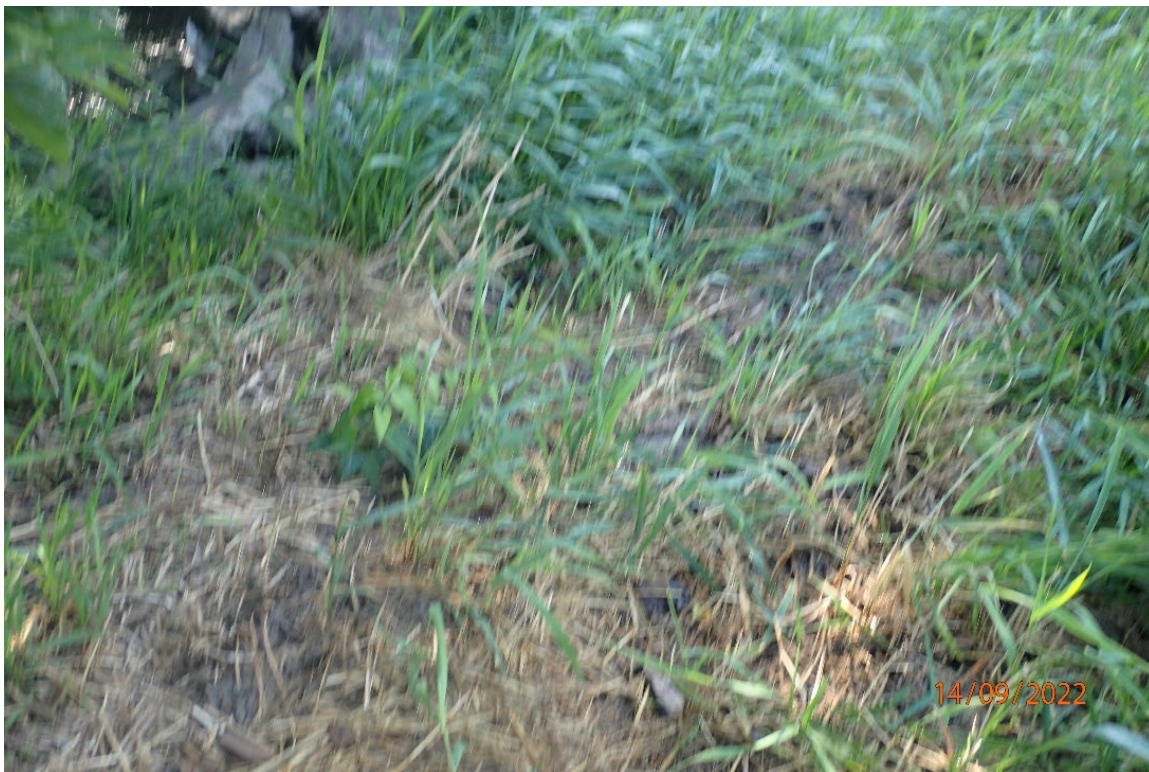
79: P9140170

The Inspectors then walked east toward Bull Branch. The Inspectors observed manure solids and burnt vegetation in a path from the area south of the Pit 4 ramp towards Bull Branch (photos 79-84).

Description: Organic solids and burnt vegetation along a path down to Bull Branch.

Description: Potential flow path from photo 79 continuing southeast toward Bull Branch.

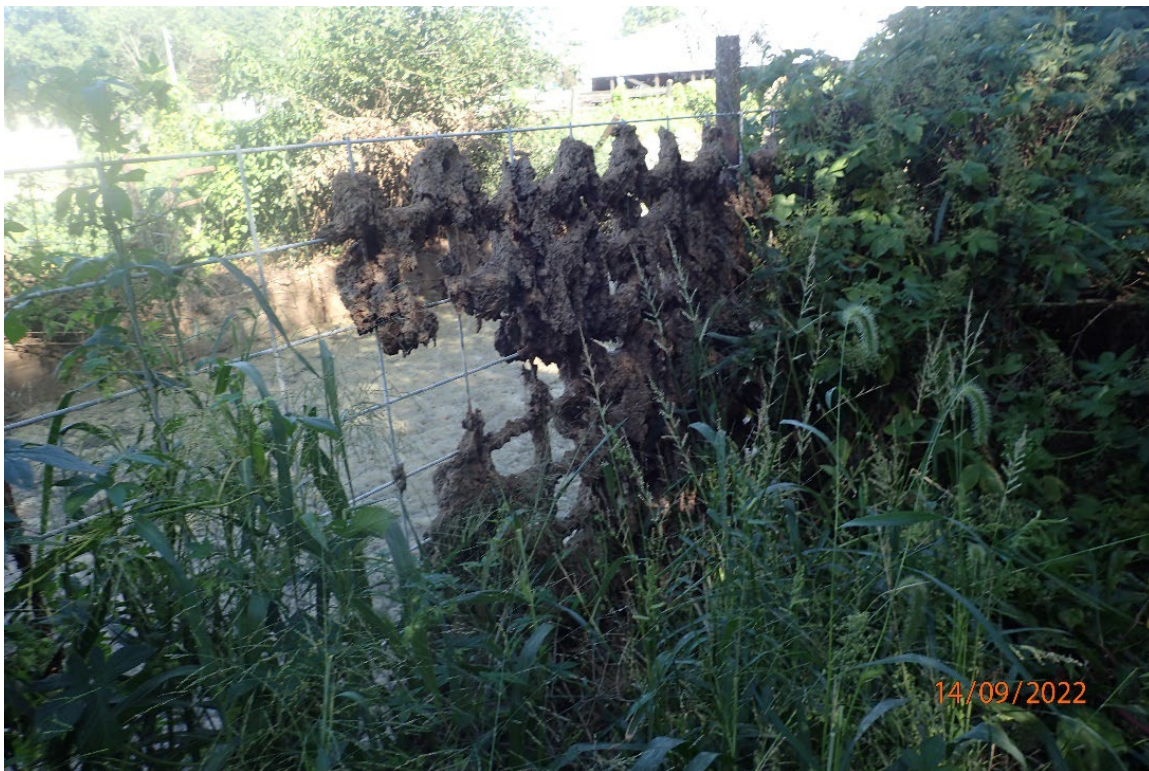
88: P9140179

The Inspectors walked north along the east side of Pit 4 and observed manure solids deposited on the fence along Pit 4 (Photos 88 and 89). The Inspectors also observed Bull Branch was covered in foam (photos 92-97). The Inspectors continued north and observed manure deposited on top and exterior side of the east concrete wall of Pit 4 (photos 99-102).

Description: Organic solids deposited on the fence on the east side of the ramp to Pit 4.

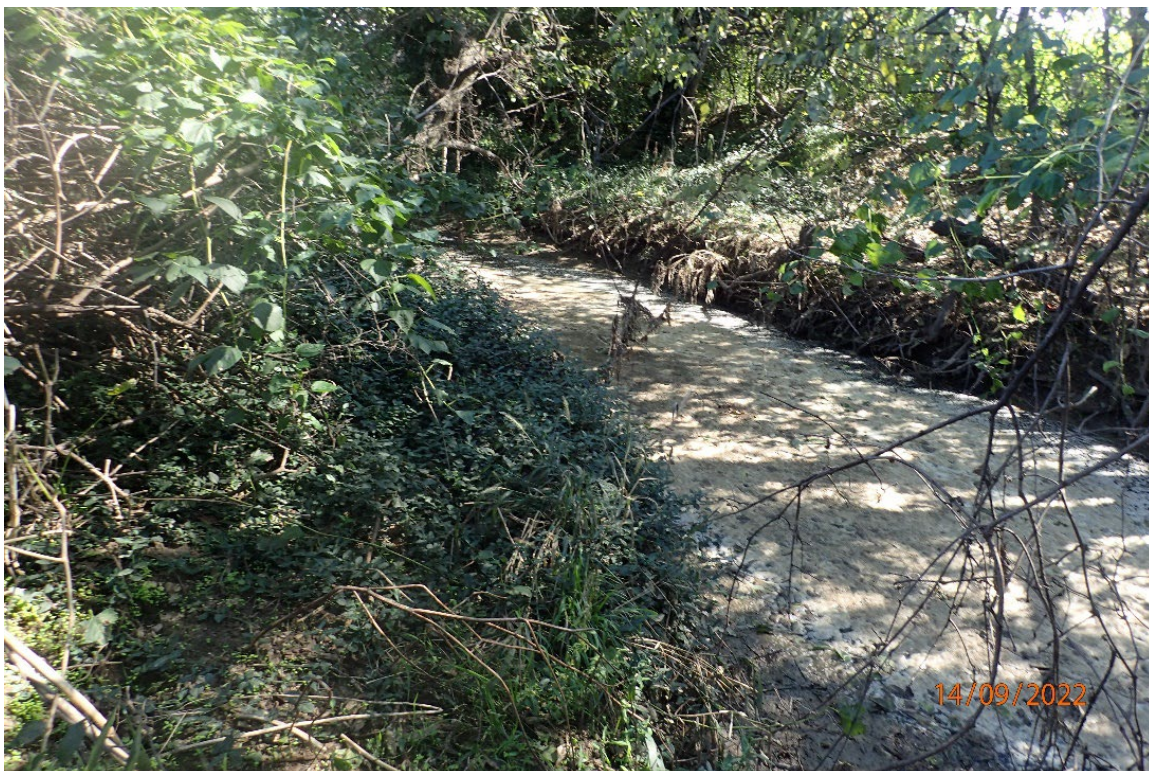
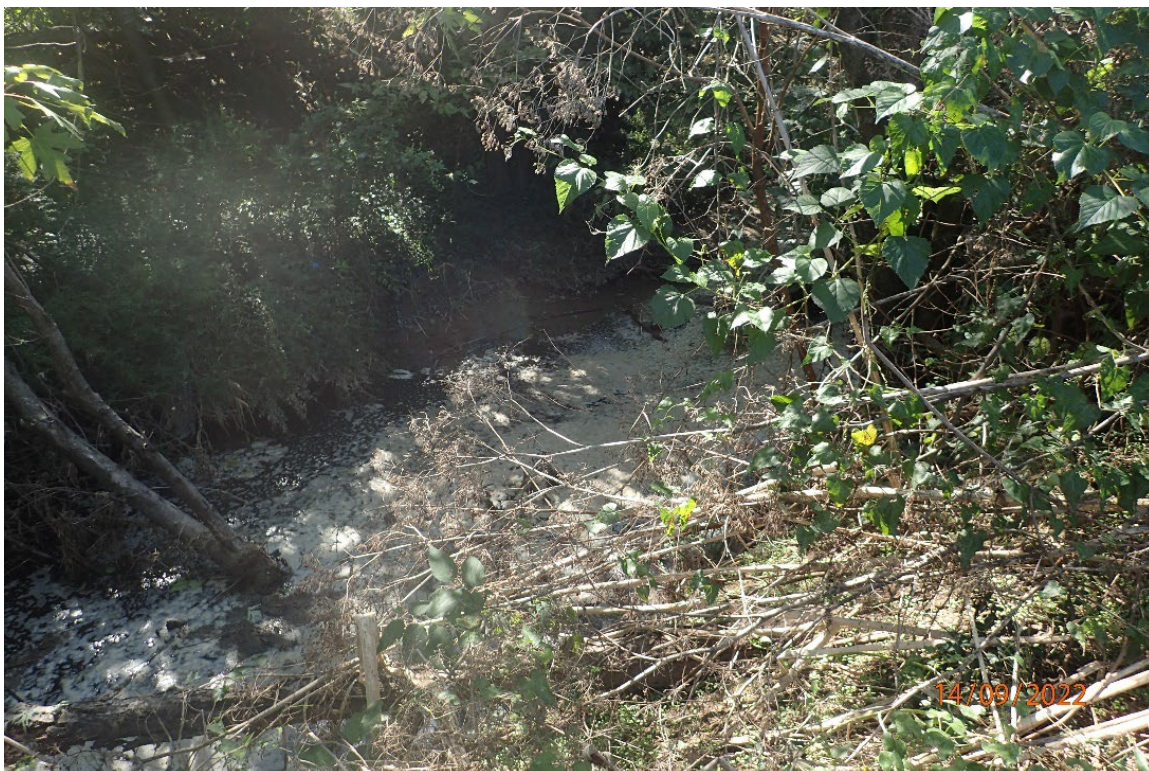
93: P9140184

Description: Upstream on Bull Branch. Note the foam on the surface of the water.

Description: Looking east into Bull Branch. Note the foam on the surface on the water.

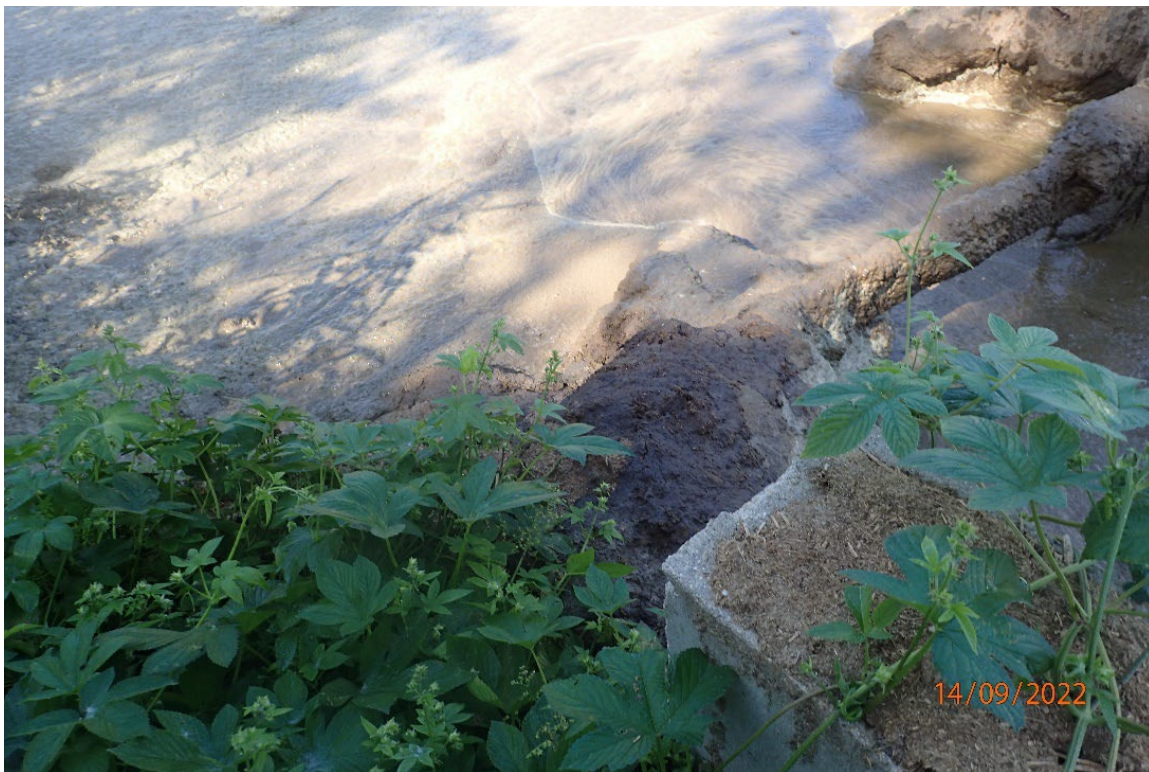
102: P9140193

Description: Manure flowing from the solids settling area into Pit 4.

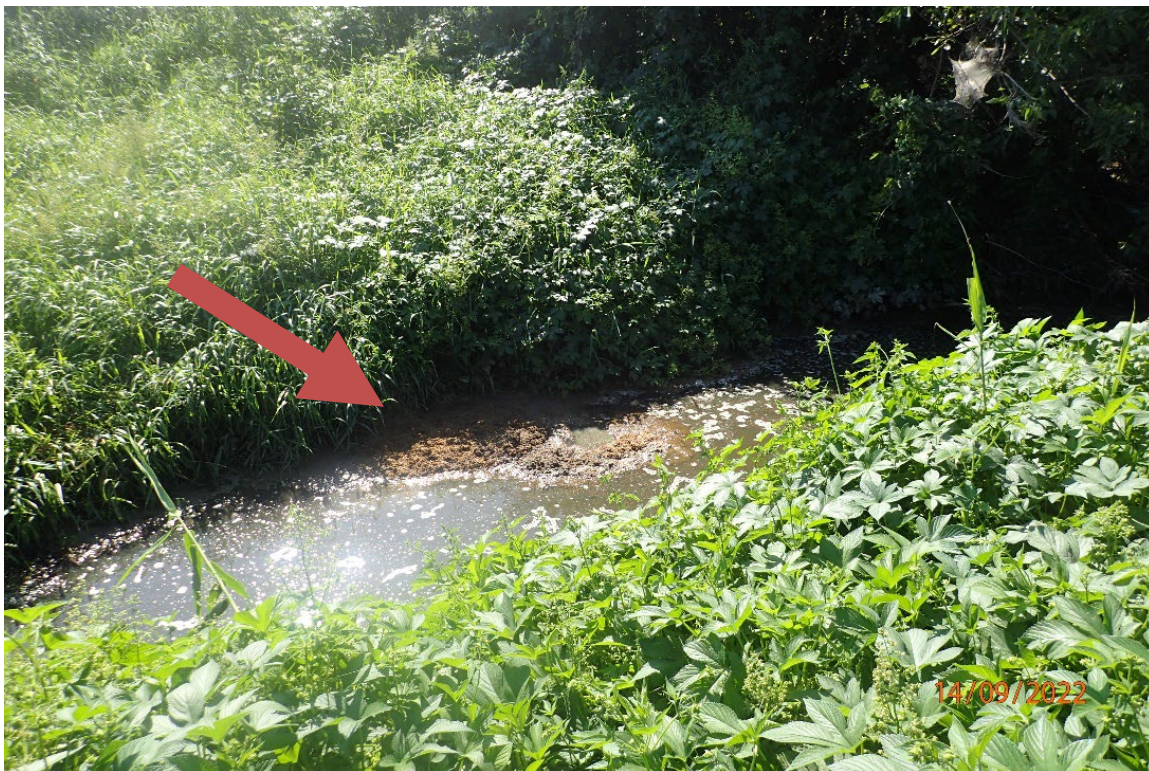
110: P9140201

The Inspectors continued north and observed manure solids in the channel of Bull Branch (photos 109 and 110). The Inspectors also observed manure on the top of and along the exterior edge of the concrete wall on the east side of the outdoor lot south of the East Milk Cow Barn (photos 111 – 113).

1. Manure was observed flowing out of a hole in the concrete wall along the east side of Pit 4 in a channel approximately 50 feet into Bull Branch.
2. Manure solids were observed in the channel of Bull Branch.

Description: Looking southeast into Bull Branch. Note organic solids deposited in the channel ( red arrow).

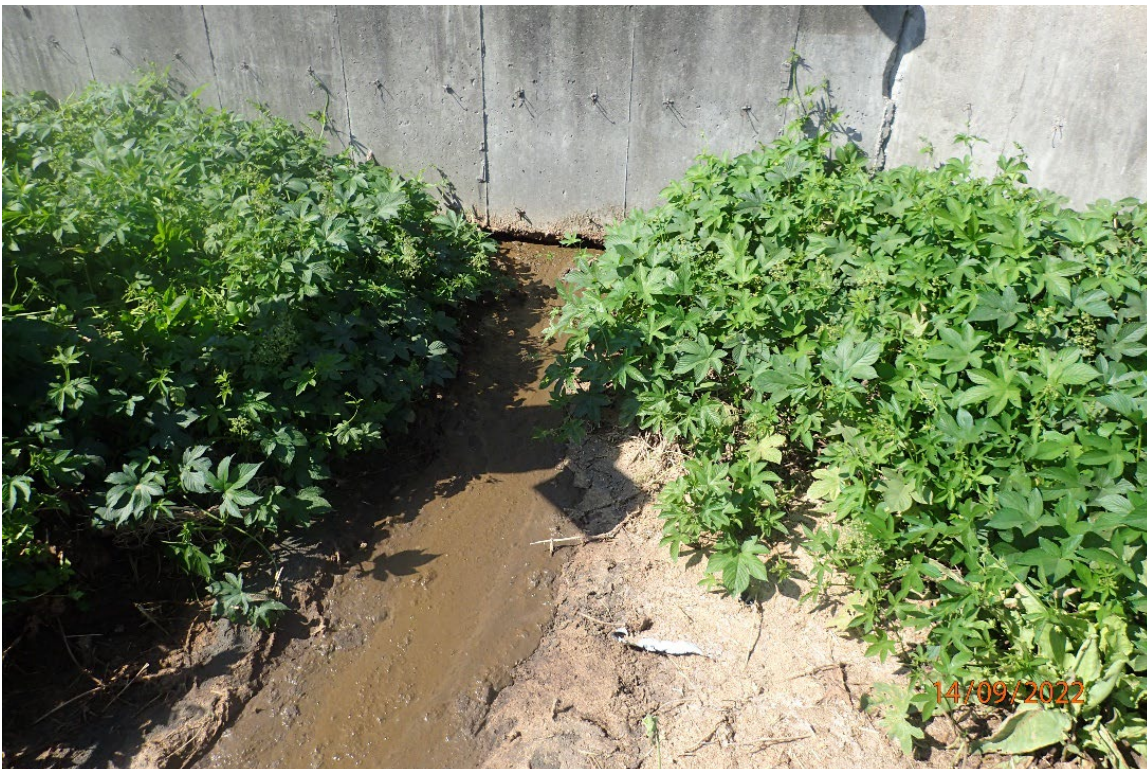
117: P9140208

The Inspectors continued walking north and observed a hole in the concrete wall east of the East Milk Cow Barn which was allowing manure to flow down through a channel into Bull Branch (photos 117 – 131). The Inspectors observed liquid manure flowing in the channel and into Bull Branch.

A follow up call to complete the interview portion of the Inspection was held on September 27th, 2022. The operator's responses during the interview portion of the Inspection were used to complete the checklist. During the interview, the Operator stated that the crack in the wall has been there for "a few months".

Description: Cracked concrete wall allowing manure to flow into channelized path to Bull Branch.

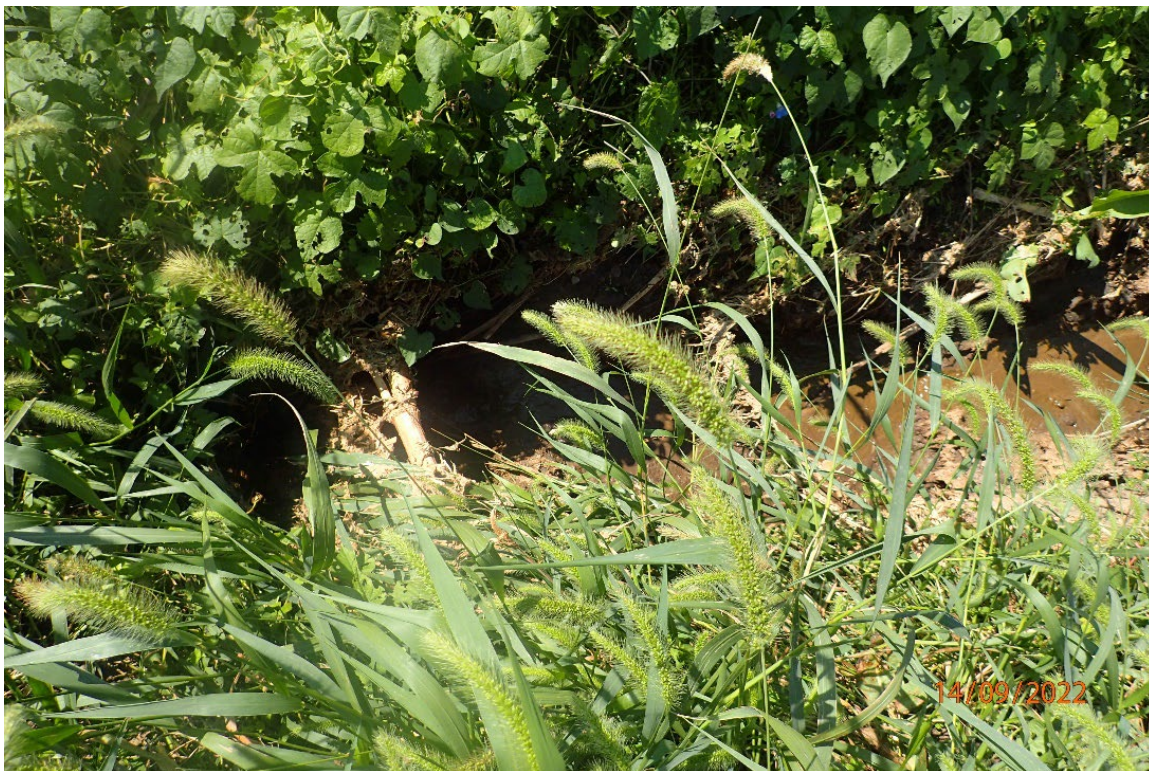
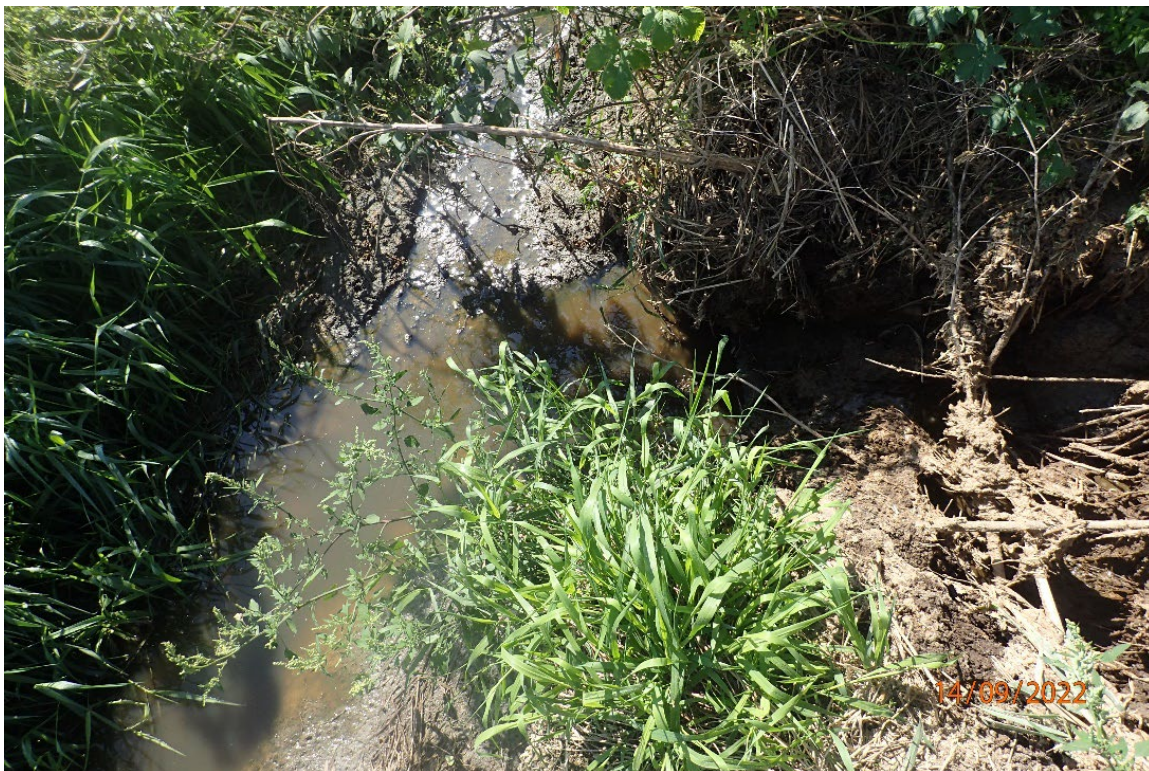
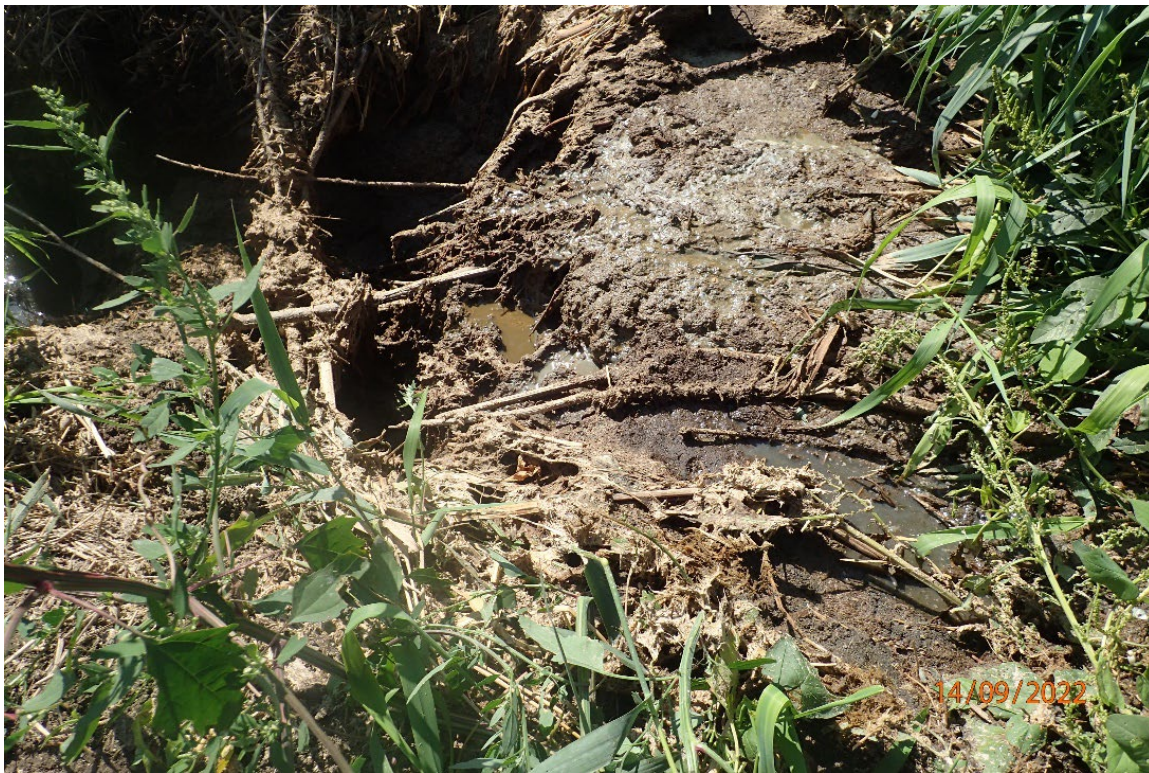
121: P9140212

Description: Manure flowing in the channelized flow path to Bull Branch.

Description: Confluence of the channelized flow path conveying manure to Bull Branch.

Description: Closeup of manure flowing into Bull Branch from the channelized flow path.

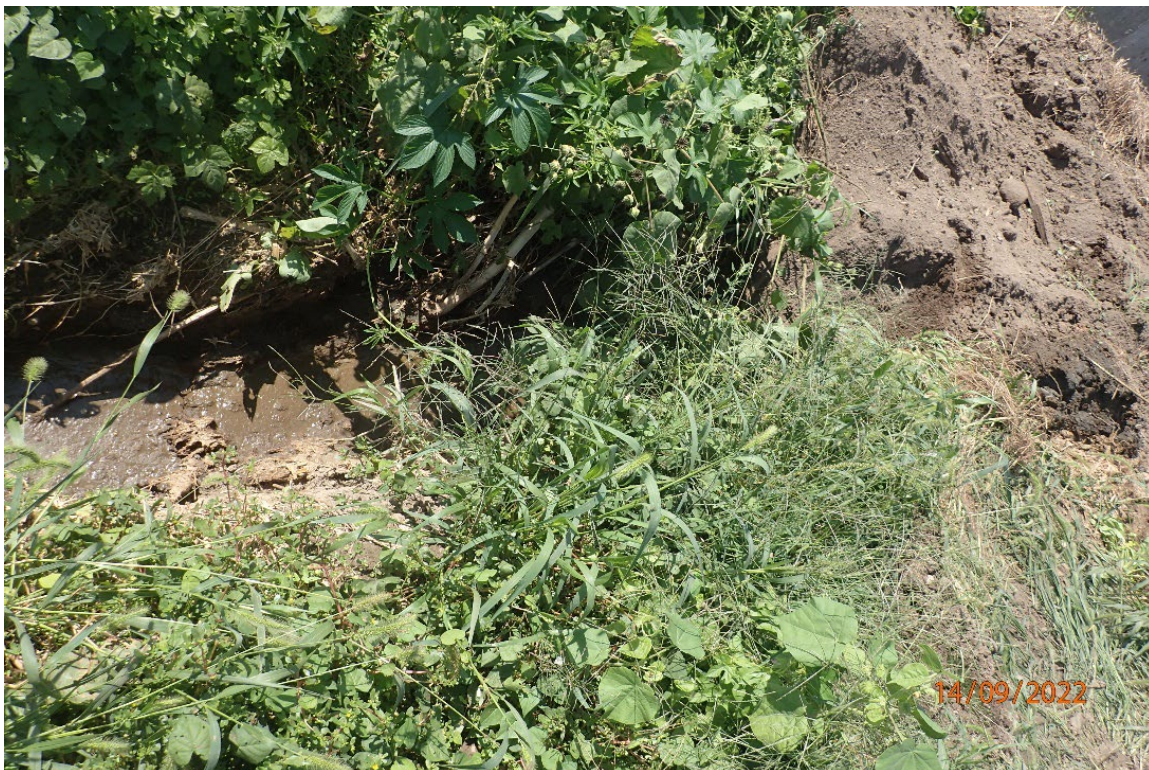
183: P9140274

The Inspectors observed that fill had been placed over the hole in the concrete wall (photos 182 and 183).

Location: Cracked concrete wall east of the East Milk Cow Barn.
