COMPLIANCE EVALUATION INSPECTION REPORT  
U.S. ENVIRONMENTAL PROTECTION AGENCY, REGION 5

**Purpose:** Clean Water Act National Pollutant Discharge Elimination System (NPDES)  
Compliance Evaluation Inspection

Ardagh Glass, Inc.  
524 East Center Street  
Dunkirk, Indiana 47336

**Dates of Inspection:** March 13 - 14, 2024

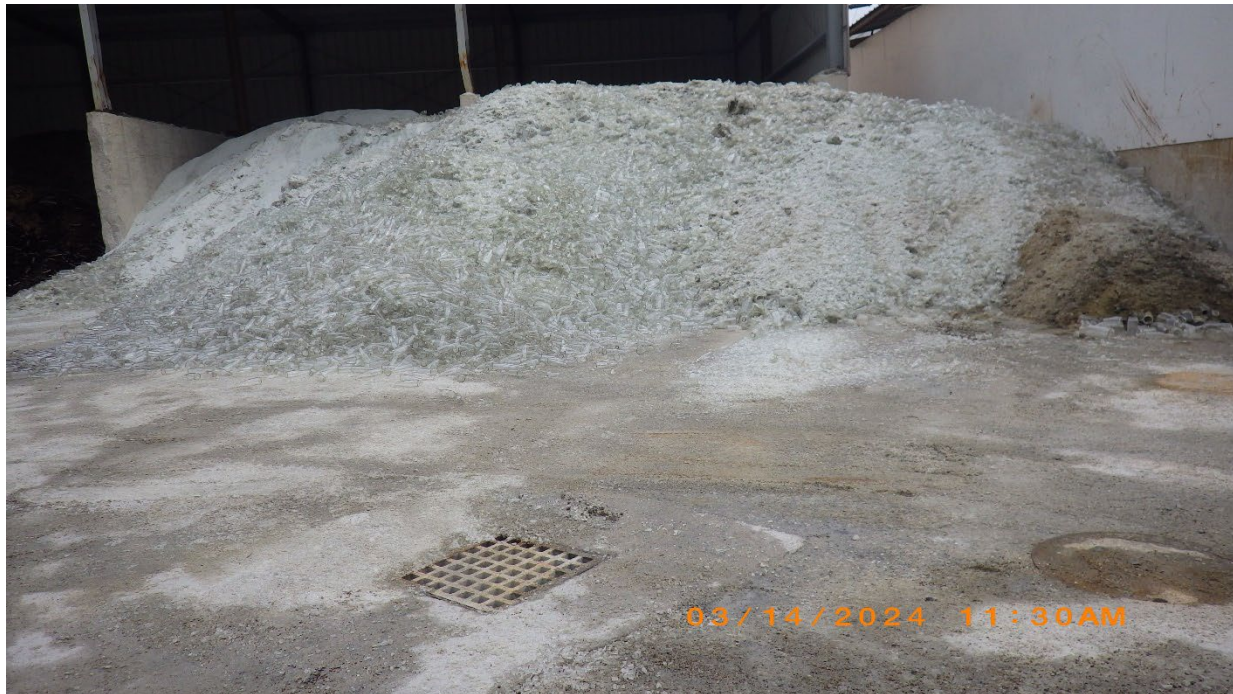
1: ARDA0377

Description: Hot flint cullet cooling pile. Square storm grate in front of the cullet pile is connected to the sanitary sewer and the round manhole at bottom right is connected to the storm sewer.

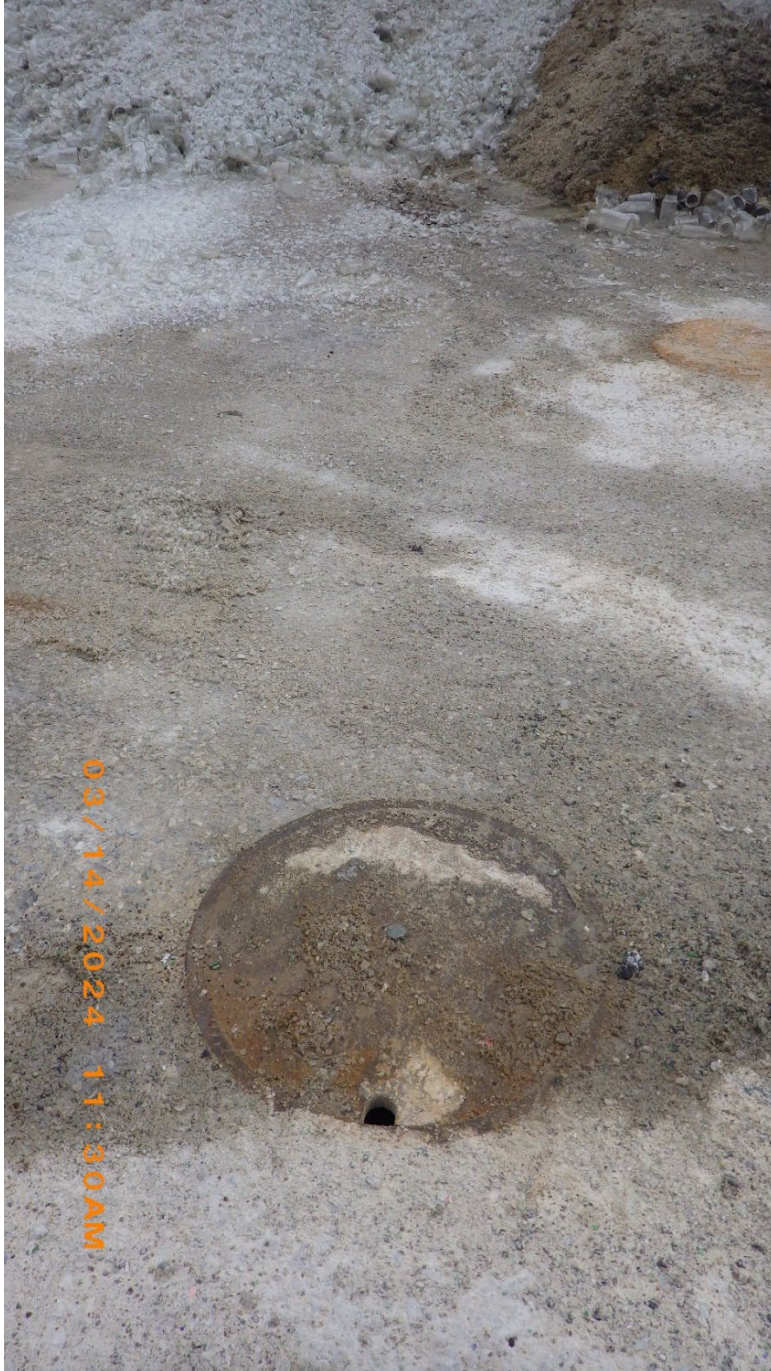
2: ARDA0378

Description: Round manhole with open access hole next to the hot flint cullet cooling pile from Photo 1. Mr. King stated that the manhole is equipped with sock filters to prevent broken glass from reaching the outfall. The procedure is to periodically pressure backwash the storm sewers starting near the outfall and collect into a vacuum truck.

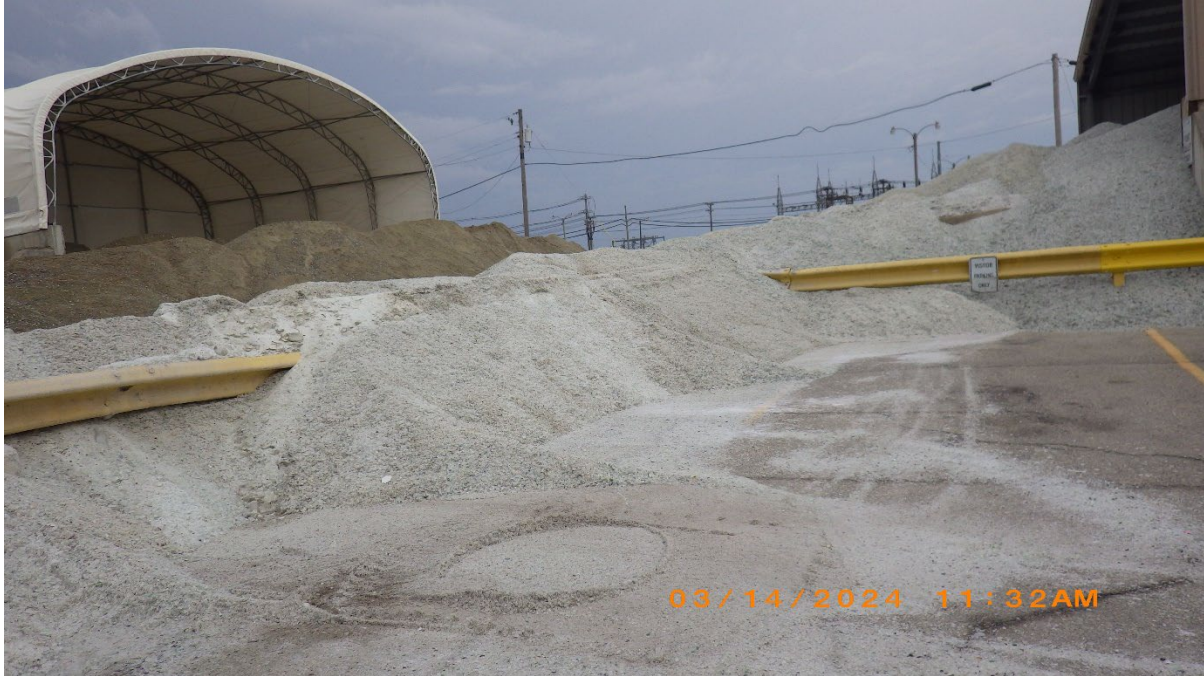
3: ARDA0379

Description: Yellow barriers demarcate the visitors parking lot located next to flint cullet pile. Cullet has overflowed and covered a concrete block wall which is located behind the yellow barriers. In rear right, the amber covered enclosure is visible and on the right the flint covered enclosure is visible and cullet is seen inside and outside of both enclosures.

We continued walking through the parking area and cullet piles. I noted cullet covering and overtopping concrete blocks next to and spilling over into the visitors parking area (Photo 3). I also noted two covered structures in the cullet storage area but the flint and amber cullet piles were significantly larger than the covered structures (Photos 3-5). At the end of the site visit, Mr. Maraldo and I returned and observed significant flow entering two different storm drains located in the visitor's parking area (Photos 33-34).

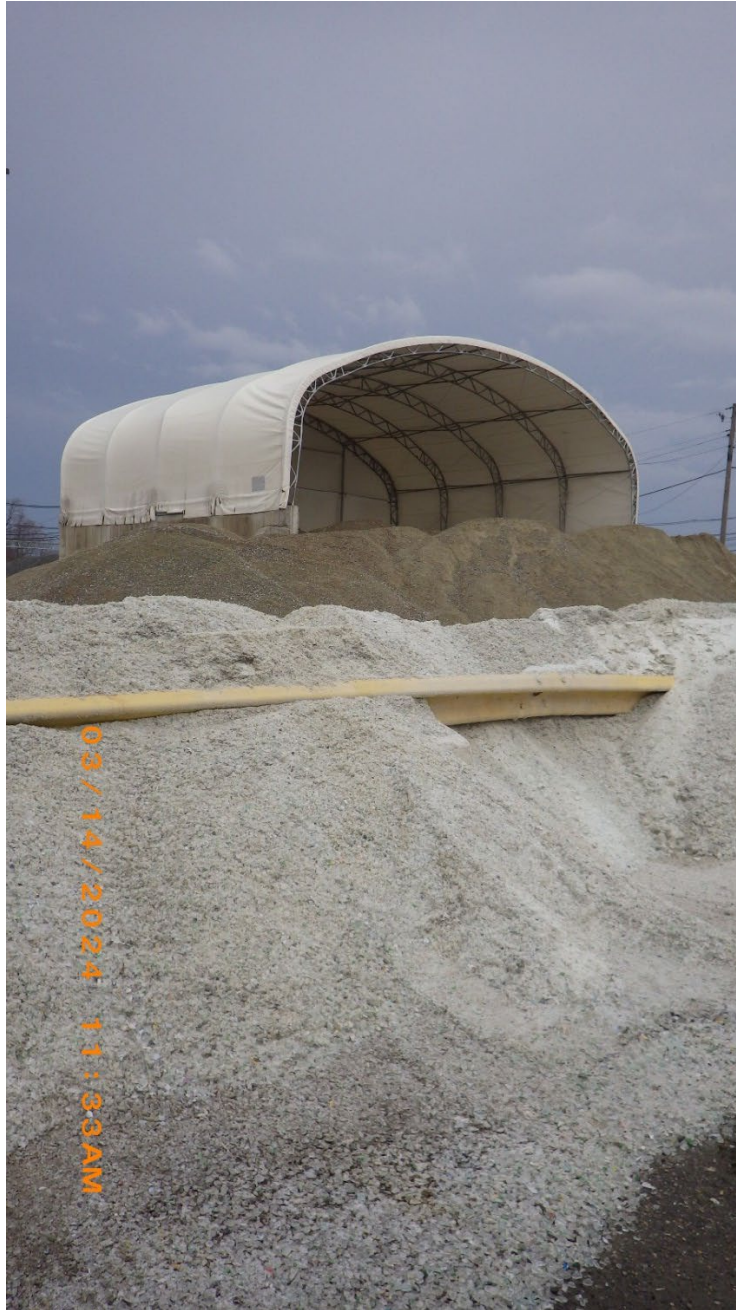
4: ARDA0380

Description: View of same enclosure and yellow barrier from the Visitor's parking lot as Photo 3. Flint cullet is in foreground and amber cullet is in rear ground.

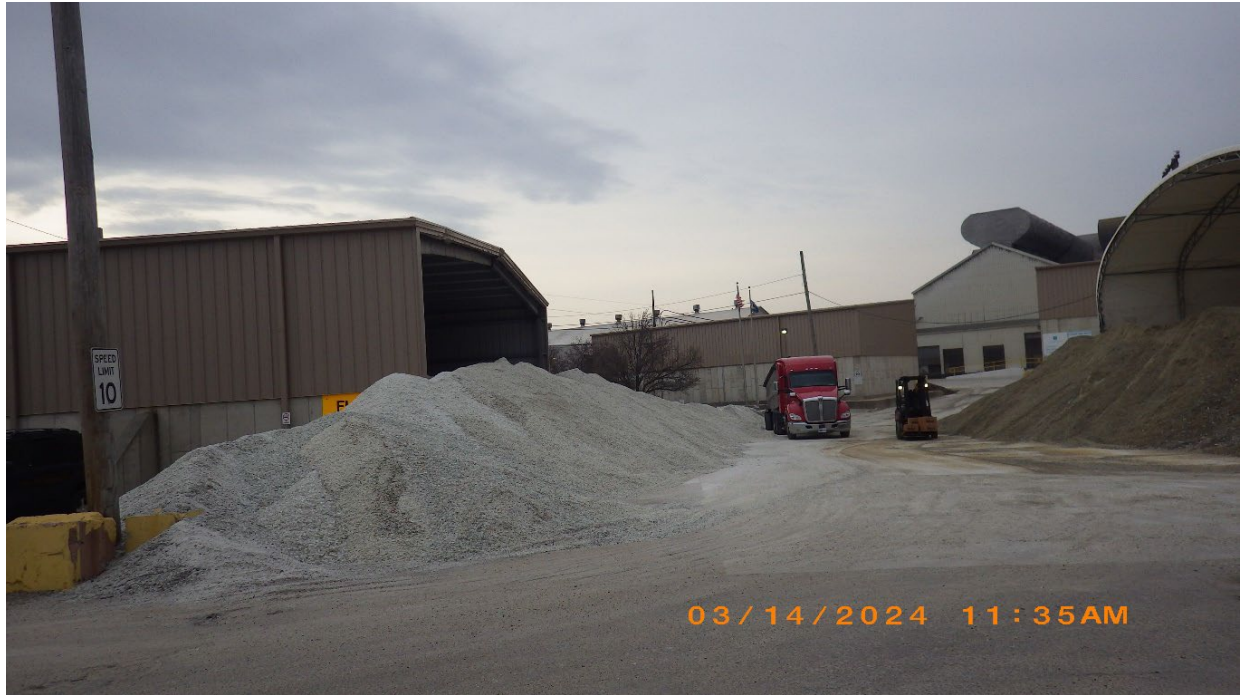
5: ARDA0381

Description: View of same two enclosures as Photo 3 from different angle. Flint cullet pile is on left and amber cullet is on right. A yellow concrete wall can be seen on the bottom left with the flint cullet on top and outside of the concrete wall.

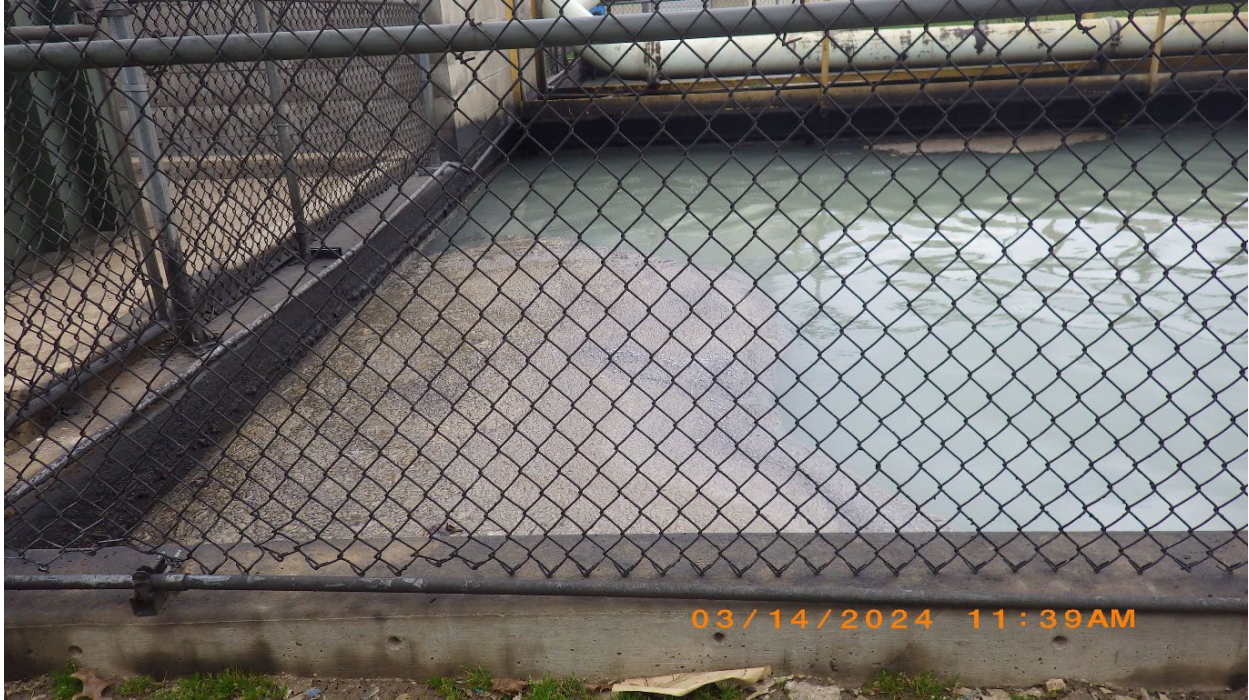
6: ARDA0382

Description: West aeration basin with floating scum visible in corner. Note some black flecks floating in the aeration basin near the scum. Black scum line can be seen built up on the edge of the aeration basin.

aerator was operating in each basin. I observed floating scum buildup on west aeration basin, black flecks floating in the aeration basin and a black scum line on the basin at the water's edge. Mr. Ostrowski noted that the floating scum is vacuumed out by Crystal Clean but they do not clean the scum off the back of the basin, only remove any accumulated floating scum. Inside the water barn, two oil water separators (Photos 13-14), two sludge thickener tanks, and enzymes and nutrient additions (Photos 9-10) are located. Mr. Ostrowski showed the valve to bypass the oil water separators and I observed that it was locked and a sign was present (Photo 12).

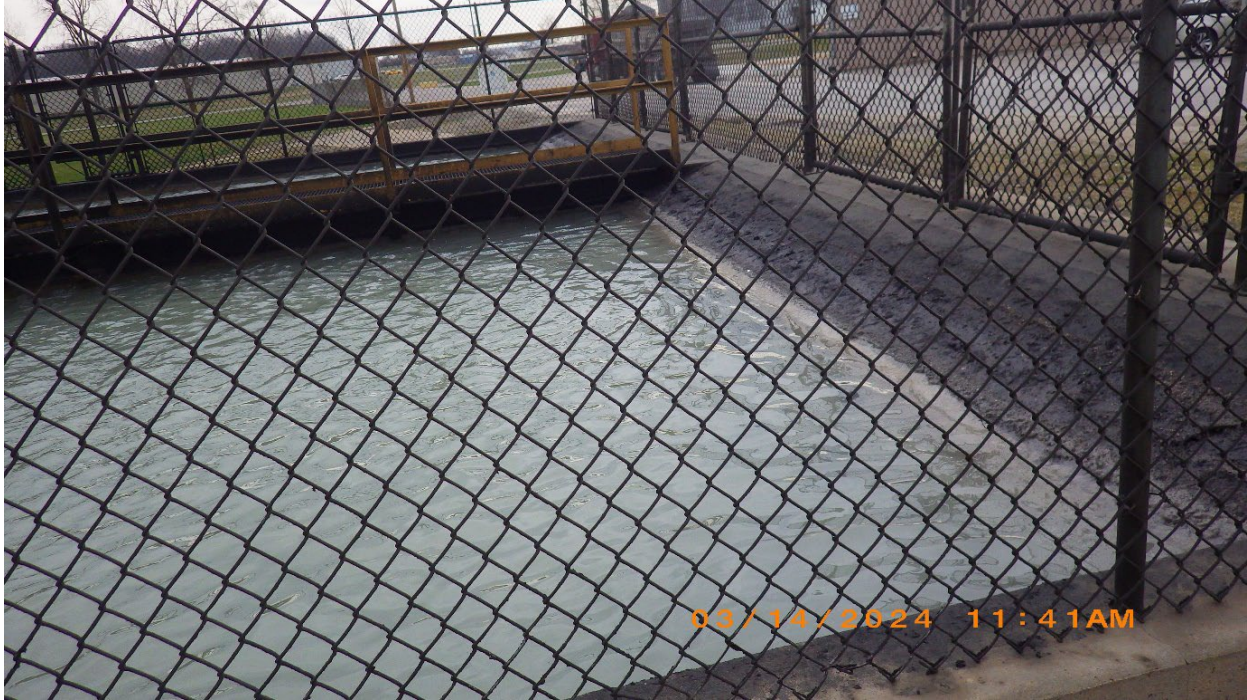
7: ARDA0383

Description: West aeration basin with black scum line.

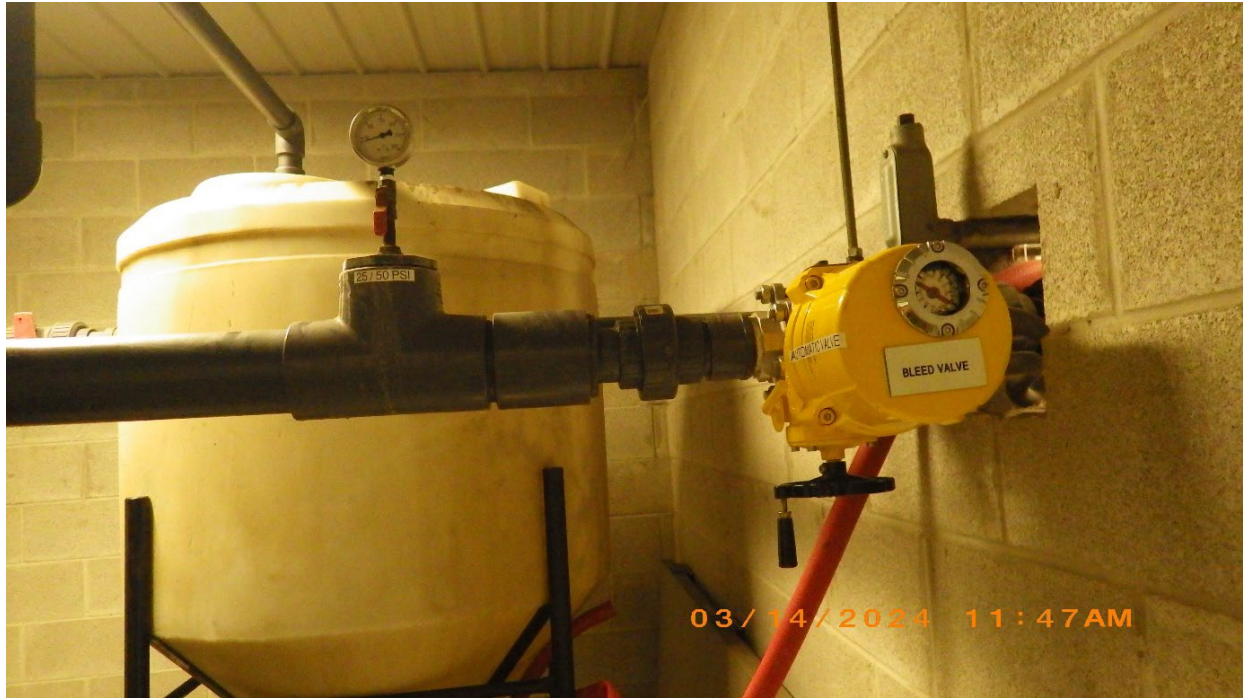
8: ARDA0384

Description: Bleed value open at 60 percent. This can be manually adjusted to keep the levels in the aeration basin and the recirculating water steady. The industrial wastewater discharge occurs through this bleed valve.

After treatment wastewater is recirculated as cullet cooling water, any additional wastewater beyond what was used passes through the bleed valve. The valve is manually adjusted to keep the levels in the aeration basin and the recirculating water steady. I observed that the valve was reading at 60% open during inspection (Photo 8). There is a sample point just beyond the bleed valve used for internal dosing. I observed a logbook and Mr. King stated that samples were collected for internal process control (Photo 11) and not for regulatory compliance.

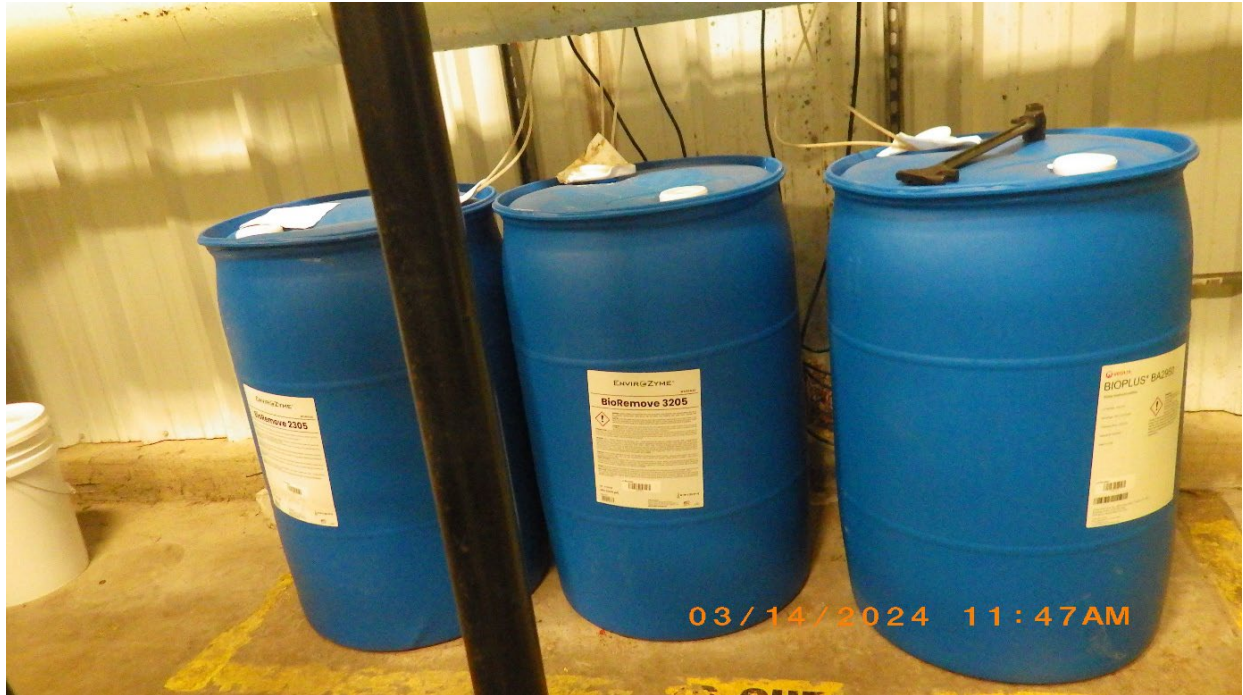
9: ARDA0385

Description: Enzymes and nutrients for hydrocarbon degradation which are added to the wastewater in the aeration basin.

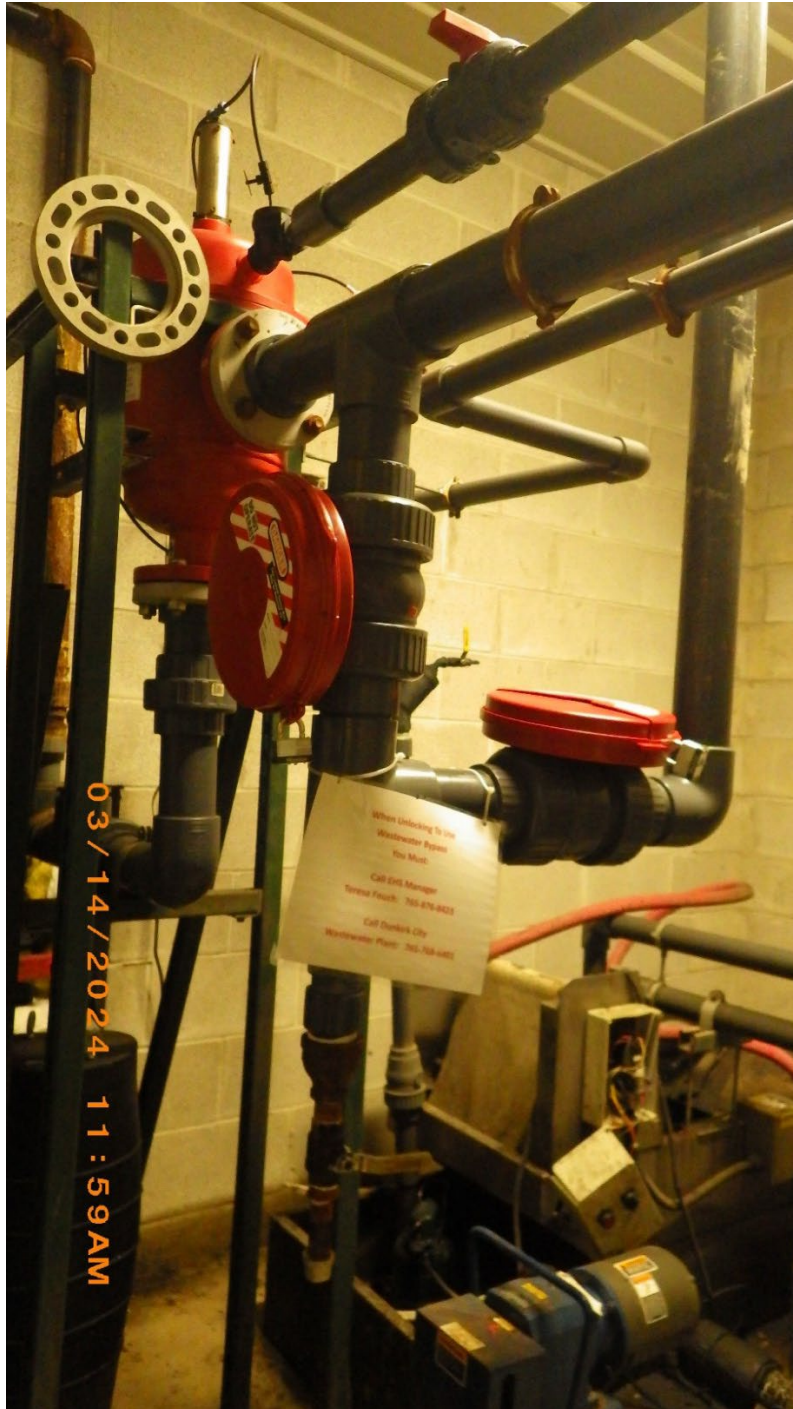
12: ARDA0388

Description: Locked oil water separator bypass valve with a sign that indicates it is locked and to call manager. According to Ms. Fouch the lock and sign were installed November 10, 2023.

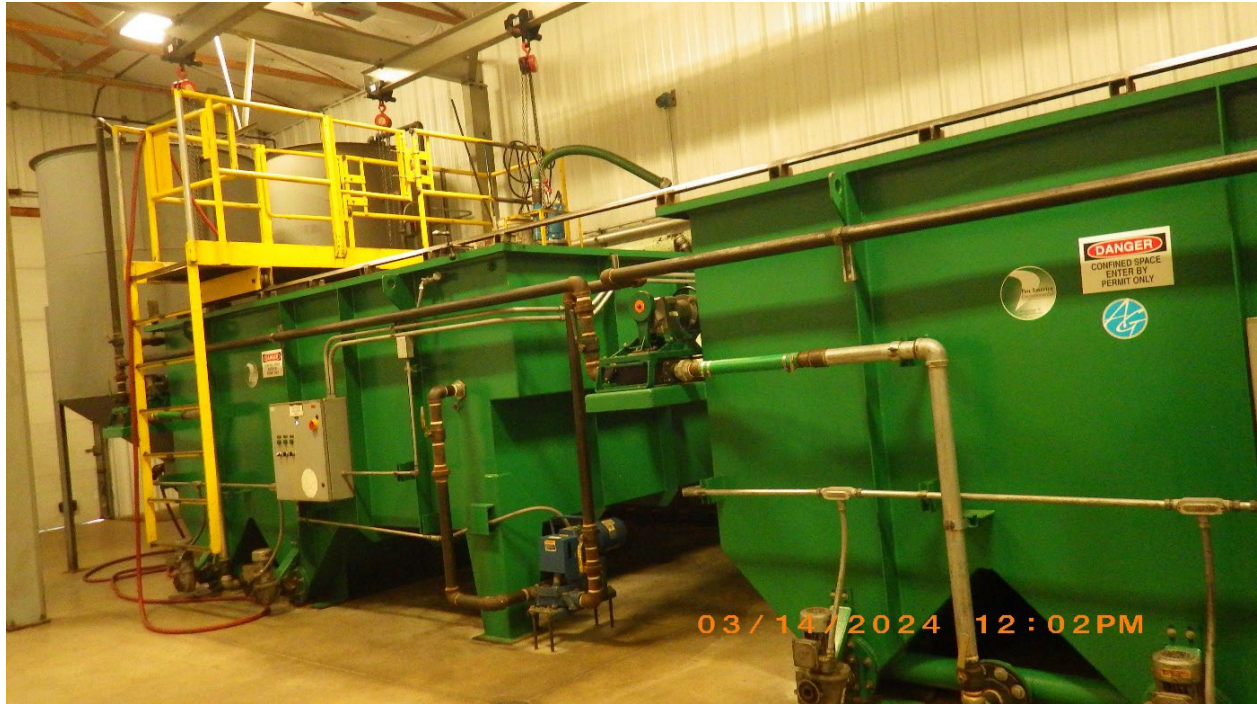
13: ARDA0389

Description: Two oil water separators in green and two oil thickeners on back left. Crystal clean will periodically collect the thickener waste. Mr. King stated that maintenance is to spray the augers on the oil water separators daily.

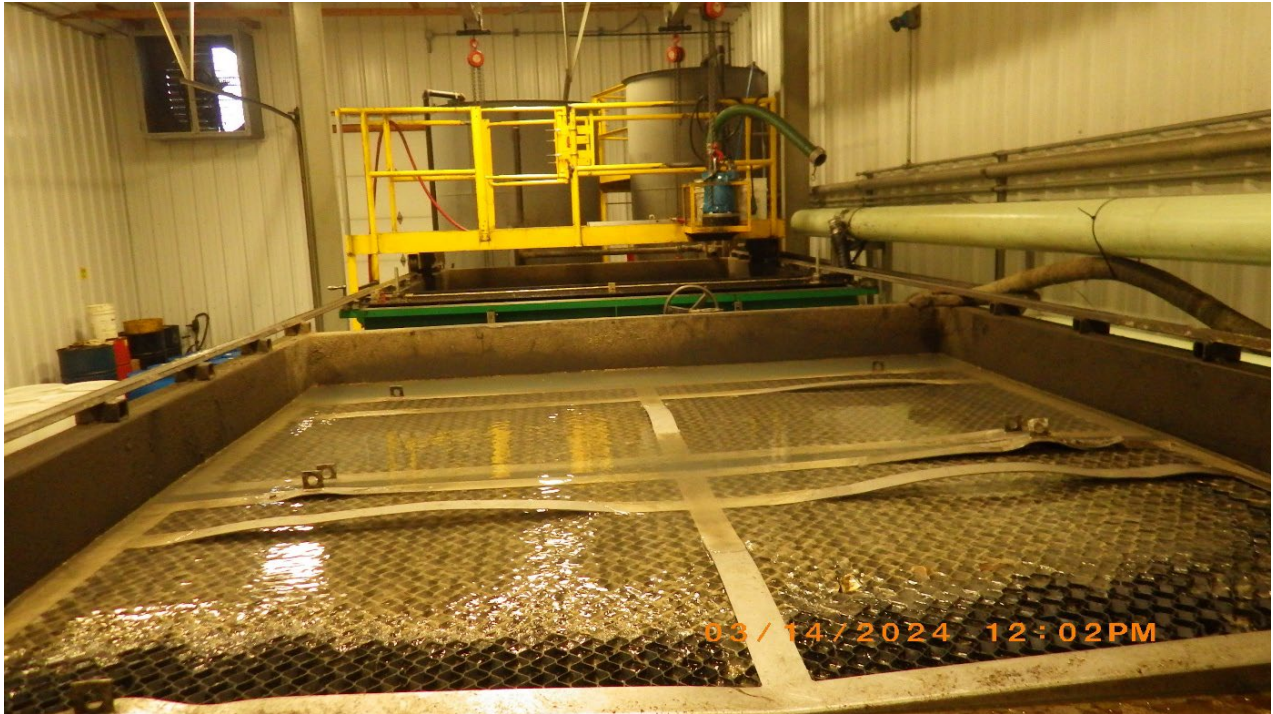
14: ARDA0390

Description: View of the top of oil water separators and oil thickeners in rear.

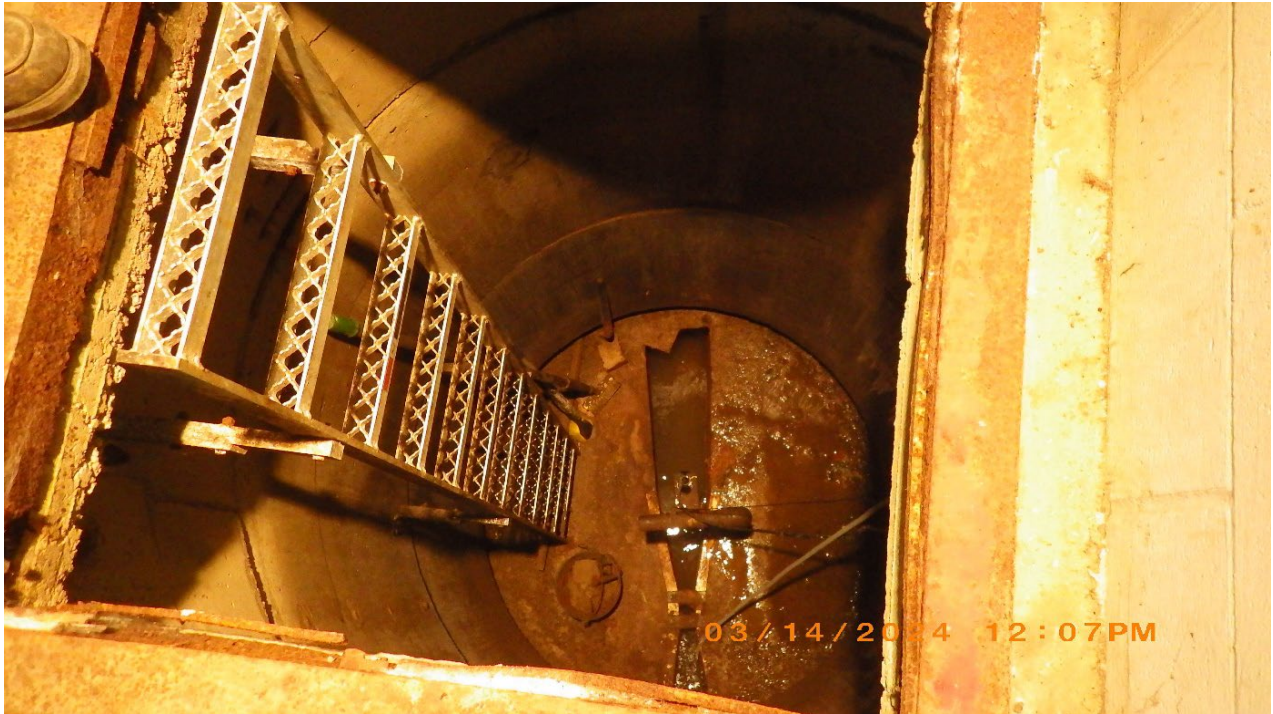
15: ARDA0391

Description: View into open vault of the combined wastestream and Parshall flume used for flow monitoring. An autosampler collects regulatory samples at this point.

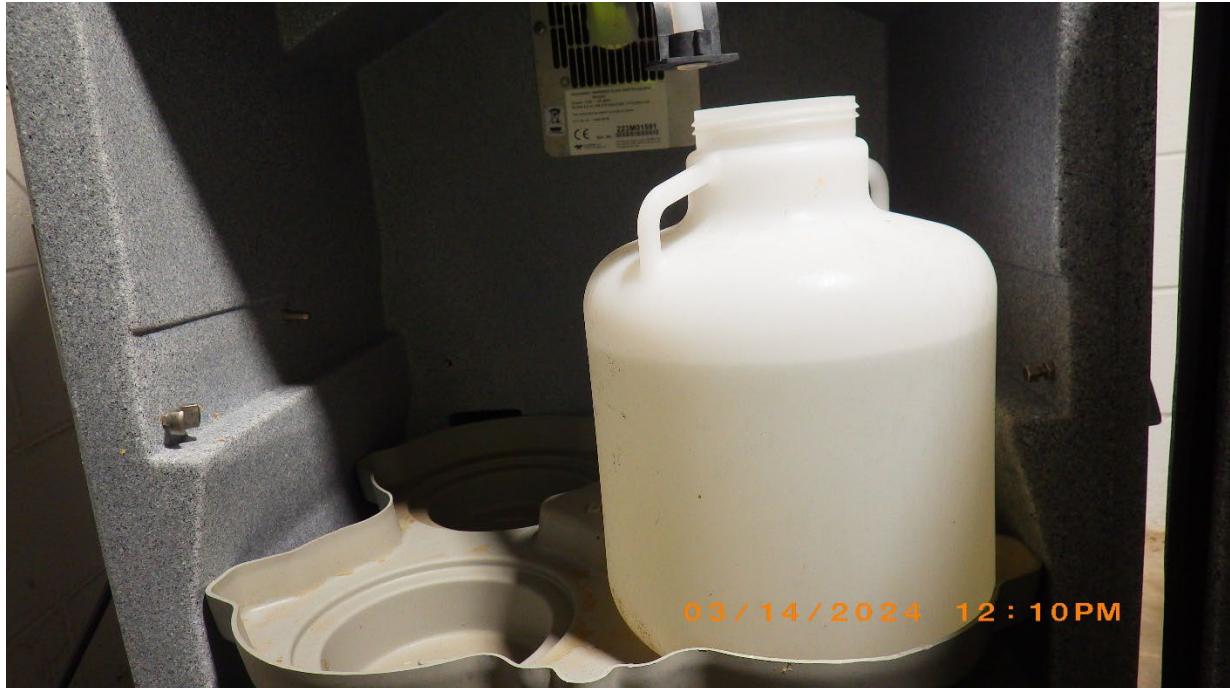
16: ARDA0392

Description: View into autosampler which was not collecting a sample at the time of inspection.  
Note, thermometer is not present and tubing is not aligned with the sample collection jug.

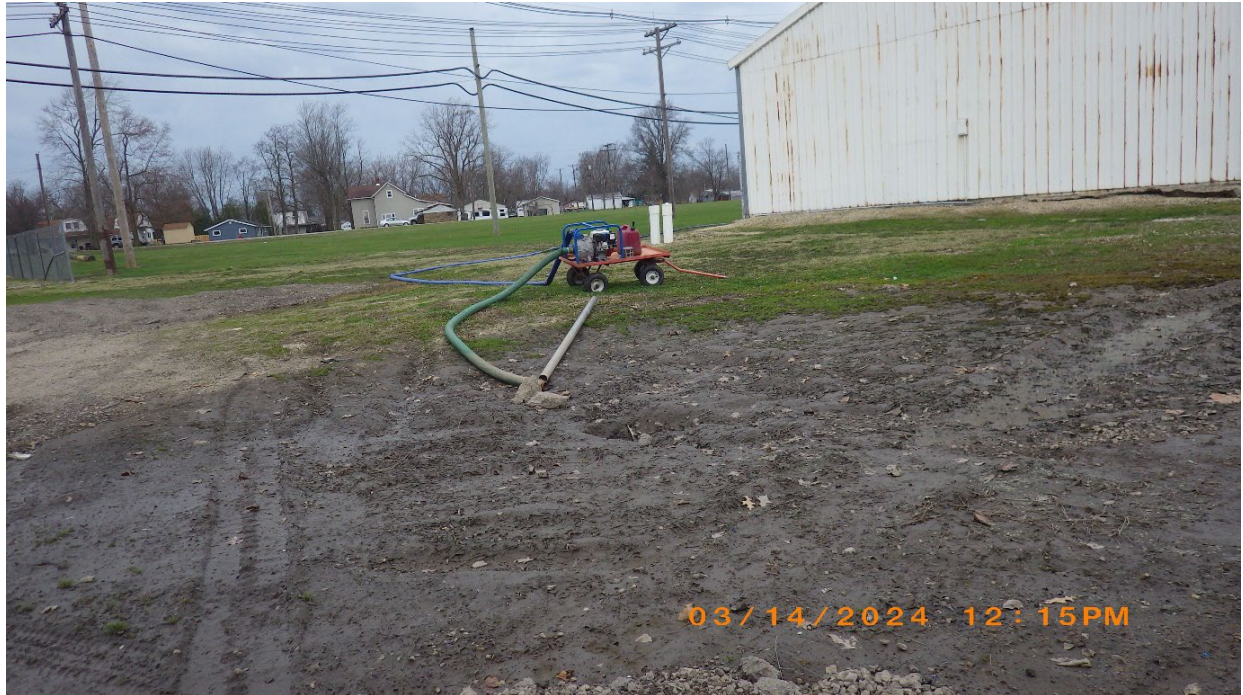
17: ARDA0393

Description: Portable pump set up near edge of paved parking lot to remove pooled stormwater and relocate to the grass yard.

While walking outside of the sample hut and towards the employee parking lot, I observed a portable pump located near a stormwater drain (Photo 17). Mr. King stated that this pump was necessary to prevent the parking lot from flooding, since stormwater would accumulate in this area.

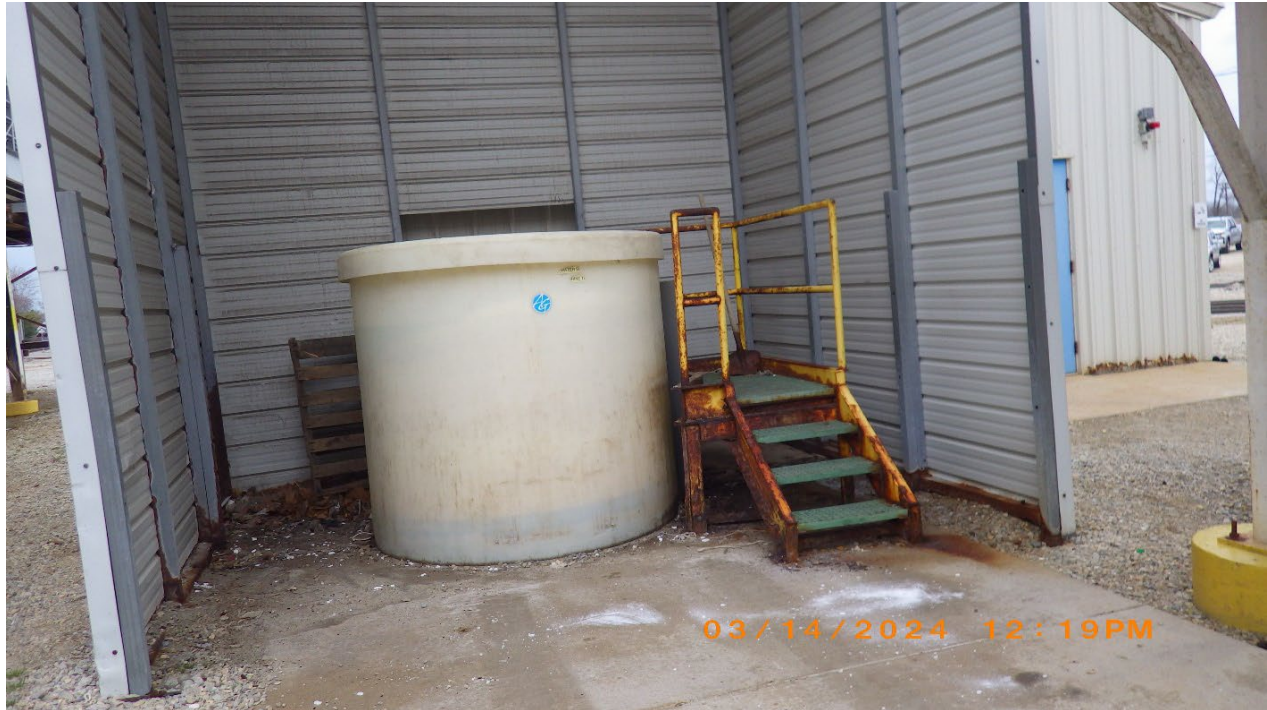
18: ARDA0394

Description: Water softener brine tank located outside and underroof.

We walked to the building that houses the water softener and iron removal treatment for process water sent to the watertower. Brine water tank is stored outside of the building and underroof (Photo 18). Mr. King identified that he would "fluff" the iron removal sand media with pressurized air. At the time of the inspection, I observed that orange water was sitting on the floor. I noticed a drip on the iron removal treatment which had a panel installed to move the water from hitting the treatment tank and instead fall onto the floor (Photo 19). In the same building, near the entry, I noted a drain (Photo 20). When I asked where this drain leads to, Mr. King replied that if the building was flooded it would drain to the sanitary sewer, but the small amount of sitting water that I observed would not reach this drain.

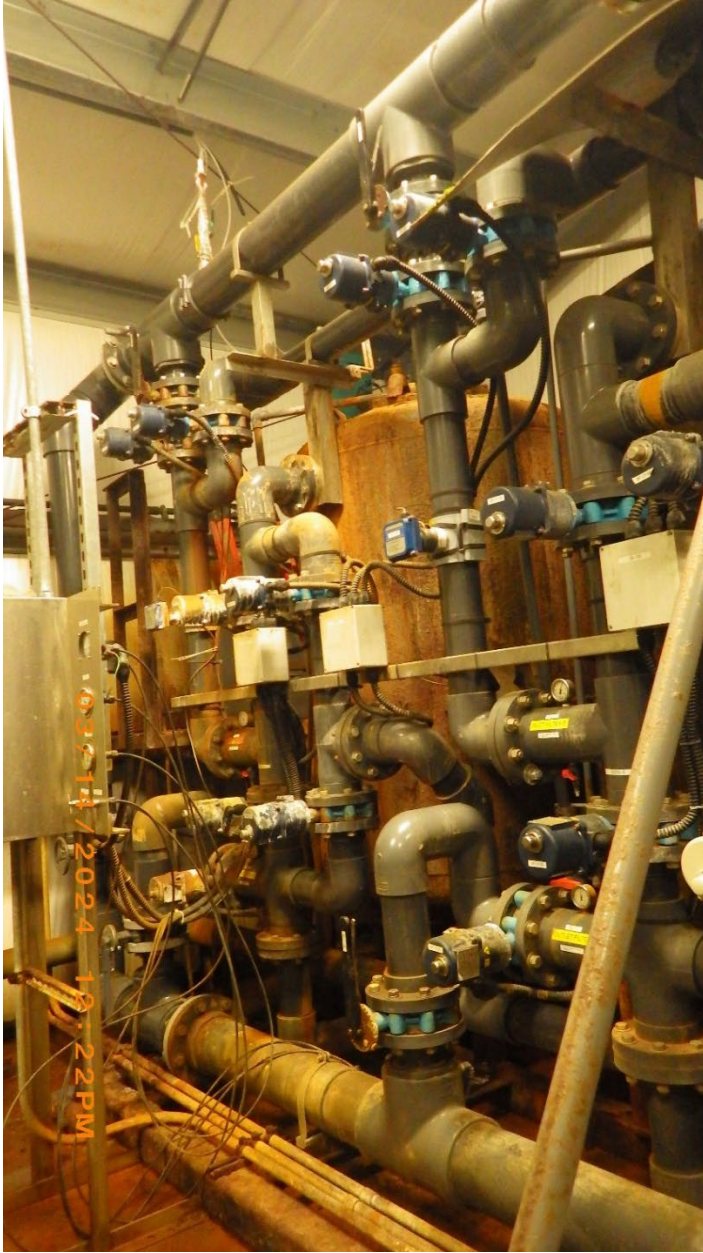
19: ARDA0395

Description: Iron removal sand filter located in water treatment building. Mr. King described the process of fluffing the sand media in the tank at the center. At the time of inspection, a panel was placed on top of the piping (top right) which would relocate a drip to the floor and not onto the pipe. At the time of the inspection, I observed orange water on the floor (bottom left).

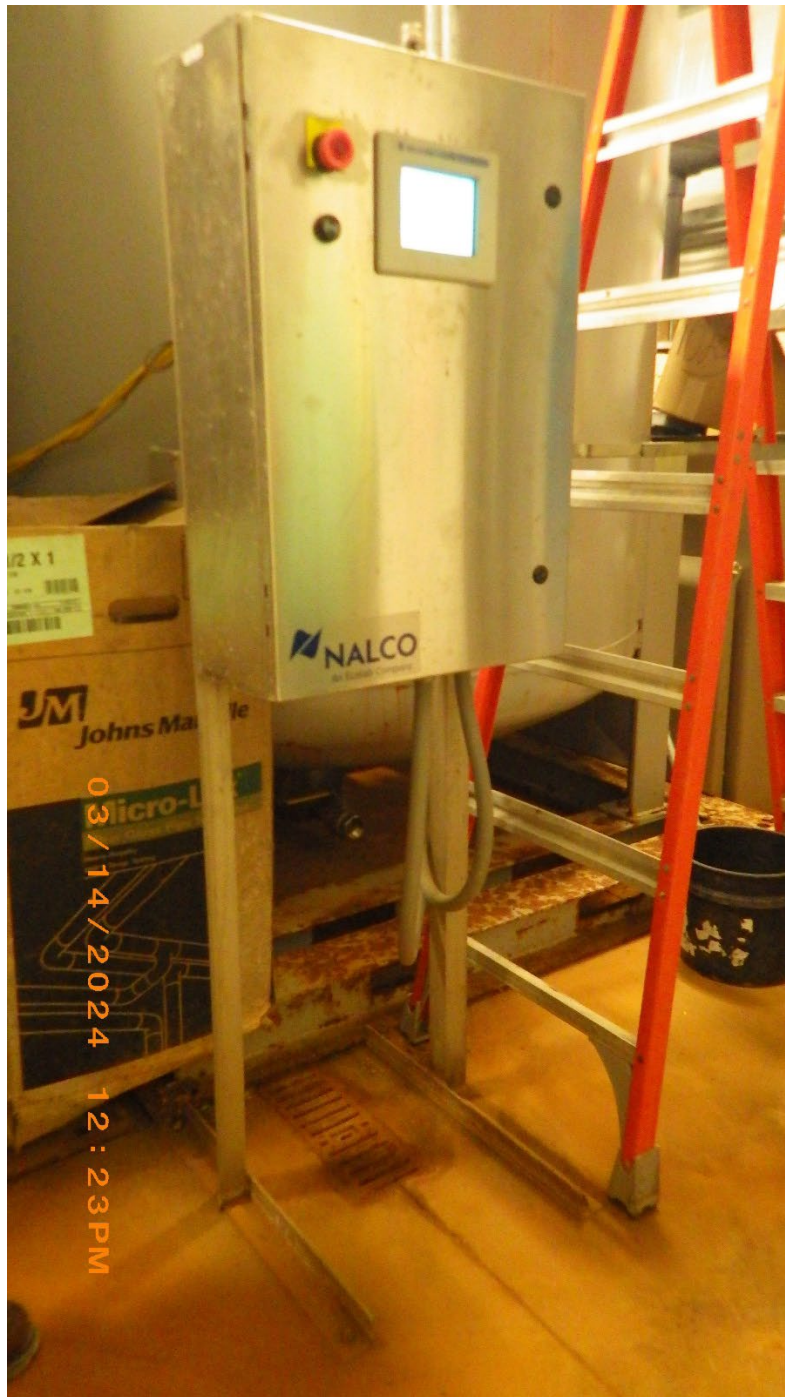
20: ARDA0396

Description: Drain in water treatment room which discharges to the sanitary sewer. Nalco controls determines ratio of city water and well water that the water tower receives for use in industrial processes.

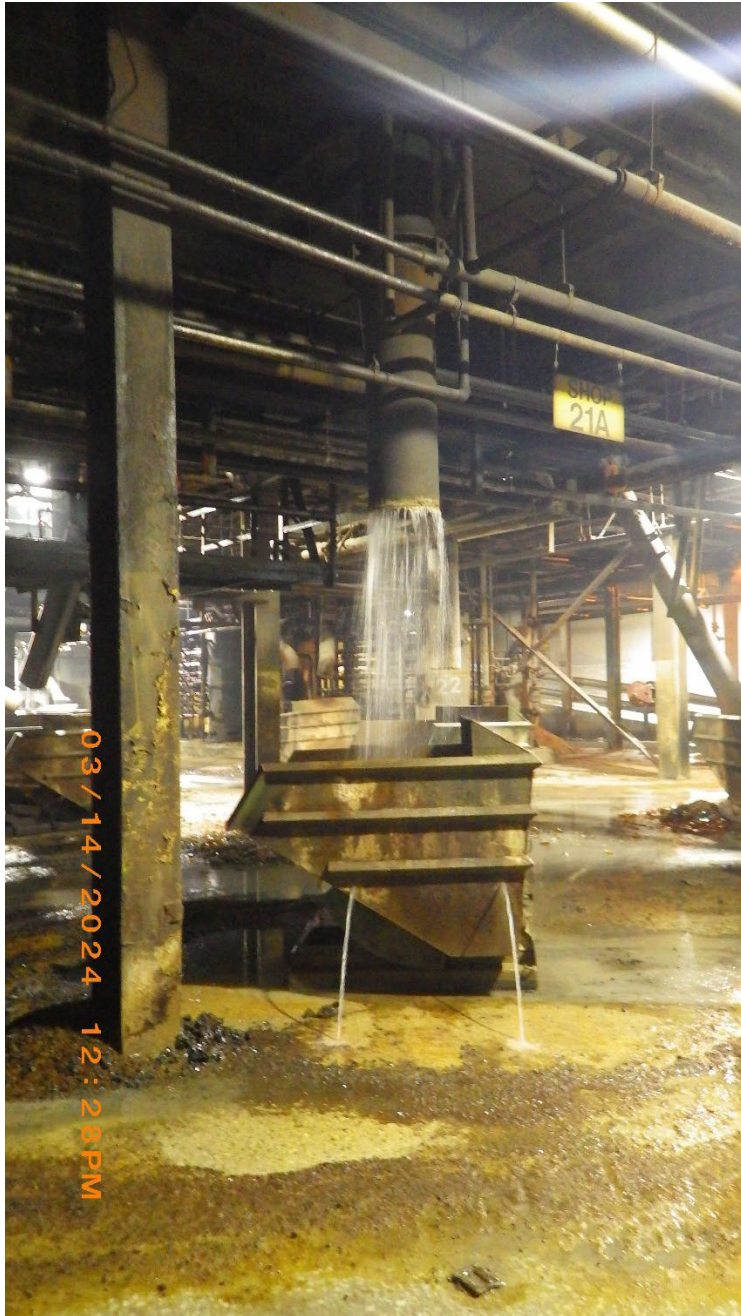
21: ARDA0397

Description: Cullet cooling water discharging in the basement and, while not pictured, hot cullet will also fall into the dumpsters. Wastewater flows through the holes in the dumpsters to the basement floor and is directed to the grit chamber for entry in the pretreatment system. Forklifts systematically discard cullet in dumpsters to the hot cullet pile for cooling. I observed sand and broken glass also on the basement floor.

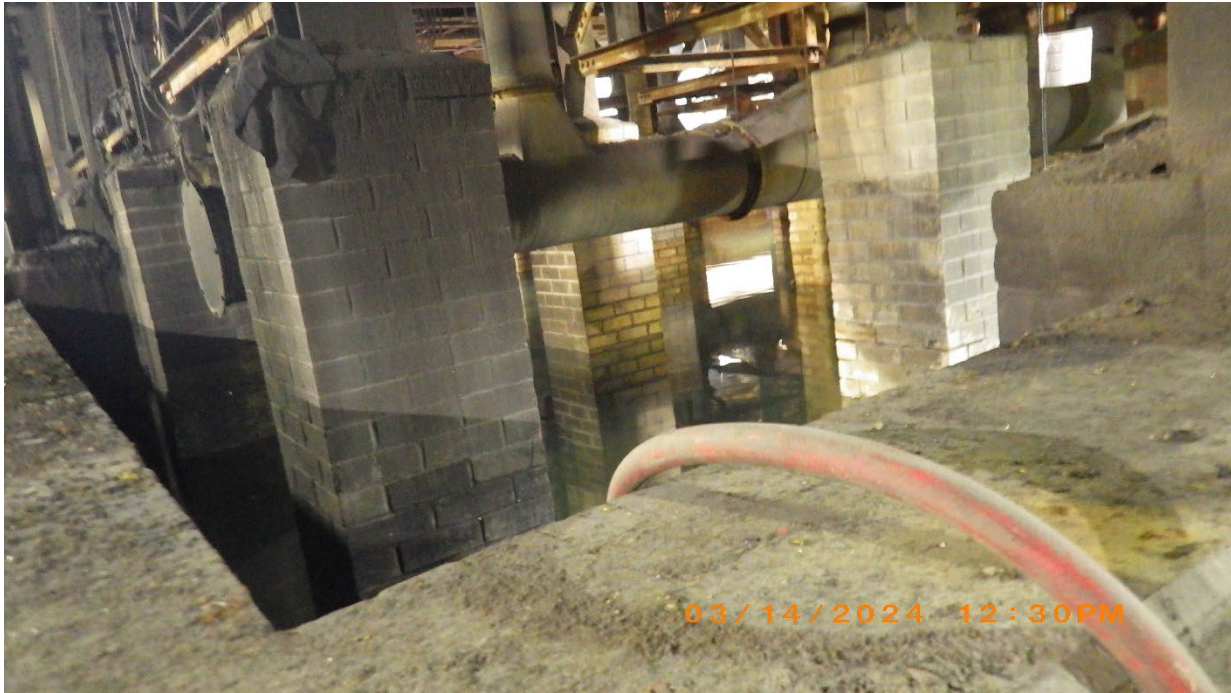
22: ARDA0398

Description: View inside the secondary containment wall into the flooded glass containment area. A hose was located in the flooded containment area and discharging water onto the basement floor.

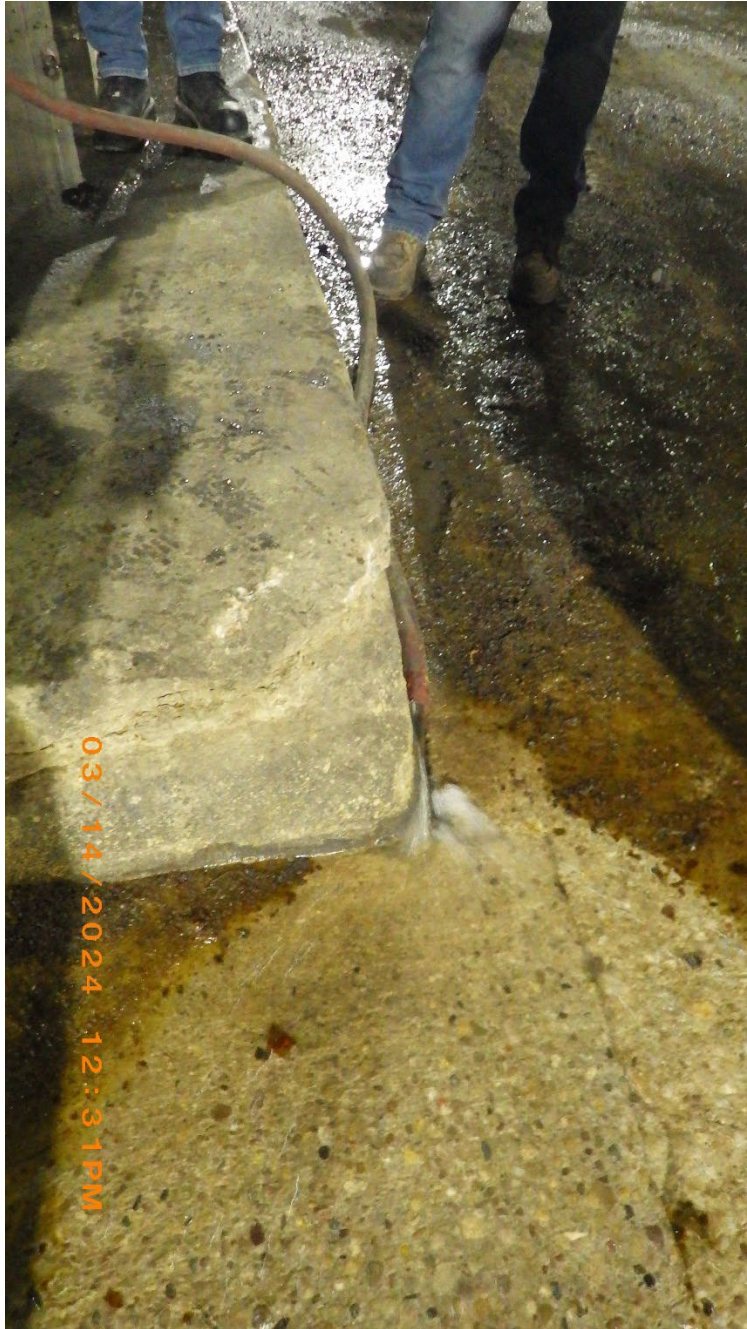
23: ARDA0399

Description: View of hose from Photo22 discharging water from glass containment area onto the basement floor.

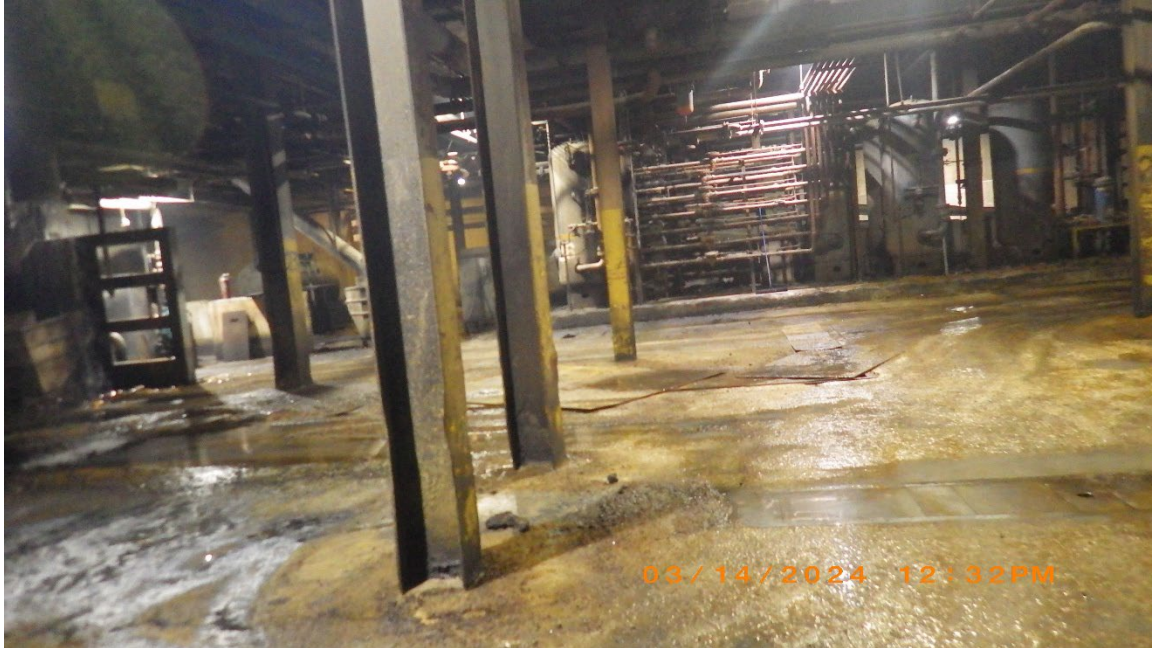
24: ARDA0400

Description: Basement floor with wastewater, sand, and glass. Mr King indicated that the grit chamber is located under the metal plates in the center of the photograph. Due to the hazards of falling cullet, inspectors did not view the grit chamber up close.
