COMPLIANCE EVALUATION INSPECTION REPORT  
U.S. ENVIRONMENTAL PROTECTION AGENCY, REGION 5

**Purpose:** Clean Water Act National Pollutant Discharge Elimination System (NPDES)  
Compliance Evaluation Inspection

Ardagh Glass, Inc.  
524 East Center Street  
Dunkirk, Indiana 47336

**Dates of Inspection:** March 13 - 14, 2024

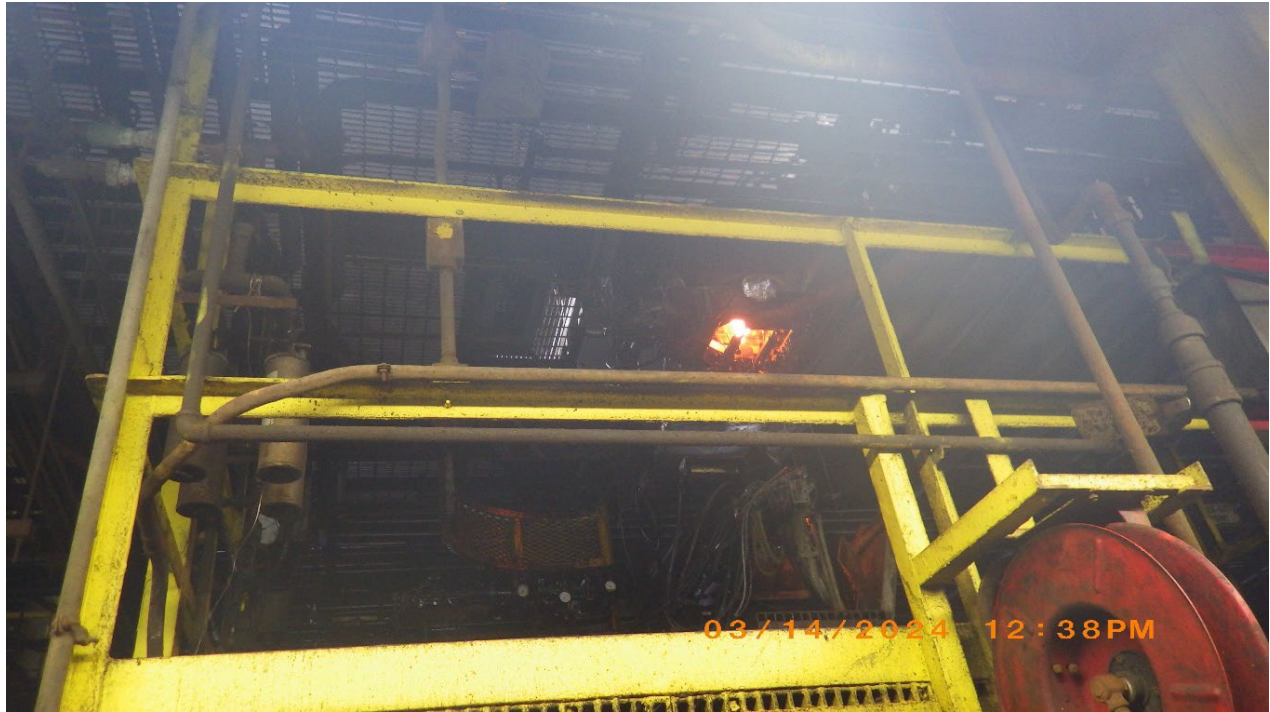
25: ARDA0401

Description: View looking up at sheet as orange gobs are cut and fall onto the IS machine (below and outside of photo). I observed sheer water, which contains sheer oil, falling along with the gobs.

We next went to the processing floor (directly above the basement) where the IS machines are located (Photos 25-28). We viewed the gob shear location where shear oil is used (Photo 25). We observed swab oil (Photo 27) being applied to molds and volatilizing. We noted the drains for cooling water which is collected in the basement (Photo 26). Mr. King identified the drains that would be used for floor cleaning (Photo 28). I observed a black residue on the floor and equipment, and Mr. Ostrowski told me that this was in part due to volatilized swab oil.

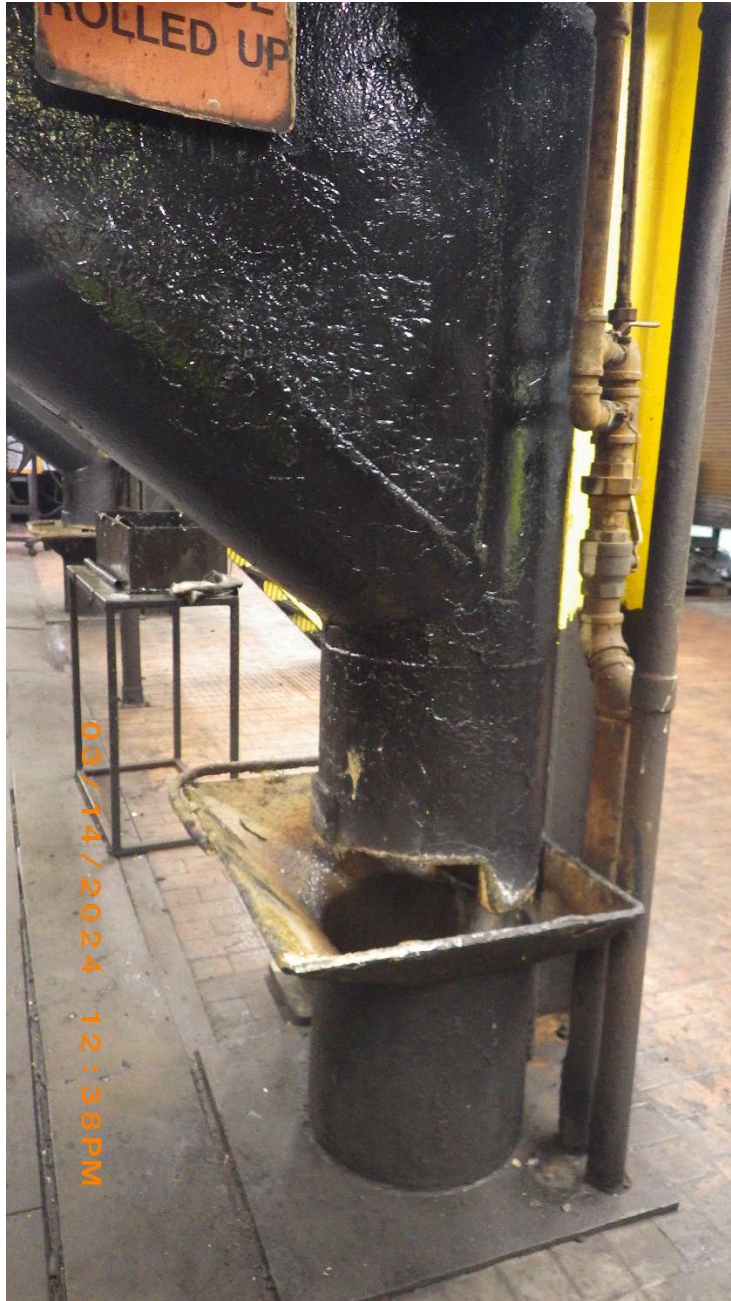
26: ARDA0402

Description: Funnel and chute which collects and transfers process cullet water to basement. The funnels are connected to the pipe discharging wastewater from Photo 21.

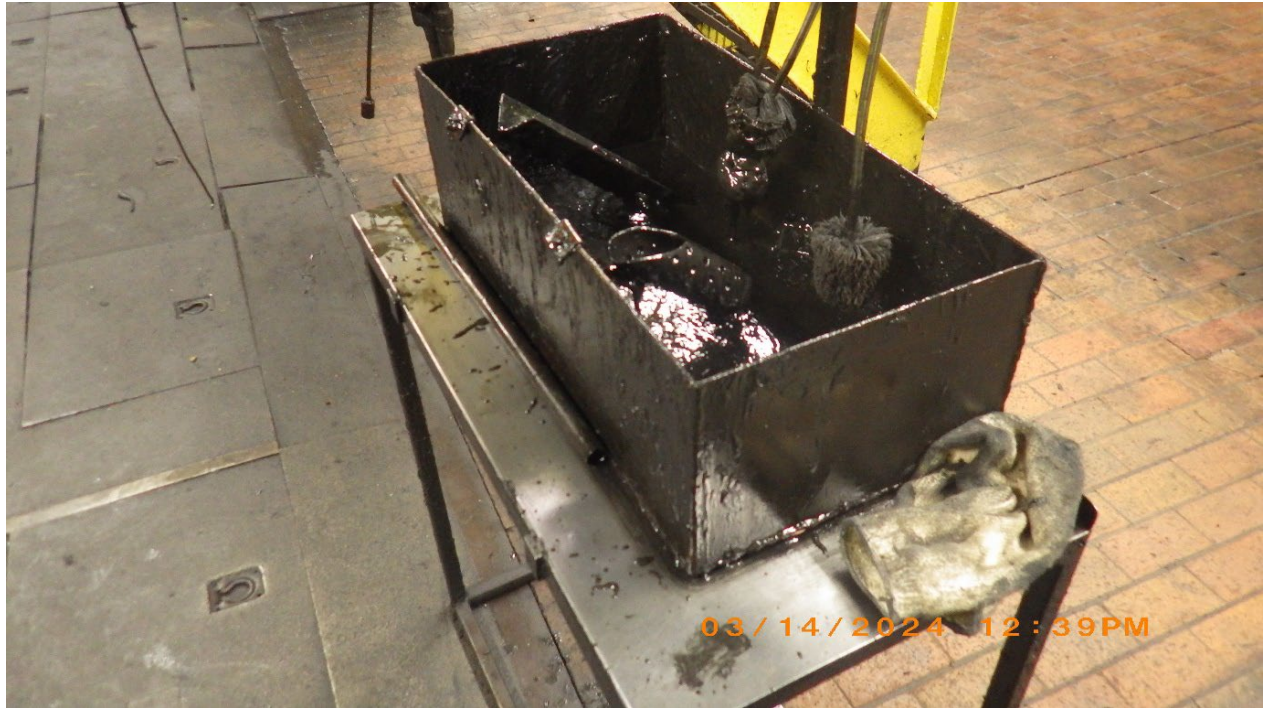
27: ARDA0403

Description: Swab oil and swabs used to lubricate molds.

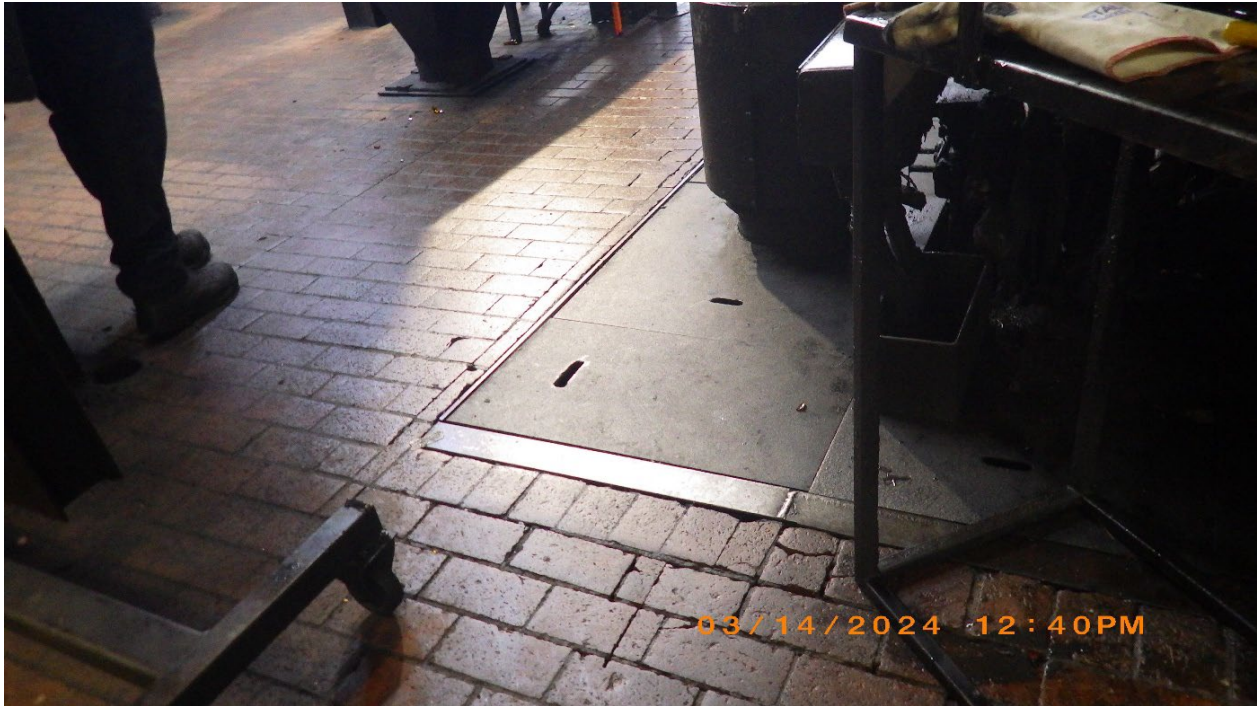
28: ARDA0404

Description: Floor drains on main floor under IS machines. Mr. King explained that when the floors are washed the water discharges to the basement through these floor drains.

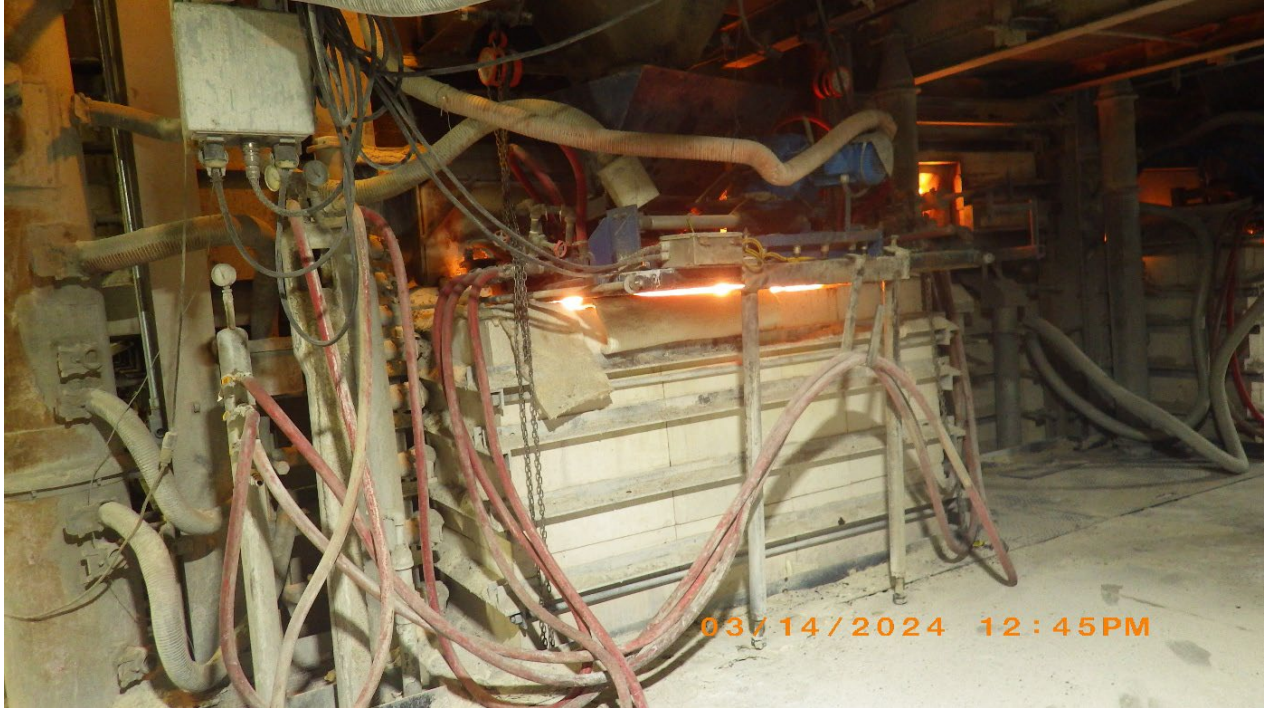
29: ARDA0405

Description: Side of charger with visible molten glass in charger. The short end of the rectangular charger is visible where ingredients are added to the furnace. Electrodes along the long end of the charger keep the molten glass at an even temperature.

We next went to the furnace floor directly above the processing floor. We observed the Furnace 2 and its forehearth with chargers (Photo 29). Mr. Ostrowski identified the location where a hot repair had recently occurred and the drains that would be used during the hot repair (Photo 30).

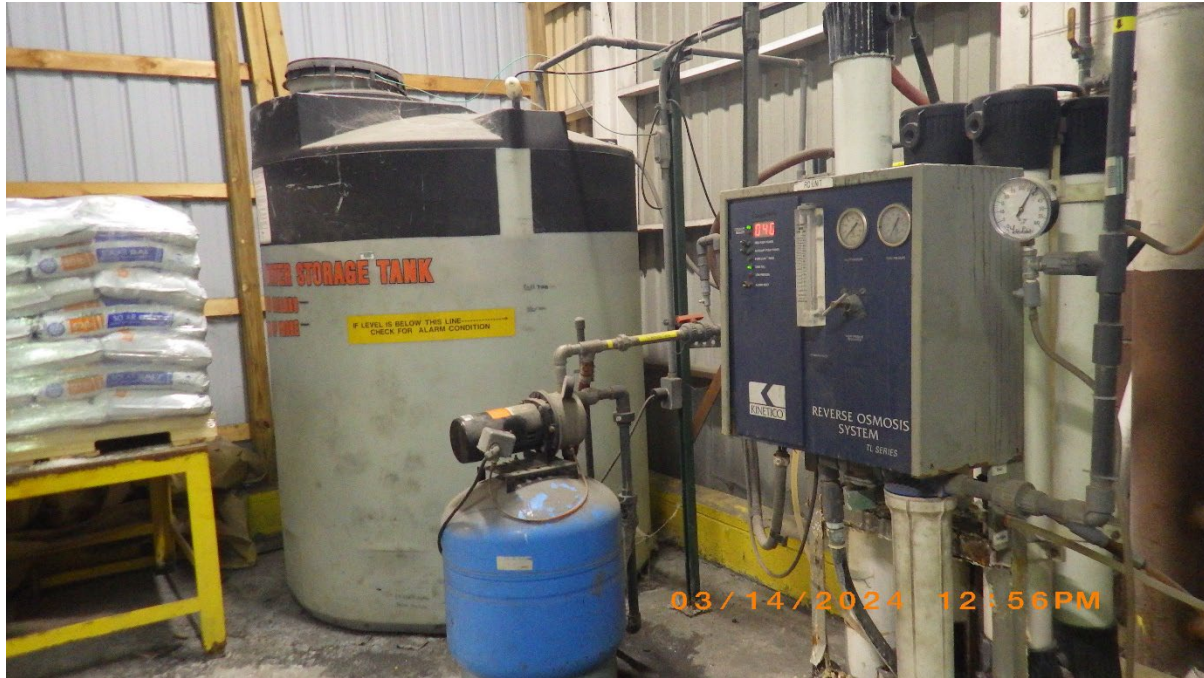
31: ARDA0407

Description: Duracote (also called poly-coat) water softener and reverse osmosis system and excess chemical stored in diked area on mezzanine level. Mr. Ostrowski explained that duracote allows the label to properly adhere to the bottles.

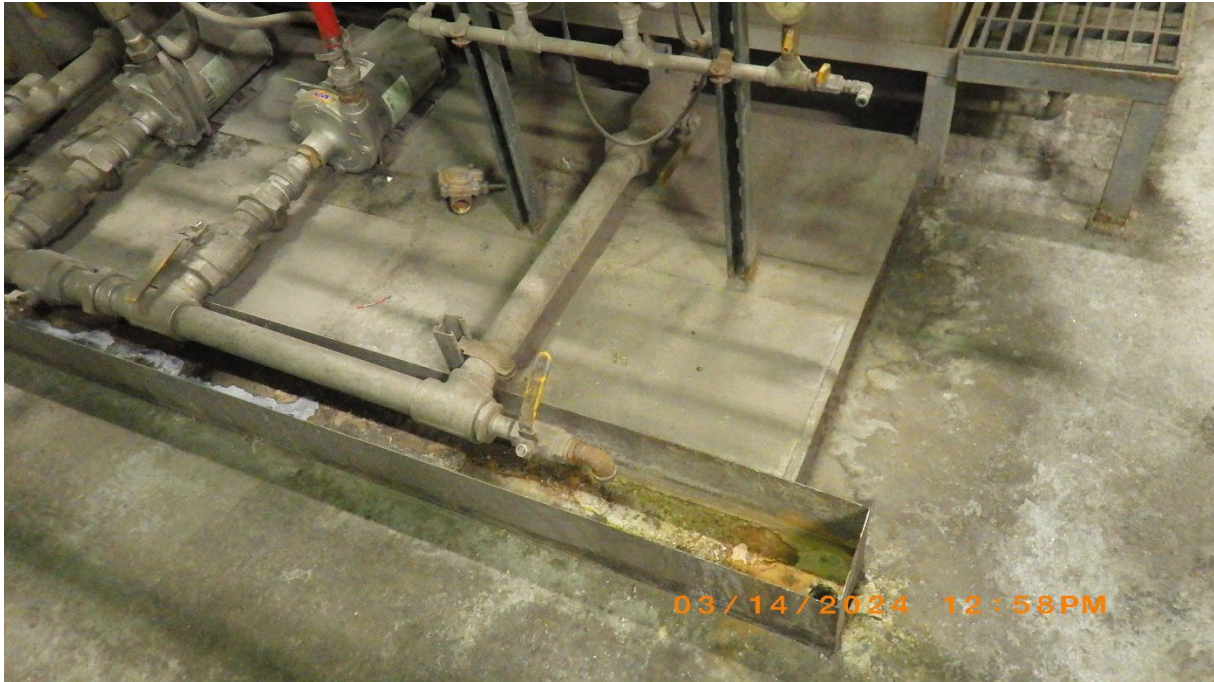
32: ARDA0408

Description: Drain located on the side of the Duracote mixer which is located outside the picture. Monthly the mixer is drained and is discharged to the basement and the pretreatment system.

We next observed the duracote applied onto flint bottles and Mr. Ostrowski informed me that any excess duracote is discharged to the basement to the pretreatment system. We then walked to the mezzanine where concentrated duracote was stored and mixed. I observed secondary containment surrounding this area, which included a small water softener unit, brine tank and mixer (Photo 31). The duracote mixer must be drained once a month through a drain that also flows to the basement. (Photo 32).

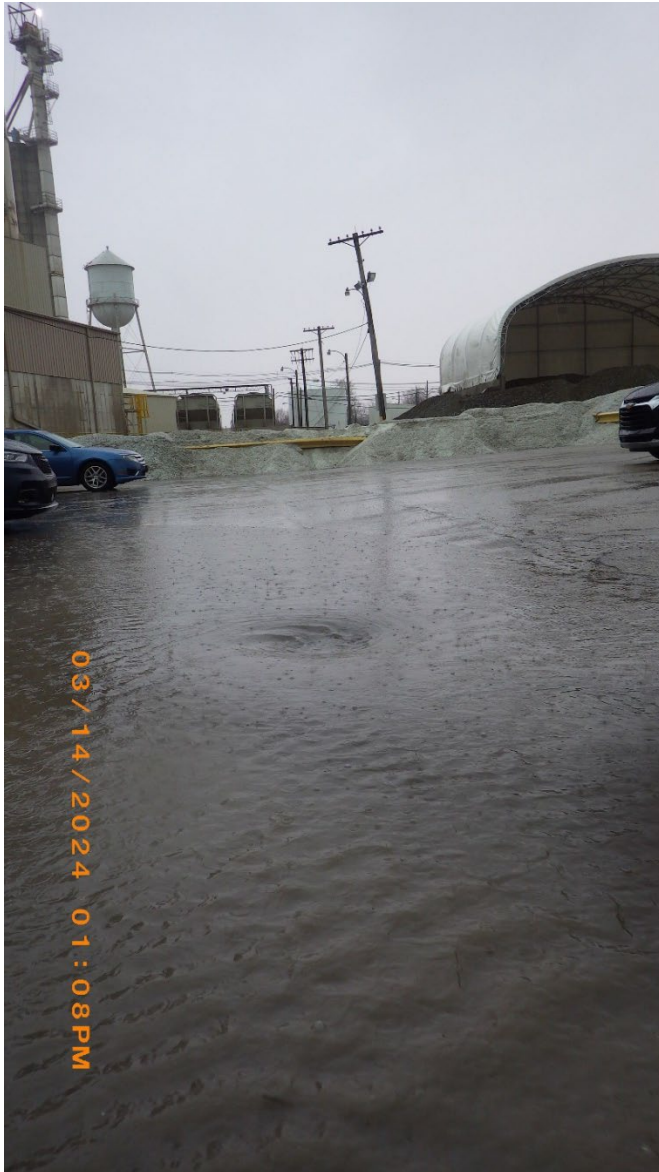
33: ARDA0409

Description: Drain in visitors parking lot. The stormwater flows from the surrounding parking areas and pools into this part of the parking lot. I observed a deep pool of stormwater and rapidly swirling water as the stormwater was entering this drain. The flint cullet is in rear. Same visitor's parking area as in Photo 3.

Once we finished at the processing building, a rain event had occurred and Inspector Maraldo and I viewed the stormwater drains next to the visitors parking lot (Photos 33-34) and I observed significant ponding and inflow. We also observed stormwater flow through the hot cullet cooling pile (Photo 35) towards the drain.

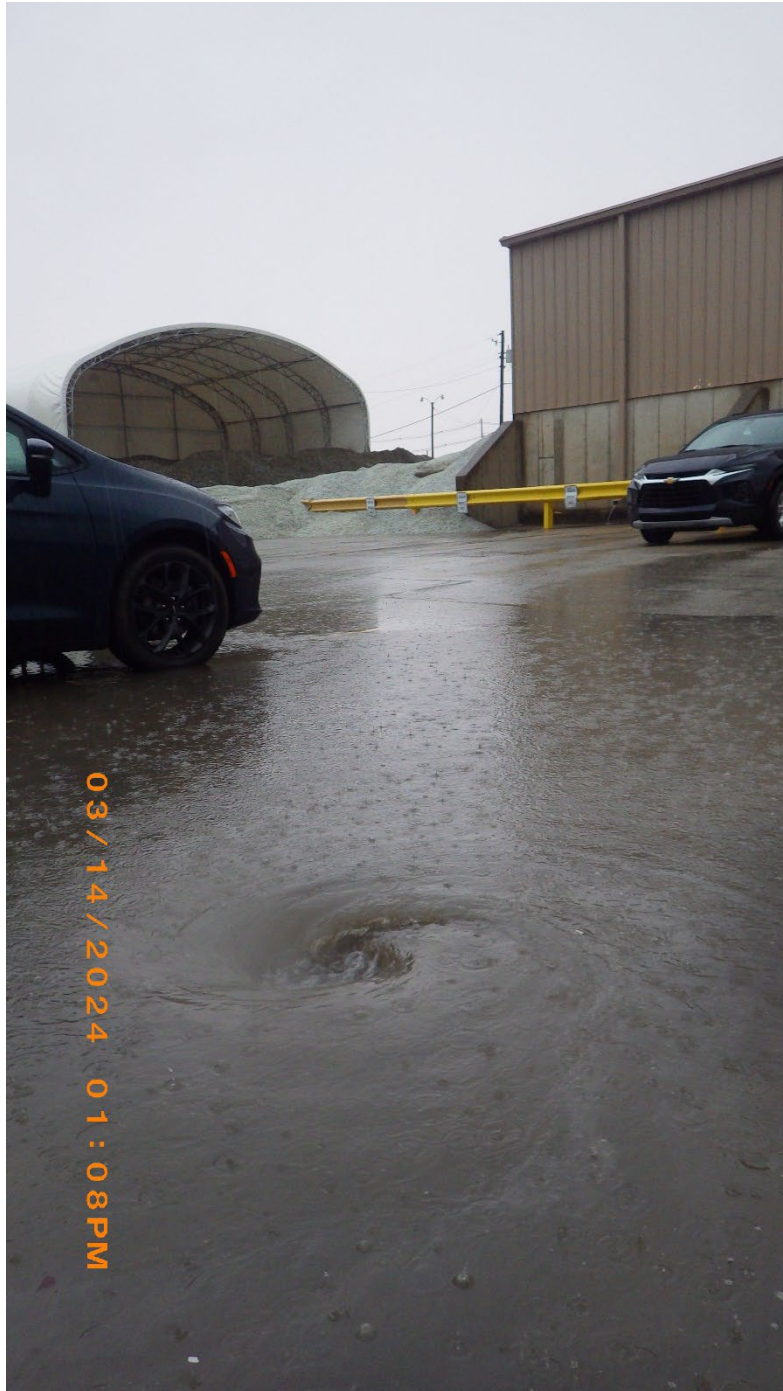
34: ARDA0410

Description: A second drain in the visitors parking lot. This is a different drain than the one in Photo 33. This is the same area though and the same area as photo 3.

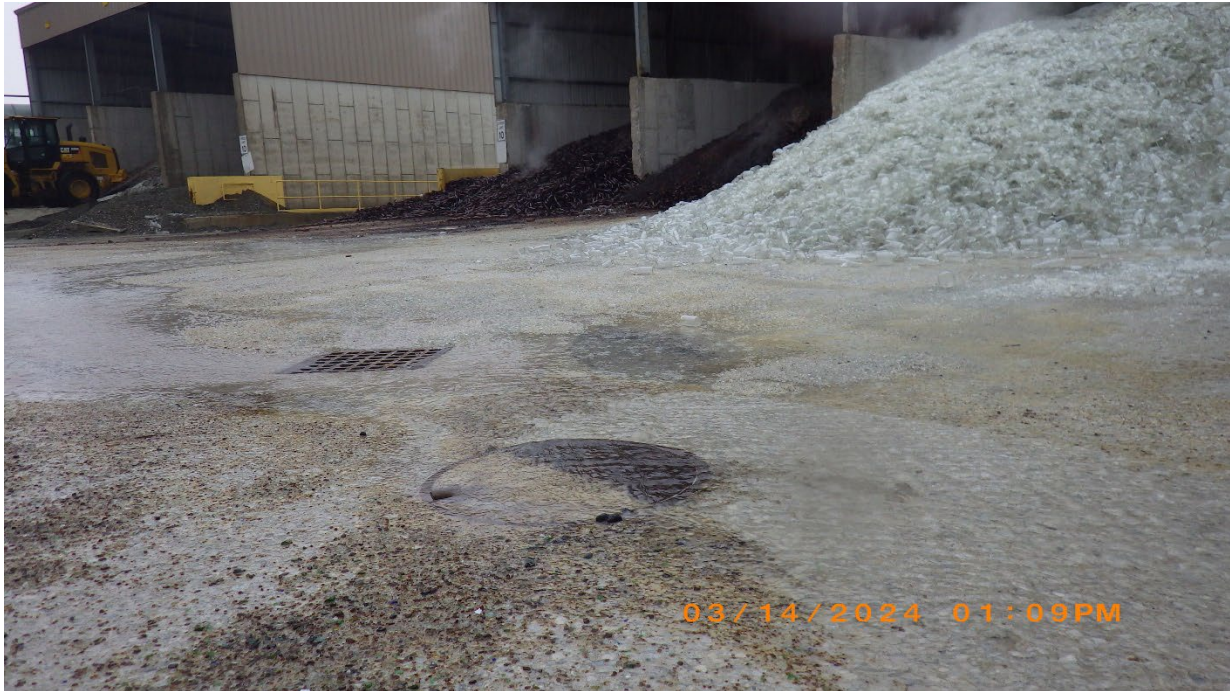
35: ARDA0411

Description: Hot cullet cooling pile. This square drain discharges to the pretreatment system and the round manholes discharge to the stormwater drain as documented in Photos 1-2.
