## Clean Water Act Section 404: Site Visit/Case Development

| Site Name | Pinnacle Springs, LLC | | | | | | |

| Inspection Purpose | Initial site visit | | |

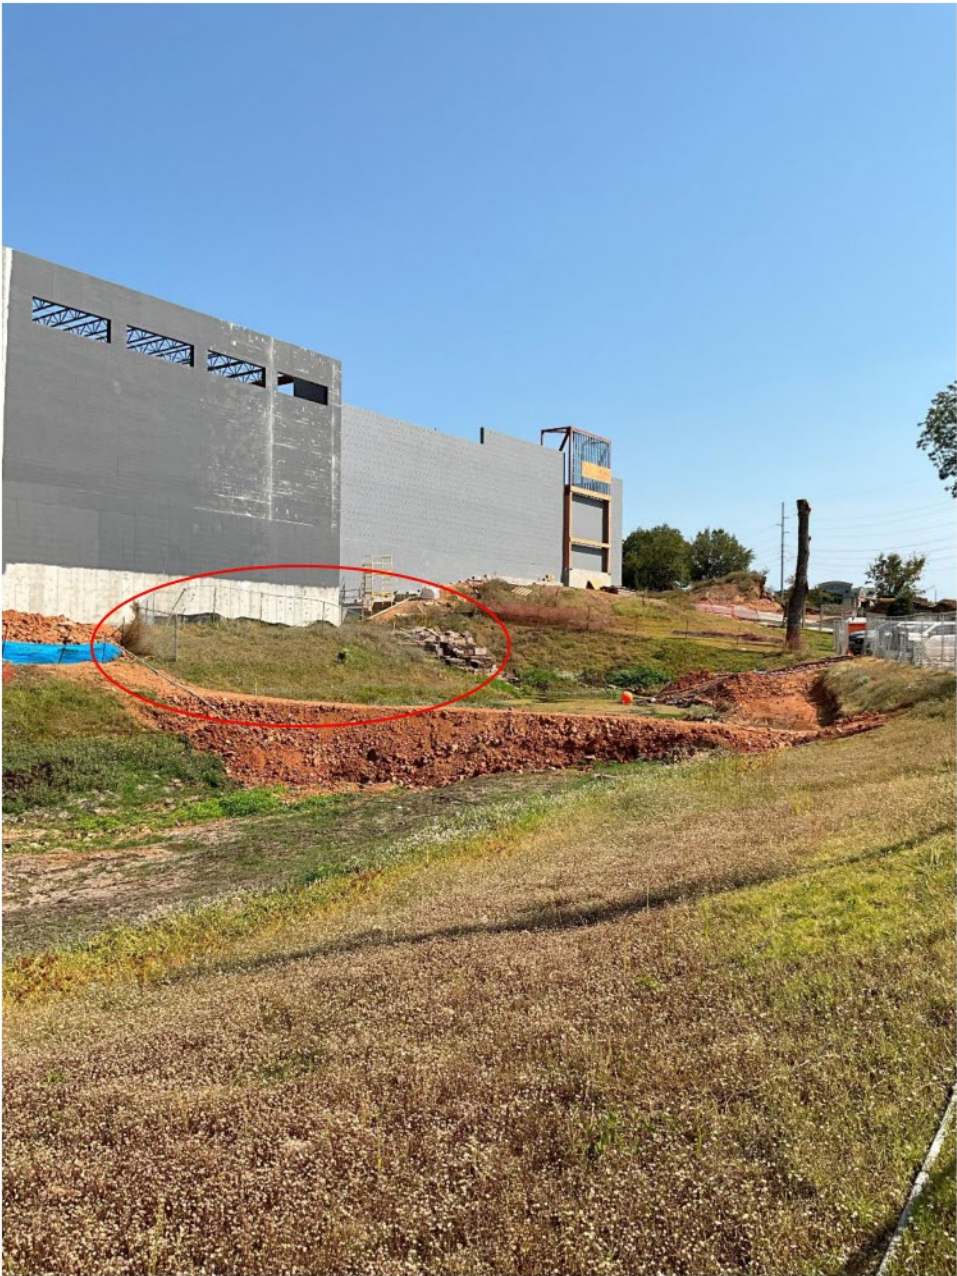
Photo No. 1

| Photo File Name | Date and Time of Photo | Photographer | Description |
|---|---|---|---|
| IMG_001.JPG | 10/09/2024, 1:04 PM | Chelsey Sherwood | Showing dam built across the Osage Spring impoundment and dewatering activities. Note: circled in red is the Osage cultural site. Picture taken facing east. |

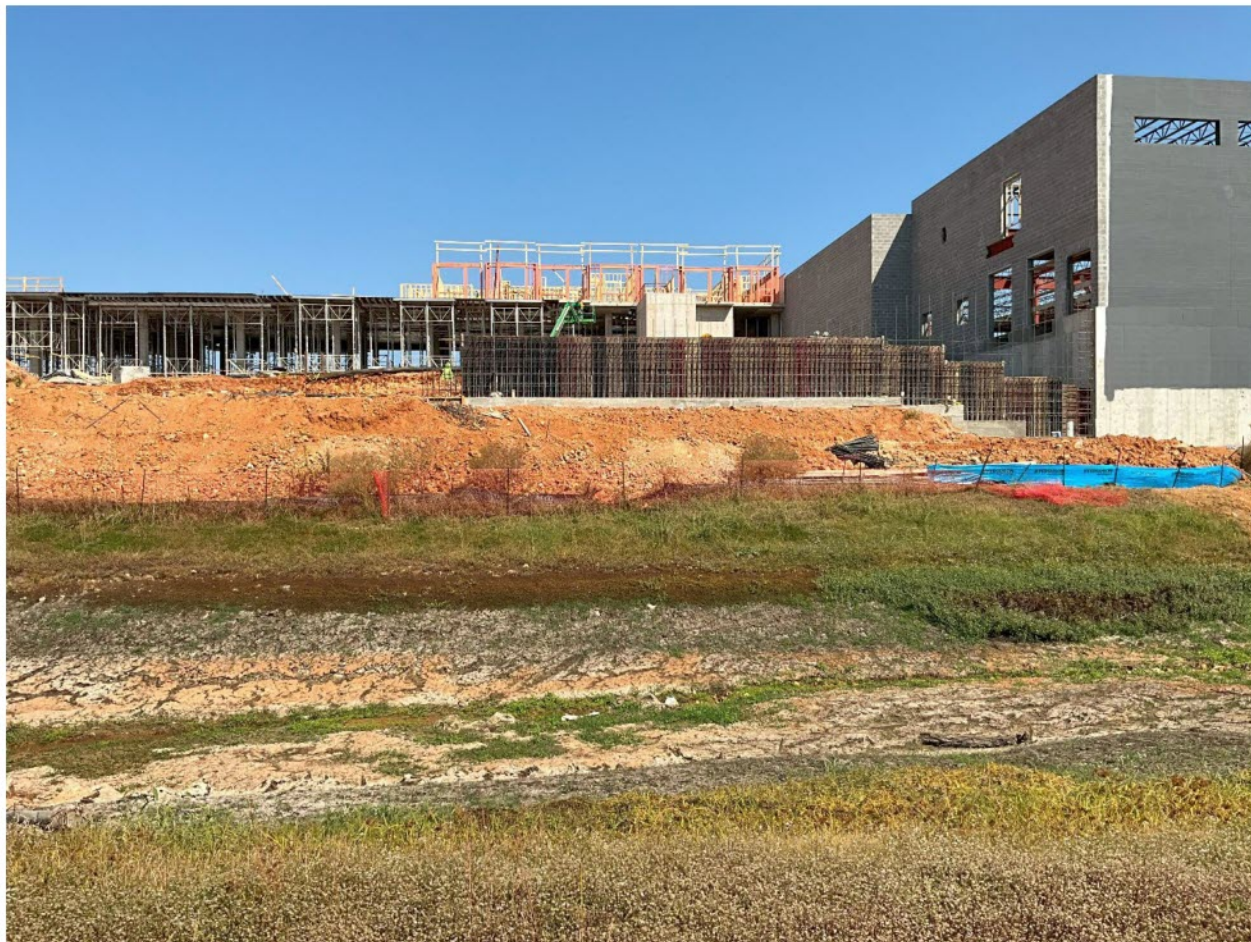
Photo No. 2

| Photo File Name | Date and Time of Photo | Photographer | Description |
|---|---|---|---|
| IMG_002.JPG | 10/09/2024, 1:05 PM | Chelsey Sherwood | Showing construction activities and the impoundment dewatered. Picture taken facing north. |

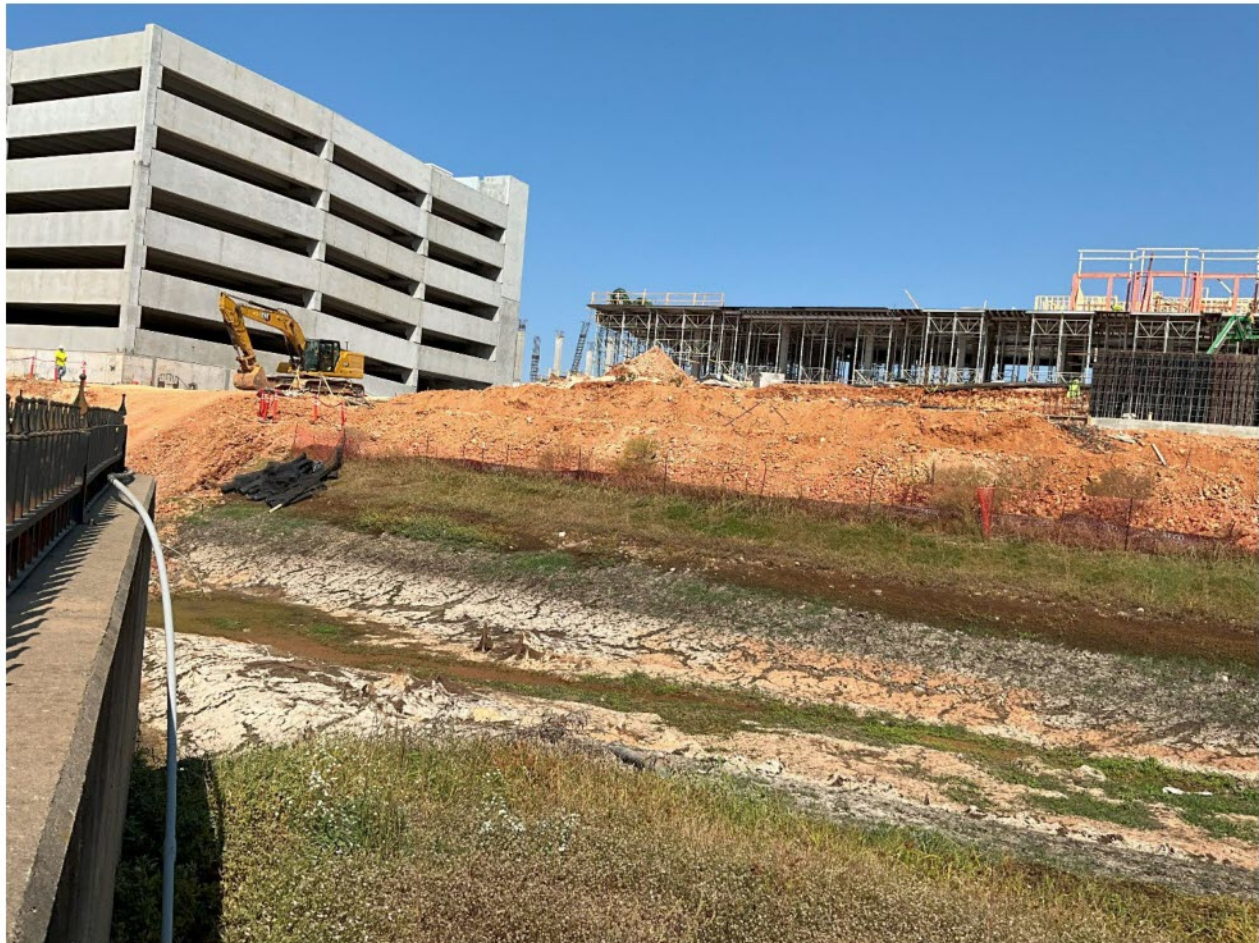
Photo No. 3

| Photo File Name | Date and Time of Photo | Photographer | Description |
|---|---|---|---|
| IMG_003.JPG | 10/09/2024, 1:05 PM | Chelsey Sherwood | Showing fill material and construction activities. Picture taken facing northwest. |

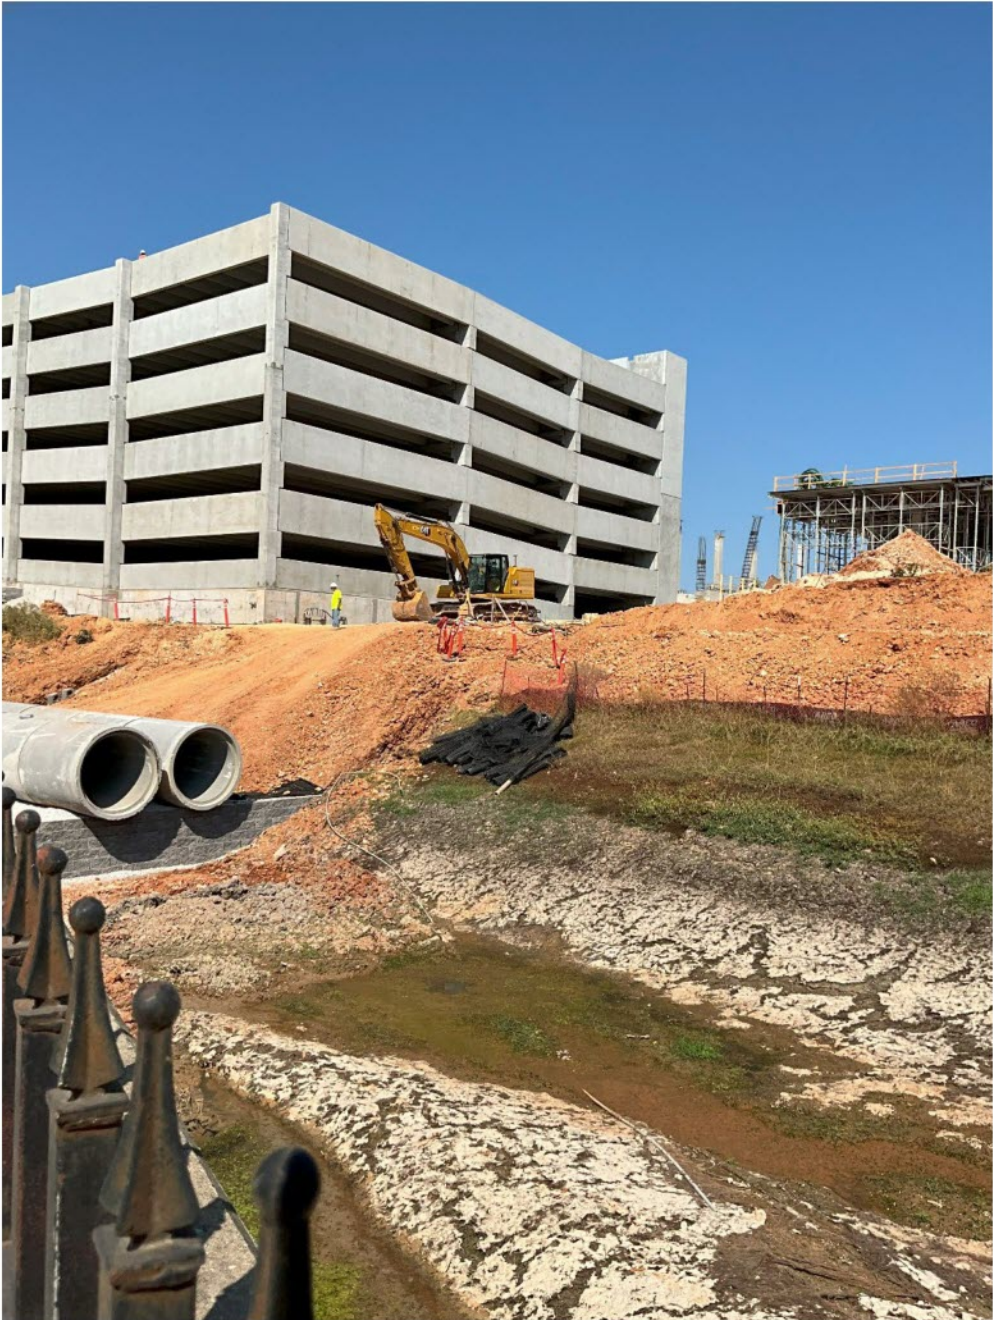
Photo No. 4

| Photo File Name | Date and Time of Photo | Photographer | Description |
|---|---|---|---|
| IMG_004.JPG | 10/09/2024, 1:09 PM | Chelsey Sherwood | Showing perched culverted crossing built across the impoundment. Picture taken facing northwest. |

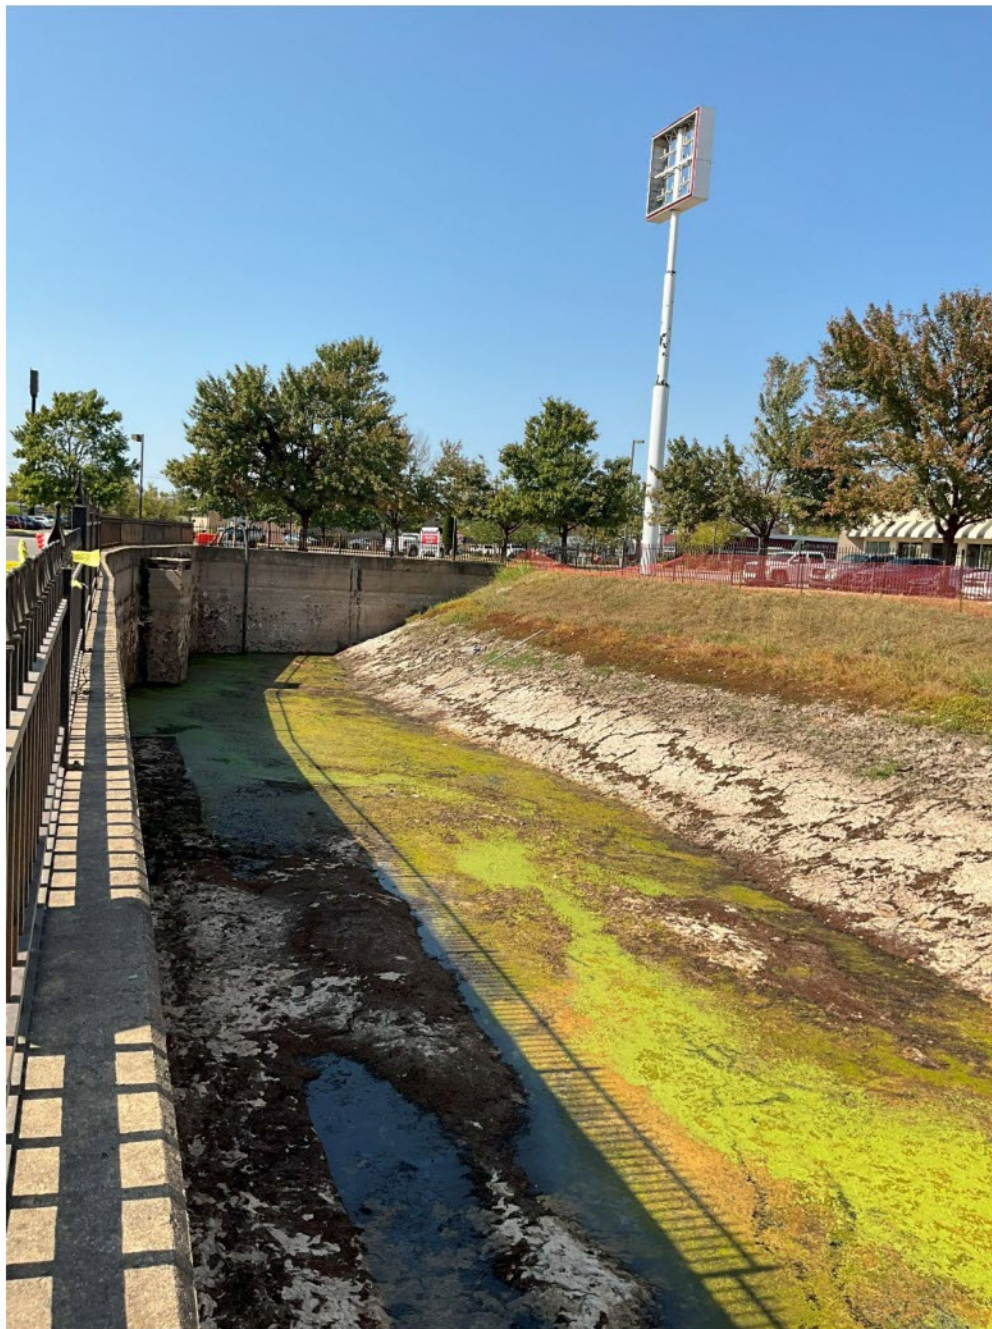
Photo No. 6

| Photo File Name | Date and Time of Photo | Photographer | Description |
|---|---|---|---|
| IMG_006.JPG | 10/09/2024, 1:15 PM | Chelsey Sherwood | Showing downstream of culverted crossing, where impoundment would flow into Osage Creek. Picture taken facing west. |

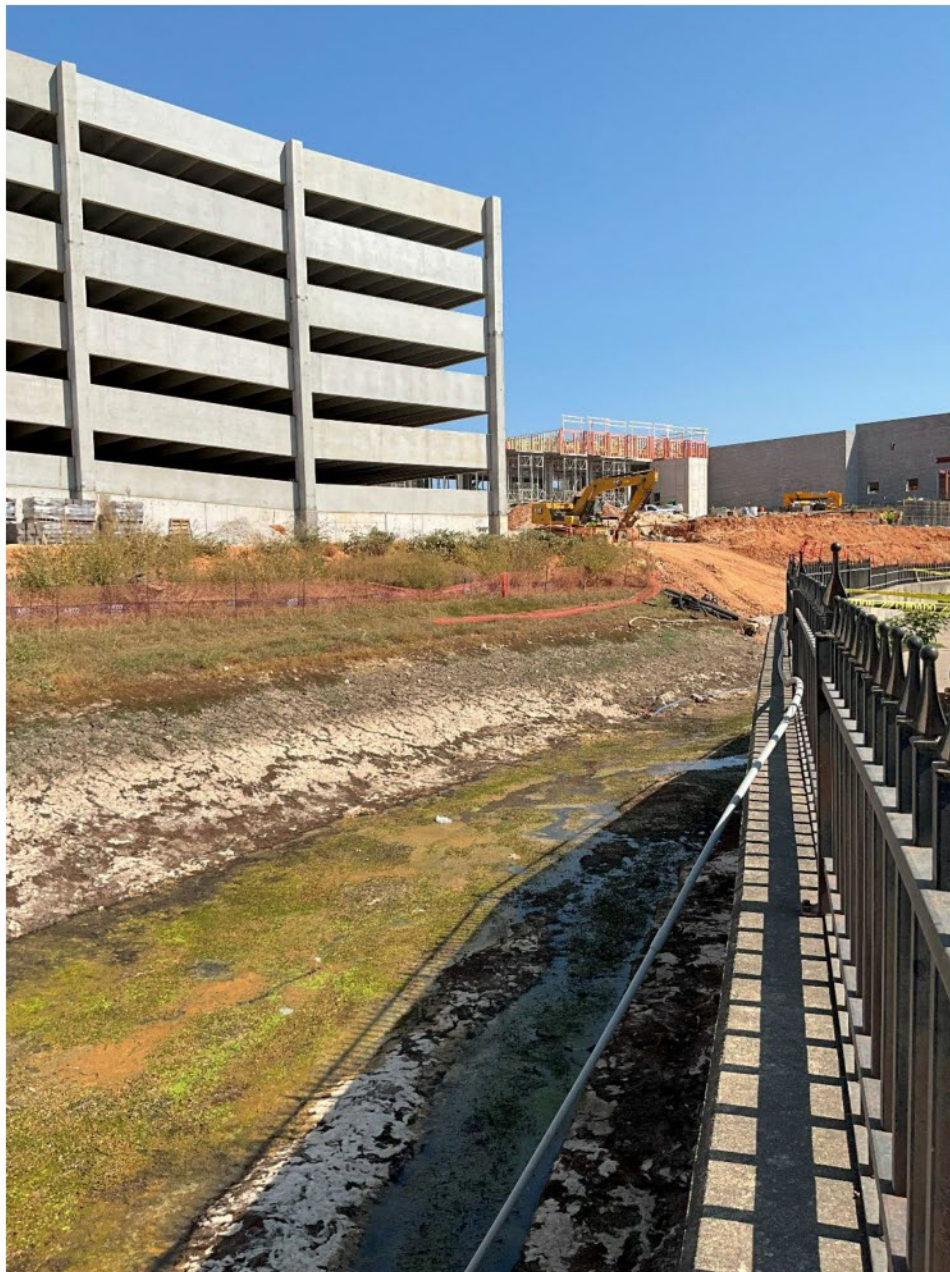
Photo No. 7

| Photo File Name | Date and Time of Photo | Photographer | Description |
|---|---|---|---|
| IMG_007.JPG | 10/09/2024, 1:15 PM | Chelsey Sherwood | Showing dewatered impoundment and construction activities on site. Picture taken facing east. |
